Building and Timber Pest Inspection Report

Inspection Date: Mon, 30 Mar 2026

Property Address: 58 Goss Dr, Collingwood Park QLD 4301,
Australia

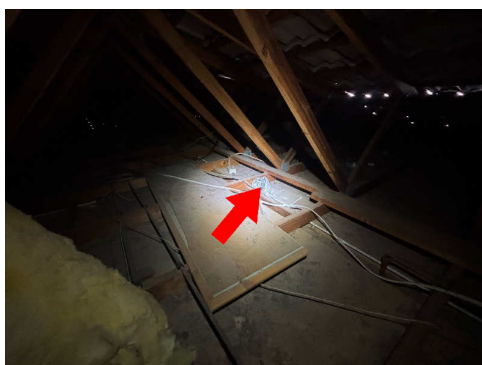
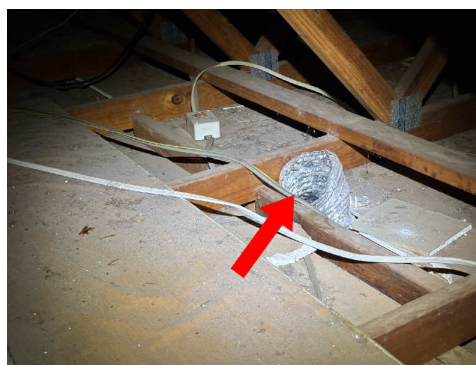
Finding 1.01

Information: At the time of the inspection, it was found that the range hood flue was found to lead directly into the roof space, rather than venting to the exterior of the building.

The positioning of this flue is likely to lead to a build-up of grease and grime in the surrounding area within the ceiling void, which can pose as a fire hazard in the roof void.

The presence of insulation surrounding the flue adds to this fire safety risk.

Without re-direction to the exterior of the building, the Rangehood is not considered fully operational and is deemed a minor safety hazard. It is therefore preferable that the flue be re-directed to vent into the external environment. A licensed plumber should be appointed as soon as possible to provide further consultation on the scope of these works and to provide quotations for any necessary works.

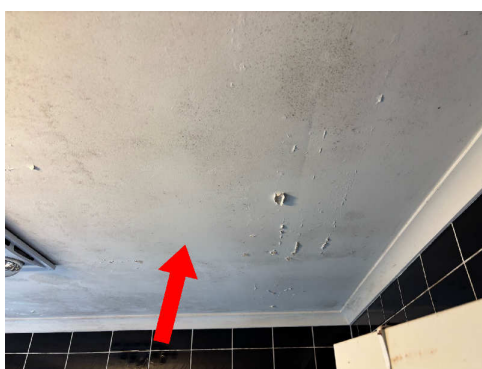
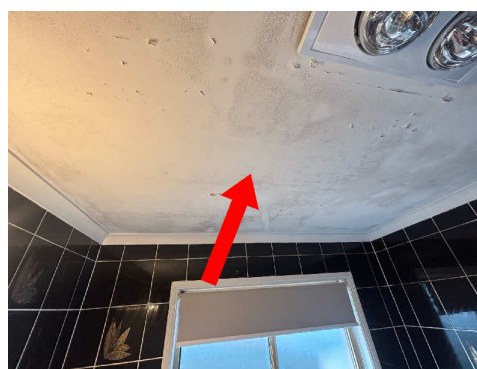
Finding 1.02

Information: At the time of the inspection, it was noted that there was mould growth to the bathroom ceiling.

Any mould found during the inspection should be cleaned immediately by a cleaning contractor or the homeowner as applicable.

Please note that severely affected building elements may require replacement by a registered builder or qualified carpenter.

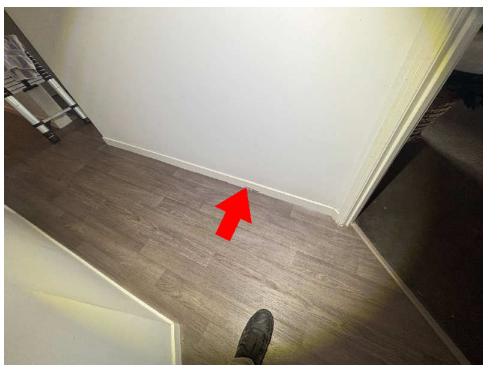
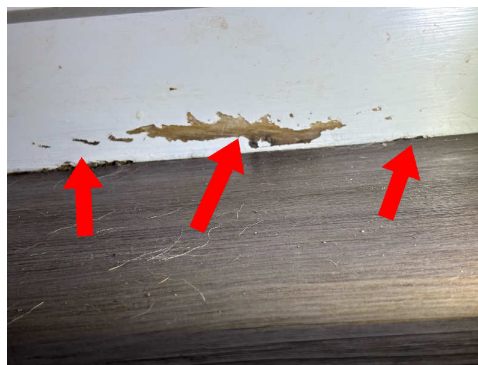
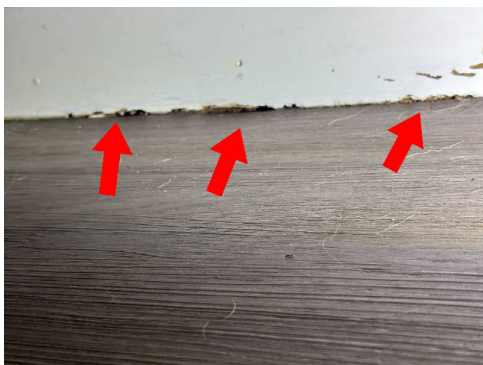
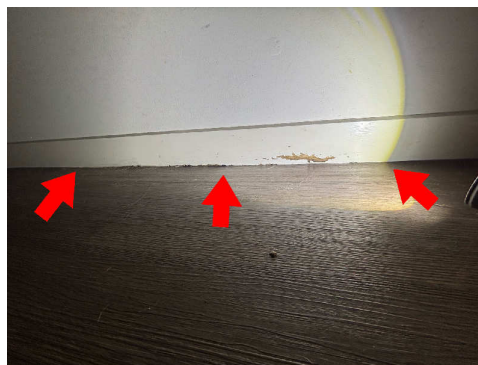
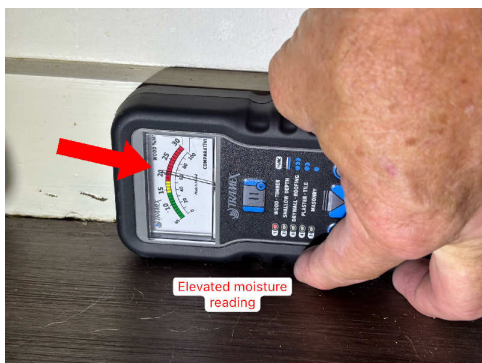
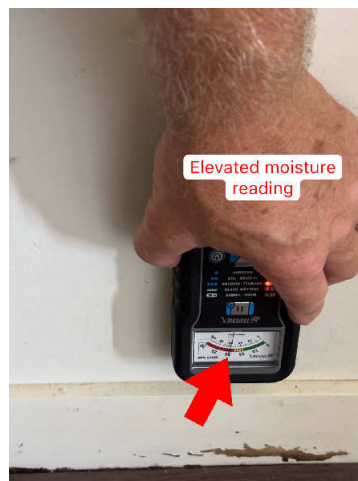
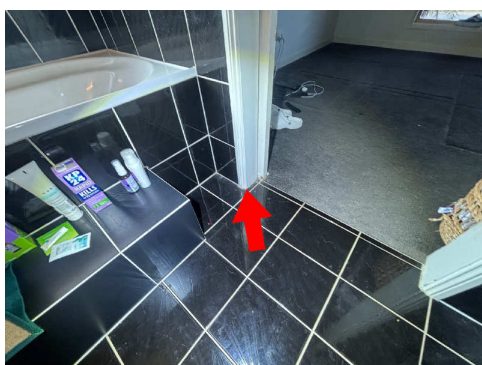
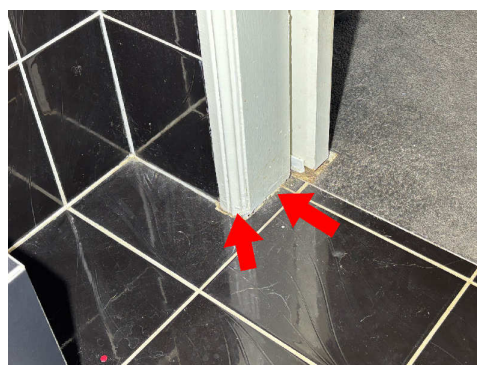
Finding 2.01

Finding: Bathroom - evidence of moisture damage

Information: At the time of the inspection, it was noted that there was evidence of moisture damage relating to the bathroom. Moisture damage was found in the hallway, the shower is on the other side of this wall. Elevated moisture readings were recorded on the timber skirting and the plasterboard wall lining. Moisture damage was found on the bottom of the timber door frame to the main bedroom.

The source of this moisture could not be detected however it is suspected that the shower is leaking.

Moisture in wall cavities creates a conducive environment for termite activity and can cause damage to the associated building materials.

An invasive inspection may be required to determine the source of the leak and if any damage has been done in the wall cavities around the shower.

A bathroom specialist should be engaged to assess the bathroom and determine if re-grouting and re-sealing the shower area would be a remedy for this issue. This should be done as a matter of urgency.

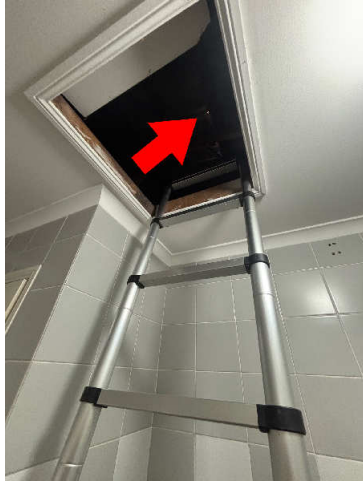
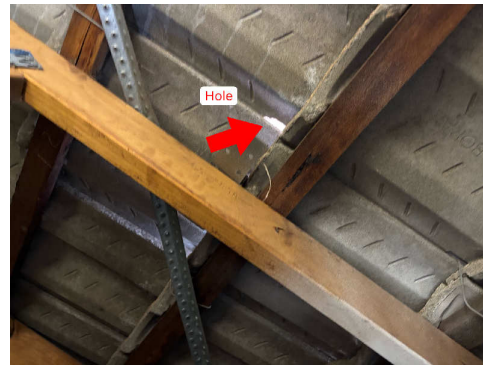
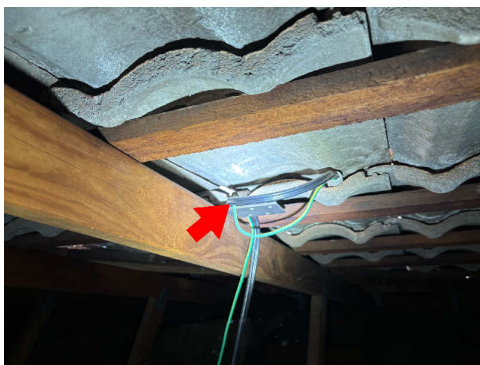
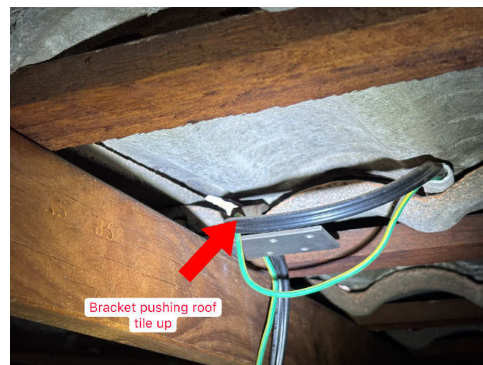
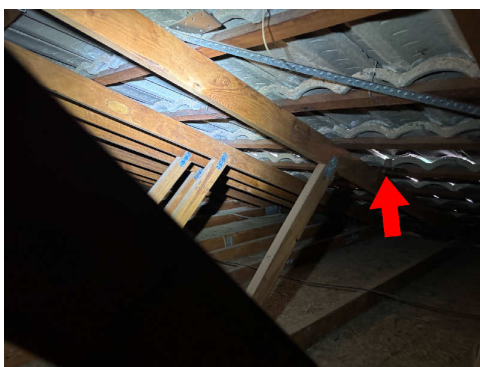
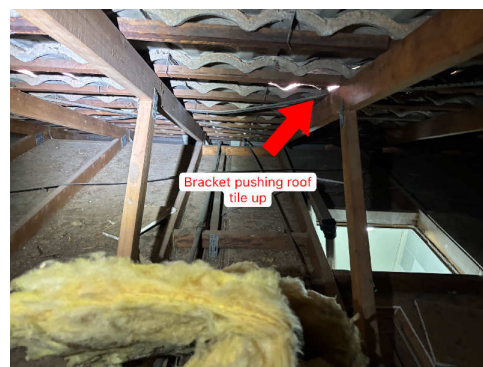
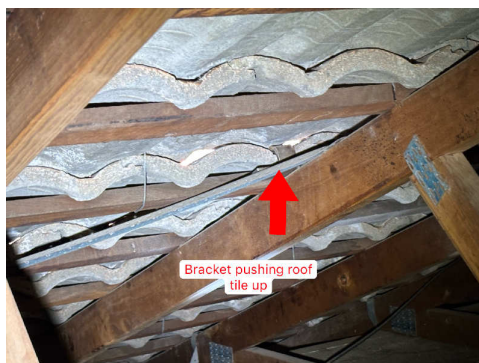
Finding 3.01

Finding: Roof tiles - moisture ingress points

Information: At the time of the inspection, it was noted that there was a hole in a roof tile above the laundry area. It was also found that the brackets for the solar panels have not been installed properly and as a result are pushing up the roof tiles directly above the brackets.

Both of these issues are creating potential ingress points for moisture into the roof space.

If left unaddressed, moisture can enter the roof void and cause undetected damage making this a major defect.

A roofing contractor should be engaged to repair these issues and perform a thorough assessment of the tiled roof covering. This should be done as a short term priority.

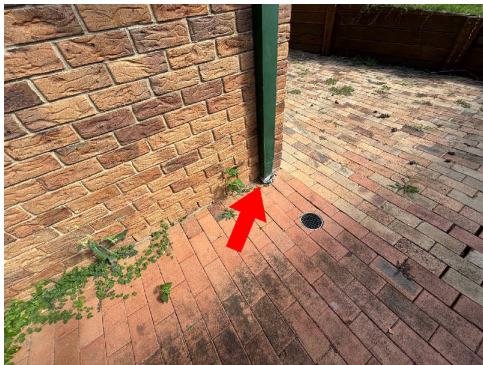
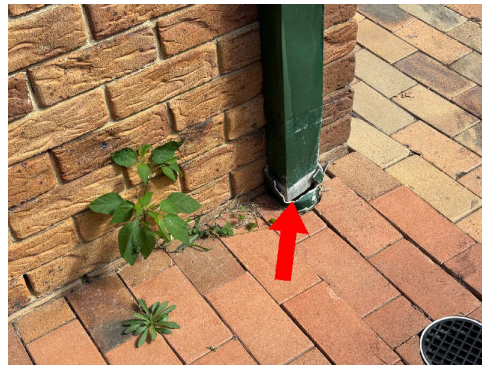
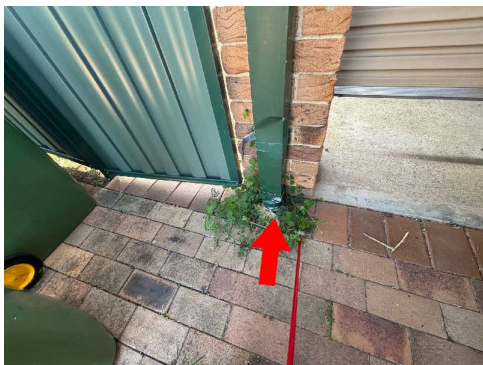
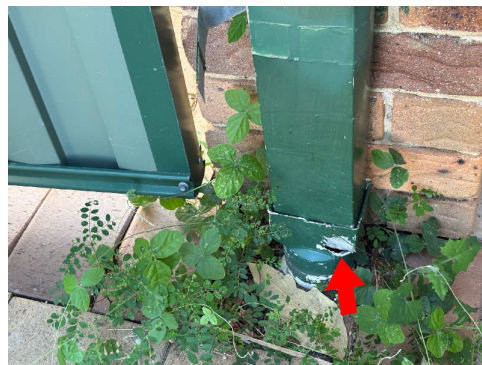
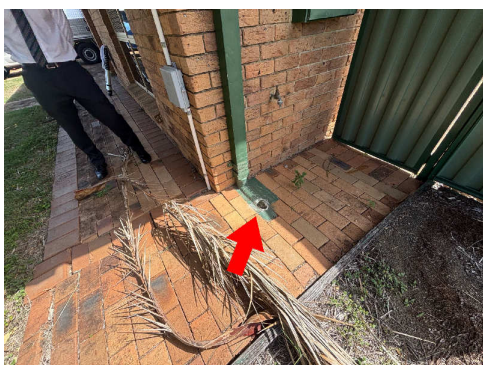
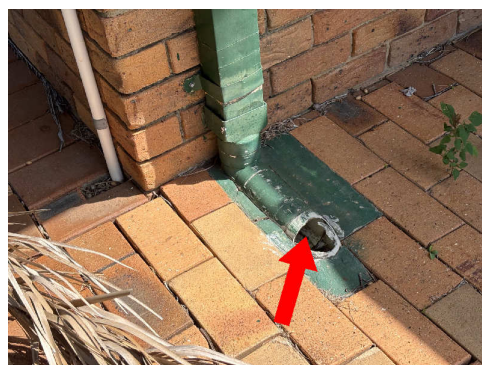
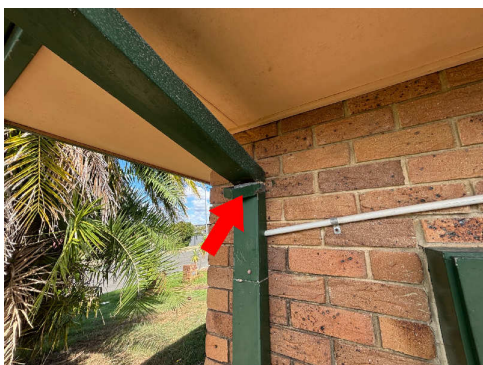
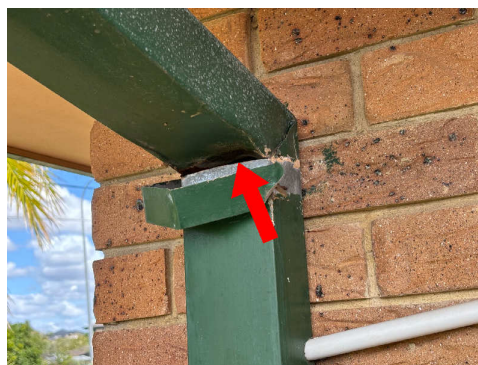
Finding 3.02

Finding: Down pipes - damaged

Information: At the time of the inspection, it was noted that the bottom sections of the down pipes at the front and rear of the dwelling are damaged. The top section of the down pipe at the front right hand side of the dwelling is also damaged.

This damage affects the functionality of the down pipe and allows water to escape near the foundation.

Excessive moisture next to the foundations of a building creates a conducive condition for termite activity. Excessive moisture may also cause deterioration of the associated building materials.

A licensed plumber should be engaged to carry out this repair. This should be done as a short term priority.

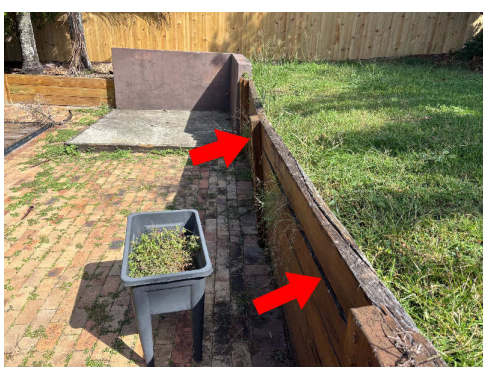
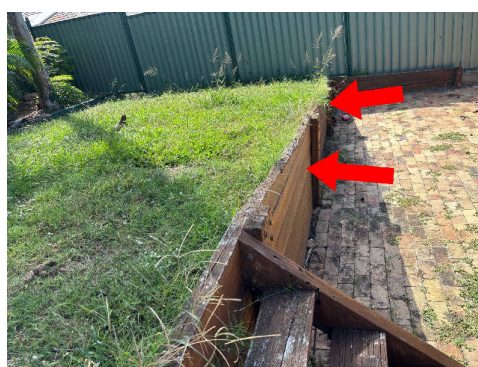
Finding 3.03

Finding: Timber retaining wall - deteriorating

Information: At the time of the inspection, it was noted that the timber retaining wall and the associated steps in the back yard are deteriorating. The retaining wall is leaning towards the house and has wood rot and termite damage to it.

Retaining walls are meant to lean towards the dirt that is being retained.

A retaining wall specialist should be engaged to replace the timber retaining wall. This can be done at the clients discretion.

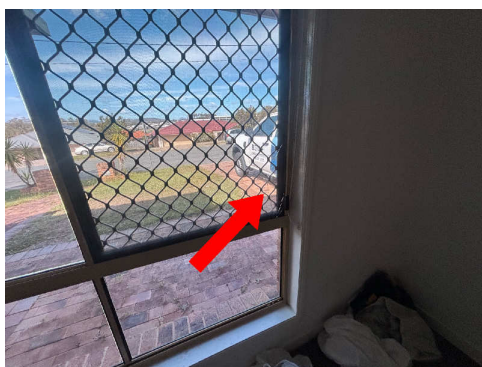
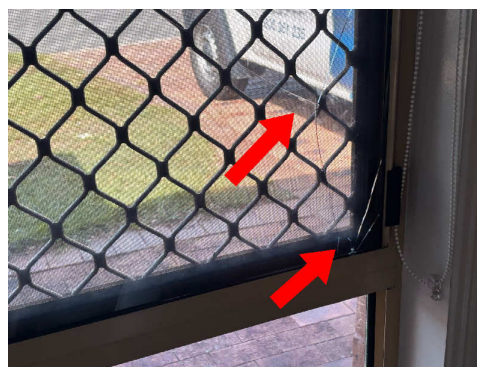
Finding 3.04

Finding: Lounge - window cracked
 Information: At the time of the inspection, it was noted that there was a cracked glass pane to the sliding window in the lounge.

A glazier should be engaged to replaced the affected glass pane. This should be done as a short term priority.

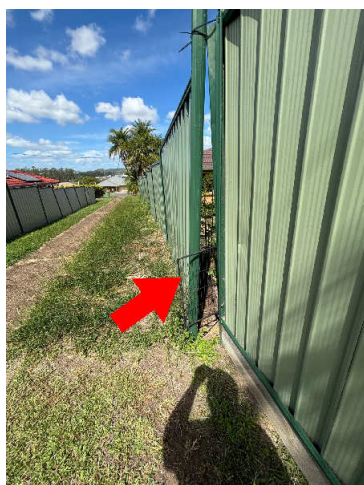
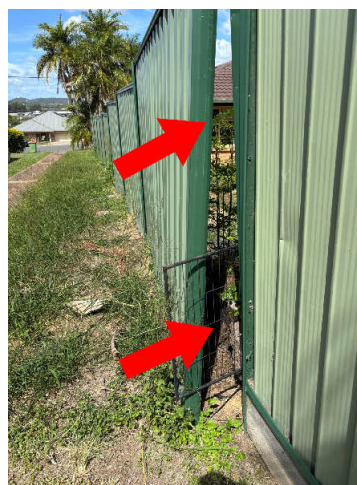
Finding 3.05

Finding: Boundary fence - panel loose

Information: At the time of the inspection, it was noted that there was a loose fence panel on the metal fence towards the rear of the yard.

A fencing contractor should be engaged to re-secure the fence panel. This can be done at the clients discretion.

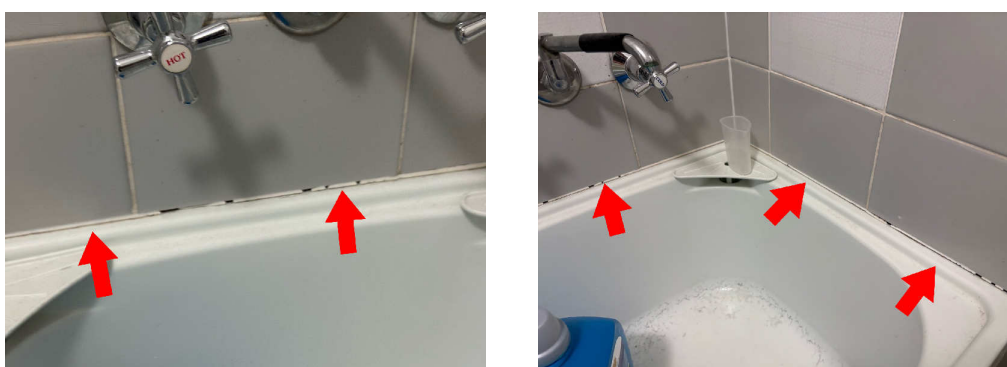
Finding 3.06

Building: Main Building
Location: Laundry
Finding: Laundry - sealant deteriorating
Information: At the time of the inspection, it was noted that the sealant around the laundry tub is deteriorating.

This can allow moisture to get behind the laundry tub.

A building maintenance professional should be engaged to replace the laundry tub sealant.

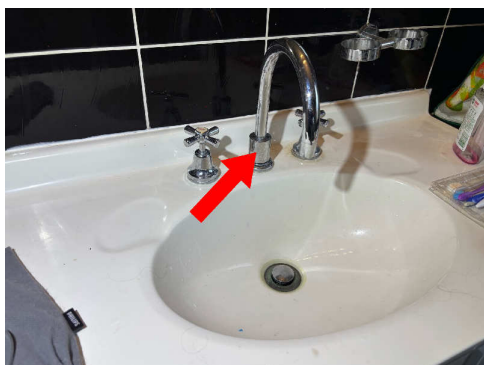
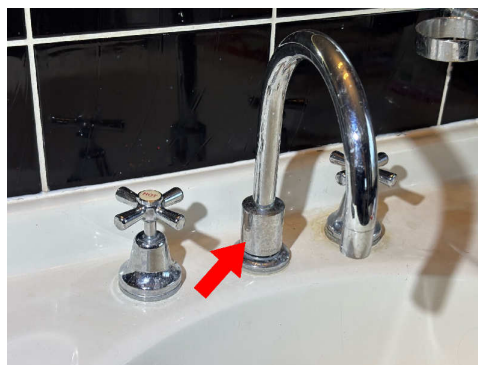
Finding 3.07

Building: Main Building
Location: Bathroom
Finding: Basin spout - loose
Information: At the time of the inspection, it was noted that the spout for the basin in the bathroom was loose at the base. This may be due to general wear and tear.

If left unaddressed, the spout deteriorate and leak into the vanity cabinet.

A licensed plumber should be engaged to replace the spout. This should be done as a short term priority.

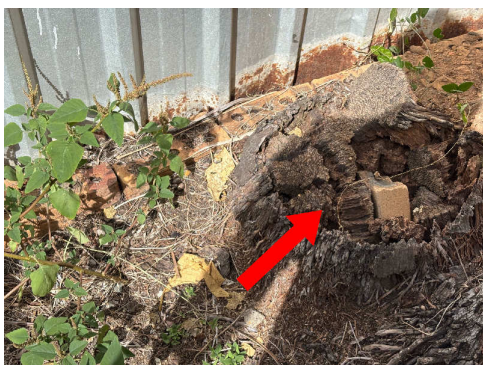
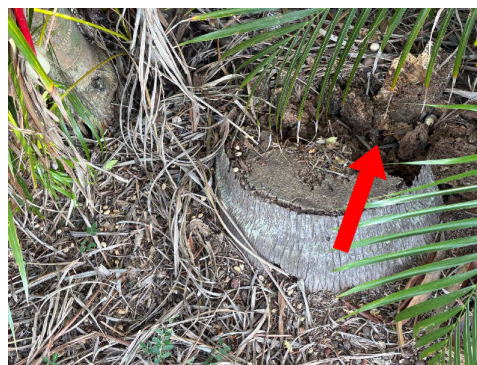
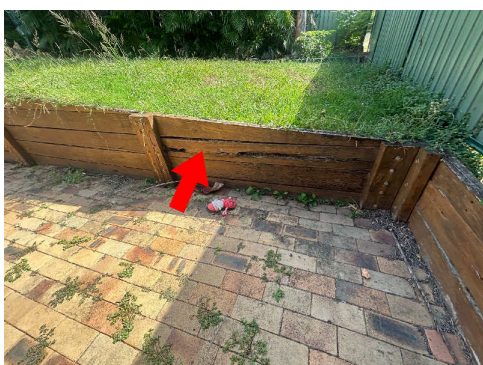
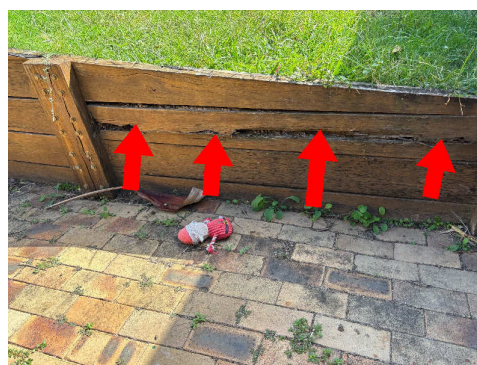
Finding: Evidence of termite damage

Information: At the time of the inspection, it was noted that there was evidence of termite damage to tree stumps and a section of the timber retaining wall.

It is advised that the area be visually inspected frequently to ensure that the condition of affected building materials does not worsen.

A building contractor may be appointed to provide a further invasive inspection if further damage is evident.

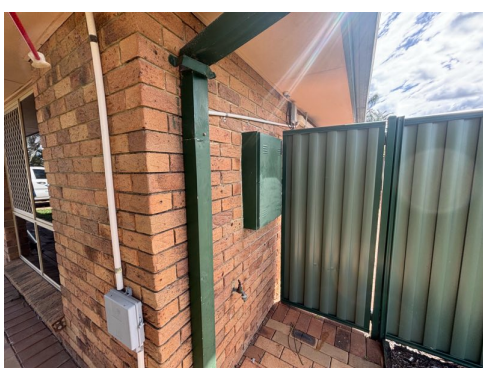
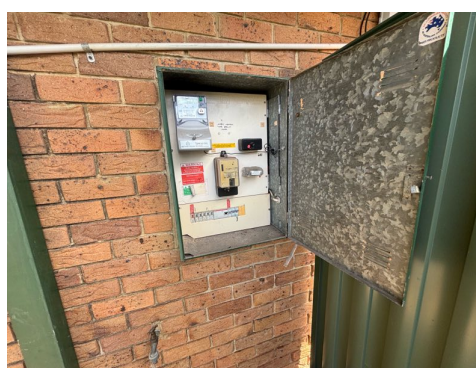
Finding 6.01

Building:	Main Building
Location:	All External Areas
Finding:	Termite Management System - no evidence of a chemical installation
Information:	At the time of the inspection, no evidence of a chemical termite management system was found. There is no durable notice in the meter box.
	The application of a post-construction chemical termite barrier is highly recommended for all properties, particularly if live termite activity has been found on the site previously.

At the time of inspection, it appeared as though no termite management system has been installed, with no evidence to suggest preventative works taking place.

The client may consider gaining further advice from a pest controller as to the costs and procedures involved with this application. It is recommended that obtaining such advice be a short-term priority.

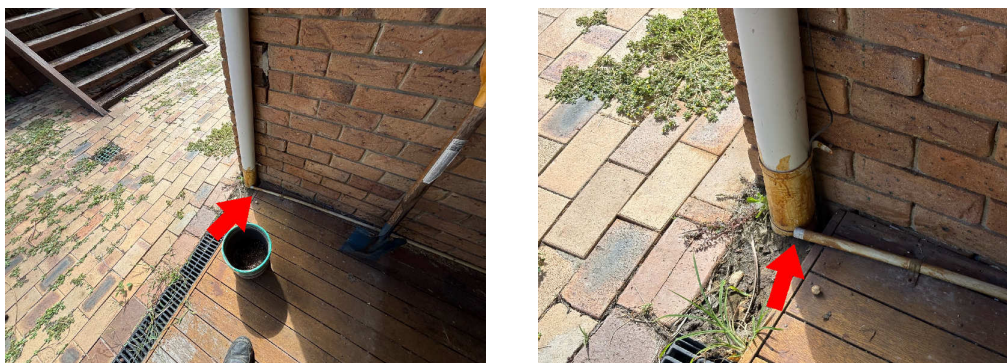
Finding 6.02

Finding: Air conditioner - Disconnected overflow

Information: At the time of the inspection, it was noted that the air conditioner drain overflow to the unit in the patio area was not connected to the storm water drainage and as a result are draining next to the foundations of the dwelling.

Air conditioning overflows that are not connected to the storm water drainage and are draining near the foundation can create excessive moisture in the surrounding area.

Such leaking creates an environment which is conducive to an array of defects, including water damage to associated building elements and the attraction of termite or timber pest infestation.

It is highly recommended that a licensed plumber be appointed to connect the A/C overflow in order to prevent such an environment from being created. These minor works should be carried out as soon as possible.

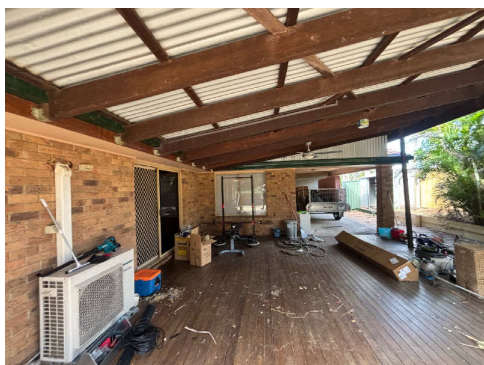
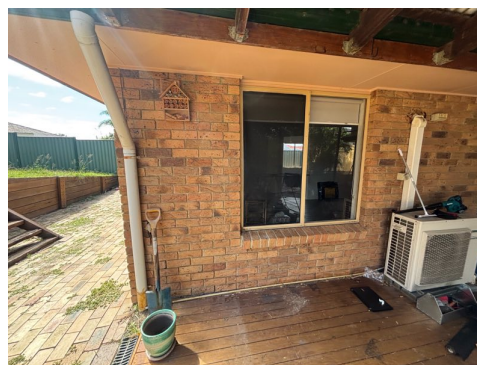
Finding 6.03

Information: At the time of the inspection, it was noted that there was a low timber deck in the patio area. It is highly likely that timber elements of this deck are touching the ground.

Where timber elements are in direct contact with the ground and consequently moisture or dampness they become conducive to termite activity.

When met with excessive moisture timber begins to decay and develop wood rot.

The removal of any such materials that may be conducive to termite activity should be removed as soon as possible to minimise the risk of termite attack.

Where timber materials cannot be removed, annual termite inspections must pay particular attention to these areas.

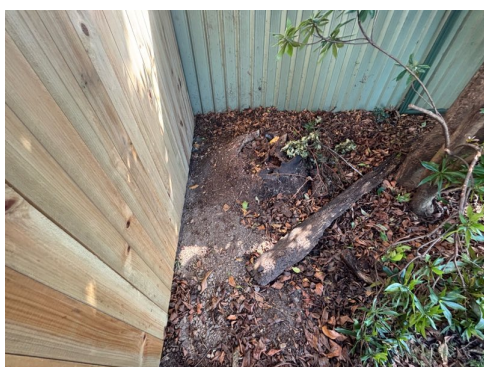
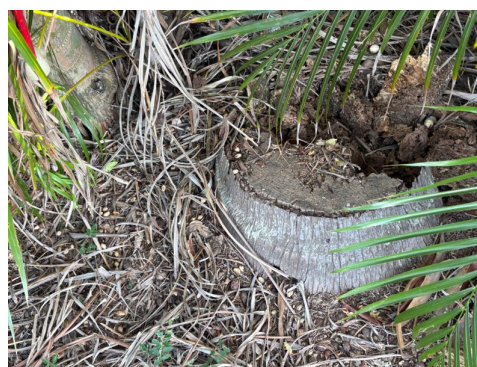
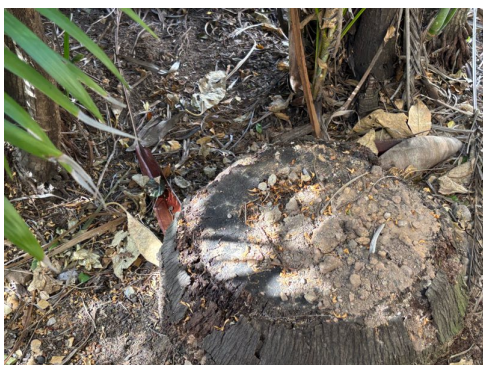
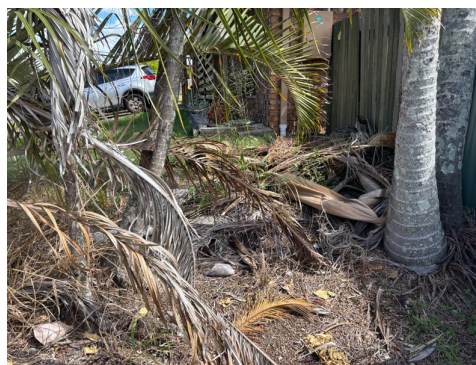
Finding 6.04

Information: The storing of garden debris in the external areas increases the risk of termite activity being present. As they are likely to come into contact with weather conditions or excessive moisture wood rot is likely to develop on timbers that are not treated.

It is highly recommended that any stored debris be immediately removed from areas in which they may attract any termite / timber pest attack. Minimisation of risk / prevention of termite attack is far more adequate than dealing with the presence of termite activity.

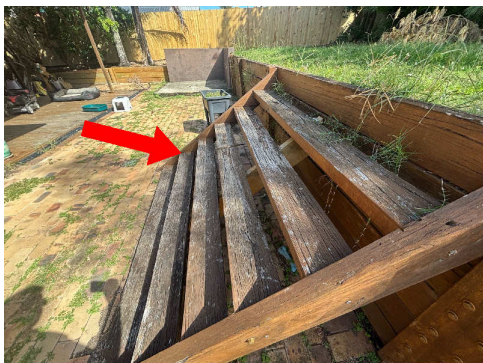
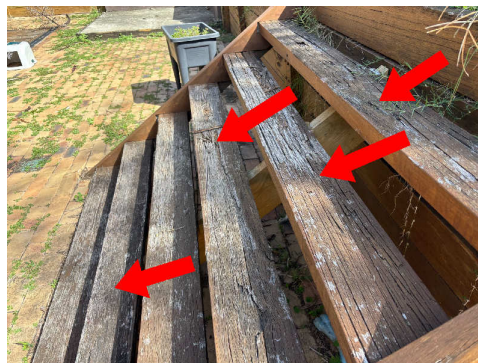
Finding 7.01

Finding: Wood rot

Information: At the time of the inspection, it was noted that there was evidence of wood rot to several of the treads to the timber steps in the backyard. This may be due to the age of the timber building elements and general weathering. The affected step treads should be replaced to avoid this from becoming a safety hazard.

This building element shows evidence of wood rot. Wood rot, also known as Fungal Decay, occurs when timbers and other cellulose building materials are exposed to damp conditions on an ongoing basis.

Early intervention and regular maintenance, particularly of exterior timbers, will prolong the useful life of these building elements. Prior to any works being performed, the cause of the moisture that has created the visible wood rot should be identified and addressed in a suitable manner. Replacement of affected timbers may then be a necessary step in protecting surrounding building elements from such deterioration.

A qualified carpenter or registered builder may also be required to replace affected building materials.

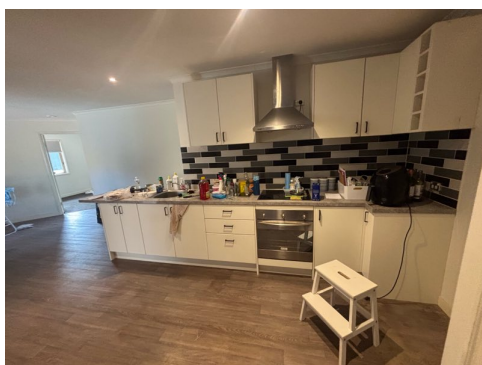
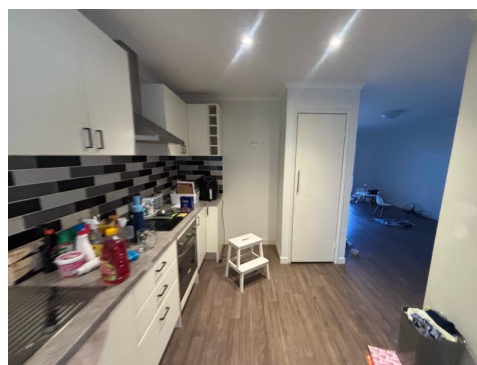
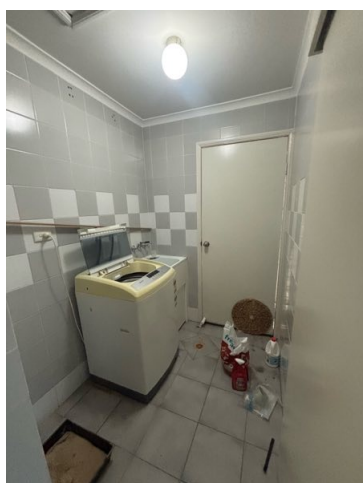
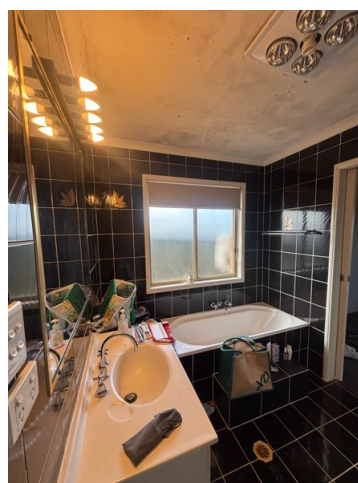
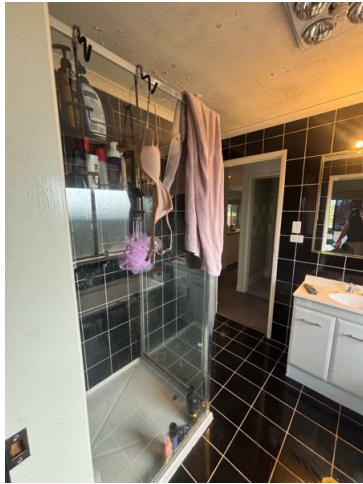
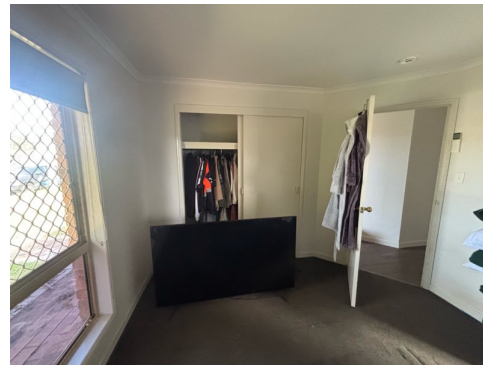
Finding: Obstructions and Limitations - Internal areas

Information: These photographs are an indication of the obstructions and limitations which impeded full inspection of the property of the internal areas at the time of inspection. These obstructions can hide an array of defects and should be removed to allow full inspection to be carried out. A re-inspection is recommended once the areas are made accessible.

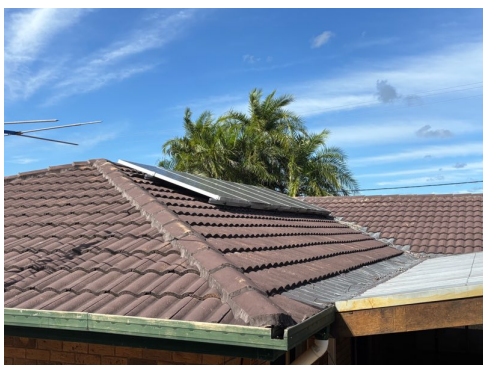
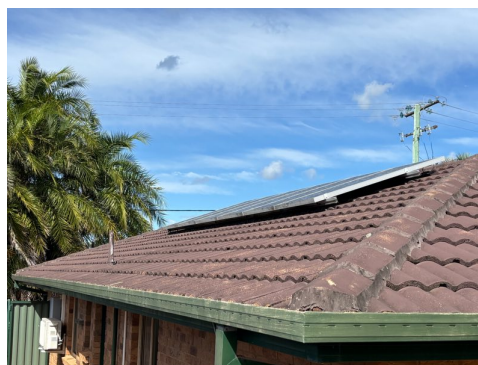
Finding: Obstructions and Limitations - Roof exterior

Information: These photographs are an indication of the obstructions and limitations which impeded full inspection of the property of the roof exterior at the time of inspection. These obstructions can hide an array of defects and should be removed to allow full inspection to be carried out. A re-inspection is recommended once the areas are made accessible.
