# Building and Timber Pest Inspection Report

Inspection Date: Wed, 18 Feb 2026

Property Address: 2 Sturt Cl, Grange SA 5022, Australia

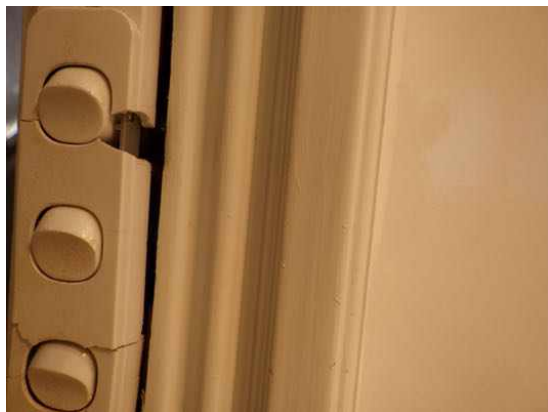
Building:	Building 1
Location:	Main bathroom and lower toilet
Finding:	Light switch - Damaged
Information:	A light switch in the lower vanity was found to be damaged at the time of inspection. Damage occurs generally when the building materials have aged and decayed, but may also be indicative of impact damage to the building element (accidental or deliberate).

Left unmanaged, the fitting is unlikely to cause further damage to surrounding building elements. However, the broken fitting may expose electrical works, and may create a minor safety hazard if there is potential contact with persons in the area.

Repair and/or replacement of the damaged fittings is advised. A Licensed electrician should be appointed immediately to repair/replace the switch mechanism.

Repair electrical switches

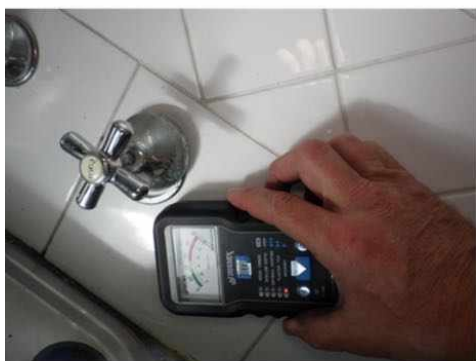
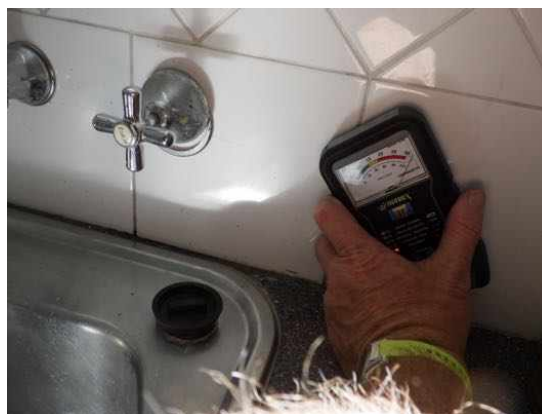
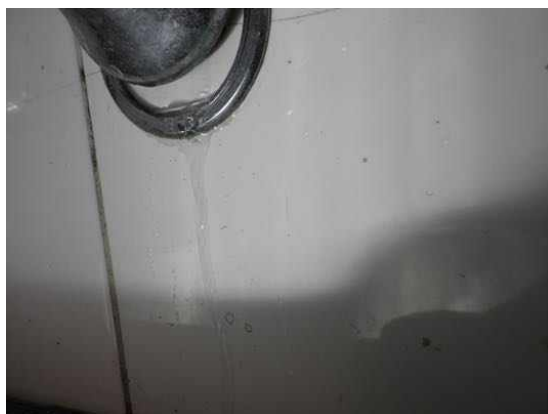
### Finding 2.01

Building:	Building 1
Location:	Laundry
Finding:	Tap - Leaking
Information:	The tap to the laundry was found to be leaking at the time of inspection. There is high moisture evident in the wall surrounding the leak.

This is a common defect that is consistent with general ageing of the building element. However, it may be indicative of substandard plumbing workmanship if the tap is relatively new.

While this defect only seems minor, if left unmanaged, it is likely to result in the development of rust, water damage and/or extensive water usage.

It is advised that a licensed plumber be appointed immediately to perform remedial works on the affected tap.

Such works should be performed prior to the development of secondary defects to ensure adequate functionality of all associated building elements.

Repair leaking tap to laundry

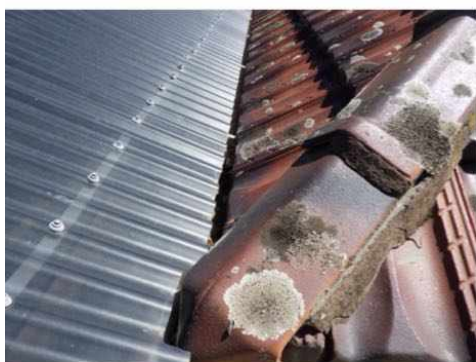
### Finding 3.01

Blocked gutters are likely to lead to high levels of moisture in the affected areas. Such moisture will not only cause rust and decay of the associated building materials, but can also provide conditions that are conducive to termite and timber pest activity. Blockages in gutters should therefore be removed immediately to ensure dry conditions are maintained.

Consult a Licensed Plumber for further specific advice on remedial works that may be required. In the interim, it is highly advised that blocked gutters be removed by the homeowner or a general handyperson as a matter of urgency.

Removal of debris may expose currently concealed defects.

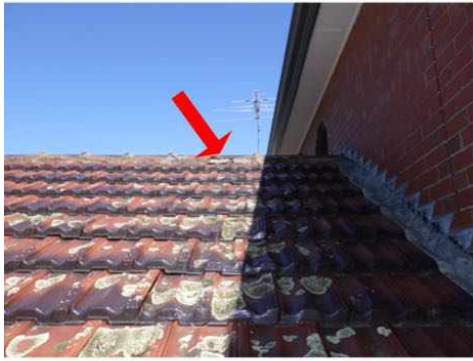
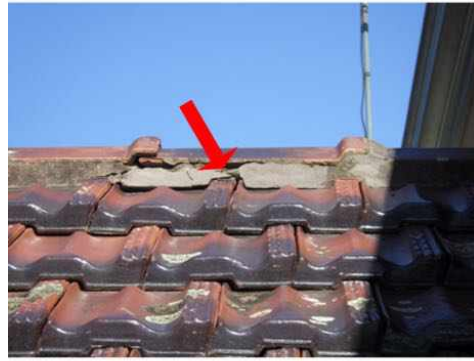
### Finding 3.02

Building:	Building 1
Location:	Roof Exterior
Finding:	Mortar - Deterioration
Information:	Mortar, or 'bedding', is the material which fills joints and intersections between tiles and other building elements on the exterior roof covering, such as gable ends, hip capping and valleys. Upon inspection of the exterior roof, it was noted that sections of the mortar show varying levels of deterioration. Most of the ridge capping appears to be in acceptable condition however two small areas appear to require maintenance.

Mortar generally deteriorates as a result of frequent exposure to weather conditions over a prolonged period of time. Mortar that is deteriorating may allow water ingress into the roof void, putting associated building elements and roofing structures at risk of water damage.

Deteriorated mortar also detracts from the functionality of roof tiles and other roofing elements, potentially decreasing weather tightness and roof drainage.

Mortar deterioration can be attended to by a handyperson where areas of deterioration are localised and easily accessible. Otherwise, consultation with a roofing contractor is advised where greater works are required.

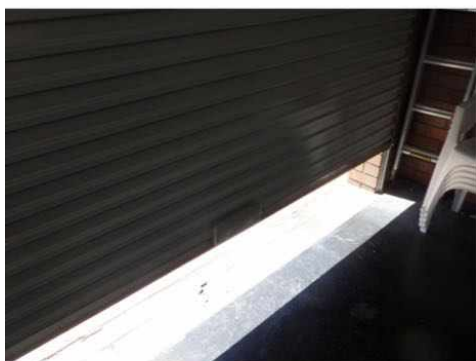
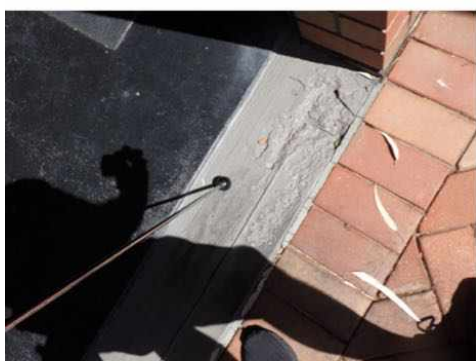
### Finding 3.03

Building:	Building 1
Location:	Garage
Finding:	Concrete damage (cancer)
Information:	There is what appears to be minor concrete damage evident to a small section of floor in the garage of the dwelling as per the following photos.

Concrete cancer is the common term used to describe a number of factors which cause concrete construction to deteriorate.

Generally, water penetration causes the concrete reinforcement to rust and expand, creating stresses on the surrounding concrete and in turn causing it to spall (or break

away). Alternatively, if the cement component is too alkaline, reactions with the general atmosphere occurs and chalking or cracks appear which allow rainwater to penetrate.

Concrete cancer may also originate from poor original water proofing or protection of the slab edge.

Repairs could be carried out by a structural repair company and a licensed Concretor at the discretion of the client.

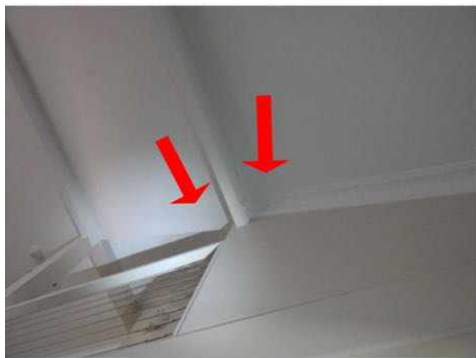
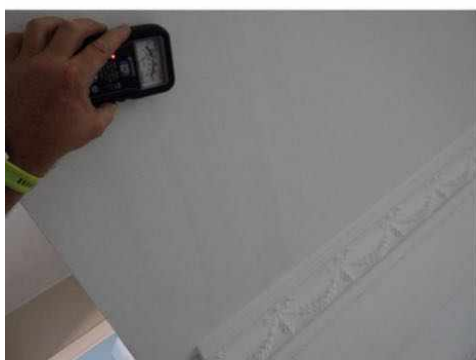
### Finding 3.04

Building:	Building 1
Location:	Living Room
Finding:	Ceiling - Water stained
Information:	Water staining to ceiling linings in the living room was evident at the time of inspection. Water staining indicates that surfaces have been exposed to excessive moisture over time. The minerals and other elements in the water lead to staining, which may graduate to corrosion and deterioration if left unmanaged.

While mostly an appearance defect, water staining can be indicative of more serious defects, which may be currently concealed by interior ceilings.

The owner indicated that a tile was broken in the area several years ago during the solar installation and was repaired immediately once recognised.

Where water staining is active, a licensed plumber must be consulted to identify the cause of the staining and to provide advice on any reparation works that may be

required. Replacement of any damaged structures is advised.

Conversely, where water staining is old and inactive, affected building materials may be repaired or replaced at client discretion.

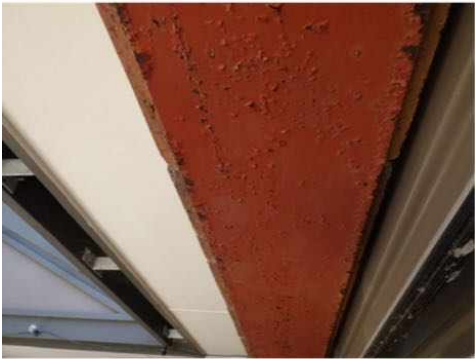
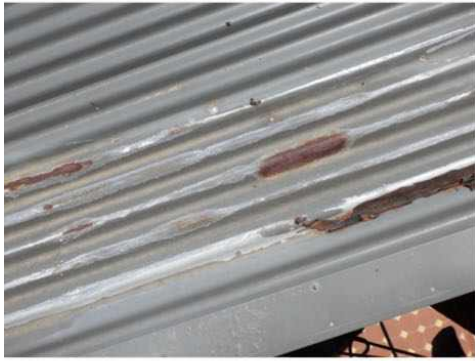
### Finding 3.05

Building:	Building 1
Location:	All Areas
Finding:	Building element - Rusted or corroded
Information:	Minor surface rust and corrosion appears to external elements including but not limited to exterior AC unit steel lentils to brickwork and a roof roofing sheet of the veranda, which is likely to have developed as a result of excessive exposure to moisture and the proximity to the ocean.

As surface rust provides no protection to the underlying iron, the deteriorating condition is likely to worsen if not addressed in the short-term future.

Where possible, the use of galvanized (treated) metals or aluminium coated metals aid in rust prevention, as does regular general maintenance. Rust formation can be controlled with coatings, such as paint, that isolate the iron from the environment.

Rusting and corrosion should be managed by ideally removing or limiting the affected surface from exposure to moisture, then treating the rust to slow the deterioration and could be carried out by appropriate licensed contractors.

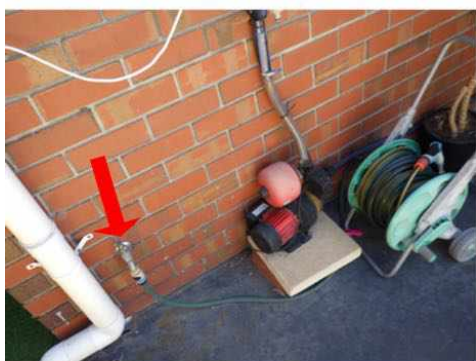
Finding 6.02

Building: Building 1  
 Location: All External Areas  
 Finding: Air conditioner and or external tap - No drainage  
 Information: Moisture around the perimeter of the building should be minimised to ensure that the area is kept dry and stable which in turn reduces the risk of water damage and termite infestation.

There appears to be no drainage points set up to the air conditioning unit, and or the external tap. While this is not a legal requirement it is recommended to reduce the risk of moisture related issues and the creation of an environment conducive to termite activity.

It is recommended that a licensed plumber be appointed to set up drainage in order to prevent such an environment from being created.

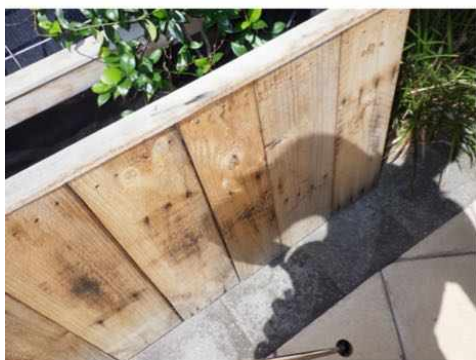
### Finding 6.03

Building: Building 1  
 Location: Yard - Back  
 Finding: Untreated or non-durable timbers in a hazardous environment  
 Information: To reduce the risk of timber pest attack it is essential that timber used in a hazardous environment (e.g. in direct contact with the ground or frequently exposed to damp conditions) is of sufficient durability and/or is adequately preservative treated.

Untreated timbers in direct contact with the ground are likely to develop severe wood rot and/or fungal decay if left unattended creating attraction for subterranean termites to infest the timbers from surrounding areas.

If untreated or non-durable timbers are found to be in a hazardous environment it is highly advised that replacement of these building elements be performed as soon as possible to aid the protection of the property against termite / timber pest attack.

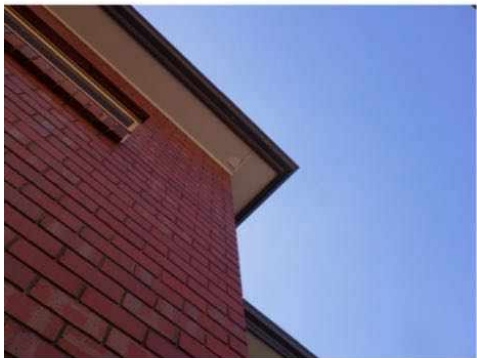
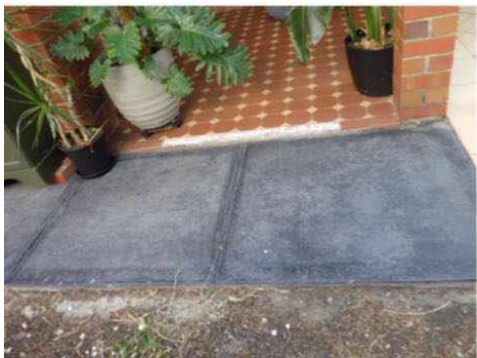
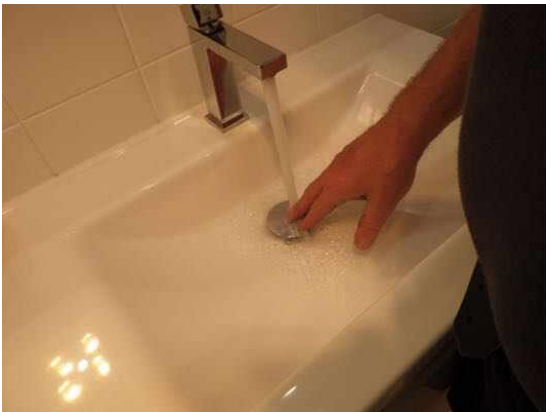
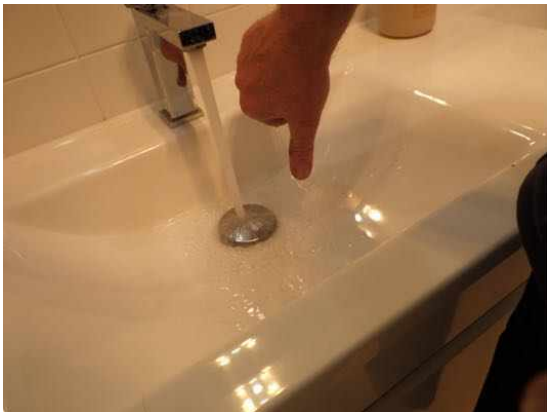
Building:	Building 1
Location:	All External Areas
Finding:	Minor defect
Information:	Minor defects were evident throughout the dwelling at the time of inspection, which are consistent with normal wear and tear and considered appropriate for a property of this age.

These defects are typical of ongoing material ageing, settlement, and general use over time, and include, but are not limited to:

- Minor cracking to internal wall and ceiling linings
- Minor deteriorated eaves paint
- Tiles missing to external porch tiling.
- Vanity drain plug jammed.

While these defects are not considered structurally significant at present, they should be addressed as part of routine and ongoing property maintenance to prevent further deterioration. Repairs and maintenance works should be carried out by appropriately licensed and qualified tradespeople to ensure the continued serviceability and longevity of the dwelling.
