Building and Timber Pest Inspection Report

Inspection Date: Tue, 13 Jan 2026

Property Address: 20 Hickory Rd, Bonnyrigg NSW 2177,
Australia

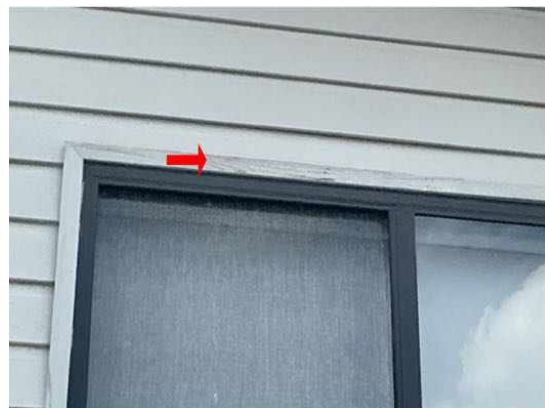
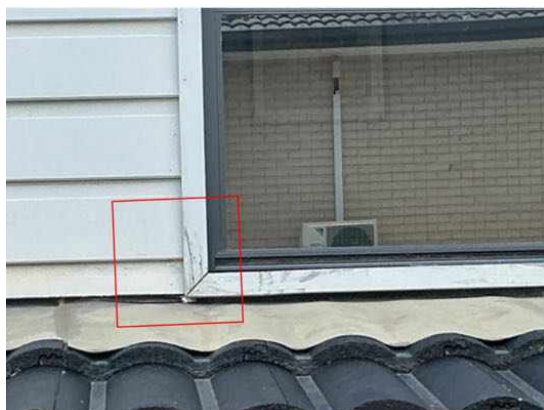
Building: Main Building
Location: Exterior walls - rear
Finding: External Timber - Weathered
Information: External timber elements around the property were observed to be showing signs of general wear and tear, including surface deterioration, fading, and early signs of weather exposure. These conditions are commonly caused by prolonged exposure to sunlight, moisture, and temperature fluctuations, which can lead to cracking, splitting, or degradation over time if not properly maintained.

It is recommended that all external timber be inspected and maintained to ensure ongoing protection. This may include sanding, sealing, or repainting affected sections. Regular maintenance will help preserve the timber's integrity, extend its lifespan, and prevent more extensive damage in the future.

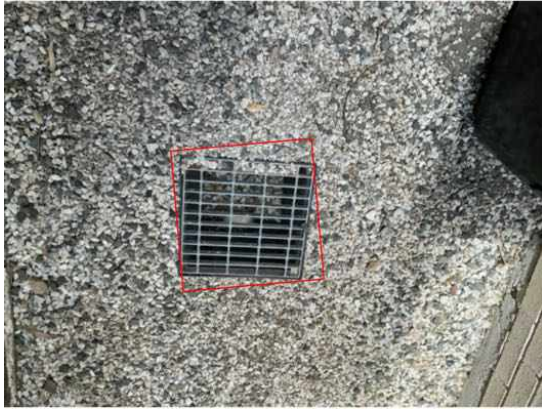
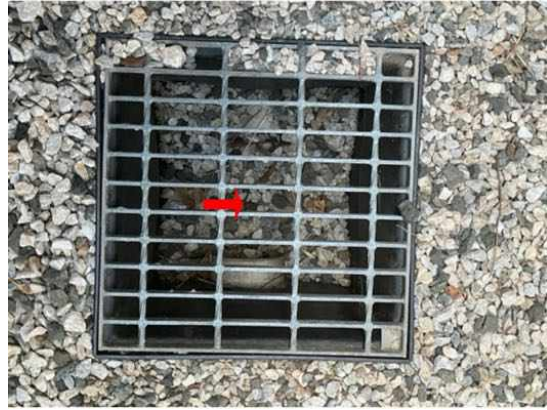
Finding 3.02

Building:	Main Building
Location:	Exterior walls - right side
Finding:	Stormwater Pits - Maintenance
Information:	The surface stormwater pits on the property are showing signs of grass growth internally, and some pits remain partially covered or filled with silt and debris. This is typically the result of poor maintenance or limited regular cleaning, allowing natural matter such as soil, organic debris, and vegetation to collect over time.

Routine Maintenance Requirement: Stormwater pits require periodic cleaning to remain functional and free from obstructions.

While no immediate issues were observed during inspection, it is advisable that the pits be cleared of silt and vegetation to ensure effective stormwater management. Ongoing maintenance will help prevent potential water-related issues and prolong the lifespan of the drainage system.

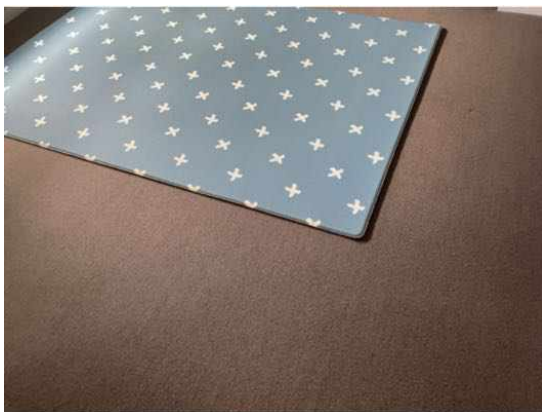
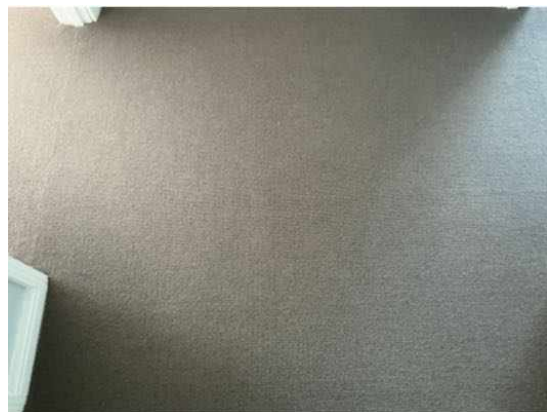
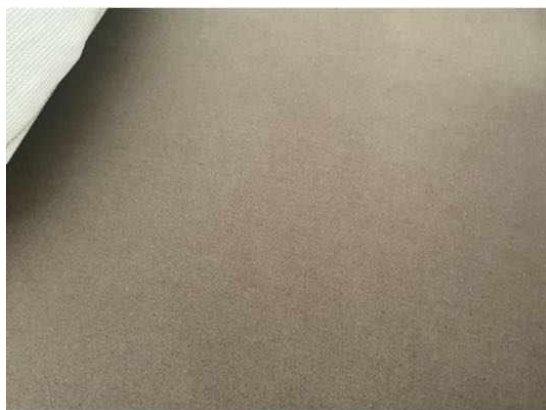
Finding 3.03

Information: The internal flooring was identified as being bouncy as pictured at the time of inspection. A bouncy floor surface generally presents as a discernible change in level as they are walked across, in noisy or creaking flooring, or in consequent movement of surrounding furniture and fixtures.

Bouncy floors generally indicate that the floorboards or the subfloor structures are coming loose from the joists that they are installed on. Bouncy flooring may also be the result of gaps between flooring structures, which require packing.

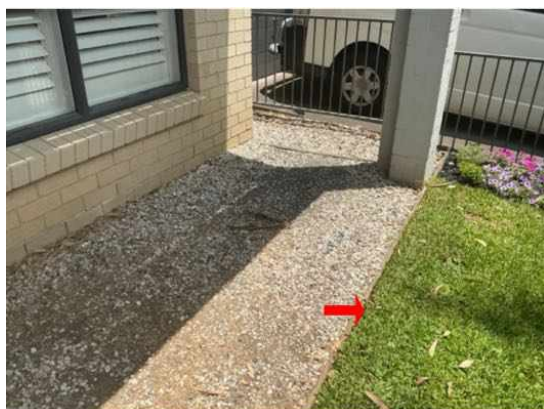
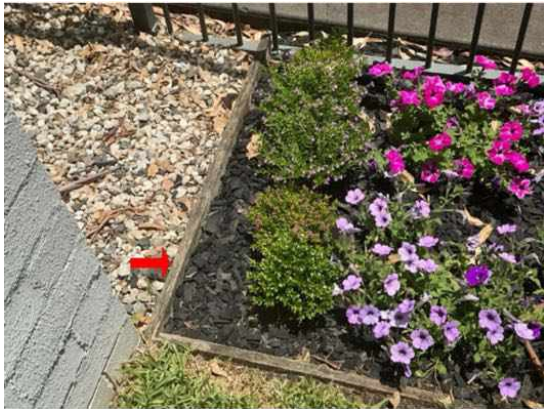
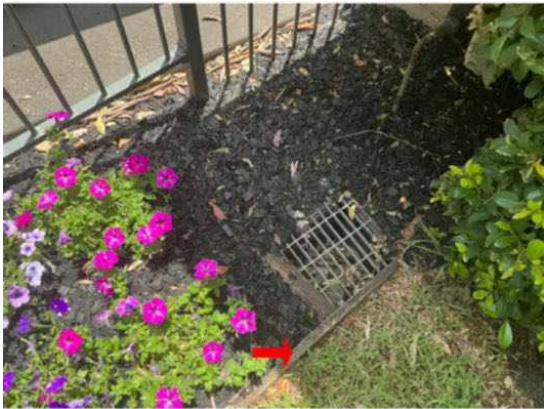
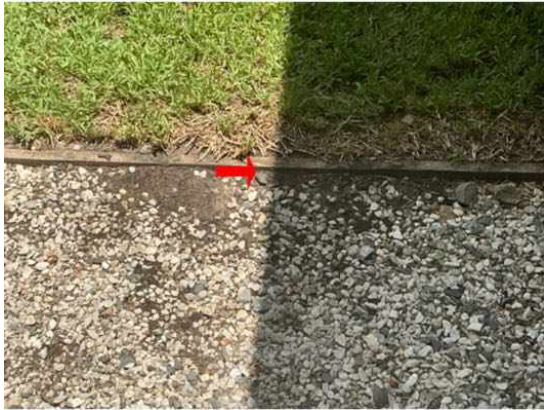
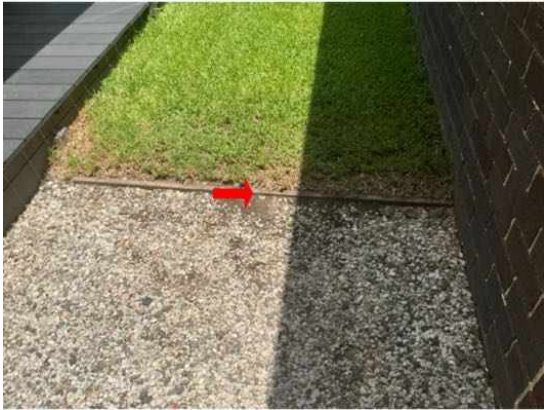
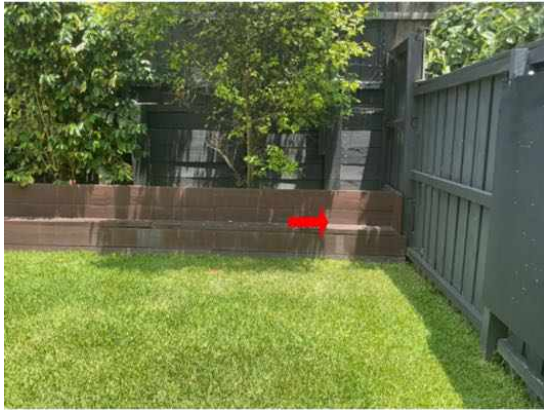
Building:	Main Building
Location:	All External Areas
Finding:	Timber Materials In Direct Ground Contact- Conducive to Termites
Information:	Timber elements that are in direct contact with the ground and exposed to moisture or damp conditions are highly conducive to termite activity. This susceptibility arises because timber, when in contact with soil and dampness, creates an environment that is particularly attractive to termites, encouraging infestation and potential structural compromise. Whether the timber is used as part of the building construction or incorporated into fencing, the presence near or on the ground can become a pathway for termites to access and damage the property.

When exposed to excessive moisture, timber begins to deteriorate developing condition such as wood decay or rot. These compromised areas of timber are even more appealing to termites as they are easier to infest and consume. This is especially true for untreated or non-durable timber, which lacks the protective treatments that can deter or withstand termite attacks. Termites can use these weakened moisture laden elements as a bridge into other parts of the structure, creating an entry point for potential infestations that can spread and cause extensive damage if left unchecked.

For any timber in direct contact with the external ground special attention is required the combination of moisture untreated wood and direct ground contact not only accelerate the decay process but also provide subterranean termites with a straightforward means of ingress into the structure this can lead to termites moving undetected into other vulnerable areas resulting in potentially significant structural issues and costly repairs.

To mitigate the risk of termite activity it is imperative that any such materials or timber elements be appropriately treated or removed as soon as possible. Timbers that are necessary for use should be made durable through appropriate treatments and maintained to ensure they do not create conditions conducive to termites. Additionally the client is advised to schedule regular termite treatments to maintain an effective barrier against infestations and ensure ongoing protection.

Regular inspections, proactive maintenance and consistent termite treatment are essential steps in minimising the risk of termite attack and protecting the structural integrity of the property. Taking these preventative measures is crucial for maintaining a termite free environment and avoiding potentially costly damage and future repairs.

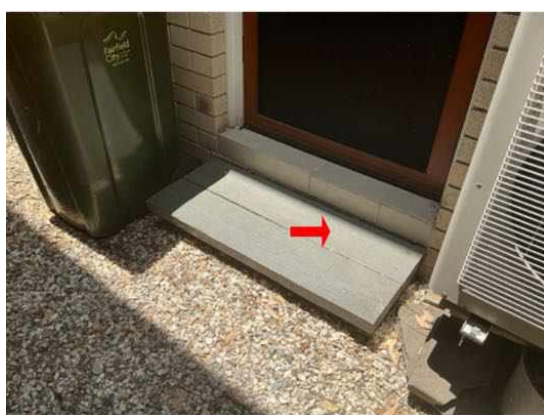
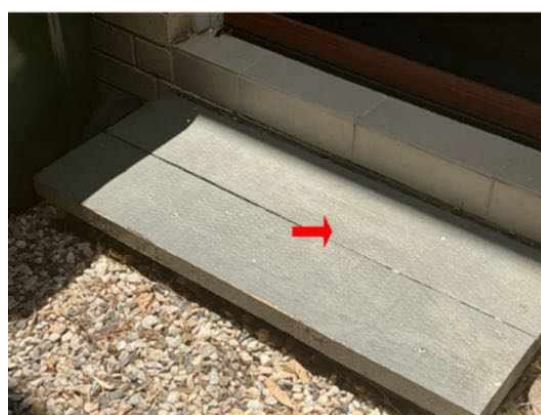
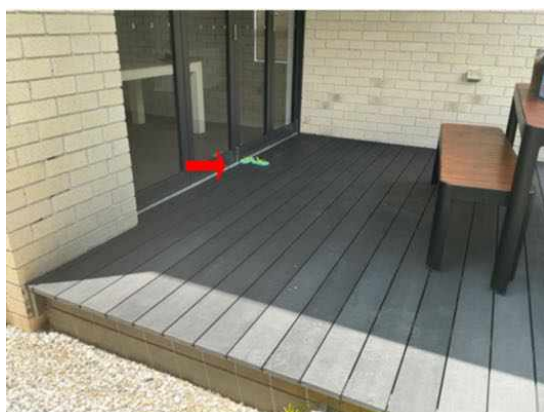
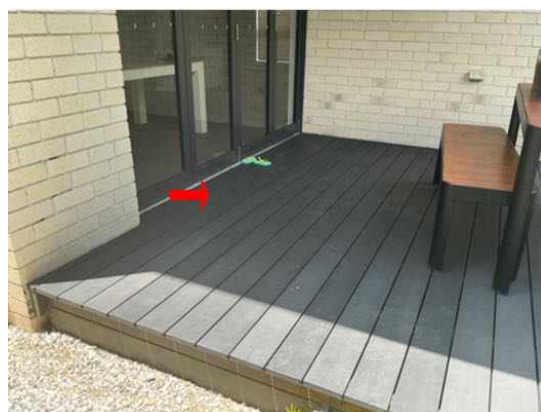
Finding 6.02

Building: Main Building
 Location: All External Areas >
 Finding: Bridging Of Physical Barriers - Patios/Porches
 Information: Breaching is the spanning of a physical termite barrier or inspection zone so that subterranean termites are provided with an entry point over or around that barrier.

The concrete porch/patios are providing a concealed entry point at the time of the inspection. Where the location of the porch is retrospectively installed against an external wall this will provide a concealed entry point for termites.

The client should consider gaining further advice from a timber pest technician as to treatments required in this area. It is recommended that obtaining such advice be a short-term priority.

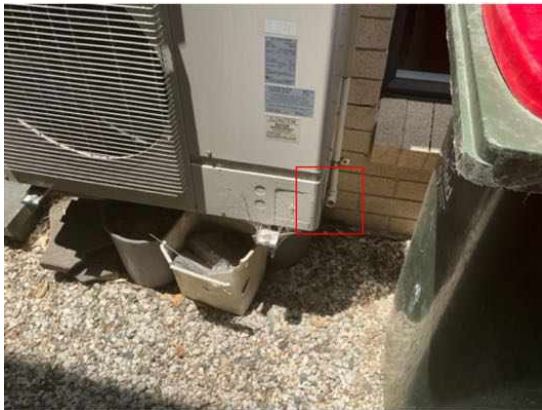
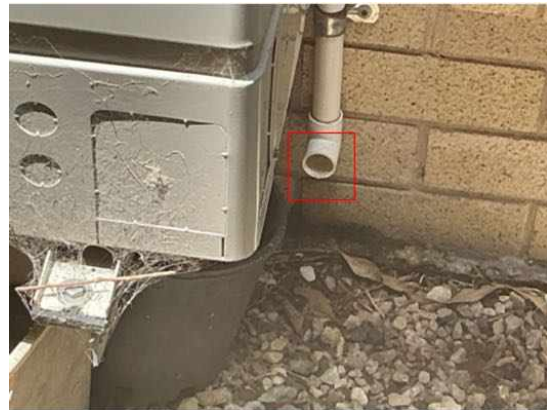
Finding 6.03

Building: Main Building
 Location: Exterior walls - right side
 Finding: HWS - Disconnected overflow
 Information: The Hot Water System overflow was found NOT to be connected to the storm water drainage and is creating excessive moisture in the surrounding area.

Poorly aligned materials can and will lead to further damage to nearby areas.

It is highly recommended that a licensed plumber be appointed to connect the A/C overflow in order to prevent such an environment from being created. These minor works should be carried out as soon as possible.

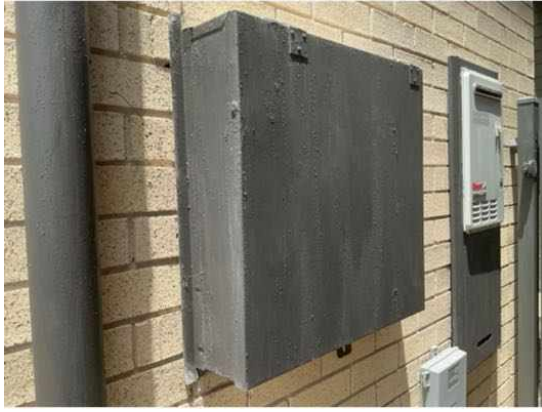
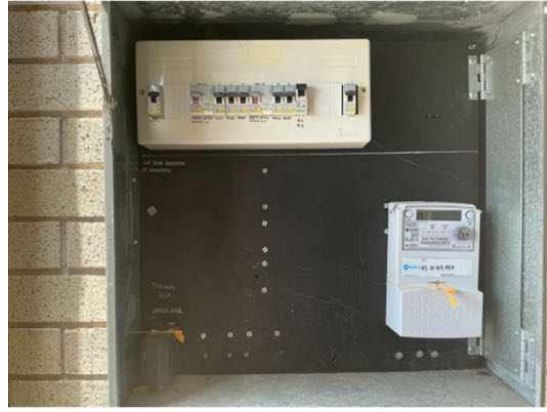
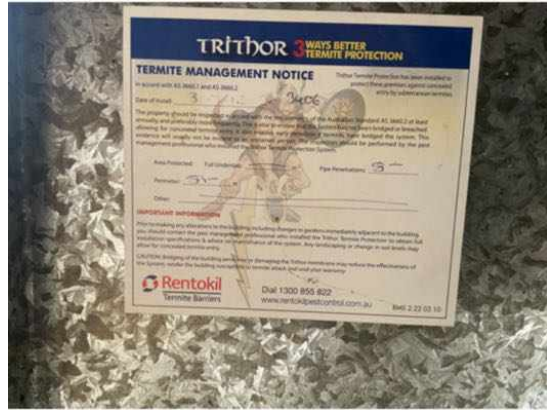
Evidence of this sticker has been located in the meter box. Please see photos attached

Where a Termite Management System has not been identified you should consult a licensed pest inspector immediately to undergo further investigation in what measures would be necessary to maintain a functional pest management system. It is also recommended that a Licensed Pest Controller attend to determine the viability of the current or past treatments
