Building Inspection Report

Inspection Date: Wed, 8 Apr 2026

Property Address: Unit 3/11 Katta Ct, ASHWOOD, VIC, 3147,
Australia

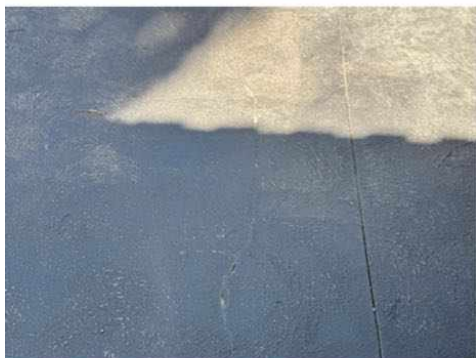
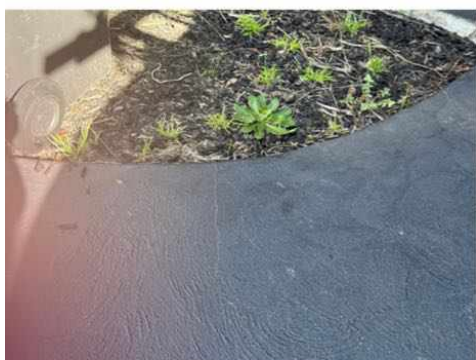
Defects 3.01

Building:	Building 1
Location:	All Areas > All Areas
Finding:	Concrete driveway cracks
Information:	Numerous cracks on the driveway were observed at the time of the inspection. Concrete cracks are a common occurrence as a result of many primary defects. Such causes may include age, general wear and tear, expected building movement, general expansion/contraction of building materials in different weather conditions, and/or minor failings in the installation or application of building materials. Monitoring of all cracking should be conducted periodically. Contact a relevant tradespersons should cracks become trip hazards for occupants.

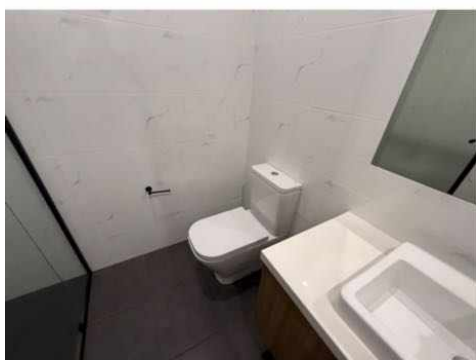
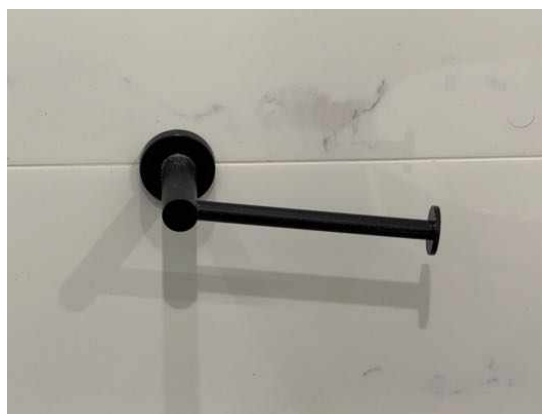
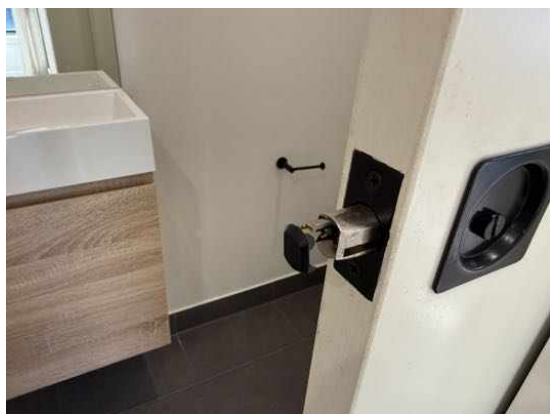
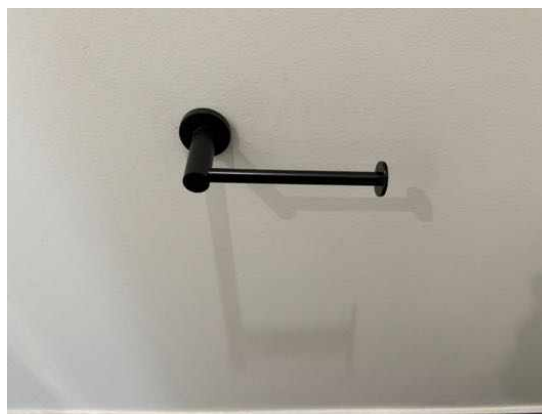
Defects 3.02

Building:	Building 1
Location:	Bathroom > All Areas
Finding:	Toilet roll holders - Loose
Information:	The toilet roll holders and towel rail were found to be loose at the time of inspection. While not a major operational defect, function can deteriorate if the problem is left unmanaged. It is recommended that some remedial works to rectify the loose toilet roll holders and towel rails to its original fixing. If these cannot be rectified to function as intended, client is recommended to renew. A qualified carpenter may be required to perform these works.

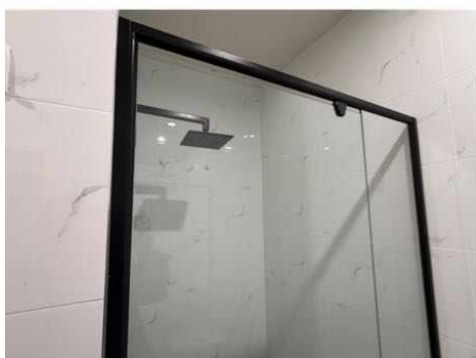
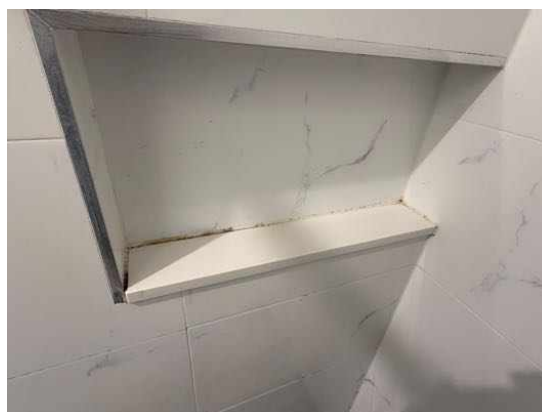
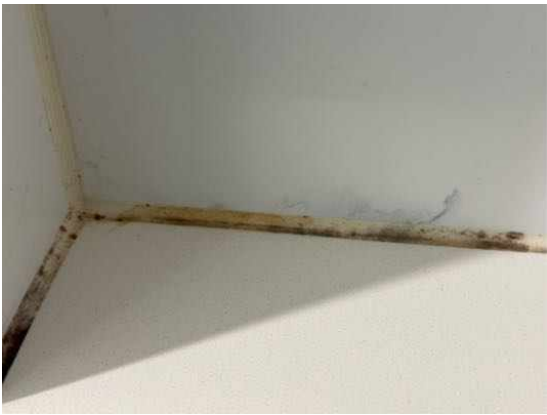
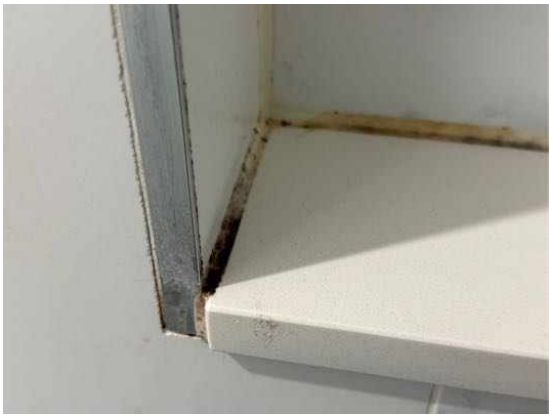
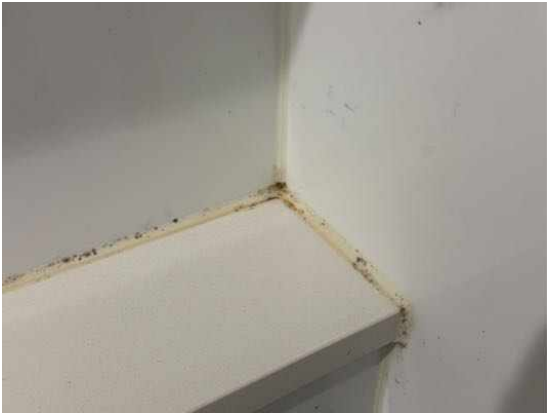
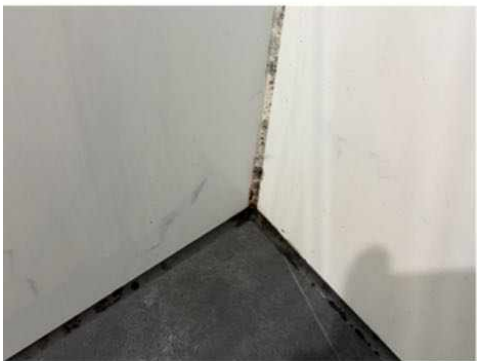
Defects 3.03

Building:	Building 1
Location:	All Areas > All Areas
Finding:	Sealant and grout in bathrooms - en-suite
Information:	It was observed on inspection that sealant or grout has been degraded due to excessive mould build up in the bathrooms and or en-suites, especially to the tiled shower alcove areas. Where there appears to be mould to the sealant and or grout, it is likely that it will require scraping out and replacing.

Different materials on the walls and floor areas move at different rates, generally causing cracking to grout or sealant at this point. A flexible sealant is required to allow for expected expansion and contraction, while keeping the joint water tight and protective of all associated building materials. Flexible and mould resistant materials should be applied to affected areas to prevent any subsequent water damage that is likely to occur.

Regular maintenance and replacement of any missing or damaged sealant and grout is highly recommended to the wet areas, as this is a regular wear and tear defect. Sealant and grouting in areas that come into regular contact with water should be maintained for the long term care of your property. A sealant specialist or tiling contractor should be appointed to complete these works as soon as possible.

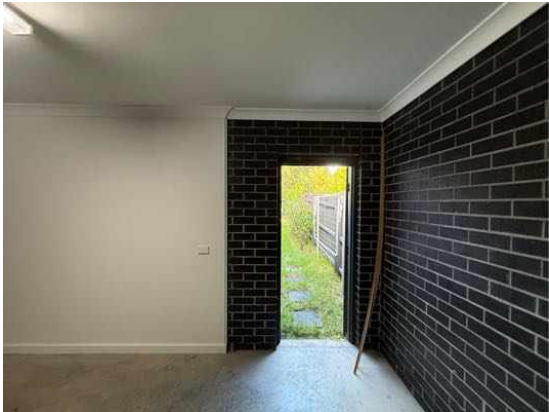
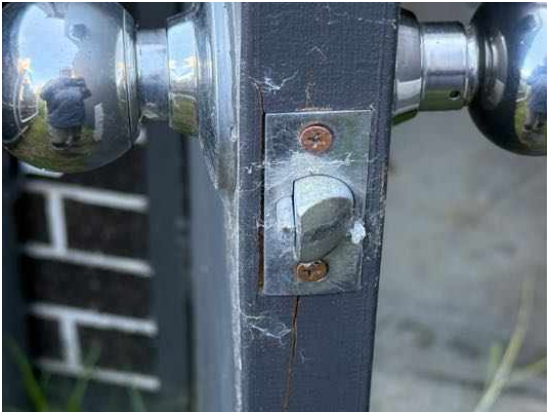
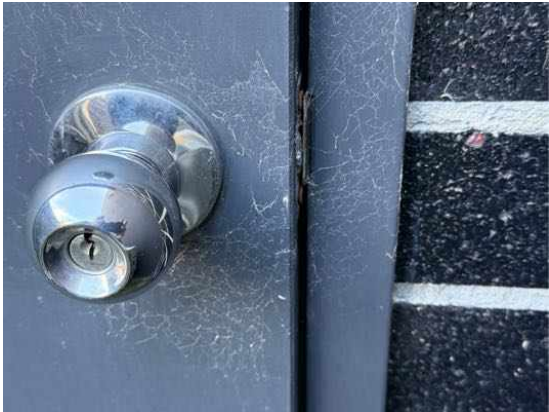
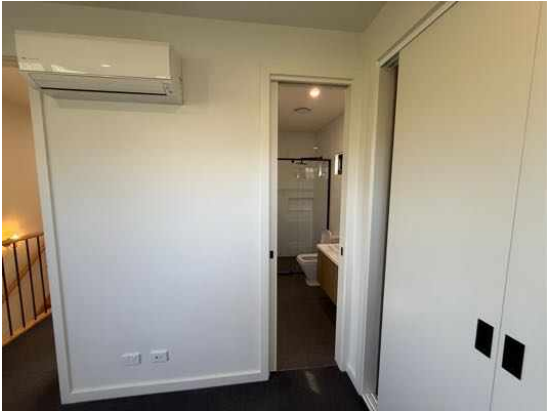
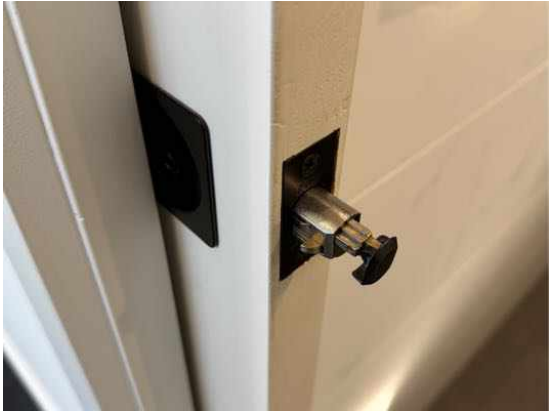
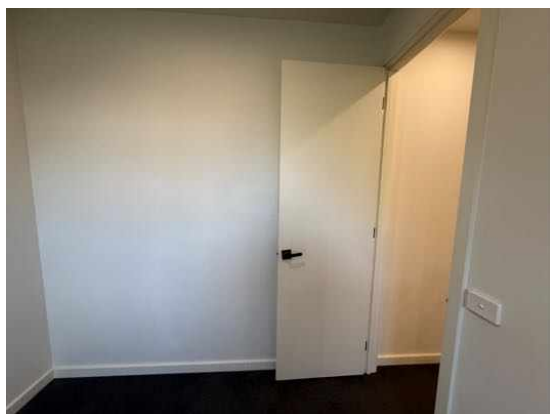
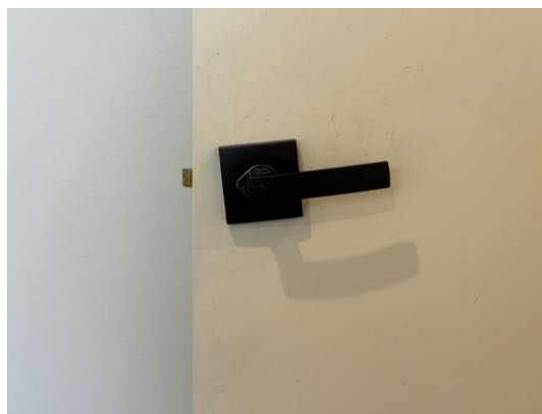
Defects 3.04

Building: Building 1
Location: Bathroom > All Areas
Finding: Doors and sliding doors
Information: The doors and sliding doors throughout the property were observed to require some remedial work and maintenance to make sure they operate as intended. Generally these type of maintenance items are due to such as age and a lack of maintenance. Renewal or replacement of some door hardware is recommended where deemed to be necessary and required, as well as minor repairs and cleaning. Where door handles, door latches are hard to operate, these types of defects will make it difficult for all occupants to safely egress the interior areas, in some cases the door hardware could cause an occupant to be stuck in a room. All door hardware should be rectified to ensure they operate easily during standard operation. These doors and door hardware defects may inhibit a safe and timely egress in the case of an emergency.

Some of these doors require some minor adjustment to ensure their functionality is not affected, they are suspected to be creating some secondary defects to associated building elements, such as damage to the associated door frames and or floor coverings in left unmanaged. A qualified carpenter will be required to carry out remedial work on the affected doors.

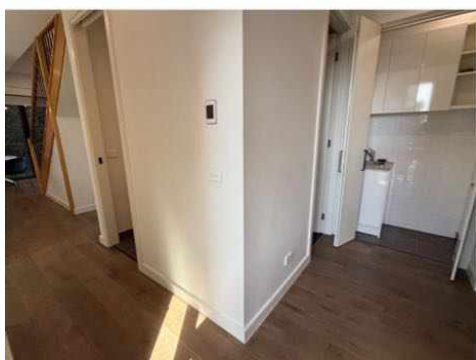
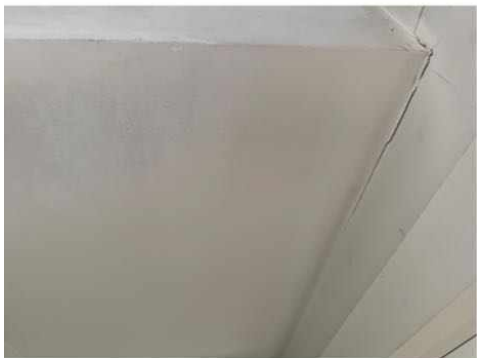
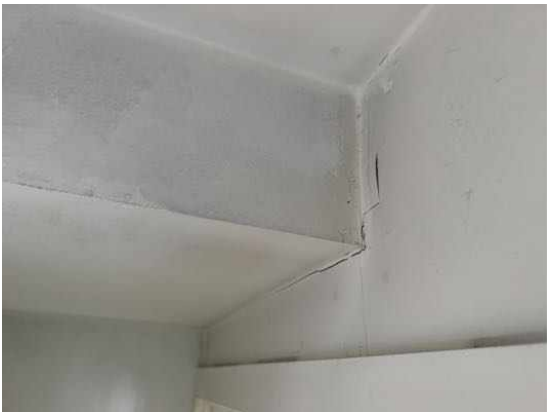
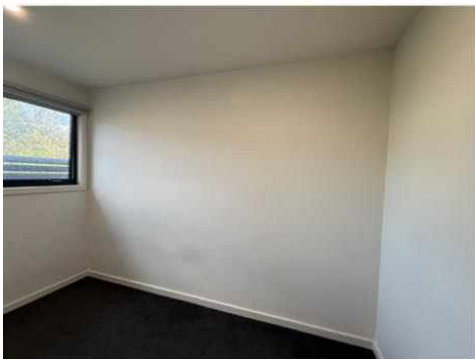
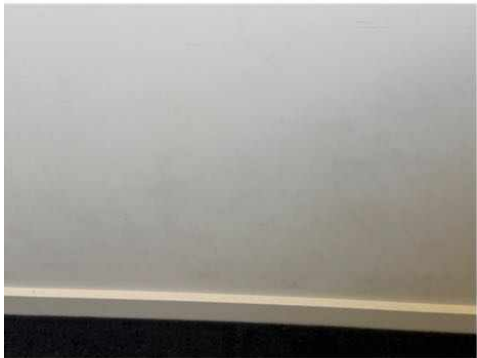
Defects 3.05

Building:	Building 1
Location:	All Areas > All Areas
Finding:	Painting show some minor marks and blemishes
Information:	At the time of the inspection the interior paint work is considered to be in a reasonably good condition showing some marks and blemishes throughout the home. These painted surfaces and finishes where it shows marks and blemishes should be sanded back, filled, leveled and painted where deemed to be necessary. The build should appoint the qualified painter to rectify any areas showing these minor defects, marks, blemishes. Re-painting in some areas may be necessary and would improve the overall condition and aesthetics throughout the home, this would ensure these areas are protected and finished adequately and professionally against further deterioration.

Incomplete, inadequate paint protection, damaged and deteriorated paint finishes, can mostly be considered appearance defects, however poor and unmaintained paint finishes can also lead to the development of secondary building defects over time. Incomplete areas of paint finish exposes these areas to moisture and secondary damage, potentially accelerating the deterioration of underlying building materials.

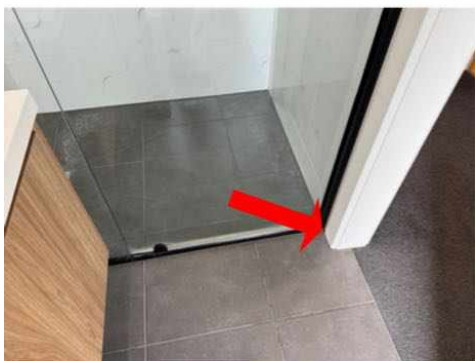
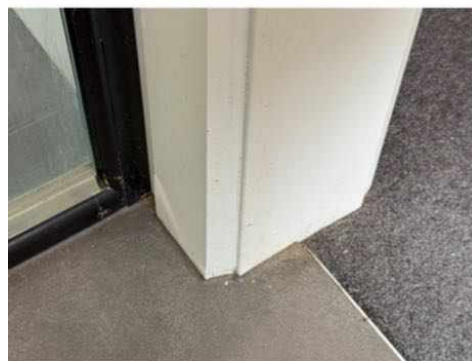
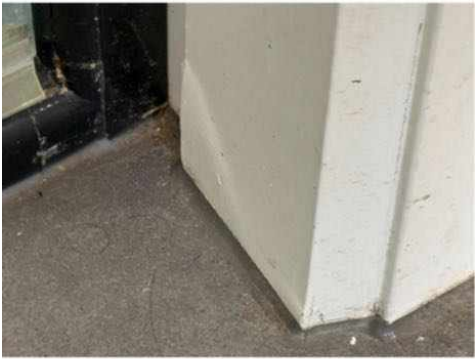
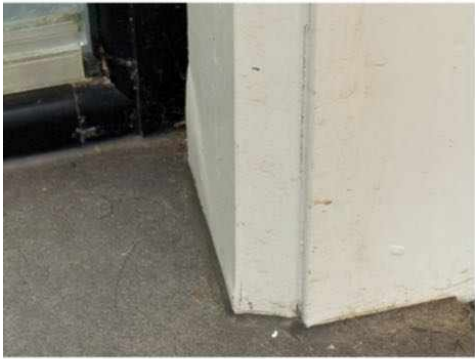
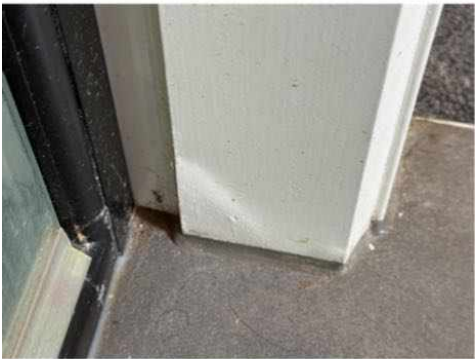
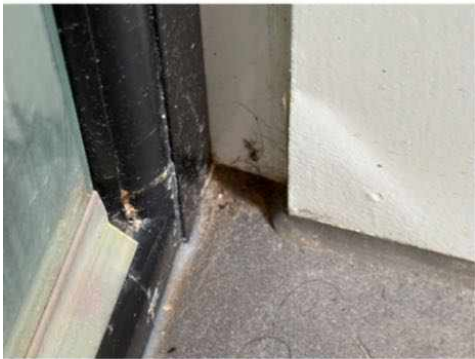
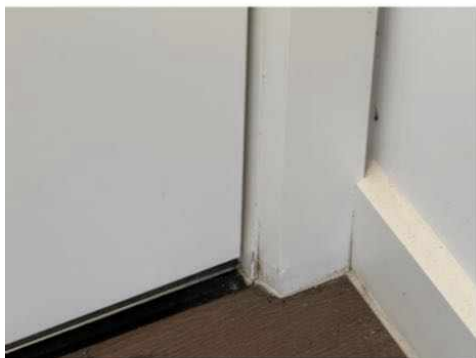
Defects 3.06

Building: Building 1
 Location: Top bathroom > All Areas
 Finding: Minor moisture damage to bathroom and laundry door jambs
 Information: Minor moisture damage to the bathroom door jamb, the bottom left hand side of the door jamb showed signs of moisture damage. Door jamb shows minor damage to the bottom area of the door jamb which may be consistent to moisture at the time of occupants showering. Client may elect to rectify or leave as is, however it is recommended that this area be closely monitored for further moisture damage. Client is recommended to take more caution during and after showering.

Minor moisture damage to Laundry door jamb :- Minor moisture damage to the laundry door jamb, the bottom right hand side door jamb showed signs of previous moisture. The door jamb has minor area of damage which may be consistent to some water and moisture at some previous time, possibly a washing machine mishap at some time. No other damage was visibly observed at the time of the inspection. The damage is not suspected to require any remedial action. Client may elect to rectify or leave as is, this is at the client's discretion.

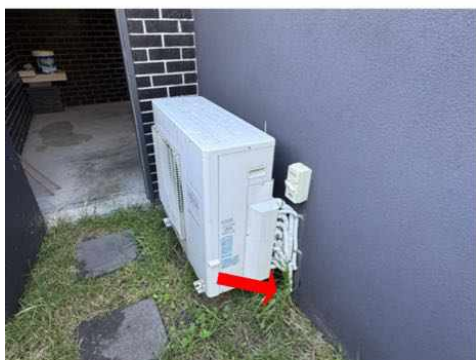
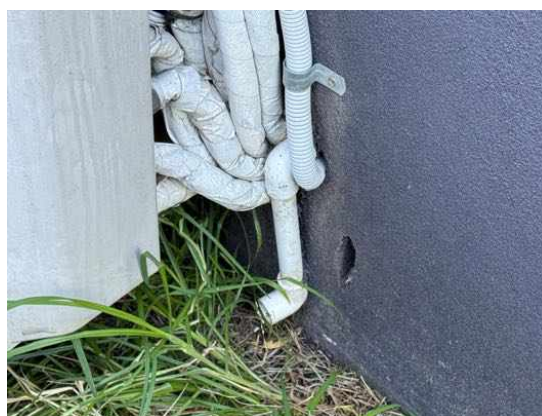
Defects 3.07

Building:	Building 1
Location:	All Areas > All Areas
Finding:	Air conditioner - disconnected overflow
Information:	The Air Conditioner (A/C) overflow was observed to be disconnected from storm water drainage and may be creating excessive moisture during its use, in the surrounding area. Such leaking from the waste pipe of the air conditioner creates an environment which is conducive to an array of defects, including water damage to associated building elements and the attraction of termite or timber pest infestation. It is highly recommended that a licensed plumber be appointed to connect the A/C overflow to a stormwater point in order to prevent such an environment from being created. These minor works should be carried out in the near future.

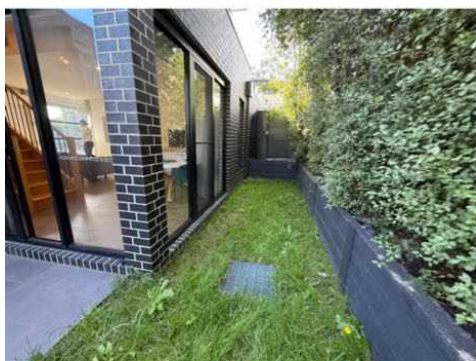
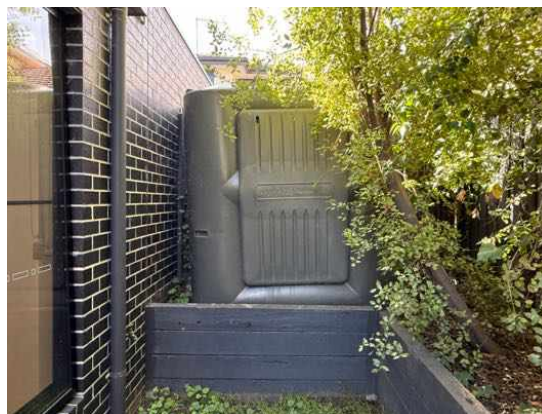
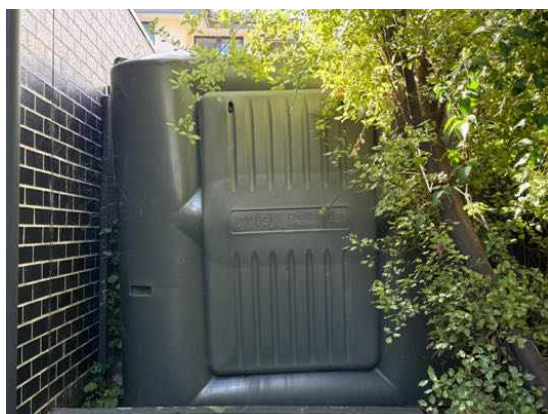
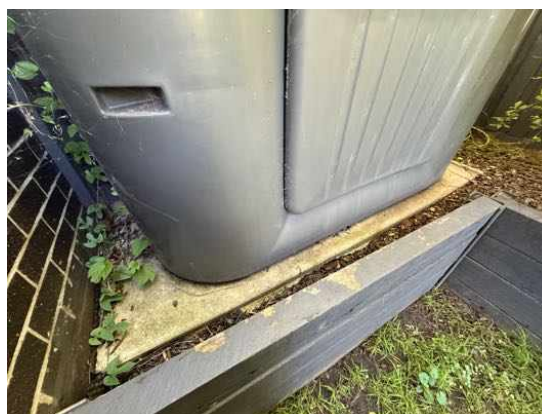
Defects 3.08

Building:	Building 1
Location:	Rear area > All Areas
Finding:	Rear water tank leaning
Information:	The rear water tank was observed to be leaning over and may become unstable and a safety hazard. It is highly recommended that the water tank be emptied and a more stable base be installed, this should be carried out as soon as possible, by the relevant tradespersons or contractors in the short term future. The concrete base is

suspected not to be stable enough to withstand the weight. It is recommended that be rectified to provide adequate support needed for the weight of the water tank and water. This type of defect is suspected to accelerate as further damage and deterioration increases.

Any overflows and or blockages should always be rectified immediately to ensure dry conditions are maintained around the perimeter of the home. Client is recommended to appoint a Licensed Plumber or other relevant contractor to gain some specific advice on remedial works that are deemed to be required.

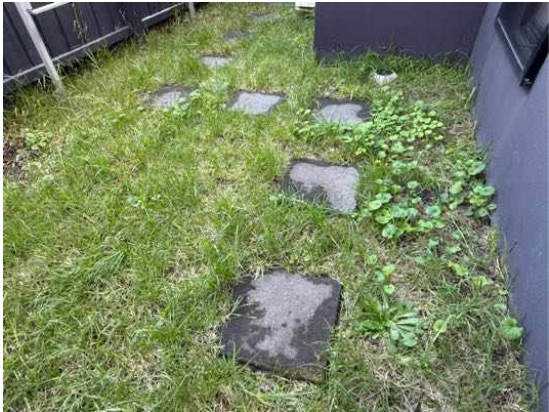
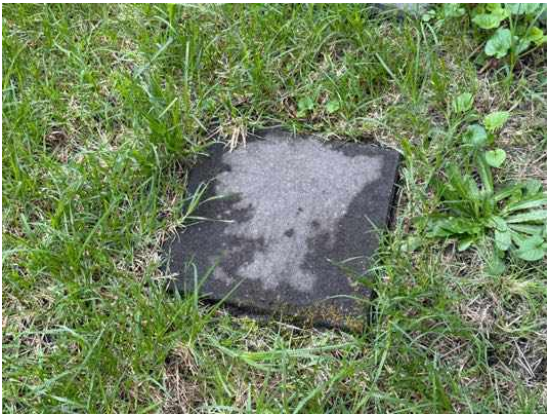
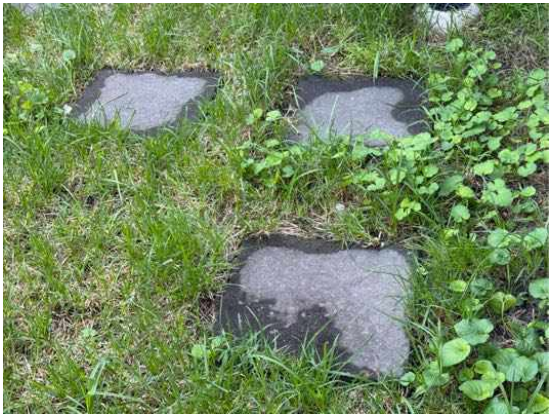
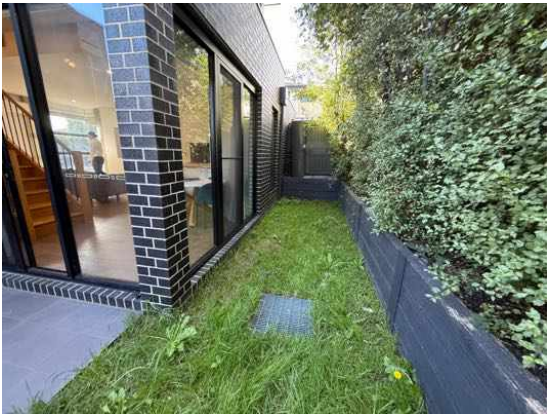
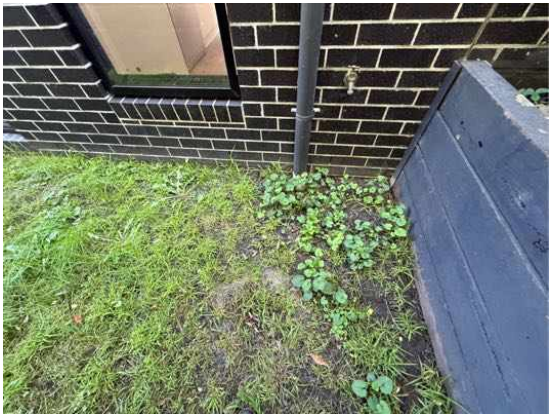
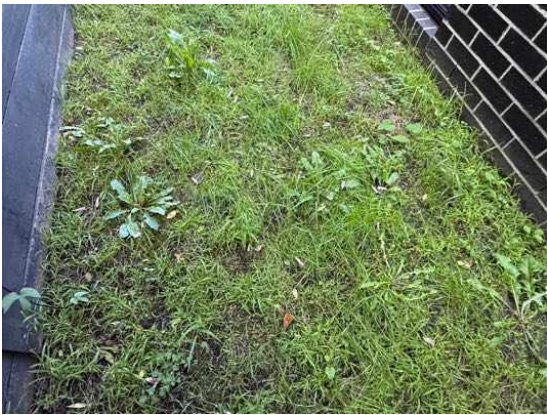
Defects 3.09

Building:	Building 1
Location:	Rear areas > All Areas
Finding:	Exterior perimeter moisture
Information:	It was observed at the time of inspection, the home site was considered to be reasonably flat and therefore has little to no water runoff and during wet weather or heavier rain periods it may become wet and rain sodden. Client must try ensure to keep any excessive moisture away from the home. If deemed to be required the client may consider additional agriculture (aggy) drainage is added to eliminate excessive moisture from around the perimeter exterior areas. Client must try to maintain dry conditions in these type of areas, this will improve the exterior perimeter conditions and makes a healthier exterior environment. It is considered to be very important to

prevent and to protect against the development of potentially harmful wet and mouldy conditions.

Client must ensure not to build up around the perimeter areas, types of obstructions would include things such things as garden beds trees and shrubs etc. Maintaining dry conditions and preventing secondary damage such as excessive moisture, mould, wood rot and pest activity, the development of mould and mildew may lead to respiratory safety hazards for occupants if left unmanaged for extended periods of time.

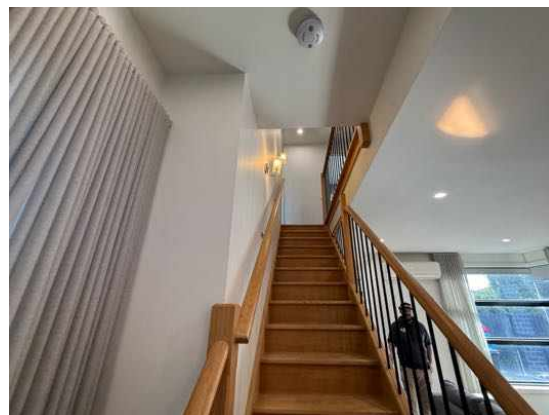
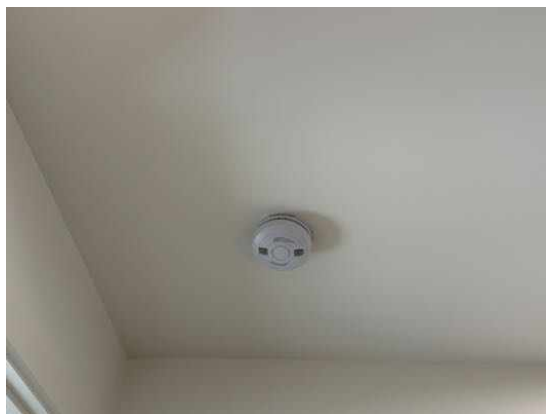
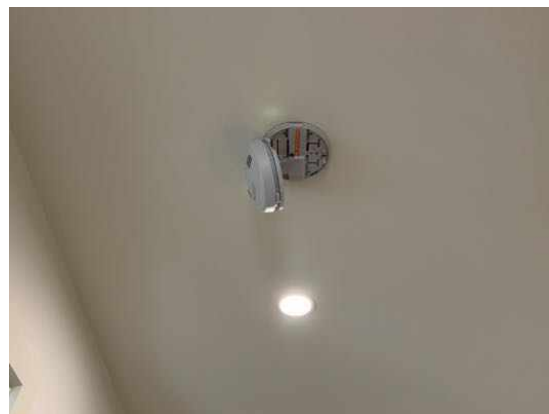
Building: Building 1
 Location: All Areas > All Areas
 Finding: Smoke detectors and alarms
 Information: Reporting on Smoke Detectors or Alarms, including hard wired smoke detection systems and their legislative requirements, is outside the Scope of this Report. Please note that this defect is highlighted as a caution only. We suspect, based on our experience in the building industry, that smoke detectors are sometimes get overlooked, or they may be in a poor condition, so we recommend that they always should be addressed prior to occupation to improve occupant safety.

Always ensure sufficient working and suitable smoke detectors are installed prior and during to occupying any building. Additionally, it is advised that all smoke detectors be tested by the homeowner on a monthly basis.

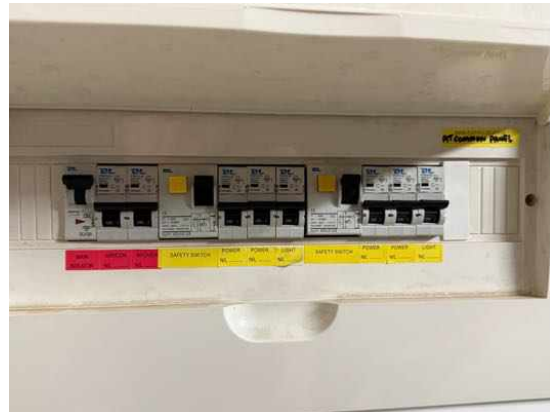
Building: Building 1
 Location: All Areas > All Areas
 Finding: Termite Management System - no evidence of a chemical installation or durable notice
 Information: At the time of the inspection no application of a chemical termite barrier or durable notice was observed. Such barriers are highly effective and highly recommended for all properties in preventing termite attack on any timber building elements throughout the property.

A durable notice should be placed in the switchboard unit or in the another accessible area to indicate current termite barriers. At the time of inspection, no evidence to suggest preventative works taking place. The client may consider gaining further advice from builders or a pest controller and as to the costs and procedures involved with this application. It is recommended that obtaining such advice be a short-term priority.
