## Building Inspection Report

Inspection Date: Sat, 21 Feb 2026

Property Address: 17A Doctors Rd, Morphett Vale SA 5162,  
Australia

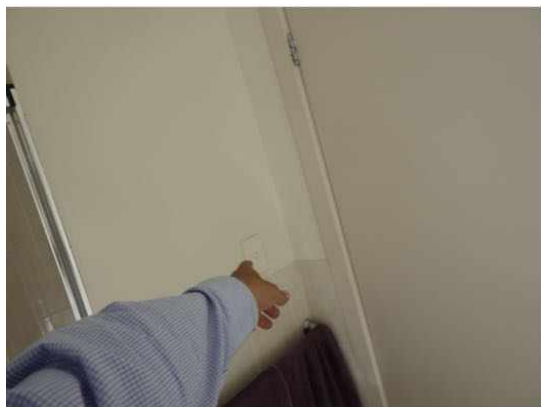
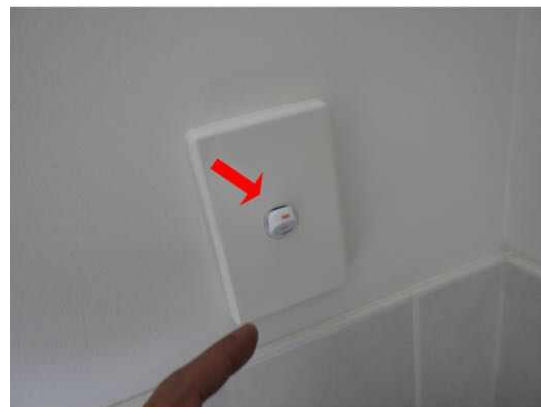
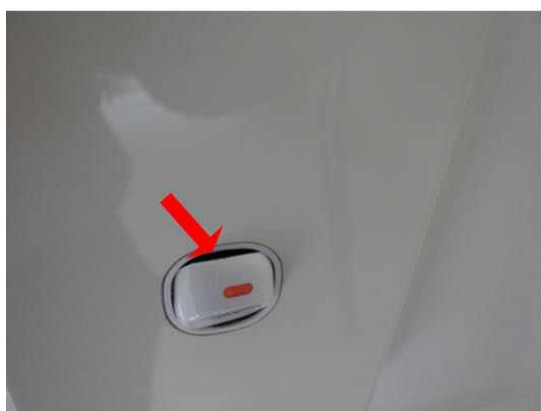
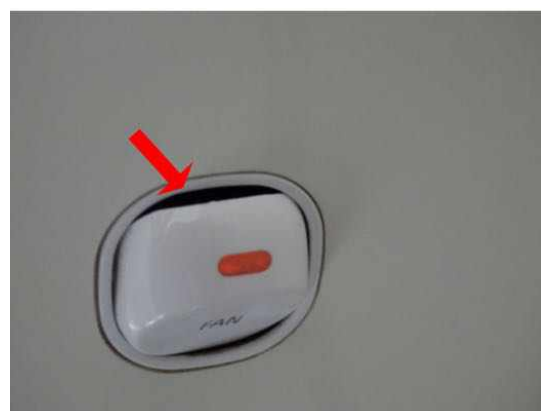
#### Defects 1.01

Building:	Building 1
Location:	Bathroom
Finding:	Electrical fitting - Broken
Information:	The electrical fitting in this bathroom area was found to be broken at the time of inspection. Breakage occurs generally when the building materials have aged and decayed, but may also be indicative of impact damage to the building element (accidental or deliberate).

Left unmanaged, the fitting is unlikely to cause further damage to surrounding building elements. However, the broken fitting does expose electrical works, and may create a safety hazard if there is potential contact with persons in the area.

Repair and/or replacement of the broken fitting is advised. A Licensed electrician should be appointed to repair/replace the fitting immediately.

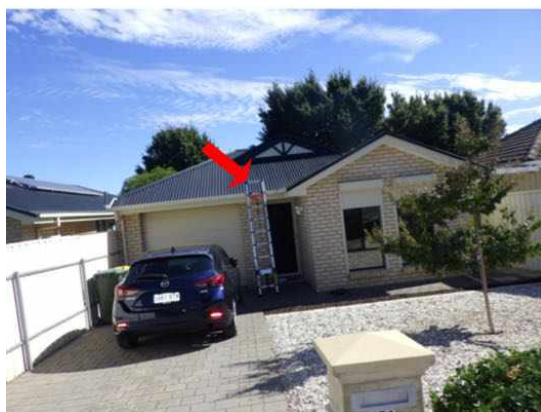
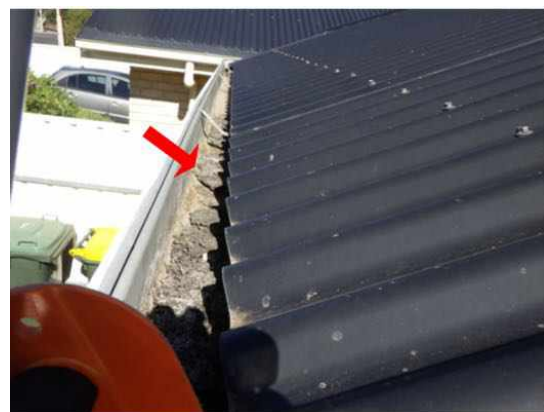
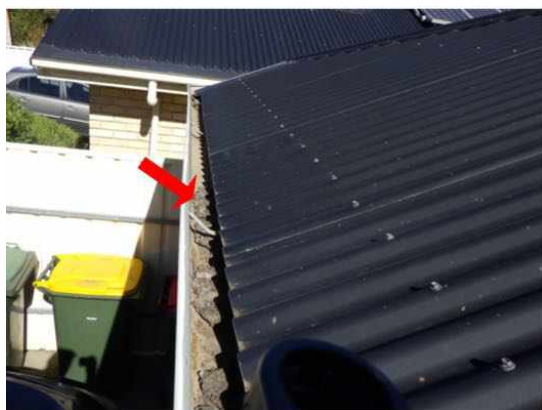
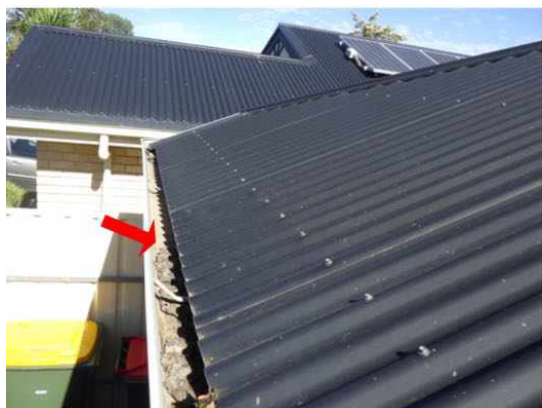
### Defects 3.01

Building: Building 1

Location: All External Areas

Finding: Gutters - Blocked

Information: At the time of inspection it was noticed that gutters were blocked in few sections around the property. Gutters have to be cleaned in regular intervals.

Roof plumbing structures, such as guttering and downpipes, should be free of all debris to prevent blockages. Blockages of the guttering and downpipes will lead to pooling and accumulated water overflows, which is likely to subsequently flood eaves and exterior walls.

Blocked gutters are likely to lead to high levels of moisture in the affected areas. Such moisture will not only cause rust and decay of the associated building materials, but can also provide conditions that are conducive to termite and timber pest activity. Blockages in gutters should therefore be removed immediately to ensure dry conditions are maintained.

Consult a Licensed Plumber for further specific advice on remedial works that may be required. In the interim, it is highly advised that blocked gutters be removed by the homeowner or a general handyperson as a matter of urgency.

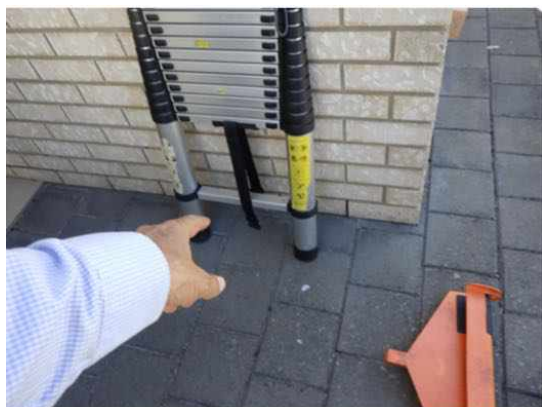
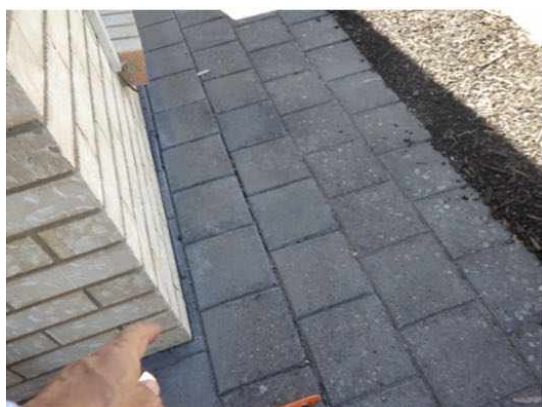
Defects 3.03

Building: Building 1  
Location: All External Areas  
Finding: Slab Edge - Exposure compromised  
Information: At the time of inspection it was noticed that slab edge exposure has been compromised in few sections around the property.

An inspection zone of at least 75mm in relation to the exposed slab edge, between the bottom brick and the perimeter pavement, is required. This inspection zone should be maintained in order to force termites into the open where they can be detected more readily during regular inspections. The slab edge should not be concealed by anything that may prevent inspection of the area, including render, landscaping, soil, turf, paving, concrete cladding or other structures.

If the slab edge is not properly exposed there is a high risk of termite attack. Sometimes, in order to determine the type of slab, a suitably qualified person such as an architect or builder may be required to consult the construction plans.

Where the slab edge cannot be properly inspected, it is highly recommended that termite or timber pest inspections be carried out every 6-12 months to aid protection of the property against infestation.

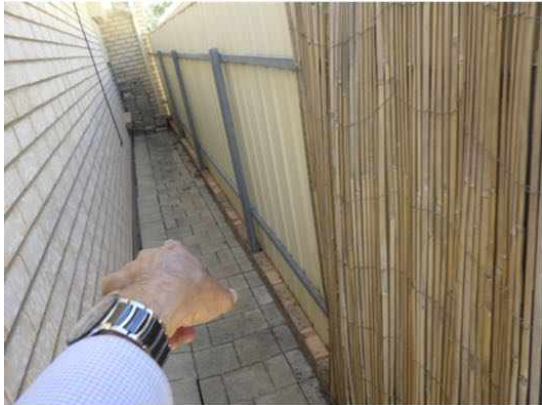
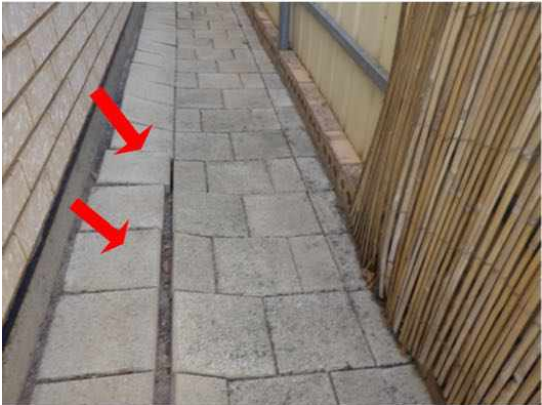
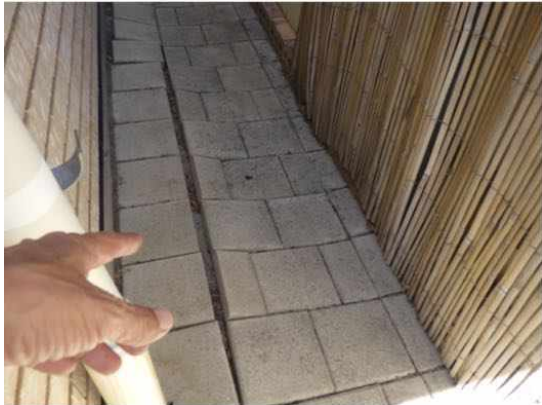
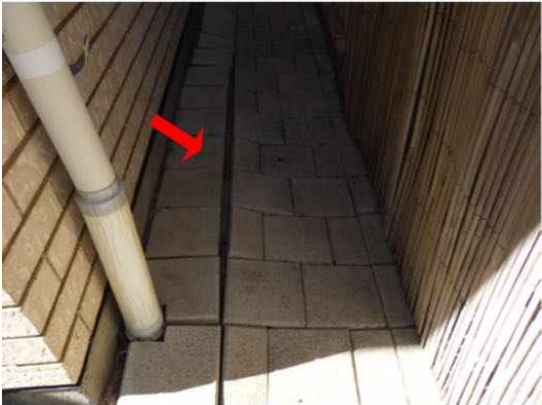
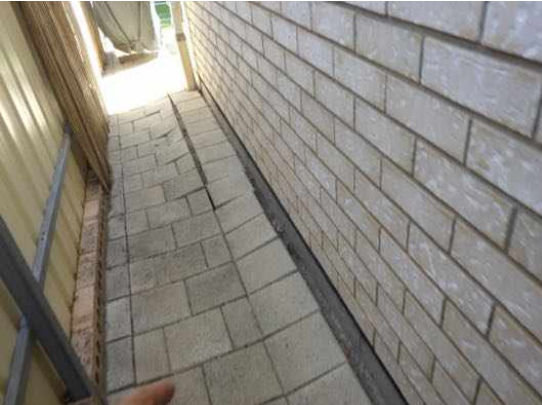
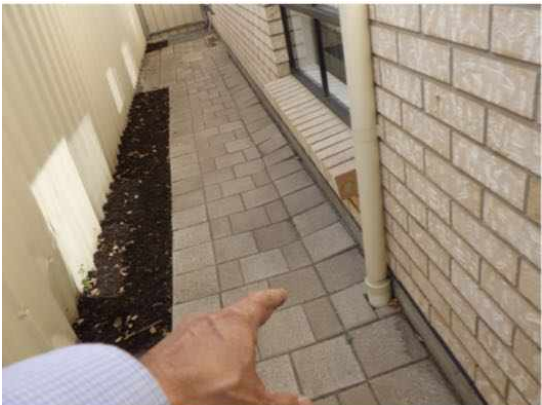
### Defects 3.04

Building: Building 1  
Location: All External Areas  
Finding: Paving - Uneven  
Information: Sections of the external paved area are uneven, creating a potential trip hazard. It appears as though the area has been subject to rough installation, or that paving sections have lifted due to movements in the foundation of the property.

Where paving creates a trip hazard, personal injury may ensue if due caution is not taken by all persons within this area.

Re-paving of the area is required as soon as possible to remedy this situation. Further consultation with a specialist concreter is advised.

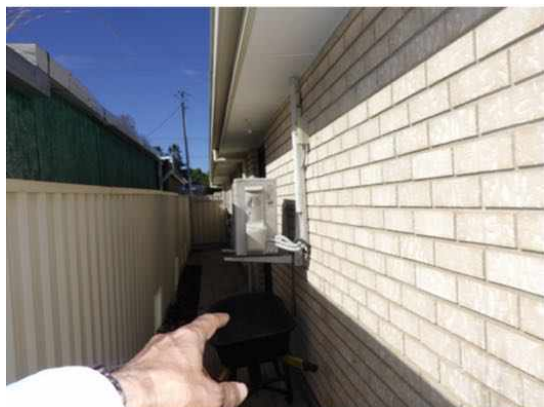
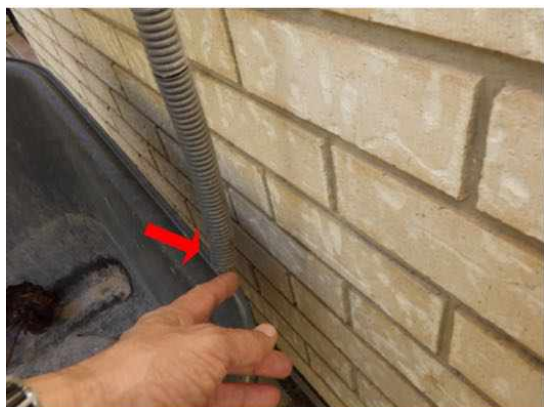
### Defects 3.05

Building:	Building 1
Location:	All External Areas
Finding:	Air conditioner - Disconnected overflow
Information:	The Air Conditioner (A/C) overflow was found to be disconnected from storm water drainage and is creating excessive moisture in the surrounding area.

Such leaking creates an environment which is conducive to an array of defects, including water damage to associated building elements and the attraction of termite or timber pest infestation.

It is highly recommended that a licensed plumber be appointed to connect the A/C overflow in order to prevent such an environment from being created. These minor works should be carried out as soon as possible.

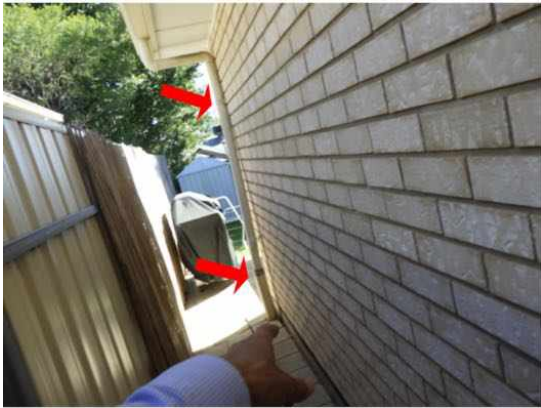
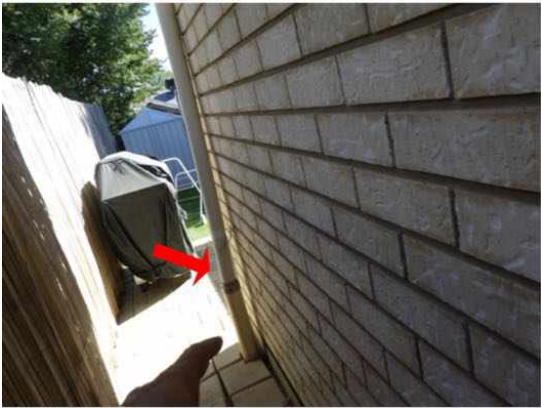
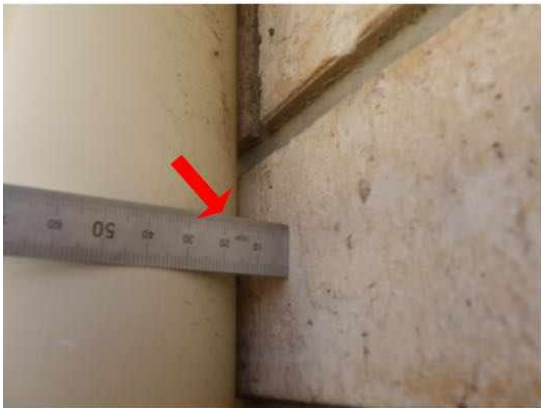
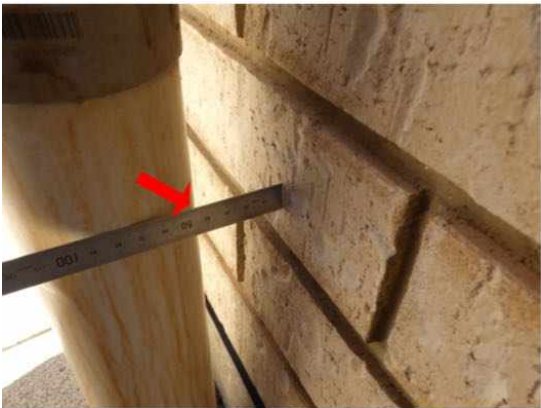
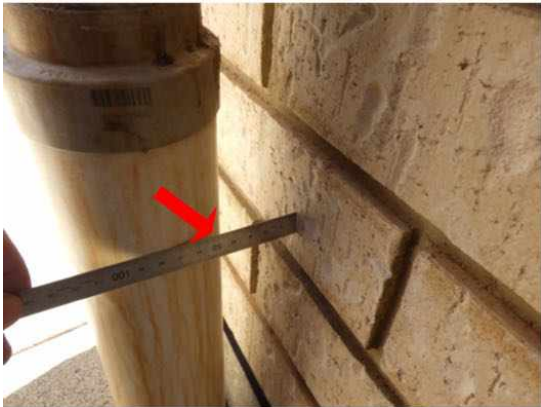
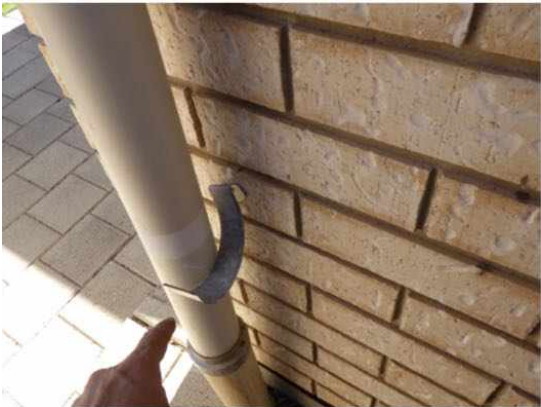
### Defects 3.06

Building:	Building 1
Location:	All External Areas
Finding:	External Walls – Rear – Downpipes (Misaligned / Loose)
Information:	At the time of inspection, it was noted that the downpipe servicing the rear external wall was misaligned and loose from its original fixing. This condition may affect the effective discharge of roof stormwater and may contribute to moisture-related issues to adjacent building elements.

In addition, it was observed that the external paving in this area is uneven, creating a potential trip hazard and increasing the risk of water ponding against the building.

Misalignment or damage to building components may occur due to age-related deterioration, movement, impact damage, or inadequate original installation. If left unrectified, such conditions may lead to further deterioration and the development of secondary defects, including moisture ingress and damage to surrounding structures.

Repair and/or replacement of the affected components is recommended to restore

proper function and to minimise the risk of further damage. All building elements play an important role in the overall performance of the structure.

It is recommended that a suitably qualified and experienced tradesperson be engaged to realign and secure the downpipe and to assess and rectify the uneven paving as required, prior to any additional damage occurring.

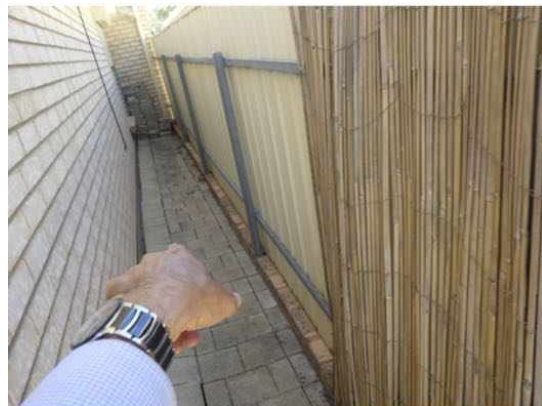
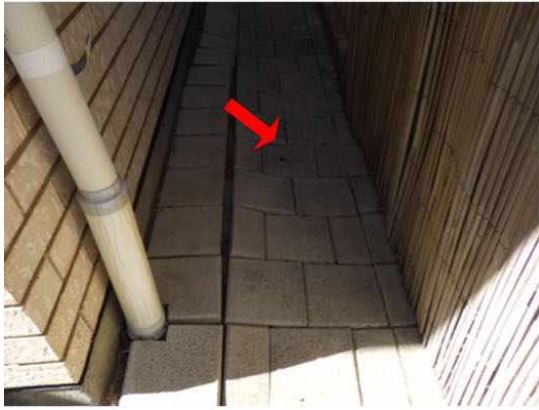
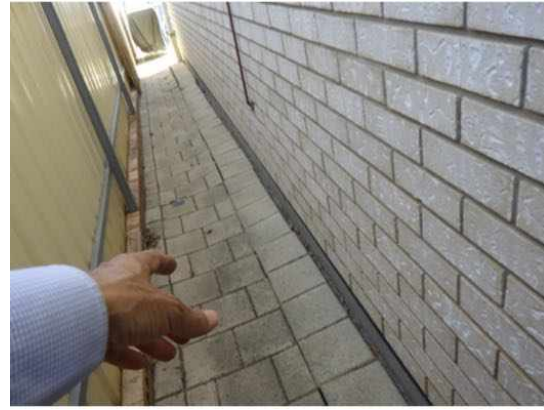
### Defects 3.07

Building:	Building 1
Location:	All External Areas
Finding:	Water pooling - against property
Information:	Water appears to be pooling against the house. It is suspected that this is a result of poor site drainage but may also be due to excessive moisture from an unidentified source.

Where water is pooling against the house water damage to the external wall cladding is imminent.

Such water pooling also increases the risk of termite activity and the development of fungal decay in the area.

Consult a Licensed Plumber regarding the cost of potential site drainage rectification works.

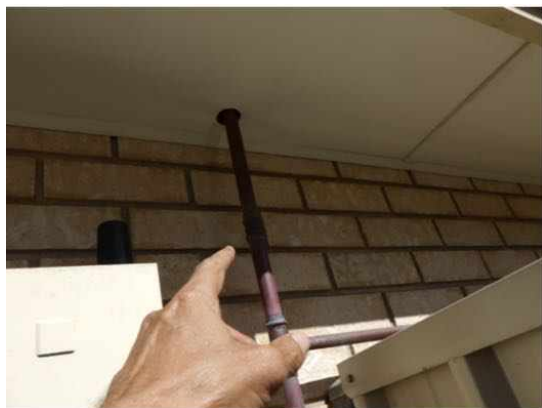
### Defects 3.08

Building:	Building 1
Location:	All External Areas
Finding:	Surface - Holes
Information:	At the time of inspection it was noticed that holes in the eaves in this area.

Holes in surfaces are generally indicative of impact damage, whether accidental or deliberate, or a failing of the surface material.

Where holes are apparent in the surface of a building material, the surface is no longer sealed against water penetration or further impact damage, which may lead to additional damage to the surrounding surface.

Repair or replacement of the affected building element is recommended as soon as possible to ensure that any secondary defects are minimised. A qualified carpenter or general handyperson should be appointed to perform these works.

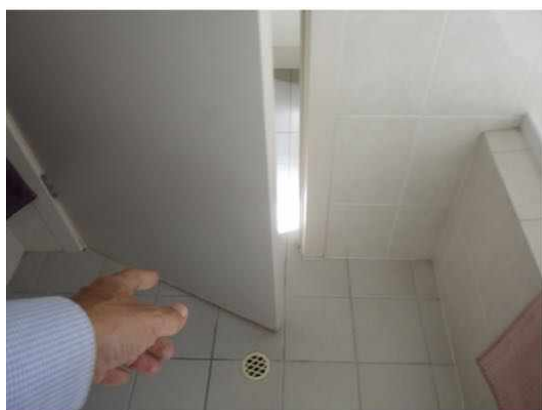
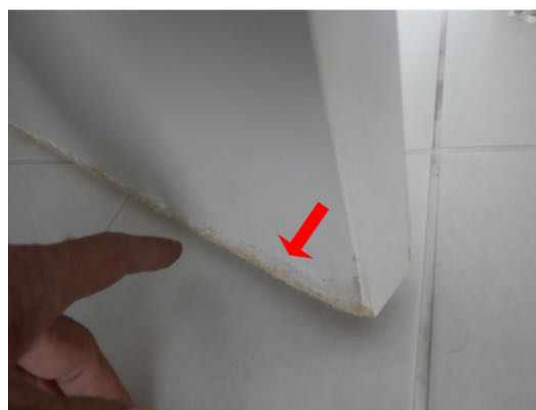
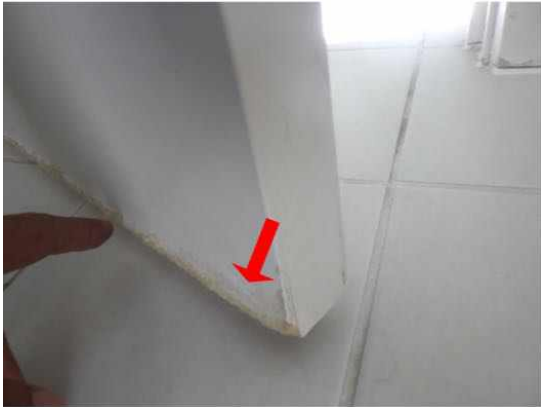
### Defects 3.09

Building:	Building 1
Location:	Bathroom
Finding:	Building element - Swollen
Information:	Swollen building elements generally indicate that the building materials have been affected by excessive moisture over a prolonged period of time, and have swollen as a result. The formation and development of mould/fungi or mildew is also a likely consequence of excessive moisture, which may pose major respiratory issues for occupants, particularly the elderly, the very young and those with existing illnesses and could be potential health safety hazards. In these cases an appropriately qualified inspector/tester should also be contacted for advice and/or technical assistance.

The structural integrity of swollen building elements can not be guaranteed, and further damage is likely to develop if left unmanaged. Excessive moisture is likely to lead to the development of secondary damage to any associated building elements, which may necessitate major reparation works if prolonged.

Rectification of the cause of the water leak should be addressed prior to any remedial works to the swollen building elements. A licensed plumber should be appointed immediately to identify the cause of the leak and provide advice on remedial works as necessary, Repair and/or replacement of swollen building elements should be conducted as a matter of urgency by a registered builder or qualified carpenter.

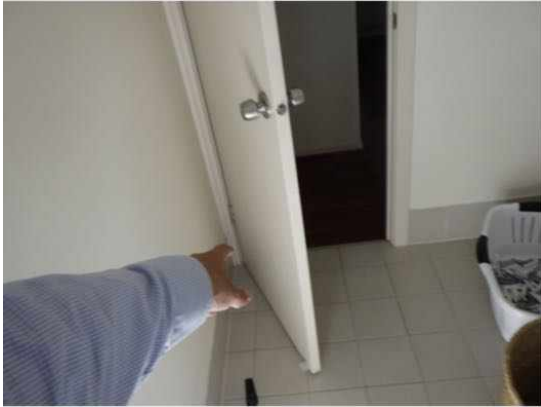
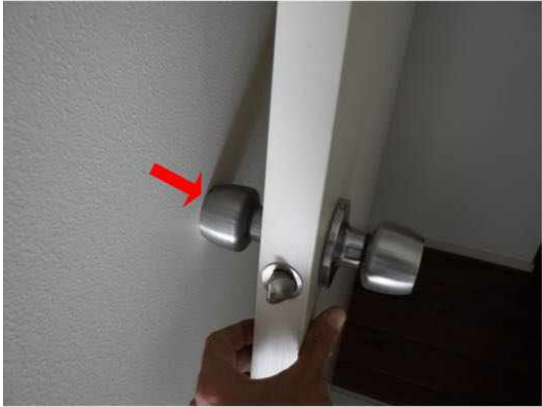
**Defects 3.10**

Building: Building 1  
Location: All Internal Areas  
Finding: Door stop - Missing  
Information: The door stop is missing or is inadequate to stop the door handle from damaging the wall. Although some building elements may seem irrelevant or unnecessary, all building elements play a key role in the operation and function of the overall structure and its performance.

Re-installation or replacement of the door stop is advised as soon as possible to prevent any subsequent damage to the door or associated structures. A general handyman may be appointed to perform these works at client discretion.

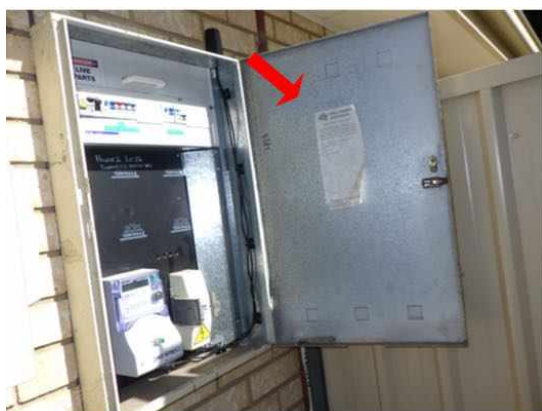
#### Noted Item

Building: Building 1  
 Location: All External Areas >  
 Finding: Termite Management System - No evidence of a chemical installation  
 Information: The application of a post-construction chemical termite barrier is highly recommended for all properties, particularly if live termite activity has been found on the site previously. Such barriers are highly effective in preventing termite attack on any timber building elements throughout the property.

A durable notice should be placed in the switchboard unit to indicate current termite barriers. At the time of inspection, it appeared as though no termite management system has been installed, with no evidence to suggest preventative works taking place.

The client may consider gaining further advice from a pest controller as to the costs and procedures involved with this application. It is recommended that obtaining such advice be a short-term priority.

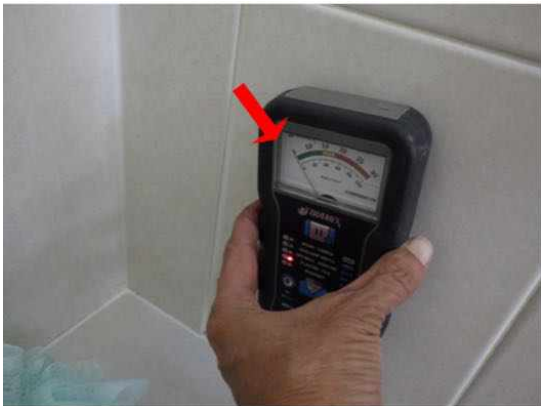
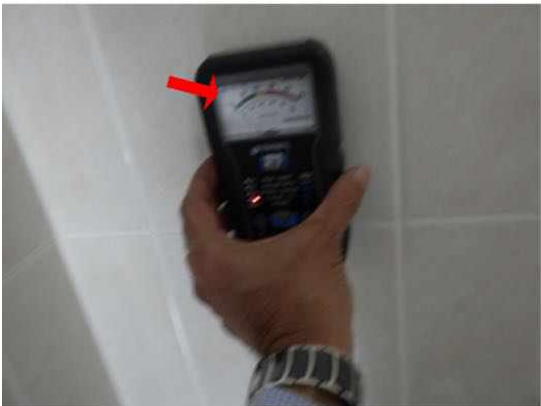
#### Noted Item

Building: Building 1  
 Location: Bathroom  
 Finding: Shower Alcove - No Damp  
 Information: At the time of inspection it was noticed that damp is not evident to the shower alcove.
