Building and Timber Pest Inspection Report

Inspection Date: Tue, 3 Feb 2026

Property Address: 7 Mallee Ct, Thurgoona NSW 2640,
Australia

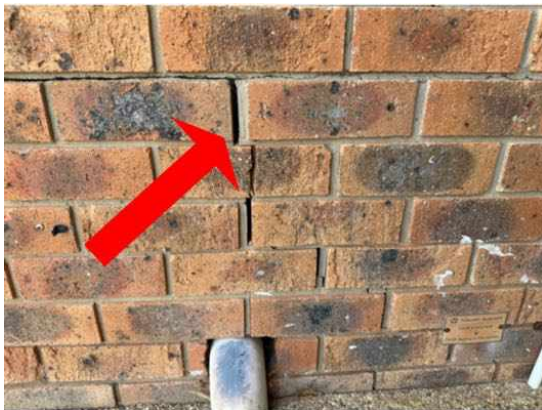
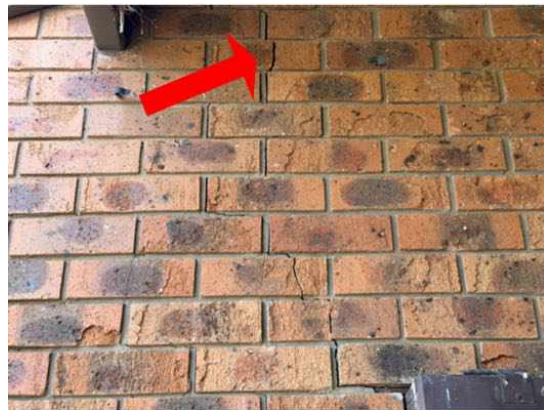
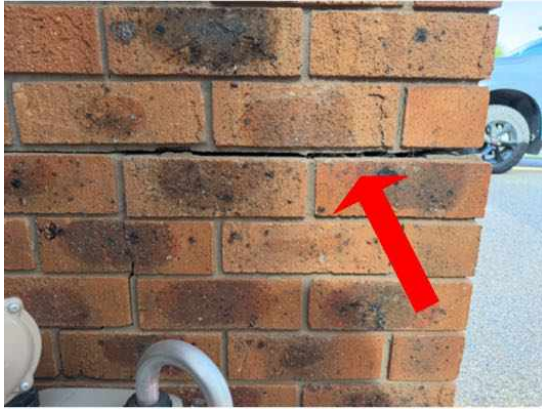
Finding 3.01

Building: Main Building
Location: Front Corner of Building
Finding: Brickwork - Step cracking
Information: Step cracking & evidence of movement was identified to some areas of the brickwork at, but not limited to the front right corner. Step cracking, has a variety of possible causes. However, the most common is general movement of adjacent footings.

The client should monitor the cracking. Should the step cracking lengthen, widen or become more numerous, the client should contact a structural engineer at their earliest convenience, to provide further advice.

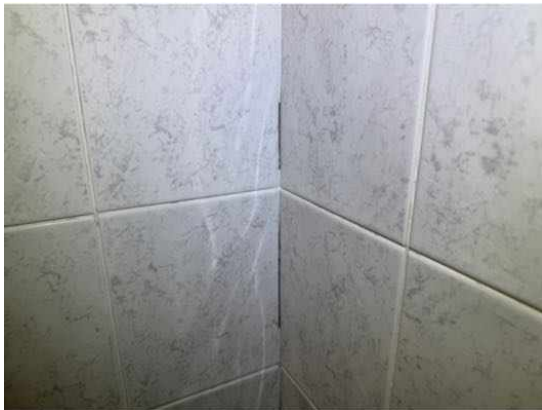
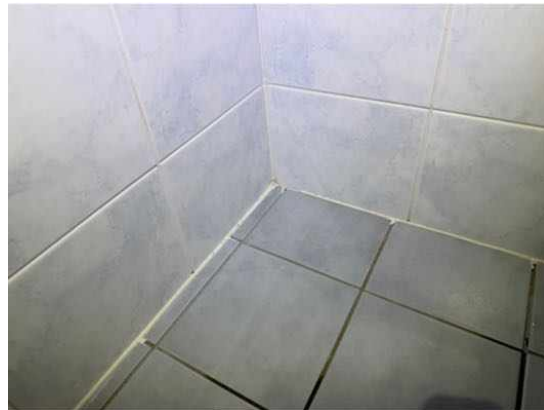
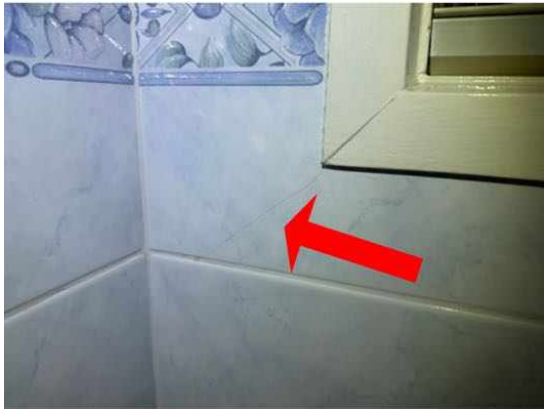
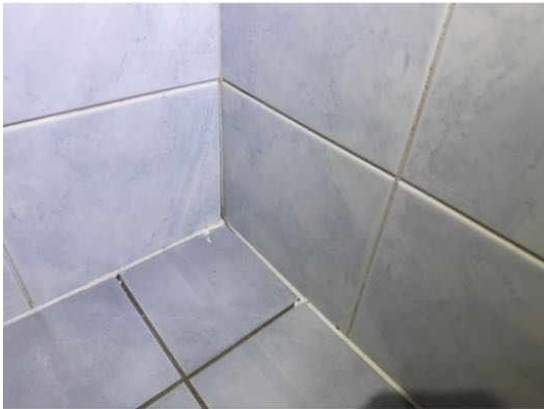
Finding 3.02

Finding: Sealant / grouting - deteriorated or missing & Cracked Tiles

Information: It appears that the sealant and grout has deteriorated in some tiled areas, a common defect in buildings of a similar age. Some cracked tiles were also noted, which can allow for moisture ingress behind the tiles, if neglected.

Sealant and grouting in areas that come into regular contact with water should be maintained for the long term care of your property.

Recommend engaging a licensed tiling contractor in the short term, to provide maintenance works where necessary.

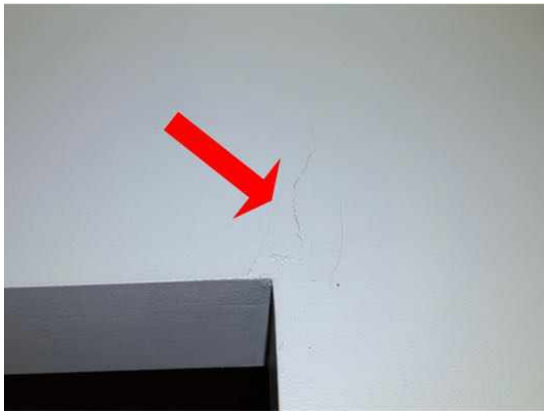
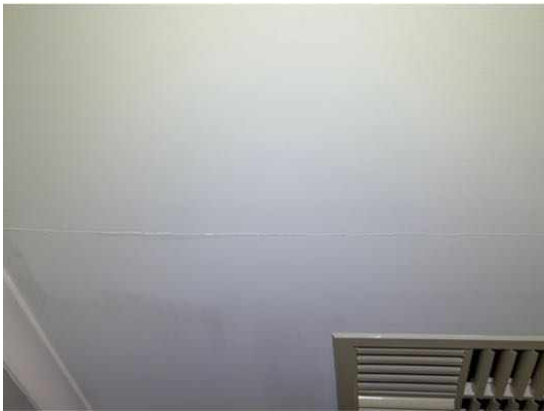
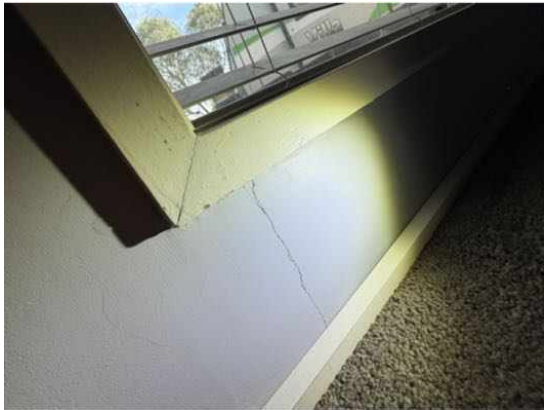
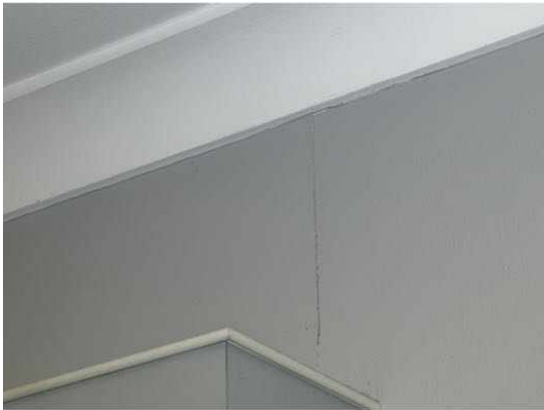
Finding 3.03

Building: Main Building
Location: Internal Walls & Ceilings
Finding: Plaster - Cracking
Information:

There appears to be cracking in some areas of the ceiling and wall linings throughout the building. Cracking of this type is common in buildings of a similar age. Although this is mostly a visual defect, it is advised that the client monitor these areas.

Should cracking widen, lengthen, or become more numerous, the client should consult with a structural engineer for further evaluation.

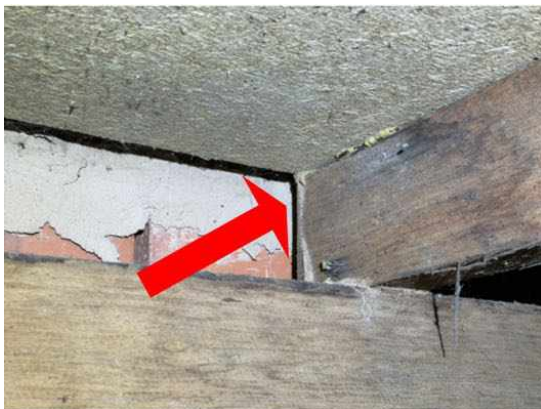
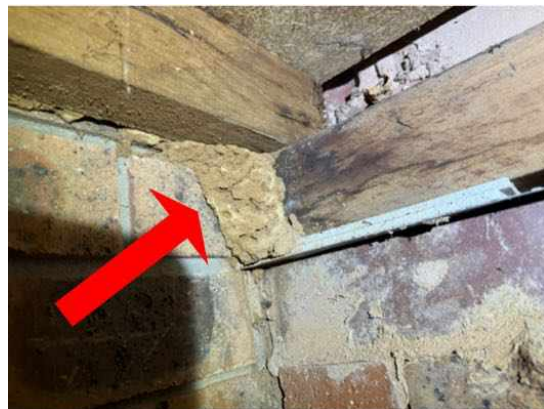
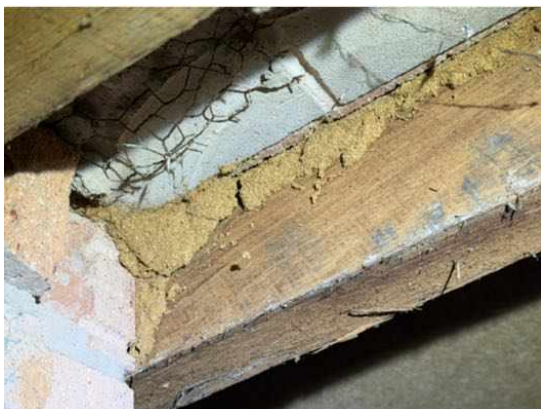
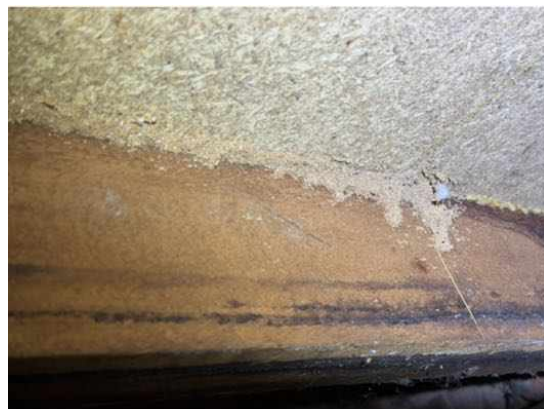
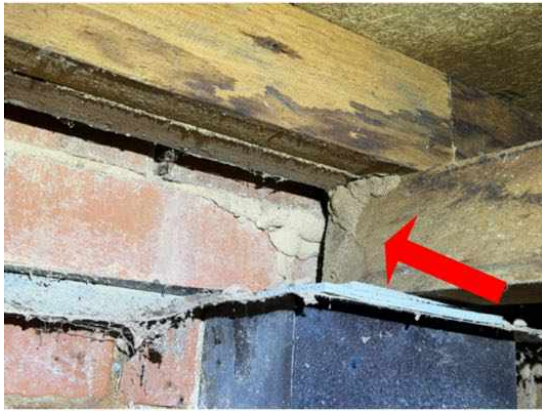
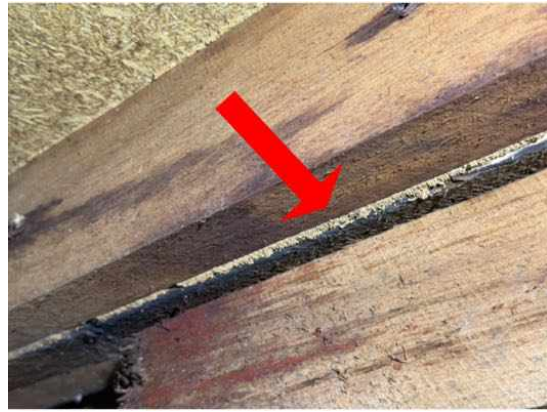
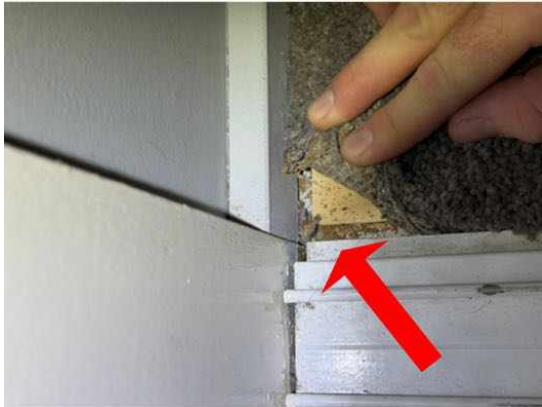
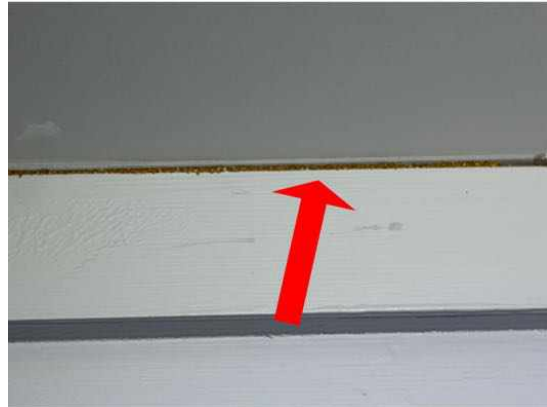
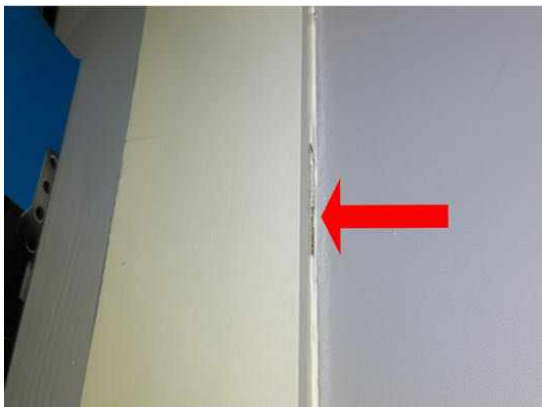
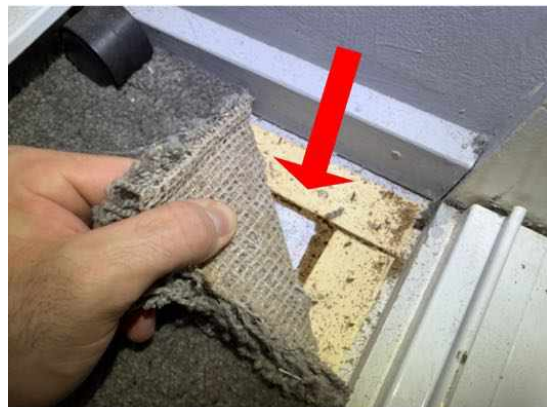
Finding 5.01

Building: Main Building
Location: Subfloor, Bedroom Cupboards
Finding: Evidence of termite workings & damage
Information: Previous termite workings were identified at, but not limited to, areas throughout the subfloor, bedroom cupboards, and carpet. It is advised that the client engage a licensed trade person to conduct a further inspection to identify the extent of termite-related damage.

Previous termite workings were found at, but not limited to several areas of the subfloor, bedroom cupboards & carpet. It is advised that the client engage a licensed trade person to conduct a further inspection to identify the extent of termite-related damage.

A termite treatment is in place & minimum 12 monthly termite inspections, conducted by a qualified termite inspector, are recommended.

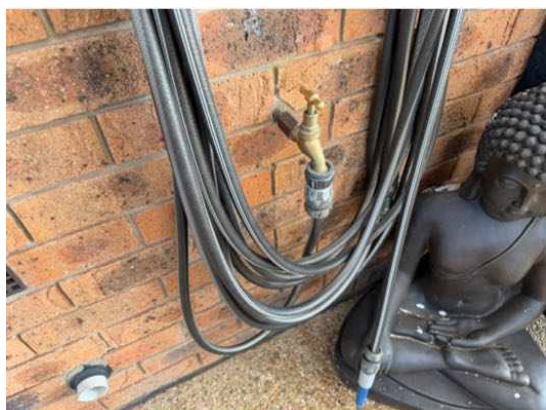
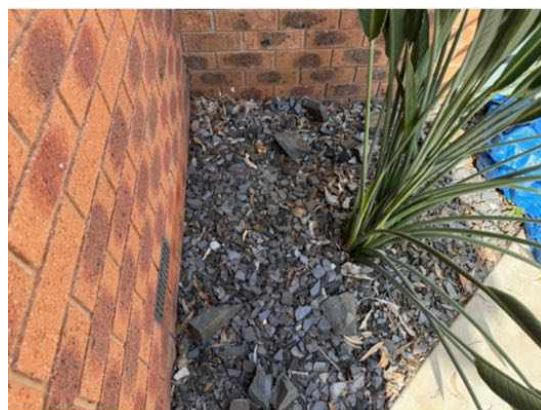
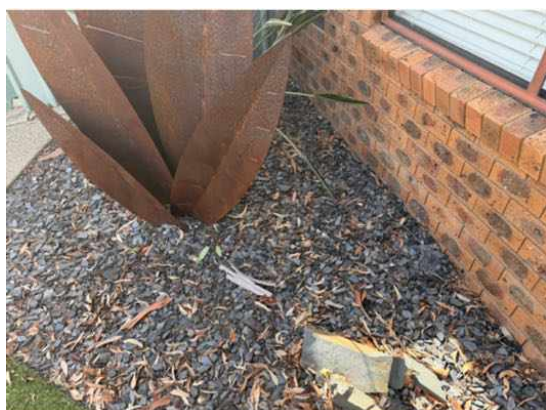
Finding 6.01

Building:	Main Building
Location:	All external areas
Finding:	Potential Water pooling - against property
Information:	It appears that there are potential areas around the perimeter of the property that could be susceptible to water pooling.

Where insufficient drainage of taps & garden beds against the house are present,

water pooling is likely to occur & can create areas conducive to timber pests and moist conditions in the subfloor, if neglected. Recommend consulting with a licensed plumber in the short term to provide remedial advice.

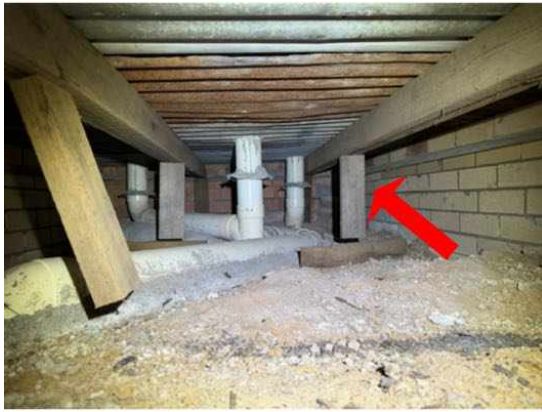
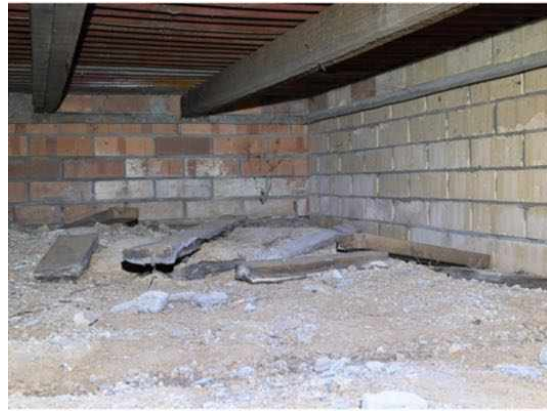
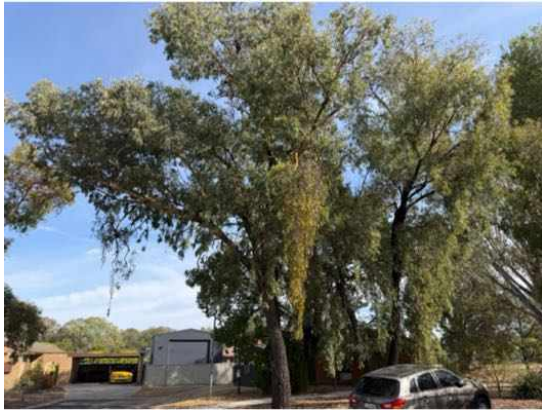
Finding 6.02

Building:	Main Building
Location:	All External Areas, Subfloor
Finding:	Timber in direct ground contact & trees - conducive to termites
Information:	Where timber materials are in direct contact with the ground and consequently moisture, they become conducive to termite activity. The timber debris in the subfloor, and trees surrounding the building create an environment conducive to termite infestation.

Where feasible, any timbers in direct contact with the ground should be removed and any trees in close proximity to the building should be removed or test drilled (inspected) at least annually to reduce the risk of termite infestation & detect any early signs of termite activity.

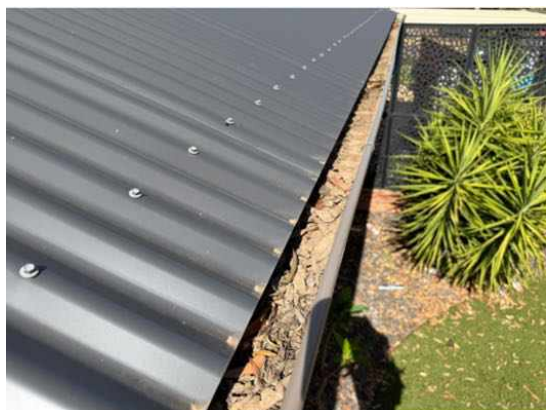
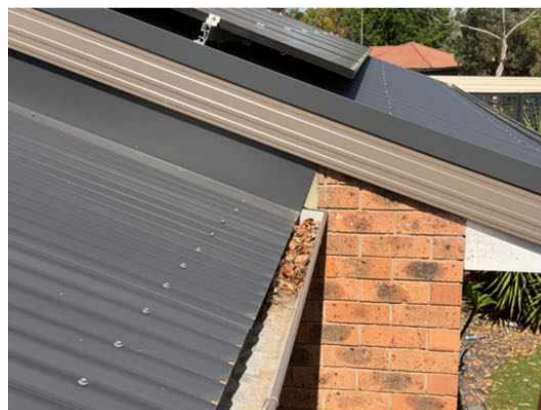
Building: Main Building
 Location: Guttering
 Finding: Debris in Gutters
 Information: It appears that some debris present in the guttering. Blockages of the guttering can lead to water pooling and accumulated water overflows, if neglected.

Recommend engaging a general handyman to remove debris from the gutters to prevent accumulated blockages.

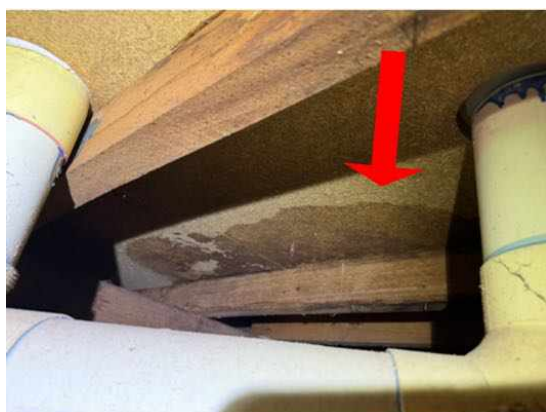
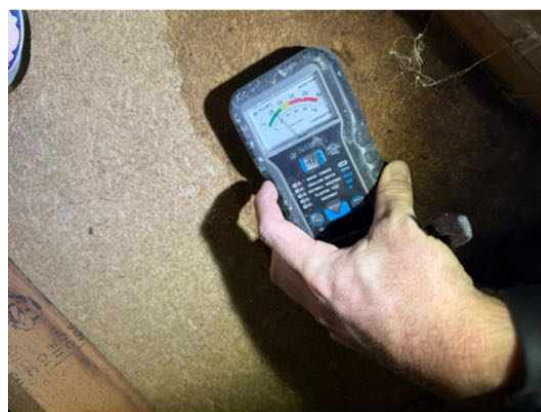
Building: Main Building
 Location: Subfloor beneath ensuite
 Finding: Water Staining Present
 Information: It appears that water staining was present at but not limited to, beneath the ensuite in the subfloor. Potential causes of leaking include deteriorated waterproofing or sealant & grout and/or damaged plumbing fittings and fixtures. No excessive moisture was evident in the area at the time of inspection.

It is recommended that the client monitor the area and engage a licensed plumber or tiling contractor, should the leak persist or return.

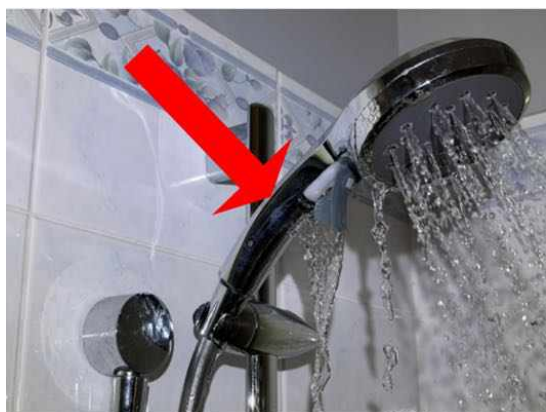
Building:	Main Building
Location:	Main Shower
Finding:	Shower Head - Leaking
Information:	Leaking was identified at, but not limited to the shower head of the main shower. Recommend engaging a licensed plumber at clients discretion, to provide minor maintenance works.
