# Building and Timber Pest Inspection Report

Inspection Date: Sat, 31 Jan 2026

Property Address: 113 Thompson St, Earlwood NSW 2206,  
Australia

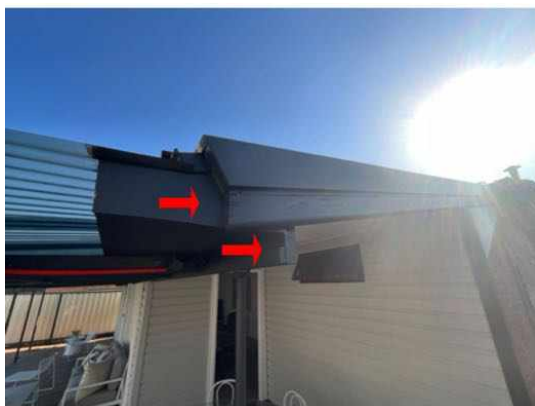
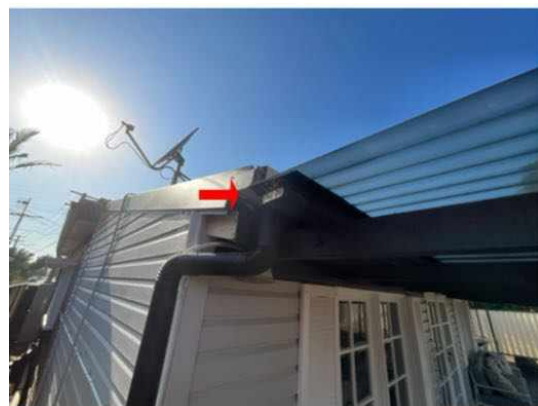
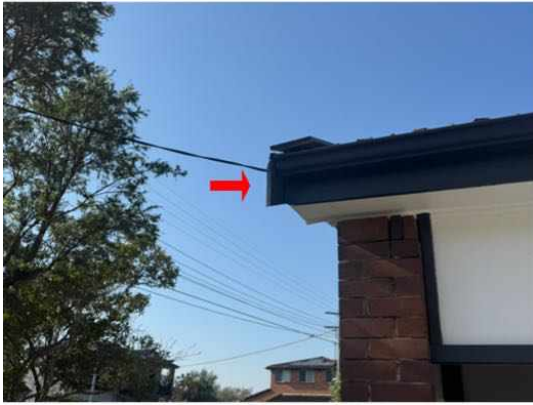
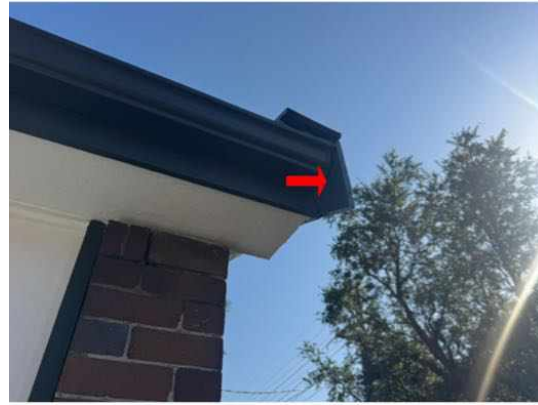
Building:	Main Building
Location:	External Areas
Finding:	Wood rot
Information:	This building element shows evidence of wood rot. Wood rot, also known as Fungal Decay, occurs when timbers and other cellulose building materials are exposed to damp conditions on an ongoing basis. This could be the result of exposure to weathering over a prolonged period of time, or the attraction of excessive moisture from other abutting building materials.

Early intervention and regular maintenance, particularly of exterior timbers, will prolong the useful life of these building elements. Prior to any works being performed, the cause of the moisture that has created the visible wood rot should be identified and addressed in a suitable manner. Replacement of affected timbers may then be a necessary step in protecting surrounding building elements from such deterioration.

A qualified carpenter or registered builder may also be required to replace affected building materials.

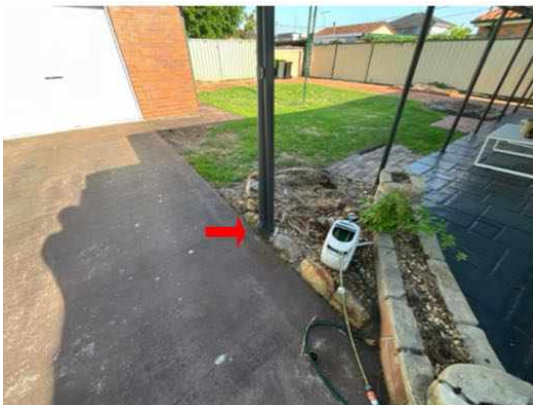
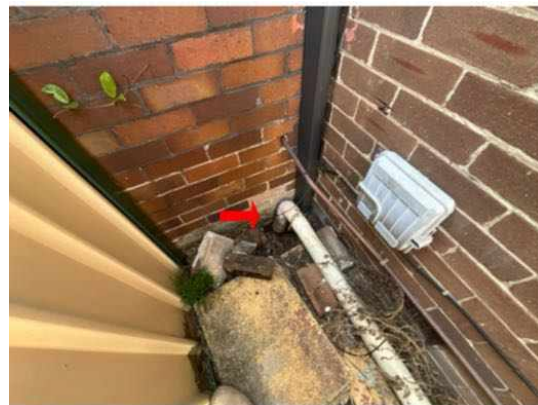
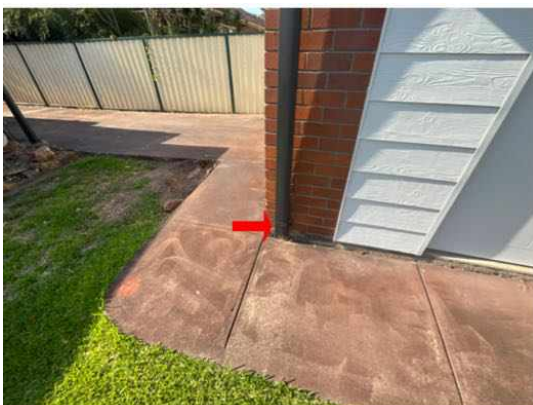
### Finding 3.02

Finding: Stormwater drain - Not connected

Information: The roof plumbing is not adequately connected to stormwater drainage on the site. This disconnection negatively impacts the functional capacity of the roof plumbing. Where roof plumbing doesn't drain adequately, the area at the base perimeter can become excessively damp, potentially creating an environment that is susceptible to rust and corrosion of surrounding building elements, as well as attracting termites and other pests. It is highly recommended that a plumber be appointed to further inspect the area and to install adequate drainage equipment where necessary.

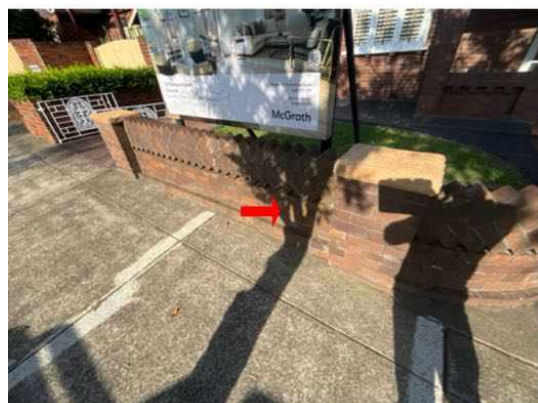
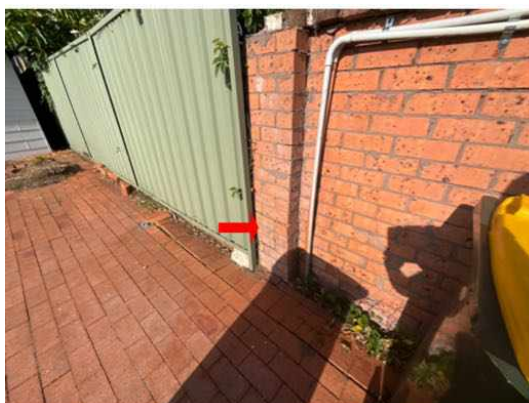
### Finding 3.03

Building:	Yard
Location:	Exterior walls
Finding:	Brickwork - Cracking noticeable
Information:	There were several cracks and or crack repairs evident to external brickwork.

Noticeable cracks are a common occurrence in external brickwork and are a likely result of age expected building movement, general expansion, and/or contraction of building materials in different weather conditions.

It is highly advised that a qualified bricklayer be appointed to provide necessary works to cracked brickwork to prevent any further damage.

Always monitor these cracks and contact a building inspector should cracks widen, lengthen, or become more numerous.

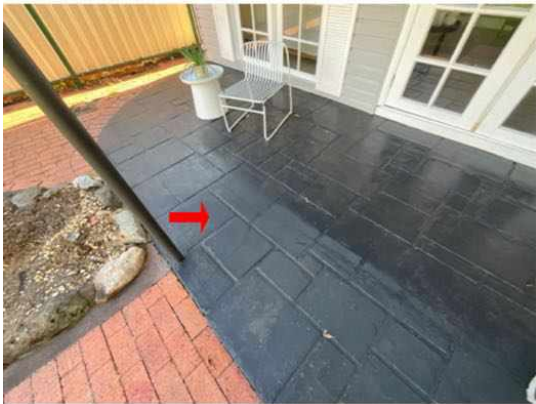
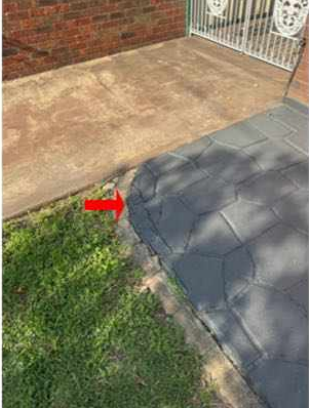
### Finding 3.04

Building:	Yard
Location:	Pathway
Finding:	Cracking - External Concrete Paving Damage Category 1 - Fine (less than 2mm)
Information:	Fine cracks were identified in external concrete paving. Although fine cracks are quite noticeable, they are often only considered to be an appearance defect, and usually do not indicate any structural damage. To be considered a Category 1 or fine crack, the crack is found to be less than 2mm in width.

Generally the cause of a hairline crack in existing concrete paving such as driveways and pathways is indicative of the expansion and contraction of the concrete. Such causes are generally due to environmental factors, such as moisture levels, weather conditions, root systems of nearby trees or the soil types on which they are laid.

Fine cracks may also be due to poor original installation of the concrete. Factors such as poor compaction of the sub surface and/or inadequate reinforcing of the slab may

create cracking and other secondary defects.

Monitoring of all cracking should be conducted frequently. Always contact a building inspector should cracks widen, lengthen, or become more numerous.

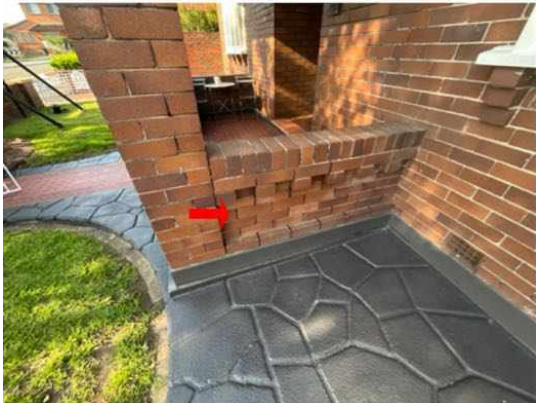
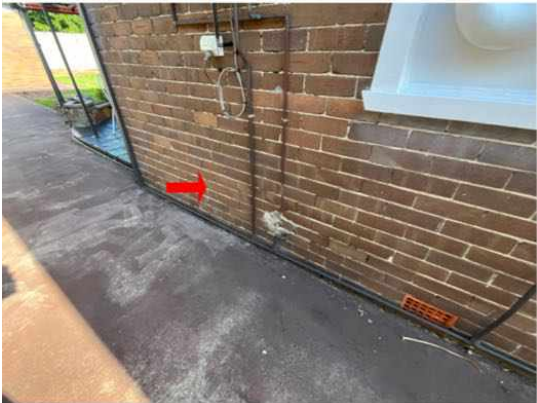
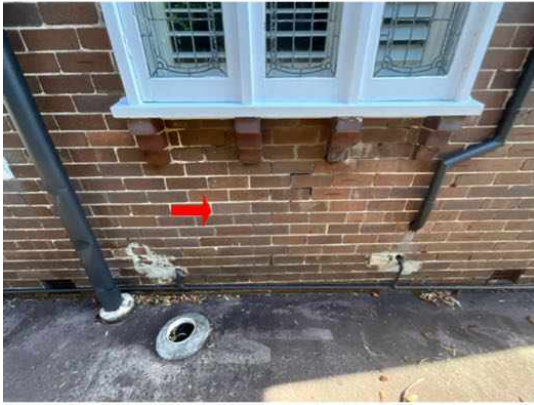
**Finding 3.05**

Building: Main Building  
Location: Exterior walls  
Finding: Brickwork - Deteriorated mortar  
Information: Mortar, or 'bedding', is the material which fills joins and intersections between bricks in masonry walls and structures. Sections of mortar in this brickwork were identified as having deteriorated.

Mortar deterioration can be addressed by a bricklayer.

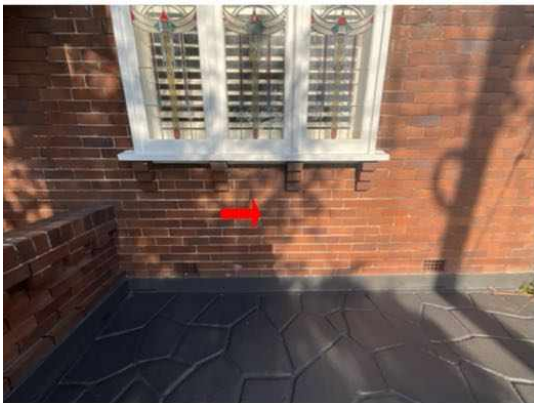
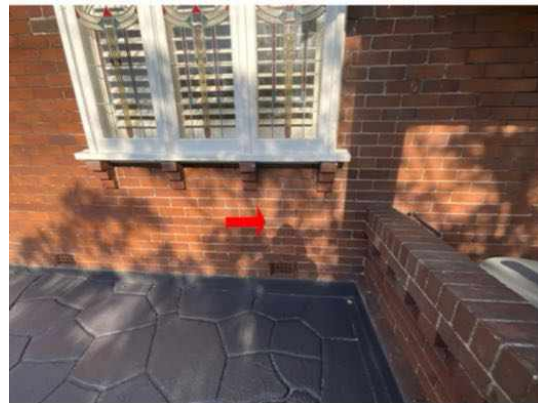
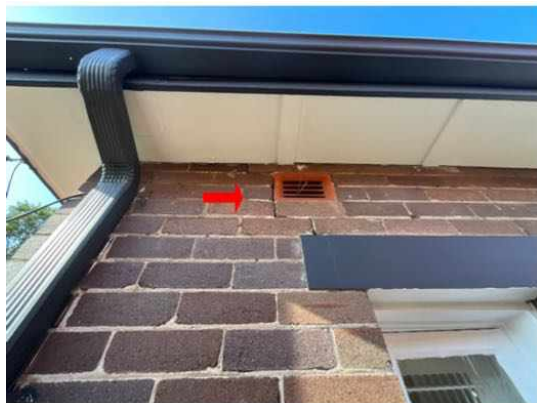
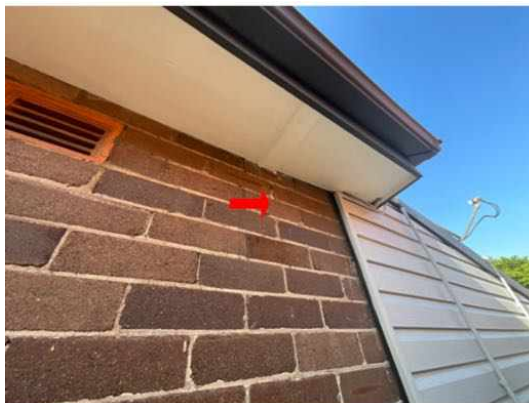
### Finding 3.06

Building:	Main Building
Location:	Exterior walls
Finding:	Brickwork - Cracking noticeable
Information:	There were several cracks and or crack repairs evident to external brickwork.

Noticeable cracks are a common occurrence in external brickwork and are a likely result of age expected building movement, general expansion, and/or contraction of building materials in different weather conditions.

It is highly advised that a qualified bricklayer be appointed to provide necessary works to cracked brickwork to prevent any further damage.

Always monitor these cracks and contact a building inspector should cracks widen, lengthen, or become more numerous.

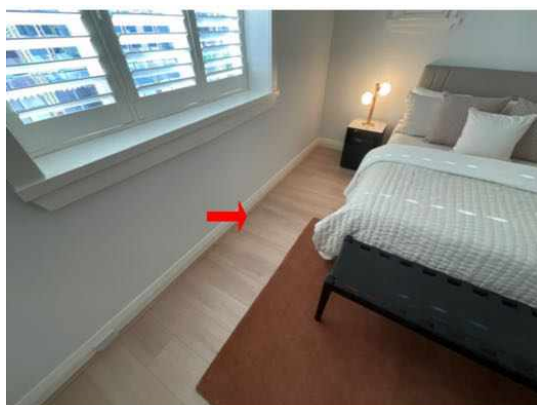
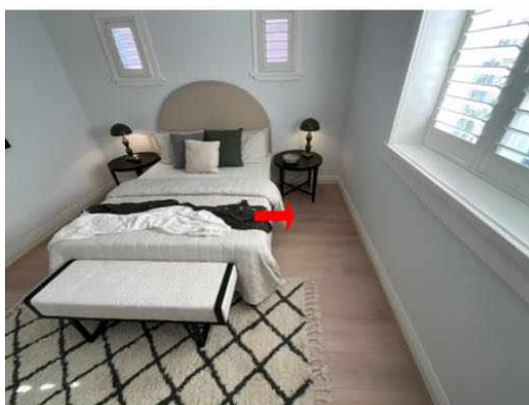
### Finding 3.07

Bouncy floors generally indicate that the floorboards or the subfloor structures are coming loose from the joists that they are installed on. Bouncy flooring may also be the result of gaps between flooring and joist structures, which require packing.

The client is advised to seek quotations for required repairs from a Registered Builder.

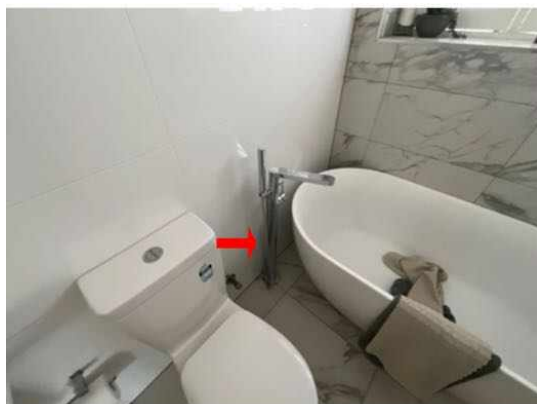
### Finding 3.08

Finding: Fitting or fixture - Loose (Bath Spout)

Information: The fitting in this area is loose and requires adjustment to tighten.

If left unmanaged, the fitting may further deteriorate, causing potential for the

development of other minor secondary defects.

A relevant tradesperson should be appointed to perform these rectification works at discretion of the client.

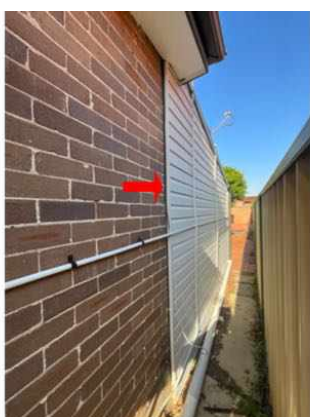
### Finding 3.09

Building:	Main Building
Location:	Exterior walls - right side
Finding:	Beads - Missing
Information:	Beading acts (like cornice or skirtings) to cover the intersection or joins of building materials. It was noted at the time of inspection that beading in this area is missing.

Beading is important in weatherproofing the surrounding building elements and preventing termite or pest ingress. Furthermore, beading works to protect the joins of building materials, which are more susceptible to deterioration and decay.

Replacement of the beading is advised to ensure the protection and longevity of any associated building elements. Such works may be performed by a general handyperson or qualified carpenter.

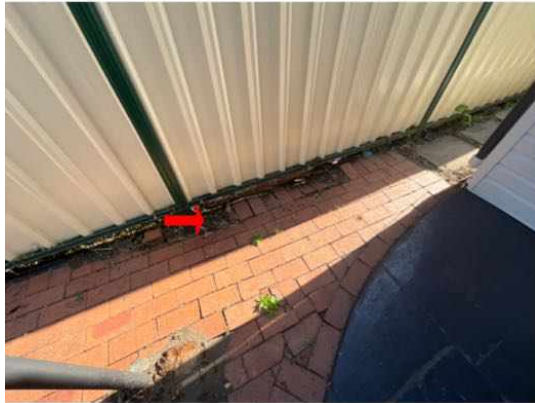
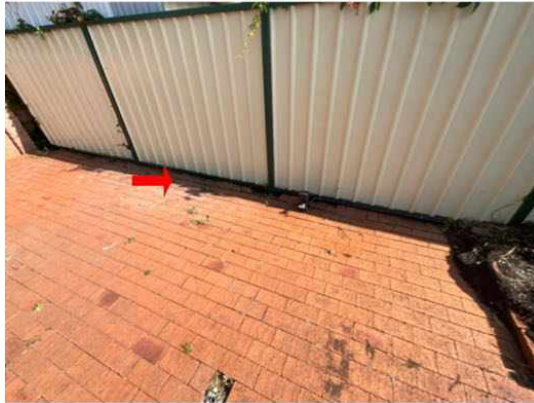
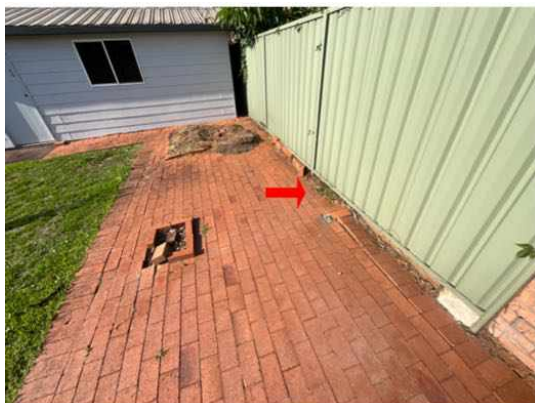
### Finding 3.10

Building: Yard  
Location: Yard - Back  
Finding: Paving - Uneven  
Information: Sections of the external paved area are uneven, creating a potential trip hazard. It appears as though the area has been subject to rough installation or uplift due to tree roots.

Re-paving of the area is required to remedy this situation.

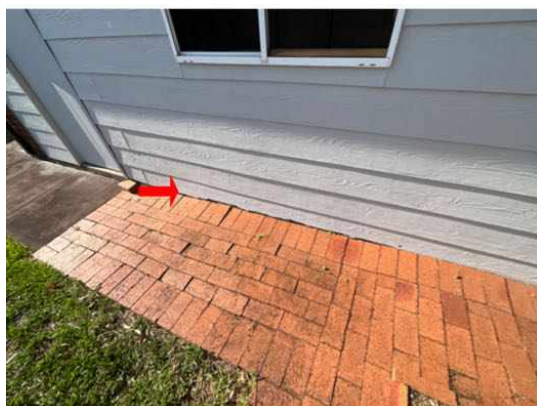
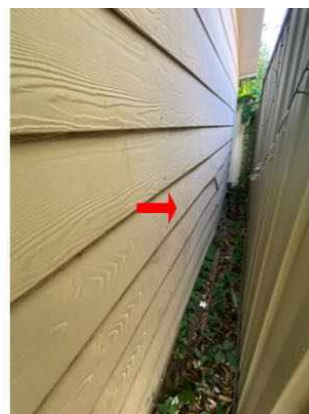
### Finding 3.11

Building: Garage  
Location: Exterior walls  
Finding: Deteriorated Linings  
Information: It was identified that the exterior lining was deteriorated.

I recommend appointing a builder to see what necessary works are required.

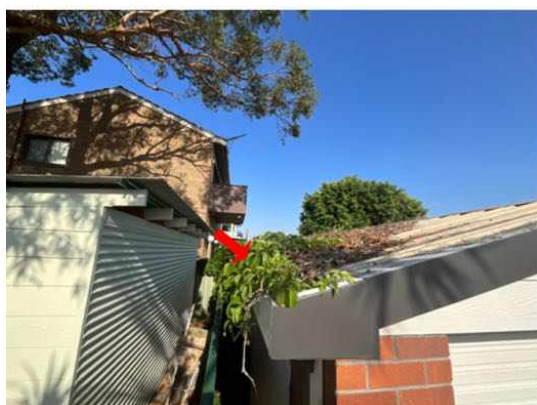
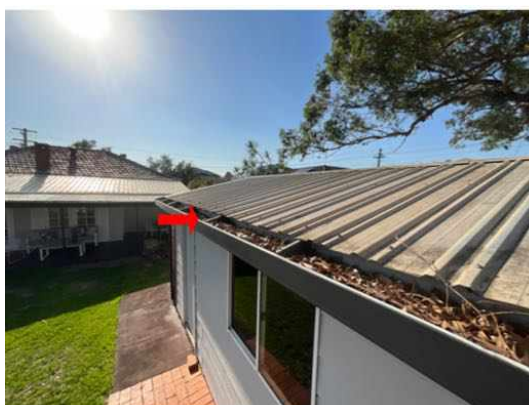
### Finding 3.12

Building:	Garage
Location:	Roof Exterior
Finding:	Gutters - Blocked
Information:	Roof plumbing structures, such as guttering and downpipes, should be free of all debris to prevent blockages. Blockages of the guttering and downpipes will lead to pooling and accumulated water overflows, which is likely to subsequently flood eaves and exterior walls.

Blocked gutters are likely to lead to high levels of moisture in the affected areas. Such moisture will not only cause rust and decay of the associated building materials, but can also provide conditions that are conducive to termite and timber pest activity. Blockages in gutters should therefore be removed to ensure dry conditions are maintained.

Consult a Licensed Plumber for further specific advice on remedial works that may be required. In the interim, it is highly advised that blocked gutters be removed by the homeowner or a general handyperson as a matter of urgency.

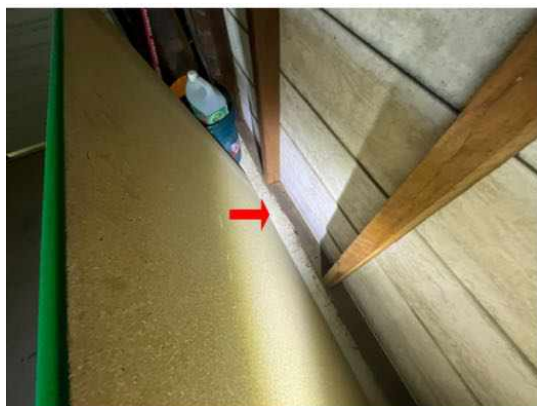
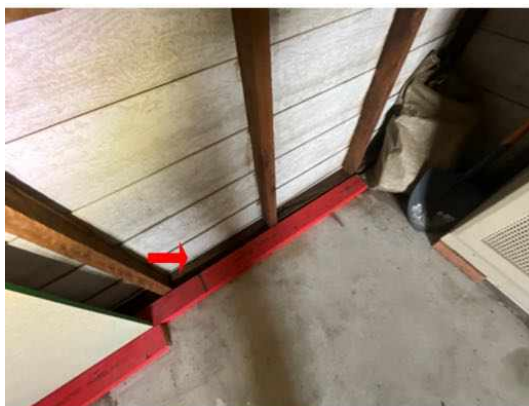
### Finding 3.13

Building:	Garage
Location:	Garage

Finding: Termite - damage identified  
 Information: Despite no live termite or timbered pest activity being indicated, termite damage was found to have affected this area.

A building contractor should be appointed to provide a further invasive inspection and to see what necessary works are required.

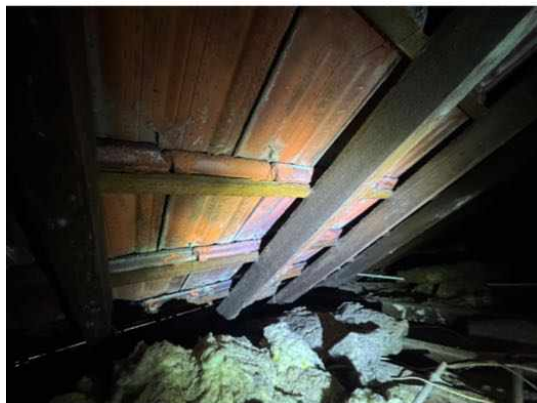
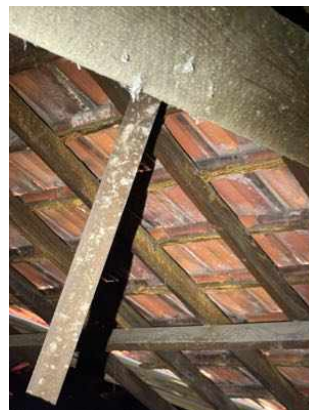
Building: Main Building  
 Location: Roof Void  
 Finding: Chemical delignification identified  
 Information: Chemical delignification also known as wood defibration refers to the chemical breakdown of timber building elements. This breakdown of the Lignin deteriorates the wood impacting on the structural integrity and tensile strength of the affected building element.

levels of salt in the air however this deterioration may also occur in other areas where timber elements are frequently exposed to damaging gases chemicals etc.

I recommend appointing a roofing contractor to see what necessary works are required.

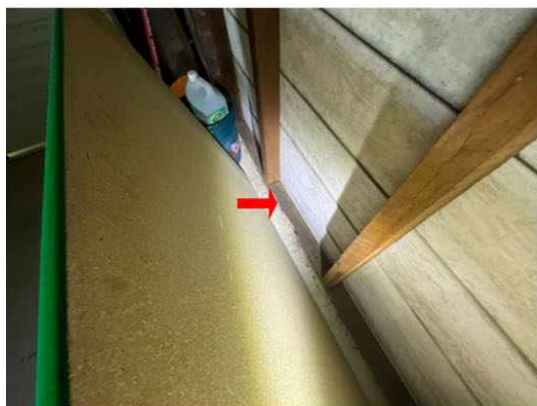
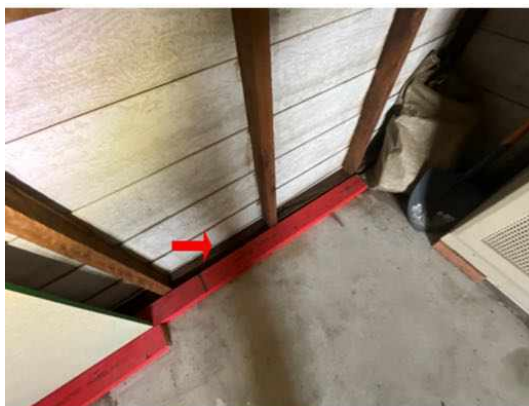
Building:	Garage
Location:	Garage
Finding:	Termite - damage identified
Information:	Despite no live termite or timbered pest activity being indicated, termite damage was found to have affected this area.

A building contractor should be appointed to provide a further invasive inspection and to see what necessary works are required.

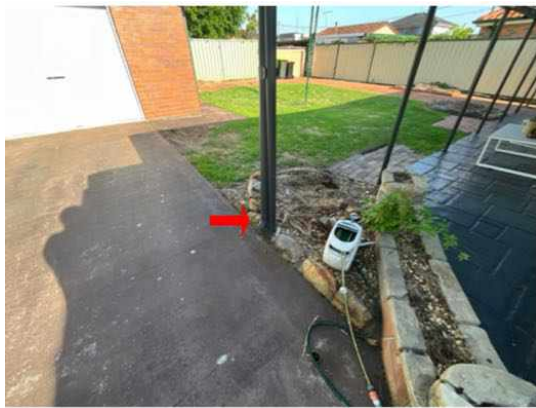
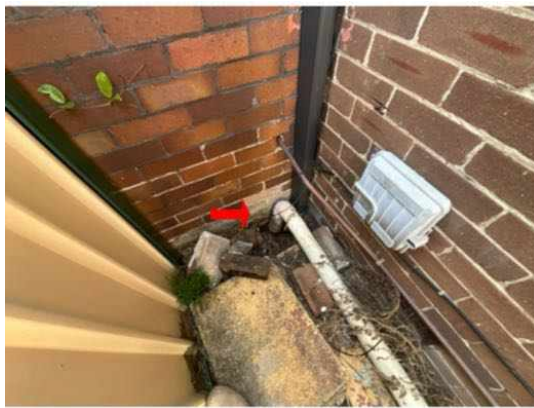
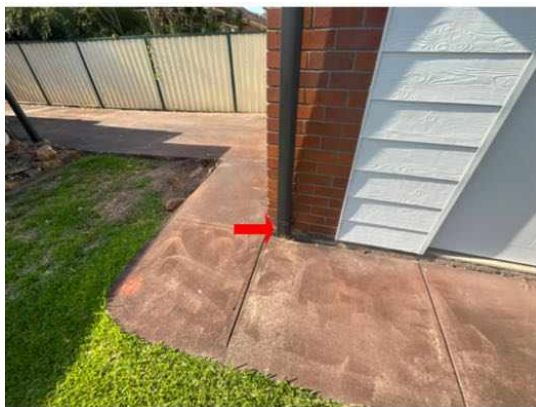
### Finding 6.01

Building:	
Location:	Exterior walls
Finding:	Excessive moisture - identified
Information:	Excessive moisture can attract termites and produce conditions that promote fungal growth and wood decay. Prior to any remedial works being performed a qualified plumber should be appointed to further inspect the property and to identify the cause of the excessive moisture.

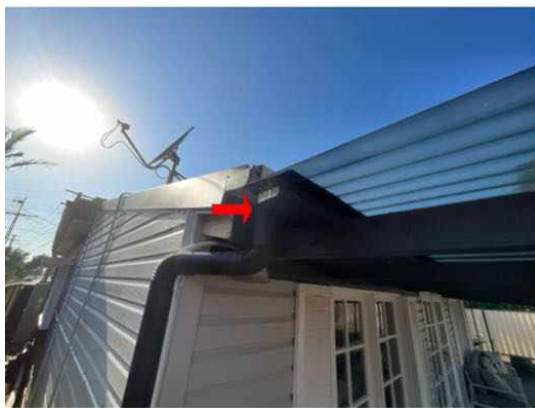
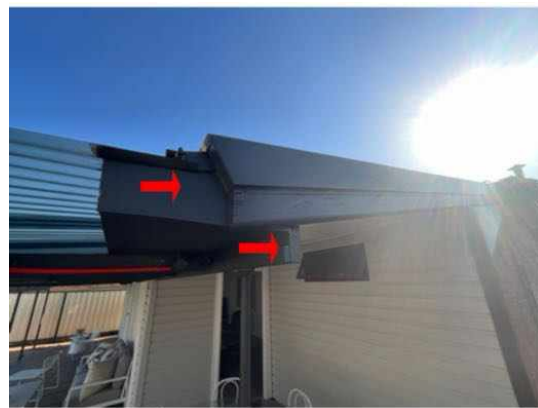
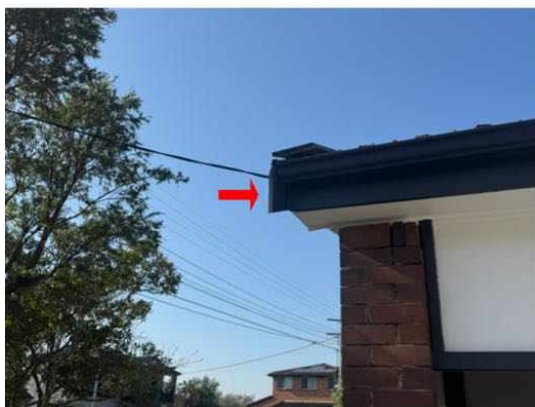
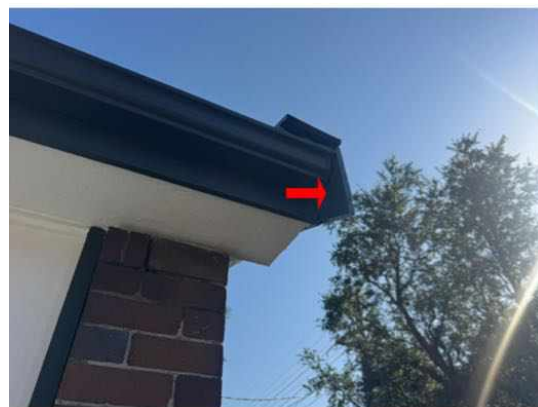
### Finding 7.01

Building:	Main Building
Location:	External Areas
Finding:	Fungal decay - present (localised)
Information:	Fungal decay also known as wood decay or wood rot generally refers to the

deterioration of timber elements when in contact with excessive levels of moisture for a prolonged period of time.

The development of fungal decay is accelerated by temperatures in the range of 5degreeC to 40degreeC as well as the presence of oxygen. Generally fungal decay develops on timber elements that are in use in an external environment which are exposed to rain penetration.

In this case although the affected timber element is in a decaying state the extent of any visible damage appears to be localised to a specific area and is yet to spread to other parts of the building element or affect adjoining structures. The fungal decay is therefore likely to be of a relatively superficial nature with minimal impact on the structural integrity or tensile strength of the timber element.
