Building Inspection Report

Inspection Date: Wed, 4 Feb 2026

Property Address: 29/17-19 Jenkins Rd, Carlingford NSW
2118, Australia

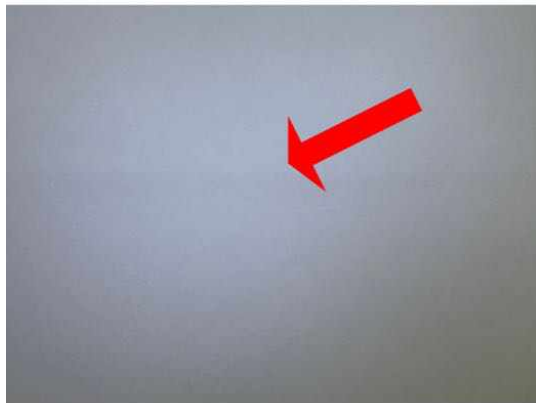
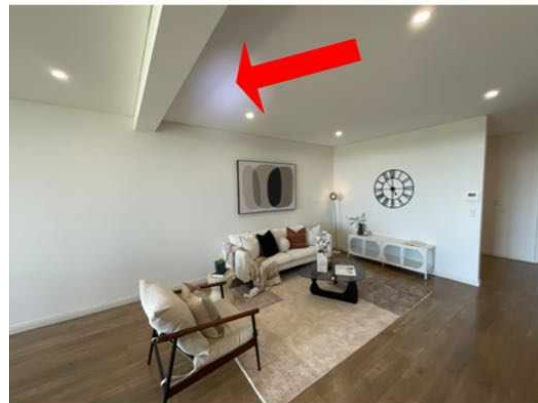
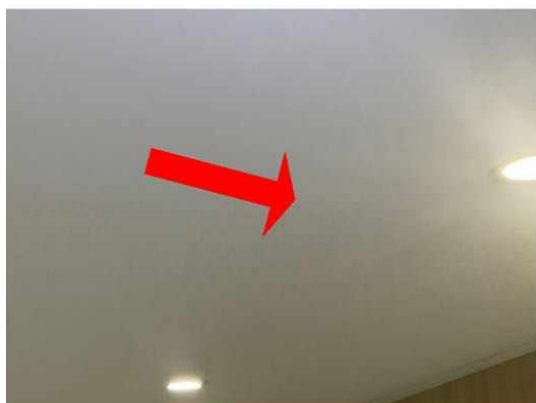
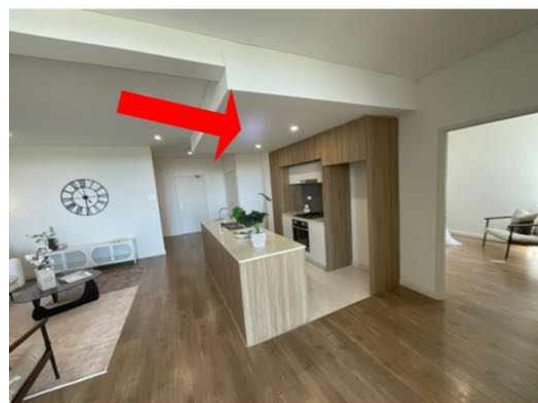
Defects 2.01

Building: Main Building
Location: All Internal Areas
Finding: Ceiling - Suspected water damaged
Information: Suspected water damage to the ceiling lining is generally an indication of excessive moisture being present in the ceiling, usually via a leak to the bathroom on top

Client to confirm with Vendor about the rectification the source of the leak. A plumber and or waterproofer should be appointed as soon as possible to identify the leak and perform rectification works as necessary, ensuring the water damage is restricted.

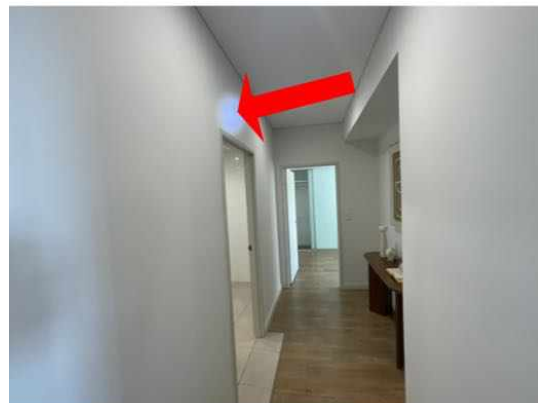
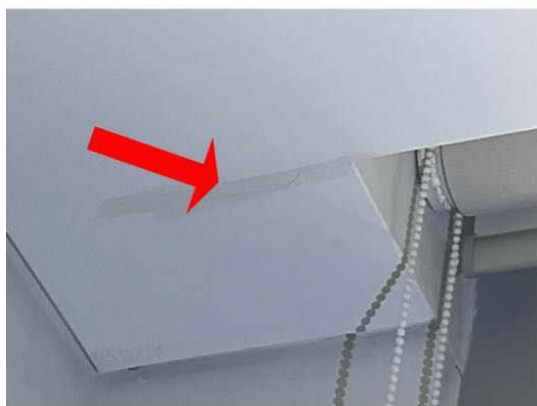
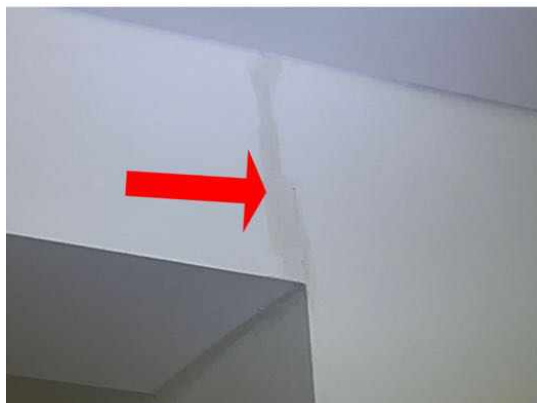
Defects 3.01

Building:	Main Building
Location:	All Internal Areas
Finding:	Cracking - Damage Category 1 - Fine (up to 1mm)
Information:	Although fine cracks are quite noticeable, they are often only considered to be an appearance defect, and usually do not indicate any structural damage. Generally, the cause of a fine crack is indicative of a separation between building materials and finishes (e.g. paint, plaster, etc.) along joins.

Cracking of this nature can generally be repaired with minor sanding, filling and/or repainting. Such works should be performed by a qualified painter or a general handyman.

Monitoring of all cracking should be conducted frequently. Always contact a building inspector should cracks widen, lengthen, or become more numerous.

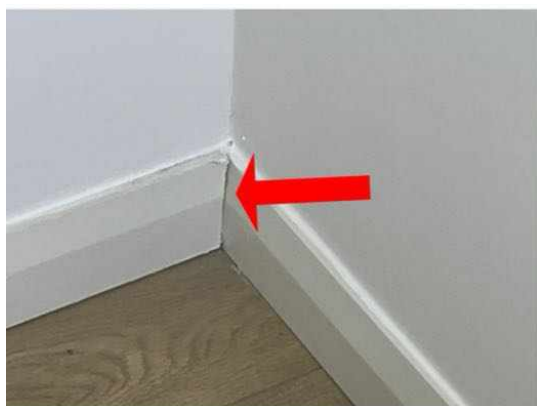
Defects 3.02

Building:	Main Building
Location:	All Internal Areas
Finding:	Paint finish - Substandard, Wear and Tear
Information:	The paint finish in this area was found to have been completed to a substandard level or wear and tear as the normal deterioration of a property from ordinary, everyday use. Exposure to the elements, time, as well as day to day living can cause fair wear and tear.

If this applies, further areas of poor and incomplete finishes could develop over time. Furthermore, substandard, wear and tear paint finishes in areas exposed to moisture, e.g. external areas or wet areas, could lead to deterioration of underlying building materials.

Substandard, wear and tear paint finishes should be sanded back, filled, leveled and repainted, as applicable. Where inadequate paint protection has led to the deterioration of the associated building element, repair and/or replacement of this building element may be required.

A painting contractor should be appointed as soon as possible to perform necessary works to aid the appearance of the affected area and to ensure that the area is protected against further deterioration. Alternatively, the homeowner following manufacturer instructions may be able to provide this service.

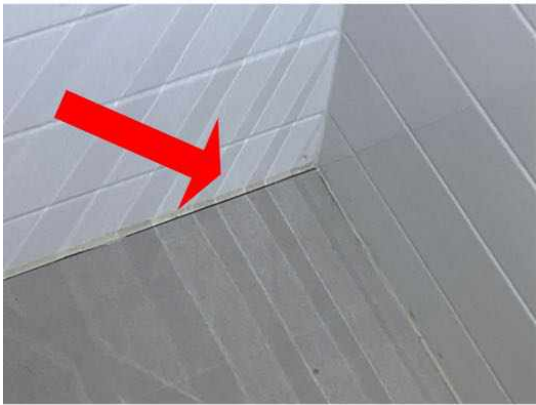
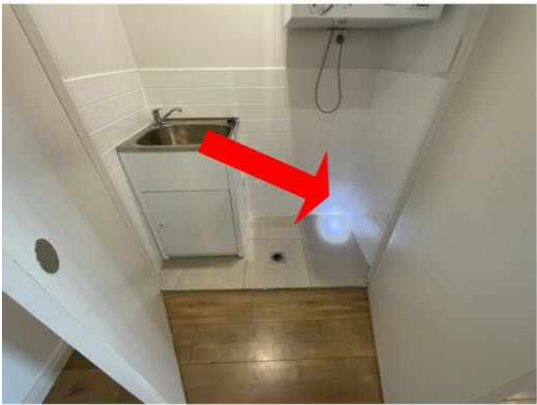
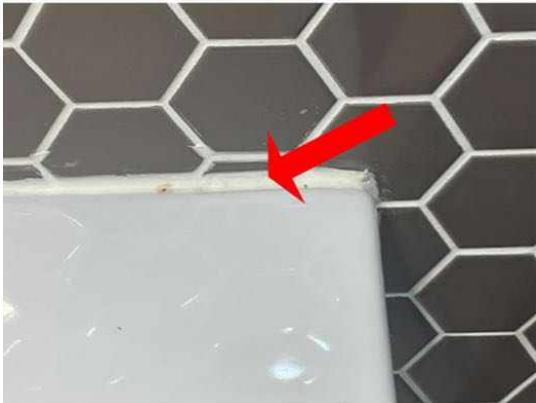
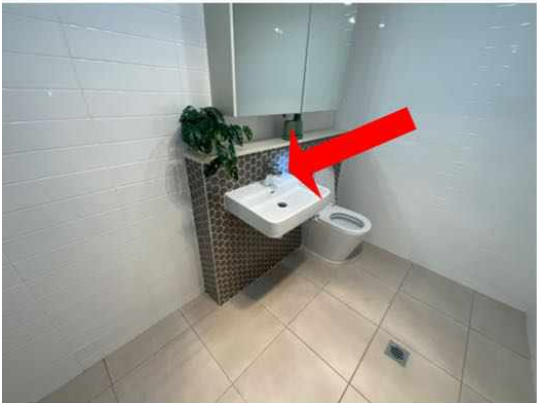
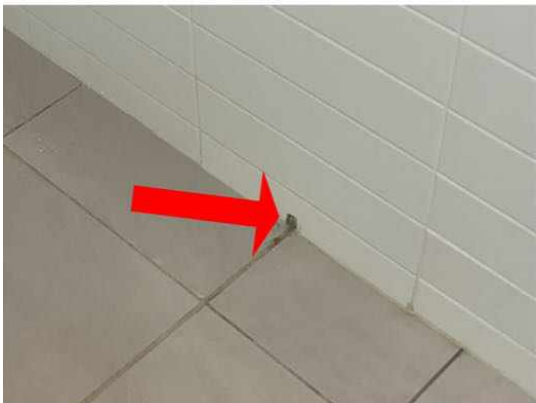
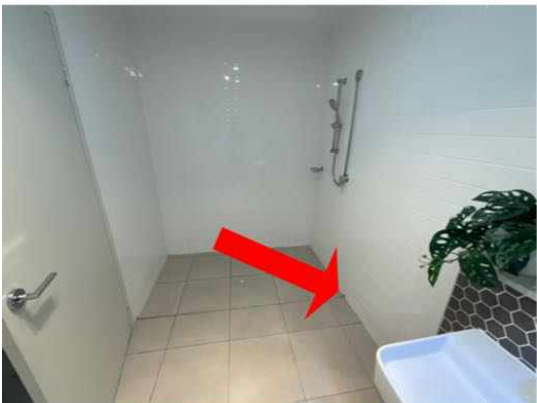
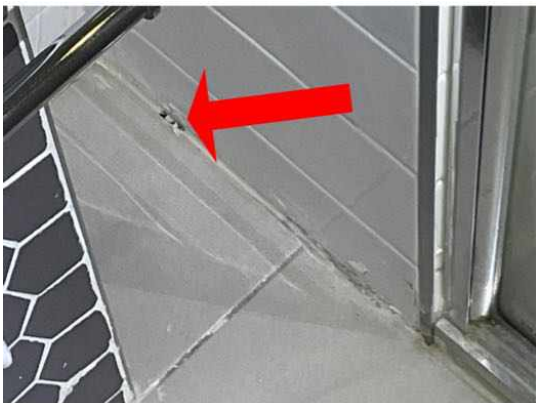
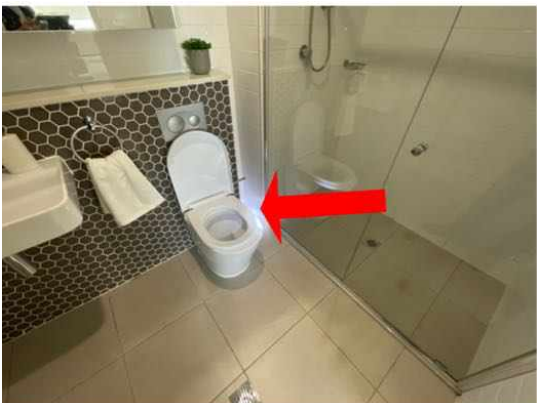
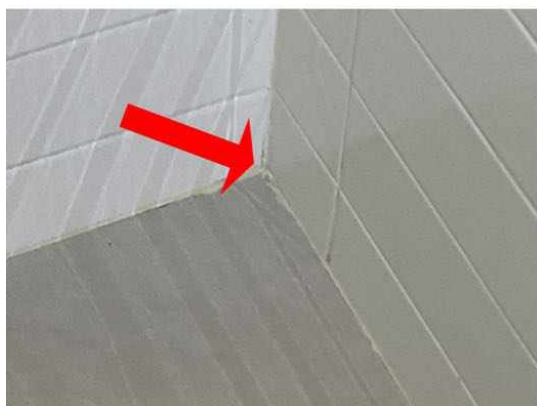
Defects 3.03

Building:	Main Building
Location:	Bathroom / Ensuite
Finding:	Sealant and grouting - Missing or damaged
Information:	It was noted on inspection that sealant or grout is degraded to the tiled shower alcove and or other areas of the bathroom.

Different materials and floor areas move at different rates, generally causing cracking to grout or sealant at this point. A flexible sealant is required to allow for expected expansion and contraction, while keeping the joint water tight and protective of all associated building materials.

There appears to be excessive mould to the sealant and grout which will likely require scraping out and replacement.

Flexible and mould resistant materials should be applied to affected areas to prevent any subsequent water damage that is likely to occur. Regular maintenance and replacement of damage or missing or damaged sealant and grout is highly recommended to the wet areas, as this is a regular wear and tear defect. Sealant and grouting in areas that come into regular contact with water should be maintained for the long term care of your property.

A sealant specialist or tiling contractor should be appointed to complete these works as soon as possible

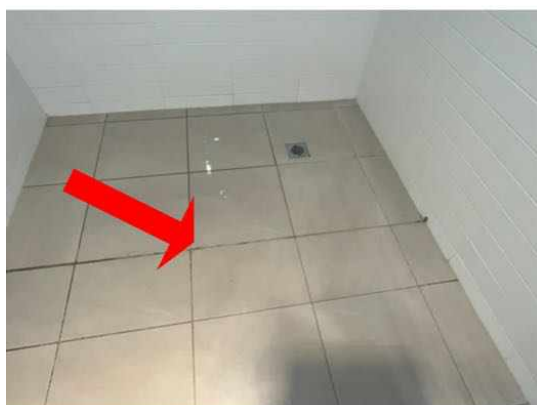
Defects 3.04

Finding: Shower Screen – Missing / Incomplete Work

Information: At the time of inspection, the shower recess was observed without a shower screen installed. The absence of a shower screen may result in water splashing outside the shower area, increasing the risk of water damage to floor finishes, wall linings, and adjoining areas.

The shower screen is required to ensure proper containment of water and to support compliance with NCC 2022 Vol 2 – Part 10.2 (Wet Areas) and AS 3740 – Waterproofing of domestic wet areas.

A compliant shower screen should be supplied and installed by a suitably qualified contractor prior to occupation.

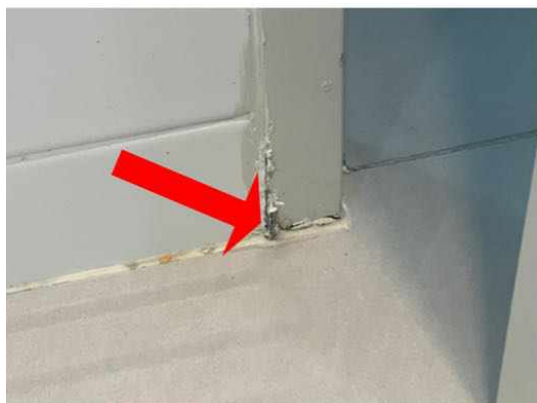
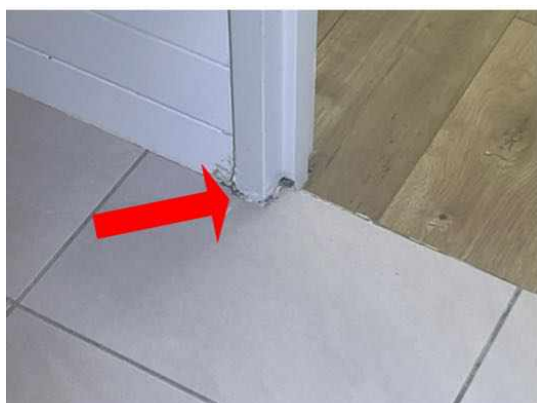
Defects 3.05

Finding: Bathroom - Damp

Information: Damp is evident to the lower 300mm of wall to the bathroom alcove. This defect is

quite common, and is suspected to have been caused by moisture permeating through the grouting in this area, which shows evidence of deterioration. Leaking pipes within the adjoining wall is also a possible cause. Damp (or structural damp) refers to the presence of unwanted moisture in the structure of a building, either as the result of intrusion from outside, or condensation from within the structure. In the bathroom area, internal water leaks or other sources of excessive moisture are generally the cause of damp. Unmanaged damp in the bathroom recess is likely to facilitate the formation and development of mould and fungi growth, decaying associated building materials and compromising their structural integrity. It is important to address damp conditions, as the World Health Organisation notes that excess moisture leads - on almost all indoor materials - to growth of microbes such as moulds, fungi and bacteria, which subsequently emit spores and other matter into the indoor air. Exposure to these contaminants is associated with a wide range of respiratory and other health-related problems. Consultation with a qualified plumber or bathroom specialist is advised immediately to identify the cause of damp and to perform remedial works as required. Where excessive mould growth is present, further inspection by a specialist environmental health inspector should also be considered. Always ensure that sealant and grout is in good condition to prevent any moisture issues occurring in the future.

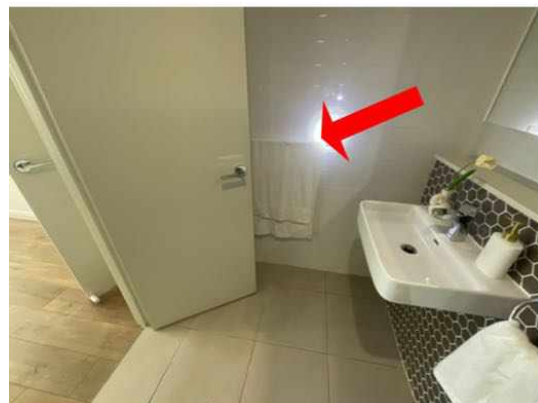
Defects 3.07

Building: Main Building
 Location: Ensuite
 Finding: Bathroom holders - Loose
 Information: The bathroom holder was found to be loose at the time of inspection. While not a major operational defect, function can deteriorate if the problem is left unmanaged.

It is advised that the homeowner performs remedial works to re-attach the bathroom holder to its original fixing. A general handyperson may be required to perform these works.

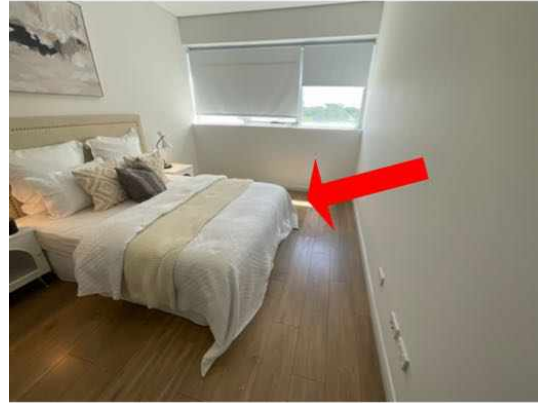
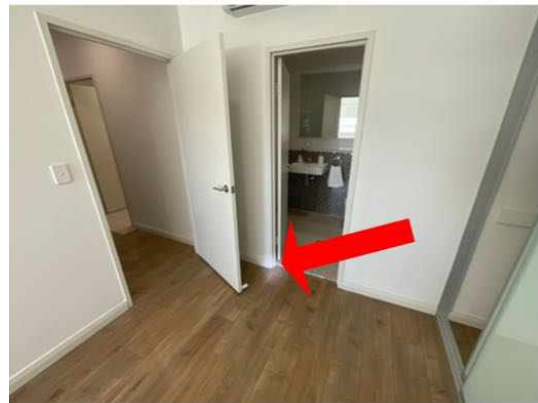
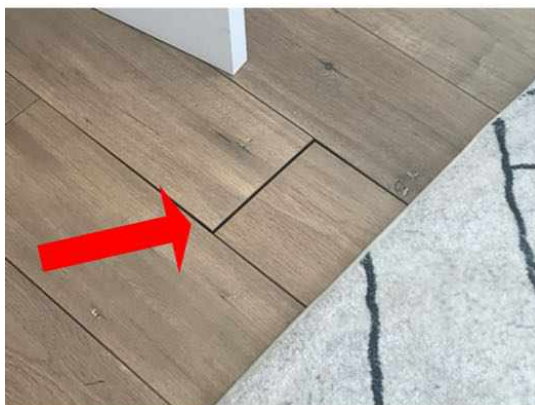
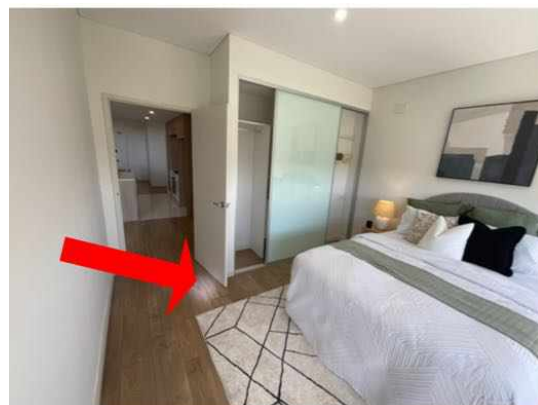
Defects 3.08

Location: All Internal Areas
 Finding: Float Timber flooring - damaged / gap
 Information: Damages / gaps to float laminate flooring were found during inspection. The laminate timber flooring is typically resistant to water damage, but standing water and large amount of moisture that gets under the floor (as the water has no place to evaporate) can eventually destroy the floor and delaminate the product.

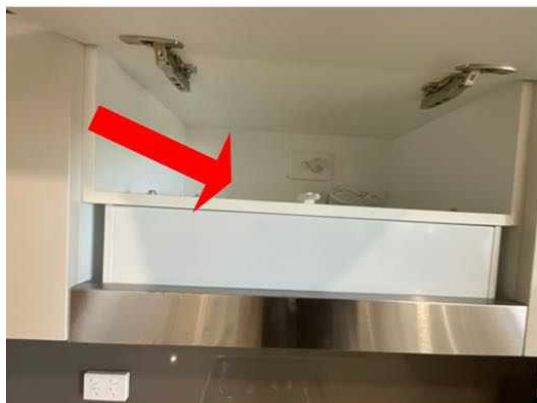
Defects 3.09

Building: Main Building
 Location: Kitchen
 Finding: Rangehood - Flue disconnected

Information: The range hood flue has become disconnected and is allowing the emission of steam and evaporative moisture into the ceiling space above.

While this does not create high potential for secondary defects, development of grease is likely to occur in the surrounding area, necessitating regular cleaning and maintenance.

Consultation with a licensed electrician may be required to reconnect the flue and thus allow the emission of gases into the external environment. Works should be completed at client discretion.

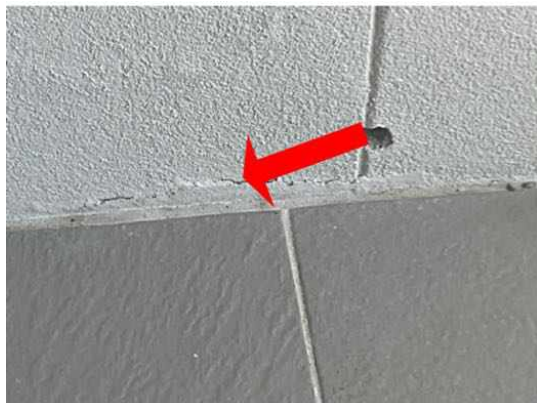
Defects 3.10

Finding: Render - Drummy

Information: Drummy rendered areas were identified at the time of inspection. The term 'drummy' refers to render that has become detached from its fixing, despite it still being solid. Such defects are generally caused by physical or moisture damage to the area. Drummy render may also be a direct result of poor workmanship during the construction process.

Render may swell and shrink with changes in air humidity if the area has sustained moisture damage. Any exposure to moisture is capable of causing rendered areas to become drummy and/or cracked over a prolonged period of time. Drummy render generally requires chipping off and re-rendering or painting.

Specialist trades are available for these types of services. A registered builder may be required to undertake works if damage is extensive, or if secondary building defects have resulted. Immediate action is recommended to ensure that no further damage is sustained in the affected area.

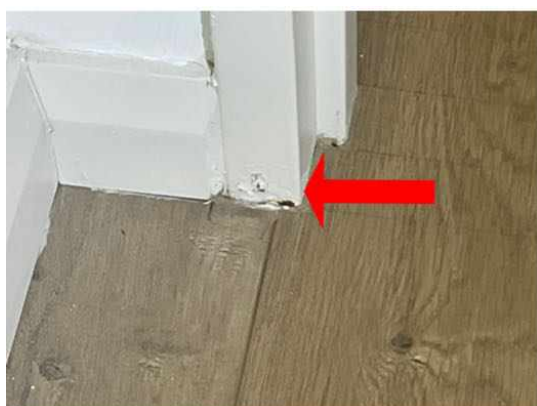
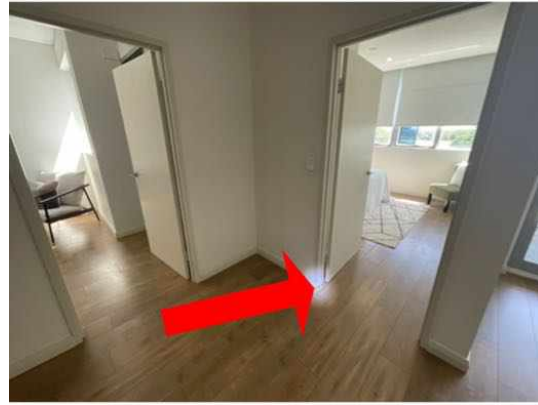
Defects 3.11

Building:	Main Building
Location:	All Internal Areas
Finding:	Building element - Rusted or corroded
Information:	This building element shows evidence of rusting and corrosion, which is likely to have developed as a result of excessive exposure to moisture and or inadequate coatings.

As surface rust provides no protection to the underlying iron, the deteriorating condition is likely to worsen if not addressed in the short-term future.

Where possible, the use of galvanized (treated) metals or aluminium coated metals aid in rust prevention, as does regular general maintenance. Rust formation can be controlled with coatings, such as paint, that isolate the iron from the environment.

Rusting and corrosion should be managed by ideally removing or limiting the affected surface from exposure to moisture. A registered builder may be appointed to replace any building elements that have been severely affected by rust or water damage.

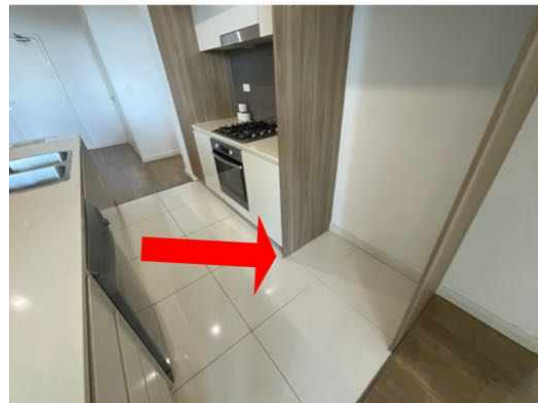
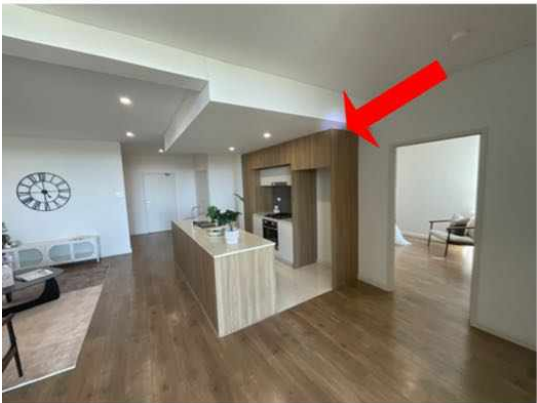
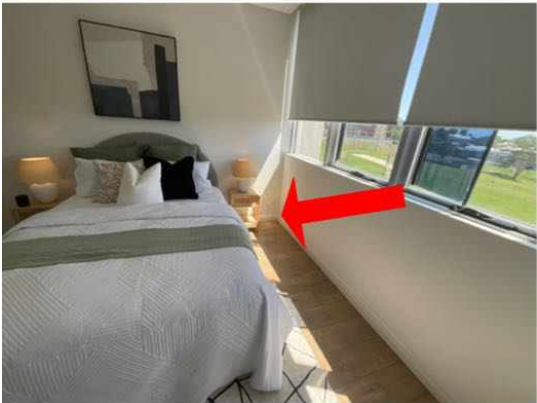
Defects 3.12

Building:	Main Building
Location:	All Internal Areas
Finding:	Incomplete or substandard works
Information:	The works to this area appear to be incomplete or have been completed to a substandard level.

Works that have not been completed to a satisfactory level create potential for the development of building defects and may impede on the safety and integrity of the overall structure.

It is highly recommended that the relevant trades be appointed to complete these works and ensure the safety of the area and the longevity of all associated building elements.

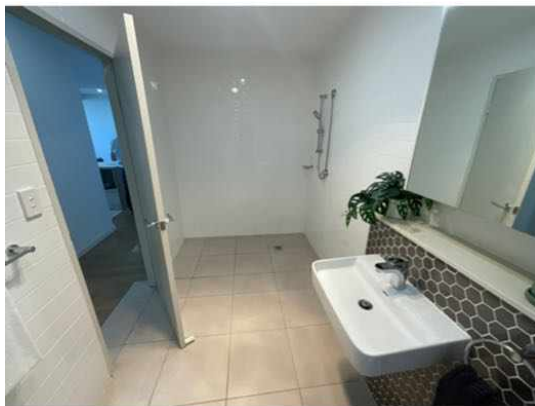
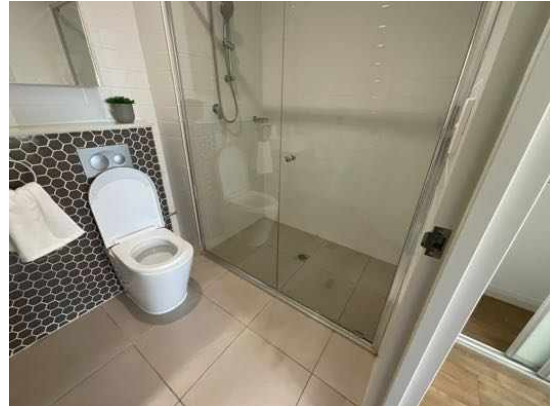
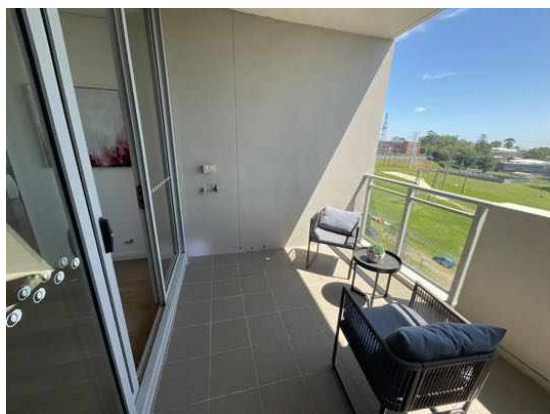
Building:	Main Building
Location:	All Areas
Finding:	Water Proofing Membranes - Information Only
Information:	<p>Internal Water Proofing Membranes, are crucial in preventing water ingress into the property is important to know that the Membrane System used is to Australian Standards and has been installed correctly. Please refer to the original Building Documents or Maintenance Schedule for the relevant information including; - Membrane used and Manufacturers Specifications. - The Installer and Installation Certification. Especially with older property's where this information is unavailable, all wet areas should be monitored. Generally new waterproofing with a certificate may only have a guarantee of 8yrs. If any leaks, water staining, peeling or bubbling of the paint become evident to any adjacent walls or ceilings below a licensed builder or waterproofing specialist is recommended to investigate further.</p>
