Building and Timber Pest Inspection Report

Inspection Date: Wed, 18 Mar 2026

Property Address: 3 & 3A St Johns Rd, Campbelltown NSW
2560, Australia

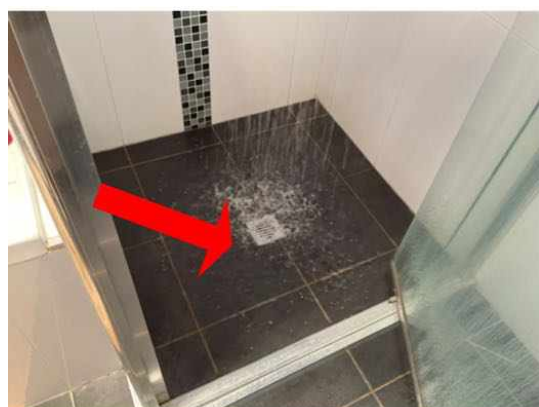
Building: Main Building
Location: Bathroom
Finding: Shower base - Water pooling
Information: Evidence of water pooling around the floor waste in the shower recess was noticed at the time of inspection. It is suspected that this excessive moisture is attributed to insufficient fall in the shower floor tiles.

This pooling is minor overall but is still considered unsatisfactory, as standard tiling practices would not permit this situation to occur. Pooling water around floor wastes can create a slip hazard in extreme cases and create conditions that are conducive to mould growth over time. Where left unmanaged, the degradation of sealant and grouting is also likely to occur, possibly necessitating further repair works.

Remedial works may involve some sections of tiling and flooring repair and replacement. A tiling contractor or bathroom specialist should be appointed to provide further advice on reparation options and to perform works as necessary.

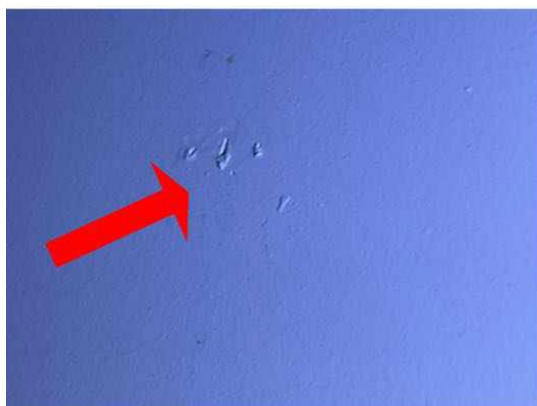
Building:	Granny-Flat
Location:	All Internal Areas
Finding:	Paint finish - Substandard, Wear and Tear
Information:	The paint finish in this area was found to have been completed to a substandard level or wear and tear as the normal deterioration of a property from ordinary, everyday use. Exposure to the elements, time, as well as day to day living can cause fair wear and tear.

If this applies, further areas of poor and incomplete finishes could develop over time. Furthermore, substandard, wear and tear paint finishes in areas exposed to moisture, e.g. external areas or wet areas, could lead to deterioration of underlying building materials.

Substandard, wear and tear paint finishes should be sanded back, filled, leveled and repainted, as applicable. Where inadequate paint protection has led to the deterioration of the associated building element, repair and/or replacement of this building element may be required.

A painting contractor should be appointed as soon as possible to perform necessary works to aid the appearance of the affected area and to ensure that the area is protected against further deterioration. Alternatively, the homeowner following manufacturer instructions may be able to provide this service.

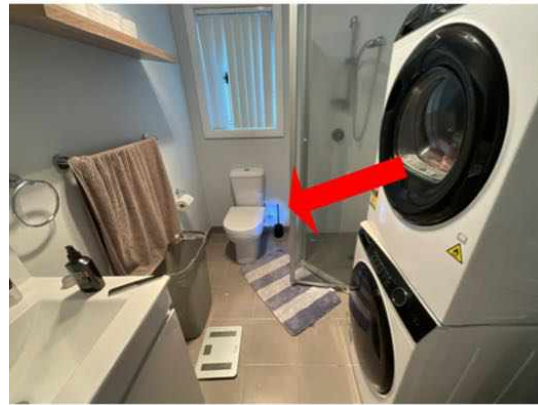
Building: Granny-Flat
Location: All Internal Areas
Finding: Plasterboard finish - defective
Information: The finish of the plasterboard in the identified area is defective as it falls below Level 4 category finish as defined in AS 2589.1 Section 6.6 Levels of Finishes for Plasterboard Surfaces. The key features of a Level 4 finish include: joints and fasteners adequately concealed joints and interior angles to have tape embedded in joint compound and at least 2 coats of joint compound to each joint angle fasteners accessories. A level 4 finish should be smooth and free of tool marks or ridges.

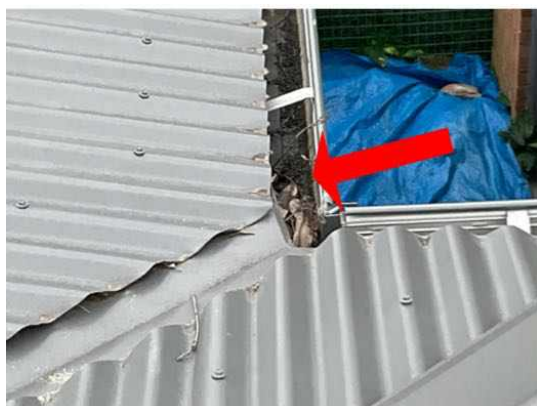
Building:	Granny-Flat
Location:	Roof Exterior
Finding:	Gutters - Blocked
Information:	Roof plumbing structures, such as guttering and downpipes, should be free of all debris to prevent blockages. Blockages of the guttering and downpipes will lead to pooling and accumulated water overflows, which is likely to subsequently flood eaves and exterior walls.

Blocked gutters are likely to lead to high levels of moisture in the affected areas. Such moisture will not only cause rust and decay of the associated building materials, but can also provide conditions that are conducive to termite and timber pest activity. Blockages in gutters should therefore be removed immediately to ensure dry conditions are maintained.

Consult a Licensed Plumber for further specific advice on remedial works that may be required. In the interim, it is highly advised that blocked gutters be removed by the homeowner or a general handyperson as a matter of urgency.

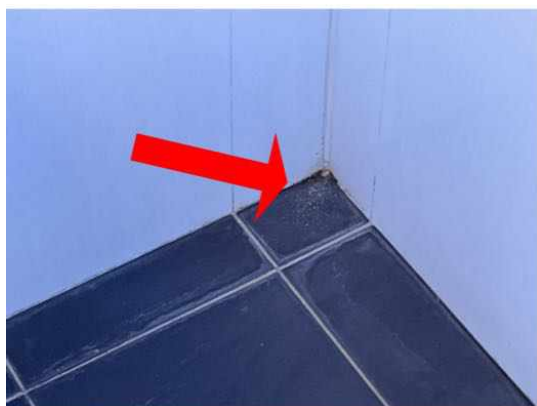
Building:	Main Building
Location:	All Areas
Finding:	Sealant and grouting - Missing or damaged
Information:	It was noted on inspection that sealant or grout is degraded to the tiled shower alcove and or other areas of the bathroom.

Different materials and floor areas move at different rates, generally causing cracking to grout or sealant at this point. A flexible sealant is required to allow for expected expansion and contraction, while keeping the joint water tight and protective of all associated building materials.

There appears to be excessive mould to the sealant and grout which will likely require scraping out and replacement.

Flexible and mould resistant materials should be applied to affected areas to prevent any subsequent water damage that is likely to occur. Regular maintenance and replacement of damage or missing or damaged sealant and grout is highly recommended to the wet areas, as this is a regular wear and tear defect. Sealant and grouting in areas that come into regular contact with water should be maintained for the long term care of your property.

A sealant specialist or tiling contractor should be appointed to complete these works as soon as possible

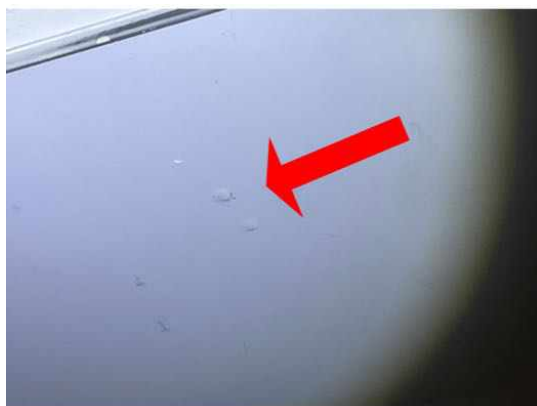
Building:	Main Building
Location:	Bedroom
Finding:	Nail Pops to Ceilings and Walls
Information:	Numerous nail pops are visible on the ceiling and some wall surfaces. These appear as raised or broken sections of plaster where fasteners have moved, causing the plasterboard surface to lift or crack around the fixing points.

Nail pops are generally caused by movement of the building frame, shrinkage of timber, or insufficient fixing of plasterboard during construction. While usually cosmetic, they can worsen over time, affect the surface finish, and may indicate minor frame movement.

According to the Guide to Standards and Tolerances 2017 (NSW), nail pops are considered a defect if they are readily visible from a normal viewing position within 12 months of completion, or if they are excessive in number.

A licensed plasterer should be engaged to repair the affected areas. Typical rectification involves re-securing the plasterboard, applying compound over fasteners, sanding, and repainting. If excessive nail pops continue to appear, further investigation into frame movement or structural settlement may be warranted.

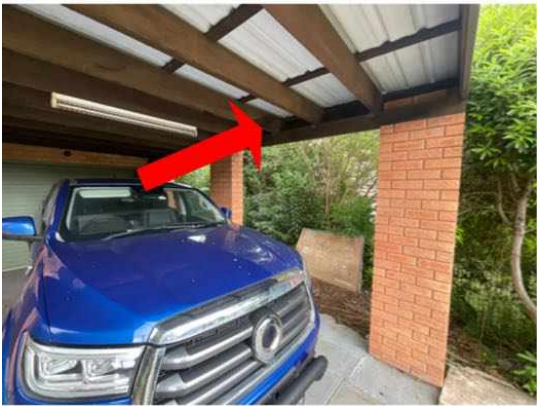
Building: Main Building
Location: All External Areas
Finding: External Timber - Weather damaged
Information: Damaged external timber were found during the inspection. External timber structures are constantly exposed to weather elements and can deteriorate in an accelerated manner, ongoing assessments are required.

It is highly recommended that a Structural engineer further assess the external timber balcony/deck to inform the client of its load capacity. Regular maintenance inspections by competent practitioners is needed.

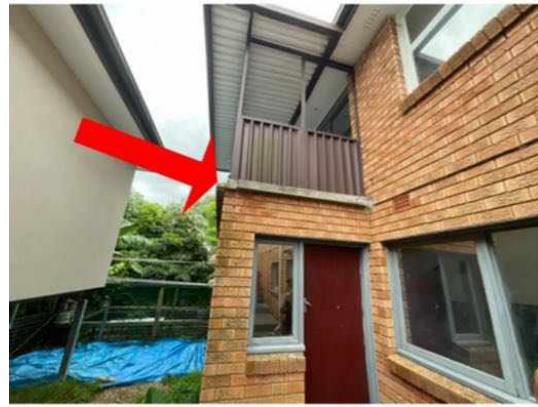
Building: Main Building
Location: Balcony
Finding: Concrete Slab - damaged
Information:

At the time of inspection, damaged concrete slab were identified. Significant deterioration is apparent in concrete slab, with areas showing signs of erosion, crumbling, and loss of material, likely due to environmental exposure or aging or building structure moving.

Evidence of structural instability is present in both the brickwork and concrete, with sections showing signs of leaning, bulging, or displacement, posing safety hazards and requiring immediate attention

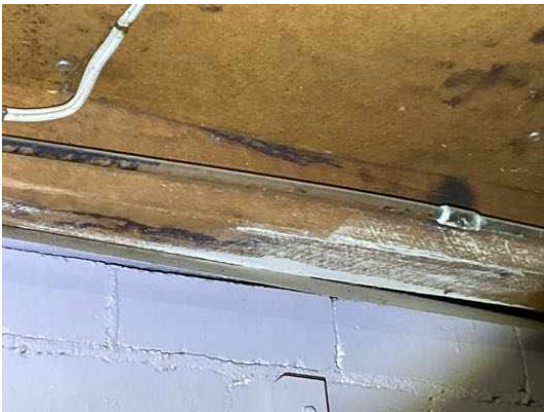
Building:	Main Building
Location:	Roof Void / Subfloor
Finding:	Chemical delignification identified
Information:	Chemical delignification also known as wood defibration refers to the chemical breakdown of timber building elements. This breakdown of the Lignin deteriorates the wood impacting on the structural integrity and tensile strength of the affected building element.

Chemical delignification is most common near marine environments due to the high levels of salt in the air however this deterioration may also occur in other areas where timber elements are frequently exposed to damaging gases chemicals etc.

Where timber building elements have deteriorated repair and / or replacement is required immediately to ensure the safety of the associated structures. The likely cause of the defibration should also be investigated and dealt with accordingly.

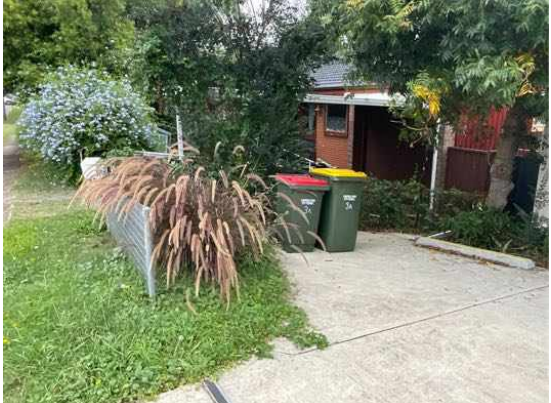
Finding 6.01

Building: Main Building
 Location: All Areas
 Finding: Garden Beds - Conditions Conducive to Termites
 Information: Garden beds were found to be evident in the garden area. These garden beds can include untreated timber, and with a combination of moisture from watering hosing can make conditions conducive to termite activity and termite ingress.

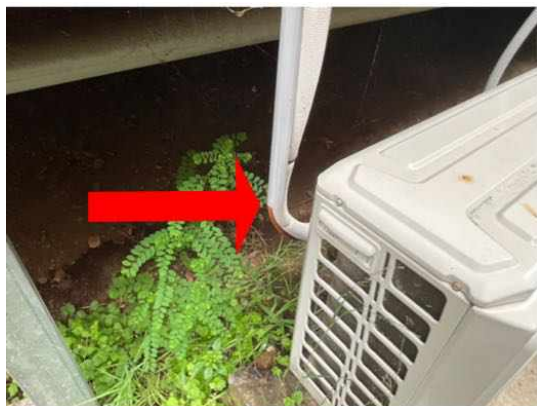
Finding 6.02

Building:	Main Building
Location:	All Areas
Finding:	Air conditioner - Disconnected overflow
Information:	The Air Conditioner (A/C) overflow was found to be disconnected from storm water drainage and is creating excessive moisture in the surrounding area.

Such leaking creates an environment which is conducive to an array of defects, including water damage to associated building elements and the attraction of termite or timber pest infestation.

It is highly recommended that a licensed plumber be appointed to connect the A/C

overflow in order to prevent such an environment from being created. These minor works should be carried out as soon as possible.

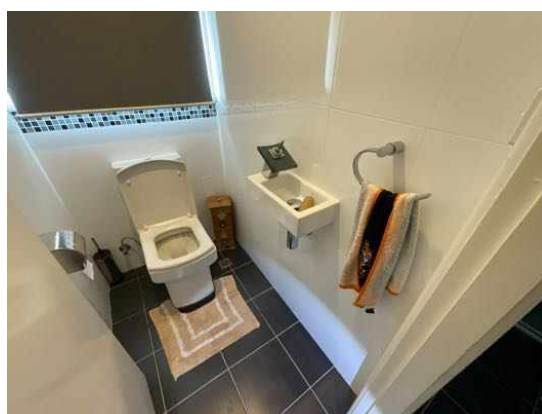
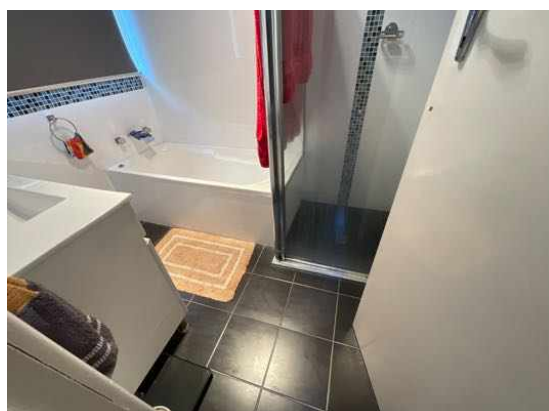
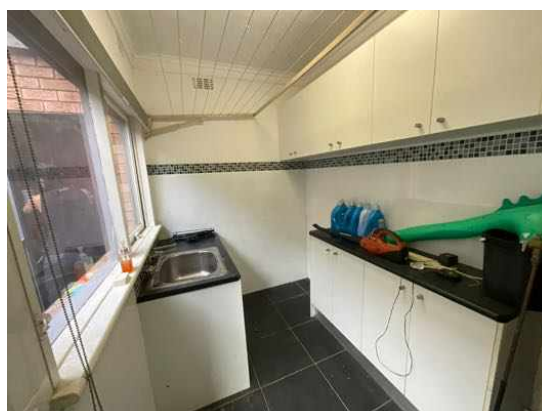
Building: Main Building
 Location: All Areas
 Finding: Water Proofing Membranes - Information Only
 Information: Internal Water Proofing Membranes, are crucial in preventing water ingress into the property is important to know that the Membrane System used is to Australian Standards and has been installed correctly. Please refer to the original Building Documents or Maintenance Schedule for the relevant information including; - Membrane used and Manufacturers Specifications. - The Installer and Installation Certification. Especially with older property's where this information is unavailable, all wet areas should be monitored. Generally new waterproofing with a certificate may only have a guarantee of 8yrs. If any leaks, water staining, peeling or bubbling of the paint become evident to any adjacent walls or ceilings below a licensed builder or waterproofing specialist is recommended to investigate further.
