Building and Timber Pest Inspection Report

Inspection Date: Wed, 21 Jan 2026

Property Address: 1 Temora Rise, Berwick VIC 3806, Australia

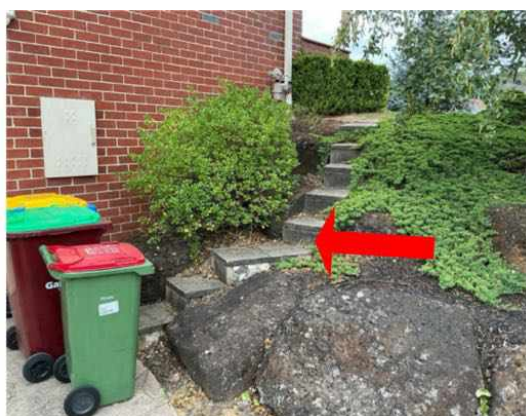
Building:	Main Building
Location:	Yard - Front
Finding:	Step riser heights non-compliant
Information:	The steps providing access from the front of the garage up to the main entry were observed to have riser heights that exceed the maximum allowable limits under the current building standards. The excessive riser heights create an increased risk of trips, slips and falls, particularly for occupants, visitors, children and the elderly.

The steps providing access from the front of the garage up to the main entry were observed to have riser heights that exceed the maximum allowable limits under the current building standards. The excessive riser heights create an increased risk of trips, slips and falls, particularly for occupants, visitors, children and the elderly.

It is recommended that a registered builder being engaged to assess and rectify the steps to ensure all riser height are uniform and compliant with current building standards. Rectification should be carried out as a matter of priority to improve safety.

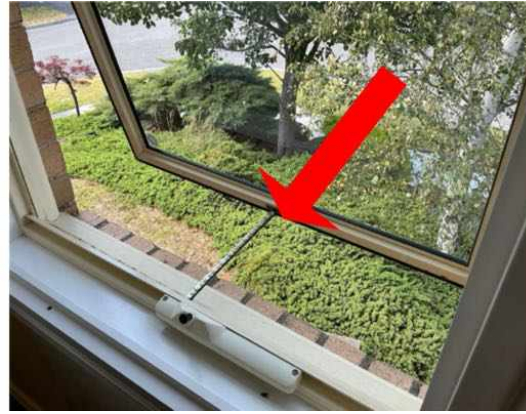
Finding 1.02

Building:	Main Building
Location:	Upper windows
Finding:	Upper floor windows open too far
Information:	The inspection identified that some upper-floor windows in this double-story property do not meet the safety guidelines for openable windows in elevated spaces. Specifically, these windows open wider than the maximum allowable width of 125mm, creating a potential fall hazard. Openable windows in elevated spaces must be restricted in their opening width or fitted with barriers to prevent accidental falls. Installing restrictors or compliant barriers will enhance safety and ensure the property adheres to Australian safety standards, providing a safer environment for all occupants, particularly young children.

The inspection identified that some upper-floor windows in this double-story property do not meet the safety guidelines for openable windows in elevated spaces. Specifically, these windows open wider than the maximum allowable width of 125mm, creating a potential fall hazard. Openable windows in elevated spaces must be restricted in their opening width or fitted with barriers to prevent accidental falls. Installing restrictors or compliant barriers will enhance safety and ensure the property adheres to Australian safety standards, providing a safer environment for all occupants, particularly young children.

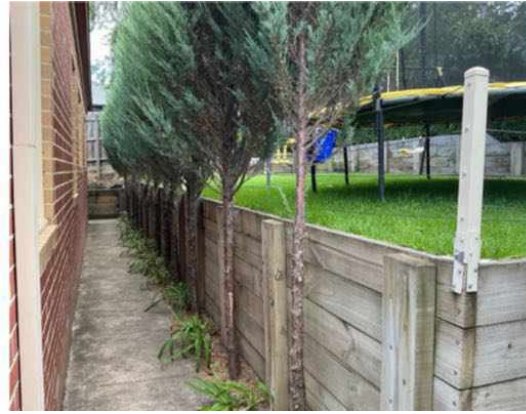
Finding 1.03

Building:	Main Building
Location:	Yard - Back
Finding:	Balustrades Suspected Non-Compliance
Information:	The balustrades near the rear retaining walls were measured and found to less than the present building regulation requirement of 1000mm high.

This defect creates a potential safety hazard and should be rectified as soon as possible to ensure the safety of the area and to meet present building standards and regulations.

The balustrades were measured and found to be less than the present building regulation requirement of 1000mm high.

A registered builder should be contacted to discuss possible rectification solutions.

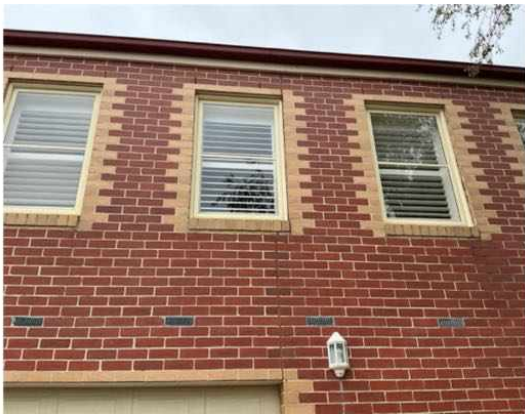
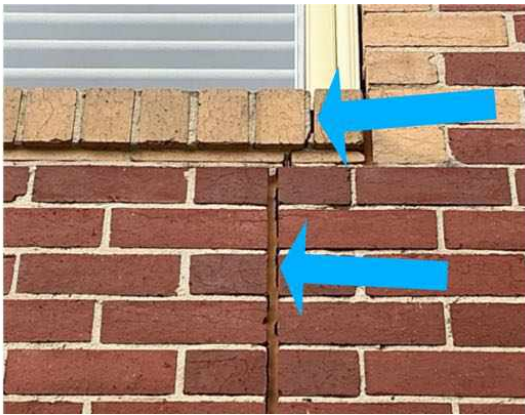
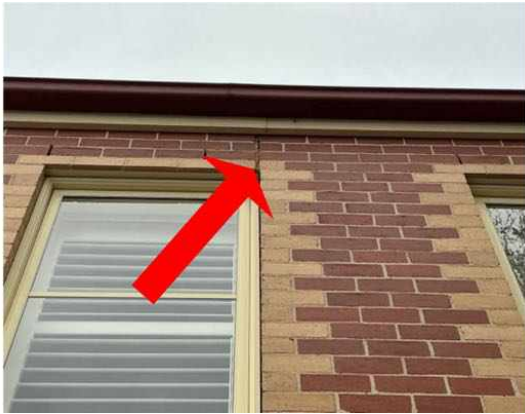
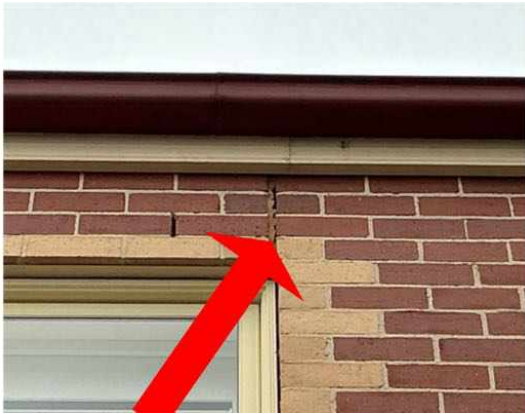
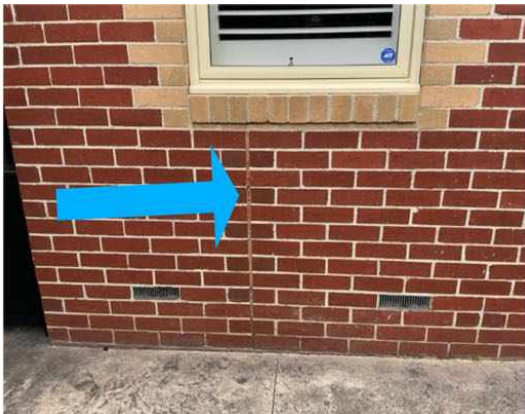
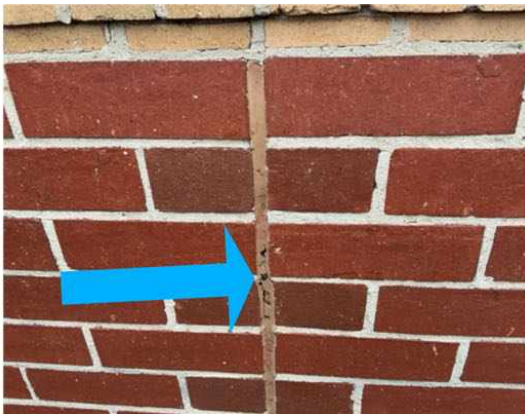
Finding 3.01

Building:	Main Building
Location:	Exterior walls
Finding:	A few gaps to the exterior walls/windows
Information:	A few gaps were noticed to some of the exterior walls/windows to the building. These gaps can let in water, drafts, and pests. Overtime moisture ingress may cause damage to internal walls, mould growth, or structural issues. Gaps also reduce the energy efficiency of the property. Recommend engaging a caulker to seal gaps with an exterior grade flexible sealant that is UV and weather resistant to reduce the risk of pest/water penetration to the building as soon as possible.

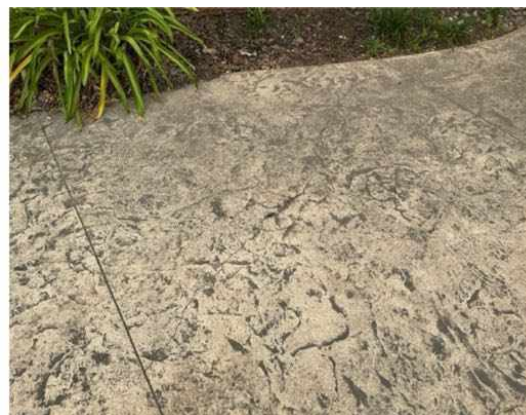
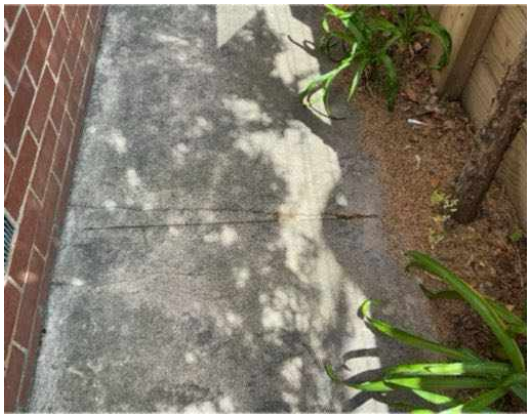
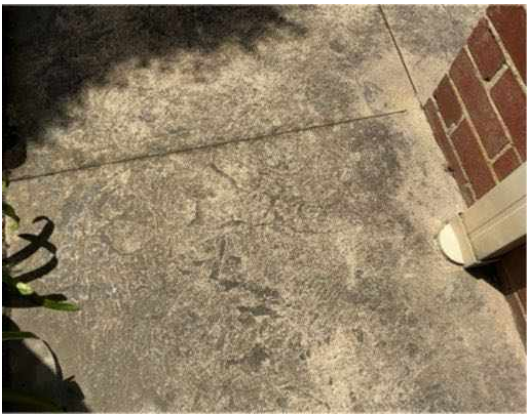
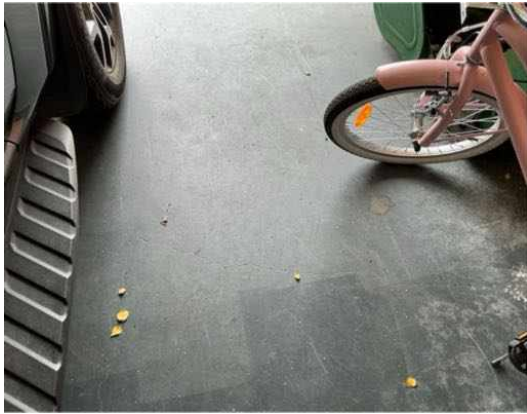
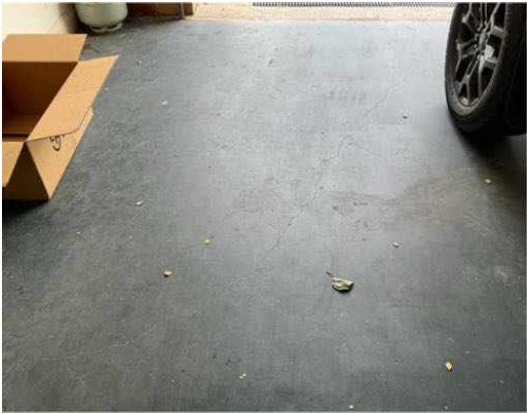
Finding 3.02

Building:	Main Building
Location:	Driveway and pathways
Finding:	Driveway/pathways Cracking Concrete Paving Damage Category 1 - Fine (less than 2mm)
Information:	Fine cracks were identified in the driveway and pathways concrete paving. Although fine cracks are quite noticeable, they are often only considered to be an appearance defect, and usually do not indicate any structural damage. To be considered a Category 1 or fine crack, the crack is found to be less than 2mm in width.

Generally the cause of a hairline crack in existing concrete paving such as driveways and pathways is indicative of the expansion and contraction of the concrete. Such causes are generally due to environmental factors, such as moisture levels, weather conditions, root systems of nearby trees or the soil types on which they are laid.

Fine cracks may also be due to poor original installation of the concrete. Factors such as poor compaction of the sub surface and/or inadequate reinforcing of the slab may create cracking and other secondary defects.

Monitoring of all cracking should be conducted frequently. Always contact a building inspector should cracks widen, lengthen, or become more numerous.

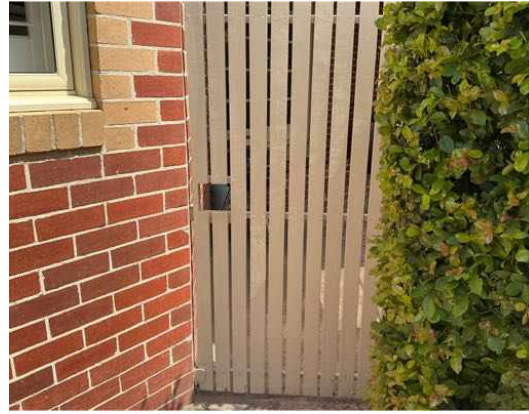
Finding 3.03

Building: Main Building
Location: Yard - Back
Finding: Gate - Binding/jamming
Information: Binding and/or jamming of the gate was evident during standard operation. This defect inhibits the functionality of the affected gate as well as creating potential for secondary defects to associated building elements.

A gate that binds to the associated frame may have several causes, ranging from minor defects, such as poor installation of the gate or deteriorated hinges.

For minor causes, a qualified carpenter or general handyperson should be appointed to perform minor rectification works at client discretion.

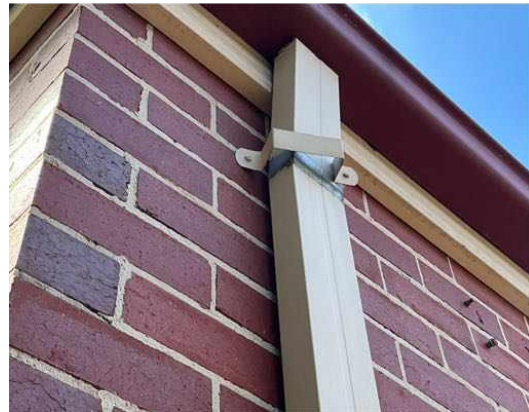
Finding 3.04

Building:	Main Building
Location:	Exterior walls - left side
Finding:	Down pipe clip loose
Information:	The left hand rear down pipe clip is loose/damaged due to poor installation.

It is recommended that a plumber be appointed to further inspect the area and to install/repair clips where necessary at the owners discretion.

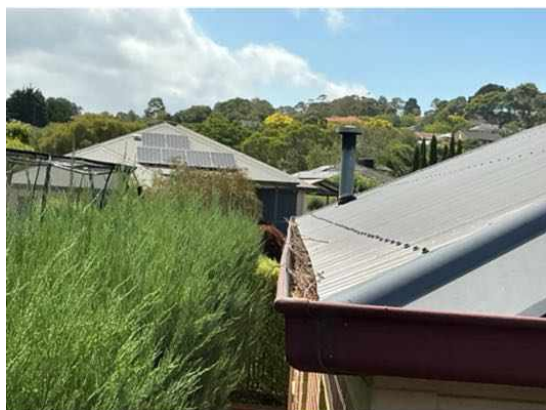
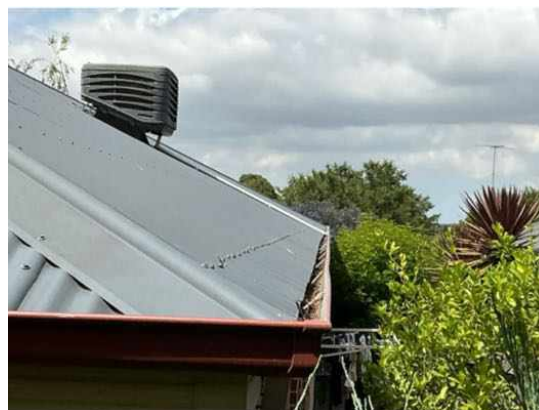
Finding 3.05

Building:	Main Building
Location:	Roof Exterior
Finding:	Gutters -Partially Blocked with debris
Information:	It was noticed on inspection that some of the gutters were partially blocked with debris. Roof plumbing structures, such as guttering and downpipes, should be free of all debris to prevent blockages. Blockages of the guttering and downpipes will lead to pooling and accumulated water overflows, which is likely to subsequently flood eaves and exterior walls.

Blocked gutters are likely to lead to high levels of moisture in the affected areas. Such moisture will not only cause rust and decay of the associated building materials, but can also provide conditions that are conducive to termite and timber pest activity. Blockages in gutters should therefore be removed immediately to ensure dry conditions are maintained.

Consult a Licensed Plumber for further specific advice on remedial works that may be required. In the interim, it is highly advised that blocked gutters be removed by the homeowner or a general handyman as a matter of urgency.

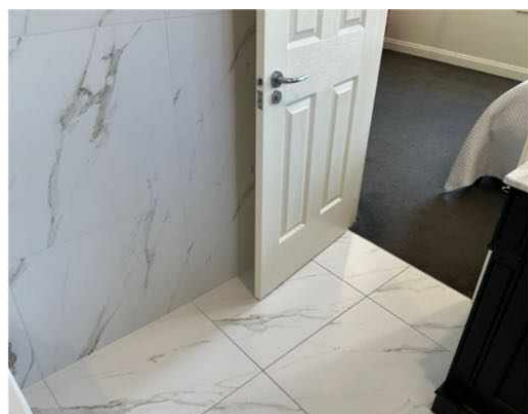
Finding 3.06

Building:	Main Building
Location:	Ensuite - Master
Finding:	Door stop missing ensuite
Information:	The door stop to the ensuite is missing and is unable to stop the door furniture from damaging the wall. Although some building elements may seem irrelevant or unnecessary, all building elements play a key role in the operation and function of the overall structure and its performance.

Re-installation or replacement of the door stop is advised as soon as possible to prevent any subsequent damage to the door or associated structures. A general handyman may be appointed to perform these works at client discretion.

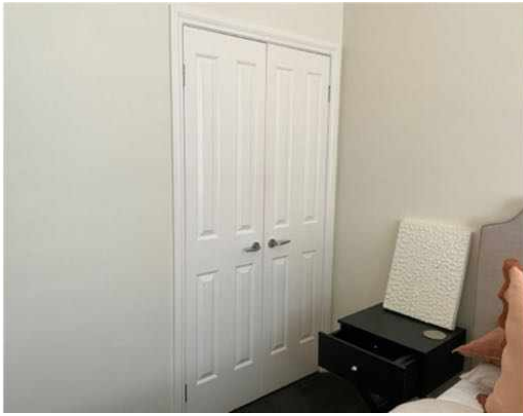
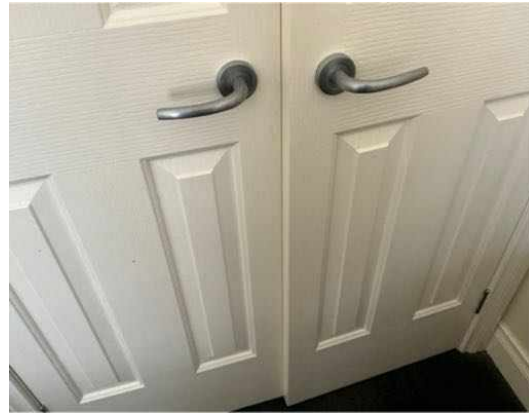
Building: Main Building
 Location: Bedroom 2
 Finding: Door - Binding/jamming bedroom
 Information: Binding and/or jamming of bedroom 2 cupboard doors is evident during standard operation. This defect inhibits the functionality of the affected door as well as creating potential for secondary defects to associated building elements, such as damage to the floor covering.

A door that binds to flooring or to the associated door frame may have several causes, ranging from minor defects, such as poor installation of the door or deteriorated hinges.

For minor causes, a qualified carpenter or general handyperson should be appointed to perform minor rectification works at client discretion.

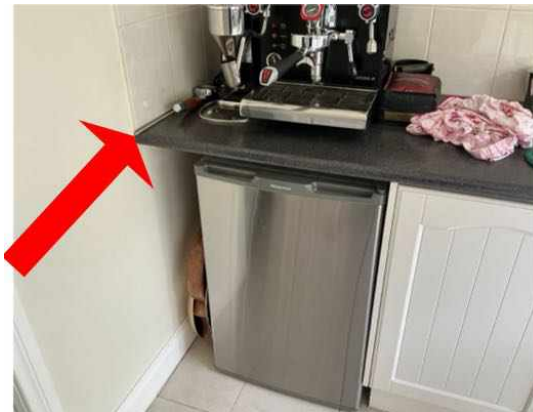
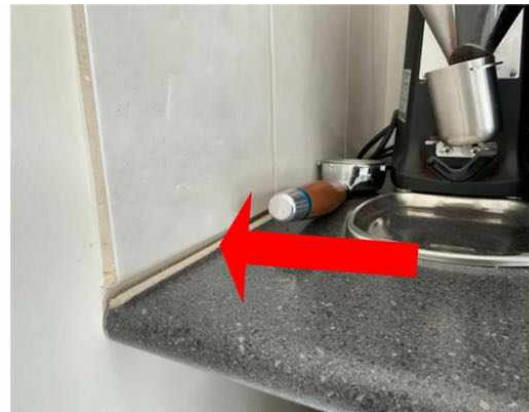
Finding 3.09

Building:	Main Building
Location:	Laundry
Finding:	Bench top coming loose
Information:	On inspection of the laundry, it was noticed that the the benchtop does not have a support and is coming loose due to too much weight on it at times. Recommend engaging a carpenter to repair to reduce the risk of further damage as soon as possible.

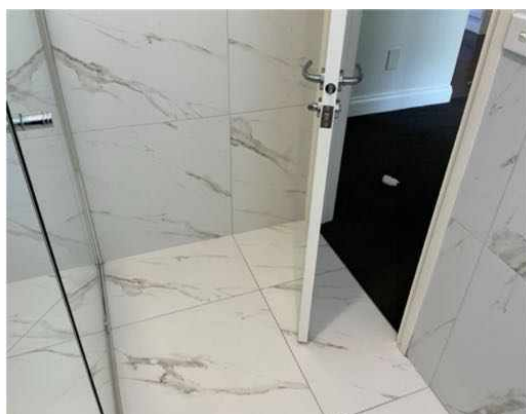
Building:	Main Building
Location:	Bathroom
Finding:	Door stop missing
Information:	The door stop to the bathroom is missing and is unable to stop the door furniture from damaging the wall. Although some building elements may seem irrelevant or unnecessary, all building elements play a key role in the operation and function of the overall structure and its performance.

Re-installation or replacement of the door stop is advised as soon as possible to prevent any subsequent damage to the door or associated structures. A general handyman may be appointed to perform these works at client discretion.

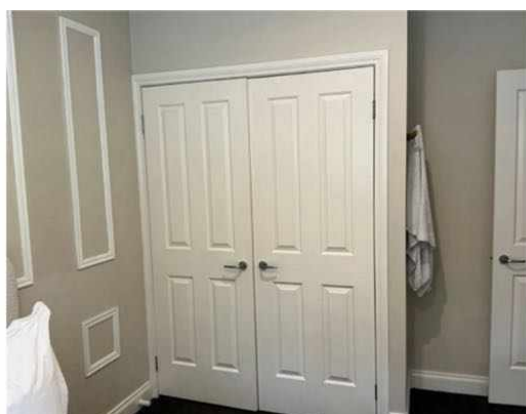
Building: Main Building
 Location: Bedroom 3
 Finding: Door - Binding/jamming bedroom
 Information: Binding and/or jamming of bedroom 3 cupboard doors is evident during standard operation. This defect inhibits the functionality of the affected door as well as creating potential for secondary defects to associated building elements, such as damage to the floor covering.

A door that binds to flooring or to the associated door frame may have several causes, ranging from minor defects, such as poor installation of the door or deteriorated hinges.

For minor causes, a qualified carpenter or general handyperson should be appointed to perform minor rectification works at client discretion.

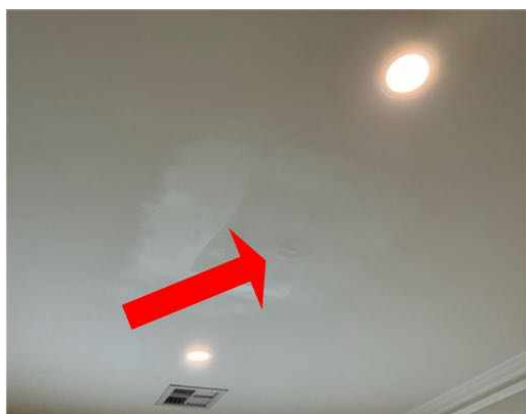
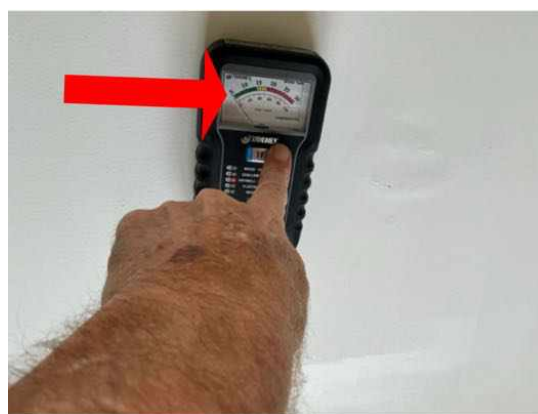
Finding 3.14

Building: Main Building
 Location: Bedroom 3
 Finding: Bedroom Evidence of moisture stains but tested dry
 Information: Evidence of previous moisture stain was found to bedroom 3 ceiling but tested dry

using a moisture meter. Recommend monitoring and if further moisture staining is noticed contact a roof plumber straight away to rectify. Excessive moisture can attract termites and produce conditions that promote termite attack, fungal growth and wood decay. Excessive moisture is generally caused by deteriorated, inadequate or missing roof drainage, leaking plumbing pipes or fixtures, poorly plumbed HWS overflows or condenser units and poor site drainage. It is highly recommended that all plumbing and drainage fixtures and fittings be maintained regularly in order to prevent excessive moisture being present in the external / internal property.

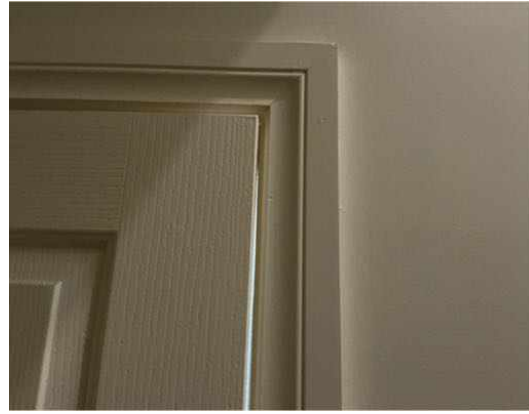
Finding 3.15

Building:	Main Building
Location:	Garage
Finding:	Door - Binding/jamming garage
Information:	Binding and/or jamming of the garage door is evident during standard operation. This defect inhibits the functionality of the affected door as well as creating potential for secondary defects to associated building elements, such as damage to the floor covering.

A door that binds to flooring or to the associated door frame may have several causes, ranging from minor defects, such as poor installation of the door or deteriorated hinges.

For minor causes, a qualified carpenter or general handyperson should be appointed to perform minor rectification works at client discretion.

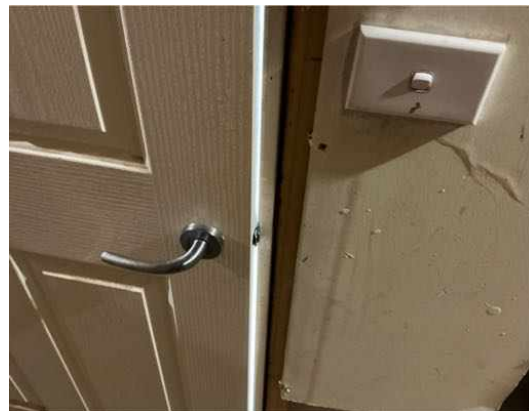
Finding 3.16

Information: Binding and/or jamming of the subfloor door is evident during standard operation. This defect inhibits the functionality of the affected door as well as creating potential for secondary defects to associated building elements, such as damage to the floor covering.

A door that binds to flooring or to the associated door frame may have several causes, ranging from minor defects, such as poor installation of the door or deteriorated hinges.

For minor causes, a qualified carpenter or general handyperson should be appointed to perform minor rectification works at client discretion.

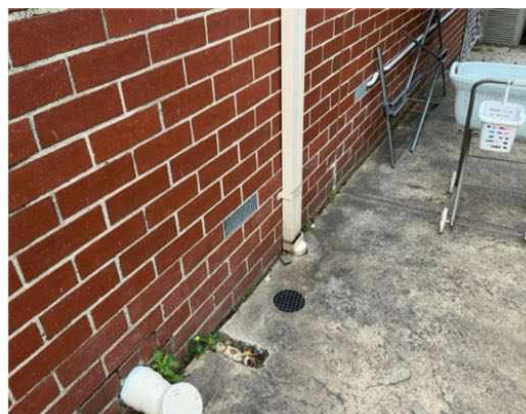
Where plumbing doesn't drain adequately, the area at the base perimeter can become excessively damp, potentially creating an environment that is susceptible to rust and corrosion of surrounding building elements, as well as attracting termites and other pests.

It is highly recommended that a plumber be appointed to further inspect the area and to install adequate drainage equipment immediately where necessary.

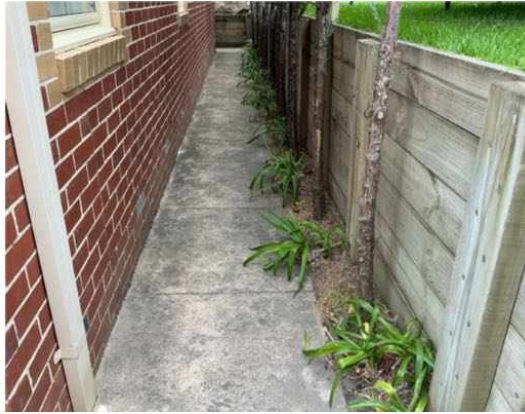
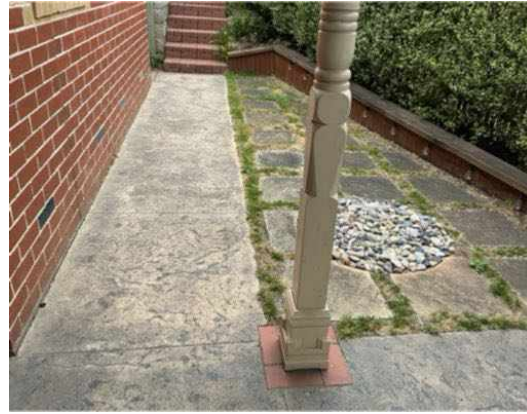
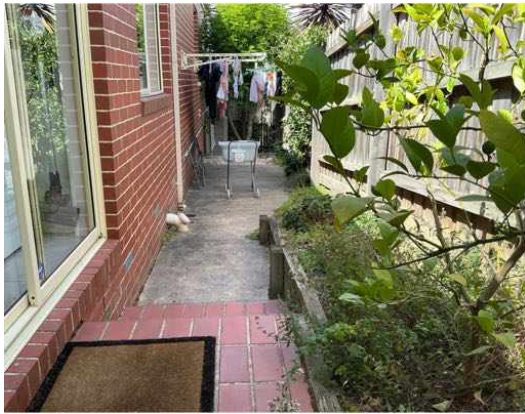
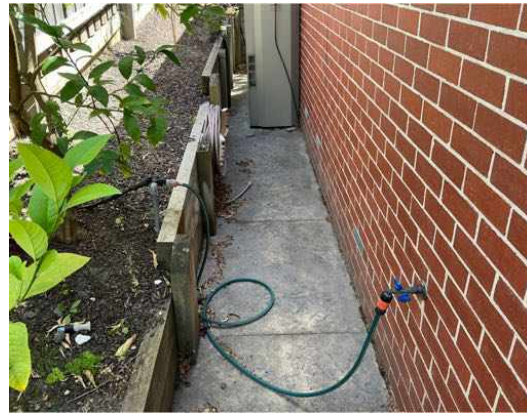
Finding 6.02

Building:	Main Building
Location:	Yards
Finding:	Site drainage - poor/inadequate
Information:	The site drainage to parts of the yards was found to be inadequate at the time of inspection, creating potential for subsequent water damage to associated building elements. Excessive moisture will attract termites.

Where site drainage is inadequate, installation of an Agricultural (Aggie) Drain may be required. A qualified plumber should be appointed to further inspect the property and perform any remedial works as necessary. Water damage and secondary defects are likely to occur if left unmanaged.

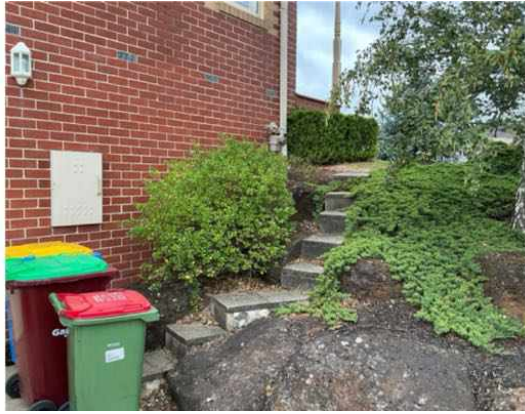
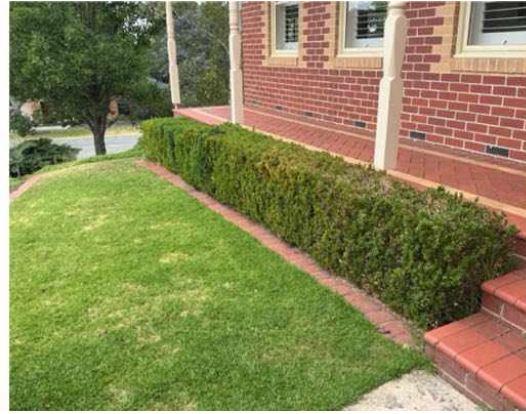
Finding 6.03

Building:	Main Building
Location:	Yard - Front
Finding:	Garden Beds Conditions Conducive to Termites
Information:	Garden beds were found to be evident in close proximity to the building. Garden beds immediately adjacent to the perimeter of the building block the visual inspection of these areas, providing a concealed termite entry point.

These garden beds can include untreated timber, and with a combination of moisture from watering hosing can make conditions conducive to termite activity and termite ingress.

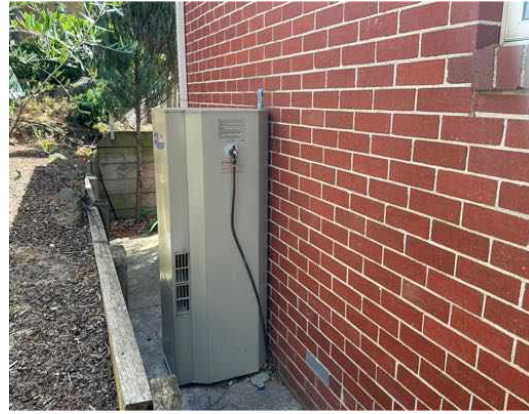
Finding 6.04

Building:	Main Building
Location:	Various parts of the building
Finding:	Bridging attachments to buildings
Information:	Bridging occurs when items against a building provide a concealed entry point for termites into the building or by passing around a termite management system.

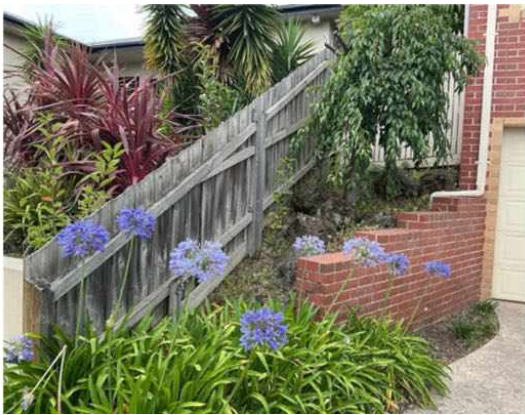
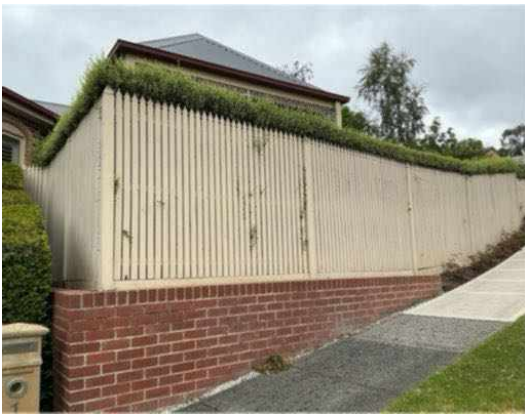
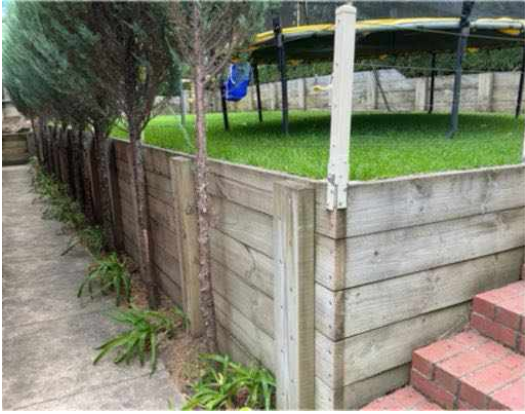
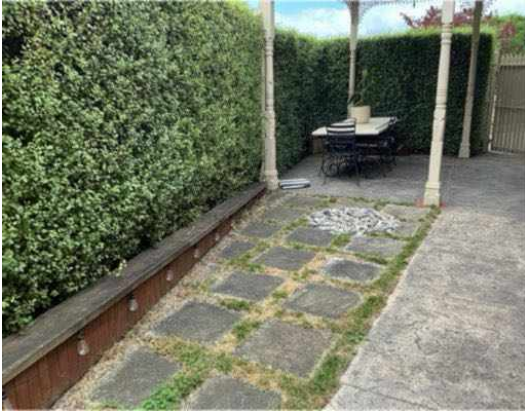
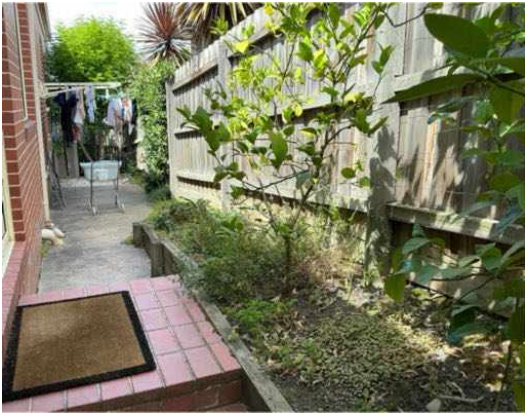
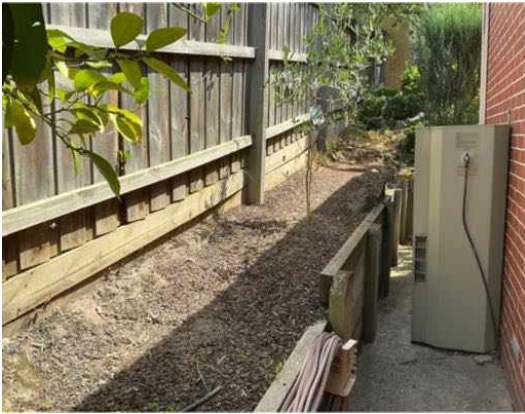
Finding 6.05

Building:	Main Building
Location:	Various parts of the building
Finding:	In ground contact
Information:	<p>Any timbers in direct ground contact provide opportunity for concealed termite entry and are likely to be subject to premature rot and decay as the soil retains moisture or damp conditions against the timbers.</p> <p>Remove untreated timber that is in direct contact with external grounds. Consider replacement with more durable materials i.e. treated timber or non timber elements. Frequent pest inspections are advised to readily identify any termite activity in these areas.</p>

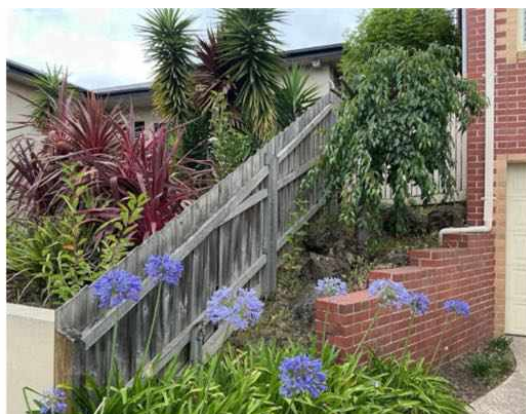
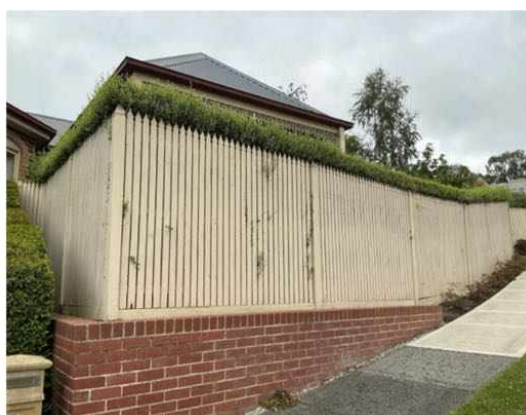
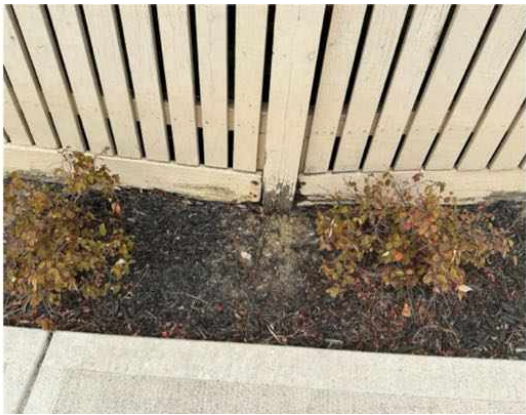
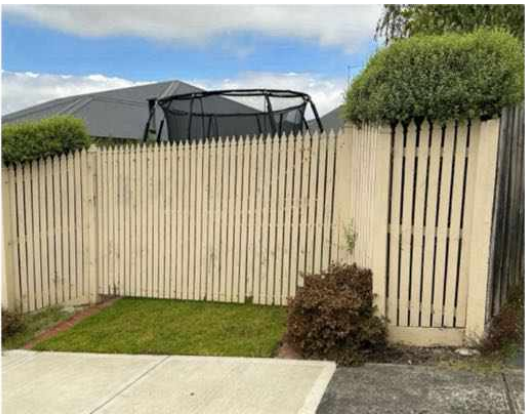
Finding 7.01

Finding: Fencing retaining walls - wood rot-fungal decay

Information: It was noted at the time of inspection that sections of the fencing and retaining walls to the property have deteriorated and have fungal decay/wood rot present and the fence is leaning near the gate. Typically fencing deteriorates due to age and or wear, rot and or rust which is generally expected for a structure of this age, due to prolonged exposure to weather conditions. Sometimes inadequate installation or maintenance can be to blame.

If left unattended, it is likely that further damage will occur. It is suspected that repair of several elements of the fencing may be required however replacement may be a consideration of the client also.

A licensed fencing contractor should be appointed to provide further advice and perform rectification works as necessary.

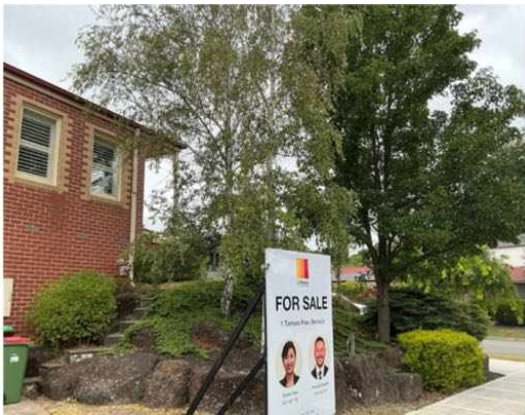
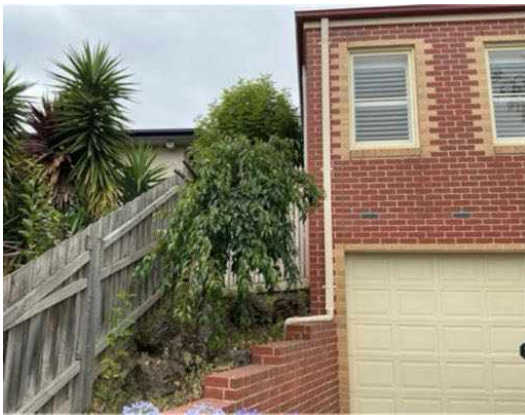
Building: Main Building
Location: Yards
Finding: large trees near property
Information: Some large trees are growing near the structure. Tree roots can cause major foundation and plumbing related issues. Recomend engaging an arborist to further investigate and advise on the severity of the root systems and any rectification works that may be required to reduce the risk of property damage and deterioration.
