Building and Timber Pest Inspection Report

Inspection Date: Thu, 19 Feb 2026

Property Address: 26/59 Neil St, Merrylands NSW 2160,
Australia

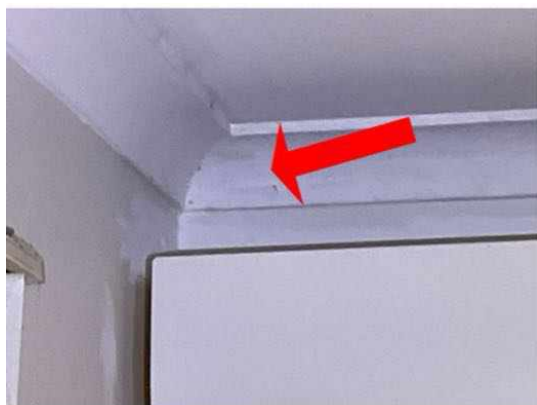
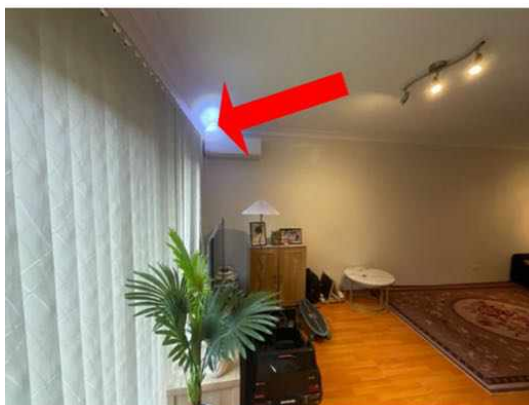
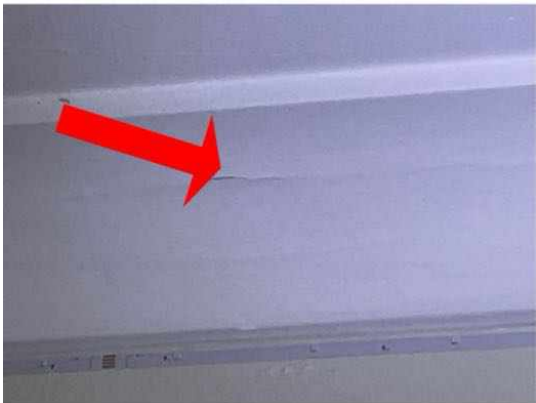
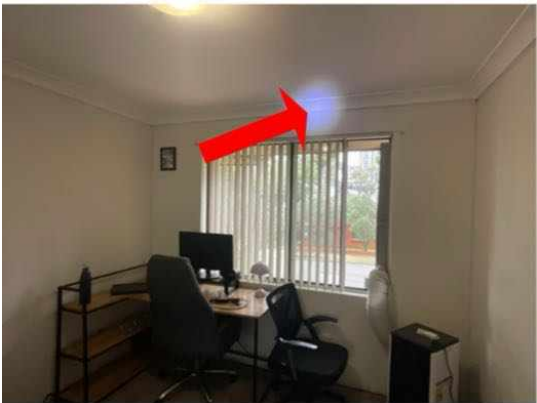
Building:	Main Building
Location:	All Internal Areas
Finding:	Ceiling - Water damaged
Information:	Water damage to the ceiling lining is generally an indication of excessive moisture being present in the roof void, usually via a leak to the roof covering.

Where water damage is evident to the ceiling, the primary requirement is to identify and rectify the source of the leak. A roofing plumber should be appointed as soon as possible to identify the leak and perform rectification works as necessary, ensuring the water damage is restricted.

Once the leak is repaired, consultation with relevant tradespeople, including plasterers and painters, is advised. Rectification works may include replacement of ceiling lining or minor repainting, depending on the extent of the damage.

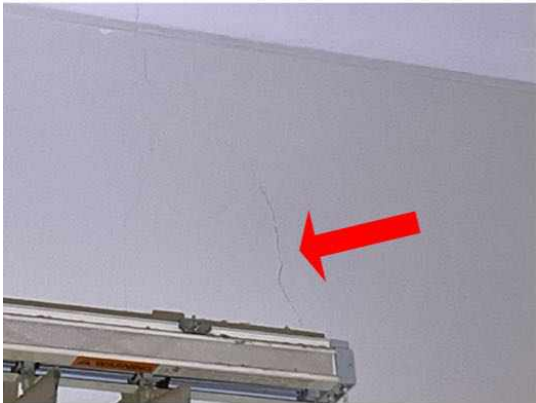
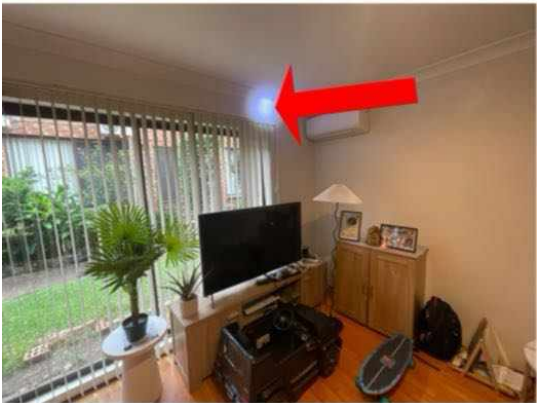
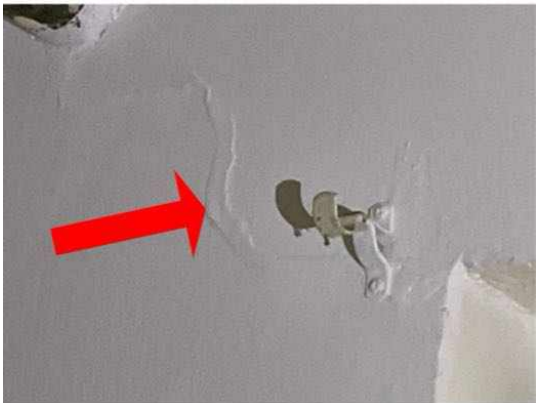
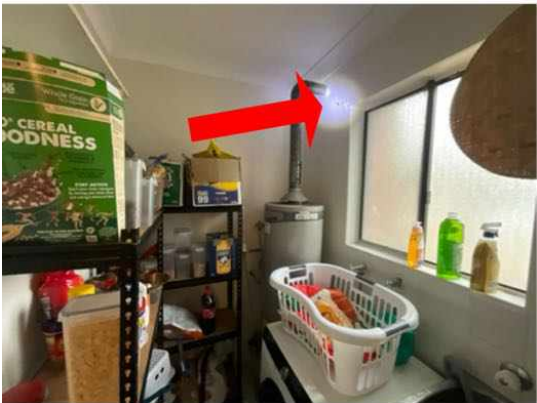
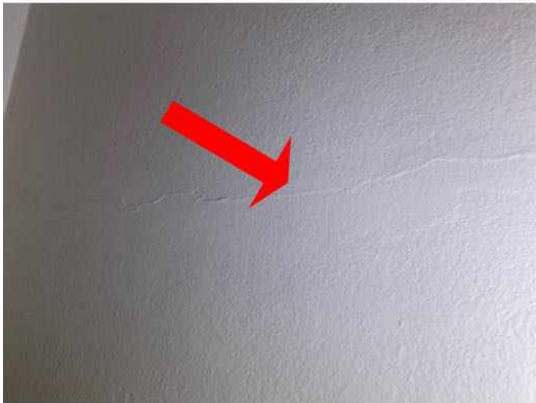
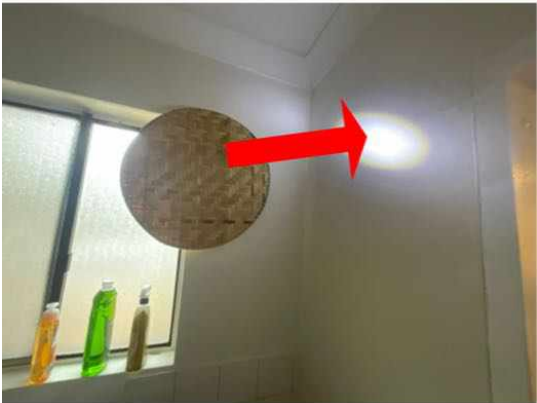
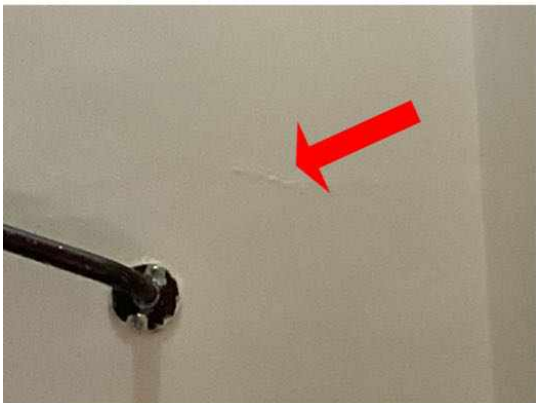
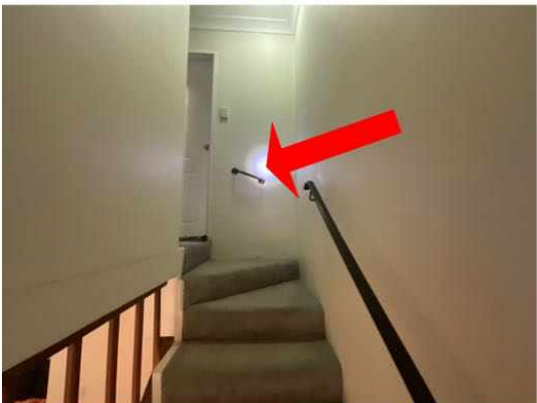
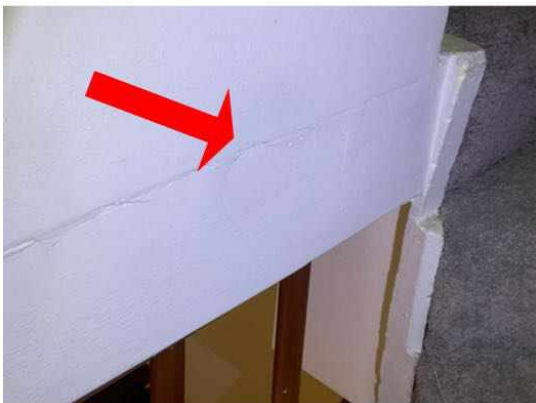
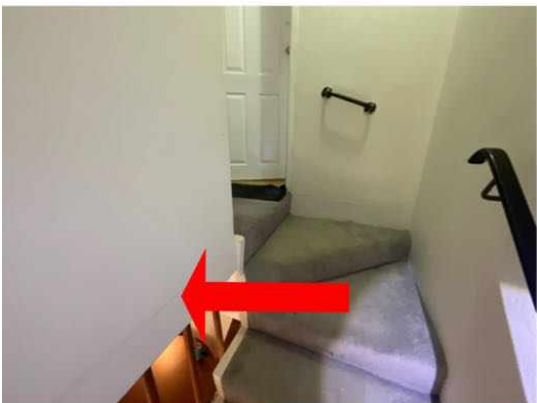
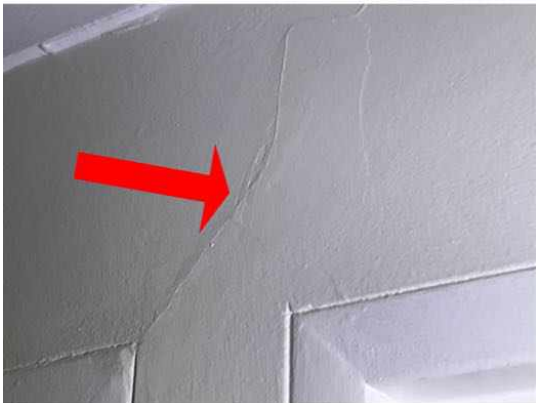
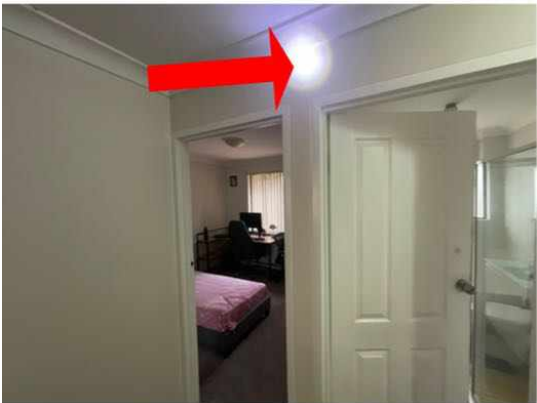
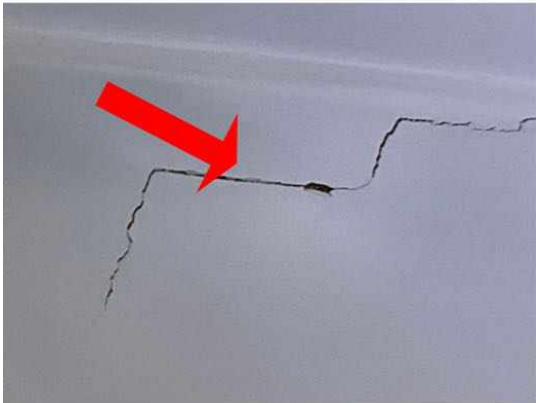
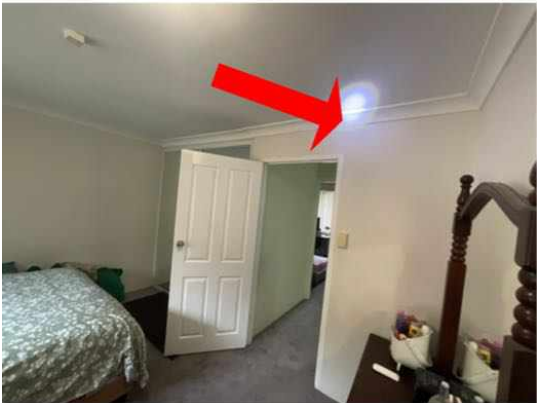
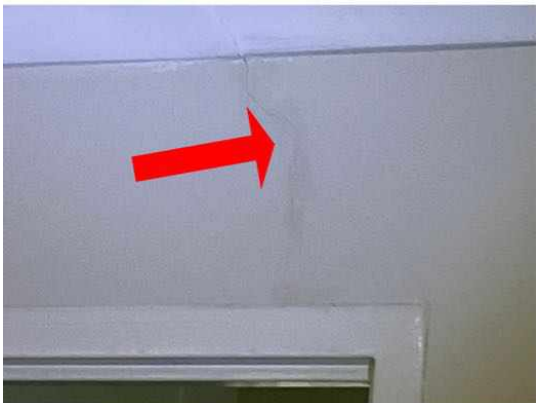
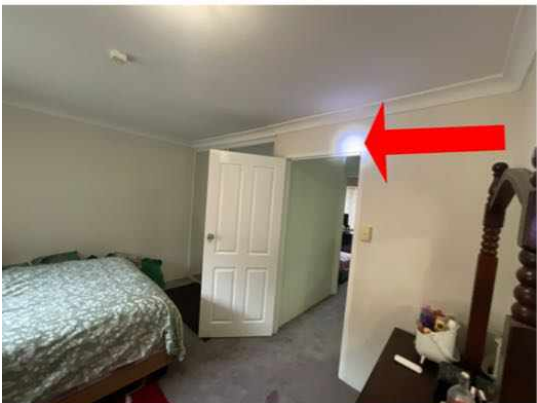
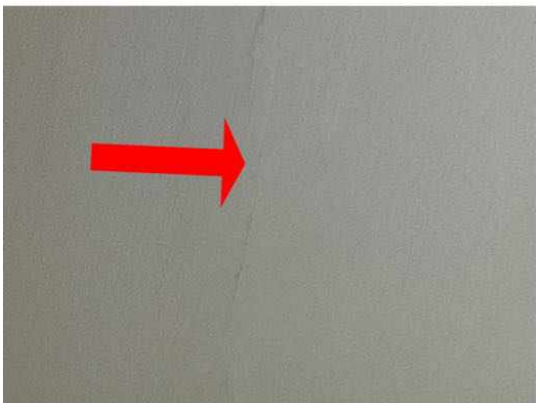
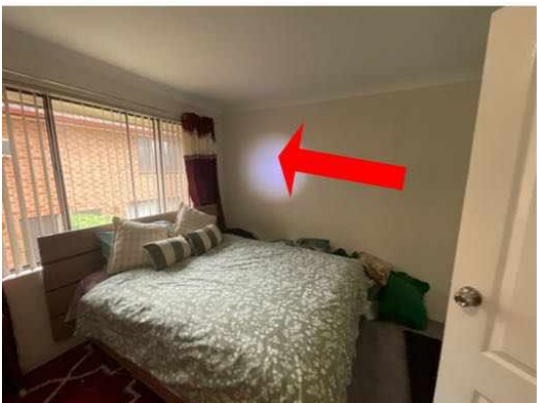
Finding 3.01

Building: Main Building
Location: All Internal Areas
Finding: Cracks to internal rendered surfaces - Category 1
Information: It has been observed that cracking to internal rendered surfaces has occurred in this area. The degree of damage falls within Category 1, described as fine cracks that do not need repair and which are less than 1.0mm in width limit.

Damage of this category is not considered a defect for rectification. Always contact your building inspector should cracks widen, lengthen, or become more numerous.

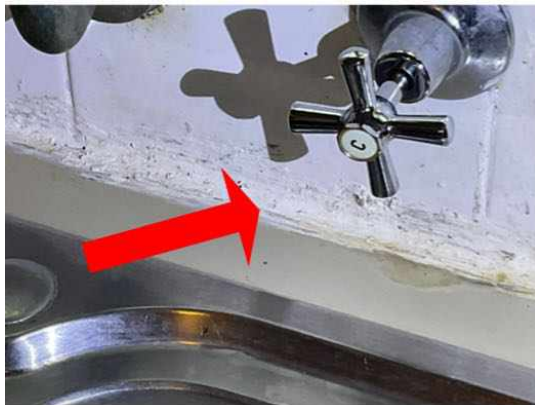
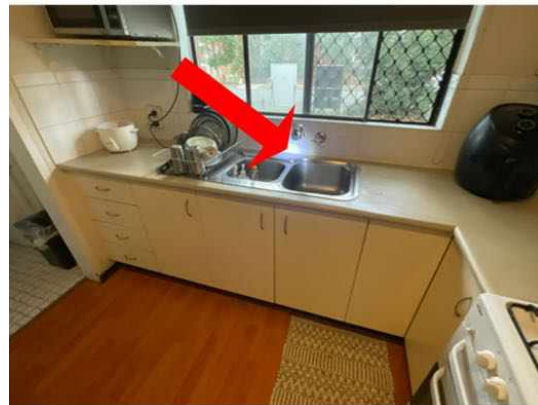
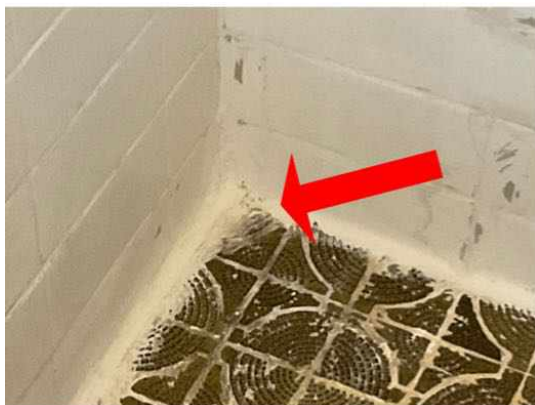
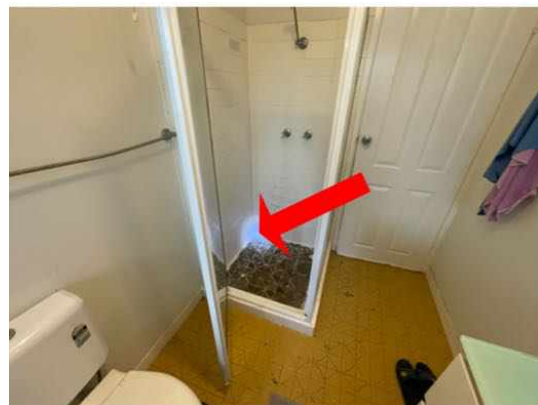
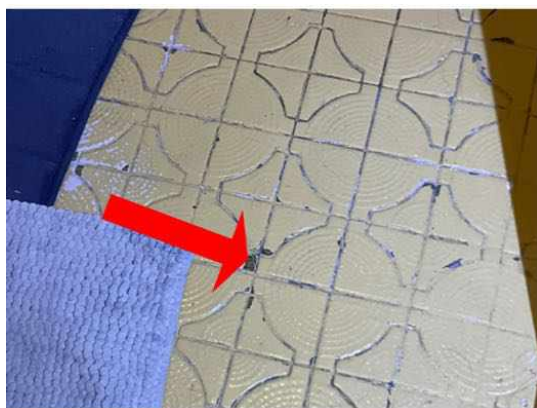
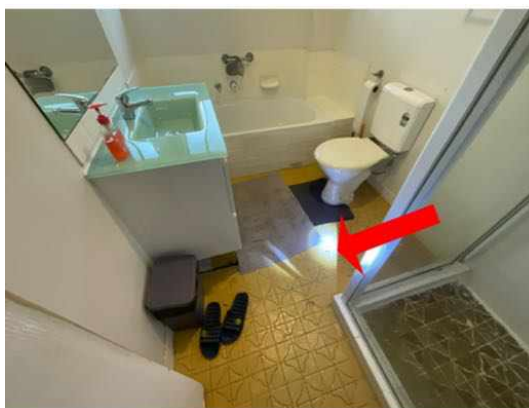
Finding 3.02

Building: Main Building
Location: Kitchen / Bathroom
Finding: Sealant and grouting - Missing or damaged
Information: It was noted on inspection that sealant or grout is degraded to the tiled shower alcove and or other areas of the bathroom.

Different materials and floor areas move at different rates, generally causing cracking to grout or sealant at this point. A flexible sealant is required to allow for expected expansion and contraction, while keeping the joint water tight and protective of all associated building materials.

There appears to be excessive mould to the sealant and grout which will likely require scraping out and replacement.

Flexible and mould resistant materials should be applied to affected areas to prevent any subsequent water damage that is likely to occur. Regular maintenance and replacement of damage or missing or damaged sealant and grout is highly recommended to the wet areas, as this is a regular wear and tear defect. Sealant and grouting in areas that come into regular contact with water should be maintained for the long term care of your property.

A sealant specialist or tiling contractor should be appointed to complete these works as soon as possible

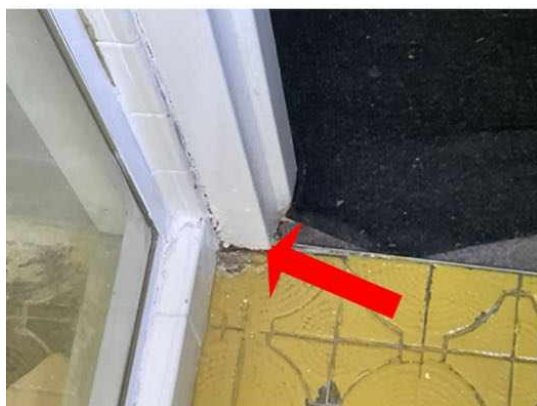
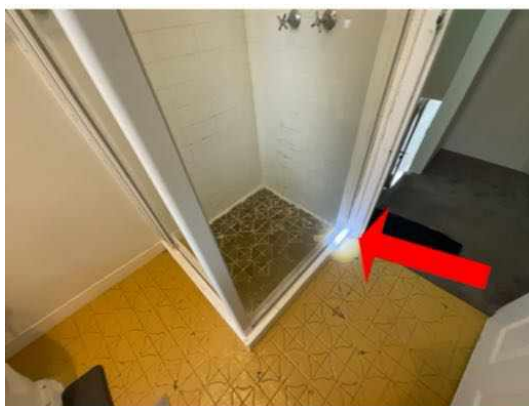
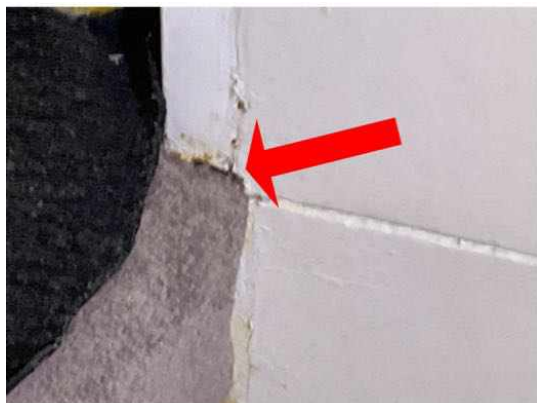
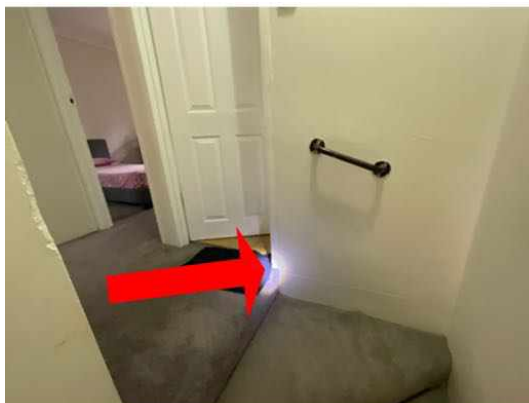
Finding 3.03

Finding: Bathroom - Damp

Information: Damp is evident to the lower 300mm of wall to the bathroom alcove. This defect is quite common, and is suspected to have been caused by moisture permeating through the grouting in this area, which shows evidence of deterioration. Leaking pipes within the adjoining wall is also a possible cause. Damp (or structural damp) refers to the presence of unwanted moisture in the structure of a building, either as the result of intrusion from outside, or condensation from within the structure. In the bathroom area, internal water leaks or other sources of excessive moisture are generally the cause of damp. Unmanaged damp in the bathroom recess is likely to facilitate the formation and development of mould and fungi growth, decaying associated building materials and compromising their structural integrity. It is important to address damp conditions, as the World Health Organisation notes that excess moisture leads - on almost all indoor materials - to growth of microbes such as moulds, fungi and bacteria, which subsequently emit spores and other matter into the indoor air. Exposure to these contaminants is associated with a wide range of respiratory and other health-related problems. Consultation with a qualified plumber or bathroom specialist is advised immediately to identify the cause of damp and to perform remedial works as required. Where excessive mould growth is present, further inspection by a specialist environmental health inspector should also be considered. Always ensure that sealant and grout is in good condition to prevent any moisture issues occurring in the future.

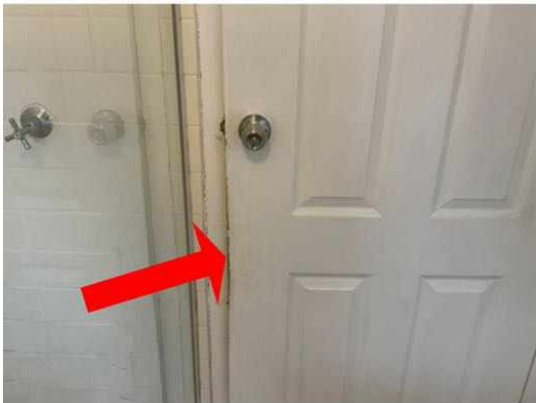
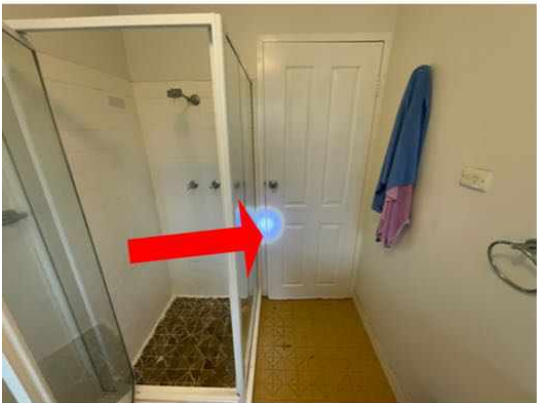
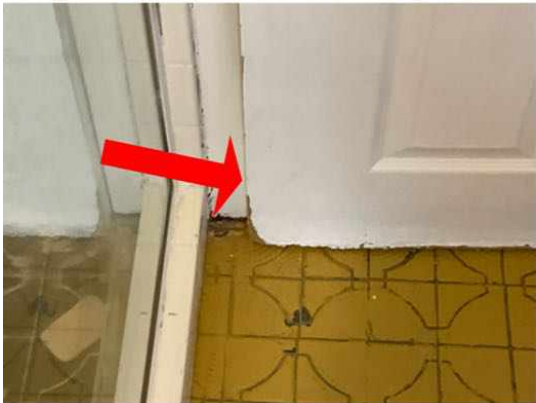
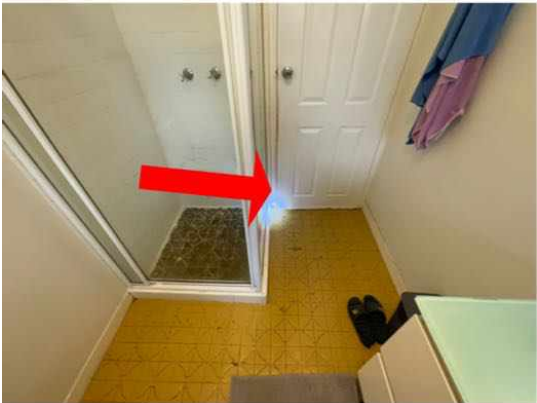
Finding 3.04

Building:	Main Building
Location:	All Internal Areas
Finding:	Door - Binding/jamming
Information:	Binding and/or jamming of this door is evident during standard operation. This defect inhibits the functionality of the affected door as well as creating potential for secondary defects to associated building elements, such as damage to the floor covering.

A door that binds to flooring or to the associated door frame may have several causes, ranging from minor defects, such as poor installation of the door or deteriorated hinges, through to major structural issues, such as damage to subfloor structures.

Where door binding/jamming appears to indicate major structural issues, a registered builder specialising in re-stumping should be appointed to provide an estimate on the cost of rectification.

For minor causes, a qualified carpenter or general handyperson should be appointed to perform minor rectification works at client discretion.

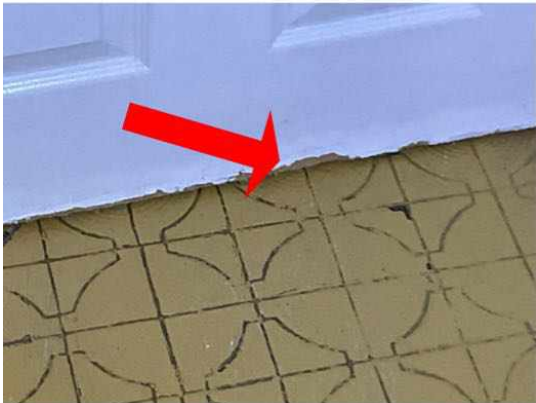
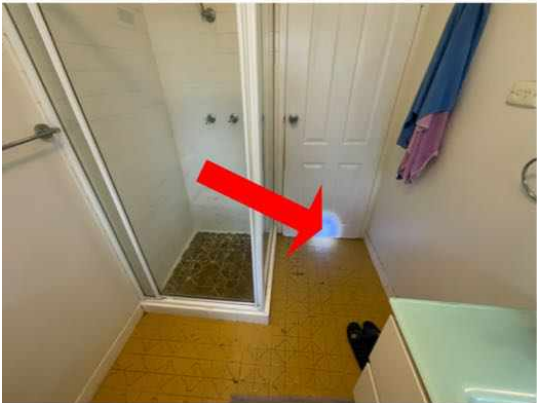
Finding 3.05

Building: Main Building
Location: Bathroom
Finding: Door - swelling and damage at the bottom edge
Information: Swollen and damaged door base in bathroom due to moisture exposure. Edges show fraying and surface degradation.

Replace or seal the affected door. Ensure door edges are properly sealed to prevent future water damage.

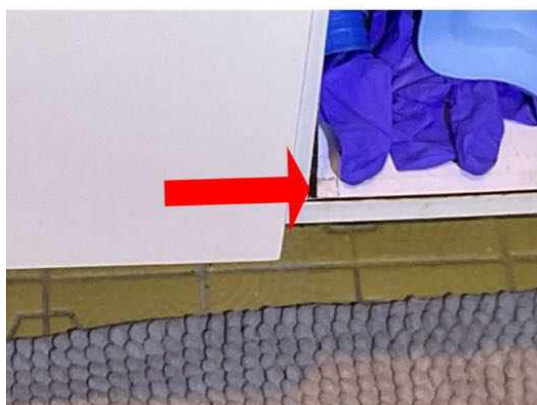
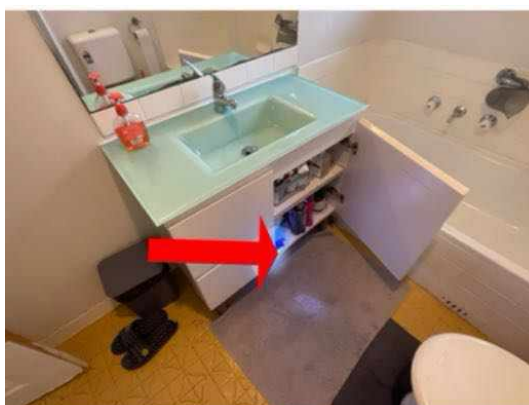
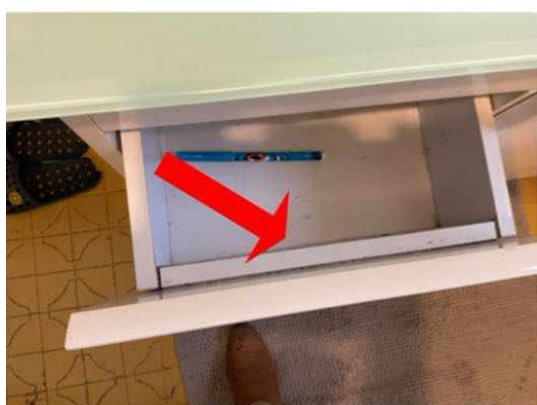
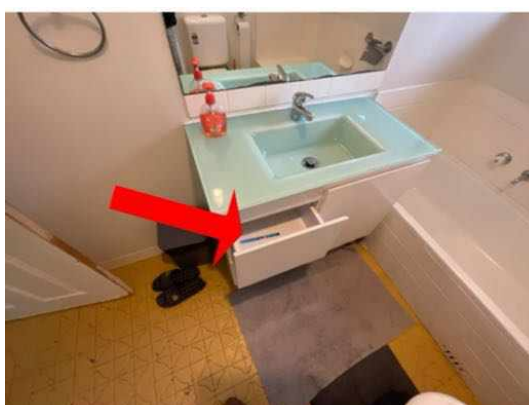
Finding 3.06

Building:	Main Building
Location:	Bathroom
Finding:	Delamination of timbers
Information:	Delamination is one means by which composite materials (e.g. layered timber composites) may fail over time. In laminated materials, repeated cyclic stresses may lead to the formation of mini-structures of separate layers, with significant loss of mechanical toughness. Water penetration or the presence of excessive moisture also generally contributes to delamination.

Where building materials have become delaminated, they lose their structural strength, and are likely to have a variety of appearance and serviceability defects as a result.

Delamination of timbers may be repaired where the area affected is minor and/or easily accessible, by gluing and screwing layers back together. However, this is an interim repair, and where delamination has occurred, the client should plan for the replacement of affected timbers sooner than would otherwise be expected.

All timber structures affected by delamination should be replaced as soon as possible to avoid any further damage. Repair and replacement estimates should be sought from a registered builder or qualified carpenter.

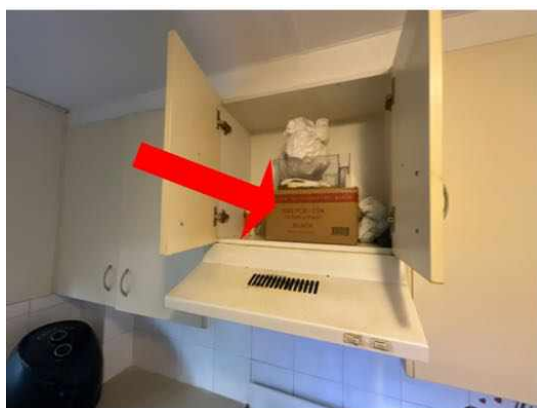
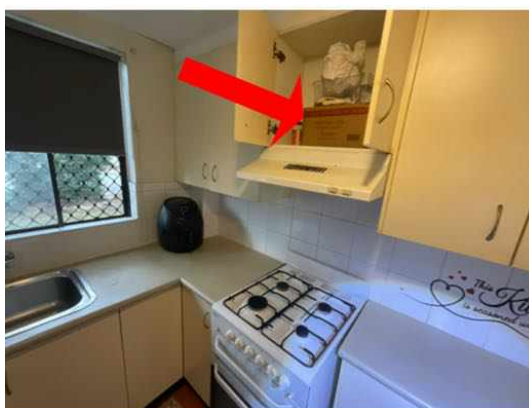
Finding 3.07

Building:	Main Building
Location:	Kitchen
Finding:	Rangehood - Flue disconnected
Information:	The range hood flue has become disconnected and is allowing the emission of steam and evaporative moisture into the ceiling space above.

While this does not create high potential for secondary defects, development of grease is likely to occur in the surrounding area, necessitating regular cleaning and maintenance.

Consultation with a licensed electrician may be required to reconnect the flue and thus allow the emission of gases into the external environment. Works should be completed at client discretion.

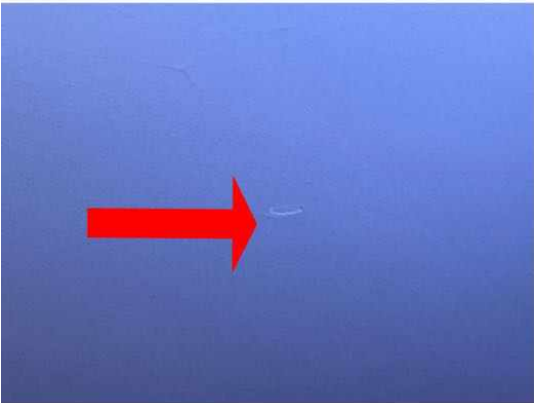
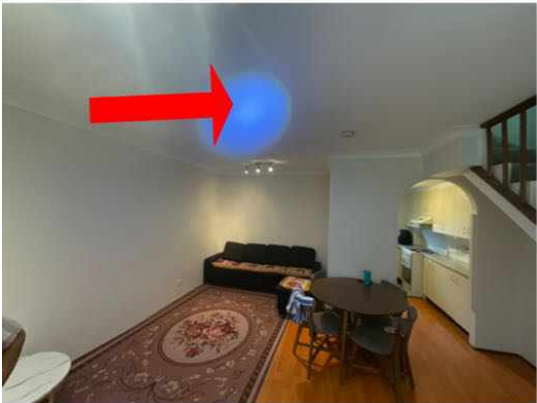
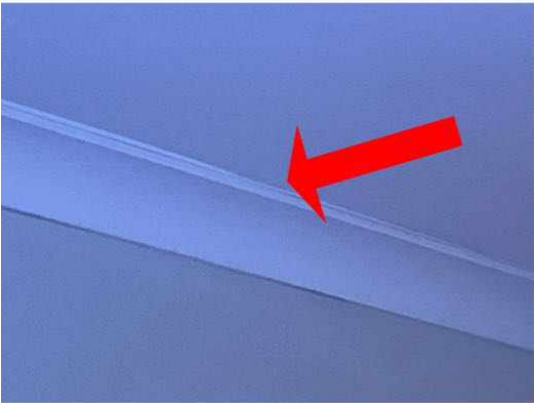
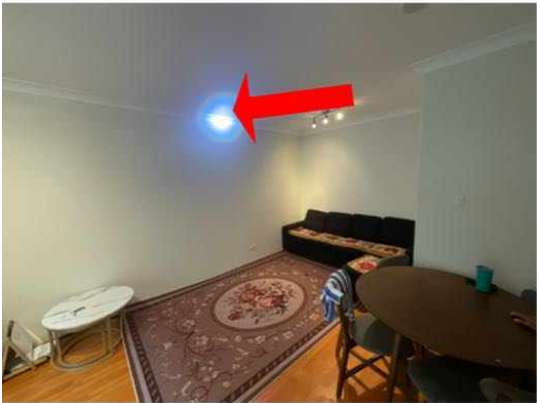
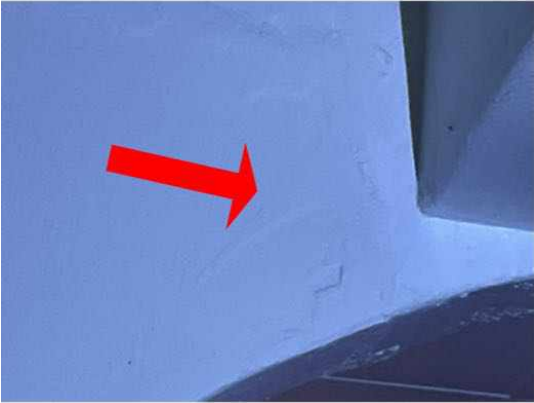
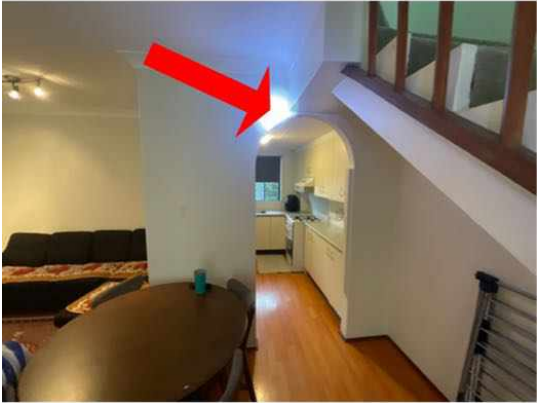
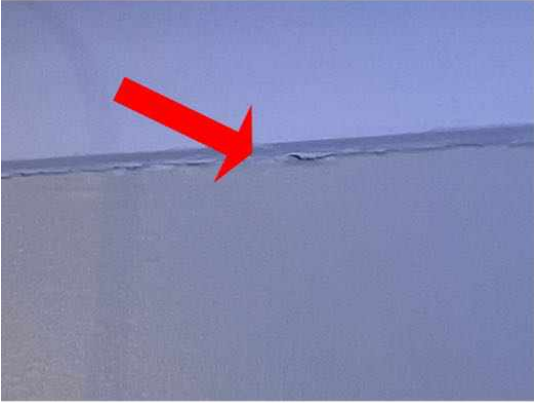
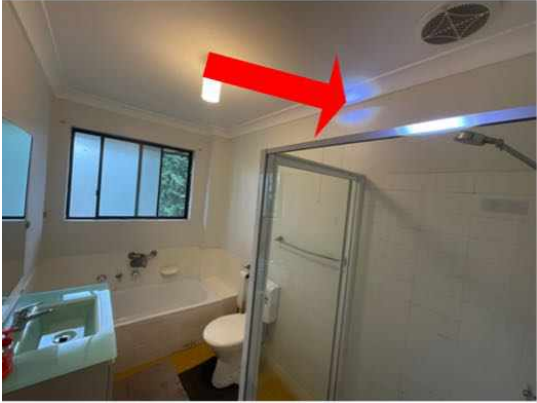
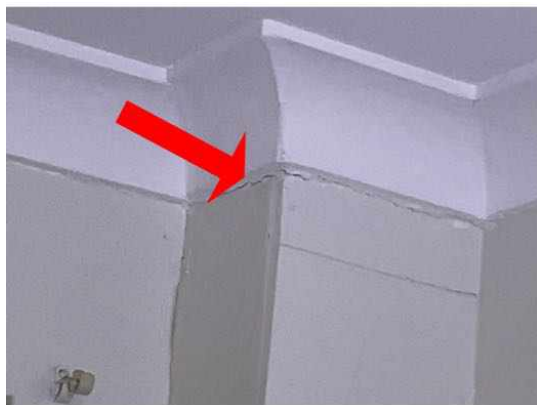
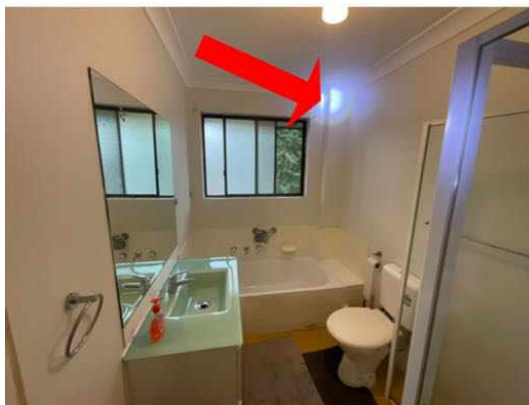
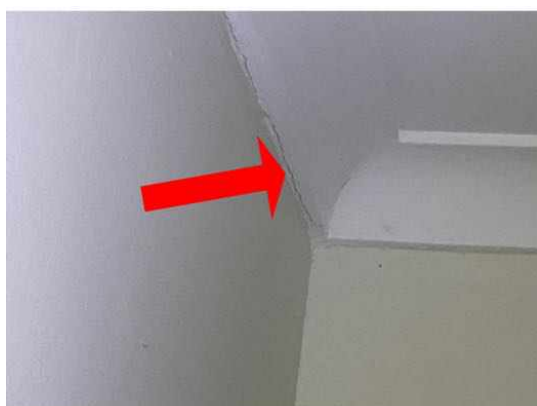
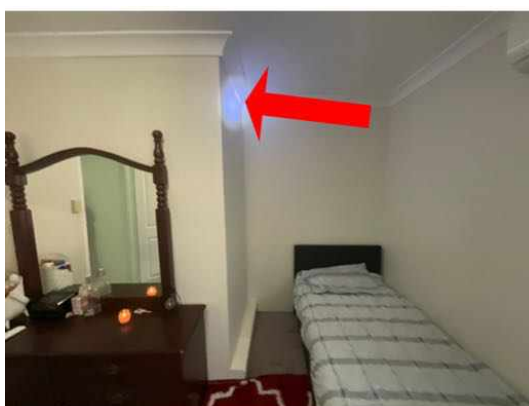
Finding 3.08

Building:	Main Building
Location:	All Internal Areas
Finding:	Paint finish - Incomplete
Information:	The paint finish in this area was identified as being incomplete at the time of inspection.

Whilst incomplete or missing paint finish is generally an appearance defect, it can also lead to the development of secondary building defects over time. Incomplete areas of paint finish expose the area to moisture, potentially accelerating the deterioration of underlying building materials.

Incomplete paint finishes should be sanded back, filled, leveled and painted, as applicable. Where inadequate or missing paint protection has led to the deterioration of the associated building element, repair and/or replacement of this building element may be required.

A painting contractor should be appointed as soon as possible to perform necessary works to aid the appearance of the affected area and to ensure the area is protected against further deterioration. Alternatively, the homeowner following manufacturer

instructions may perform these works.

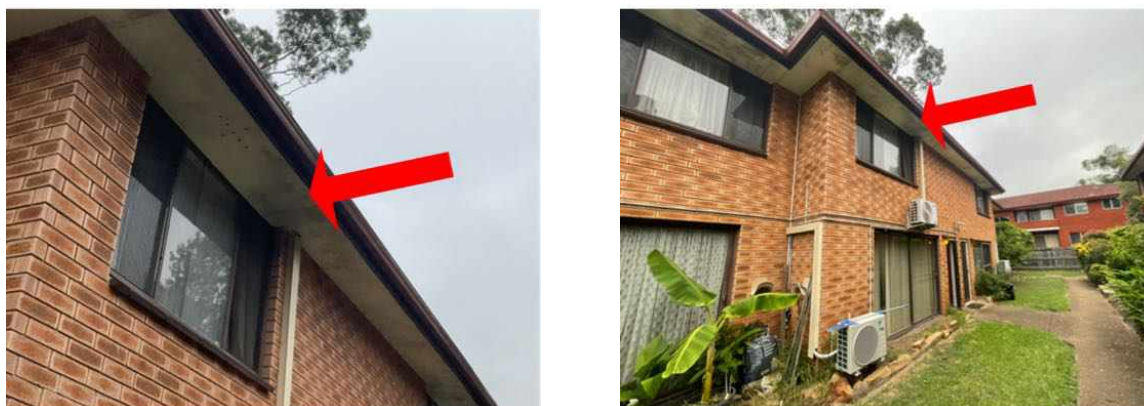
Finding 3.09

Building:	Main Building
Location:	All External Areas
Finding:	Eaves lining - Mould
Information:	Mould to eave linings in this area was evident at the time of inspection. Mould indicates that surfaces have been exposed to excessive moisture over time. The minerals and other elements in the water lead to staining, which may graduate to corrosion and deterioration if left unmanaged.

While mostly an appearance defect, mould can be indicative of more serious defects, which may be currently concealed by lining.

Where water staining is active, a licensed plumber must be consulted to identify the cause of the staining and to provide advice on any reparation works that may be required. Replacement of any damaged structures is advised.

Conversely, where water staining is old and inactive, affected building materials may be repaired or replaced at client

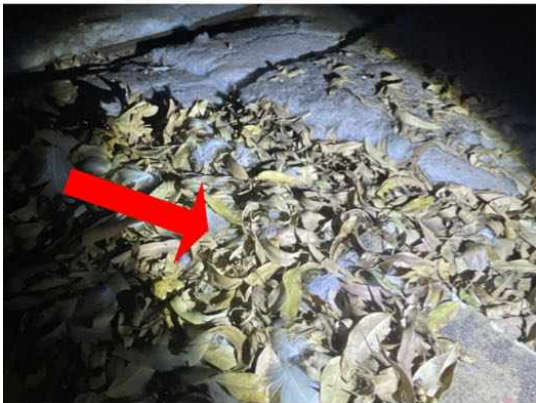
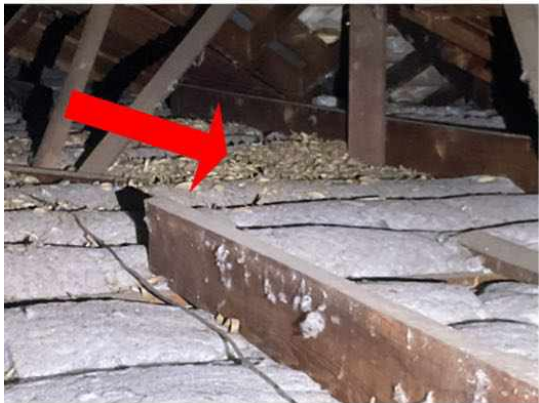
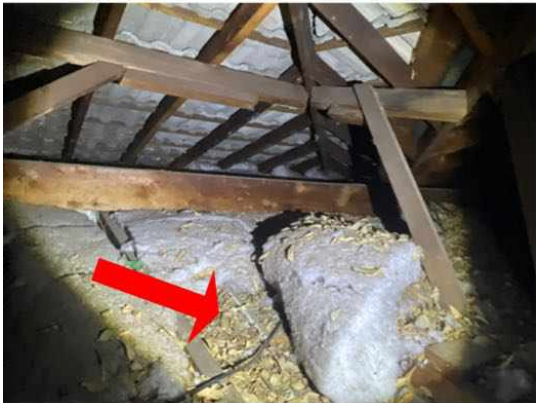
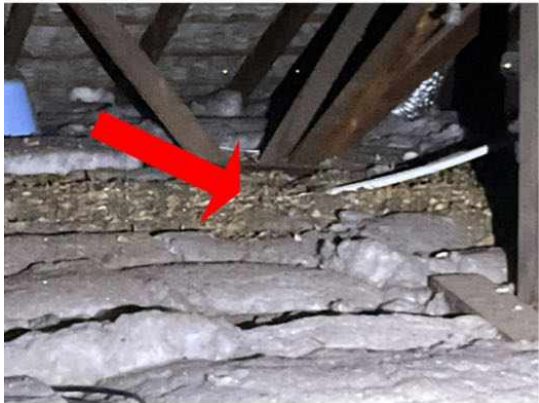
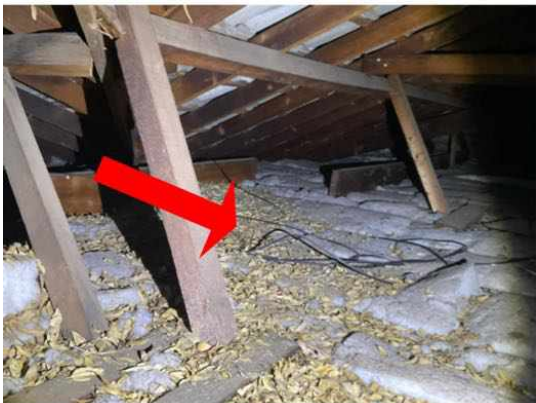
Finding 3.10

Building:	Main Building
Location:	Roof Void
Finding:	Foreign Debris (Leaves) Present Within Roof Space
Information:	Loose leaf debris was observed within the roof void space above the ceiling insulation. The presence of external debris within the roof cavity suggests that the roof covering may not be fully sealed against wind-driven entry.

This condition may be caused by:

- Gaps at eaves, ridge capping, or flashing
- Dislodged or poorly fitted roof tiles/sheets
- Deteriorated sarking or missing insulation barriers
- Openings at gable ends or roof penetrations

While no active water ingress was observed at the time of inspection, the presence of debris indicates the roof may be vulnerable to wind-driven rain penetration during severe weather events.

A licensed roofing contractor should inspect the roof covering, ridge capping, flashing, and sarking to ensure the roof system is properly sealed and weather-tight.

If staining, damp insulation, or ceiling marks are present internally, a further invasive inspection may be required to confirm whether moisture ingress is occurring.

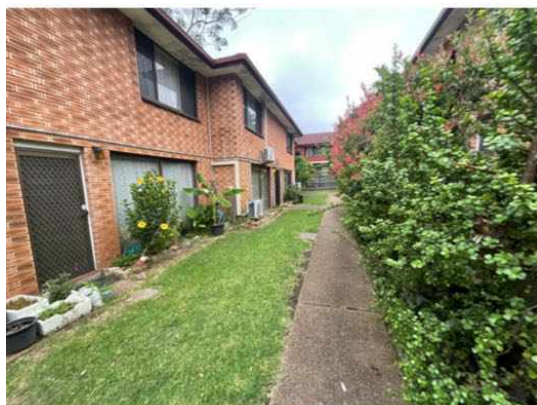
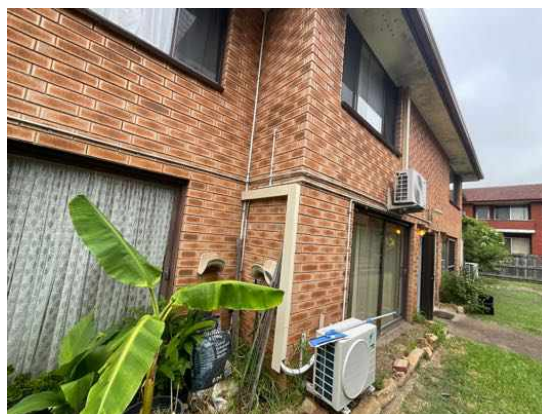
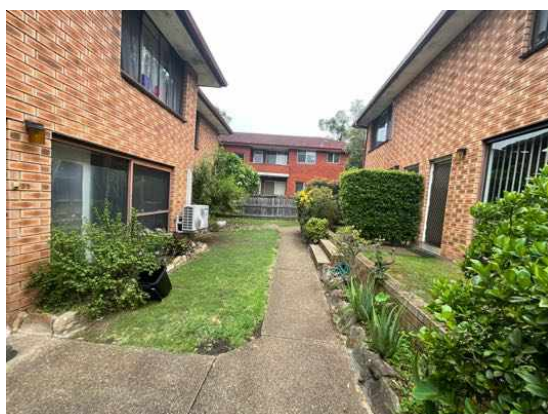
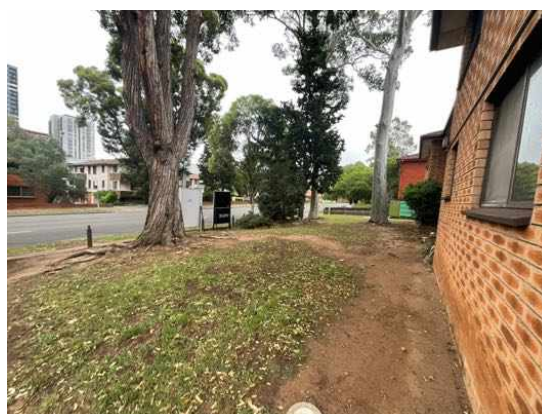
Finding 6.01

Building:	Main Building
Location:	All Areas
Finding:	Garden Beds - Conditions Conducive to Termites
Information:	Garden beds were found to be evident in the garden area. These garden beds can include untreated timber, and with a combination of moisture from watering hosing can make conditions conducive to termite activity and termite ingress.

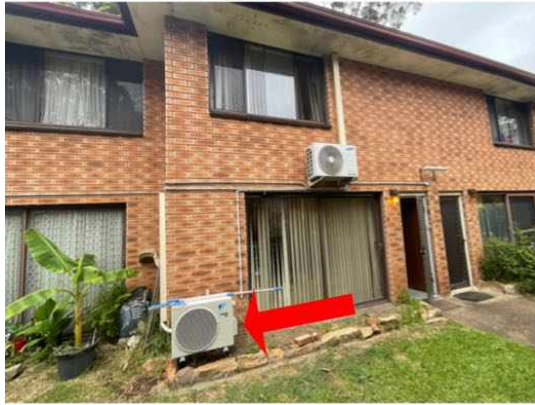
Finding 6.02

Building:	Main Building
Location:	All Areas
Finding:	Bridging of termite barrier/inspection zones
Information:	Bridging is the spanning of a termite barrier or inspection zone so that subterranean termites are provided with passage over or around that barrier.

Where bridging has occurred, full inspection is prevented and termites may enter a property in a concealed or undetectable manner.

It is recommended that minimum 75mm clearance below the bottom of weep or ventilation holes be maintained where possible, otherwise annual inspections should be conducted by a licensed pest control company. Vegetation should also be kept clear of walls to allow regular inspection of all areas.
