Building and Timber Pest Inspection Report

Inspection Date: Thu, 8 Jan 2026

Property Address: 6 Percival St, Shepparton VIC 3630,
Australia

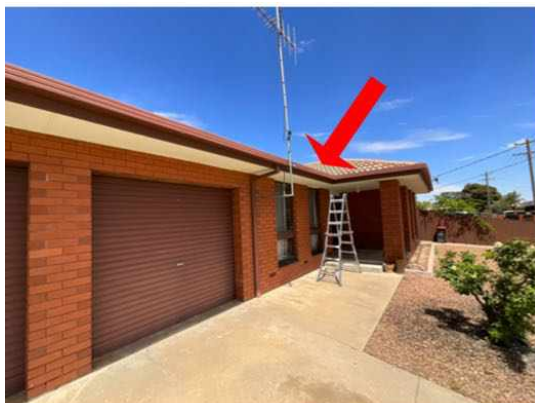
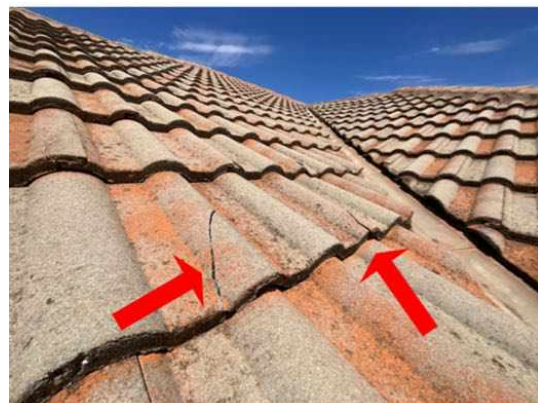
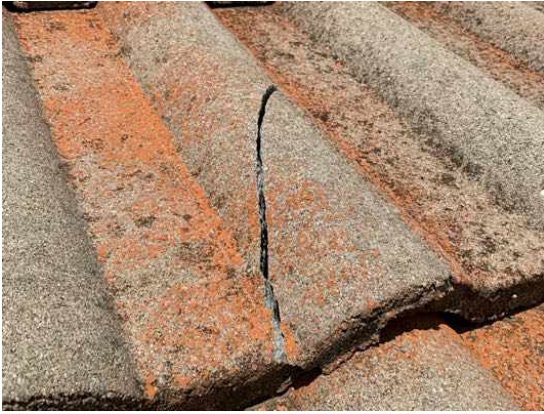
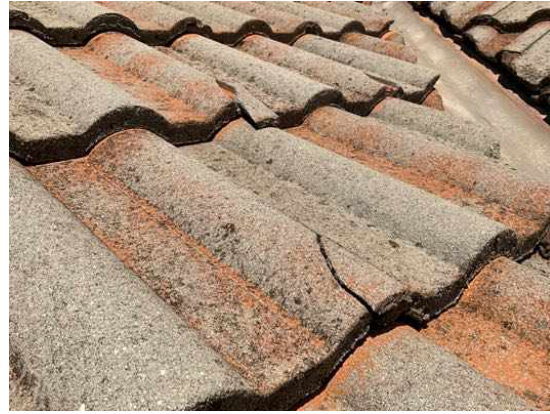
Finding 3.01

Building: Building 1
Location: Roof Exterior
Finding: Roof tiles - Broken
Information: Upon inspection of the exterior roof covering, broken roofing tiles were identified. Broken and friable roof tiles are generally the result of ageing and weathering of what is essentially a porous material.

If left to further deteriorate, broken and brittle roof tiles are likely to lead to water penetration via the roof into the ceiling space, causing secondary damage to ceiling linings, insulation and roof structures. Broken roof tiles are also likely to detract from the effectiveness of the roof drainage system, creating potential for secondary damage to the exterior roof covering and roof plumbing.

Replacement of broken tiles is required and should be performed by a roofing contractor as soon as possible.

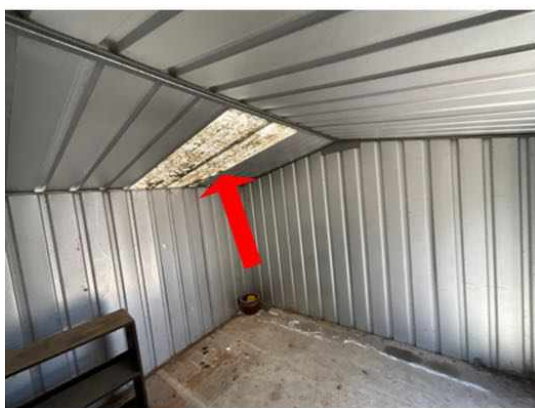
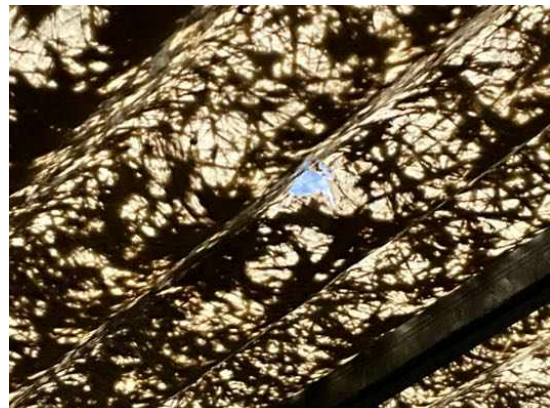
Finding 3.02

| Finding: | Polycarbonate sheeting - Damaged |
| Information: | The polycarbonate sheeting has deteriorated as a result of exposure to weather conditions over a prolonged period of time. Exposure to elements, such as heavy rain and hailstorms, is likely to damage polycarbonate sheeting, which is not as strong as other roof coverings. |

Further deterioration of the polycarbonate sheeting is likely to occur if left unmanaged. Such deterioration creates potential for water penetration and secondary damage to the internal roofing structure, accelerating deterioration of all associated building elements.

Repair and replacement of several sections of the sheeting is required. Appointment of a roofing restorer is required to perform these works as soon as possible to prevent any further damage being sustained.

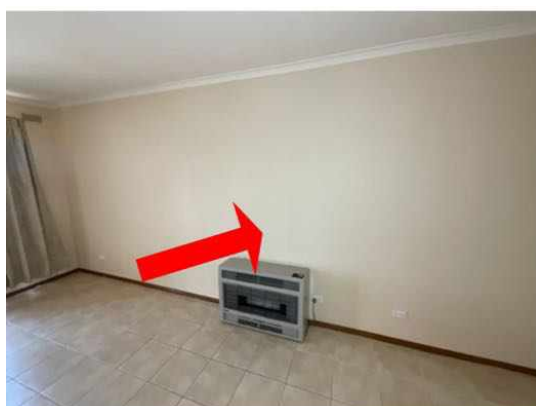
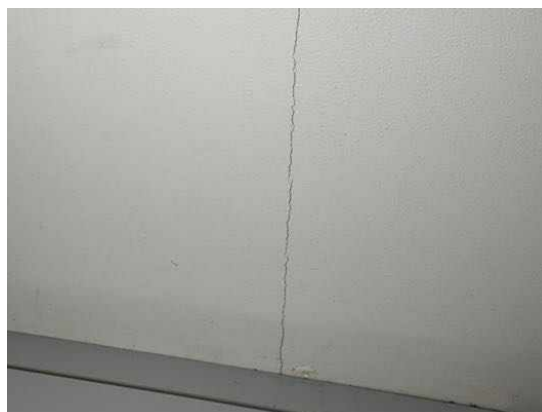
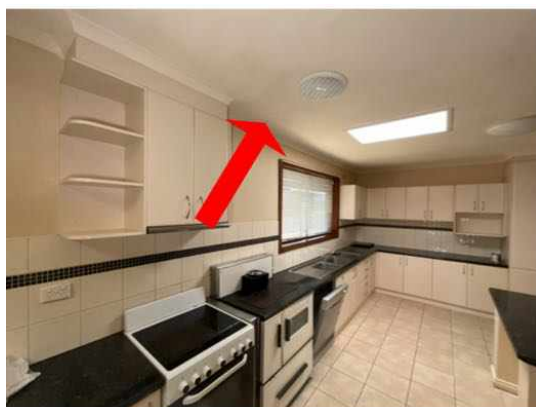
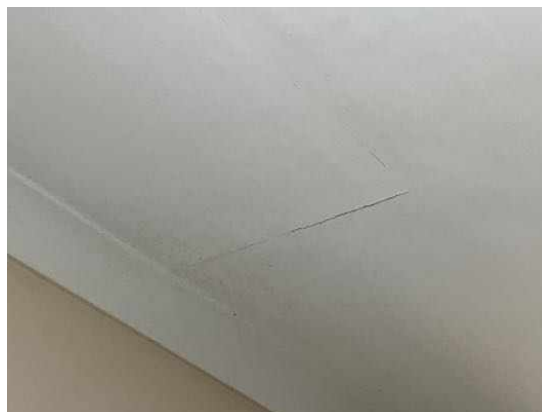
Finding 3.03

Finding: Cracking - Damage Category 1 - Fine (up to 1mm)
 Information: Although fine cracks are quite noticeable, they are often only considered to be an appearance defect, and usually do not indicate any structural damage. Generally, the cause of a fine crack is indicative of a separation between building materials and finishes (e.g. paint, plaster, etc.) along joins.

Cracking of this nature can generally be repaired with minor sanding, filling and/or repainting. Such works should be performed by a qualified painter or a general handyman.

Monitoring of all cracking should be conducted frequently. Always contact a building inspector should cracks widen, lengthen, or become more numerous.

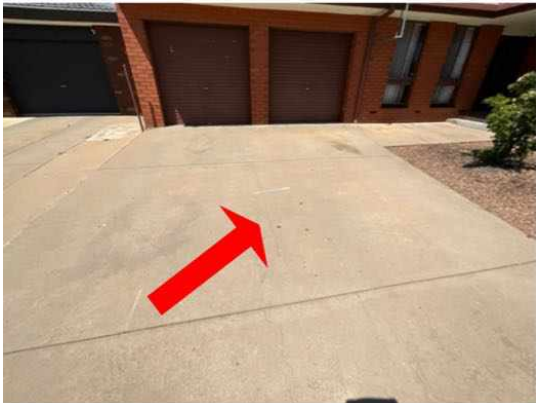
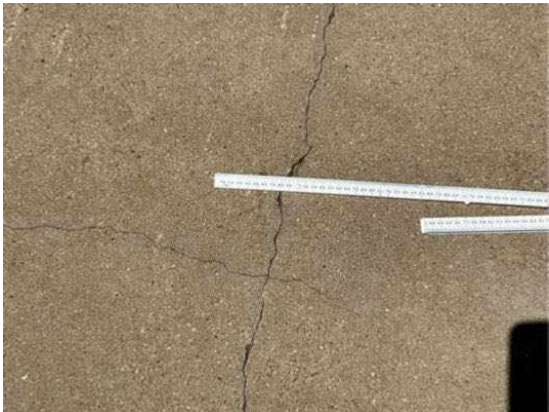
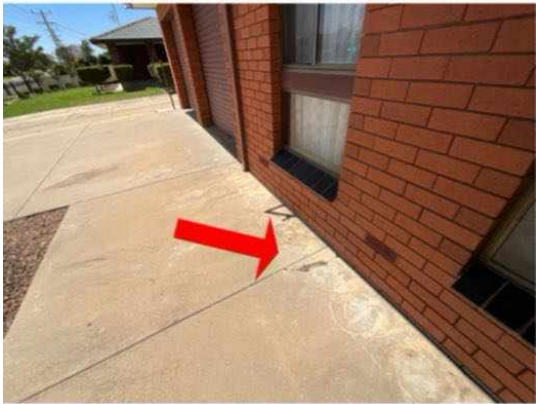
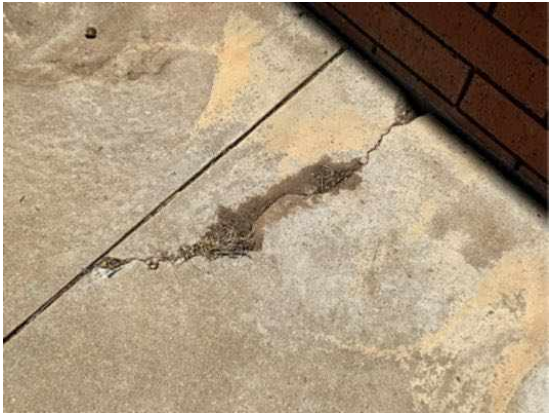
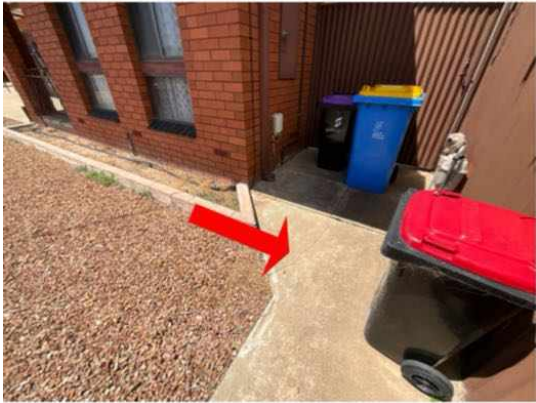
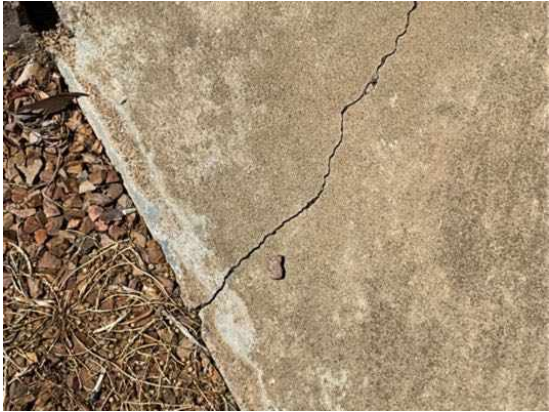
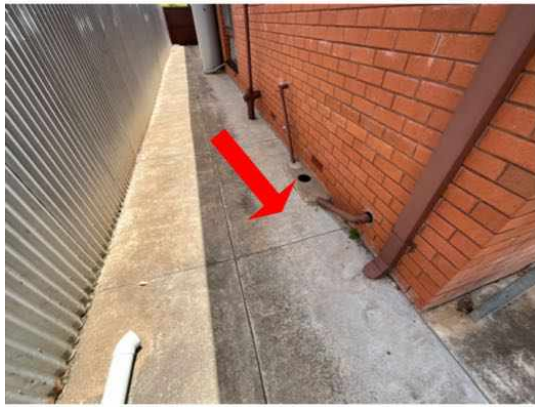
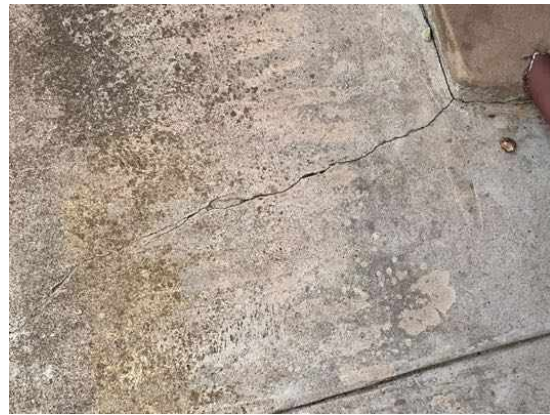
Finding 3.04

Building: Building 1
 Location: Driveway area, yard - front, side
 Finding: Cracking - External Concrete Paving Damage Category 1 - Fine (less than 2mm)
 Information: Fine cracks were identified in external concrete paving. Although fine cracks are quite noticeable, they are often only considered to be an appearance defect, and usually do not indicate any structural damage. To be considered a Category 1 or fine crack, the crack is found to be less than 2mm in width.

Generally the cause of a hairline crack in existing concrete paving such as driveways and pathways is indicative of the expansion and contraction of the concrete. Such causes are generally due to environmental factors, such as moisture levels, weather conditions, root systems of nearby trees or the soil types on which they are laid.

Fine cracks may also be due to poor original installation of the concrete. Factors such as poor compaction of the sub surface and/or inadequate reinforcing of the slab may create cracking and other secondary defects.

Monitoring of all cracking should be conducted frequently. Always contact a building inspector should cracks widen, lengthen, or become more numerous.

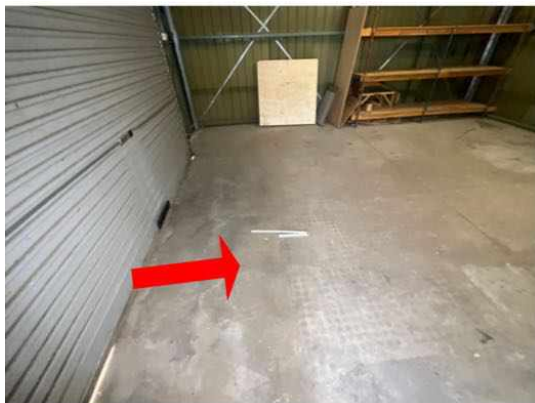
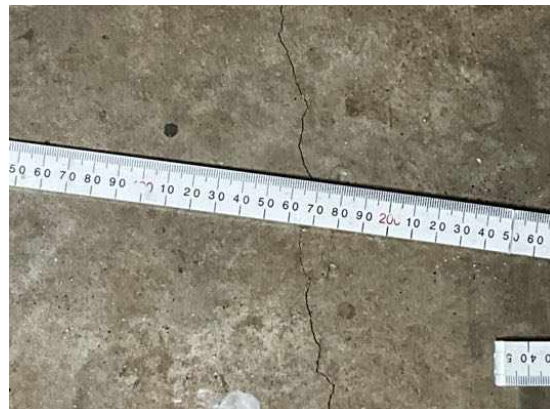
Finding 3.05

Building: Building 1
 Location: Shed
 Finding: Crack in concrete slab - Category 1
 Information: A crack coded as Category 1 was identified in the slab. A Category 1 crack is described as a fine but noticeable crack, with the slab at an otherwise reasonable level.

To be considered Category 1, the approximate width of the crack is less than 1.0mm, or a less than 10mm change in offset when a 3m straight edge is placed over the defect.

Category 1 cracks should be monitored for a period of 12 months. At the end of the monitoring period, identified cracks that are rated greater than Category 2 are considered defects, and require rectification.

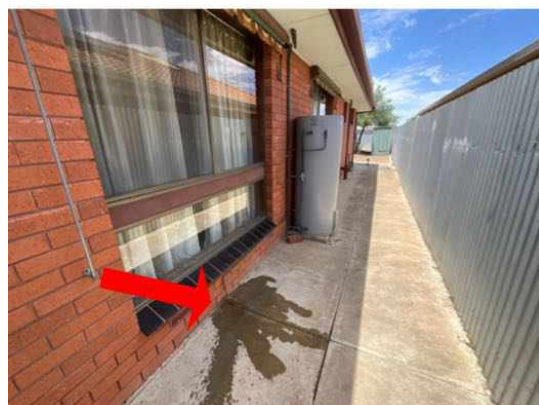
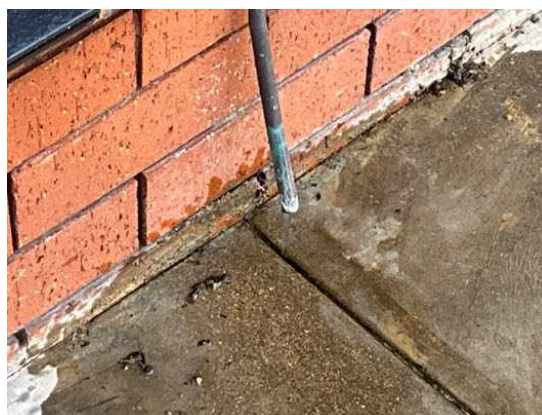
Building: Building 1
 Location: Yard - Side
 Finding: HWS Overflow - Not Connected
 Information: The Hot Water System (HWS) overflow was found to be disconnected from storm water drainage and is creating excessive moisture in the surrounding area.

These damp conditions can lead to secondary defects such as rot, rust or corrosion of associated building elements, the formation of fungal decay, or even the creation of potential slip hazards. When coupled with poor site drainage, pooling of water may also attract termite activity to this area.

It is highly recommended that a licensed plumber be appointed to connect the HWS overflow in order to prevent such an environment from being created. These minor works should be carried out as soon as possible.

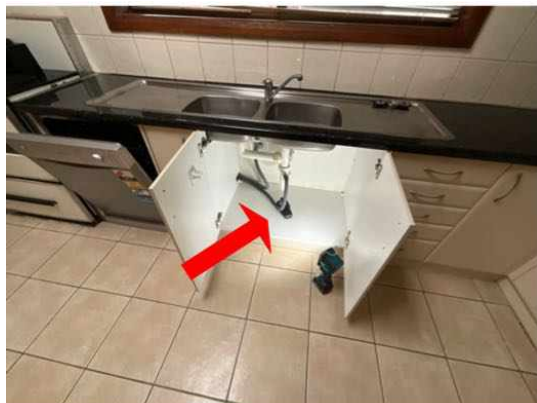
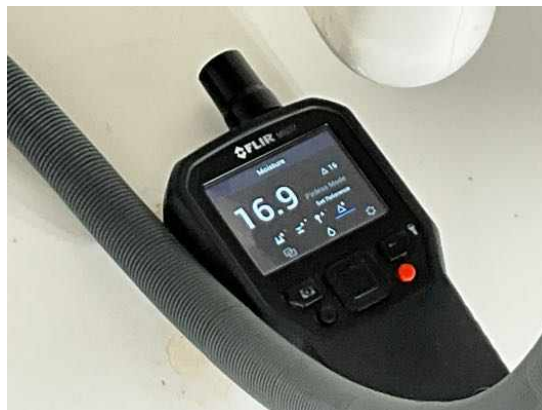
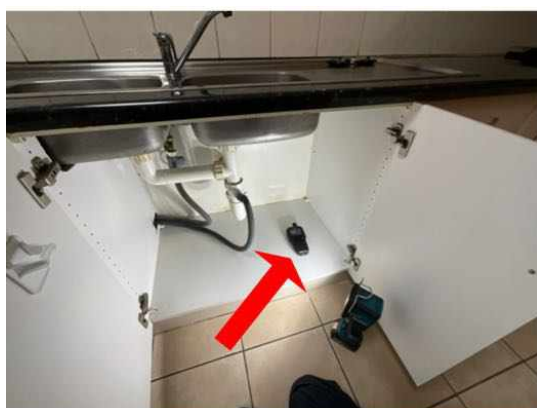
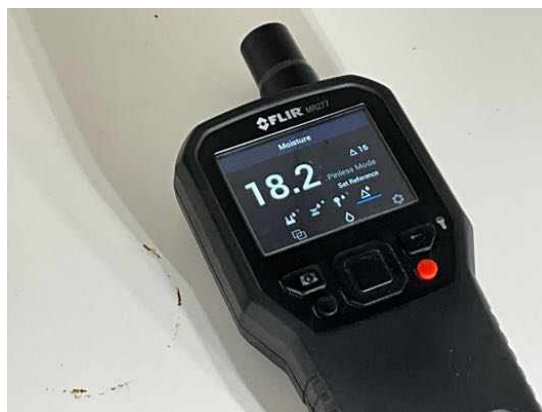
Finding 6.02

Building: Building 1
 Location: Kitchen
 Finding: Evidence of moisture- present
 Information: Excessive moisture can attract termites and produce conditions that promote termite attack, fungal growth and wood decay.

In this case the trap may be leaking.

This area should be monitored for any increase in moisture levels.

If mould or cracking damage increases, appropriate trades should be contacted to make all needed repairs/ restoration.

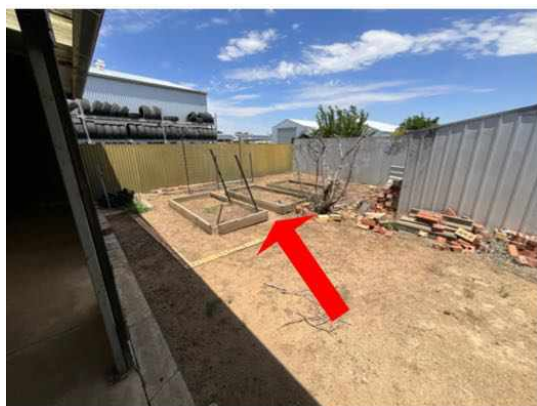
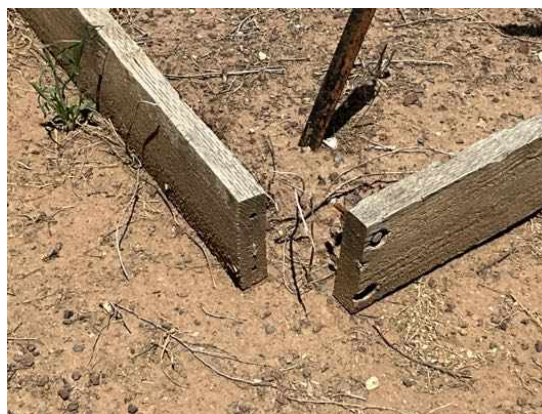
Finding 6.03

| Finding: | Untreated or non-durable timbers in a hazardous environment |
| Information: | To reduce the risk of timber pest attack it is essential that timber used in a hazardous environment (e.g. in direct contact with the ground or frequently exposed to damp conditions) is of sufficient durability and/or is adequately preservative treated. |

Untreated timbers in direct contact with the ground are likely to develop severe wood rot and/or fungal decay if left unattended creating attraction for subterranean termites to infest the timbers from surrounding areas.

If untreated or non-durable timbers are found to be in a hazardous environment it is highly advised that replacement of these building elements be performed as soon as possible to aid the protection of the property against termite / timber pest attack.

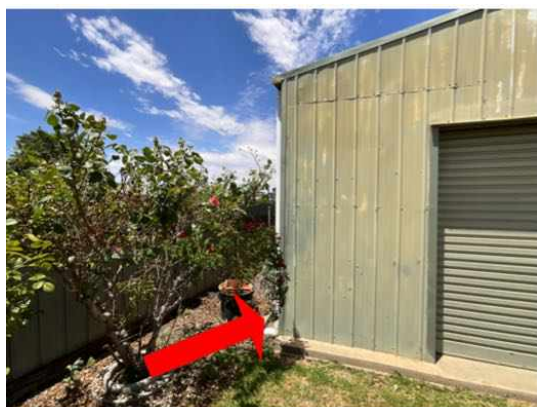
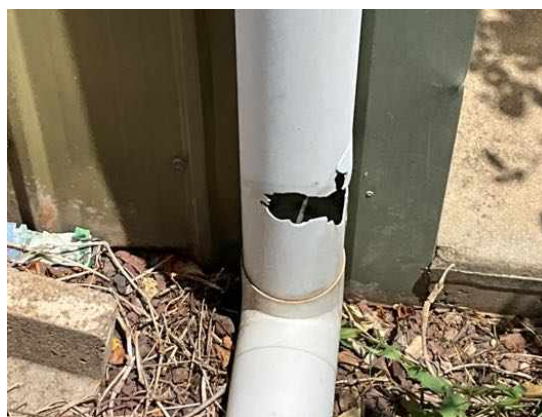
Finding 6.04

| Finding: | Downpipe- Damaged |
| Information: | The Downpipe was found to be damaged at the time of inspection. This damage has occurred because of impact from a foreign object. |

Downpipes ensure excess water is directed away from the structure to prevent damage. This damage includes Fungal timber decay, Termite attack and sinking of the stumps that support the floor. All of this type of damage may lead to costly repairs.

A Plumber should be contacted to make repairs as soon as possible to prevent deterioration of the Structure.

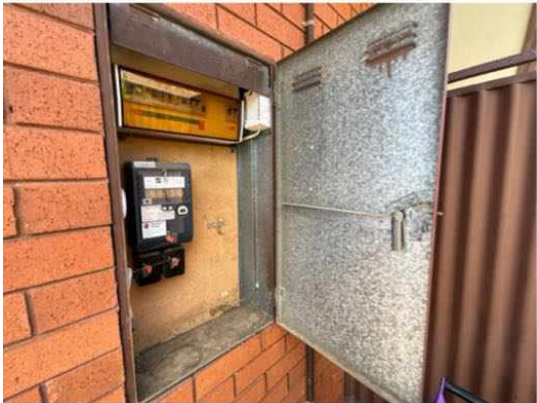
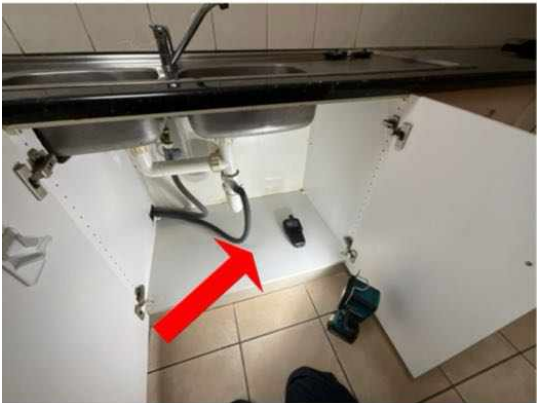
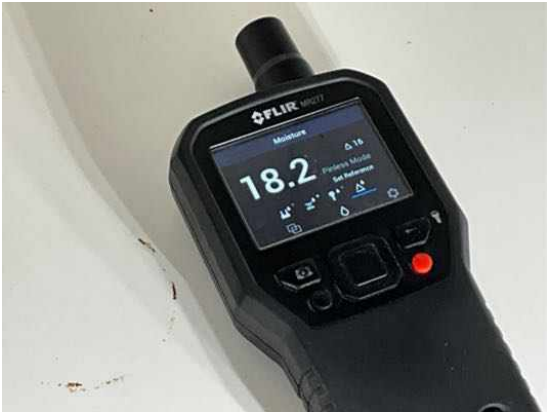
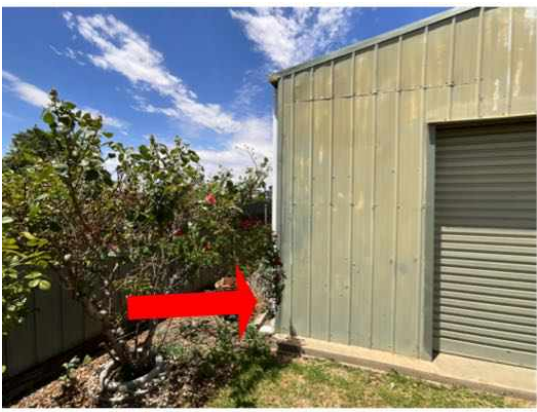
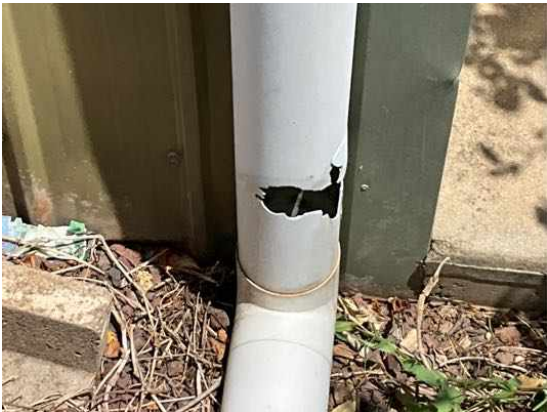
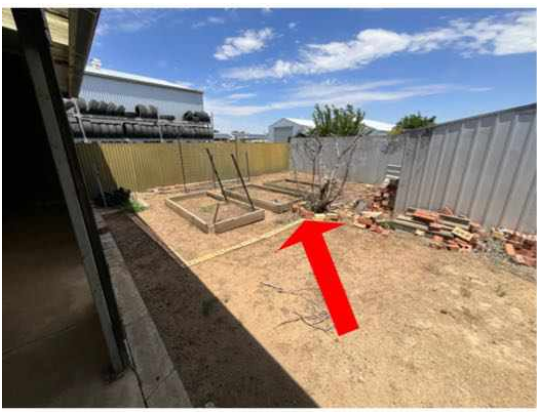
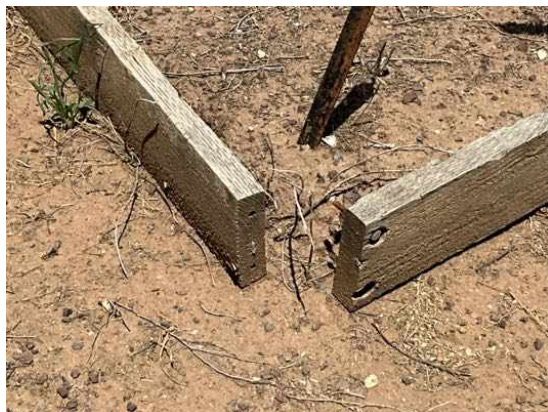
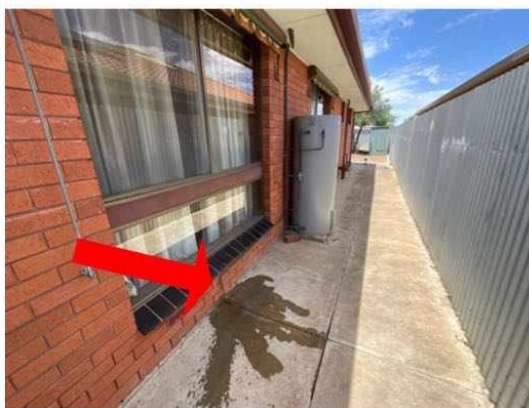
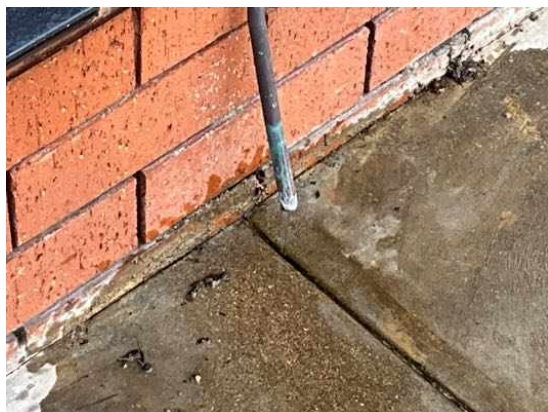
Finding 6.05

| Information: | The application of a post-construction chemical termite barrier is highly recommended for all properties, particularly if live termite activity has been found on the site previously. Such barriers are highly effective in preventing termite attack on any timber |

A durable notice should be placed in the switchboard unit to indicate current termite barriers. At the time of inspection, it appeared as though no termite management system has been installed, with no evidence to suggest preventative works taking place.

The client may consider gaining further advice from a pest controller as to the costs and procedures involved with this application. It is recommended that obtaining such advice be a short-term priority.

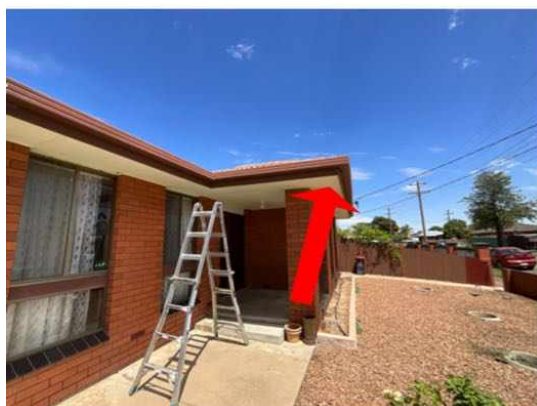
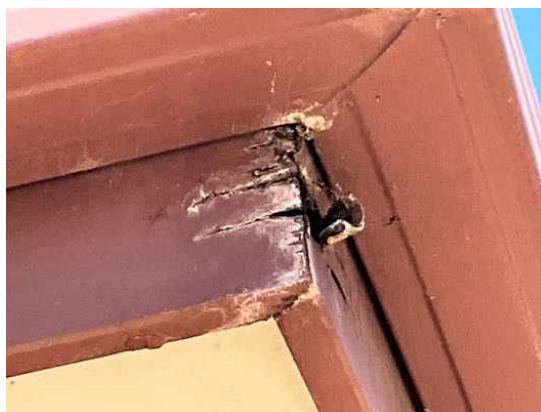
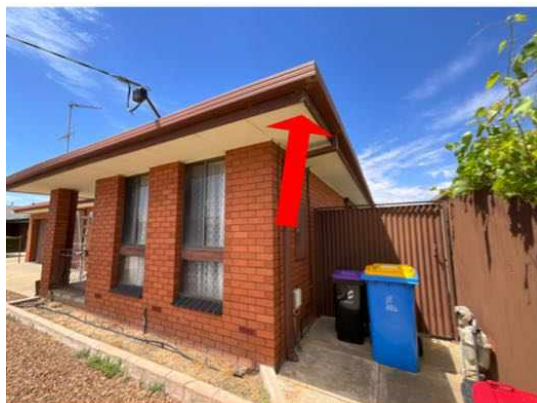
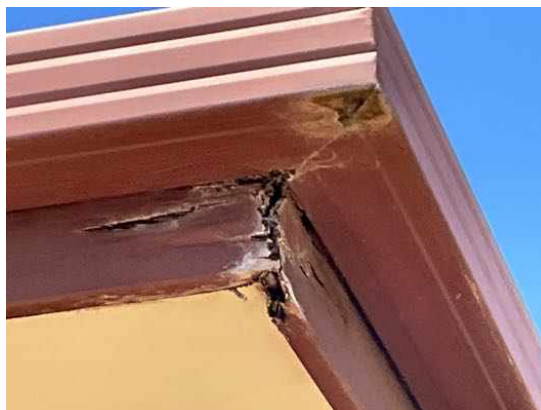
Finding 7.01

| Finding: | Fungal decay - present (localised) |
| Information: | Fungal decay also known as wood decay or wood rot generally refers to the deterioration of timber elements when in contact with excessive levels of moisture for a prolonged period of time. |

The development of fungal decay is accelerated by temperatures in the range of 5degreeC to 40degreeC as well as the presence of oxygen. Generally fungal decay develops on timber elements that are in use in an external environment which are exposed to rain penetration.

In this case although the affected timber element is in a decaying state the extent of any visible damage appears to be localised to a specific area and is yet to spread to other parts of the building element or affect adjoining structures. The fungal decay is therefore likely to be of a relatively superficial nature with minimal impact on the structural integrity or tensile strength of the timber element.

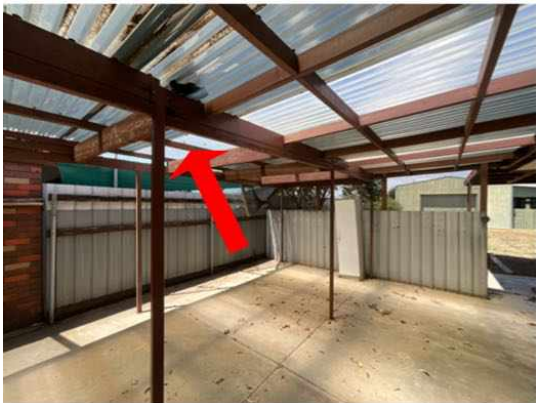
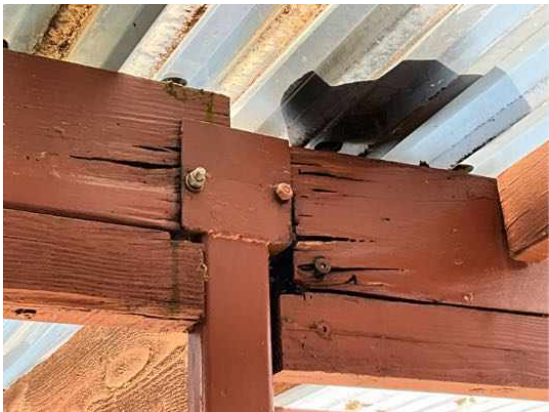
Finding 7.02

| Finding: | Fungal decay - present (localised) |
| Information: | Fungal decay also known as wood decay or wood rot generally refers to the deterioration of timber elements when in contact with excessive levels of moisture for a prolonged period of time. |

The development of fungal decay is accelerated by temperatures in the range of 5degreeC to 40degreeC as well as the presence of oxygen. Generally fungal decay develops on timber elements that are in use in an external environment which are exposed to rain penetration.

In this case although the affected timber element is in a decaying state the extent of any visible damage appears to be localised to a specific area and is yet to spread to other parts of the building element or affect adjoining structures. The fungal decay is therefore likely to be of a relatively superficial nature with minimal impact on the structural integrity or tensile strength of the timber element.

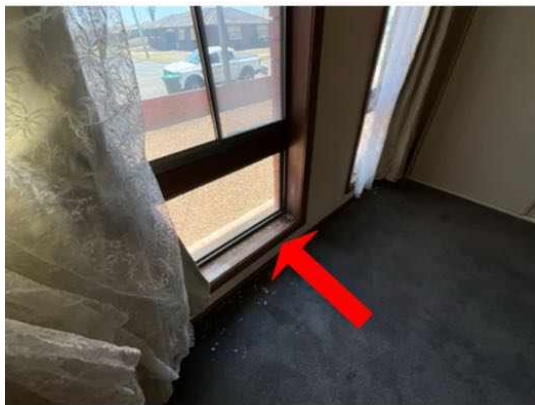
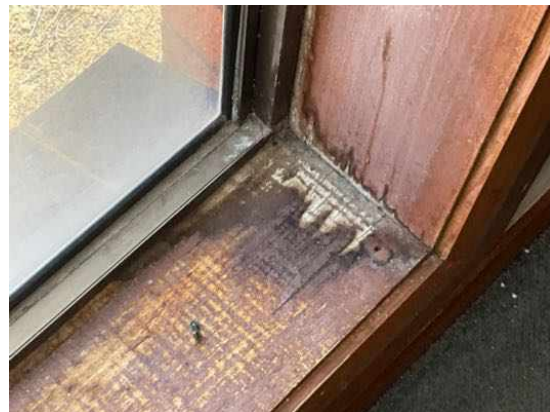
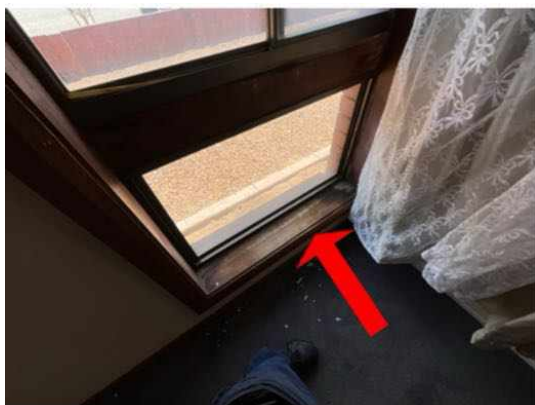
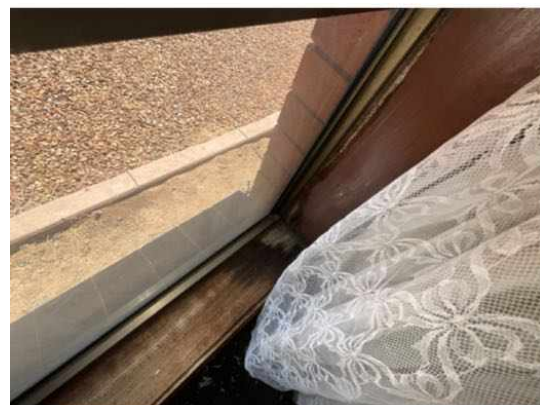
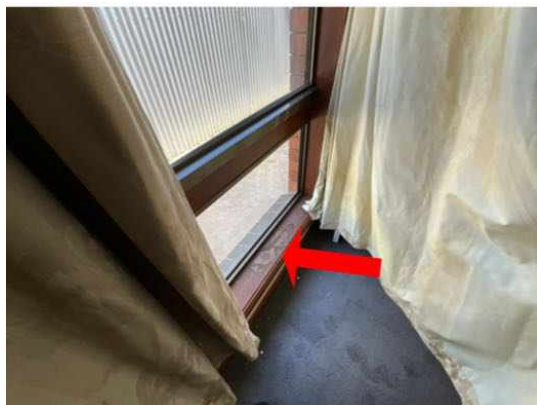
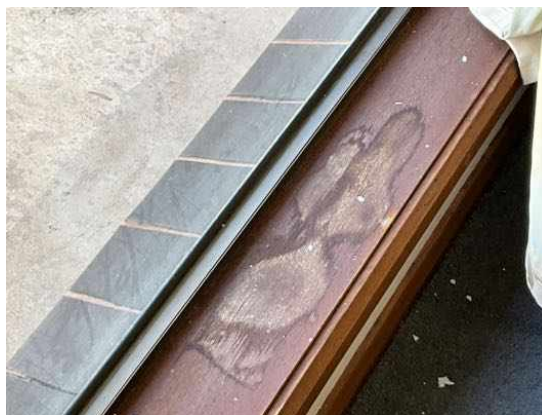
Building: Building 1
 Location: Timber window surrounds
 Finding: Timber window Surrounds
 Information: The finish around the timber window surrounds was found to have deteriorated. The original sealant has broken down over time and has allowed moisture to penetrate the timber, creating mould.

Substandard paint finishes in areas exposed to moisture, e.g. external areas or wet areas, could lead to deterioration of underlying building materials.

Substandard paint/ sealant finishes should be sanded back, filled, leveled and repainted, as applicable.

A painting contractor should be appointed as soon as possible to perform necessary works to aid the appearance of the affected area and to ensure that the area is protected against further deterioration. Alternatively, the homeowner following manufacturer instructions may be able to provide this service.

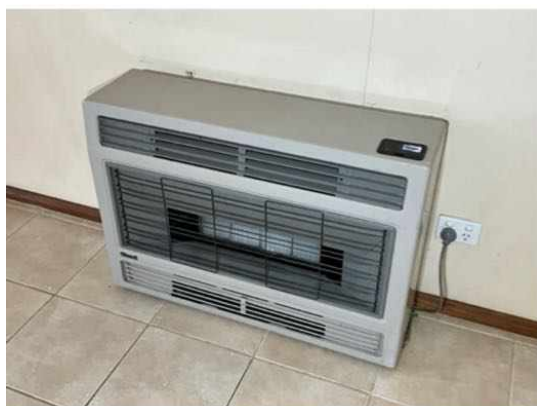
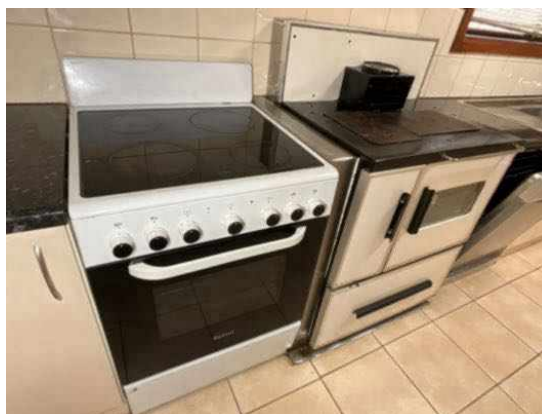
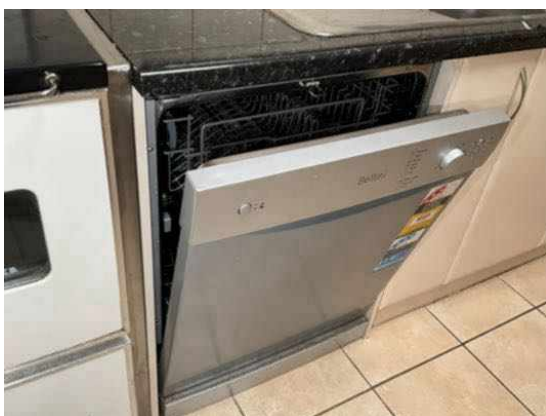
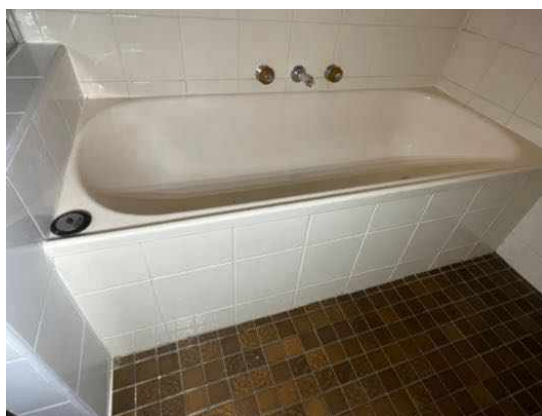
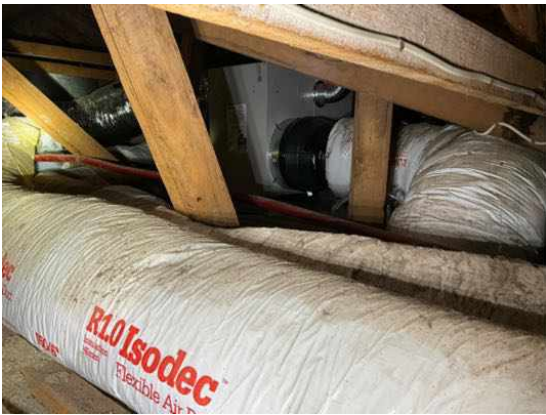
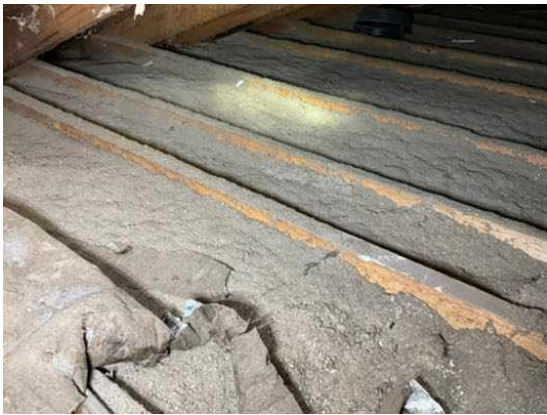
Building: Building 1
Location: All Areas
Finding: Additional Photos - Obstructions and Limitations
Information: These photographs are an indication of the obstructions and limitations which impeded full inspection of the property at the time of inspection. These obstructions can hide an array of defects and should be removed to allow full inspection to be carried out. A re-inspection is recommended once the areas are made accessible.
