Building and Timber Pest Inspection Report

Inspection Date: Thu, 26 Feb 2026

Property Address: 401/10 Norfolk St, Liverpool NSW 2170,
Australia

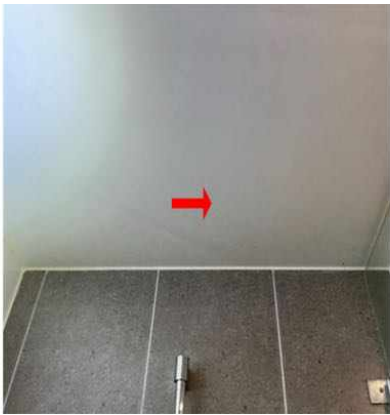
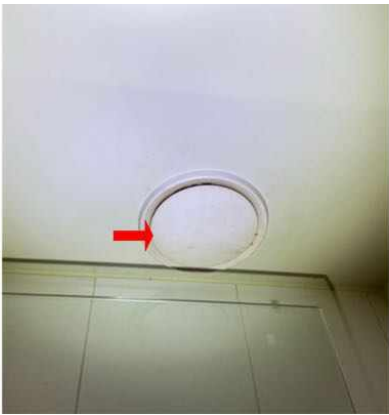
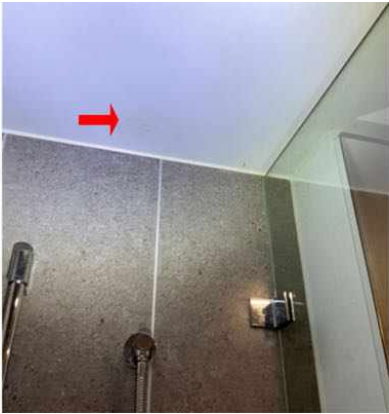
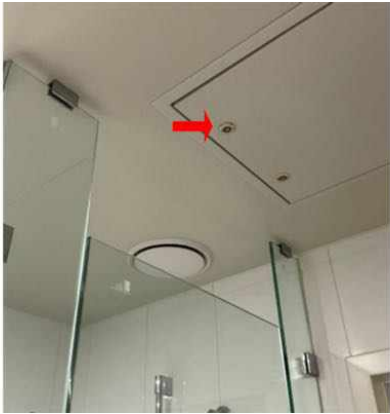
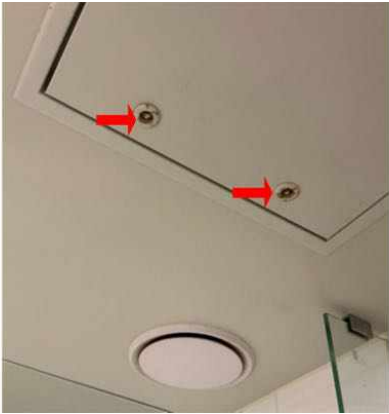
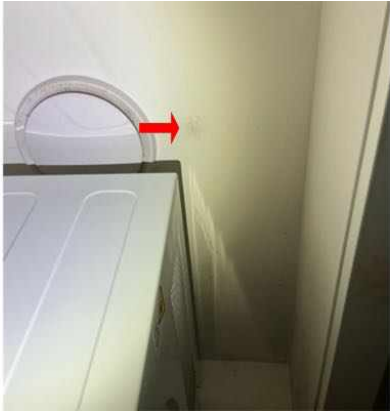
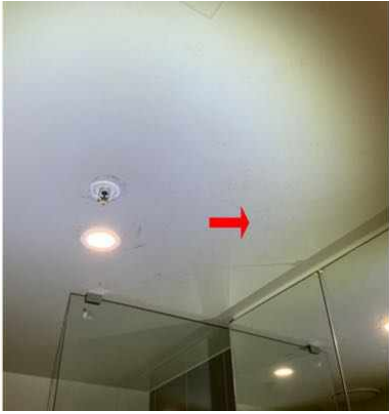
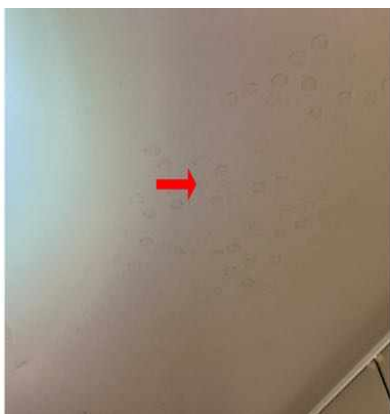
Finding 3.02

Building:	Main Building
Location:	Bathrooms , Laundry
Finding:	Water Staining - Humidity or Ventilation
Information:	The ceiling surface shows peeling paint and water staining on the walls faint commonly consistent with humidity-related staining, often found in bathroom or wet areas with insufficient ventilation. While there is no visible sagging or major water damage, the pattern suggests prolonged moisture exposure, possibly due to steam accumulation or minor condensation issues. According to AS 4349.1–2007 (Appendix C), this would be classified as a minor defect unless further deterioration or active leaks are found. Recommend improving mechanical or natural ventilation, cleaning the surface with mould treatment, and monitoring for recurrence.

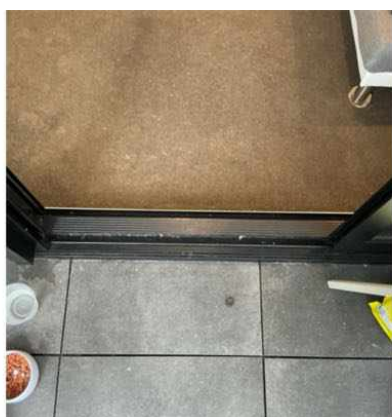
Finding 3.03

Building:	Main Building
Location:	Balcony
Finding:	Balcony Floor Level Differential
Information:	The balcony finished surface appears to be close to, or at the same level as, the internal floor. Standard construction practice requires a step-down of approximately 50 mm unless a fully engineered threshold drainage system is provided. No such drainage features were visible during inspection. This configuration increases the risk of water ingress, and confirmation of the balcony waterproofing detail through strata/building management is recommended.

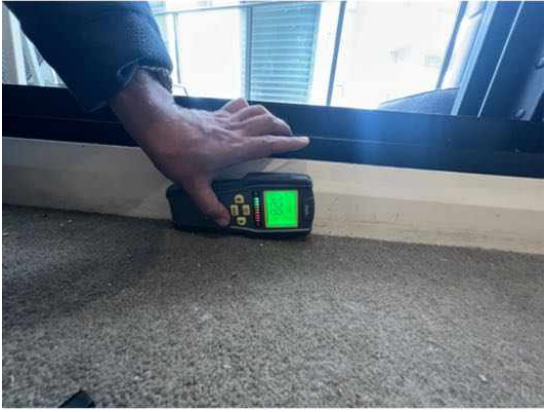
Finding 3.04

Building:	Main Building
Location:	Balcony
Finding:	Elevated Moisture Detected - Strata
Information:	Slightly Elevated moisture levels were detected in skirting any lower walls adjacent to balcony area . The areas should be monitored for and changes to existing conditions e.g damp , paint bubbling of staining.Further invasive investigation by a licensed plumber or waterproofing specialist is recommended to confirm the source and extent of water ingress if condition persists. As this relates to a multi-residential building, the source of water ingress may involve common property, a suitably qualified

waterproofing contractor is recommended to determine cause, responsibility, and scope if required.

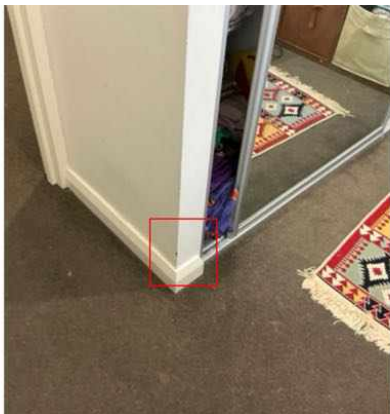
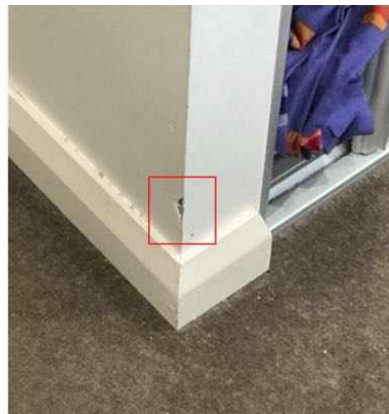
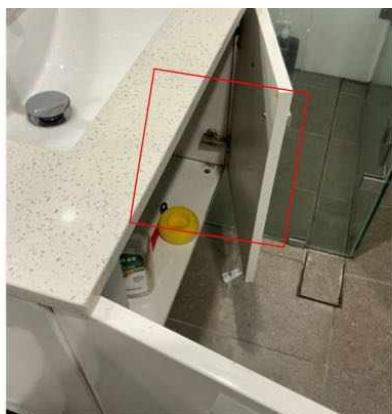
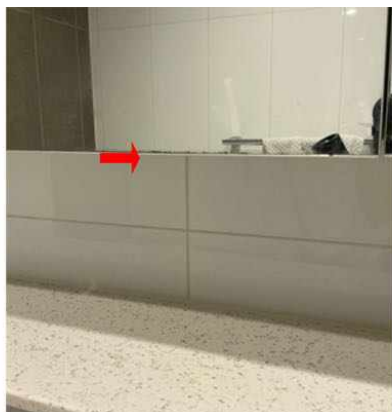
Building:	Main Building
Location:	All Internal Areas
Finding:	Building element - Damaged - Plaster damaged , trim damaged bathroom , vanity moisture damage bathroom , mirror desilvering bathroom
Information:	Breakage occurs generally when the building materials have either aged and decayed, or as a result of damage (accidental or deliberate).

Repair and/or replacement of broken elements is advised to ensure that additional secondary defects do not arise as a consequence. Such works are necessary, as all building elements play a key role in the operation and function of the overall structure and its performance.

A relevant tradesperson should be appointed to repair or replace the affected building element prior to any subsequent damage being caused.

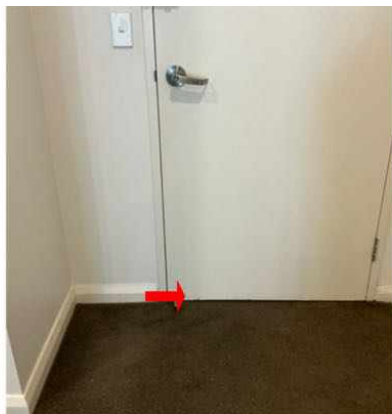
Finding 3.07

Building:	Main Building
Location:	All Internal Areas - Front door
Finding:	Delamination of timbers
Information:	Delamination is one means by which composite materials (e.g. layered timber composites) may fail over time. In laminated materials, repeated cyclic stresses may lead to the formation of mini-structures of separate layers, with significant loss of mechanical toughness. Water penetration or the presence of excessive moisture also generally contributes to delamination.

Where building materials have become delaminated, they lose their structural strength, and are likely to have a variety of appearance and serviceability defects as a result.

Delamination of timbers may be repaired where the area affected is minor and/or easily accessible, by gluing and screwing layers back together. However, this is an interim repair, and where delamination has occurred, the client should plan for the replacement of affected timbers sooner than would otherwise be expected.

All timber structures affected by delamination should be replaced as soon as possible to avoid any further damage. Repair and replacement estimates should be sought from a registered builder or qualified carpenter.

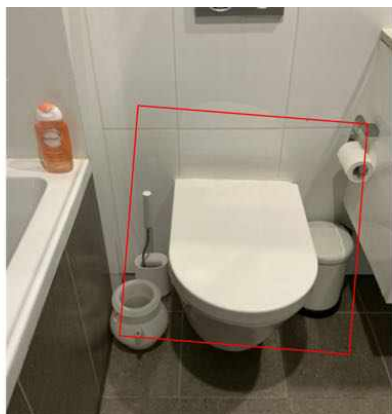
Finding 3.08

Information: The installation of this building element appears to have been completed to a substandard level of workmanship or is incomplete. Generally substandard repairs or installation are related to poor workmanship, the use of inappropriate materials, or a failure to complete installation to a suitable standard.

Toilet seat alignment appears slightly uneven relative to horizontal tile datum. Recommend adjustment of seat hinge fixings. Pan level could not be confirmed visually and would require physical verification.

Recommend a licensed plume right to access and rectify if required

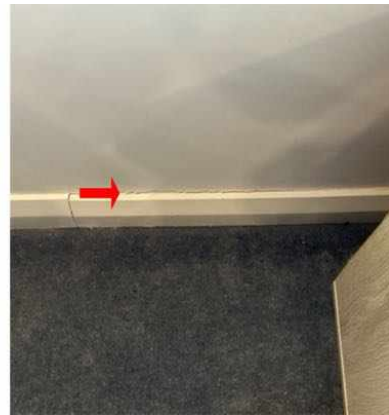
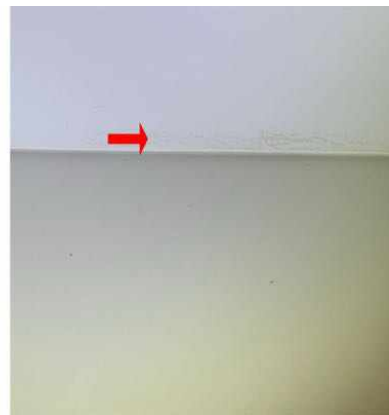
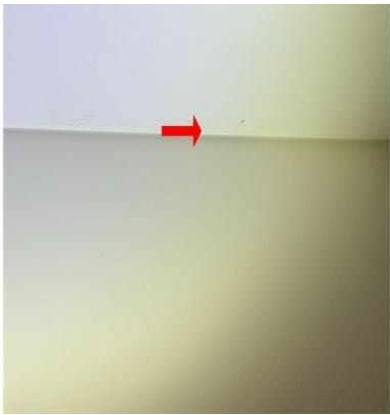
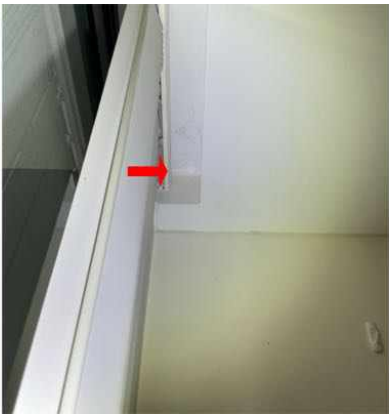
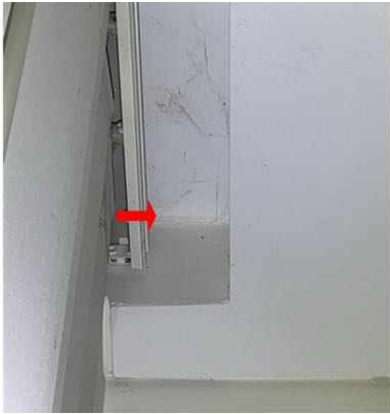
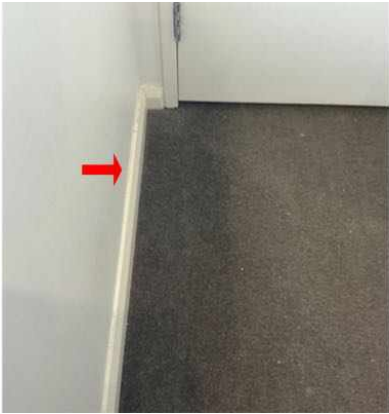
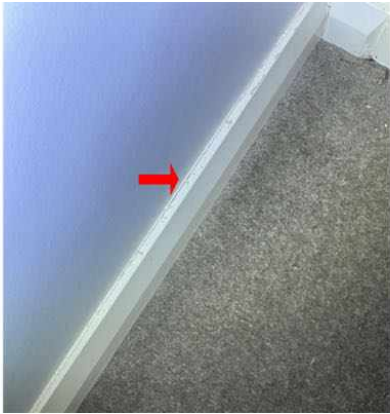
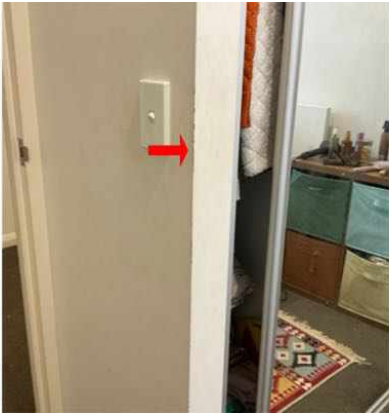
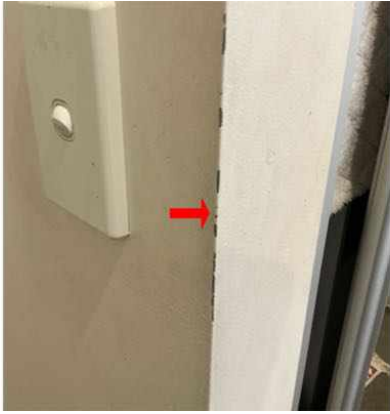
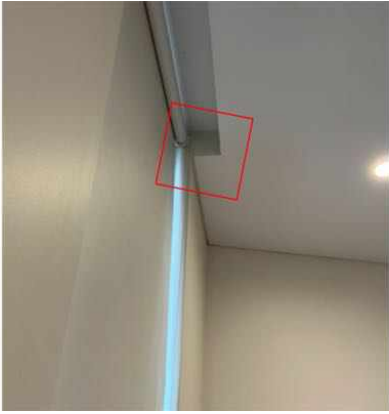
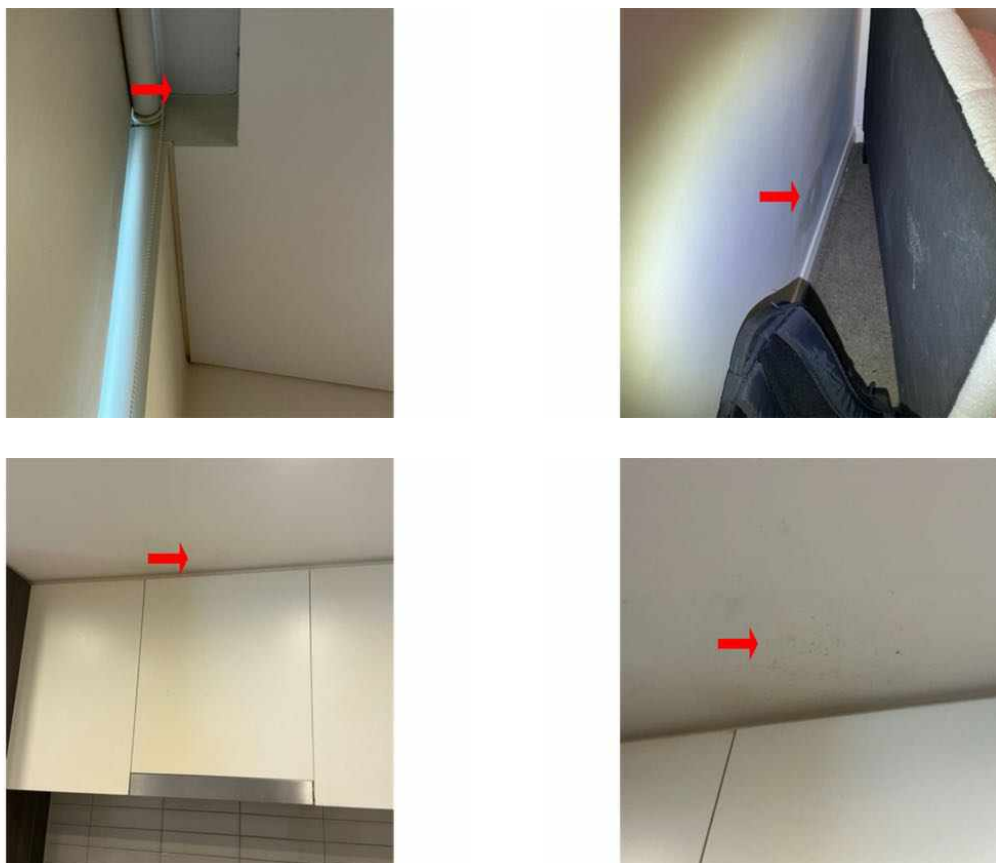
Finding 3.09

Finding: Paint finish and hairline cracking to some areas

Information: The paint finish in this area was identified as being incomplete at the time of inspection including some hairline minor cracking.

Whilst incomplete or missing paint finish is generally an appearance defect, it can also lead to the development of secondary building defects over time. Incomplete areas of paint finish expose the area to moisture, potentially accelerating the deterioration of underlying building materials.

Incomplete paint finishes should be sanded back, filled, leveled and painted, as applicable. Where inadequate or missing paint protection has led to the deterioration of the associated building element, repair and/or replacement of this building element may be required.

A painting contractor should be appointed as soon as possible to perform necessary works to aid the appearance of the affected area and to ensure the area is protected against further deterioration. Alternatively, the homeowner following manufacturer instructions may perform these works.

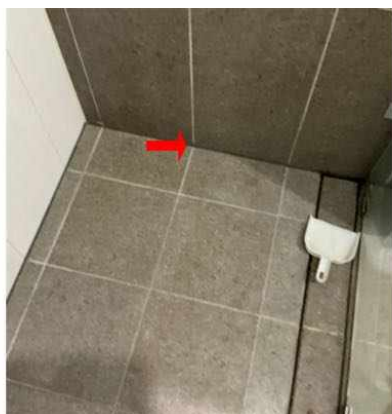
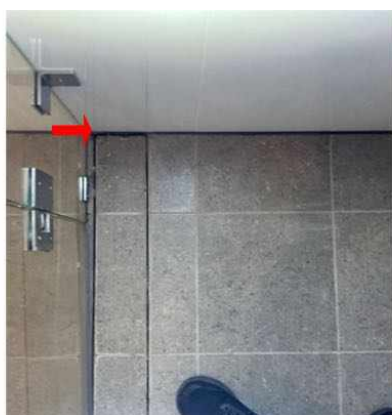
Finding 3.10

Building:	Main Building
Location:	All Internal Areas
Finding:	Sealant and grouting - Missing or degraded (Excessive silicone use)
Information:	It was noted on inspection that sealant or grout is degraded. There is also evidence of poor workmanship and excessive use of sealant. Silicone should never be used as a first line of defence against waterproofing. Further inspection by a licensed waterproofing contractor is highly recommend

Different materials and floor areas move at different rates, generally causing cracking to grout or sealant at this point. A flexible sealant is required to allow for expected expansion and contraction, while keeping the joint water tight and protective of all associated building materials.

There appears to be excessive mould to the sealant and grout which will likely require scraping out and replacement.

Flexible and mould resistant materials should be applied to affected areas to prevent any subsequent water damage that is likely to occur. Regular maintenance and replacement of damage or missing or damaged sealant and grout is highly recommended to the wet areas, as this is a regular wear and tear defect. Sealant and grouting in areas that come into regular contact with water should be maintained for the long term care of your property.

A sealant specialist or tiling contractor should be appointed to complete these works as soon as possible

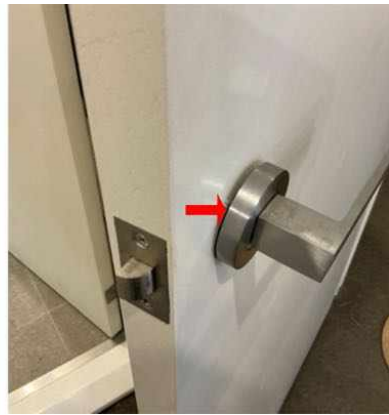
Building: Main Building
 Location: Bedroom master
 Finding: Door - Broken/loose handle
 Information: The door handle in this area was found to be broken at the time of inspection. Breakage occurs generally when the building materials have aged and decayed, but may be indicative of impact damage (accidental or deliberate).

Repair and/or replacement of the broken door handle is advised to improve the operational state of the associated door.

A qualified carpenter or general handyman should be appointed to repair/replace the door handle at the client's discretion.

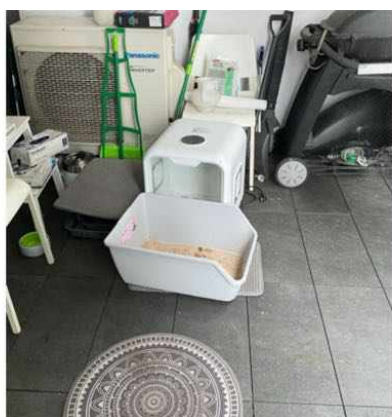
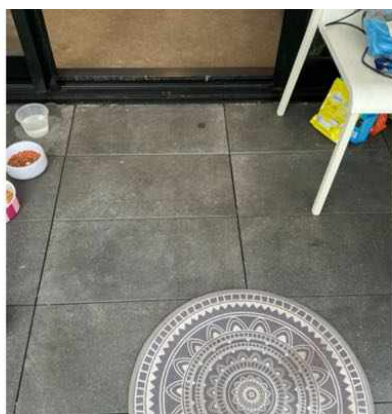
Building:	Main Building
Location:	Balcony
Finding:	Pedestal Paver System - Balcony
Information:	The balcony appears to incorporate a raised pedestal paver system. Minor movement of individual pavers can be characteristic of this system, however, any excessive rocking or instability should be assessed and adjusted to ensure even support and minimise trip hazards. Ongoing maintenance of pedestal alignment and drainage beneath the pavers is recommended.

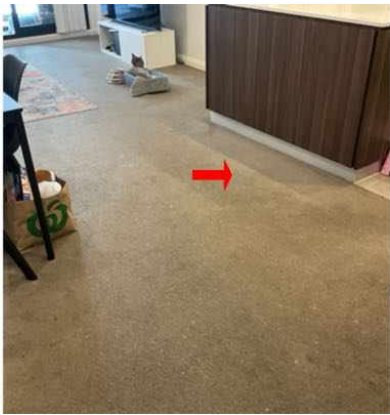
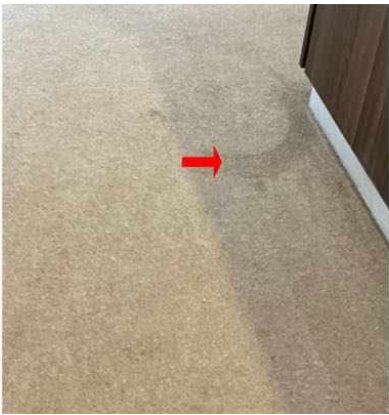
Building: Main Building
Location: All Internal Areas
Finding: Carpet Wear and Shading
Information: -Carpet throughout shows pile flattening, shading, staining , and visible traffic patterns..

Condition is consistent with normal wear and tear. Professional steam cleaning is recommended to improve appearance.
