Building and Timber Pest Inspection Report

Inspection Date: Fri, 27 Mar 2026

Property Address: 1 Gwynne St, Gwynneville NSW 2500,
Australia

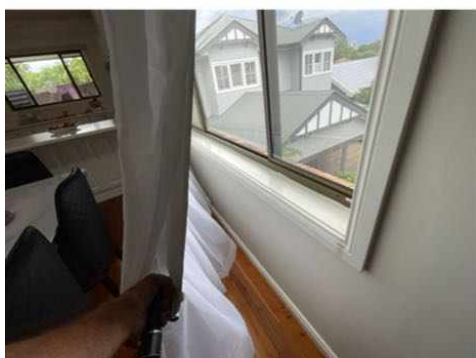
Building: Building 1
 Location: Pictured upstairs windows
 Finding: Window opening restrictors missing.
 Information: These pictured windows are missing window restrictors. The Building Code of Australia rules require all openable windows (where the internal floor is more than 2m above the ground outside) in residential rooms to be fitted with a suitable screen or restrictor. Windows located 1.7m above the floor level do not require protection.

Window restrictors are required where people who are vulnerable to the risk of falling have access to windows. This means all windows above ground level which do not have another fall prevention safety measure in place, such as a balcony or balustrade should have a restrictor.

These need to be added urgently for the safety of all persons.

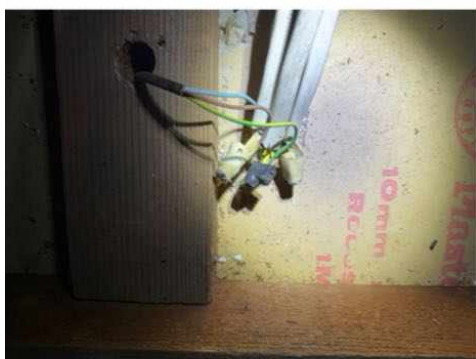
Finding 1.02

Building: Building 1
 Location: Roof Cavity areas
 Finding: Electrical cables missing a junction boxes
 Information: The electrical fittings in this roof area was found to be missing a junction boxes at the time of inspection.

This missing fittings and loose cables does expose electrical works, and may create a safety hazard if there is potential contact with persons in the area.

A Licensed electrician should be appointed to rectify these areas immediately.

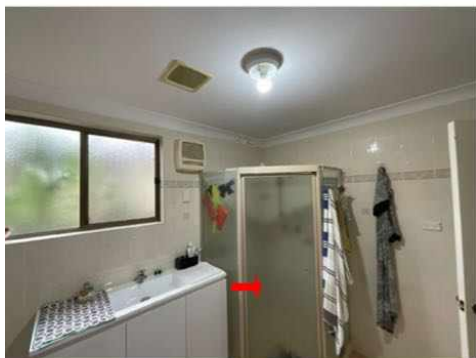
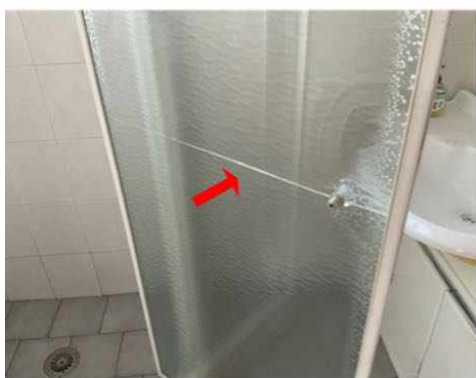
Finding 1.03

Building: Building 1
 Location: Lower Bathrooms
 Finding: Shower screen - Cracked
 Information: Cracks were identified in the shower screen in this bathroom. This is generally the result of impact damage, and is likely to develop further when left unmanaged.

The likelihood of further cracking and shattering is increased exponentially, providing a safety hazard in the area. A qualified glazier is required to repair the screen as soon as possible.

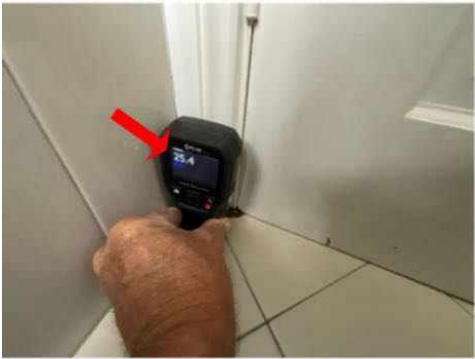
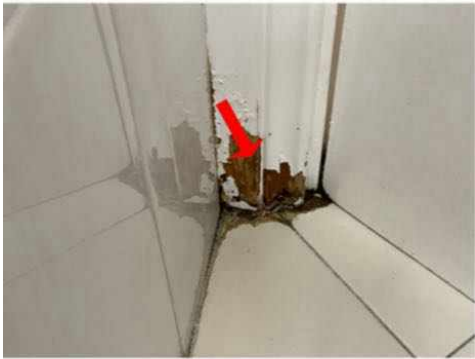
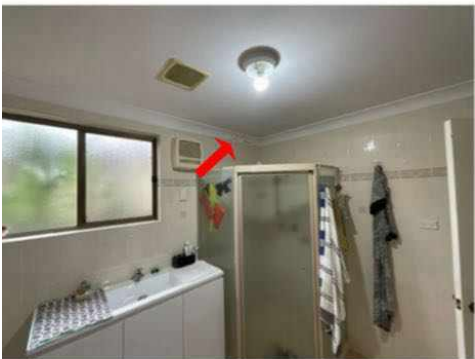
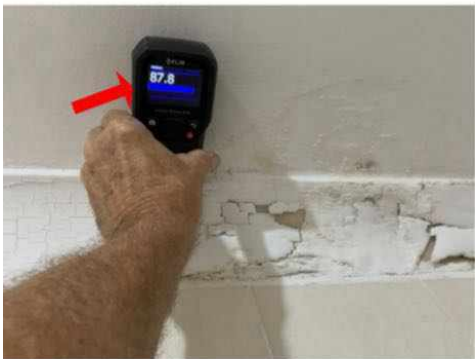
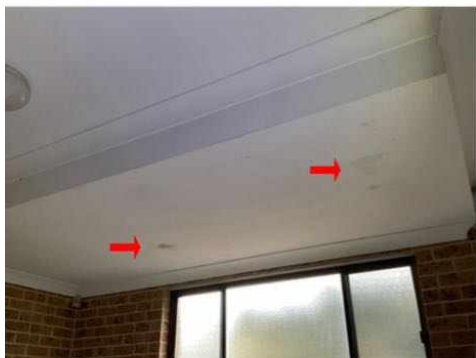
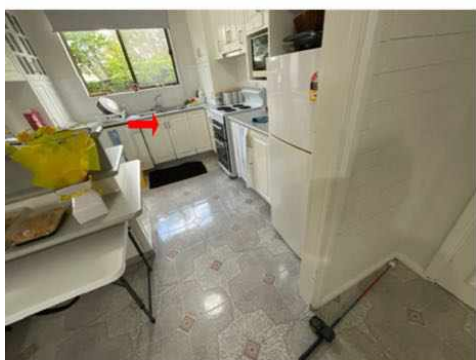
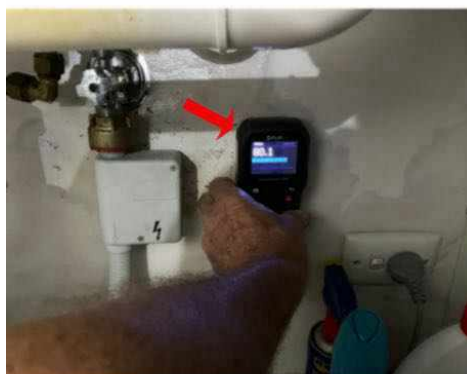
Finding 2.01

| Finding: | Evidence of excessive moisture was present at the time of inspection |
| Information: | Excessive moisture and moisture damage was found in these 5 areas at the time of the inspection. Medium to high readings of up to 87.8 was recorded. |

This high moisture and moisture damage has occurred as a result of leaks from the ensuite roof area, the upper bathrooms through the waterproofing membranes, and in both kitchens and lower bathroom vanity. This moisture can attract termites and produce conditions that promote termite attack, fungal growth and wood decay.

All these areas show moisture damage includes swelling, wood rot and mould (See these defects in this report).

In the upper toilet and ensuite where moisture was travelled under and in walls and flooring areas, structural wood rot to wall and floor framing is likely increasing the

costs of renovations and repairs. This damage can only be assessed once renovations begin as internal wall and floor framing cannot be seen.

Where waterproofing membranes are damaged, very costly repairs are required and quotes should be sought prior to purchase from bathroom renovation companies.

It is highly recommended that quotes be sought for all damaged areas prior to purchase and all plumbing and drainage fixtures and fittings be maintained regularly in order to prevent this excessive moisture damage being present in the internal property in the future.

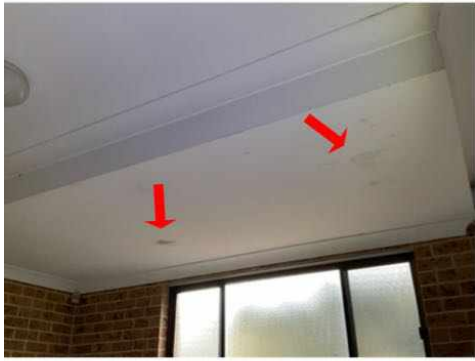
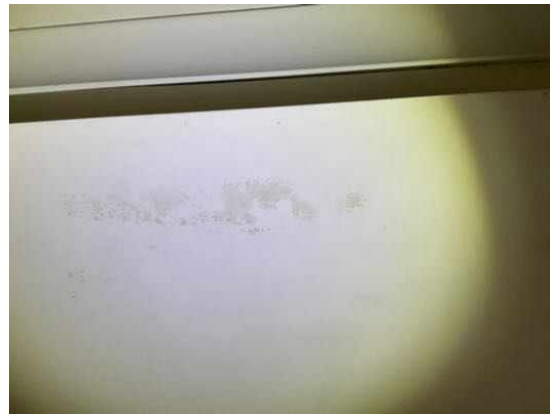
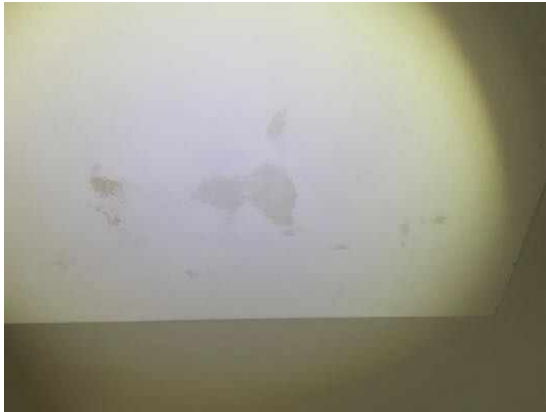
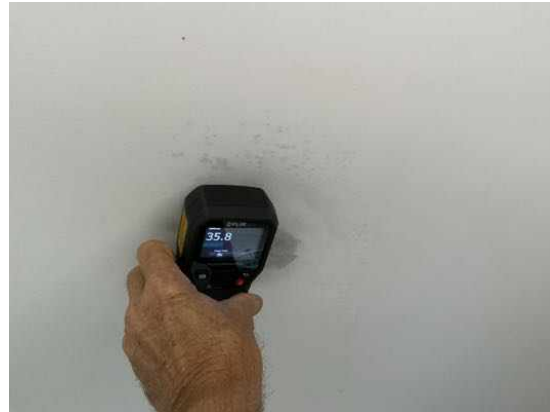
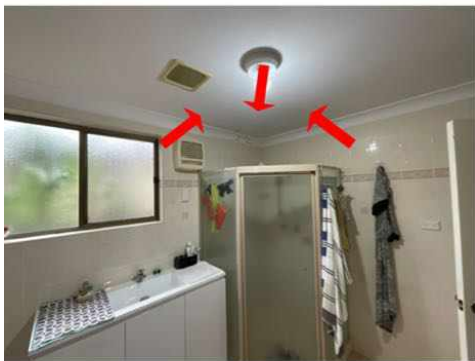
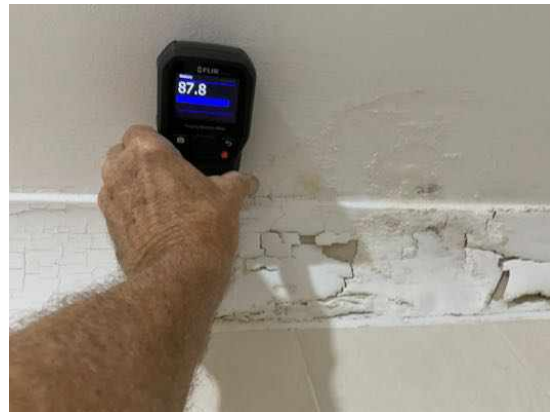
Finding 3.01

| Finding: | Ceiling - Water stained |
| Information: | Water staining to ceiling linings in this area was evident at the time of inspection. Water staining indicates that surfaces have been exposed to excessive moisture over time. The minerals and other elements in the water lead to staining, which may graduate to corrosion and deterioration if left unmanaged. |

While mostly an appearance defect, water staining can be indicative of more serious defects, which may be currently concealed by interior ceilings.

Where water staining is active, a licensed plumber must be consulted to identify the cause of the staining and to provide advice on any reparation works that may be required. Replacement of any damaged structures is advised.

Conversely, where water staining is old and inactive, affected building materials may be repaired or replaced at client discretion.

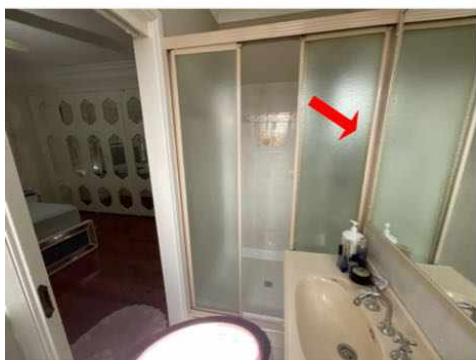
Finding 3.02

| Finding: | Waterproofing membranes damaged and none evident in ensuite shower |

With older property's where this information is unavailable all wet areas should be monitored. The leaks, water staining and peeling or bubbling of the paint found in the bathrooms indicate these waterproofing membranes have failed.

The ensuite shower wall where the spout is missing, shows no membrane in this area. Other bathroom membranes may also be missing and this can only be determined with an invasive inspection.

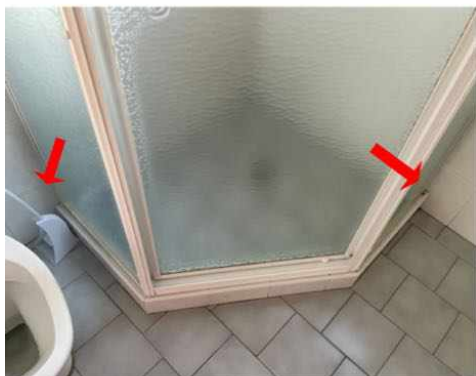
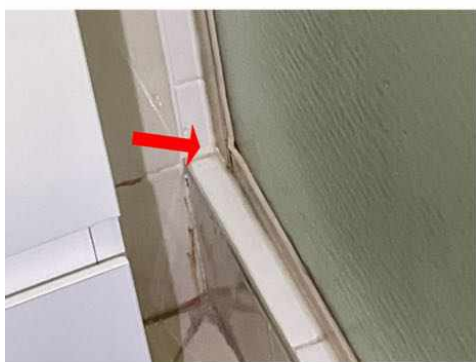
Finding 3.03

| Finding: | Shower screens - Leaking |
| Information: | Leaking was evident to the shower screens at the time of inspection. It is suspected that the leaking has occurred as a result missing sealant. Leaking from the shower , where left unattended, is likely to lead to water damage to adjoining flooring and walls. Such damage can lead to water damage and necessitate extensive remedial works being required. Active water leaks may also create an environment that is susceptible to the formation and development of mould. |

Appointment of a sealant expert is required to repair or replace this missing sealant. Such works should be performed as soon as possible to ensure that no further damage occurs.

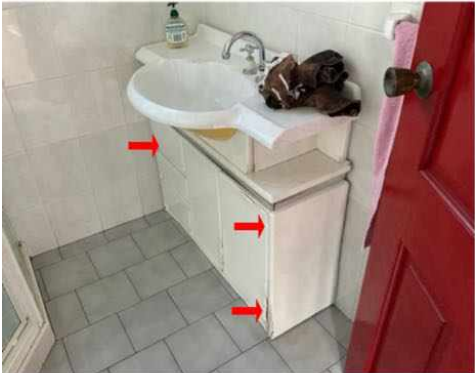
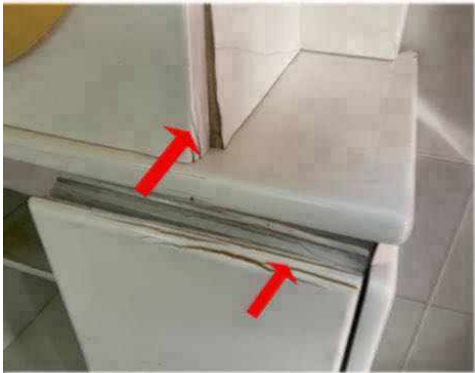
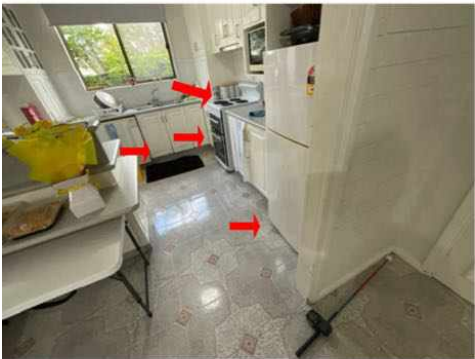
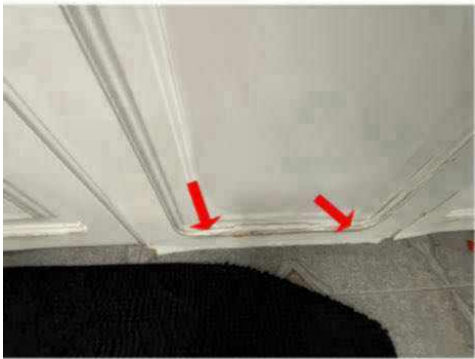
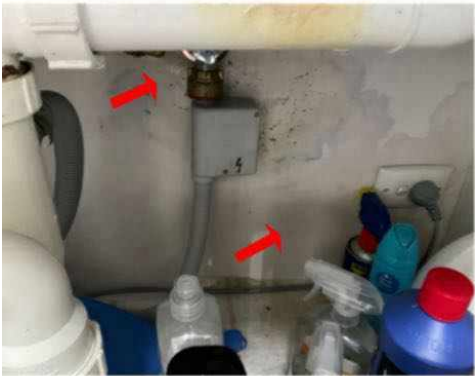
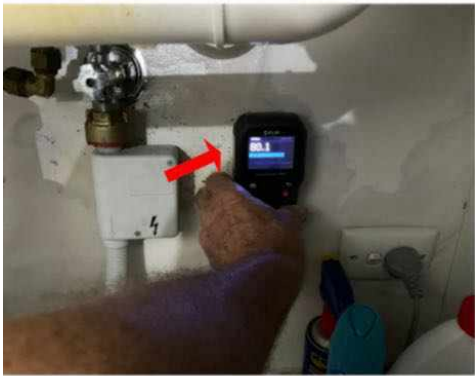
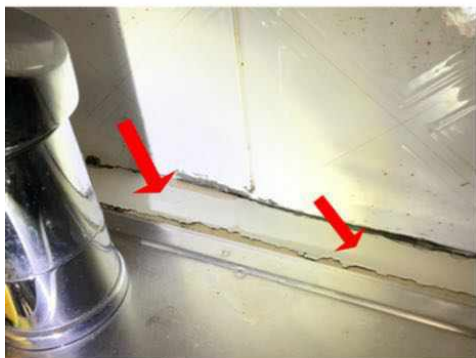
Finding 3.04

| Finding: | Swollen and damaged cabinetry |
| Information: | One vanity and both kitchens cabinetry have been affected by excessive moisture over a prolonged period of time, and have swollen as a result. The structural integrity of swollen building elements cannot be guaranteed, and further damage is possible if these areas are left unmanaged. Both kitchens are extremely damaged, the under sink areas are water damaged with mould present. Very high moisture of 80.1 was recorded under the lower kitchen sink indicating water leaks present. |

Repair or replacement of swollen building elements should be conducted by a qualified carpenter or cabinet maker after a plumber has repaired any leaks.

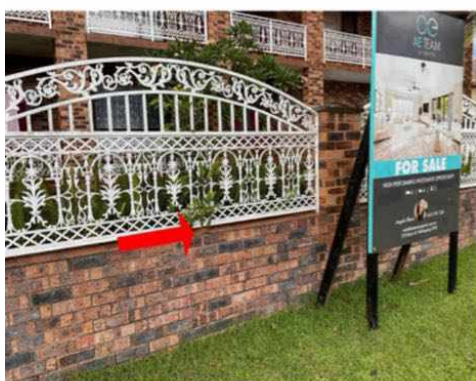
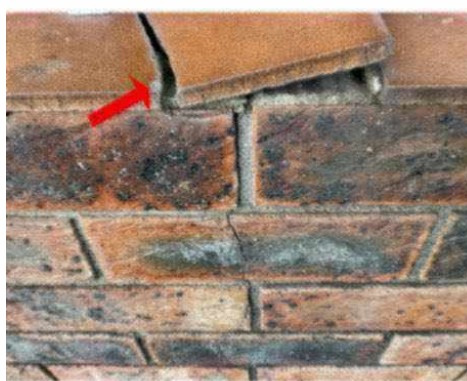
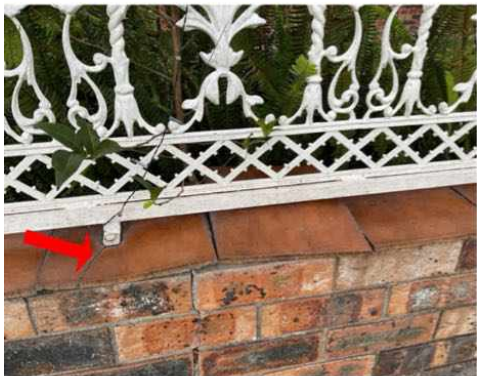
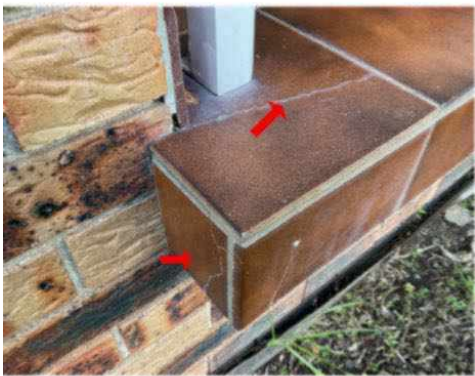
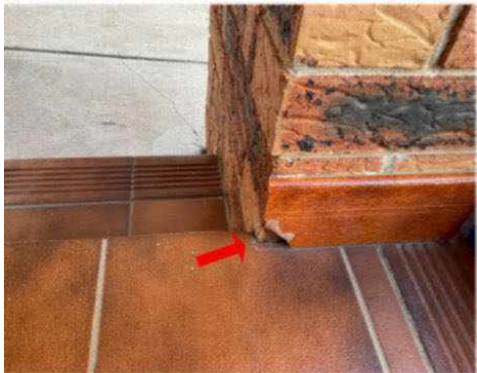
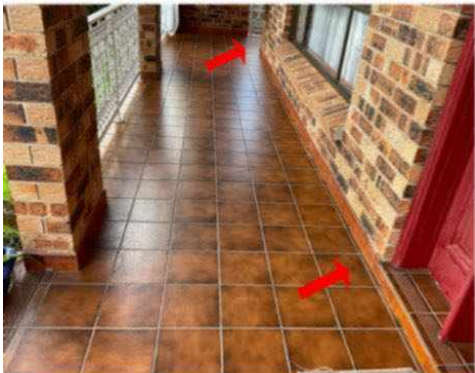
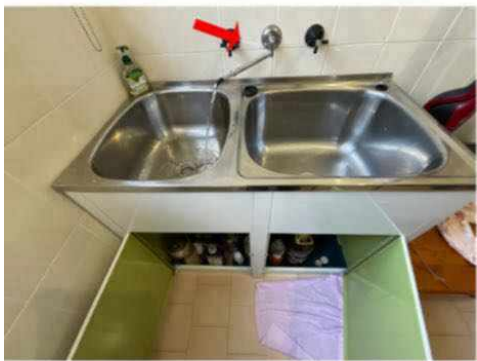
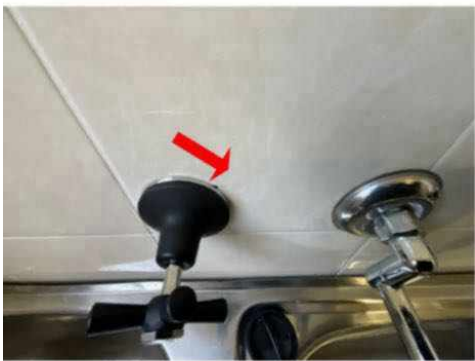
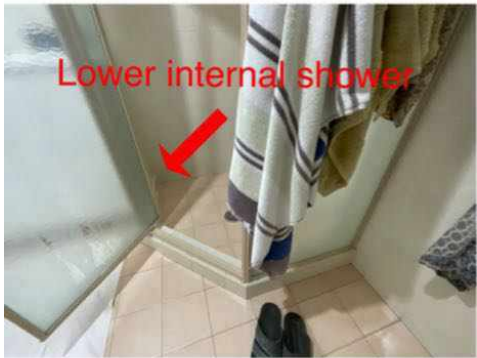
Finding 3.05

| Finding: | Tiles cracked |
| Information: | Cracked tiles were evident in these pictured areas at the time of inspection. It is suspected that this cracking has occurred as a result of minor settlement or impact damage. |

Cracked tiles throughout the household detract from the overall appearance of the affected areas. In wet areas of kitchens and bathrooms, it can lead to water damage of adjoining walls and floors.

Replacement of cracked tiles is recommended as soon as possible. A tiling contractor may be appointed to perform these works. Where cracks become more numerous, contact a licensed building inspector for further investigation.

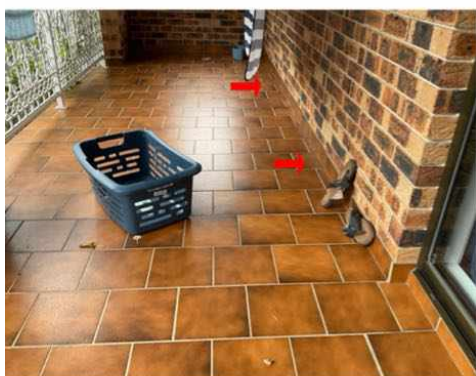
Finding 3.06

| Information: | Drummy tiled areas were identified at the time of inspection. The term 'drummy' refers to tiles that have become detached from their fixing, despite otherwise being in relatively good condition. Such defects are generally caused by physical or moisture damage to the area. Drummy tiled areas may also be a direct result of poor workmanship during the construction process. |

Tiled areas may swell and shrink with changes in air humidity if the area has sustained moisture damage. Any exposure to moisture is capable of causing tiled areas to become drummy and/or cracked over a prolonged period of time. Drummy tiled areas generally require removal and replacement of affected tiles, with adequate sealant and grouting.

Specialist trades are available for these types of services. A registered builder may be required to undertake works if damage is extensive or if secondary building defects have resulted. Otherwise, it is advised that a tiling contractor be appointed to perform works as necessary. Immediate action is recommended to ensure that no further damage is sustained in the affected area.

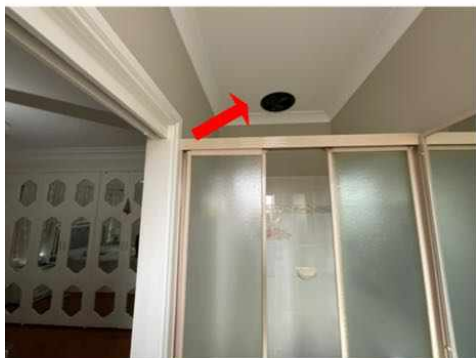
| Information: | The exhaust fan in this area is not operating. If left unmanaged, a lack of general maintenance is likely to lead to the development of more significant defects, such as water damage to surrounding building materials from inadequate ventilation. If left unattended for a prolonged period of time, poor ventilation in this area may also be conducive to the development of mould. |

Where no secondary damage has developed, the Homeowner may undertake minor cleaning of the area and consider replacement of the exhaust fan. Alternatively, consultation with a Licensed Electrician is required to check for any secondary or concealed damage and consider repair or replacement.

Please be advised that a cabinet maker or qualified carpenter may also be required if water damage has occurred and that an additional specialist mould inspection may be required if severe mould has resulted.

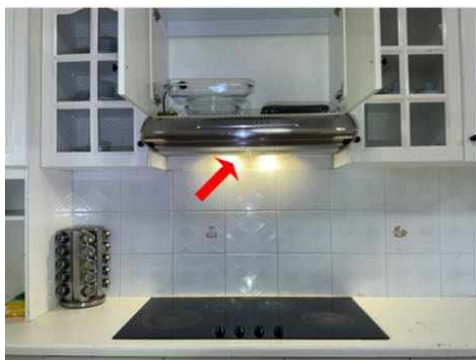
Finding 3.09

Without a fully functional fan, a build-up of grease and evaporative moisture is likely to accelerate deterioration of the range hood and associated flue.

A licensed electrician should be appointed to repair the fan on the range hood to restore it to a fully operational state.

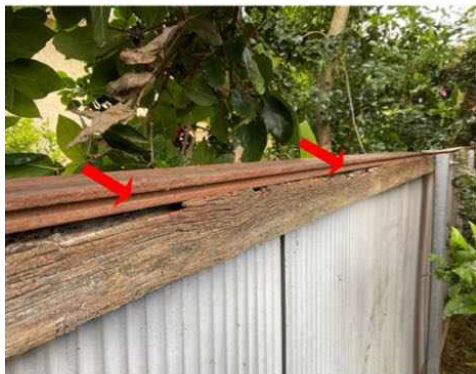
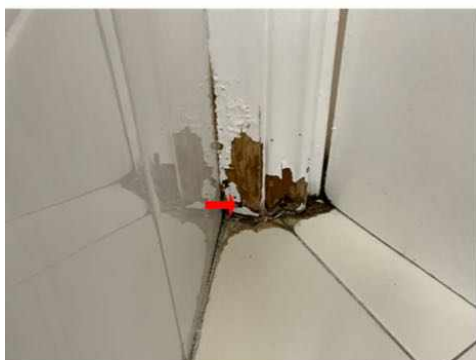
| Finding: | Wood rot on fencing and due to water leaks |
| Information: | These pictured areas show evidence of wood rot. If the bathroom and kitchen water leaks have been occurring for many years, there may be wood rot to wall framing that could not be seen by this inspector during this inspection. Wood rot, also known as Fungal Decay, occurs when timbers and other cellulose building materials are exposed to damp conditions on an ongoing basis. This could be the result of exposure to weathering over a prolonged period of time, or the attraction of excessive moisture from other abutting building materials. |

Early intervention and regular maintenance, particularly of exterior timbers, will prolong the useful life of these building elements. Prior to any works being performed, the cause of the moisture that has created the visible wood rot should be identified and addressed in a suitable manner. Replacement of affected timbers may then be a

necessary step in protecting surrounding building elements from such deterioration.

A qualified carpenter or registered builder may also be required to replace affected building materials.

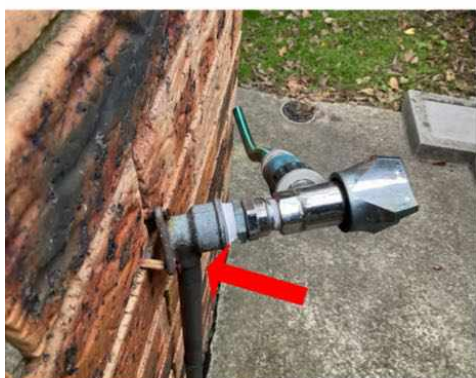
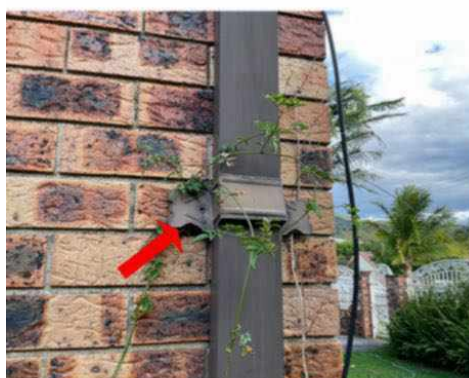
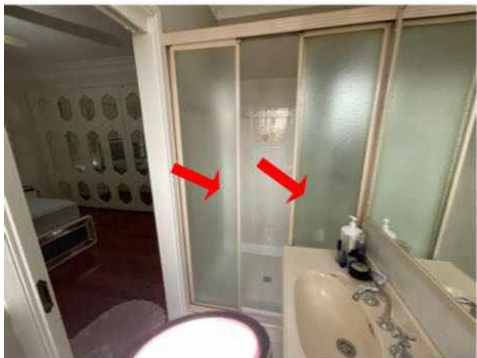
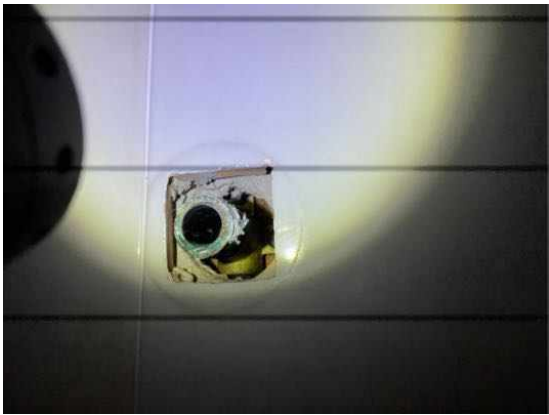
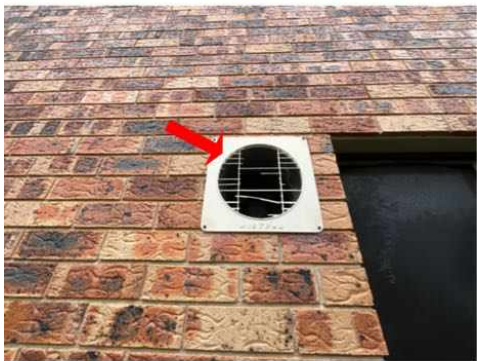
| Finding: | Building elements - Missing or Damaged |
| Information: | Evidence of minor missing or damaged areas was identified at the time of the inspection. These include - |

1. The left rear tap and left downpipe are loose requiring refixing.
2. The lower laundry drain needs clearing of debris.
3. The ensuite shower screen door is damaged and the shower spout has been removed, likely because of the water damage in the lower garage.
4. The external right wall exhaust fan grill is damaged requiring replacement.

A carpenter and plumber would be the trades responsible for rectification of these areas when convenient.

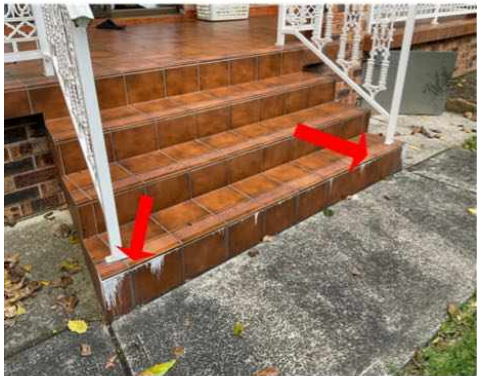
Finding 3.14

Building: Building 1
Location: Stairs
Finding: Efflorescence
Information: Calcification or efflorescence caused by water coming from a deck or balcony that occurs on walls below or beside the deck or balcony, or that appears in the mortar joints of the deck or balcony tiling, may be considered a defect if it is due to defective or missing flashings, membrane, a damp proof course DPC or faulty design and needs to be investigated to identify the cause. Activities of others, such as owners watering plants, may also contribute to the efflorescence, which may not be attributed to the work of the builder.

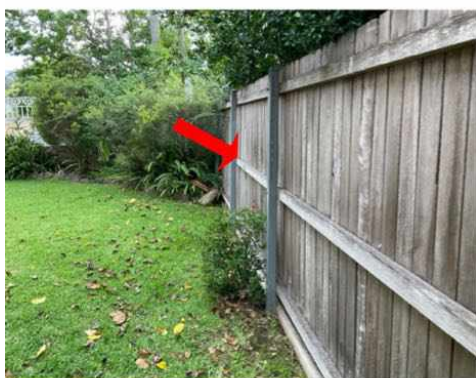
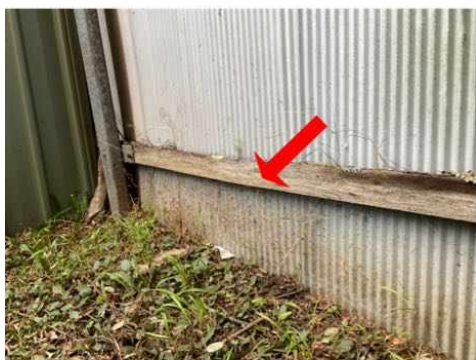
Finding 3.15

| Finding: | Fences damaged - leaning |
| Information: | Evidence of damage to the pictured side fences was identified at the time of the inspection. The likely cause of this fence leaning is not enough concrete used in the post footings. |

If left unmanaged this fence may deteriorate further.

It is suggest a fencing contractor be engaged for rectification when convenient.

The cost of repairing some fences is often shared between neighbours.

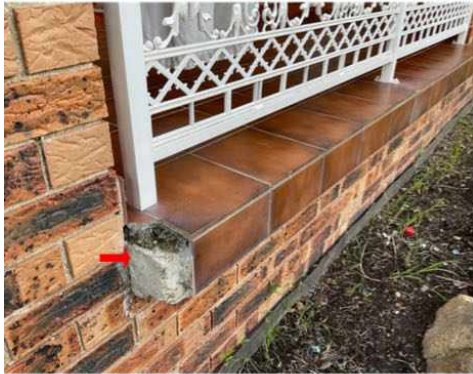
Finding 3.16

| Finding: | Concrete spalling |
| Information: | This verandahs has suffered Concrete Spalling. This is the breakdown of concrete via natural weathering and/or chemical reaction that results in sections of cement chipping off the main body – often resulting in fractured, compromised concrete. Spalling looks |

like pitted and scarring and breaks off in flecks which can expose rebar.

A concreting contractor can provide advice on repairs of this damaged concrete when convenient.

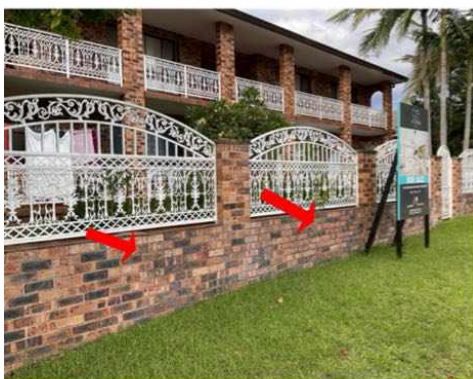
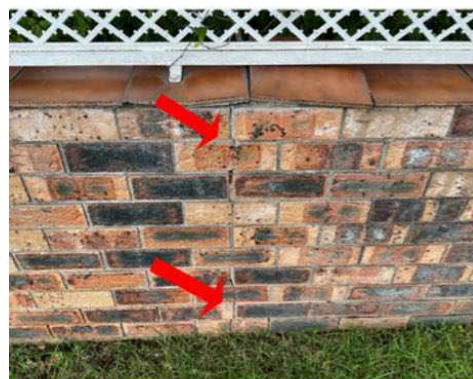
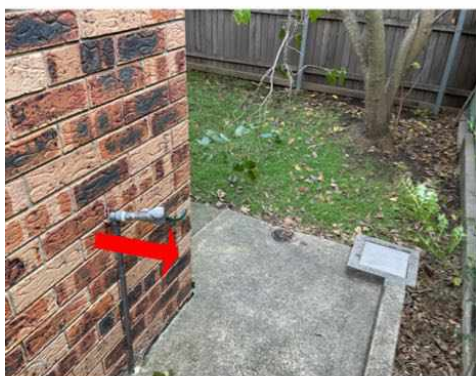
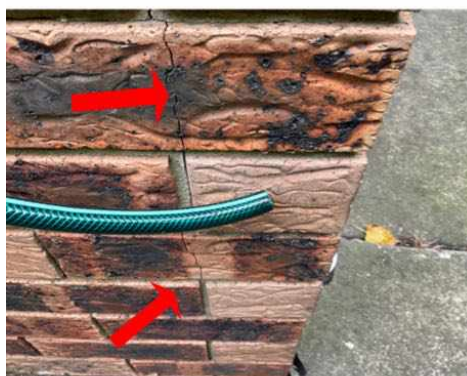
Finding 3.17

| Finding: | Step cracking to brickwork (minor) |
| Information: | Step cracking was identified to the brickwork in these areas at the time of inspection. Step cracking, which is similar to other forms of cracking, has a variety of possible causes. However, the most common is the subsidence of adjacent footings. |

Step cracking is a relatively common defect, and is most likely to occur adjacent to windows, doors and other openings. Mortar failure in the gaps between affected bricks indicates the stresses and tensions affecting the wall.

Where step cracking is extensive or severe, the client is advised to consult a structural engineer. This minor step cracking can be used as a warning sign to address factors causing stress to the wall, which can include the effect of surrounding trees, water leaks, soil erosion, or even the presence of reactive soils in the surrounding area.

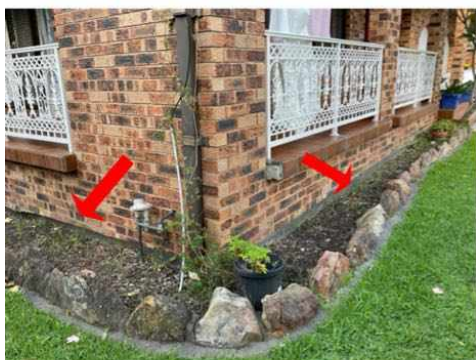
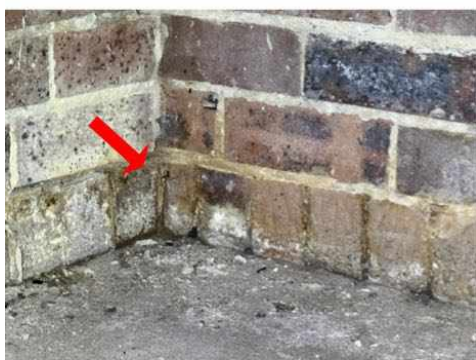
Finding 3.18

Rising damp is generally managed by the installation of a damp proof course during construction. A Damp Proof Course (DPC) is an impermeable barrier at the base of the wall above ground level. However, many 19th Century buildings have no damp course installed, or the materials have failed. The DPC may have been omitted as a consequence of poor workmanship, or it may have been bridged where materials built up against the side of the house allow moisture ingress above the DPC level.

The first step in addressing rising damp is to diagnose the cause. The identified cause should be addressed first before addressing the appearance and other defects which have resulted from the rising damp. If the original cause is not resolved, further cases of damp are likely to ensue, resulting in secondary defects.

Consultation with a qualified plumber is advised immediately to identify the cause of the damp and perform remedial works as required.

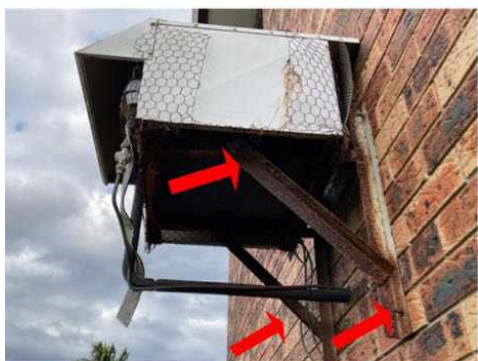
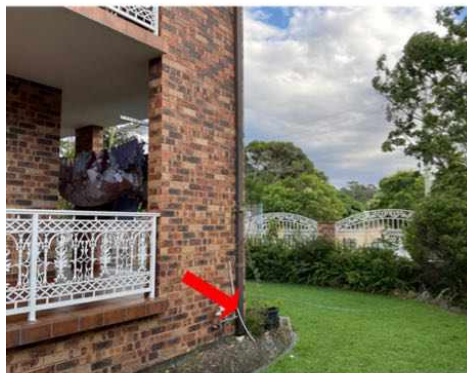
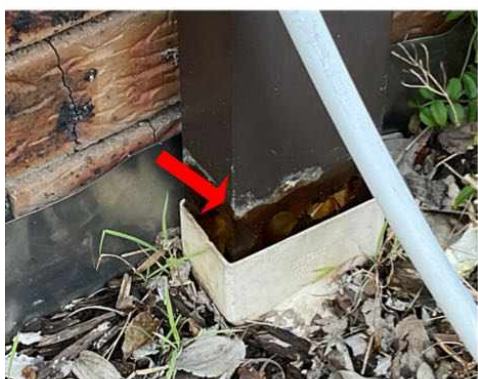
| Finding: | Building elements - Rusted or corroded |
| Information: | This areas shows evidence of rusting and corrosion, which is likely to have developed as a result of excessive exposure to moisture and or inadequate coatings. |

As surface rust provides no protection to the underlying iron, the deteriorating condition is likely to worsen if not addressed in the short-term future.

Where possible, the use of galvanized (treated) metals or aluminium coated metals aid in rust prevention, as does regular general maintenance. Rust formation can be controlled with coatings, such as paint, that isolate the iron from the environment.

Rusting and corrosion should be managed by ideally removing or limiting the affected

surface from exposure to moisture. A registered builder may be appointed to replace any building elements that have been severely affected by rust or water damage.

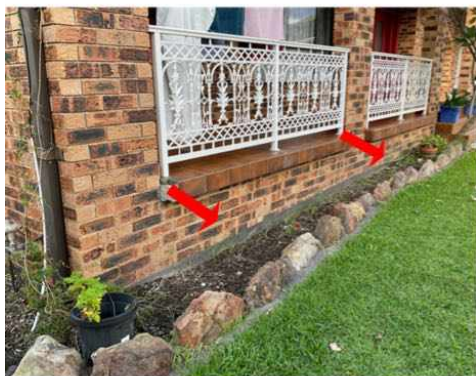
Finding 6.02

If the slab edge is not properly exposed there is a high risk of termite attack. Sometimes, in order to determine the type of slab, a suitably qualified person such as an architect or builder may be required to consult the construction plans.

Where the slab edge cannot be properly inspected, it is highly recommended that termite or timber pest inspections be carried out every 6-12 months to aid protection of the property against infestation.

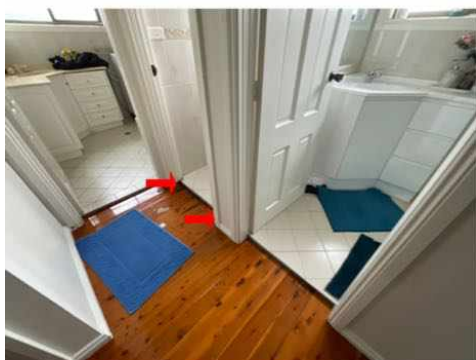
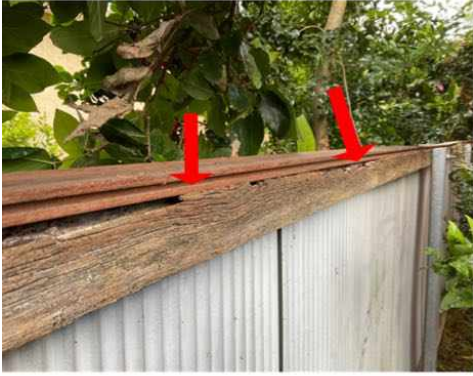
Finding 7.01

| Finding: | Fungal decay - present (localised) |

Note - See ALL wood rot photos in building defects above, all these show fungal decay.

In this case, the affected timber element is in a decaying state and will need replacement by a carpenter or licensed builder.
