Building and Timber Pest Inspection Report

Inspection Date: Fri, 6 Feb 2026

Property Address: 20 McMullen Ave, Carlingford NSW 2118,
Australia

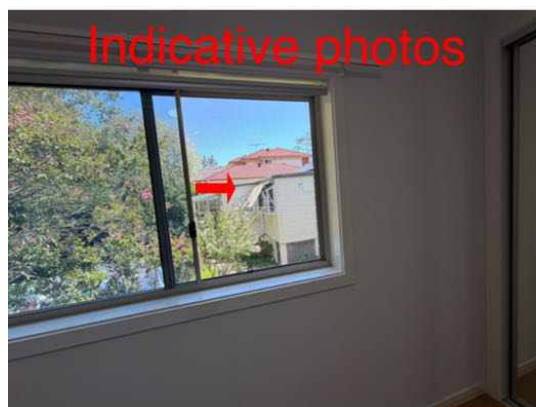
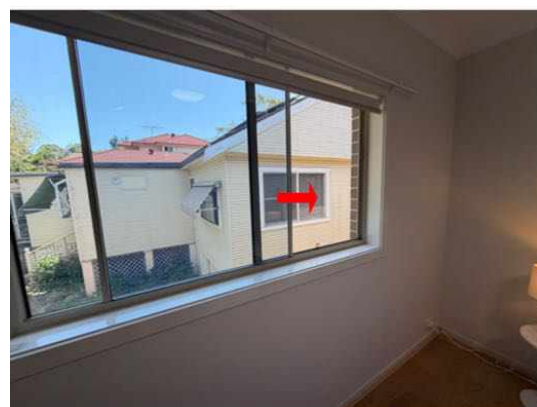
Building:	Main Building
Location:	Upstairs Windows
Finding:	Window restrictions - Missing
Information:	Window restrictors were found to be missing.

The National Construction Code (NCC) requirements apply to all openable bedroom windows in residential buildings, including hotels, motels and for all windows in early childhood centres.

Windows need to be locked at 12.5cm when the devices are engaged. The safety devices must be robust and child proof. The alternative is security screens such as bars or grills on the windows so long as they have gaps no bigger than 12.5cm. Flyscreens do not comply unless they are the reinforced security type and capable of resisting the very strong outward pressure which would prevent a child falling through. The laws apply to openable windows in a building within 1700mm of the internal floor and if the internal floor is more than 2m above the ground floor outside.

Windows upstairs lack appropriate child locks, creating a safety hazard. Window restrictors must be installed on these Windows immediately for added safety.

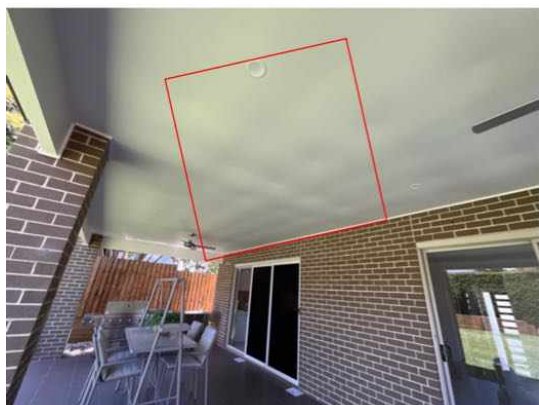
Building: Main Building
 Location: Alfresco
 Finding: Ceiling - Sagging
 Information: Sections of the ceiling were found to be sagging at the time of inspection. Sagging to the fixed ceiling structure generally indicates that the building materials have swollen, due to contact with water, or that fixings (e.g. nails or glue) have become loose and require reattachment.

Where minor sagging is evident, comparatively minor works, such as re-gluing of ceiling sheets, may be required. Such works may be performed by relevant tradespeople, such as plasterers and painters. Where excessive moisture has caused the roofing structure to swell and sag, the source of the water leak should primarily be identified prior to any remedial works being performed.

The appropriate action should be taken by the client as soon as possible to ensure

that any potential further damage is limited.

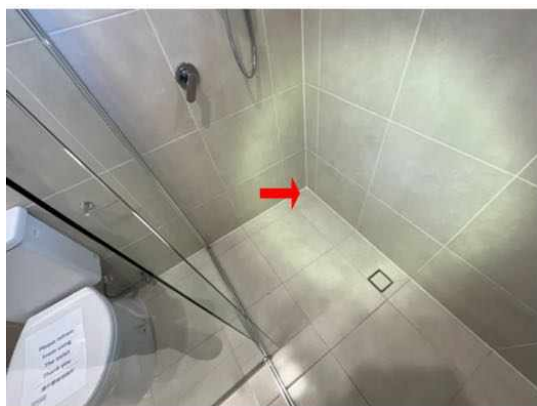
Finding 3.03

Building:	Main Building
Location:	Bathroom, ensuite 2
Finding:	Wet area tiles - Cracked or damaged
Information:	Cracking was evident to the tiling in this area at the time of inspection. While the cracking appears to be minor, this area is frequently exposed to water, allowing potential for water penetration into adjoining sections of walls or flooring.

If left unmanaged, water penetration to these areas may lead to subsequent water damage, which is likely necessitate repair work to affected building elements.

A bathroom specialist should be appointed to determine the integrity of the bathroom waterproofing membrane. If the membrane was found to be intact then relatively minor works to replace the cracked tiles should be carried out to ensure no further damage occurs. The re-application of silicone and grouting throughout remaining tile work is also advised, to further protect the area against water penetration.

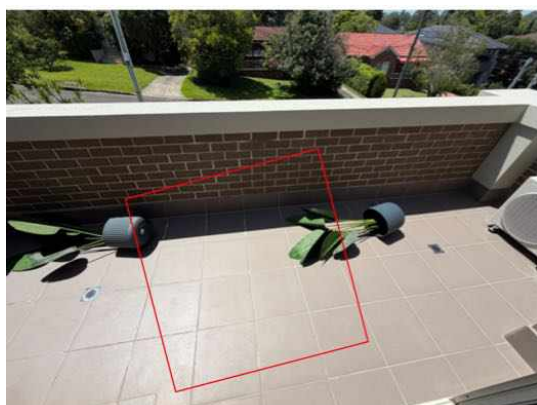
Finding 3.04

Building: Main Building
 Location: Balcony
 Finding: Sealant and grouting - Missing or damaged
 Information:

It was noted on inspection that sealant or grout is degraded to this area.

Different materials and floor areas move at different rates, generally causing cracking to grout or sealant at this point. A flexible sealant is required to allow for expected expansion and contraction, while keeping the joint water tight and protective of all associated building materials.

Flexible and mould resistant materials should be applied to affected areas to prevent any subsequent water damage that is likely to occur. Regular maintenance and replacement of damage or missing or damaged sealant and grout is highly recommended to the wet areas, as this is a regular wear and tear defect. Sealant and grouting in areas that come into regular contact with water should be maintained for the long term care of your property.

A sealant specialist should be appointed to complete these works as soon as possible.

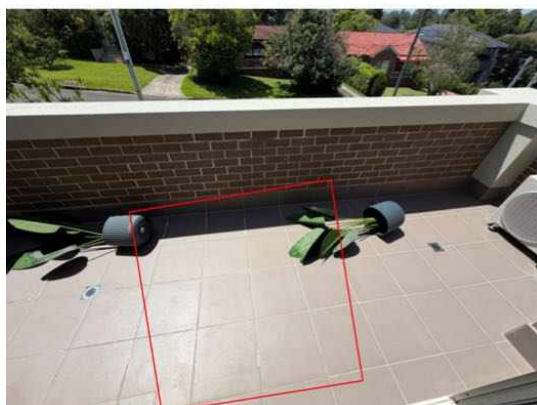
Finding 3.05

Building:	Main Building
Location:	Balcony
Finding:	Efflorescence
Information:	Efflorescence appears to be affecting the tiles in this area. Efflorescence typically occurs when excess salts within the concrete or cement mortar is leached to the surface due to water transfer.

It is typically seen as white salt deposits on the surfaces of concrete pavement or mortar between bricks or tiles. While detracting from the overall appearance of the affected area, efflorescence is not likely to develop into secondary damage if left unmanaged.

Generally, soluble salt deposits can be removed by dry brushing with a stiff-bristled brush. Repeated dry brushing is an ideal treatment for eliminating this forming of efflorescence. A cleaning contractor or general handyperson may be appointed to perform these works at the discretion of the client.

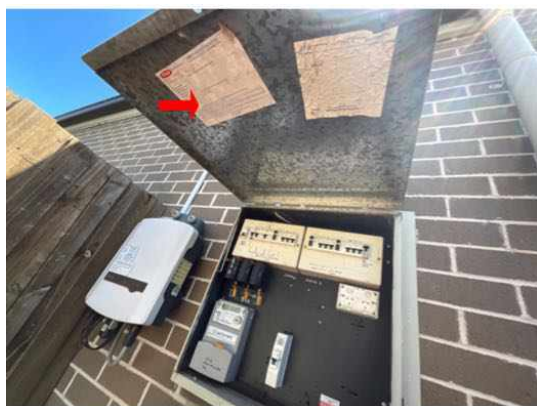
Building:	Main Building
Location:	All Areas
Finding:	Re-application of chemical termite barrier - required
Information:	Chemical treated barriers deteriorate over time necessitating the need for re-application of a barrier every 6-10 years depending on the product type environment etc. Due to this deterioration chemical barriers decline in their effectiveness exponentially if not replenished.

Consult the record of installation to identify the type of chemical and date of application. It is then advised to consult a licensed pest controller regarding reapplication intervals. Annual inspections are almost always required for all system types.

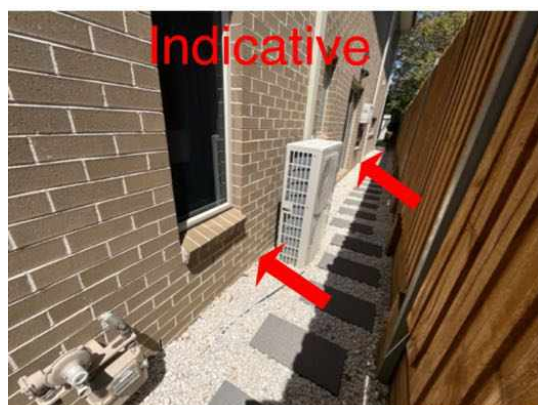
Finding 6.02

Building:	Main Building
Location:	Perimeter
Finding:	Slab Edge - Exposure
Information:	Slab Edge Exposure: Where external concrete slab edges are not exposed there is a high risk of concealed termite entry. In some buildings built since July 1995 the edge of the slab forms part of the termite shield system. In these buildings an inspection zone of at least 75mm should be maintained to permit detection of termite entry. The concrete edge should not be concealed by render, tiles, cladding, flashings, adjoining structures, paving, soil, turf or landscaping etc. Where this is the case you should arrange to have the slab edge exposed for inspection. Concealed termite entry may already be taking place but could not be detected at the time of the inspection. This may have resulted in concealed timber damage. Does the slab edge inspection zone fully comply?

Not able to comment. A very high proportion of termite attacks are over the edge of both Infill and other concrete slabs types. Covering the edge of a concrete slab makes concealed termite entry easy. Infill slab type construction has an even higher risk of concealed termite ingress as the slab edge is concealed due to the construction design and cannot be exposed. The type of slab may only be determined by assessment of the construction plans by a qualified person e.g. Builder, Architect. Construction Plans may be obtainable by your local Council or Builder. Termite activity and or damage may be present in concealed timbers of the building. We strongly recommend frequent regular inspections in accordance with AS 3660.2. Where the slab edge is not fully exposed or the slab is an infill slab or the slab type cannot be determined then we strongly recommend inspections every 3 to 6 months in accordance with AS 3660.2 or AS 4349.3.

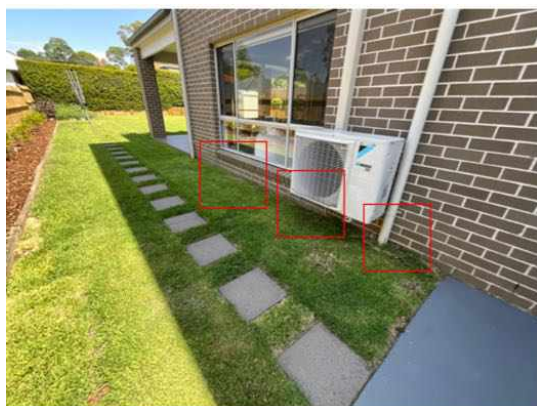
Finding 6.03

Building:	Main Building
Location:	Exterior walls - left side
Finding:	Bridging or breaching of termite barriers - weep holes
Information:	Bridging is the spanning of a termite barrier or inspection zone so that subterranean termites are provided with passage over or around that barrier.

Weep holes in the exterior brickwork of the property are designed to allow condensation that may build up between the brickwork and subsequent timber framework to drain from within the wall hence preventing any deterioration of the timber building elements.

Additionally build-up of moisture is likely to occur if weep holes are covered further attracting termite activity to these areas.

It is highly recommended that weep holes are left exposed in all areas throughout the external property. Therefore if any termite activity leading into weep holes becomes easily detectable during frequent pest inspections.

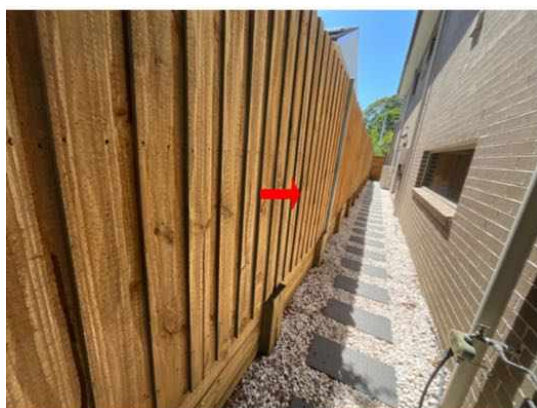
Building:	Main Building
Location:	Fencing & Landscaping
Finding:	Building materials in direct ground contact - conducive to termites
Information:	Where timber elements are in direct contact with the ground and consequently moisture or dampness they become conducive to termite activity. Whether timber is used as a building element part of a fencing structure or stored as an unused item they can provide an environment that is attractive to termite infestation.

When met with excessive moisture timber begins to decay and develop wood rot. Any timbers that are in direct contact with external grounds especially if left untreated or non-durable also provide ingress for subterranean termites into that particular element.

The removal of any such materials that may be conducive to termite activity should be removed as soon as possible to minimise the risk of termite attack.

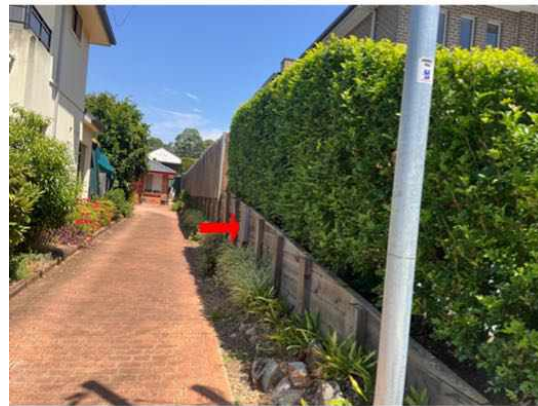
Building: Main Building
 Location: Retaining walls
 Finding: Retaining walls
 Information: At the time of inspection the retaining walls were checked and no defects were observed other than those which May have been mentioned earlier in this report.

AS4349.1-2007 requires all retaining walls in excess of 700mm to be inspected by a licensed and practicing structural engineer.
