Building Inspection Report

Inspection Date: Thu, 19 Mar 2026

Property Address: 3 Irene Ct, Cheltenham VIC 3192, Australia

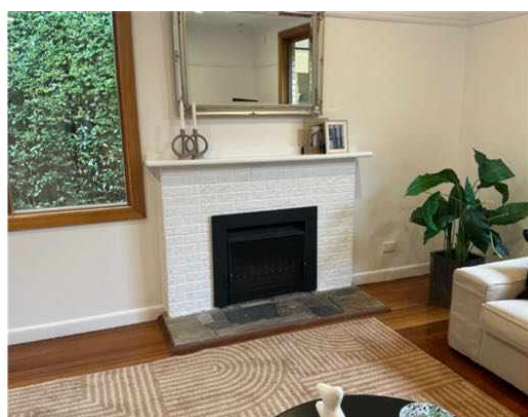
Defects 1.01

Building:	Main Building
Location:	Lounge Room
Finding:	Fireplace
Information:	It is beyond the scope of this inspection report to comment on fireplaces, we recommend a professional chimney sweep check the safety of this fireplace prior to use.

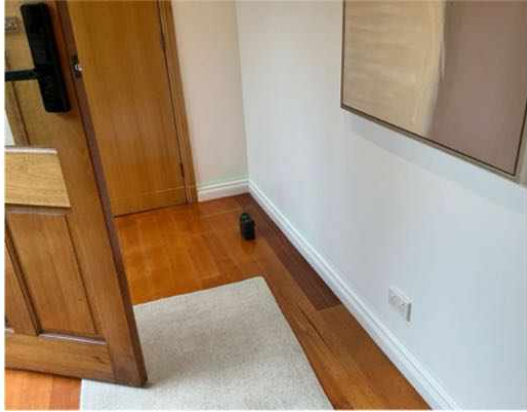
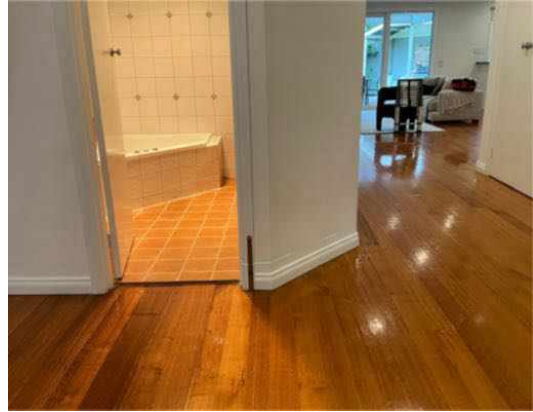
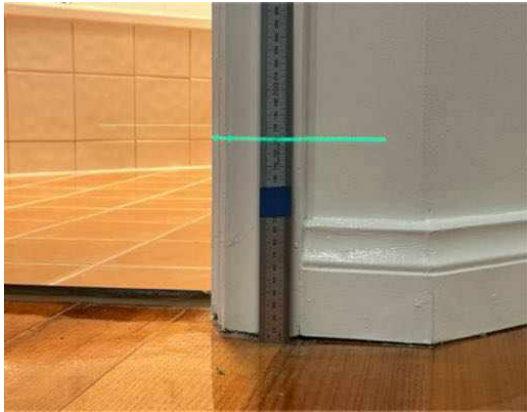
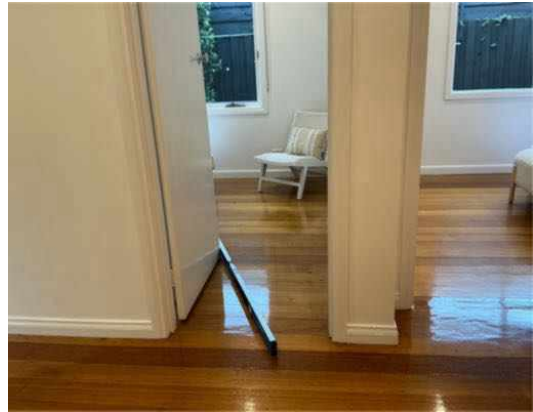
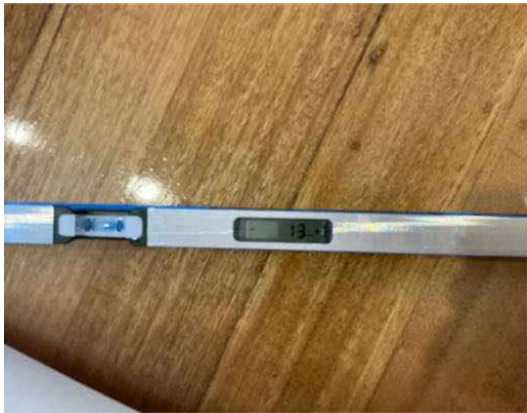
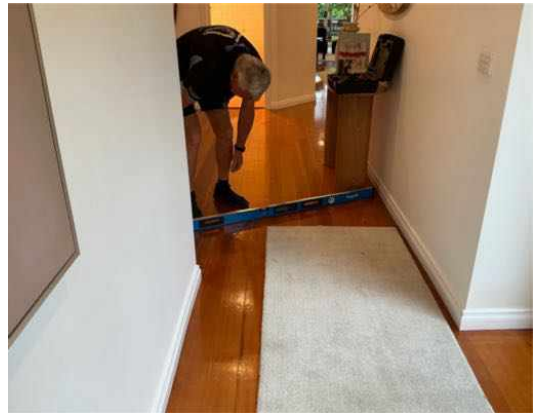
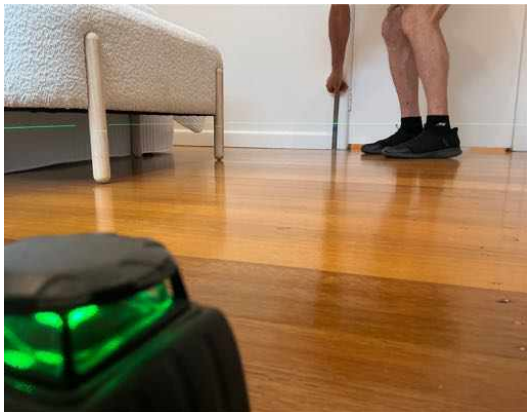
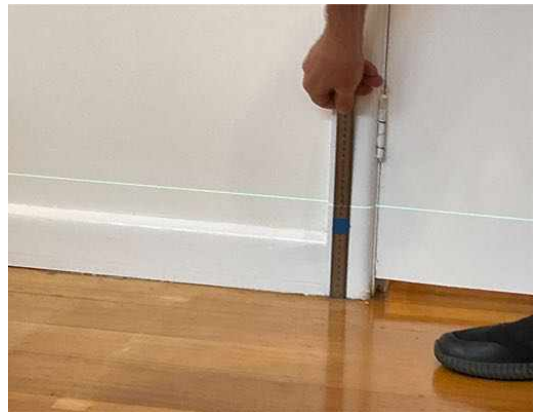
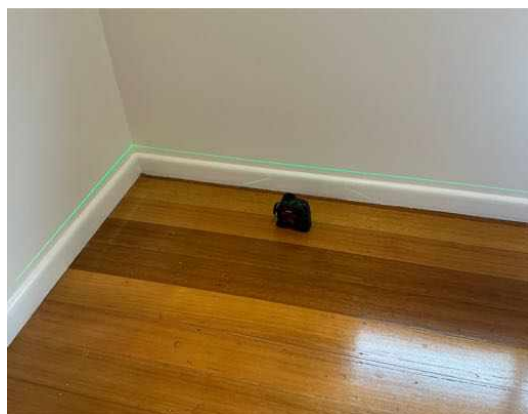
Defects 2.01

Building:	Main Building
Location:	All Areas
Finding:	Flooring - Uneven
Information:	The internal flooring in this area is out of level and uneven. Uneven flooring is likely to indicate minor defects such as expected movement of the foundations of the property, but may also indicate subsidence of the associated subfloor stumps.

The major defect is uneven flooring throughout that was found to be well beyond tolerance for a building of this construction method. A specialist Restumping expert will be able to assess the subfloor structures and recommend and quote on any Restumping/stabilization works required.

It is advised that the flooring be closely monitored to identify any further movement. Where flooring remains relatively unchanged for an extended period of time (i.e. several months), it is likely that this defect has been caused by expected movement of the foundations of the property.

However, where flooring is uneven further, potentially invasive inspection of the subfloor structures and stumps in this area is required. In this case, works to repair are likely to be required, and would be carried out by a registered builder specialising in re-stumping.

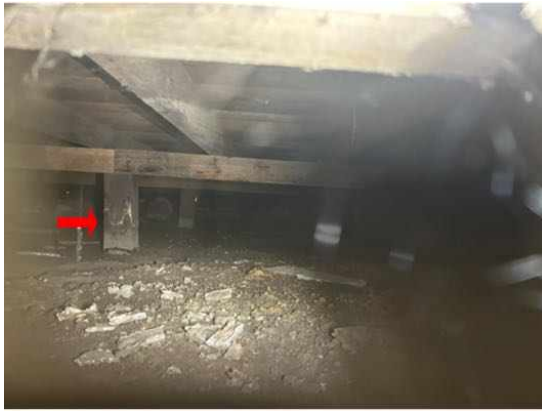
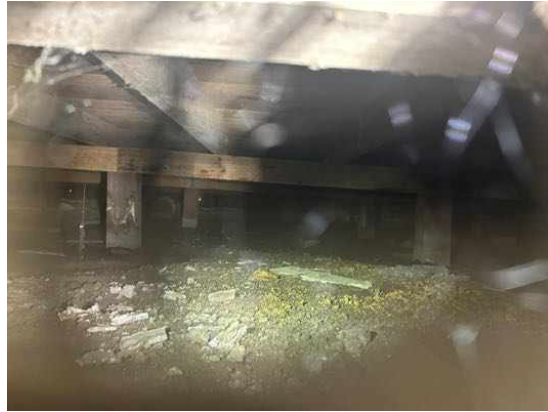
Defects 2.02

Building:	Main Building
Location:	Subfloor
Finding:	Timber stumps - Suspected deterioration
Information:	It was noted that the property has timber stumps. Inspection of the condition of the timber stumps - below the surface of the ground - is excluded from the scope of this report. However, it is suspected that several timber stumps are deteriorating, evidenced by secondary defects such as uneven flooring, visually-observable subsidence or major cracking within the property. Even without these secondary defects, deteriorated stumps may still be present.

Where timber stumps are failing, a high degree of maintenance or even replacement of stumps may be required in the short- to medium-term future. It is probable that there is some degree of wood rot or deterioration beginning to occur in areas that are currently inaccessible for inspection. Timber stumps are no longer used in current building practices due to their susceptibility to wood rot and deterioration over a prolonged period of time.

The client should be prepared that in purchasing a property with timber stumps, that the need to restump the property in the short- to medium-term future is highly likely, which involves expensive works.

Timber Stumps could be glimpsed to subfloor of the front part of the house through subfloor vents, uneven flooring. It is suspected that these timbers don't have deteriorated over the time and will need to be replaced. Timber Stumps are always considered a major defect as they will need to be replaced in the short term.

A registered builder specialising in re-stumping may be appointed to provide a more invasive inspection of the timber stumps and provide estimates on any works that may be required.

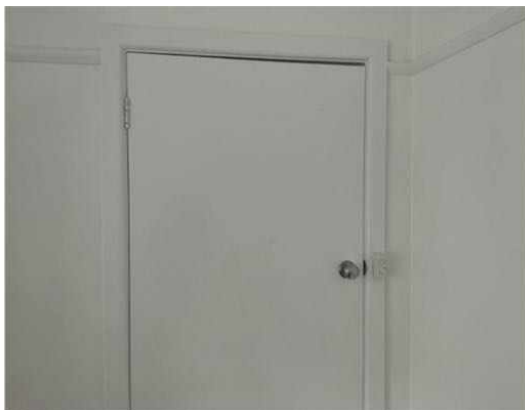
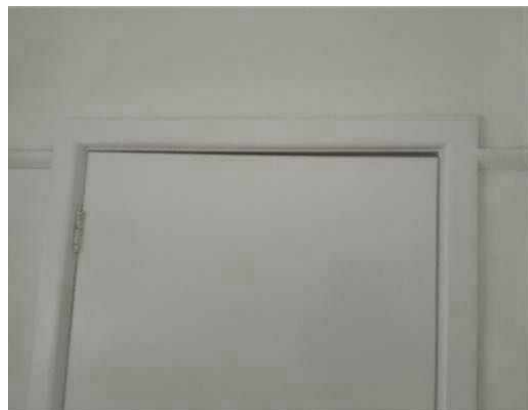
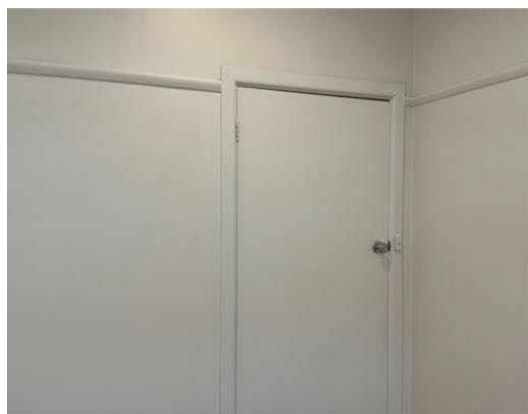
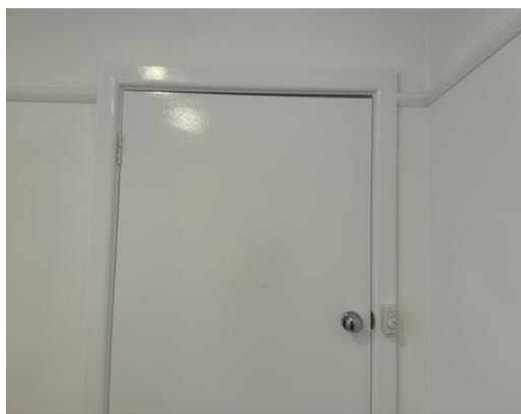
Defects 3.01

Building: Main Building

Location: All Areas

Finding: Door - Gap

Information: A significant gap was identified between the door and door frame in this area. Where large gaps to the head or foot of door frames appear, it may indicate a variety of defects, ranging from uneven framework, sagging hinges or uneven flooring.

A gap to the head of the door may also indicate movement of the foundation of the property, which is a common occurrence and does not indicate structural damage.

A qualified carpenter should be appointed to perform remedial works to restore the door to a fully operational level.

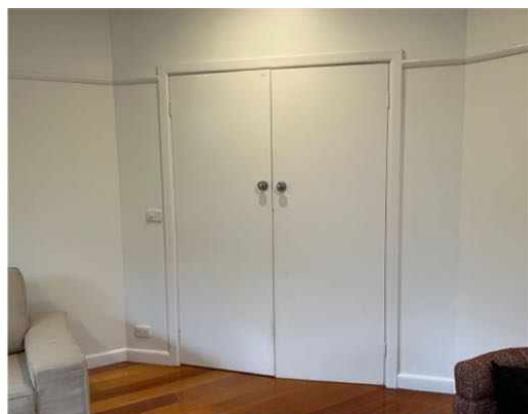
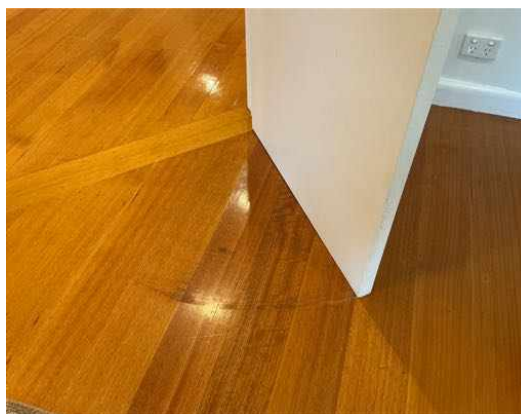
Defects 3.02

Building:	Main Building
Location:	Lounge Room
Finding:	Door - Binding/jamming
Information:	Binding and/or jamming of this door is evident during standard operation. This defect inhibits the functionality of the affected door as well as creating potential for secondary defects to associated building elements, such as damage to the floor covering.

A door that binds to flooring or to the associated door frame may have several causes, ranging from minor defects, such as poor installation of the door or deteriorated hinges, through to major structural issues, such as damage to subfloor structures.

Where door binding/jamming appears to indicate major structural issues, a registered builder specialising in re-stumping should be appointed to provide an estimate on the cost of rectification.

For minor causes, a qualified carpenter or general handyperson should be appointed to perform minor rectification works at client discretion.

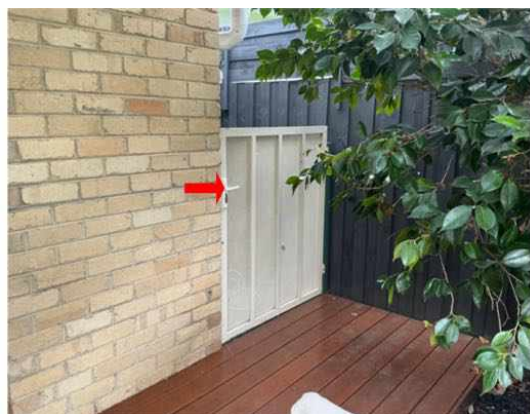
Defects 3.03

Location:	Exterior walls - left side
Finding:	Sticking or jamming
Information:	Building elements which are sticking or jamming are difficult to operate and don't function as intended. There are a variety of causes for sticking and jamming.

The most usual causes are swelling of timbers due to moisture, bulging or bowing of metal frames, or general material deterioration. Generally, sticking and jamming building elements indicate that their frames are uneven or out of level, generally as result of movement to surrounding walls and floors.

Easement will be required, which usually depends on the building materials used. This may involve some sanding and/or application of a lubricant. It will almost always include ensuring the areas are cleaned and free of any debris that may be detrimental to their operational state.

Appointment of a carpenter or general handyman is recommended to rectify any sticking/jamming building elements.

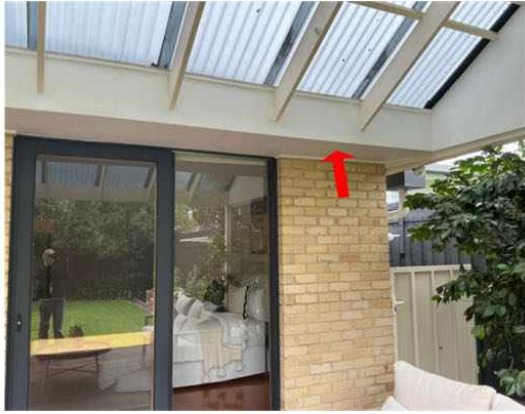
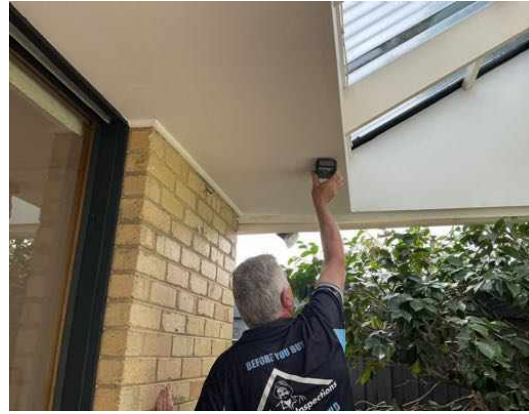
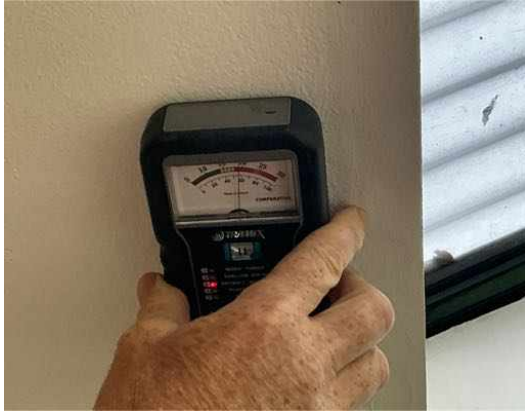
Defects 3.04

Building:	Main Building
Location:	Alfresco
Finding:	Evidence of excessive moisture was present at the time of inspection
Information:	Excessive moisture can attract termites and produce conditions that promote termite attack, fungal growth and wood decay. Excessive moisture is generally caused by deteriorated, inadequate or missing roof drainage, leaking plumbing pipes or fixtures, poorly plumbed HWS overflows or condenser units and poor site drainage. It is highly recommended that all plumbing and drainage fixtures and fittings be maintained regularly in order to prevent excessive moisture being present in the external / internal property.

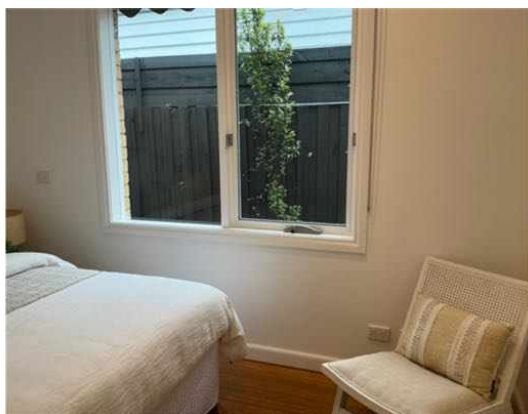
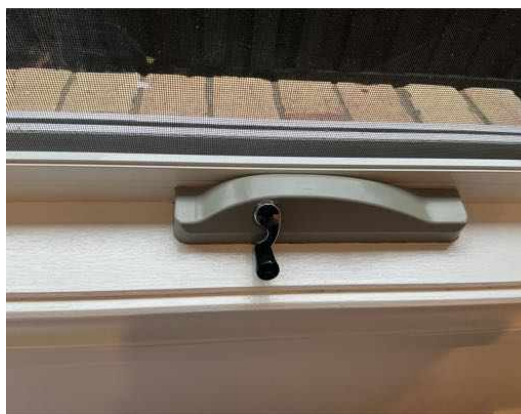
Defects 3.05

Location: Bedroom

Finding: Window- Broken handle

Information: The window handle in this area was found to be broken at the time of inspection. Breakage occurs generally when the building materials have aged and decayed, but may be indicative of impact damage (accidental or deliberate).

Repair and/or replacement of the broken handle is advised to improve the operational state of the associated window

A qualified carpenter or general handyman should be appointed to repair/replace the handle at the client's discretion.

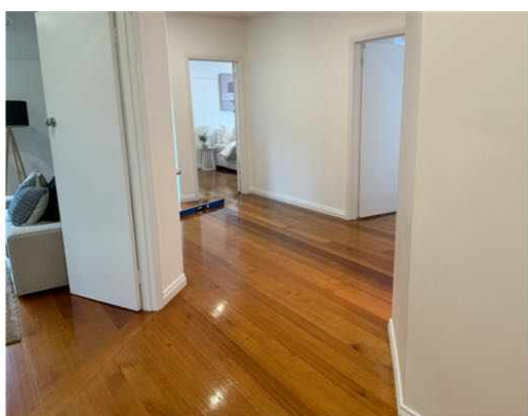
Defects 3.06

Building:	Main Building
Location:	All Areas
Finding:	Floors - bouncy
Information:	The internal flooring in this area was identified as being bouncy at the time of inspection. A bouncy floor surface generally presents as a discernible change in level as they are walked across, in noisy or creaking flooring, or in consequent movement of surrounding furniture and fixtures.

Bouncy floors generally indicate that the floorboards or the subfloor structures are coming loose from the joists that they are installed on. Bouncy flooring may also be the result of gaps between flooring and stumps or joist structures, which require packing.

The client is advised to seek quotations for required repairs from a Registered Builder specialising in re-stumping. The potential resolution may range from packing gaps in subfloor structures through to replacement of subfloors stumps and refixing of flooring.

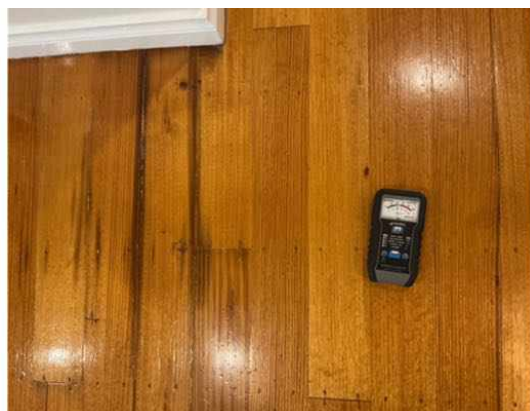
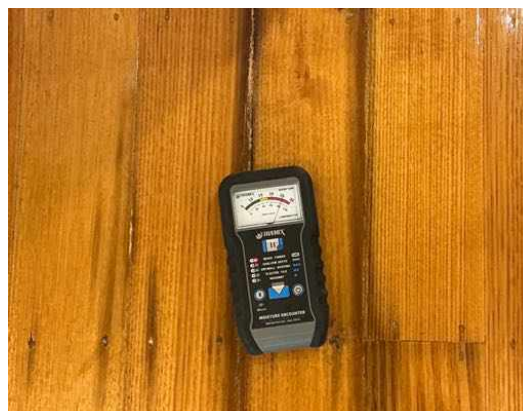
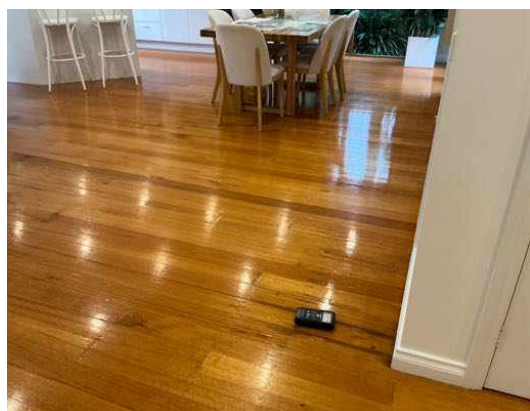
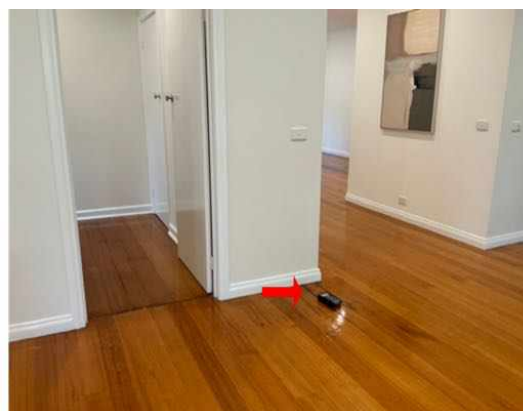
Defects 3.07

Building:	Main Building
Location:	Lounge Room

Finding: Evidence of excessive moisture was present at the time of inspection
 Information: Excessive moisture was found in this area, further investigation is required in order to determine the cause of this excess moisture

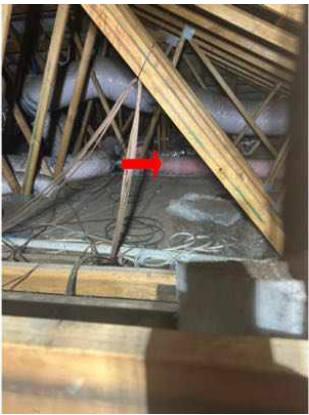
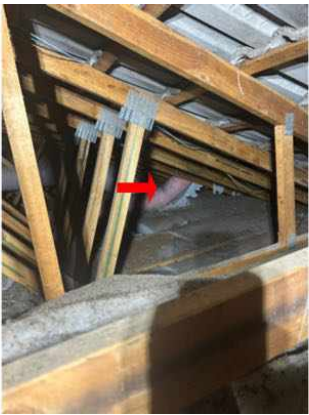
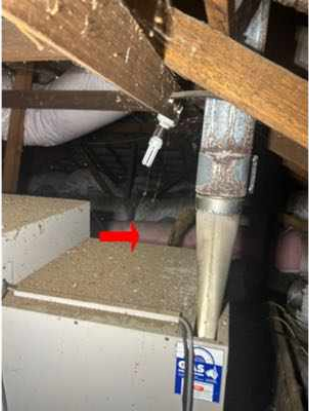
Defects 3.08

Building: Main Building
 Location: All Areas
 Finding: Heating / Cooling Ducts - damaged
 Information: The heating/cooling ducts were found to be damaged and not at a fully operational level. Generally, damage to ducts occurs as a result of aging and material deterioration, but impact damage or pest damage may also be the underlying cause.

The damage sustained by the ducts detracts from the energy efficiency of the property. The airflow within the property is likely to be restricted, particularly in areas where ducting shows signs of major damage.

A heating/cooling specialist should be appointed to provide further advice on remedial work options and to perform any works deemed necessary.

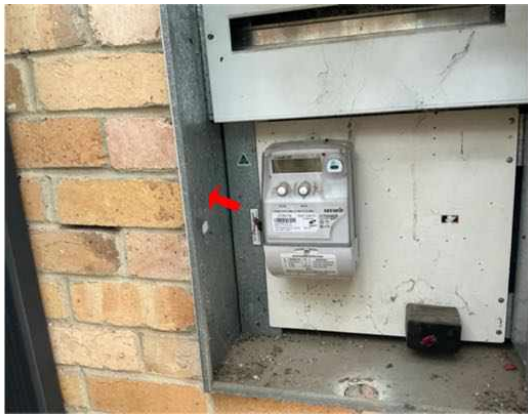
Building:	Main Building
Location:	Electrical meter box
Finding:	Termite Management System - no evidence of a chemical installation
Information:	The application of a post-construction chemical termite barrier is highly recommended for all properties, particularly if live termite activity has been found on the site previously. Such barriers are highly effective in preventing termite attack on any timber building elements throughout the property.

A durable notice should be placed in the switchboard unit to indicate current termite barriers. At the time of inspection, it appeared as though no termite management system has been installed, with no evidence to suggest preventative works taking place.

The client may consider gaining further advice from a pest controller as to the costs and procedures involved with this application. It is recommended that obtaining such advice be a short-term priority.

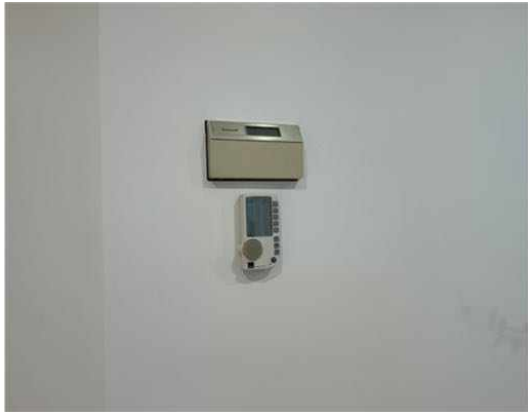
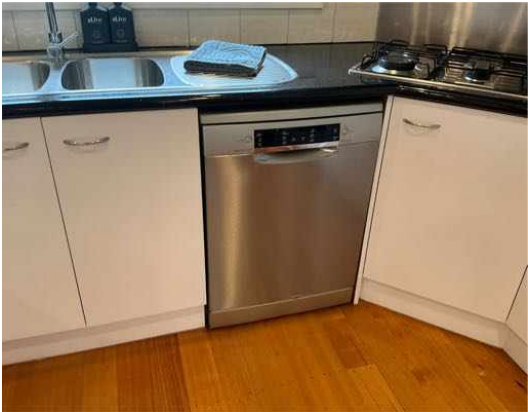
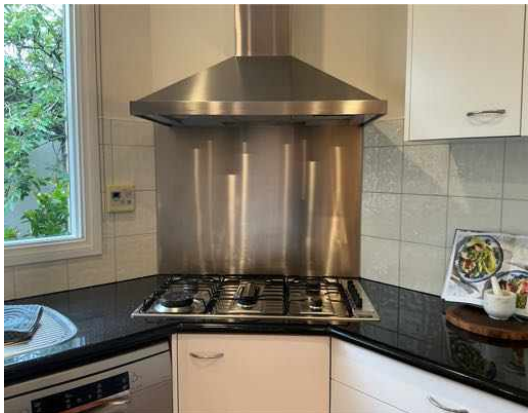
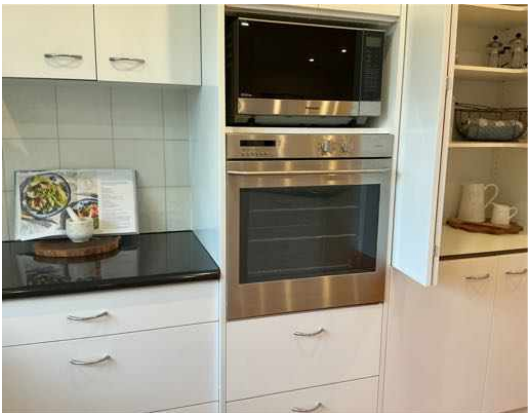
Building: Main Building
Location: All Appliances
Finding: Warranty - Expired
Information: Where appliances are beyond their warranty period, the owner should be prepared to meet the cost of replacement or repair of the item at any time. The operation of the appliance can not be guaranteed and further inspection by an appropriately qualified tradesperson may be required.
