# Building and Timber Pest Inspection Report

Inspection Date: Tue, 10 Feb 2026

Property Address: 19 Cavendish St, CONCORD WEST, NSW,  
2138, Australia

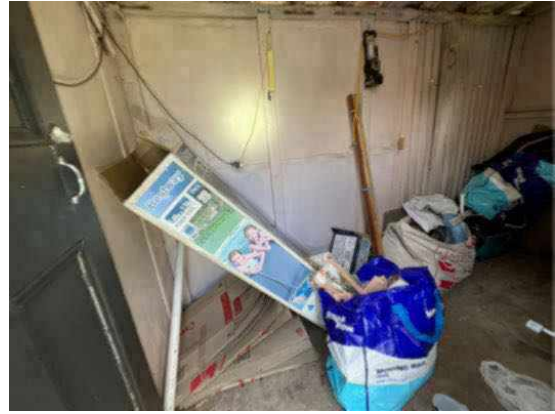
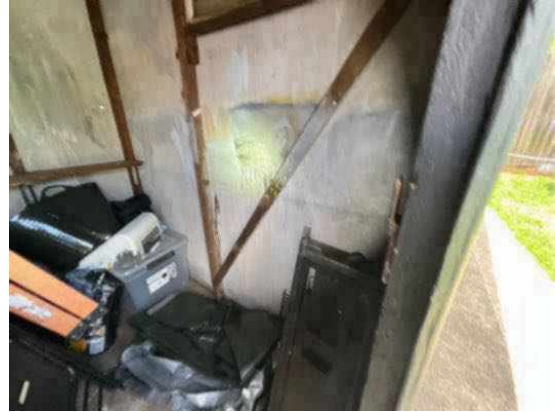
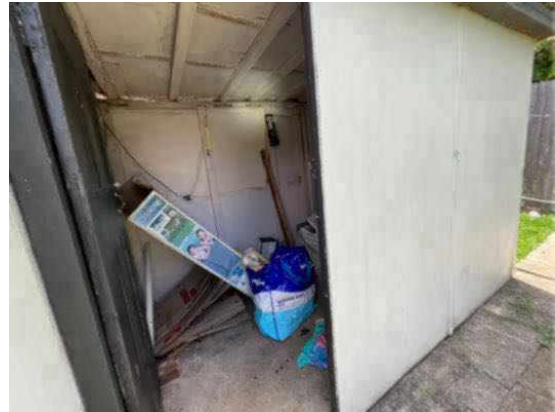
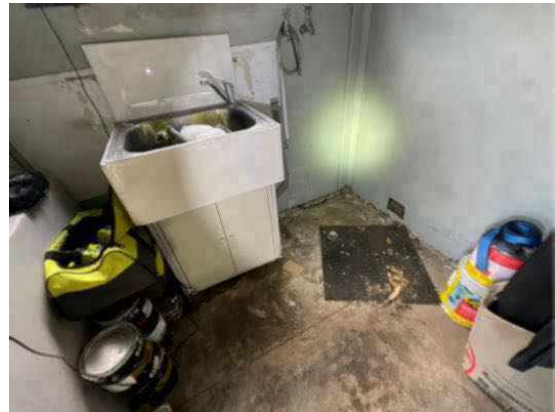
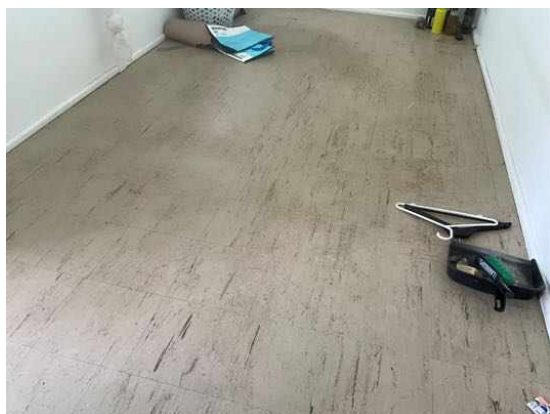
Building:	Main Building
Location:	All Areas
Finding:	Asbestos - Suspected ACM Identified on Site
Information:	Reporting on Asbestos is outside the Scope of this Report. This suspected defect is highlighted as a caution only. We suspect, based on our experience in the building industry, that there is a higher risk of the identified building element containing asbestos.

As Asbestos Reporting is outside the scope of this report, we advise that you consider a separate Asbestos Inspection and Condition Audit, which can include the taking of samples for definitive confirmation of the presence of Asbestos.

In the interim, the client is advised to act with caution, especially when considering any damage to building materials general wear and tear renovations extensions demolition and general maintenance activities due to the suspected presence of Asbestos.

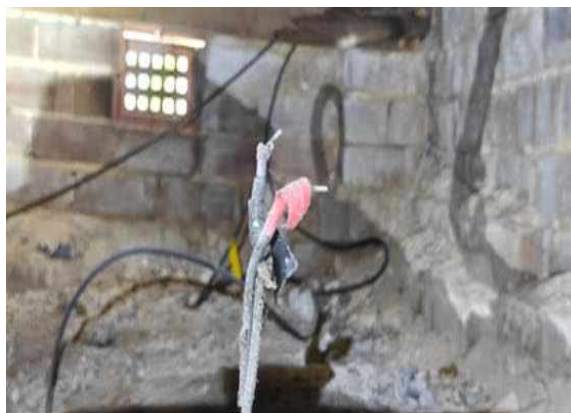
### Finding 1.02

Building:	Main Building
Location:	Subfloor
Finding:	Exposed Electrical Wiring
Information:	The electrical wiring is exposed with visible copper conductors. This condition poses a potential electrical hazard, particularly environment where moisture, dust, or accidental contact may occur. Exposed wiring is a non-compliant installation under Australian Standards and requires immediate attention.

This issue should be classified as a major defect due to the high safety risk associated with exposed electrical wiring.

- **Engage a Licensed Electrician:** A licensed electrician should be contacted to assess and repair the exposed wiring. They may need to replace damaged cables, enclose

the wiring in a conduit, or re-route it to ensure it meets safety standards.

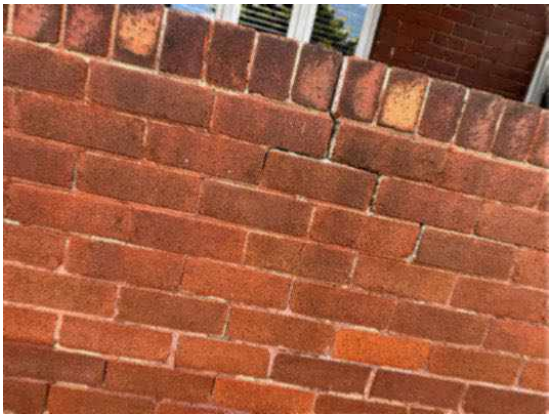
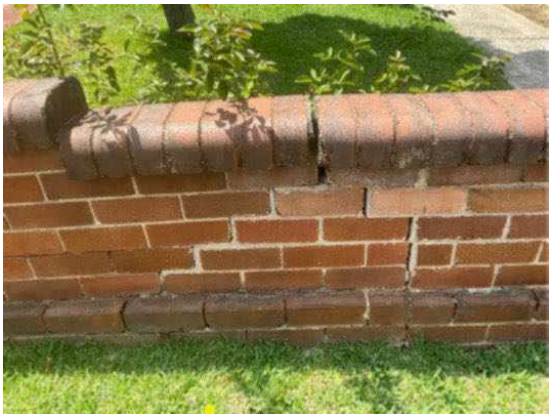
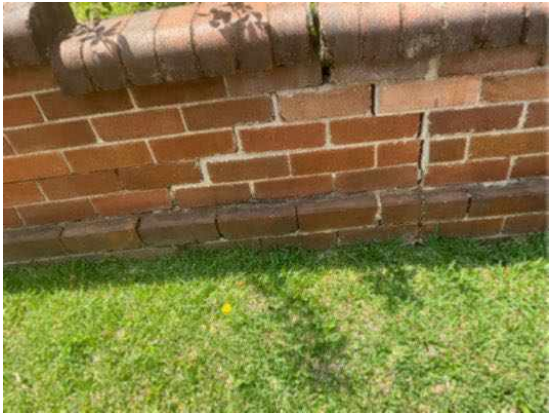
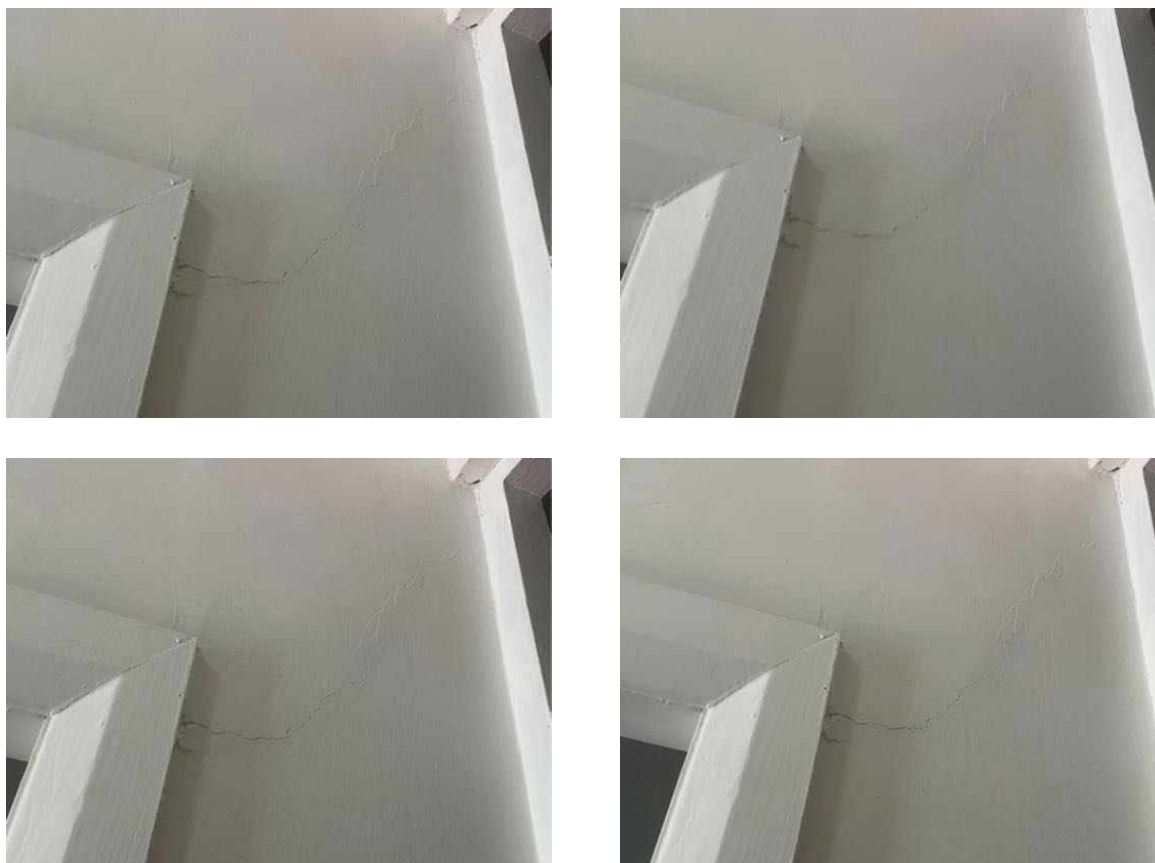
### Finding 2.01

Building:	Main Building
Location:	All Areas
Finding:	Brickwork - Cracking [Repair required]
Information:	Major cracking was identified to the brickwork in this area. Cracks of this type are likely to have been caused by minor expected movement of building elements, but may also have a structural cause that is more significant.

A crack of this size may be repaired by extensive filling. Additionally, further remedial works to associated building elements, such as eave sheeting or external door frames, is likely to be required.

A qualified bricklayer should be contacted immediately to estimate and perform repair and restoration works. Consultation with a structural engineer may be required where structural instability is found to be the underlying cause of the cracking.

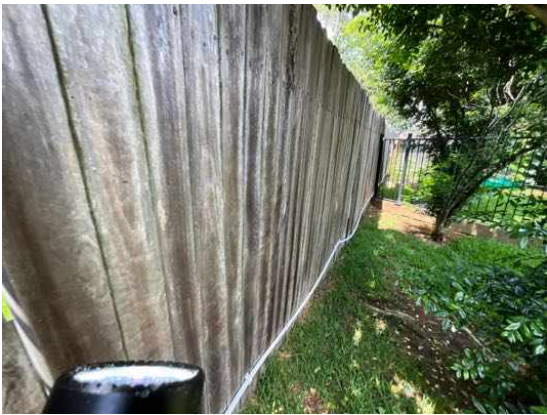
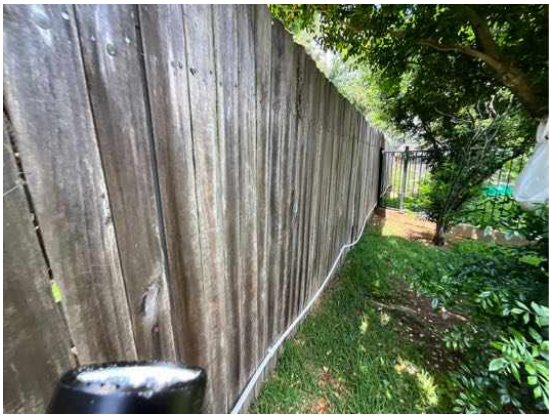
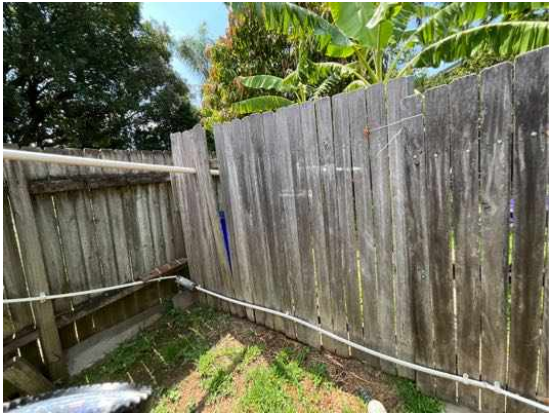
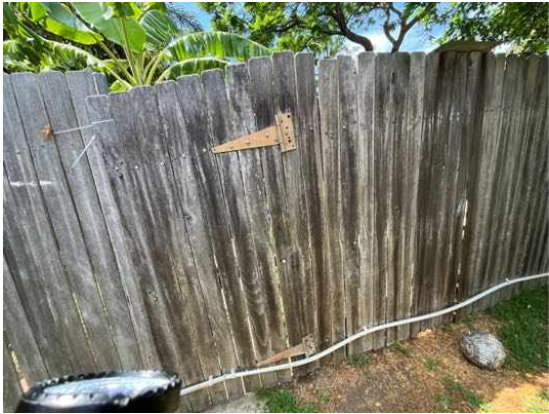
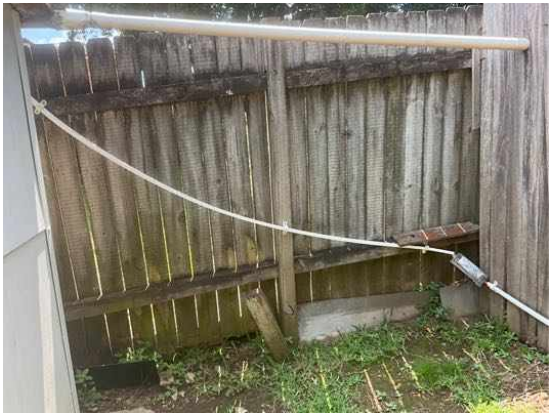
Building:	Main Building
Location:	All Areas
Finding:	Deteriorated fence
Information:	The fence along the property boundary has deteriorated significantly, showing signs of rot, rust, and structural weakness. Several sections are leaning or have become detached, compromising the integrity of the fence and its ability to perform its intended function.

1. **Safety Hazard:** The unstable fence may collapse, posing a risk of injury to residents, visitors, and passersby.
2. **Security Concern:** The compromised fence may allow unauthorized access to the property, increasing the risk of theft, vandalism, or trespassing.
3. **Property Damage:** Falling sections of the fence could damage nearby structures, plants, or other property features.
4. **Legal Liability:** If the fence were to fail and cause injury or damage to neighboring properties, the property owner may be held liable.

- **Licensed Fencing Contractor:** A professional fencing contractor should be hired to assess the extent of the damage and either repair or replace the deteriorated sections.
- **Handyman Services:** For minor repairs, a qualified handyman could be engaged to reinforce or repair specific sections of the fence.
- **Landscaper (if the fence is part of a larger garden feature):** If the fence is integrated into the landscape design, a landscaper with experience in fencing could be involved in the repair or replacement process.

It's important to ensure that whoever is hired is experienced and qualified to ensure the fence is restored to a safe and functional condition, compliant with local regulations.

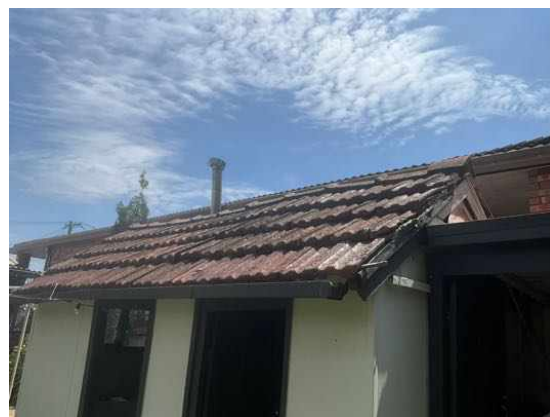
Finding 2.04

Building: Main Building  
 Location: Shed  
 Finding: Roof Weathered  
 Information: Upon inspection of the exterior roofing, the majority of roof was not in a fair condition. While weathering of the roof is consistent with the age of the property, maintenance works are required.

Isolated areas of mortar have come loose in the valleys and minor cracking is also present. Re-pointing and re-sealing the may be considered as an interim solution by the client to help preserve and extend the life span of the tiles.

Where left unmanaged, deteriorating roof are likely to lead to a number of secondary defects, including minor water leaks and weather exposure to internal roofing structures.

Consultation with a roofing contractor is highly advised to gain advice on cost of remedial works that may be required in the short to medium term. Remedial works are likely to increase the longevity of the exterior roofing structure.

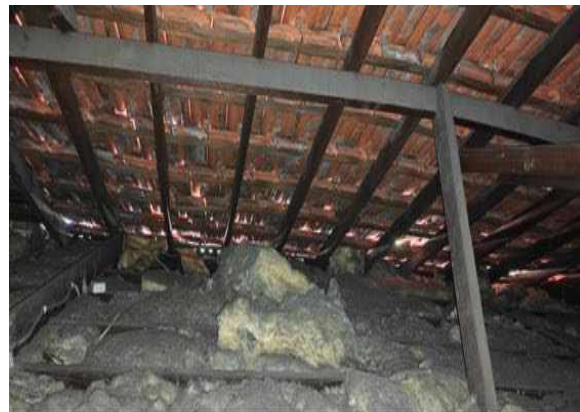
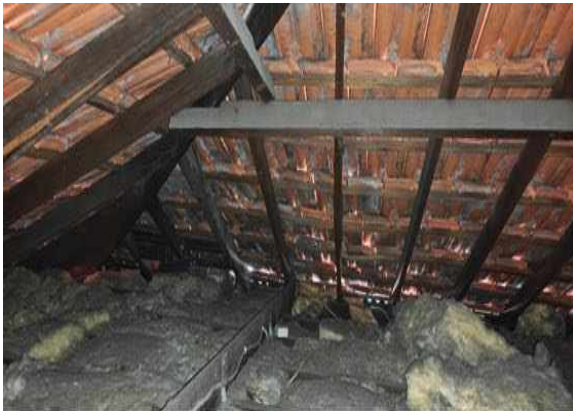
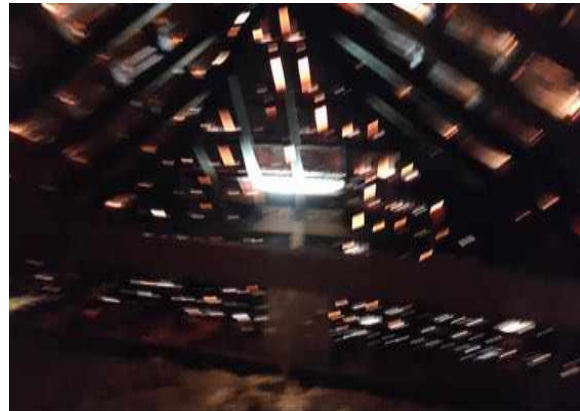
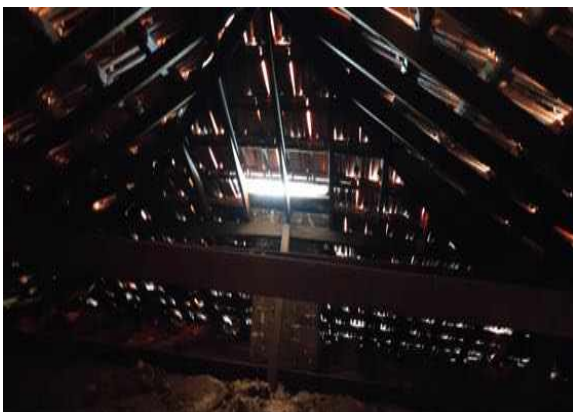
Building:	Main Building
Location:	Roof Void
Finding:	Roof Void - Evidence of batten movement
Information:	Evidence of batten movement and visible daylight through the roof covering was observed from within the roof void. Several roof battens appear to have shifted or become dislodged from their original positions.

This condition compromises the structural integrity of the roof, as battens are essential for supporting roof tiles or sheeting. Movement or displacement can result in roof tile failure, leading to water ingress and potential damage to internal building elements,

including insulation, ceiling linings, and electrical wiring. It also increases the risk of wind uplift or progressive roof failure in severe weather conditions.

A licensed roofing contractor or qualified builder should be engaged urgently to assess the full extent of structural batten movement and carry out remedial works. This may include re-fixing or replacing battens, ensuring all roofing elements are adequately secured, and checking for any related structural damage.

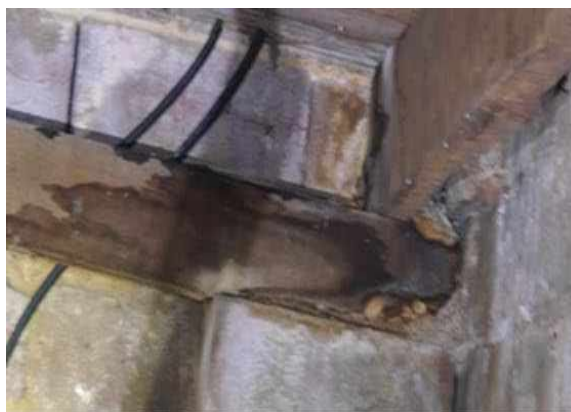
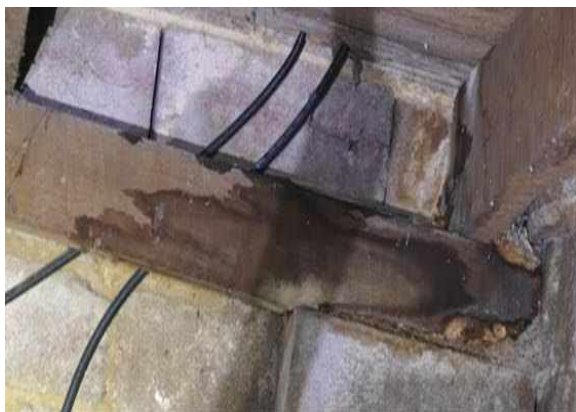
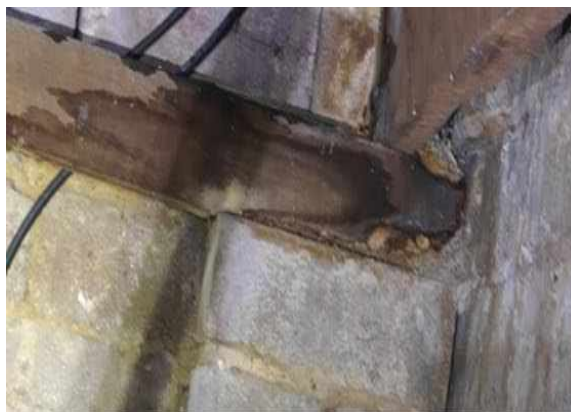
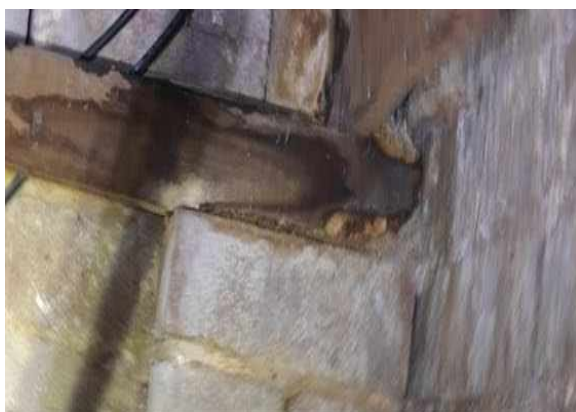
## Finding 2.09

Building:	Main Building
Location:	Subfloor
Finding:	Subfloor- Wood Rot in Bearer and Joist
Information:	The bearer and joist in the subfloor show significant wood rot, which has compromised the structural integrity of the timber. Wood rot typically occurs due to prolonged exposure to moisture, and in this case, it has led to severe decay, weakening the timber and reducing its load-bearing capacity. This deterioration poses a critical risk to the overall stability of the floor structure.

- **Structural Risk:** High risk of structural failure in the affected area due to compromised load-bearing capacity. If left unaddressed, this could lead to sagging, uneven floors, or even collapse in extreme cases.
- **Safety Risk:** Elevated safety risk for occupants, as a weakened subfloor could fail under load, posing a potential hazard.
- **Moisture and Decay Propagation Risk:** The presence of rot in the timber can spread if the source of moisture is not addressed, potentially affecting adjacent timbers and leading to widespread damage.

This defect should be classified as a major defect due to the severe impact on structural integrity and safety. Immediate action is required to rectify the issue and maintain the building's stability.

- **Engage a Licensed Carpenter or Structural Engineer:** A qualified carpenter or structural engineer should assess the extent of the damage and replace the affected bearer and joist. They will ensure the replacement timbers are adequately treated and installed to meet structural standards.
- **Address Moisture Source:** It is critical to identify and eliminate the moisture source contributing to the wood rot. Improving subfloor ventilation, repairing leaks, or installing a moisture barrier may be necessary to prevent future decay.

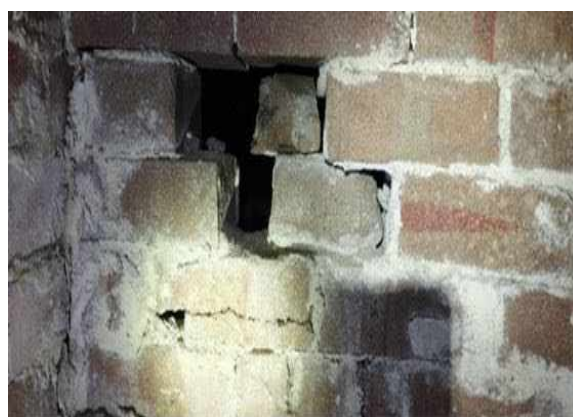
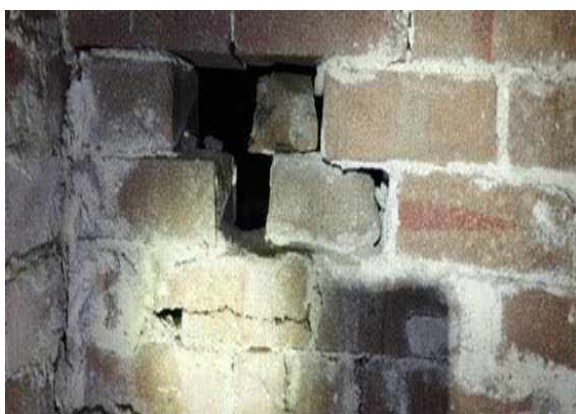
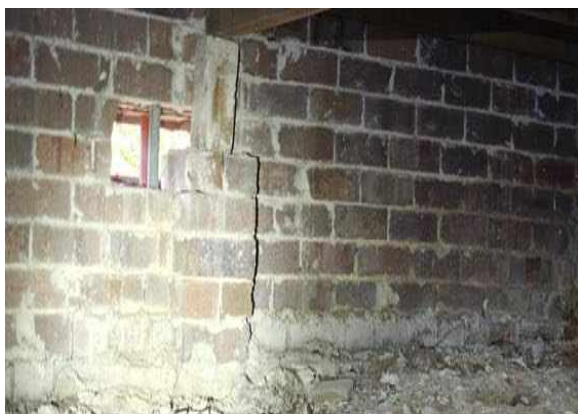
### Finding 2.10

Building:	Main Building
Location:	Subfloor
Finding:	Subfloor - Substandard Works
Information:	Evidence of substandard construction and repair work in the subfloor area. This includes poorly constructed and uneven brick piers, use of inappropriate materials, and a general lack of structural integrity in the support system.

- **\*\*Structural Failure:\*\*** The inadequate support from substandard construction could lead to uneven settling, sagging floors, or even collapse of the structure above.

- **Safety Hazard:** The compromised subfloor structure poses a significant risk of injury to occupants and anyone accessing the subfloor area for maintenance.

- **Further Damage:** Substandard repairs may not effectively address underlying issues, leading to progressive damage and increased repair costs over time.

- **Structural Engineer:** A structural engineer should be consulted to assess the extent of the substandard work and to design an appropriate remediation plan.

- **Professional Contractor:** Following the structural engineer's recommendations, a professional contractor with experience in foundation and subfloor repairs should be hired to perform the necessary corrective work to bring the subfloor up to standard.

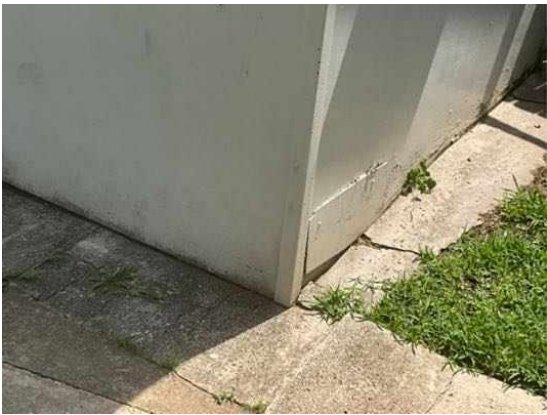
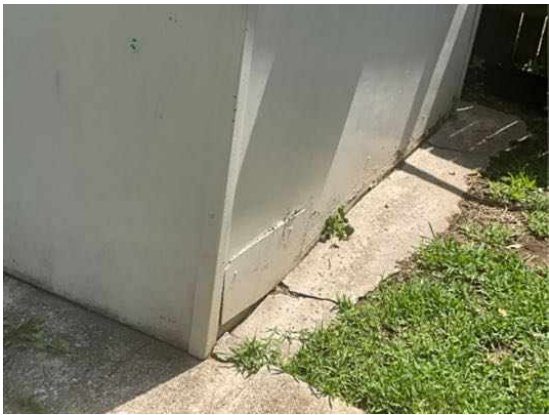
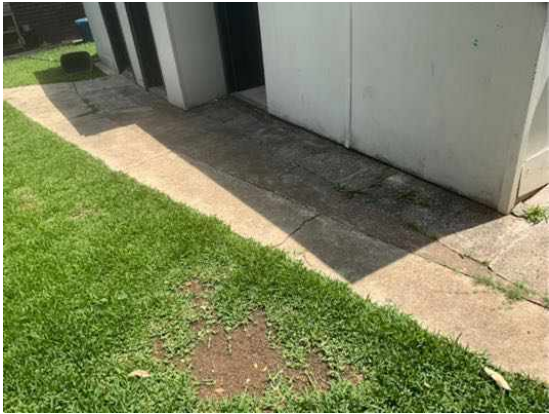
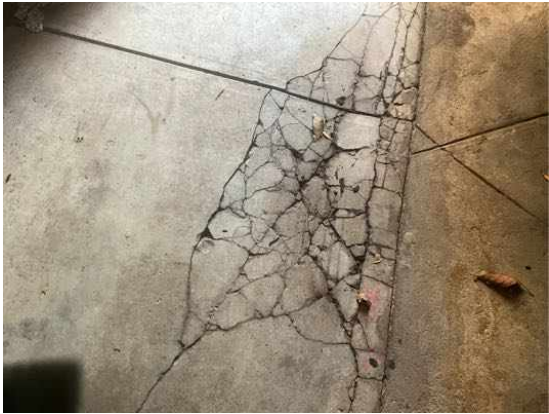
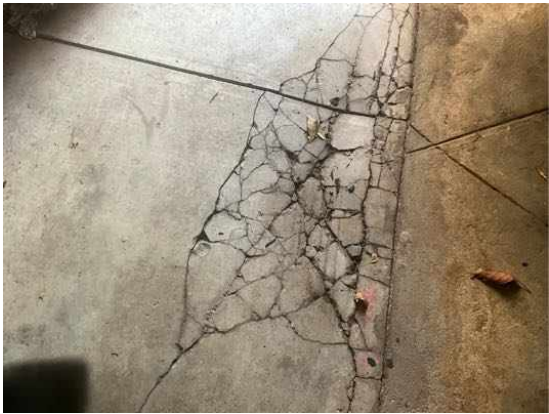
### Finding 3.01

Building:	Main Building
Location:	All Areas
Finding:	Noticeable Cracking in Concrete Slab
Information:	Noticeable cracking has been observed in the concrete slab, failing to meet the required construction and quality standards.

- .
- Cracks are visible on the surface and may extend through the depth of the slab.
- Evidence of improper curing or inadequate reinforcement leading to cracking.

- Compromised structural integrity of the slab, potentially leading to failure under load.
- Water ingress through cracks, causing corrosion of reinforcement and further weakening the structure.
- Potential trip hazards and aesthetic issues, reducing the overall value and safety of the property.
- Increased maintenance and repair costs due to ongoing deterioration.

- A structural engineer should be engaged to assess the extent of the cracking and recommend appropriate repair methods.

- A licensed contractor or concrete repair specialist should carry out the recommended repairs under the guidance of the structural engineer.

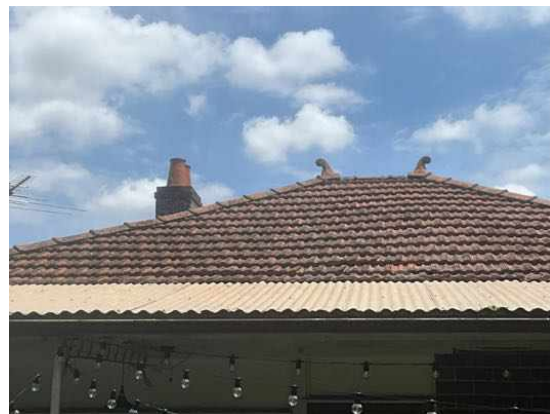
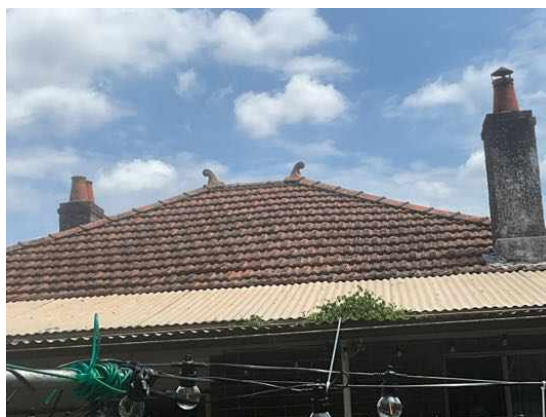
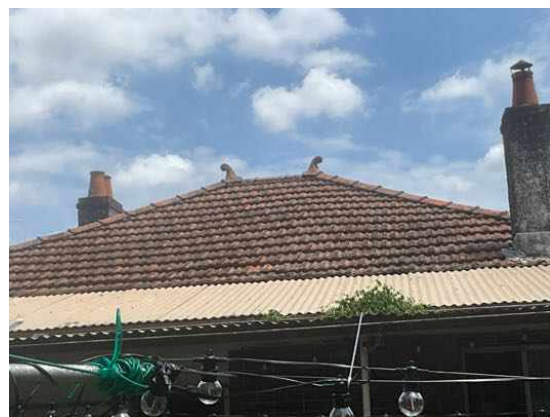
Finding 3.02

Building: Main Building  
 Location: All Areas  
 Finding: Roof Weathered  
 Information: Upon inspection of the exterior roofing, the majority of roof was not in a fair condition. While weathering of the roof is consistent with the age of the property, maintenance works are required.

Isolated areas of mortar have come loose in the valleys and minor cracking is also present. Re-pointing and re-sealing the may be considered as an interim solution by the client to help preserve and extend the life span of the tiles.

Where left unmanaged, deteriorating roof are likely to lead to a number of secondary defects, including minor water leaks and weather exposure to internal roofing structures.

Consultation with a roofing contractor is highly advised to gain advice on cost of remedial works that may be required in the short to medium term. Remedial works are likely to increase the longevity of the exterior roofing structure.

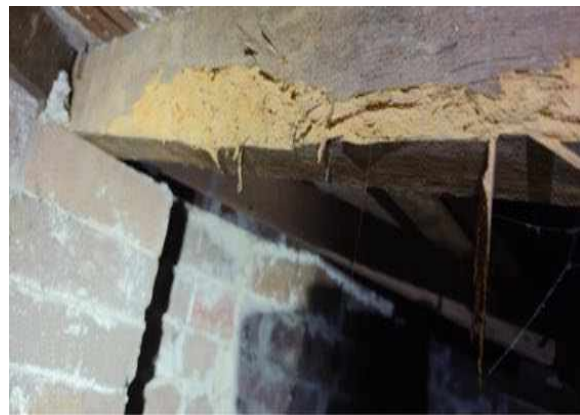
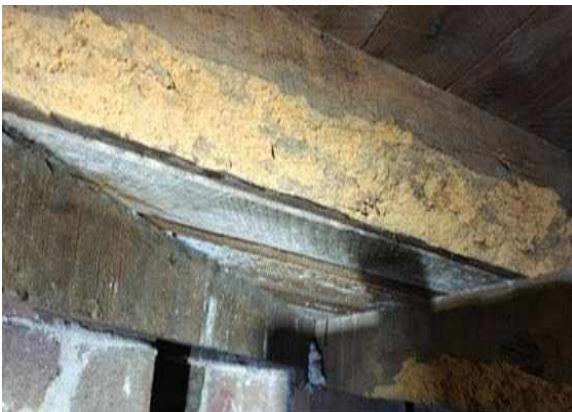
The presence of Suspected timber pest damage increases the risk of further structural deterioration, weakening the subfloor and potentially causing instability in the entire structure. If left unaddressed, this may lead to severe structural issues, compromising safety and necessitating extensive repairs.

A licensed pest control professional should conduct a thorough & invasive inspection to assess the extent of damage. Subsequently, a qualified contractor experienced in subfloor repairs should be engaged to address and rectify the damage. Swift action is crucial to prevent further harm and ensure the long-term stability of the building.

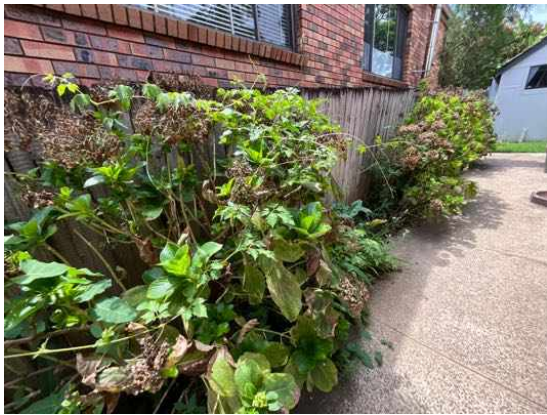
Building: Main Building  
Location: All Areas  
Finding: Dense vegetation around a property can increase the risk of termite infestation  
Information: The presence of dense vegetation around a property can increase the risk of termite infestation, as it provides a conducive environment for them. To address this, consider maintaining a clear space between the vegetation and your home. If you suspect a termite issue, it's advisable to consult with a licensed pest control professional for inspection and treatment.

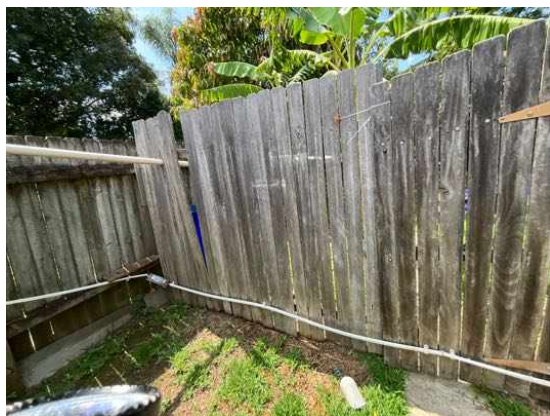
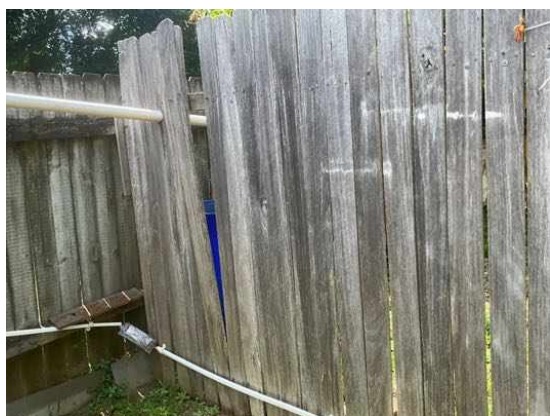
**Finding 6.03**

Building: Main Building  
 Location: All Areas  
 Finding: Timber on ground / conducive conditions to termite damage  
 Information: Timber on the ground is indeed conducive to termite damage. Termites are known to thrive in moist environments, and wood in contact with soil or moisture is more susceptible to infestation.

To prevent this, it's important to keep timber elevated and away from direct ground contact. Regular inspections and proper termite control measures are also essential to protect your wooden structures from termite damage.

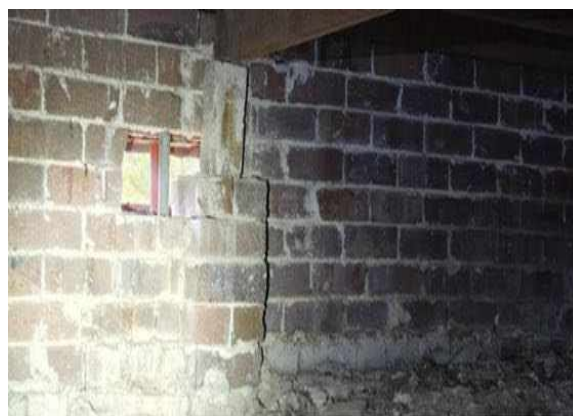
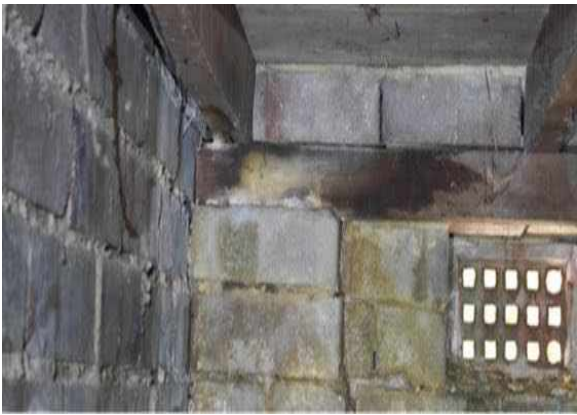
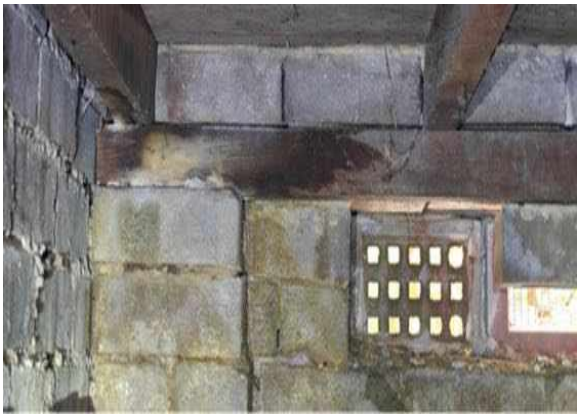
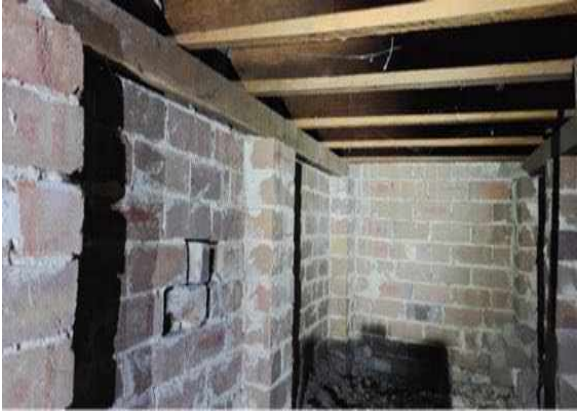
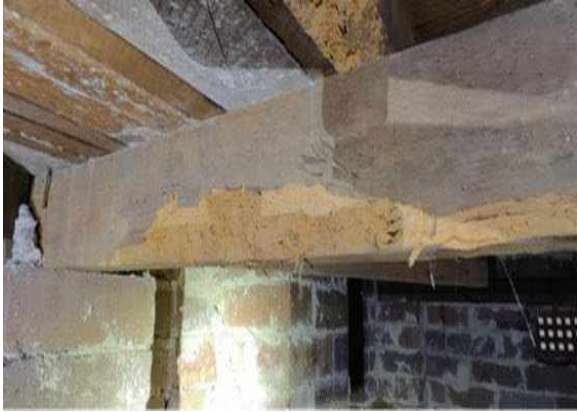
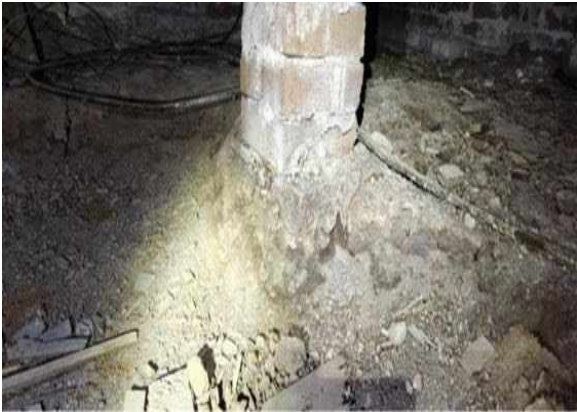
Risk: The combination of poor ventilation, inadequate drainage, water stains, and absence of ant caps significantly increases the risk of timber pest infestations. Termites are attracted to moist environments and can thrive in subfloors with high humidity levels and water damage. The lack of proper ventilation and drainage exacerbates moisture retention, providing an ideal habitat for timber pests to establish colonies and cause extensive damage to the subfloor structure. Additionally, water stains indicate previous or ongoing moisture issues, which further attract timber pests and contribute to the deterioration of timber materials.

A licensed pest control professional specializing in timber pest management should be consulted to assess the extent of the infestation and develop a comprehensive treatment plan. They can implement strategies to eliminate existing timber pests, such as termites and prevent future infestations by addressing underlying moisture issues. Additionally, a qualified contractor or builder may be needed to improve subfloor ventilation, enhance site drainage, repair water-damaged areas, and install ant caps to prevent pest entry points. Regular inspections and maintenance are essential to ensure ongoing protection against timber pests and maintain the structural integrity of the subfloor.

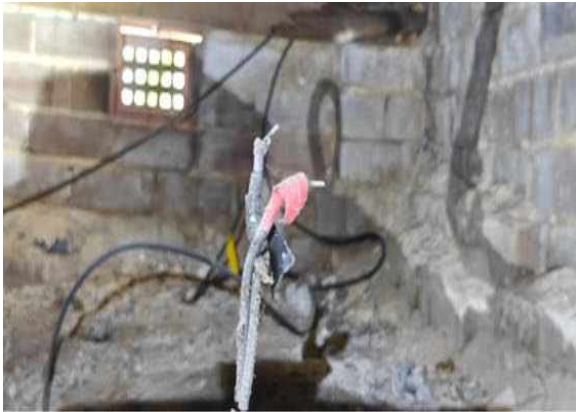
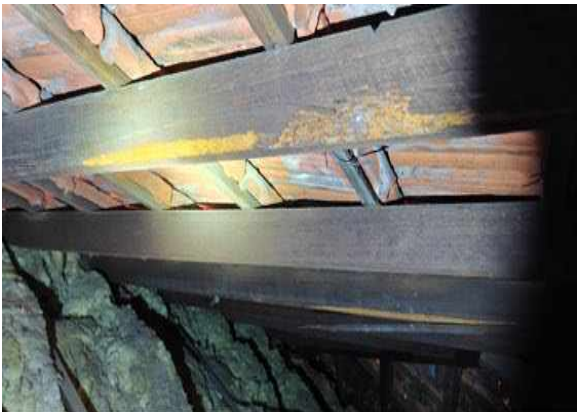
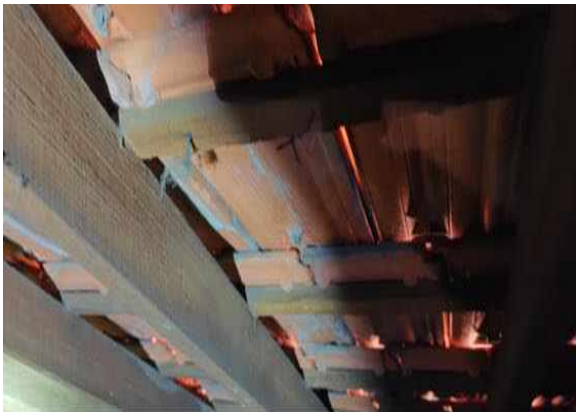
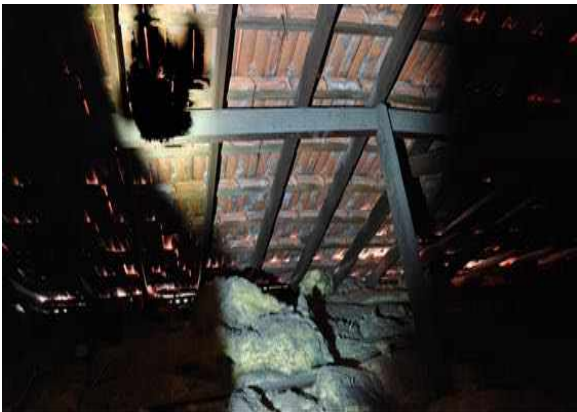
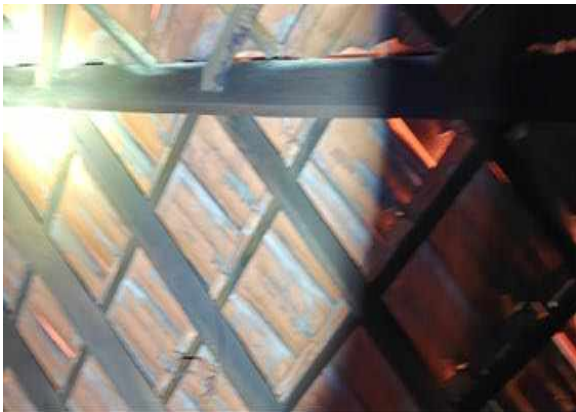
Building: Main Building  
Location: All Areas  
Finding: Additional Photos - Obstructions and Limitations  
Information: These photographs are an indication of the obstructions and limitations which impeded full inspection of the property at the time of inspection. These obstructions can hide an array of defects and should be removed to allow full inspection to be carried out. A re-inspection is recommended once the areas are made accessible.
