Building and Timber Pest Inspection Report

Inspection Date: Wed, 28 Jan 2026

Property Address: 11/41 Victoria St, Werrington NSW 2747,
Australia

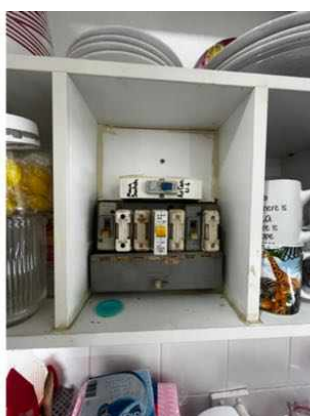
| Information: | Upon Inspection of the Electrical Fuse Box, it is suggested to replace with new circuit breakers to ensure safety from power breakages and an easy maintenance - |

The fitting does expose electrical works, and may create a safety hazard if there is potential contact with persons in the area.

It is better to seek advise from a licensed Electrician for further Inspection and guidance.

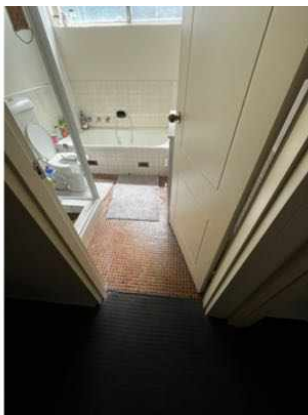
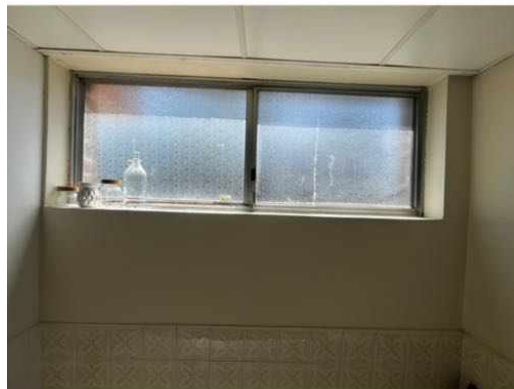
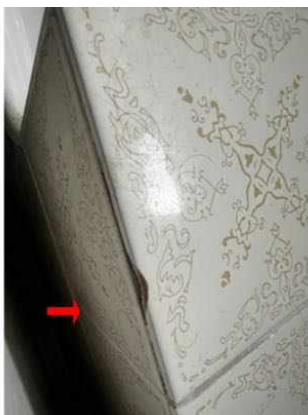
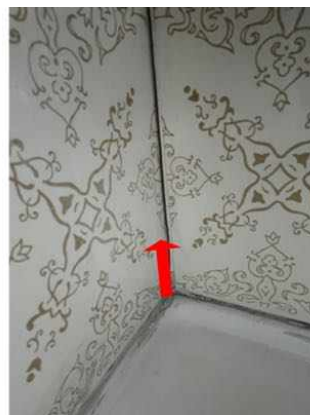
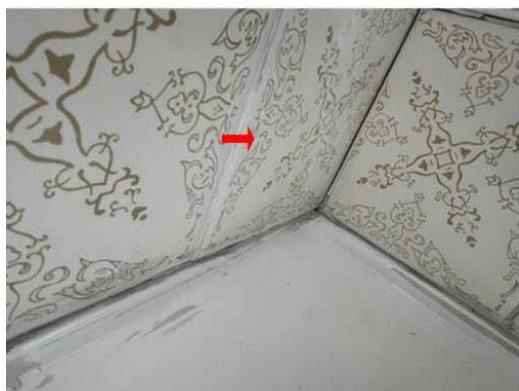
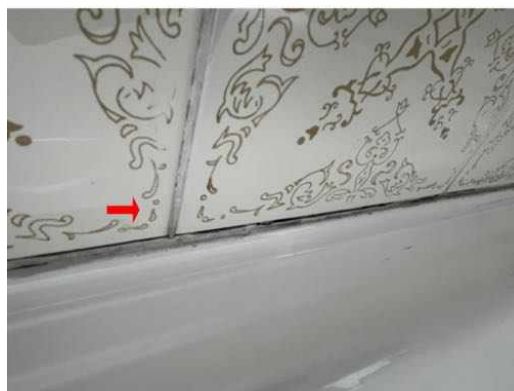
Finding 2.01

Building: Main Building
 Location: Bathroom >
 Finding: Sealant and grouting - Missing or damaged
 Information: It was noted on inspection that sealant or grout is degraded to the tiled shower alcove and or other areas of the bathroom.

Different materials and floor areas move at different rates, generally causing cracking to grout or sealant at this point. A flexible sealant is required to allow for expected expansion and contraction, while keeping the joint water tight and protective of all associated building materials.

There appears to be excessive mould to the sealant and grout which will likely require scraping out and replacement.

Flexible and mould resistant materials should be applied to affected areas to prevent any subsequent water damage that is likely to occur. Regular maintenance and replacement of damage or missing or damaged sealant and grout is highly recommended to the wet areas, as this is a regular wear and tear defect. Sealant and grouting in areas that come into regular contact with water should be maintained for the long term care of your property.

A sealant specialist or tiling contractor should be appointed to complete these works as soon as possible

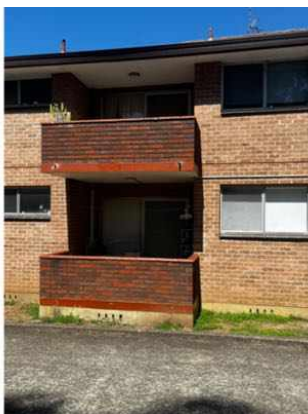
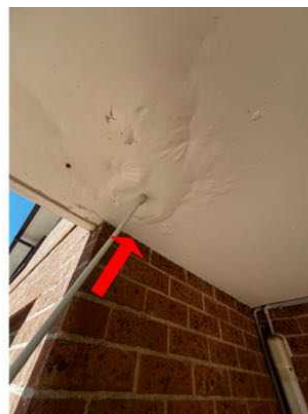
Building: Main Building
 Location: Balcony
 Finding: Balcony Area - Ceiling Damage
 Information: Upon Inspection The gradients of the Balcony floor levels are checked and found to be ok.

Upon inspection of the ceiling Evidence of Previous Water Leak was found during Inspection in the ceiling of the Balcony.

Missing roof drainage, leaking plumbing pipes or fixtures, poorly plumbed HWS overflows or condenser units and poor site drainage are generally the causes of the leakage.

It is highly recommended that all plumbing and drainage fixtures and fittings be maintained regularly in order to prevent excessive moisture being present in the external / internal property.

Suggest to Take the advise of the Licensed Plumber to inspect and verify the cause of the leak and remedy the situation.

Suggest to always keep the area clear of rubbish and leaves, for the free flow of water/ rainwater to go through the downpipes.

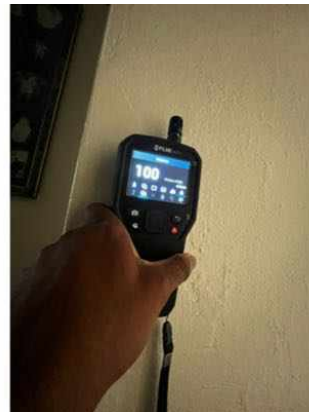
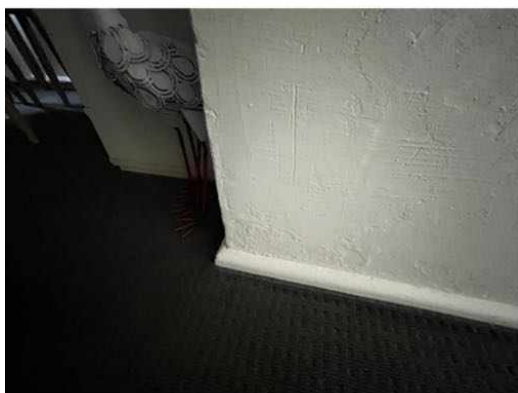
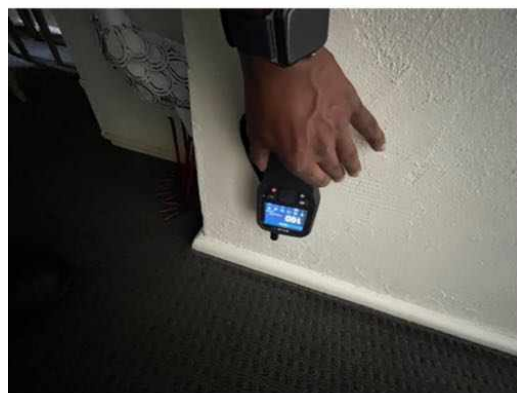
Finding 2.03

Building: Main Building
 Location: Bathroom walls/ Laundry walls
 Finding: High Moisture Readings - Evidence of high moisture was present during Inspection.
 Information: All areas of dwellings are checked with particular attention paid to wet areas which were closely assessed to check for moisture levels of moisture and temperature anomalies.

High readings for moisture were found in the walls adjacent the showers in the bathroom and the laundry plumbing area at the time of inspection.

Excessive moisture is generally caused by deteriorated, inadequate or missing roof drainage, leaking plumbing pipes or fixtures, poorly plumbed HWS overflows or condenser units and poor site drainage.

It is highly recommended that all plumbing and drainage fixtures and fittings be maintained regularly in order to prevent excessive moisture being present in the external / internal property.

It is highly advised to consult a Licensed Plumber to inspect and remedy the situation.

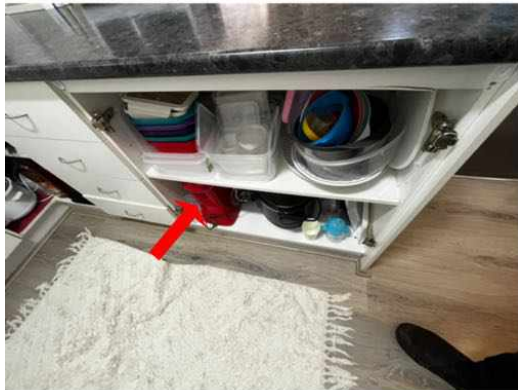
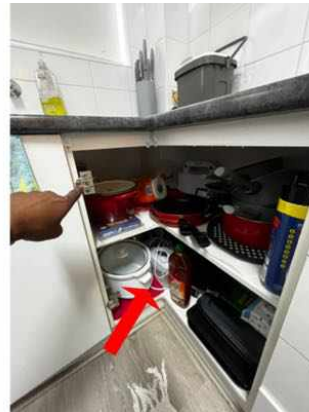
Information: Though comments on Kitchen joinery is not part of the report, Still we would like to bring to your note few photos where the Joinery has been damaged due to Wear and tear/ daily Usage.

The Buyer may consider renovation costs involved by requesting quotes from Joinery manufacturers etc if relevant.

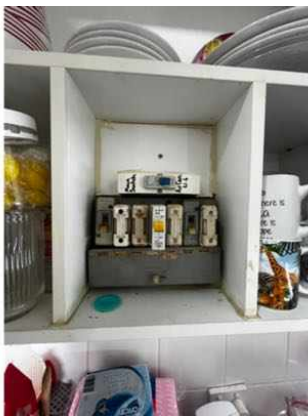
| Information: | The application of a post-construction chemical termite barrier is highly recommended for all properties, particularly if live termite activity has been found on the site previously. Such barriers are highly effective in preventing termite attack on any timber building elements throughout the property. |

A durable notice should be placed in the switchboard unit to indicate current termite barriers. At the time of inspection, it appeared as though no termite management system has been installed, with no evidence to suggest preventative works taking place.

The client may consider gaining further advice from a pest controller as to the costs and procedures involved with this application. It is recommended that obtaining such advice be a short-term priority.

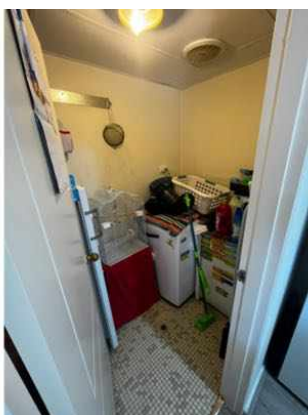
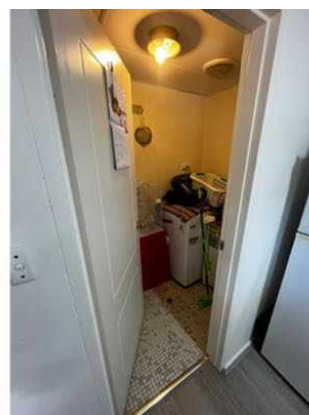
Finding 6.02

Building: Main Building
 Location: Roof Void
 Finding: Roof - No Access
 Information: Limited access to the roof void was present due to facts including but not limited to access hatch size or placement, Its a Concrete roof with very limited access to the aircon ducting and other items present.

These obstructions can hide an array of defects and should be removed to allow full inspection to be carried out.

A re-inspection is recommended once the areas are made accessible.
