# Building and Timber Pest Inspection Report

Inspection Date: Tue, 24 Feb 2026

Property Address: 1 Burraneer St, Leumeah NSW 2560,  
Australia

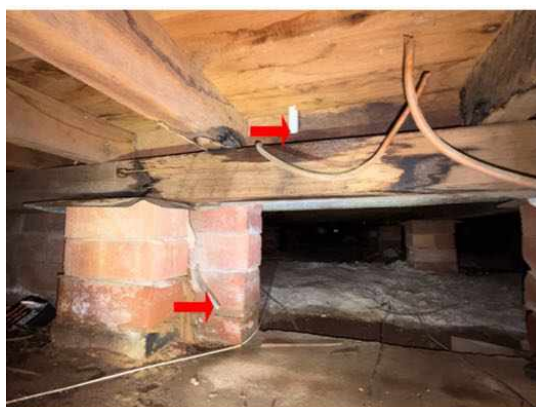
These damp conditions can lead to secondary defects such as rot, rust or corrosion of associated building elements, the formation of fungal decay, or even the creation of potential slip hazards. When coupled with poor site drainage, pooling of water may also attract termite activity to this area.

It is highly recommended that a licensed plumber be appointed to install adequate drainage to the overflow. These works will ensure that the area remains dry and free of any secondary defects.

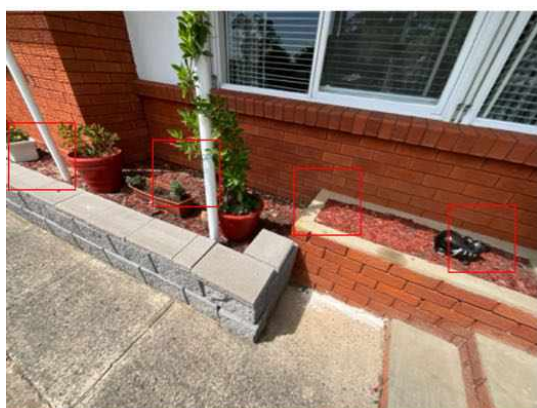
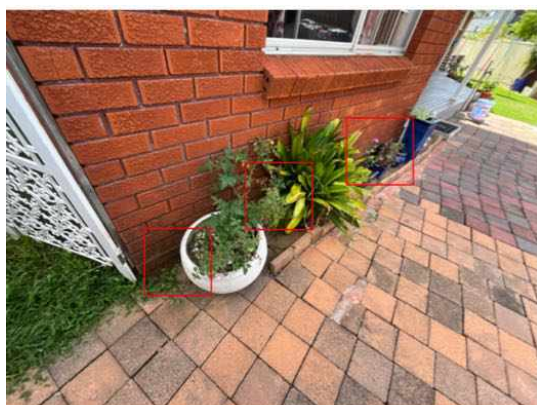
#### Finding 3.01

Building: Main Building  
 Location: Multiple areas  
 Finding: Air vents - Blocked or inadequate  
 Information: It was noted at the time of inspection that the subfloor area lacks adequate ventilation.

The cause of this inadequate ventilation is the state of the air vents to the subfloor area. Where air vents are insufficient in number or are blocked, either fully or partially, subfloor ventilation is decreased.

A well ventilated subfloor aids in maintaining dry conditions, preventing secondary damage such as wood rot and pest activity, as well as preventing the development of mould/fungi and mildew (which can lead to major respiratory issues or safety hazards for occupants, particularly the elderly, the very young and those with existing illnesses).

All air vents should be cleared of blockages to promote adequate air flow to the area. Where ventilation is still insufficient, retrospective installation of air vents may be required. Appointment of a licensed builder may be required to perform these works as necessary.

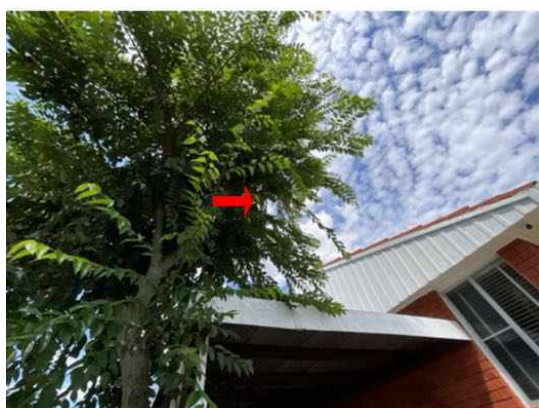
### Finding 3.04

Building:	Main Building
Location:	Roof Exterior
Finding:	Trees - Overhanging and filling gutters
Information:	Overhanging trees often result in excessive amounts of leaf debris accumulating in

Gutters are a critical part of the building's management of storm water and rain. It is therefore important that they be kept clear to prevent secondary damage to associated building elements, including exterior and interior walls, ceiling linings and any adjoining building elements. Where gutters are blocked, pooling of rainwater is likely to occur, fast-tracking rust and corrosion of the roof plumbing elements.

It is highly advised that all overhanging tree branches be removed as soon as possible to prevent any further damage. Repair and/or replacement of sections of damaged guttering may also be required where the extent of the damage necessitates.

Such works should be performed by the homeowner; however, appointment of a landscape contractor or an arborist may be required. Consultation with a licensed roof plumber is required where guttering has been damaged.

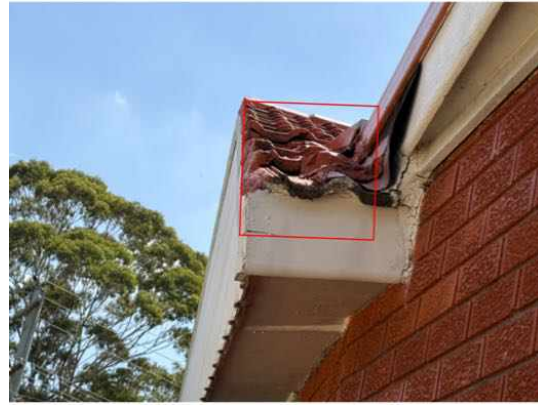
Building:	Main Building
Location:	Roof Exterior RHS
Finding:	Roof plumbing - Missing
Information:	Some sections of the roof are not adequately drained via gutters and downpipes. Gutters and downpipes that are not installed adequately are likely to result in excessively damp conditions against the exterior surfaces and around the base perimeter of the building.

Excessive moisture creates an environment which accelerates the deterioration of building elements in the area, as well as being conducive to termite and pest infestation. Such an environment is likely to necessitate repair and/or replacement of building elements, which are prone to sustaining wood rot, rust or corrosion.

A roofing plumber should be appointed as soon as possible to install relevant roof plumbing materials.

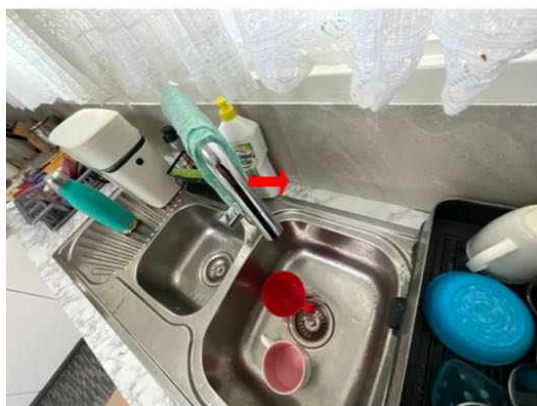
### Finding 3.08

Building:	Main Building
Location:	All Wet Areas
Finding:	Sealant and grouting - Missing or damaged
Information:

It was noted on inspection that sealant or grout is degraded to this area.

Different materials and floor areas move at different rates, generally causing cracking to grout or sealant at this point. A flexible sealant is required to allow for expected expansion and contraction, while keeping the joint water tight and protective of all associated building materials.

Flexible and mould resistant materials should be applied to affected areas to prevent any subsequent water damage that is likely to occur. Regular maintenance and replacement of damage or missing or damaged sealant and grout is highly recommended to the wet areas, as this is a regular wear and tear defect. Sealant and grouting in areas that come into regular contact with water should be maintained for the long term care of your property.

A sealant specialist should be appointed to complete these works as soon as possible.

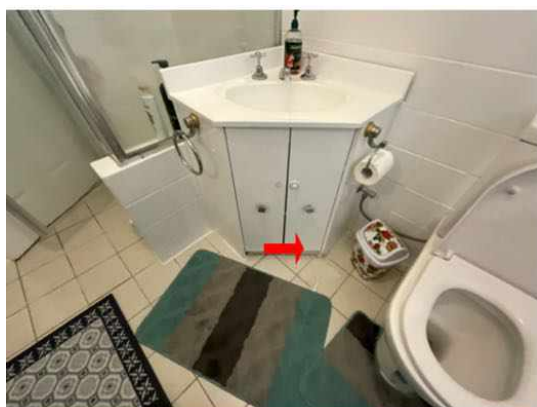
### Finding 3.09

Building:	Main Building
Location:	Bathroom
Finding:	Cupboard/vanity - Swollen/Water Damaged
Information:	Water damage was identified inside the vanity/cupboards in this area and it was also found to be swollen. Water damaged/swollen building elements generally indicate that the building materials have been affected by excessive moisture over a prolonged period of time, and have swollen as a result. A licensed plumber should be engaged to assess where the moisture is coming from and carry out any rectification as soon as possible. Replacement of the vanity/cupboards is also advised by a licensed cabinetmaker.

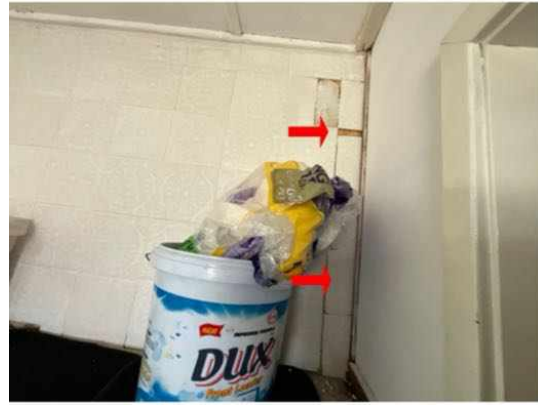
Building: Main Building  
 Location: Laundry  
 Finding: Tiles - Damaged  
 Information: Damage was evident to the tiling in this area at the time of inspection.

If left unmanaged, water penetration to these areas may lead to subsequent water damage, which is likely necessitate repair work to affected building elements.

A tiling contractor should be appointed to ensure that no further water damage occurs. The re-application of silicone and grouting throughout remaining tile work is also advised, to further protect the area against water penetration.

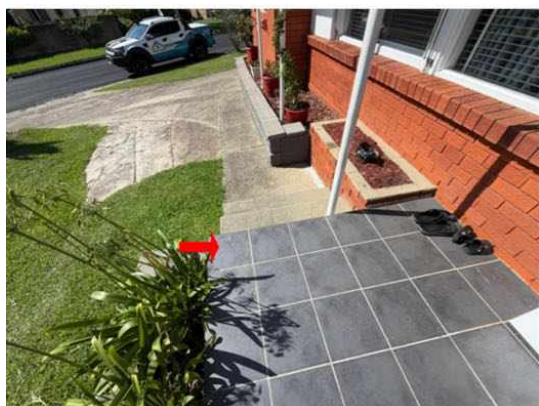
### Finding 3.14

Building: Main Building  
 Location: Porch  
 Finding: Cracked floor tiles  
 Information:

Cracking in the floor tiles was evident in this area at the time of inspection. It is suspected that this cracking has occurred as a result of minor settlement or shrinkage.

Cracked tiles throughout the household detract from the overall appearance of the affected areas however it is unlikely to create or lead to any secondary defects.

While not considered a matter of urgency, replacement of cracked floor tiles is recommended at the clients discretion. A licensed tiling contractor may be appointed to perform these works. Where cracks become more numerous, contact a licensed building inspector for further investigation.

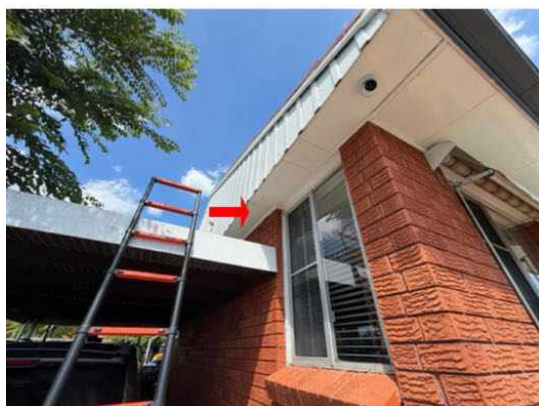
Building:	Main Building
Location:	Multiple areas
Finding:	Paint cracking and peeling
Information:	Cracking and ultimately flaking of paint can occur for a variety of reasons. Often these failures are due to the fact that the paint has inadequate adhesion and flexibility, both common problems with lower quality exterior flat paints.

When timber is involved, moisture intrusion results in swelling of the wood surface followed by contraction as the wood dries. The expansion and contraction cycles, can result in cracking and subsequent paint failure by flaking and peeling.

Inadequate surface preparation can also cause these failures, especially when paint is applied to bare wood or a very porous surface without first applying a primer.

A qualified painter should be appointed to rectify the problem.

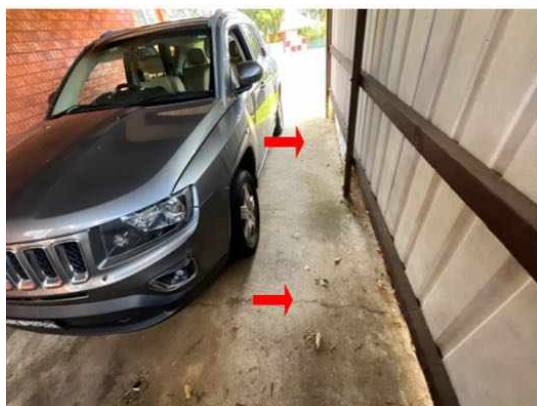
### Finding 3.18

Building:	Main Building
Location:	Carport
Finding:	Cracking - External Concrete Paving Damage Category 0 - Hairline (less than 1mm)
Information:	Hairline cracks were identified in external concrete paving. Hairline cracks are very minor in nature and generally are only ever an appearance defect. To be classified as a Category 0 or hairline crack, the crack width would be less than 0.3mm. While such cracking may be noticeable in some cases, it is common and does not indicate any structural damage.

Hairline cracks may also be due to poor original installation of the concrete. Factors such as poor compaction of the sub surface and/or inadequate reinforcing of the slab may create cracking and other secondary defects.

Monitoring of all cracking should be conducted frequently. Always contact a building inspector should cracks widen, lengthen, or become more numerous.

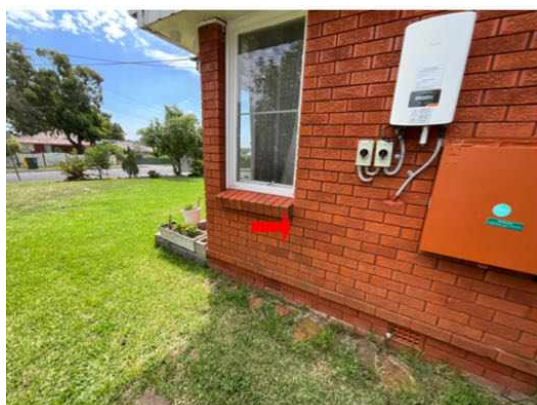
### Finding 3.19

Building:	Main Building
Location:	Front left corner
Finding:	Brickwork - Step cracking
Information:	Step cracking was identified to the brickwork in this area at the time of inspection. Step cracking, which is similar to other forms of cracking, has a variety of possible causes. However, the most common is the subsidence of adjacent footings.

The degree of damage falls within Category 1, described as fine cracks, which are less than 1.0mm in width limit, and that do not need repair.

Damage of this category is not considered a defect for rectification.

Minor step cracking can be used as a warning sign to address factors causing stress to the wall, which can include the effect of surrounding trees, water leaks, soil erosion, or even the presence of reactive soils in the surrounding area. Always contact your building inspector should cracks widen, lengthen, or become more numerous.

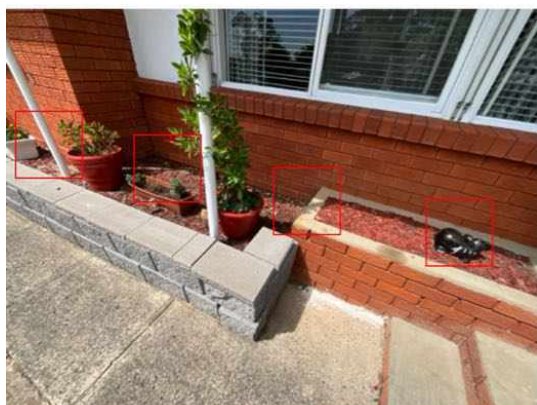
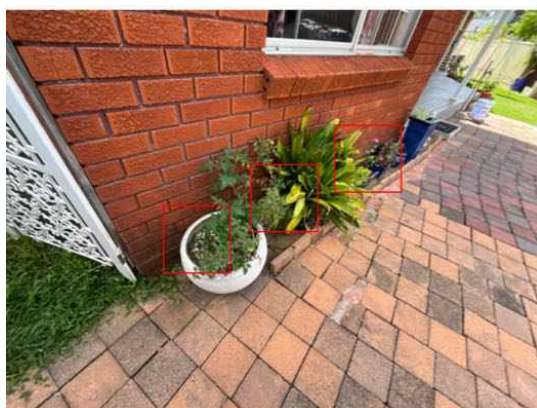
A well ventilated subfloor aids in maintaining dry conditions, preventing secondary damage such as wood rot and pest activity, as well as preventing the development of mould/fungi and mildew (which can lead to major respiratory issues or safety hazards for occupants, particularly the elderly, the very young and those with existing illnesses).

All air vents should be cleared of blockages to promote adequate air flow to the area. Where ventilation is still insufficient, retrospective installation of air vents may be required. Appointment of a licensed builder may be required to perform these works as necessary.

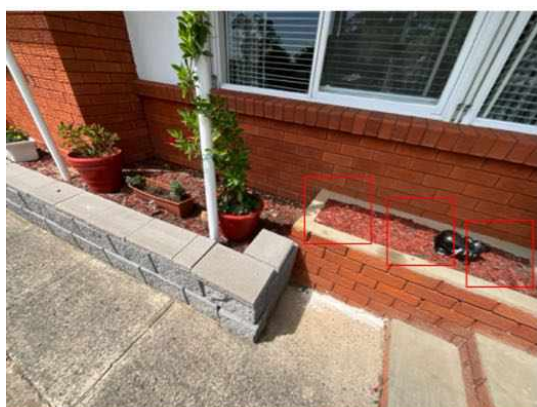
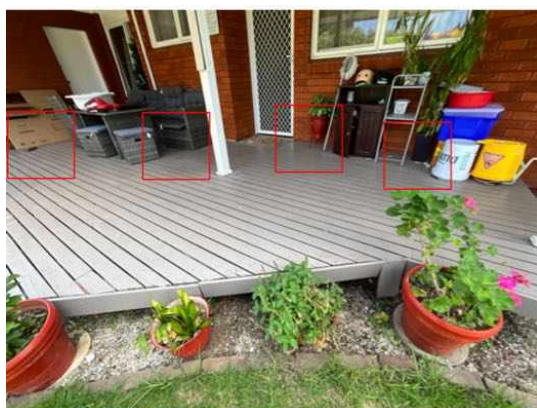
### Finding 6.03

Building:	Main Building
Location:	Multiple areas
Finding:	Bridging or breaching of termite barriers - damp course level
Information:	Bridging is the spanning of a termite barrier or inspection zone so that subterranean termites are provided with passage over or around that barrier.

Such conditions attract termites into these damp areas which is likely to lead to infestation if left untreated.

While retrospective fitting of DPC is considered to be impractical works are required in order to prevent the extraction of moisture from the external environment into exterior brickwork or wall materials. Landscaping or re-paving of external grounds may be considered by the client. Regular annual inspections are strongly advised.

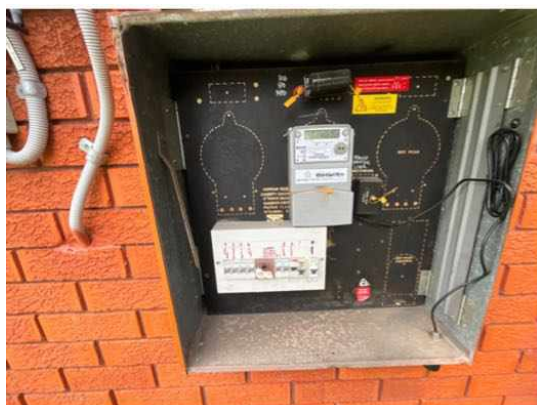
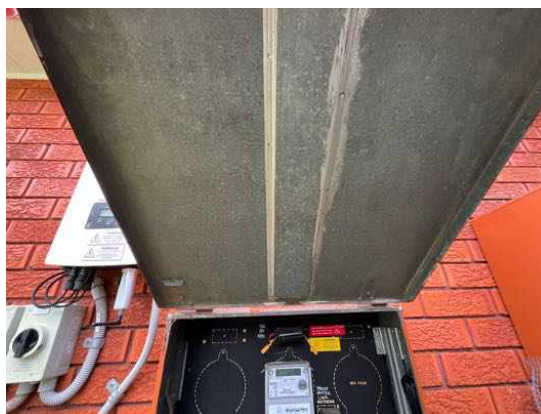
#### Finding 6.04

Building:	Main Building
Location:	Meterbox
Finding:	Termite Management System - no evidence of installation
Information:	The application of a post-construction chemical termite barrier is highly recommended for all properties, particularly if live termite activity has been found on the site previously. Such barriers are highly effective in preventing termite attack on any timber building elements throughout the property.

barriers. At the time of inspection, it appeared as though no termite management system has been installed, with no evidence to suggest preventative works taking place.

The client may consider gaining further advice from a pest controller as to the costs and procedures involved with this application. It is recommended that obtaining such advice be a short-term priority.

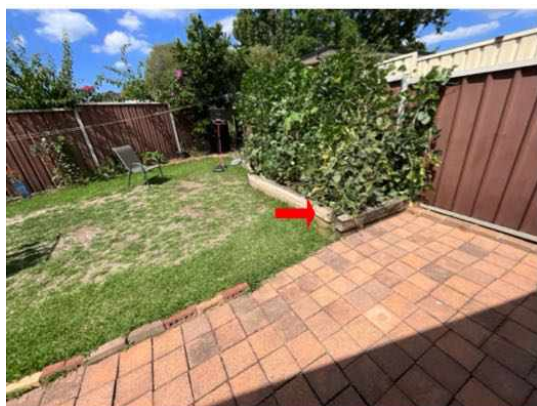
### Finding 6.05

Building:	Main Building
Location:	Fencing & Landscaping
Finding:	Building materials in direct ground contact - conducive to termites
Information:	Where timber elements are in direct contact with the ground and consequently moisture or dampness they become conducive to termite activity. Whether timber is used as a building element part of a fencing structure or stored as an unused item they can provide an environment that is attractive to termite infestation.

When met with excessive moisture timber begins to decay and develop wood rot. Any timbers that are in direct contact with external grounds especially if left untreated or non-durable also provide ingress for subterranean termites into that particular element.

The removal of any such materials that may be conducive to termite activity should be removed as soon as possible to minimise the risk of termite attack.

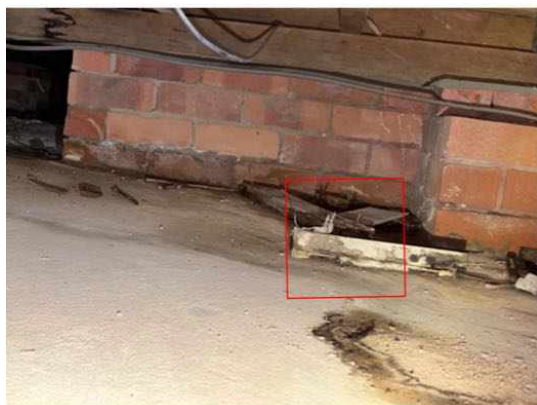
### Finding 6.06

Building:	Main Building
Location:	Subfloor
Finding:	Stored timbers - subfloor space or external area
Information:	The storing of timbers in the subfloor space or around the external property increases the risk of termite activity being present. As they are likely to come into contact with weather conditions or excessive moisture wood rot is likely to develop on timbers that are not treated.

It is highly recommended that any stored timbers be immediately removed from areas in which they may attract any termite / timber pest attack. Minimisation of risk / prevention of termite attack is far more adequate than dealing with the presence of termite activity.

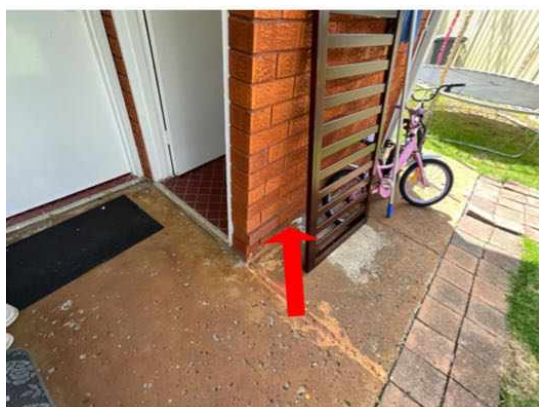
### Finding 6.07

Building:	Main Building
Location:	External toilet
Finding:	Slab Edge - Exposure
Information:	Slab Edge Exposure: Where external concrete slab edges are not exposed there is a high risk of concealed termite entry. In some buildings built since July 1995 the edge of the slab forms part of the termite shield system. In these buildings an inspection

zone of at least 75mm should be maintained to permit detection of termite entry. The concrete edge should not be concealed by render, tiles, cladding, flashings, adjoining structures, paving, soil, turf or landscaping etc. Where this is the case you should arrange to have the slab edge exposed for inspection. Concealed termite entry may already be taking place but could not be detected at the time of the inspection. This may have resulted in concealed timber damage. Does the slab edge inspection zone fully comply?

Not able to comment. A very high proportion of termite attacks are over the edge of both Infill and other concrete slabs types. Covering the edge of a concrete slab makes concealed termite entry easy. Infill slab type construction has an even higher risk of concealed termite ingress as the slab edge is concealed due to the construction design and cannot be exposed. The type of slab may only be determined by assessment of the construction plans by a qualified person e.g. Builder, Architect. Construction Plans may be obtainable by your local Council or Builder. Termite activity and or damage may be present in concealed timbers of the building. We strongly recommend frequent regular inspections in accordance with AS 3660.2. Where the slab edge is not fully exposed or the slab is an infill slab or the slab type cannot be determined then we strongly recommend inspections every 3 to 6 months in accordance with AS 3660.2 or AS 4349.3.
