Building and Timber Pest Inspection Report

Inspection Date: Sat, 7 Mar 2026

Property Address: 11 Ellerstone Ct, Kellyville NSW 2155,
Australia

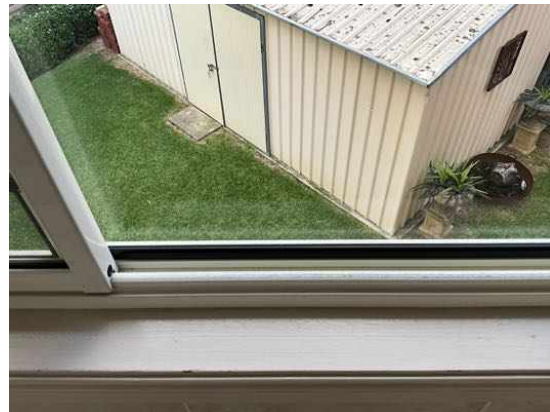
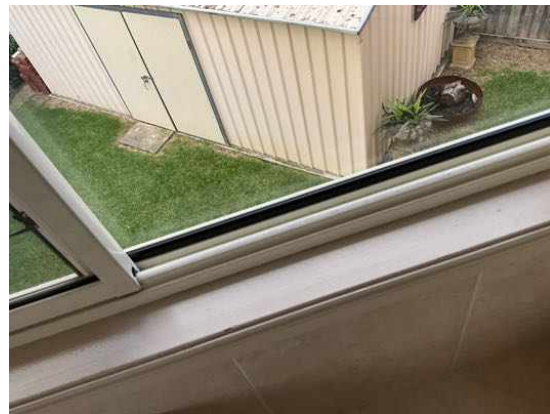
Building:	Main Building
Location:	All Areas
Finding:	Window child lock missing
Information:	The window in question lacks a child lock mechanism, which poses a potential safety risk to young occupants in the premises. As per Australian Standards windows

accessible to children should be equipped with appropriate child safety locks to prevent accidental opening, reducing the risk of falls and ensuring compliance with safety regulations.

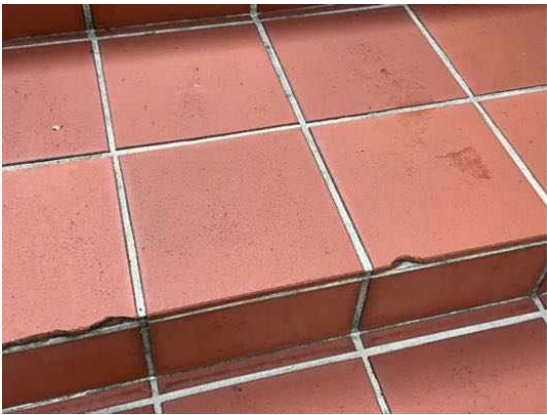
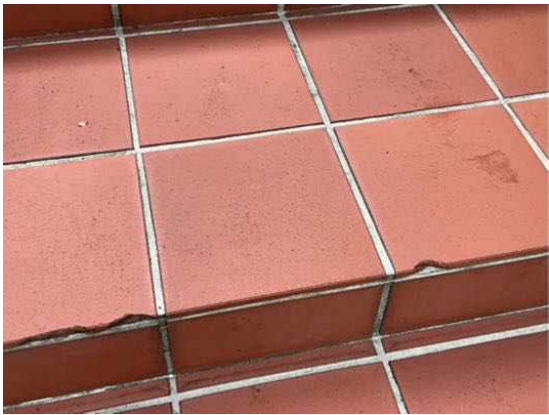
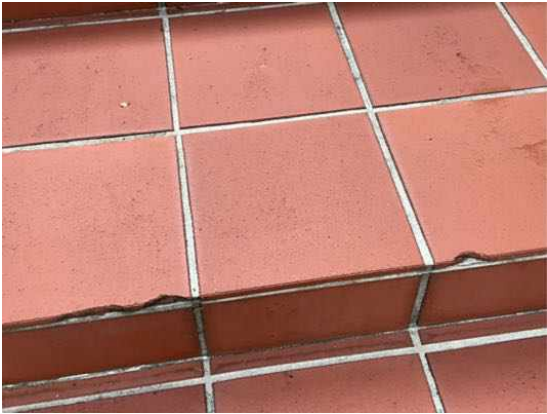
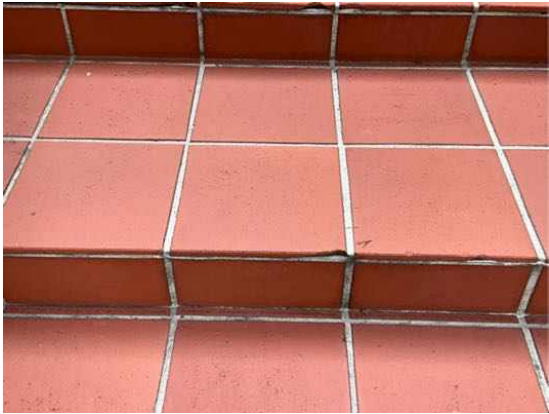
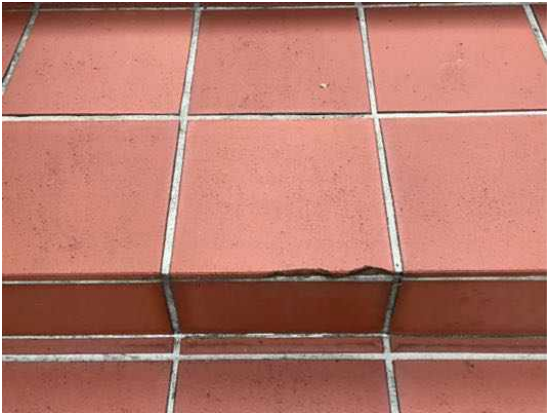
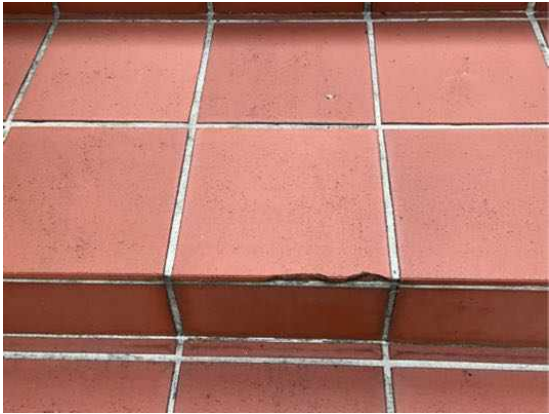
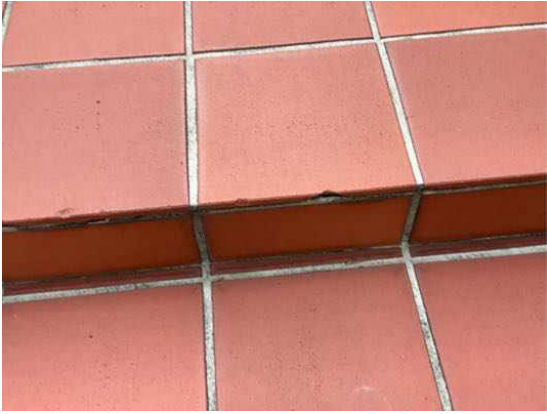
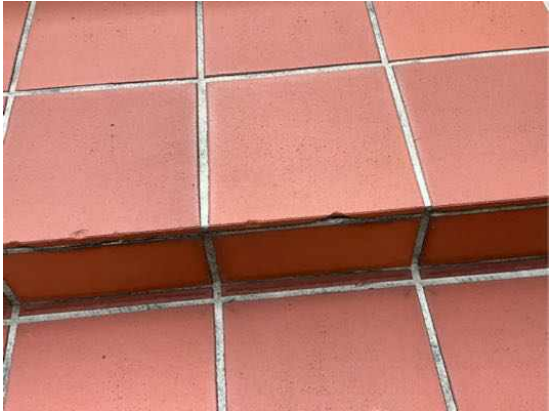
Building: Main Building
 Location: Yard - Front
 Finding: Floor Tile crack
 Information: A floor tile has a visible crack on the surface.

The damaged tile presents a trip hazard, may lead to cuts if stepped on barefoot, and can allow moisture ingress into the substrate, which may cause further deterioration or loosening of adjacent tiles. It also affects the overall appearance of the floor.

A licensed tiler should be engaged to remove the damaged tile and install a matching replacement. If spare tiles are unavailable, additional remedial work may be required to blend the repair with surrounding finishes.

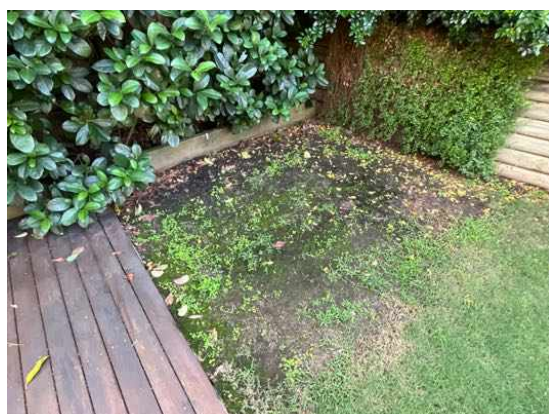
Pooling water around can create a slip hazard in extreme cases and create conditions that are conducive to mould growth over time. Where left unmanaged, the degradation is likely to occur, possibly necessitating further repair works.

Remedial works may involve some sections of repairs . A licensed builder or specialist should be appointed to provide further advice on reparation options and to perform works as necessary.

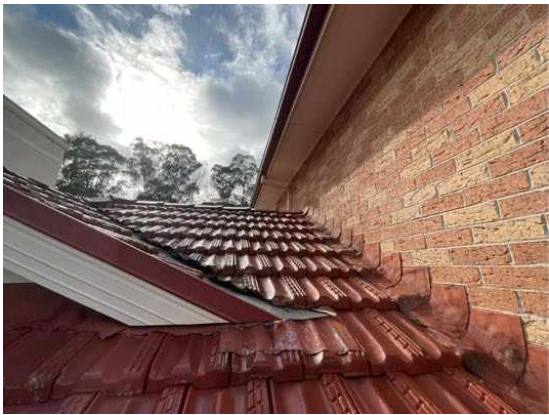
Information: Inspection of the roof revealed widespread weathering to the tiled roof surface. The tiles show loss of surface finish, colour fading, and age-related deterioration typical of older roof coverings. Although no significant cracking was noted, weathering can lead to increased porosity, reduced water-shedding capability, and a higher risk of future cracking or displacement during adverse weather conditions.

A licensed roofer should be engaged to undertake a closer inspection, carry out routine maintenance, and replace any tiles that may be compromised. Ongoing monitoring is recommended due to the age and condition of the roof covering.

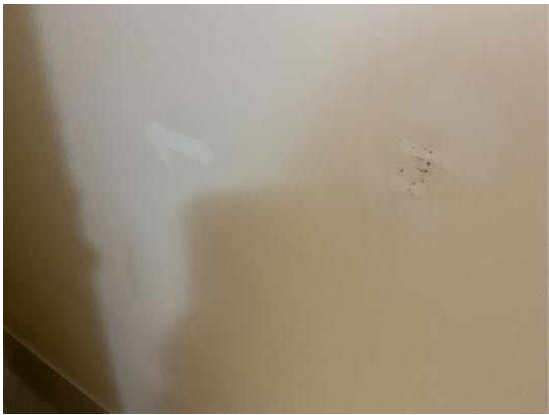
1. Aesthetic Degradation: Scratches mar the appearance of the painted surface, diminishing its visual appeal and potentially lowering property value.
2. Corrosion Vulnerability: Exposed areas of bare metal due to scratched paint are susceptible to corrosion, leading to structural damage and compromised durability.
3. Environmental Hazards: Scratched paint can release hazardous chemicals into the environment, posing risks to both human health and the ecosystem.

A qualified painter should address the issue promptly to repair the scratched paint. Depending on the severity of the scratches, repair options may include sanding, priming, and repainting the affected area to restore the integrity and appearance of the paint surface.

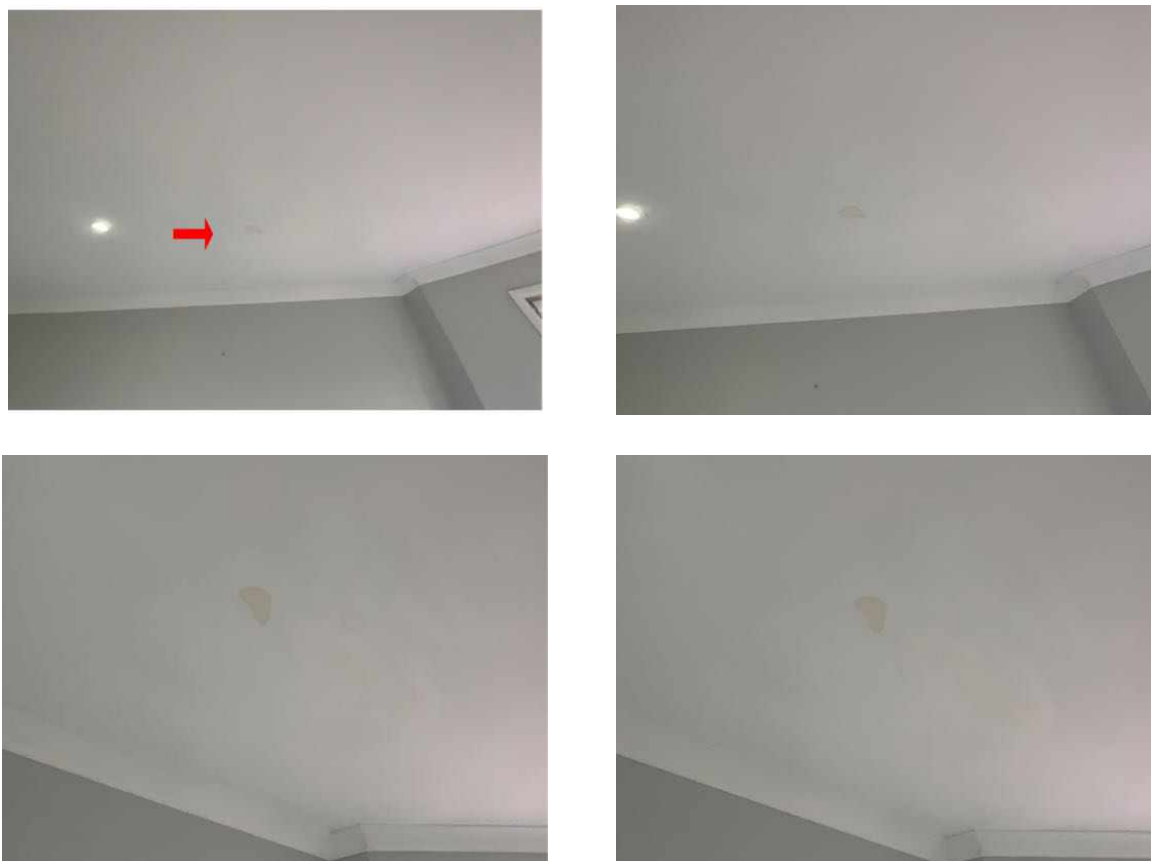
Building: Main Building
Location: All Areas
Finding: Water staining
Information:

Water staining was evident in this area at the time of inspection. Water staining indicates that surfaces have been exposed to excessive moisture over time. The minerals and other elements in the water lead to staining, which may graduate to corrosion and deterioration if left unmanaged.

While mostly an appearance defect, water staining can be indicative of more serious defects, which may be currently concealed by other building elements.

Where water staining is active, a licensed plumber must be consulted to identify the cause of the staining and to provide advice on any reparation works that may be required. Replacement of any broken or damaged structures is advised.

Conversely, where water staining is old and inactive, affected building materials may be repaired or replaced at client discretion. A qualified carpenter or registered builder may be appointed to perform these works.

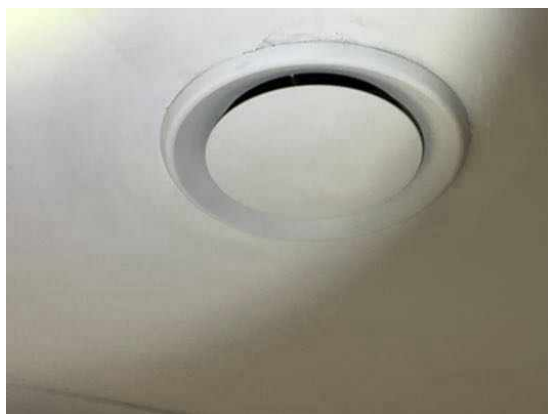
Building:	Main Building
Location:	All Areas
Finding:	Condensation stains near vents
Information:	Condensation stains near vents in a roof cavity can indicate potential moisture issues that, if not addressed, could lead to mold growth, structural damage, and decreased insulation effectiveness. Here are the risks and steps to fix it:

1. ****Mold Growth****: Persistent moisture can create an environment conducive to mold growth, which can affect indoor air quality and cause health problems.
2. ****Structural Damage****: Over time, moisture can weaken the wooden structure, leading to rot and compromised structural integrity.

3. **Insulation Damage**: Moisture can reduce the effectiveness of insulation, leading to higher energy costs and reduced comfort.

1. **Identify the Source**: Determine where the moisture is coming from. This could be due to poor ventilation, leaks in the roof, or condensation from HVAC ducts.
2. **Improve Ventilation**: Ensure that the attic or roof cavity is well-ventilated. This can be done by installing additional vents or improving existing ones.
3. **Seal Ducts**: Make sure HVAC ducts are properly sealed to prevent condensation from forming on their surfaces.
4. **Insulate Ducts**: Insulating ducts can reduce the temperature difference between the air inside the duct and the surrounding air, which can reduce condensation.
5. **Check for Leaks**: Inspect the roof and any penetrations (e.g., vents, chimneys) for leaks and repair as needed.

1. **Roofing Contractors**: For leaks and structural issues in the roof.
2. **HVAC Professionals**: For duct insulation and sealing issues.
3. **Insulation Specialists**: For improving attic or roof cavity insulation.
4. **General Contractors**: For overall assessment and coordination of different repairs.

It's recommended to have a professional inspect the area to determine the exact cause and scope of the issue. They can provide specific recommendations and solutions based on the condition observed.

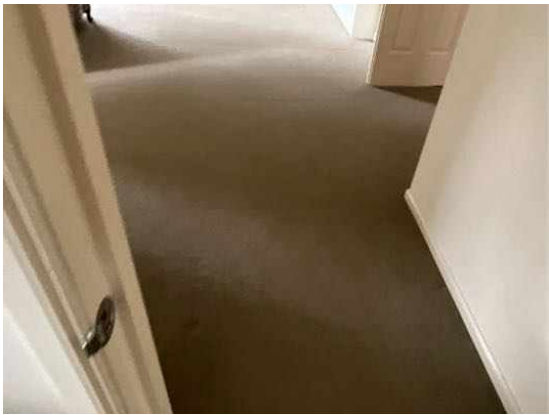
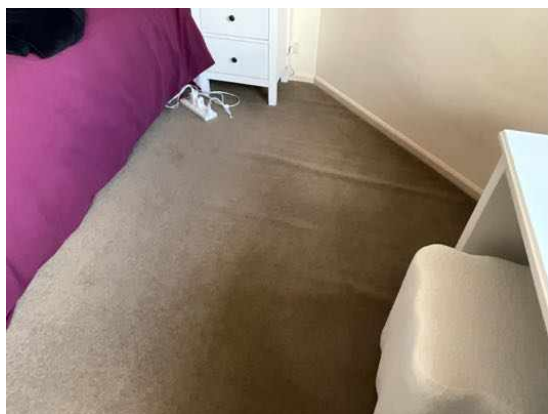
Building:	Main Building
Location:	All Areas
Finding:	carpet exhibits visible signs of aging
Information:	Carpets are exhibiting visible signs of aging, including fraying edges, faded colors, and flattened fibers, diminishing their aesthetic appeal and functional quality.
Risk:	The risk associated with aging carpets includes diminished appearance, decreased comfort, potential tripping hazards due to frayed edges, and a negative impact on indoor air quality if fibers begin to degrade and release particles into the air.
Who can fix it:	Professional carpet cleaning and restoration services can address issues such as deep cleaning to rejuvenate colors, repairing frayed edges, and restoring fibers. Additionally, replacing the carpets entirely may be necessary in severe cases of aging or damage beyond repair.

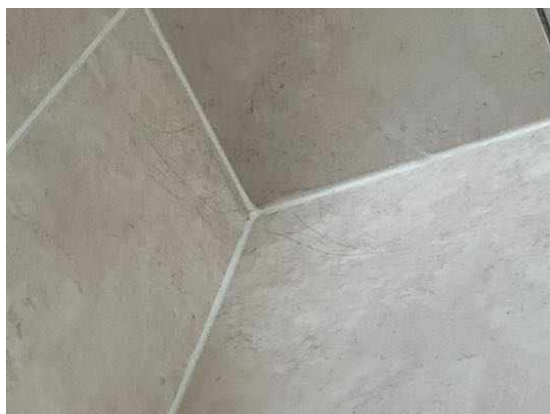
Information: Visible surface scratches were observed, While this is primarily a cosmetic defect, it can negatively impact the visual appeal and reduce the durability of the tile glaze over time.

A qualified tiler or handyman should assess the extent of the damage. Minor scratches may be polished or concealed with appropriate tile repair products, while deeper scratches may require tile replacement to restore the original finish.

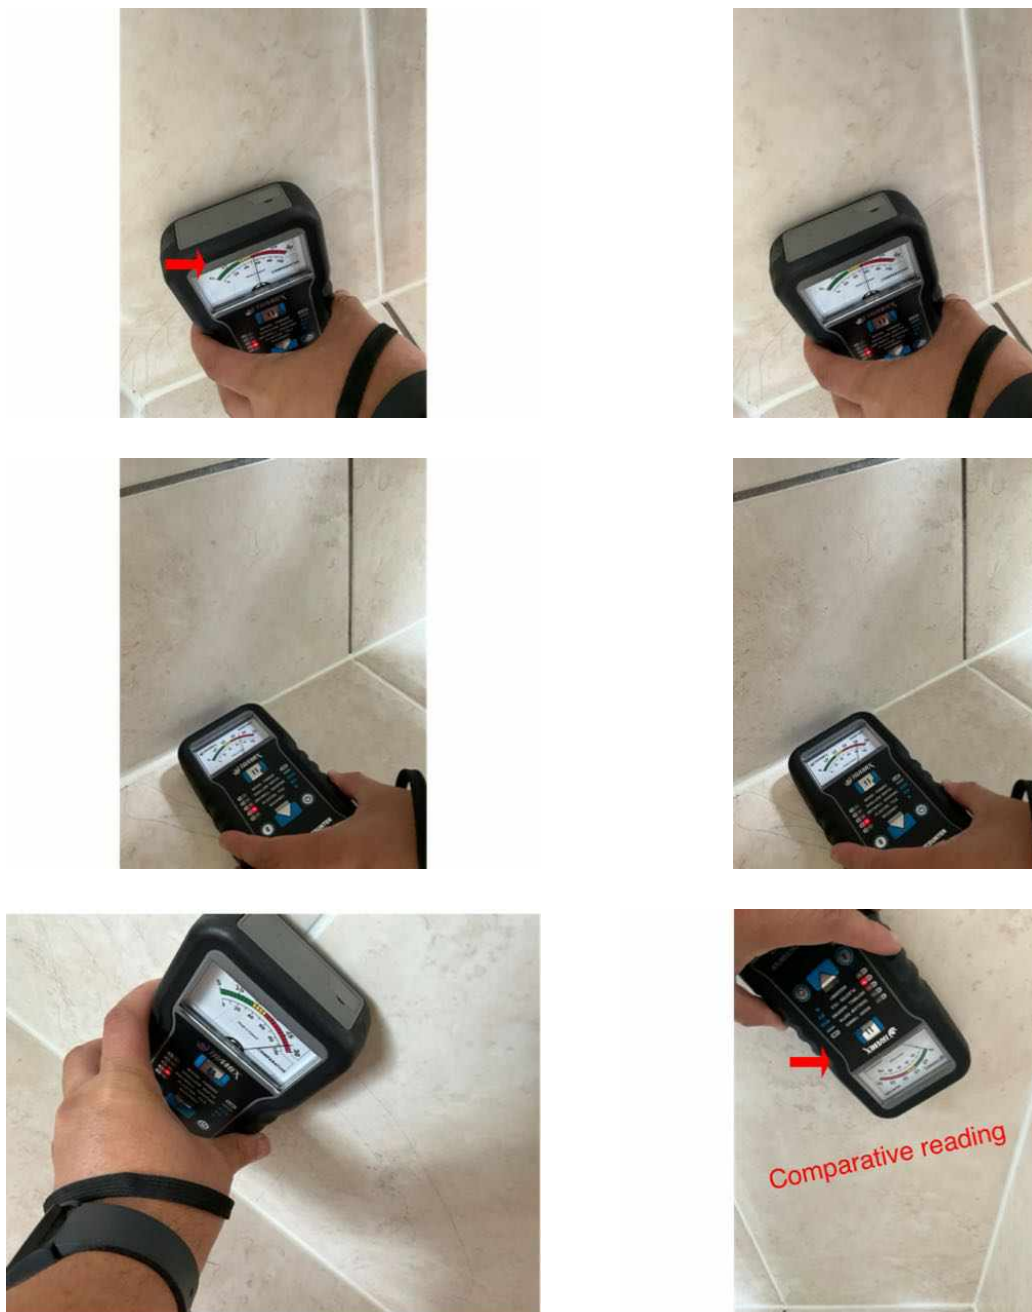
Building:	Main Building
Location:	Ensuite
Finding:	Shower - Damp
Information:	Damp is evident to the lower 300mm of wall to the shower alcove. This defect is quite common, and is suspected to have been caused by moisture permeating through the grouting in this area, which shows evidence of deterioration. Leaking pipes within the adjoining wall is also a possible cause.

Damp (or structural damp) refers to the presence of unwanted moisture in the structure of a building, either as the result of intrusion from outside, or condensation from within the structure. In the shower area, internal water leaks or other sources of excessive moisture are generally the cause of damp.

Unmanaged damp in the shower recess is likely to facilitate the formation and development of mould and fungi growth, decaying associated building materials and compromising their structural integrity. It is important to address damp conditions, as the World Health Organisation notes that excess moisture leads - on almost all indoor materials - to growth of microbes such as moulds, fungi and bacteria, which subsequently emit spores and other matter into the indoor air. Exposure to these contaminants is associated with a wide range of respiratory and other health-related problems.

Consultation with a qualified plumber or bathroom specialist is advised immediately to identify the cause of damp and to perform remedial works as required. Where excessive mould growth is present, further inspection by a specialist environmental health inspector should also be considered.

Always ensure that sealant and grout is in good condition to prevent any moisture issues occurring in the future.

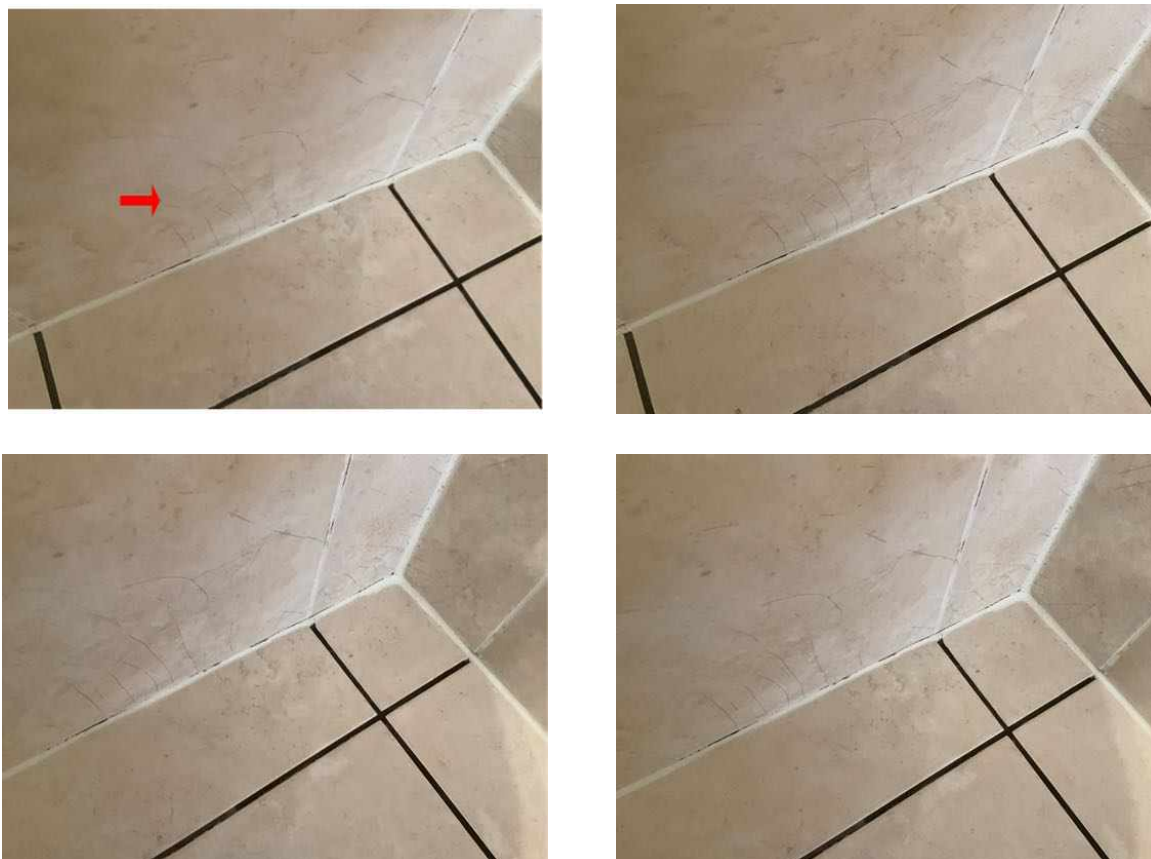
Information: Visible surface scratches were observed, While this is primarily a cosmetic defect, it can negatively impact the visual appeal and reduce the durability of the tile glaze over time.

A qualified tiler or handyman should assess the extent of the damage. Minor scratches may be polished or concealed with appropriate tile repair products, while deeper scratches may require tile replacement to restore the original finish.

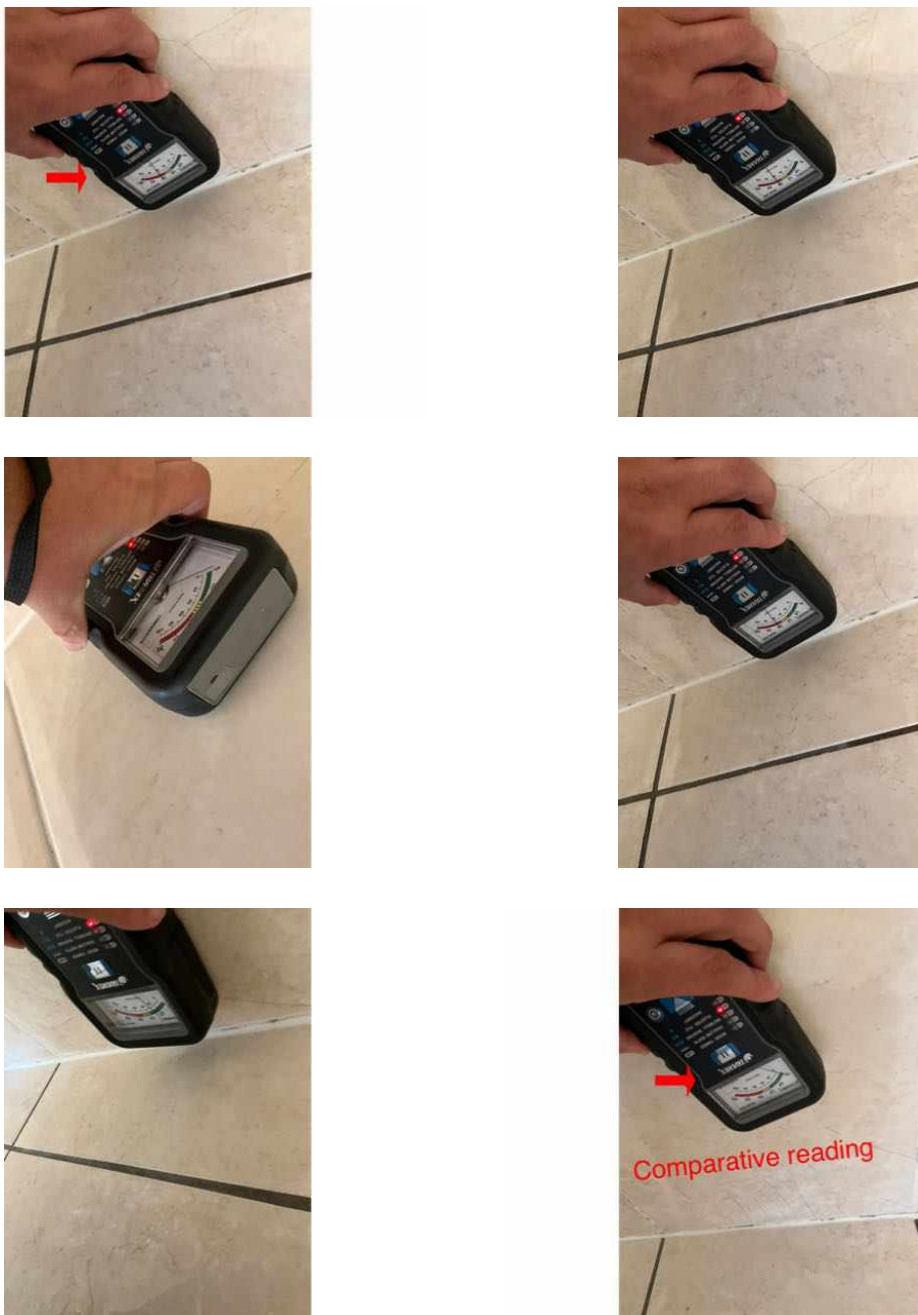
Building:	Main Building
Location:	Bathroom
Finding:	Shower - Damp
Information:	Damp is evident to the lower 300mm of wall to the shower alcove. This defect is quite common, and is suspected to have been caused by moisture permeating through the grouting in this area, which shows evidence of deterioration. Leaking pipes within the adjoining wall is also a possible cause.

Damp (or structural damp) refers to the presence of unwanted moisture in the structure of a building, either as the result of intrusion from outside, or condensation from within the structure. In the shower area, internal water leaks or other sources of excessive moisture are generally the cause of damp.

Consultation with a qualified plumber or bathroom specialist is advised immediately to identify the cause of damp and to perform remedial works as required. Where excessive mould growth is present, further inspection by a specialist environmental health inspector should also be considered.

Always ensure that sealant and grout is in good condition to prevent any moisture issues occurring in the future.

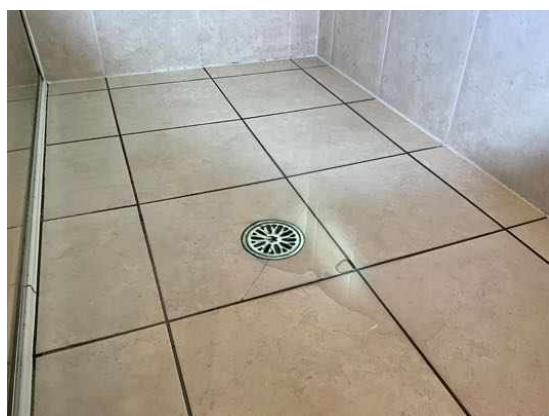
This pooling is minor overall but is still considered unsatisfactory, as standard tiling practices would not permit this situation to occur. Pooling water around floor wastes can create a slip hazard in extreme cases and create conditions that are conducive to mould growth over time. Where left unmanaged, the degradation of sealant and grouting is also likely to occur, possibly necessitating further repair works.

Remedial works may involve some sections of tiling and flooring repair and replacement. A tiling contractor or bathroom specialist should be appointed to provide further advice on reparation options and to perform works as necessary.

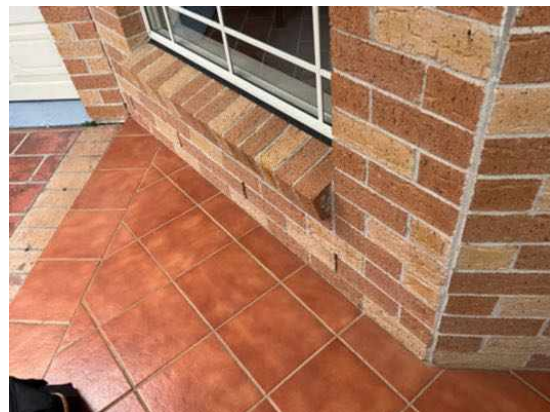
If the slab edge is not properly exposed there is a high risk of termite attack. Sometimes, in order to determine the type of slab, a suitably qualified person such as an architect or builder may be required to consult the construction plans.

Where the slab edge cannot be properly inspected, it is highly recommended that termite or timber pest inspections be carried out every 6-12 months to aid protection of the property against infestation.

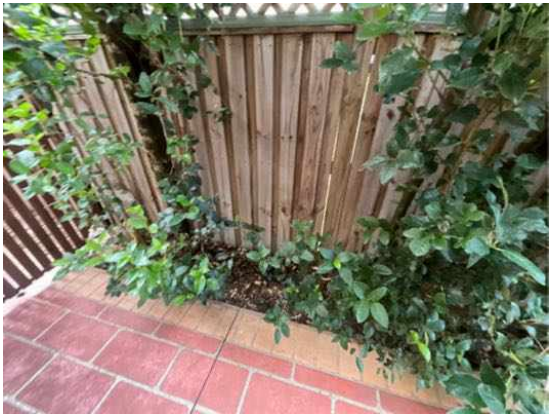
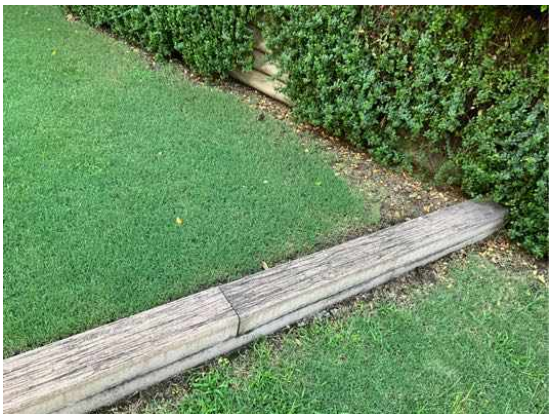
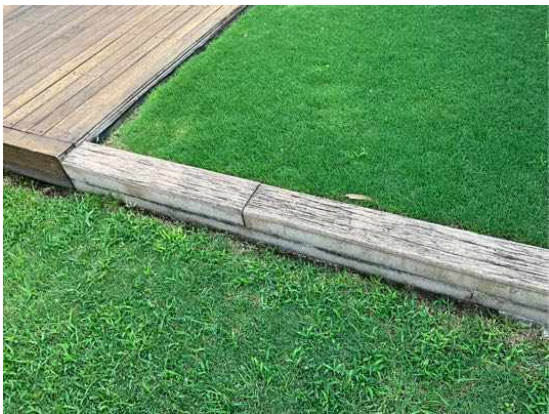
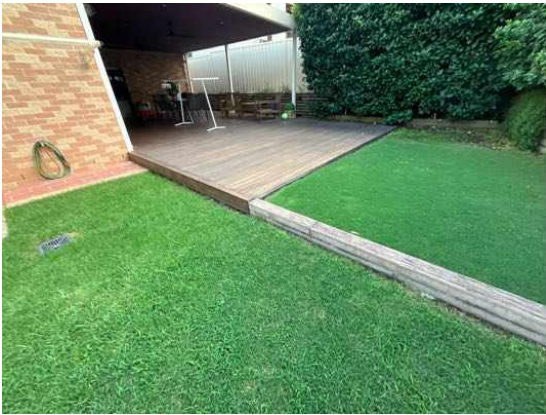
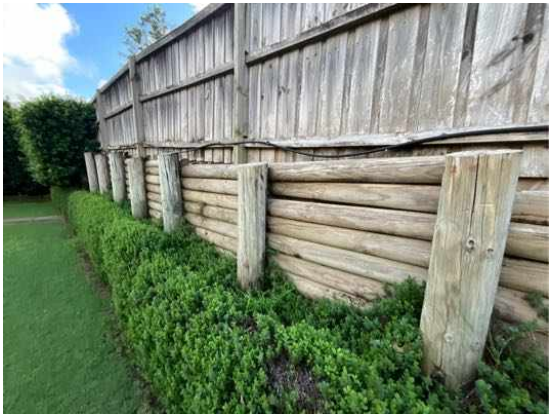
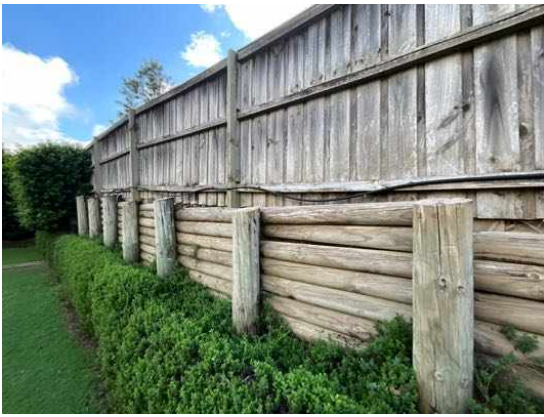
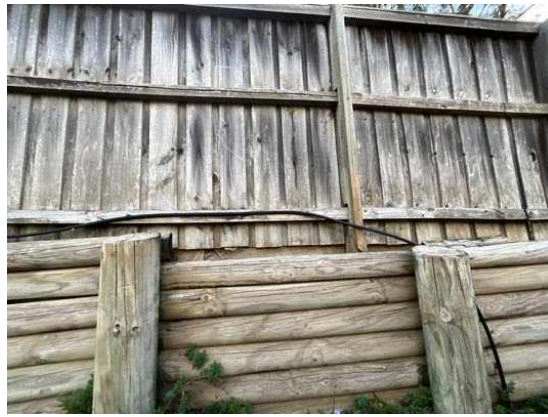
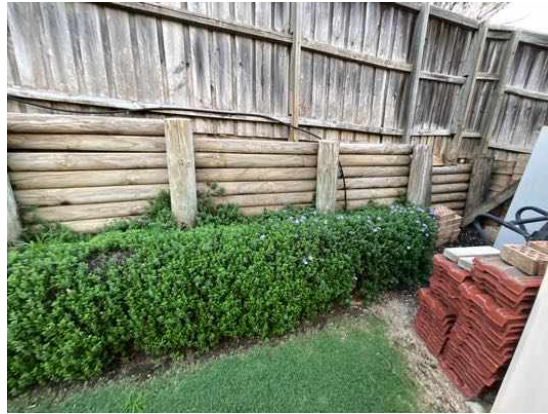
Building:	Main Building
Location:	All Areas
Finding:	Timber on ground / conducive conditions to termite damage
Information:	Timber on the ground is indeed conducive to termite damage. Termites are known to thrive in moist environments, and wood in contact with soil or moisture is more susceptible to infestation.

To prevent this, it's important to keep timber elevated and away from direct ground contact. Regular inspections and proper termite control measures are also essential to protect your wooden structures from termite damage.

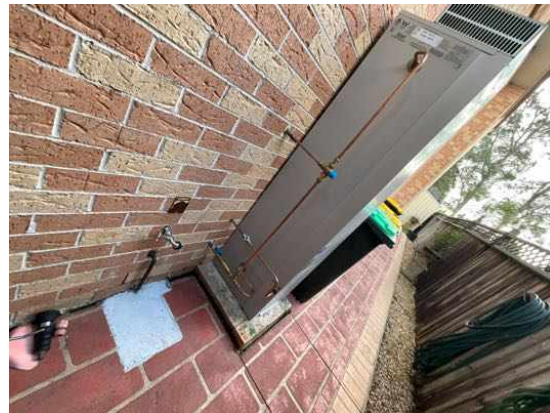
Building:	Main Building
Location:	All Areas
Finding:	Bridging or Obstruction Conducive environment for Termites
Information:	Bridging of termite barriers occurs when termites bridge (usually by building a mud tunnel) a termite barrier or inspection zone or where termites have a passage, allowing them to bridge the barrier.

property in a concealed or undetected manner.

Recommended moving obstructions away from the external walls for further and future inspections.

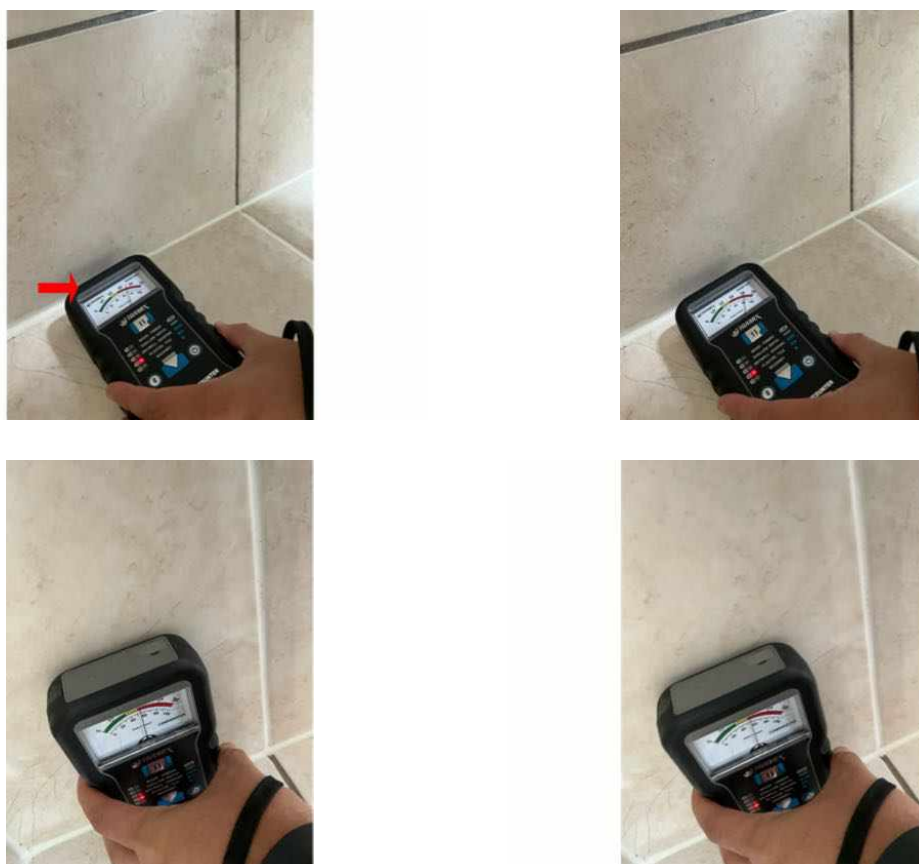
If mould growth has been found there may be environmental biological or health issues involved. In these cases an appropriately qualified inspector should also be contacted.

Prior to any remedial works being performed a qualified plumber should be appointed to further inspect the property and to identify the cause of the excessive moisture. Works to remove affected building elements may then be necessary and should be performed by an appropriate tradesperson.

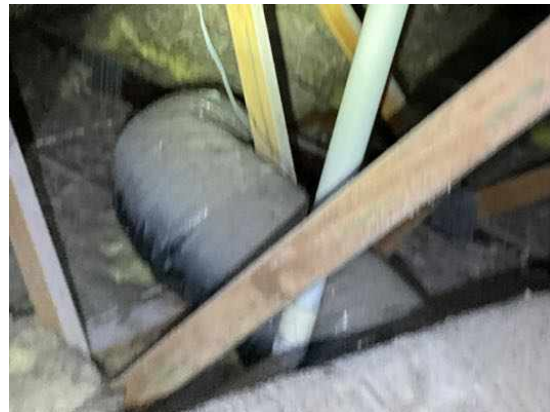
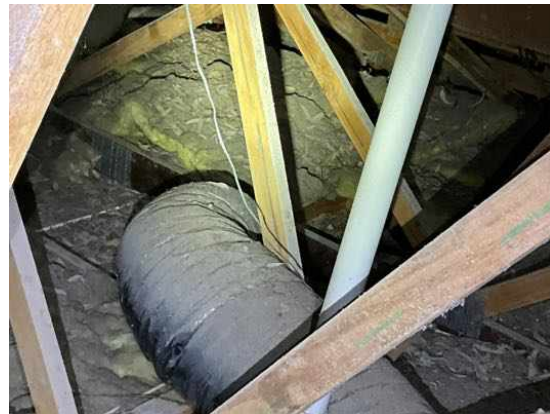
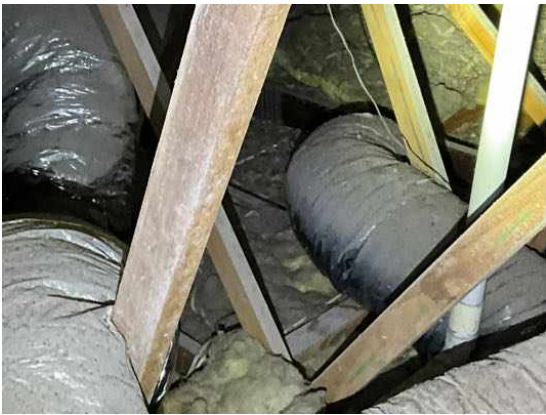
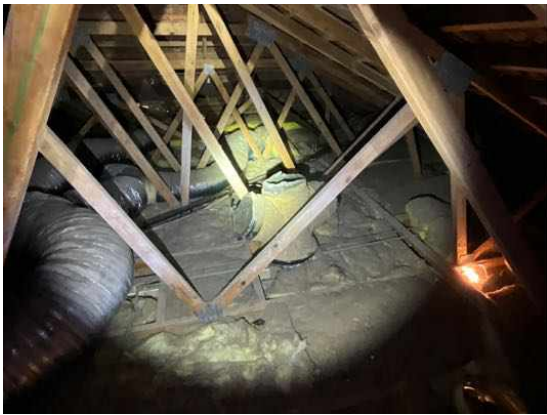
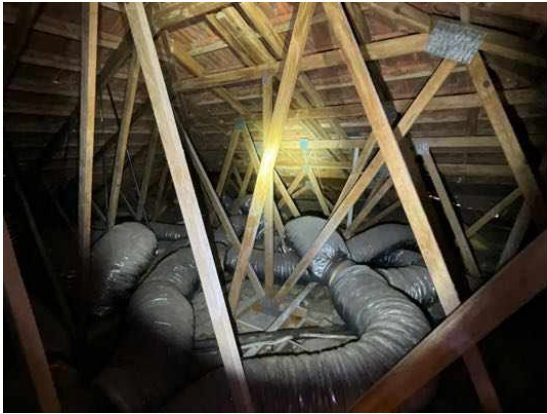
Building: Main Building
Location: All Areas
Finding: Additional Photos - Obstructions and Limitations
Information: These photographs are an indication of the obstructions and limitations which impeded full inspection of the property at the time of inspection. These obstructions can hide an array of defects and should be removed to allow full inspection to be carried out. A re-inspection is recommended once the areas are made accessible.
