# Building and Timber Pest Inspection Report

Inspection Date: Fri, 23 Jan 2026

Property Address: 20 Onslow St, Nerang QLD 4211, Australia

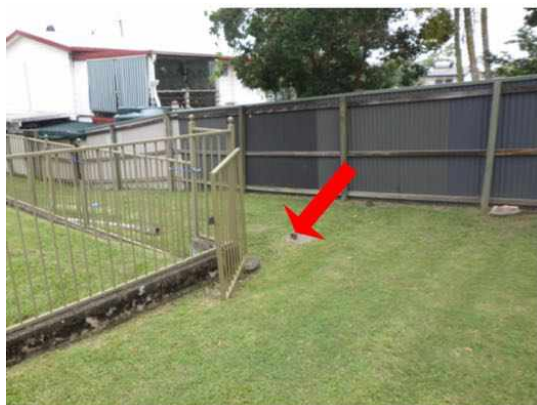
Building: Main Building  
 Location: Yard - Back > Centre Left  
 Finding: Exposed - Sharp Metal  
 Information: At the time of inspection it was noted there was exposed sharp box section metal protruding above the finished ground surface at the rear of the property.

It appears the box section metal may be from a previously removed fixtures or fittings.

A licensed carpenter or general handyman could be engaged to cut the metal below surface level and or fit protective cover plates.

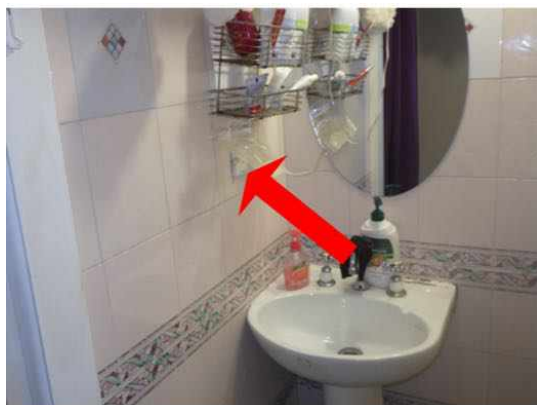
### Finding 1.03

Building: Main Building  
 Location: Bathroom 2 > Front Left  
 Finding: Electrical switch exposed  
 Information: An exposed electrical switch was observed in the ground floor bathroom area. Exposed electrical switches in bathroom or wet areas represent a potential safety hazard including for personal contact.

A licensed electrician should be engaged as a matter of priority to confirm the electrical switch as compliant with electrical installation regulations.

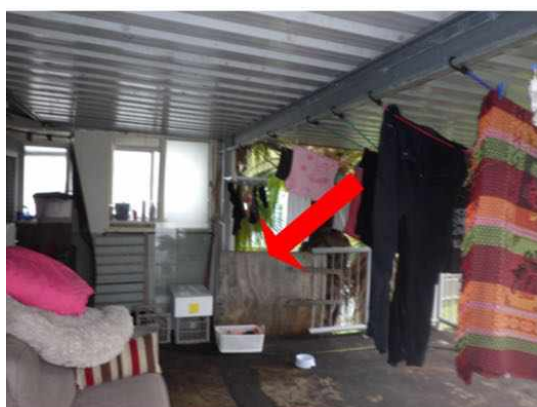
## Finding 1.04

Building:	Main Building
Location:	Alfresco > Centre Left
Finding:	Balustrade - Deteriorated
Information:	It was noted at the time of inspection that sections of the balustrade to the alfresco area show signs of rudimentary repair or have deteriorated. Typically balustrading deteriorates due to age and or wear, rot and or rust which is generally expected for a structure of this age, due to prolonged exposure to weather conditions. Sometimes inadequate installation or maintenance can be to blame.

A licensed carpenter could be appointed to perform rectification works as necessary.

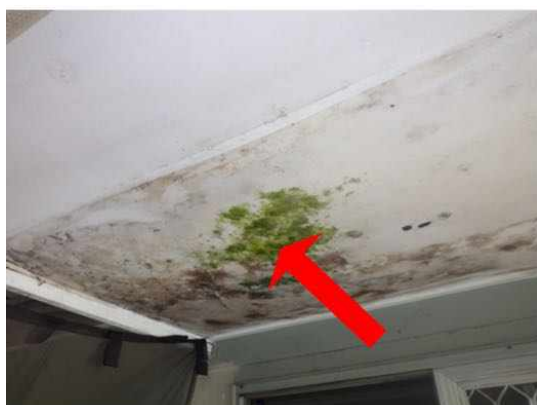
Building: Main Building  
 Location: Laundry > Front  
 Finding: Ceiling - Water damaged  
 Information: At the time of inspection there was water staining and mould growth to the upper level laundry area ceiling linings.

Water damage to the ceiling lining is generally an indication of excessive moisture being present in the roof void, usually via a leak to the roof covering.

Where water damage is evident to the ceiling, the primary requirement is to identify and rectify the source of the leak. A roofing plumber should be appointed as soon as

possible to identify the leak and perform rectification works as necessary, ensuring the water damage is restricted.

Once the leak is repaired, consultation with relevant tradespeople, including plasterers and painters, is advised. Rectification works may include replacement of ceiling lining or minor repainting, depending on the extent of the damage.

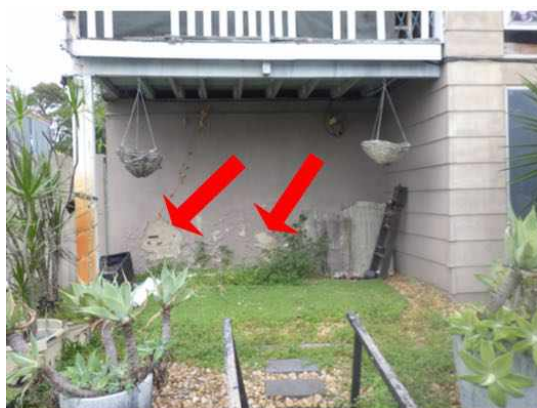
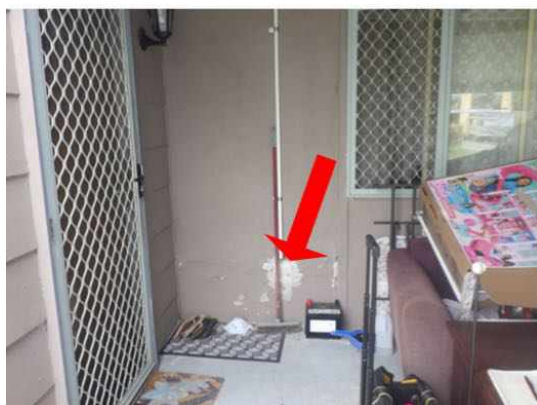
Building: Main Building  
 Location: Exterior walls - front > Front Left, Centre  
 Finding: Render Damaged  
 Information: At the time of inspection it was noted that there was chipped and broken render areas to the brick walls at the front of the property.

The chipped or broken render appears consistent with impact damage and/or exposure to moisture.

A qualified solid plasterer should be engaged to undertake repair work as required.

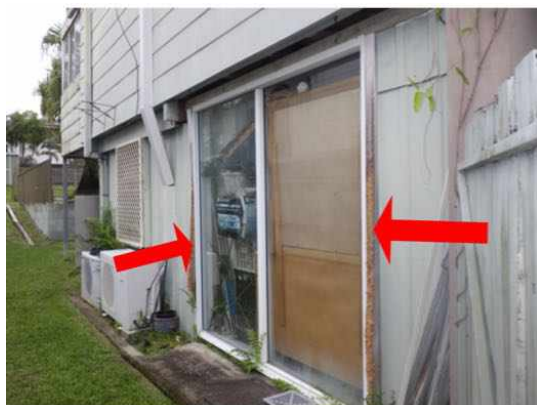
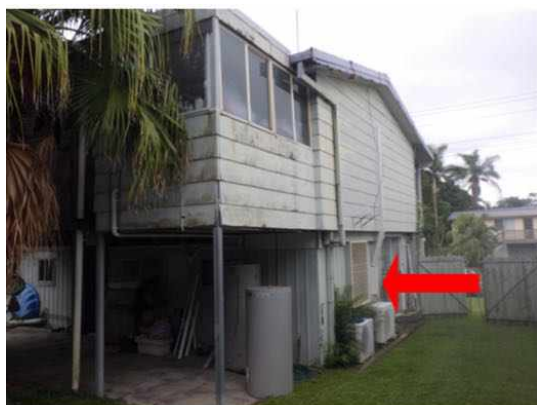
### Finding 3.04

Building: Main Building  
 Location: Exterior walls - left side > Centre Left  
 Finding: Wood Rot  
 Information: At the time of inspection an area of the MDF timber facing board to the exterior wall cladding showed signs significant deterioration or wood rot. The wood rot /damage appears to be caused from excessive moisture and/or unsuitable building materials.

The client could engage a qualified carpenter or general handyman to undertake repair work.

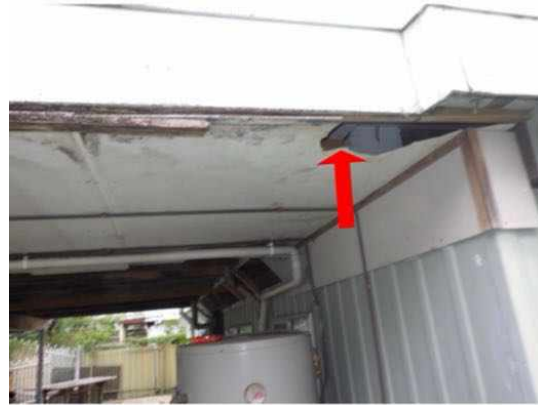
### Finding 3.05

Finding: Eaves - Damaged

Information: At the time of inspection the eaves around the exterior property were found to have suffered deterioration, damage and/or have been affected by surface mould in a number of areas (as per example photos). The damage may have been sustained as a result of a number of possible causes, including poor roof drainage, leaking roof plumbing or minor impact damage.

The damage and surface mould to the eave sheathing in these areas detracts from the appearance of the structure.

Where eaves show moderate to severe damage, remedial works may be required. Where water damage is suspected as being the underlying cause, appointment of a licensed plumber is advised as a matter of urgency to identify the source of the water leak.

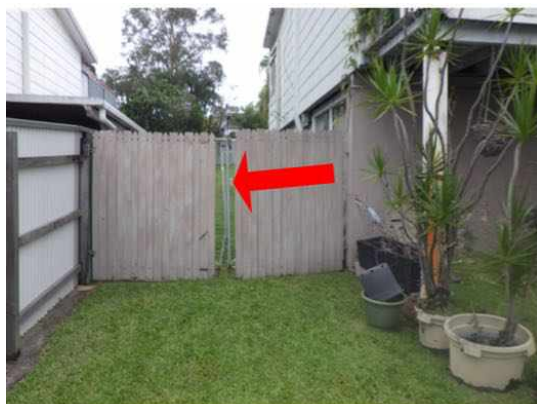
### Finding 3.06

Building: Main Building  
 Location: Yard > Existing  
 Finding: Fencing - Deteriorated  
 Information: It was noted at the time of inspection that sections of the fencing and gates to the front left and right side of the property have deteriorated (as per example photos). Typically fencing deteriorates due to age and or wear, rot and or rust which is generally expected for a structure of this age, due to prolonged exposure to weather conditions. Sometimes inadequate installation or maintenance can be to blame.

If left unattended, it is likely that further damage will occur. It is suspected that repair of several elements of the fencing may be required however replacement may be a

A licensed fencing contractor should be appointed to provide further advice and perform rectification works as necessary.

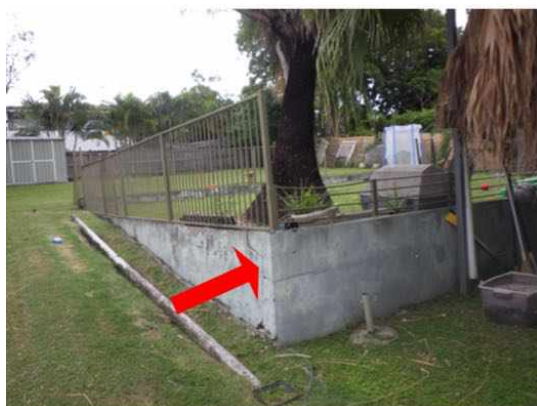
### Finding 3.07

Building:	Main Building
Location:	Yard - Back > Centre
Finding:	Retaining wall - Deteriorated
Information:	The rendered brick retaining wall to the rear of the property showed evidence of cracking and movement at the time of inspection. The level of cracking is considered category 2 - 3 which will require repair.

Deteriorated retaining walls may be a result of substandard construction, poor site drainage or unmanaged stormwater flows.

A licensed brick layer or brick retaining wall installer could be appointed to repair or replace the wall, at the discretion of the client.

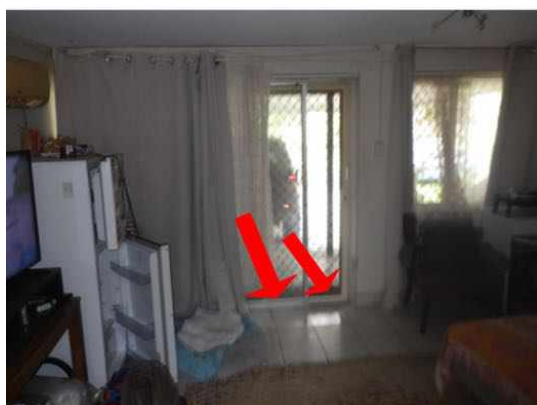
### Finding 3.08

Building:	Main Building
Location:	Utilities Room 1 > Front
Finding:	Door - Stiff to slide
Information:	The aluminium sliding door and security screen door to the ground floor utilities room 1 area were stiff to open and difficult to operate at the time of the inspection. Doors provide ventilation to the adjoining area and should be at a fully operational level to ensure user comfort. Restricted function of the door may also pose as a potential safety hazard if required for emergency egress from the building.

Generally, factors such as general age of the building element and a lack of maintenance are the usual causes for this type of defect.

An aluminium sliding door service agent will be required to repair the affected doors.

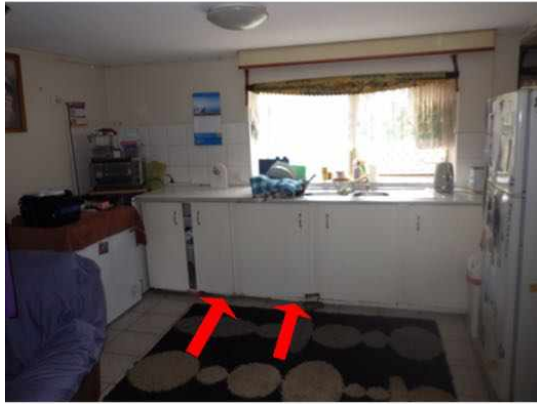
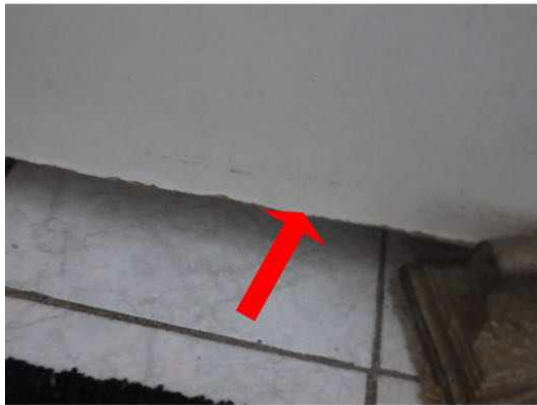
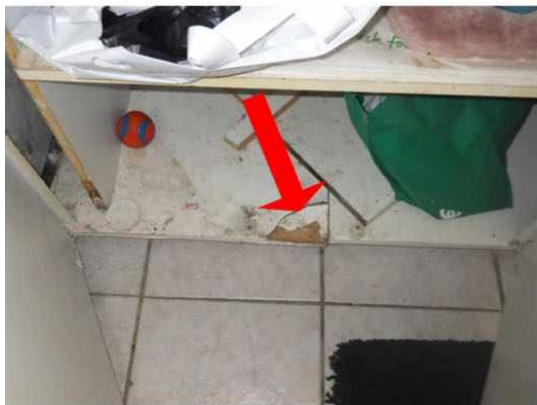
### Finding 3.09

Building:	Main Building
Location:	Kitchenette > Existing
Finding:	Cabinetry - Deterioration
Information:	At the time of inspection the kitchenette cabinetry showed signs of deterioration. The level of damage appears consistent with exposure to moisture or general wear and

tear.

A qualified cabinet maker or general handyman could be engaged to undertake repair works at the clients discretion.

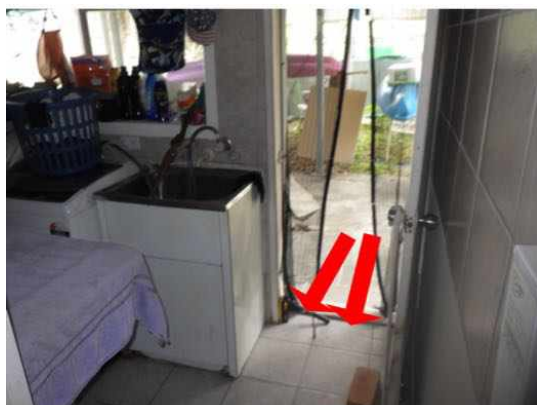
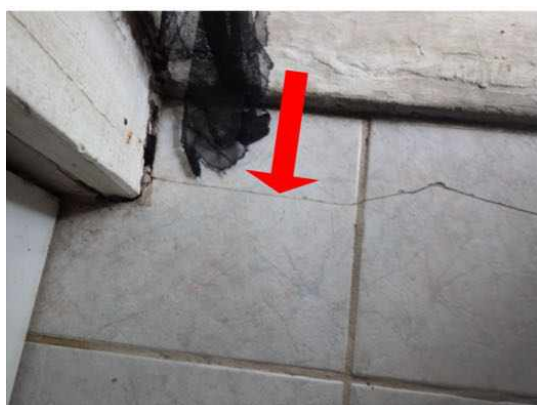
### Finding 3.12

Building: Main Building  
 Location: Laundry > Rear Right  
 Finding: Tile - Cracked  
 Information: Cracked tiles to the ground floor laundry area were identified at the time of inspection. Such defects are generally caused by impact. Cracked or broken tiled areas may also be a direct result of poor workmanship during the construction process.

A tiling contractor could be appointed to perform repair works at the clients discretion.

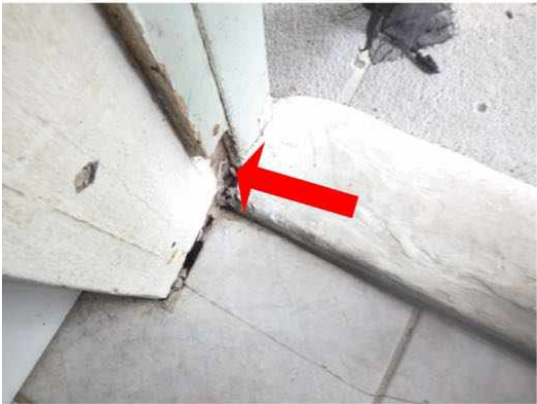
Building: Main Building  
Location: Laundry > Rear Right  
Finding: Architraves Damaged  
Information: At the time of inspection the exterior door frame and timber architraves in the ground floor laundry showed signs of damage or deterioration. The deterioration appears consistent with moisture exposure.

A qualified carpenter or general handyman could be engaged to repair or replace the timber architraves as required.

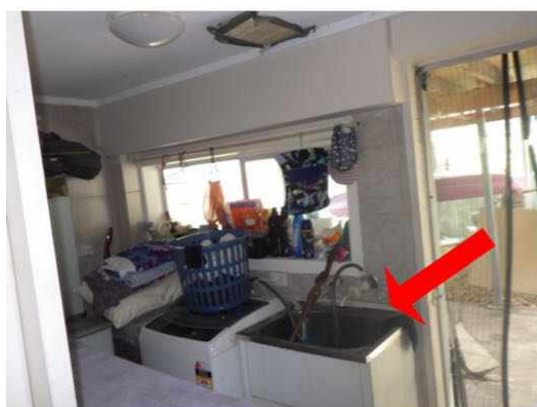
### Finding 3.15

Building: Main Building  
 Location: Laundry > Centre,Rear  
 Finding: Sealant - Deteriorated  
 Information: It was noted on inspection that sealant has deteriorated to the ground floor laundry tub /tiled wall intersection. Sealant is used to protect gaps and crevices in building materials to ensure that they are water-tight and prevent water penetration to the associated structure

A sealant specialist or general handyman should be appointed to complete repair work.

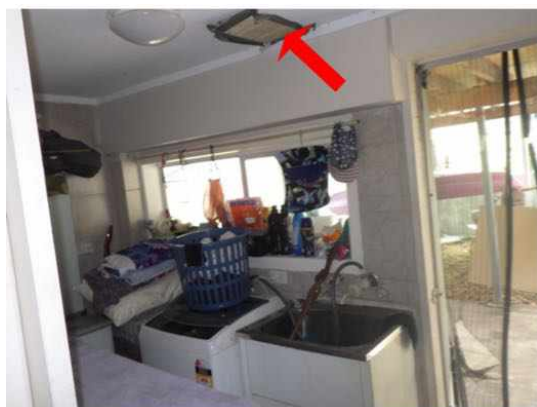
### Finding 3.16

Building: Main Building  
 Location: Laundry > Centre  
 Finding: Vent Cover  
 Information: At the time of inspection it was noted the ceiling space ventilation panel in the ground floor laundry area was hanging loosely.

A general handyman could be engaged to replace the damaged vent cover.

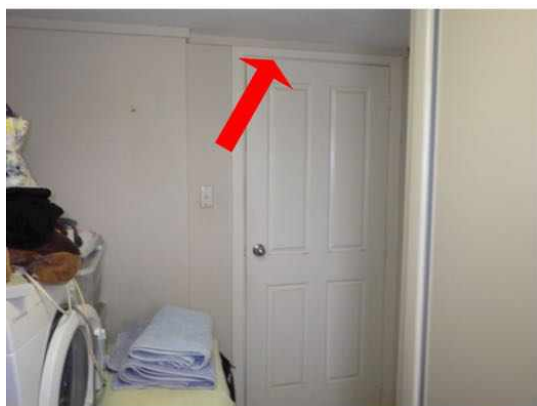
### Finding 3.17

Building: Main Building  
 Location: Utilities Room 2 > Front  
 Finding: Door - Binding/Jamming  
 Information: Binding and/or jamming of the utilities room 2 door on the door frame was evident during standard operation. This defect inhibits the functionality of affected door as well as creating potential for secondary defects to associated building elements, such as damage to the door framing.

A qualified carpenter or general handyperson could be appointed to perform minor rectification works at client discretion.

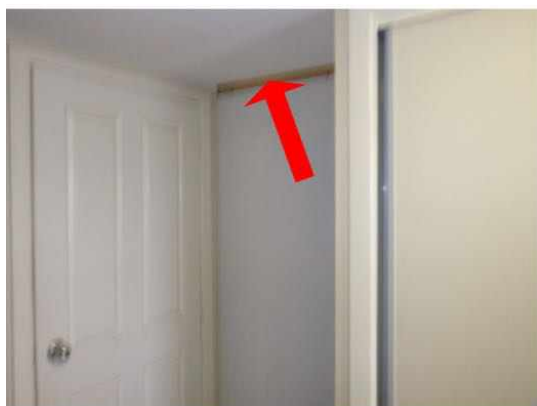
### Finding 3.18

Building: Main Building  
 Location: Utilities Room 2 > Front Left  
 Finding: Timber Trim - Missing  
 Information: At the time of inspection it was observed there was a section of timber trim missing from the internal wall/ ceiling linings internal corner in utilities room 2. It is important these gaps or areas are sealed with an appropriate trim to prevent pest and/or vermin activity or nesting.

A qualified carpenter or general handyman could be engaged to replace any missing timber trims.

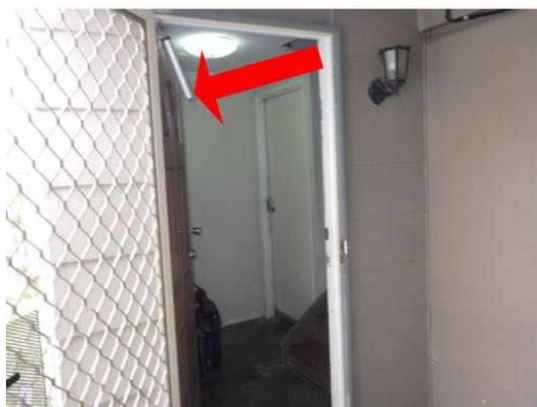
### Finding 3.19

Building: Main Building  
 Location: Entry > Front  
 Finding: Door - Closer  
 Information: The door closer to the entry area security door was found to be detached and/or broken at the time of inspection. Breakage occurs generally when the building materials have aged and decayed, but may be indicative of impact damage (accidental or deliberate).

A general handyman could be appointed to repair or replace the door closer at the client's discretion.

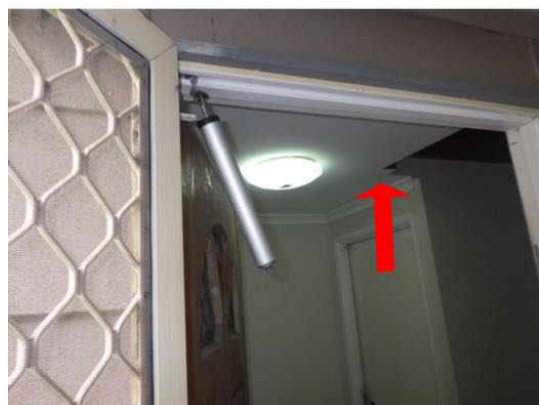
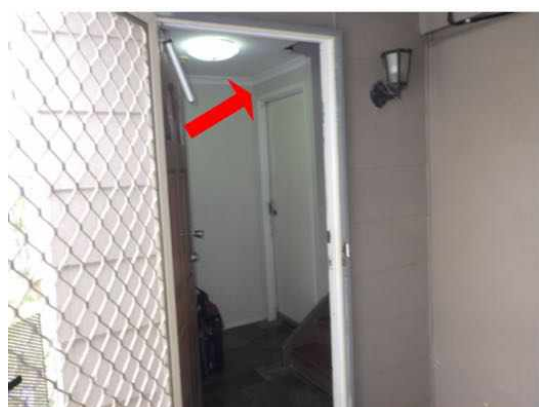
### Finding 3.20

Building: Main Building  
 Location: Entry > Centre Right  
 Finding: Cracking - Ceiling  
 Information: There is cracking to an area of the entry area ceiling and wall lining.

Monitoring of all cracking should be conducted frequently. Always contact a building inspector should cracks widen, lengthen, or become more numerous.

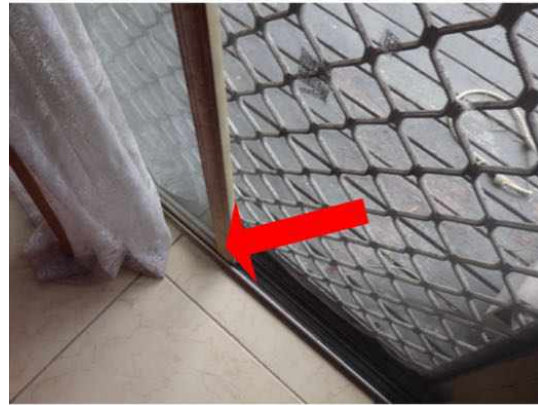
### Finding 3.28

Building: Main Building  
 Location: Bedroom 2 > Rear  
 Finding: Door - Stiff to slide  
 Information: The aluminium sliding door in bedroom 2 was stiff to open and difficult to operate at the time of the inspection. Doors provide ventilation to the adjoining area and should be at a fully operational level to ensure user comfort. Restricted function of the door may also pose as a potential safety hazard if required for emergency egress from the building.

An aluminium sliding door service agent will be required to repair the affected door.

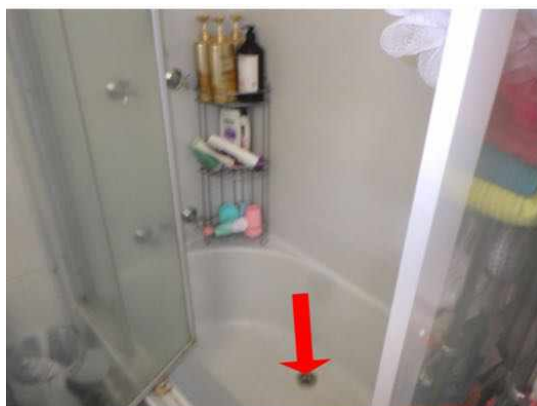
### Finding 3.33

Building: Main Building  
 Location: Bathroom > Centre  
 Finding: Shower - Drain Grate  
 Information: The bathroom shower drain grate was missing at the time of inspection. Shower drain grates serve the purpose of preventing debris from entering and blocking the drainage system. It is advised that maintenance is carried out on the waste so as it functions as intended.

A handyman could be appointed to perform any remedial works where required.

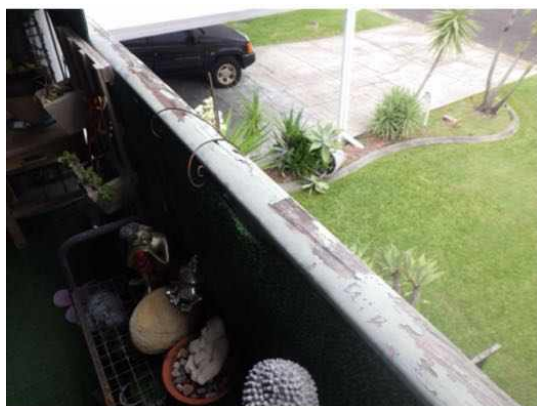
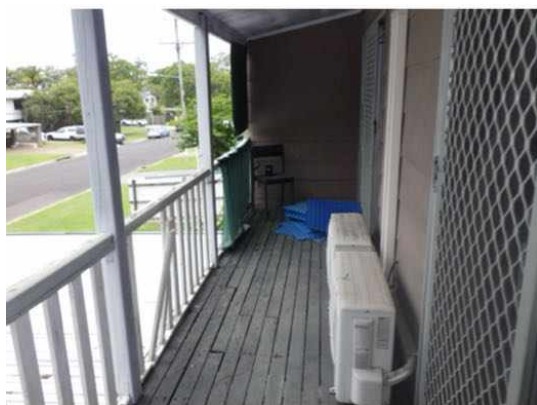
### Finding 3.34

Building: Main Building  
 Location: Balcony > Existing  
 Finding: Timber - exposed to weather  
 Information: At the time of inspection the upper level balcony areas showed signs of weathering and/or deterioration.

Adequate treatment or painting of the balcony area decking timbers and balustrade is required by a qualified painting contractor.

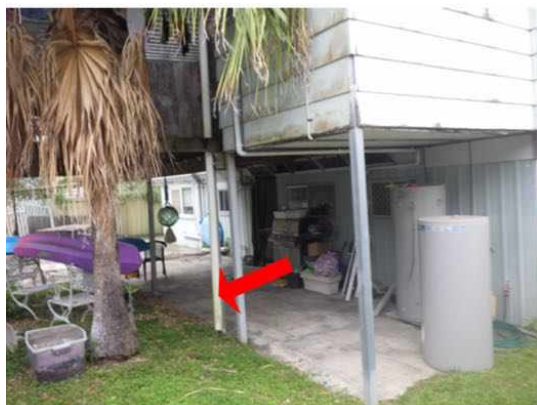
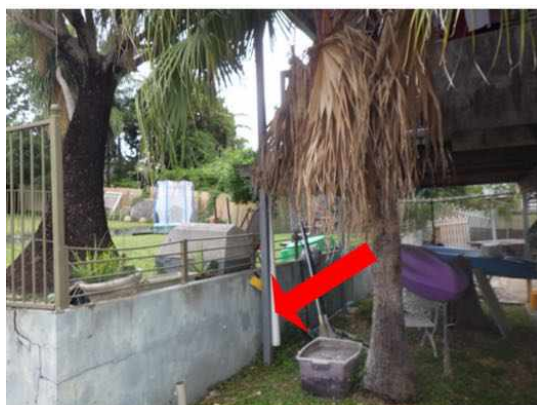
Finding 6.04

Building:	Main Building
Location:	Exterior walls - rear > Rear Left
Finding:	Stormwater downpipes
Information:	The down pipes to the roof area at the rear of the property are not connected to the stormwater drainage on the site. This disconnection negatively impacts the functional capacity of the downpipes and the surrounding ground area.

It is recommended that a licensed plumber be appointed to further inspect and to extend the down pipes to the properties stormwater line as necessary.

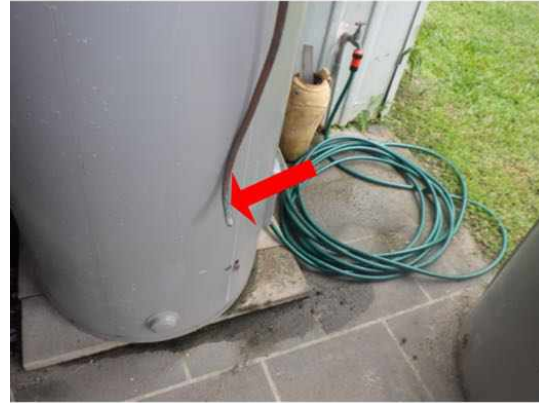
### Finding 6.05

Building:	Main Building
Location:	Exterior walls - rear > Centre Left
Finding:	Overflow - Not plumbed for drainage
Information:	The hot water system overflow is not plumbed or connected to suitable drainage, which can result in the surrounding area becoming excessively damp. These damp conditions can lead to secondary defects such as rot, rust or corrosion of associated

building elements, the formation of fungal decay, or even the creation of potential slip hazards. When coupled with poor site drainage, pooling of water may also attract termite activity to this area. It is highly recommended that a qualified plumber be appointed to install adequate drainage to the overflow. These works will ensure that the area remains dry and free of any secondary defects.
