Building and Timber Pest Inspection Report

Inspection Date: Wed, 18 Mar 2026

Property Address: 58/8 Casey St, Caboolture South QLD 4510,
Australia

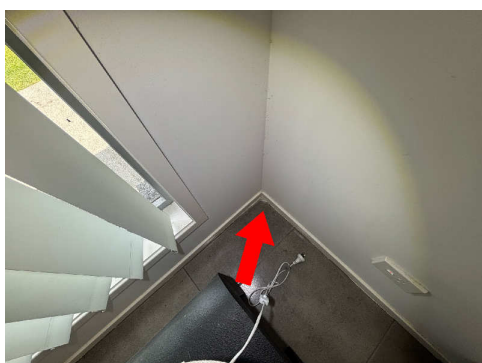
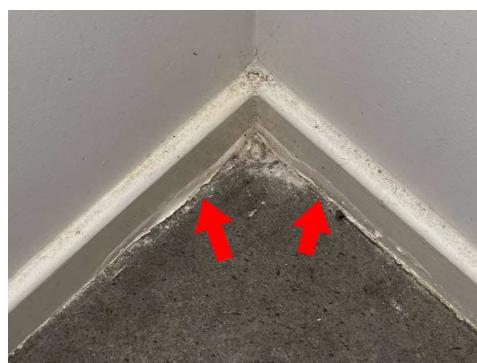
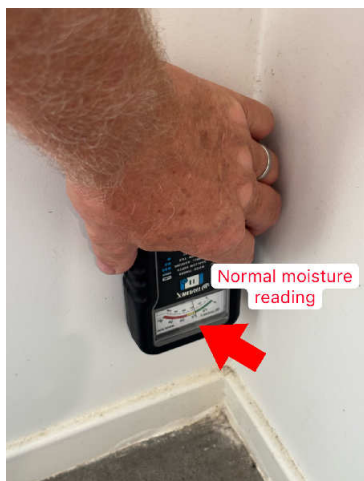
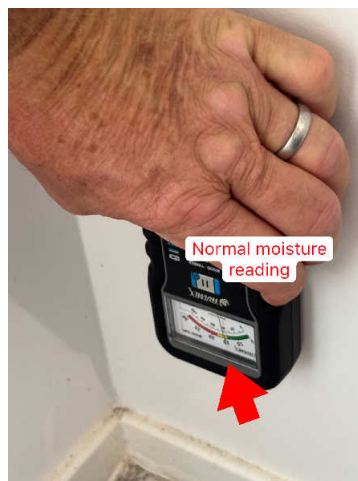
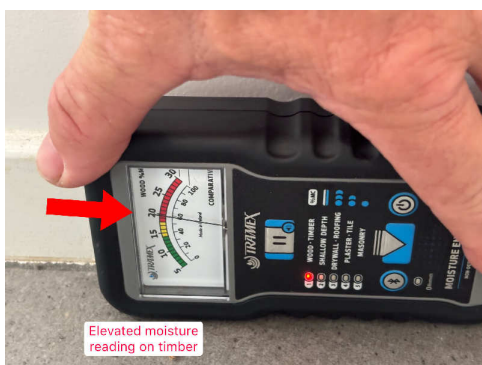
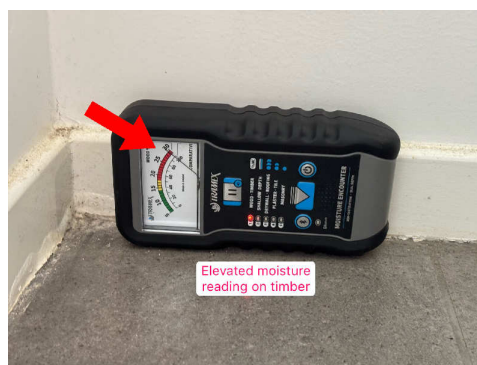
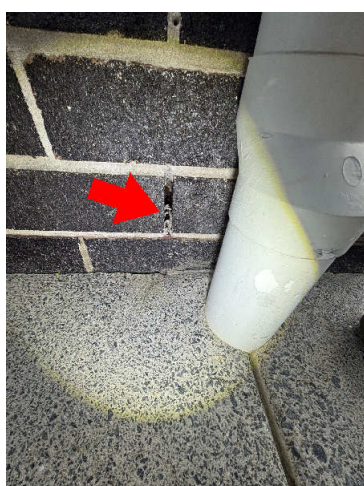
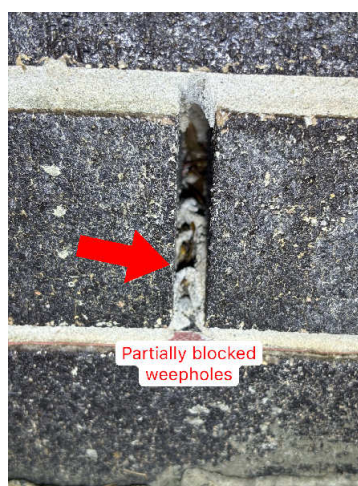
Finding 3.01

Finding: Lounge - evidence of moisture damage

Information: At the time of the inspection, it was noted that there was evidence of moisture damage to a section of timber skirting in the lounge area.

Normal moisture readings were recorded on the plasterboard wall lining. Elevated moisture readings were recorded on the timber skirting.

It could not be determined where the moisture may have come from. A weephole on the exterior of this area was found to be partially blocked. The client should monitor the area for any change in appearance to the timber skirting.

A building maintenance professional or painting contractor could be engaged to repair the timber skirting. This can be done at the clients discretion.

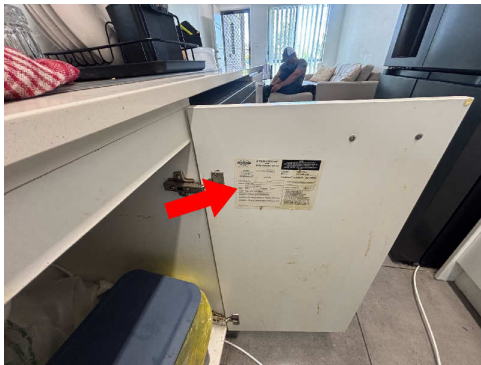
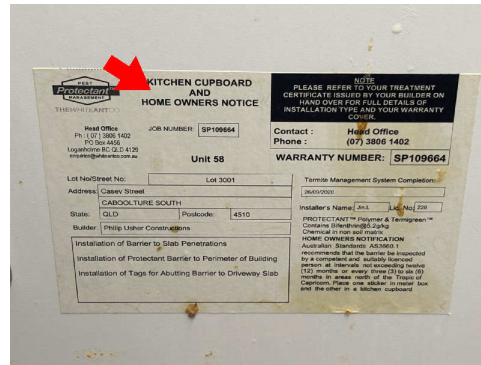
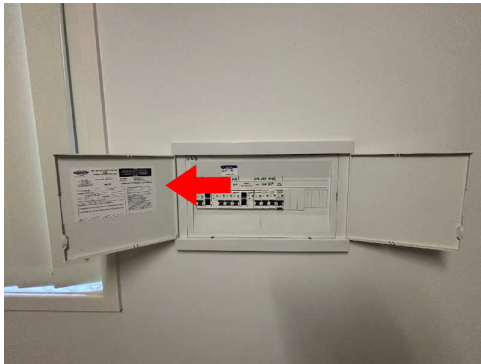
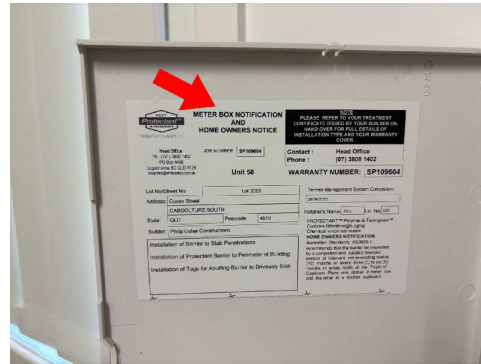
Finding 9.01

Finding: Evidence of a physical termite management system was identified.

Information: At the time of the inspection, evidence of a physical termite management system was found by way of a durable notice in the electricity meter box and in the kitchen sink cabinet.

A physical termite barrier was installed to the slab penetrations, perimeter and tags for abutting barrier to the driveway slab during construction. The durable notice is dated the 14/01/2002.

A physical termite barrier does not stop or eliminate termites. A physical termite barrier is designed to expose concealed termite activity which will be found during a visual inspection.

The client may wish to enquire of the body corporate as to the nature of the termite management plan for the complex and the individual units. Also, are annual termite inspections carries out and up to date.

A termite and timber pest technician should be engaged to carry out annual termite inspections as per AS 3660 in order to further protect the dwelling. Annual termite inspections must be carried out in partnership with any termite treatment system, physical or chemical, as no termite treatment system can be expected to be 100% effective.

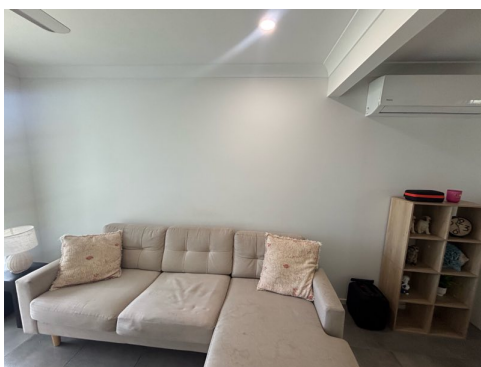
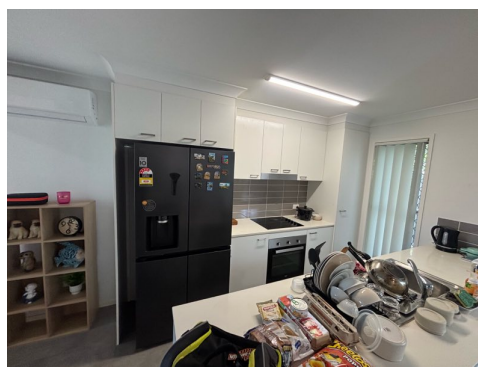
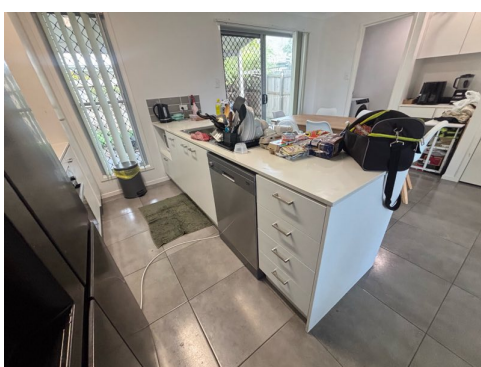
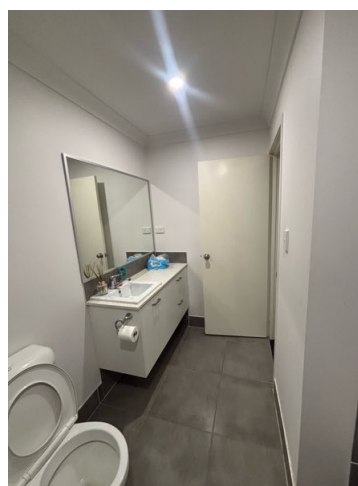
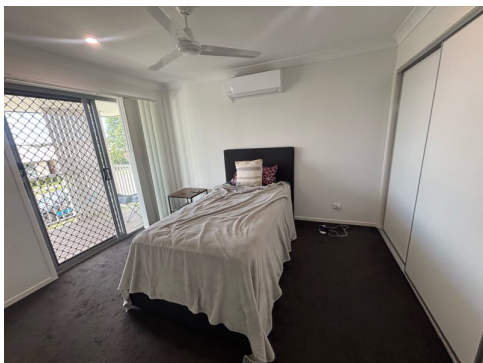
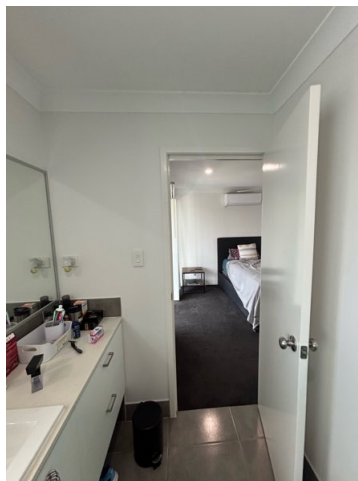
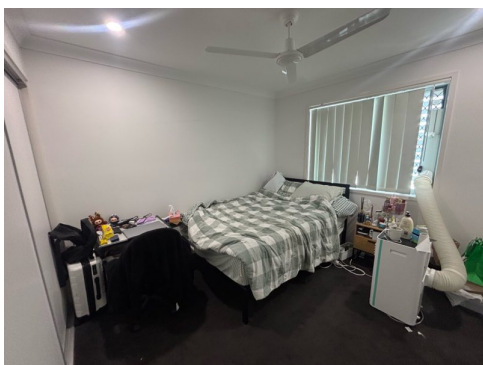
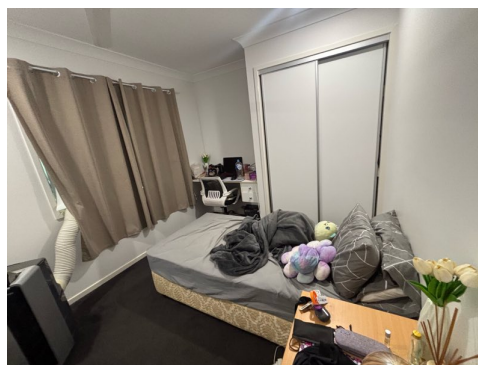
Finding: Obstructions and Limitations - Internal areas

Information: These photographs are an indication of the obstructions and limitations which impeded full inspection of the property of the internal areas at the time of inspection. These obstructions can hide an array of defects and should be removed to allow full inspection to be carried out. A re-inspection is recommended once the areas are made accessible.

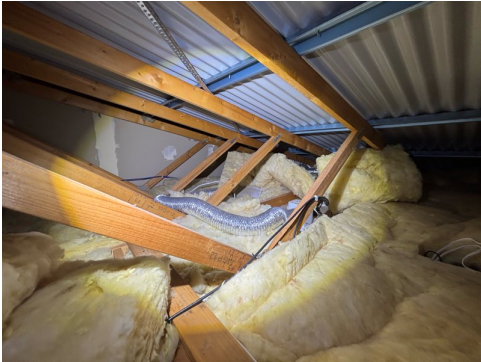
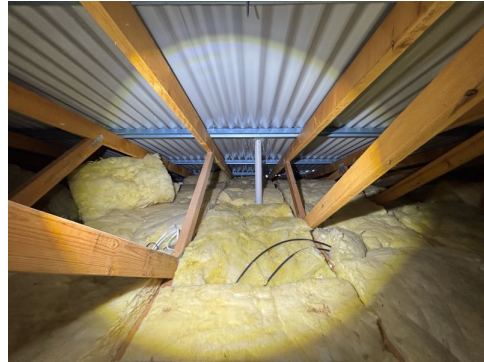
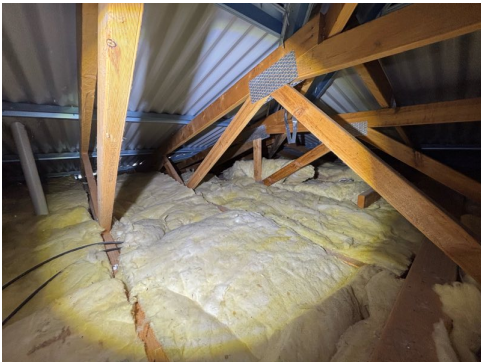
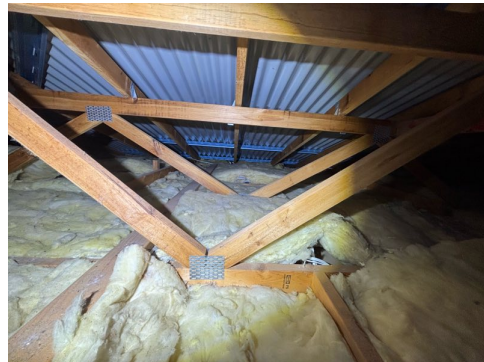
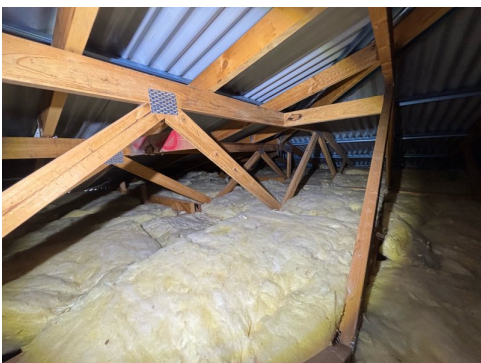
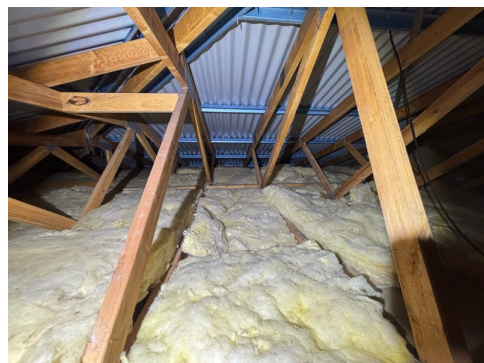
Finding: Obstructions and Limitations - Roof cavity

Information: These photographs are an indication of the obstructions and limitations which impeded full inspection of the property of the roof cavity at the time of inspection. These obstructions can hide an array of defects and should be removed to allow full inspection to be carried out. A re-inspection is recommended once the areas are made accessible.
