# Building and Timber Pest Inspection Report

Inspection Date: Wed, 25 Mar 2026

Property Address: 14 Taylors Road, Silverdale NSW 2752

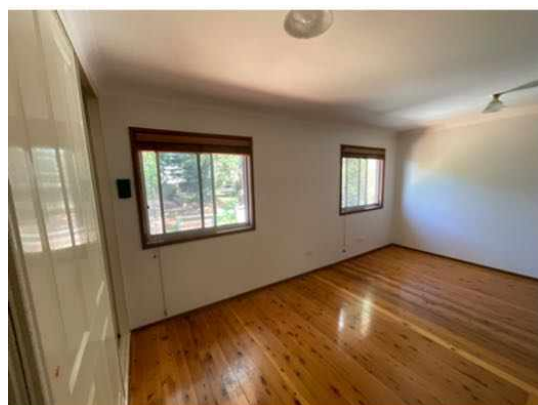
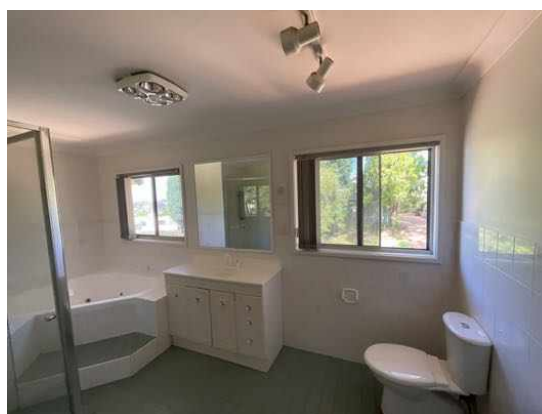
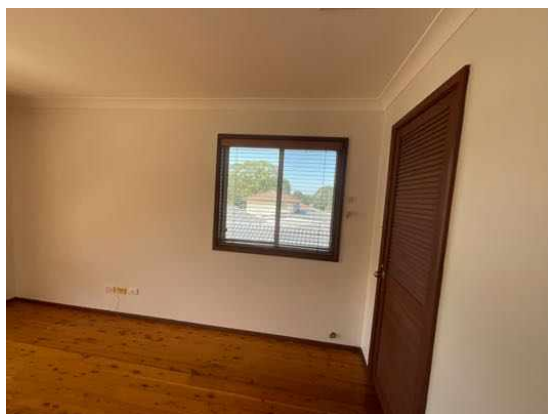
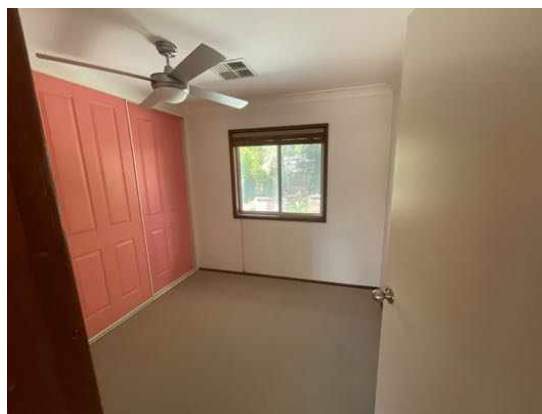
Building:	Main Building
Location:	All Areas upstairs
Finding:	Caution: Missing Window Restriction Devices.
Information:	Please note that this is highlighted as a caution only.

It has been noted that window restriction devices are either missing or not installed on the affected windows.

It is strongly recommended that window restrictors be installed to mitigate this safety hazard. A qualified window specialist should be appointed to fit the appropriate safety devices as soon as possible to comply with safety standards and ensure the protection of occupants.

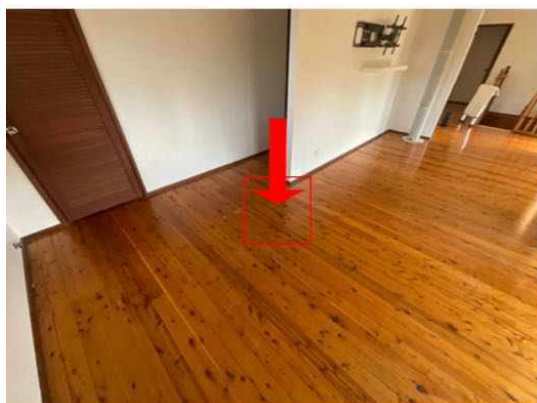
## Finding 1.02

Building:	Main Building
Location:	Living Room > Upstairs
Finding:	Flooring – Damaged Timber Floorboard (Safety Hazard).
Information:	Observation:

A timber floorboard was observed to be damaged at an upstairs location, with a section chipped away resulting in a localised hole within the board. While the extent of physical damage appears minor, the defect is situated within a commonly trafficked area.

Due to its location and the presence of an uneven surface and hole, the defect presents a potential trip hazard to occupants and visitors. This increases the risk of slips, trips, or falls, particularly in low-light conditions or where the defect may not be immediately visible. If left unaddressed, the damage may worsen with continued use, potentially leading to further deterioration of the surrounding flooring and an increased safety risk.

It is recommended that the damaged section of flooring be repaired as a priority to eliminate the trip hazard. Rectification may involve repair, patching, or replacement of the affected floorboard by a suitably qualified flooring contractor or carpenter. Works should ensure the finished surface is level, secure, and free from defects.

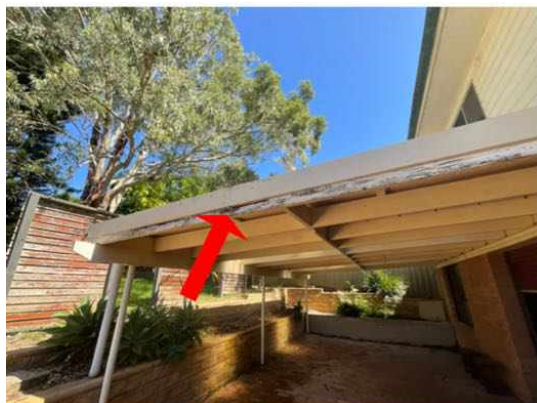
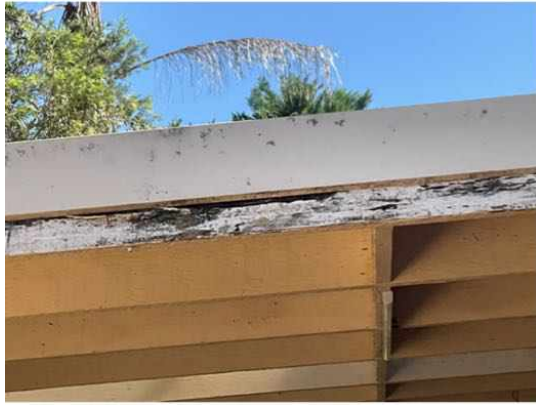
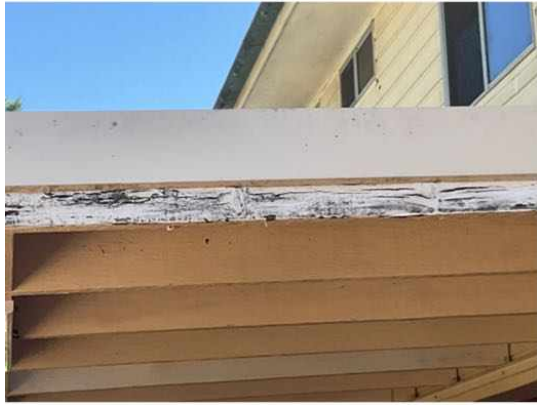
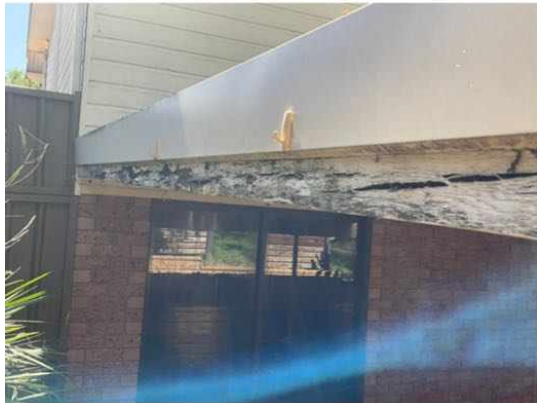
### Finding 2.01

Building: Main Building  
 Location: Pergola  
 Finding: Major Defect – Timber Decay to Pergola Roof Structure  
 Information:

Evidence of timber decay consistent with fungal rot was identified to sections of the roof rafters within the rear pergola at the time of inspection. The affected timbers exhibited deterioration indicative of prolonged moisture exposure. This condition typically develops where timber remains damp over extended periods, allowing fungal activity to break down the structural fibres.

In this instance, the decay appears likely associated with ongoing exposure to weather elements, including rain penetration and general environmental conditions. Contributing factors may include inadequate sealing, lack of protective coatings, and/or insufficient maintenance of exposed timber components.

Given the structural role of rafters, the presence of decay is considered a significant defect requiring attention.

- A suitably qualified and licensed carpenter or building contractor should be engaged to carry out a detailed assessment of the pergola structure to determine the full extent of deterioration.
- All decayed or structurally compromised timber members should be repaired or replaced as necessary to restore structural integrity.
- Any contributing moisture sources should be identified and rectified, which may include improving drainage, weatherproofing, or protective finishes.
- Exposed timbers should be appropriately sealed, painted, or treated to reduce future moisture ingress and prolong service life.

Timely remediation is recommended to prevent further deterioration and potential safety risks associated with structural weakening.

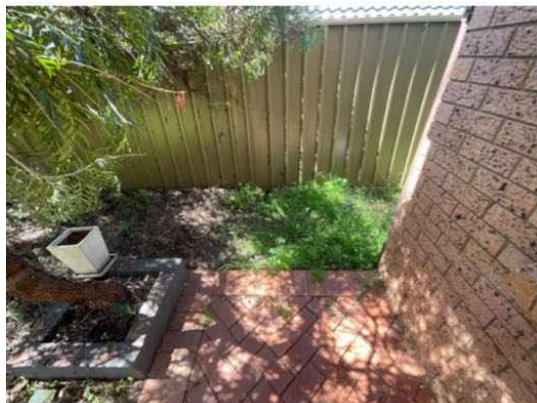
### Finding 3.01

Building: Main Building  
 Location: Exterior - left side  
 Finding: Site/Yard Drainage – Below Average.  
 Information: Defect – Below Average Site Drainage

Site drainage in the inspected areas appears to be below average, with no surface drains observed at the time of inspection. Ground surfaces and paved areas adjacent to the building do not appear to be adequately graded to facilitate effective surface water runoff.

- A licensed plumber and/or landscaping contractor should be engaged to:
  - Evaluate the current site grading and surface runoff conditions
  - Install or upgrade surface water drainage (e.g. strip drains, spoon drains, grated channels) as required
  - Improve grading around the building to ensure water flows away from the structure

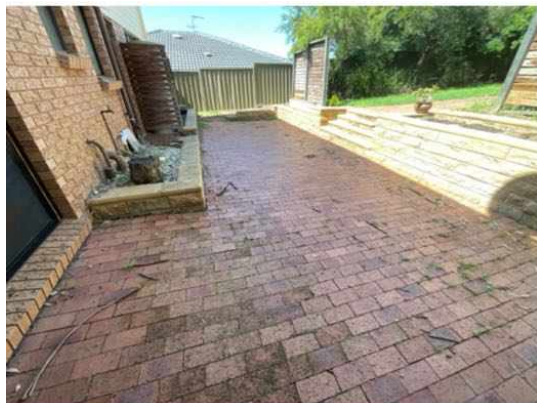
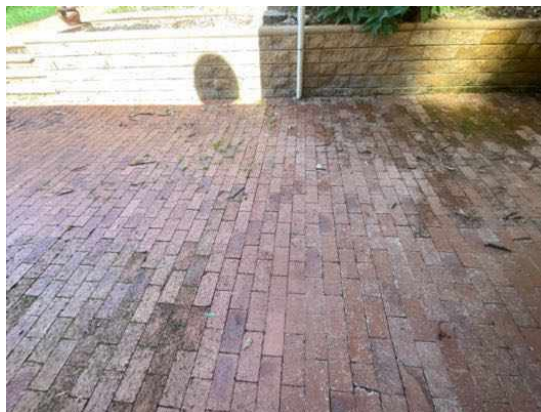
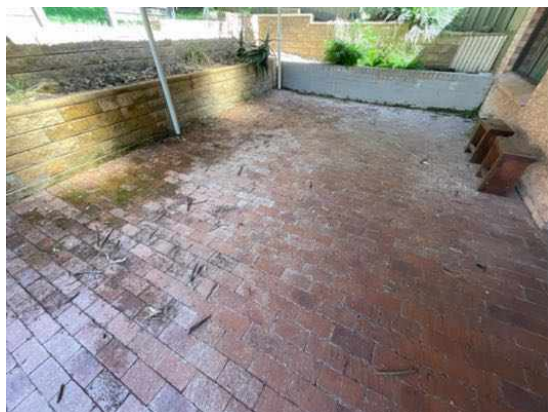
### Finding 3.02

Building: Main Building  
 Location: Pergola  
 Finding: Defect: Inadequate Surface Drainage – Rear Paved Area  
 Information:

At the time of inspection, the rear paved area was observed to exhibit inadequate surface drainage, with evidence of water ponding noted adjacent to the rear retaining walls. While the paving generally appeared to fall away from the building, localised low points and insufficient drainage provisions are likely contributing to water accumulation. No surface drainage systems (e.g. grated drains or strip drains) were observed within this area.

Although the paving falls away from the dwelling, the absence of adequate drainage infrastructure may result in ongoing water ponding during and after rainfall events. This condition is considered a nuisance issue; however, prolonged water retention may contribute to accelerated surface deterioration, increased slip hazards, and potential moisture-related impacts to nearby structures such as retaining walls over time.

It is recommended that a suitably qualified contractor assess the paved area and install appropriate surface drainage (e.g. strip drains or similar) to facilitate effective water runoff. Regrading or localised rectification of paving may also be required to eliminate low points and prevent ponding. Regular maintenance should be undertaken to ensure continued drainage performance.

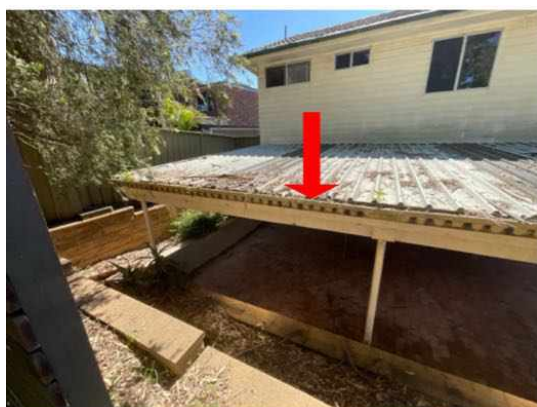
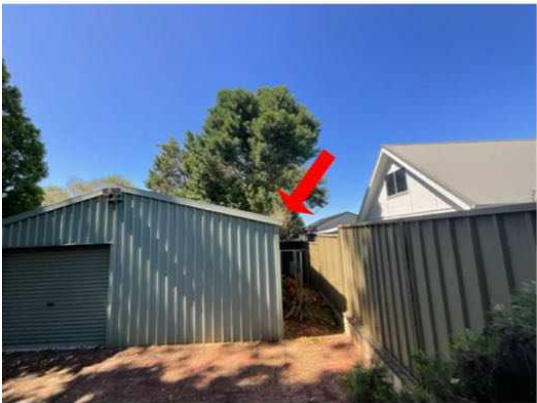
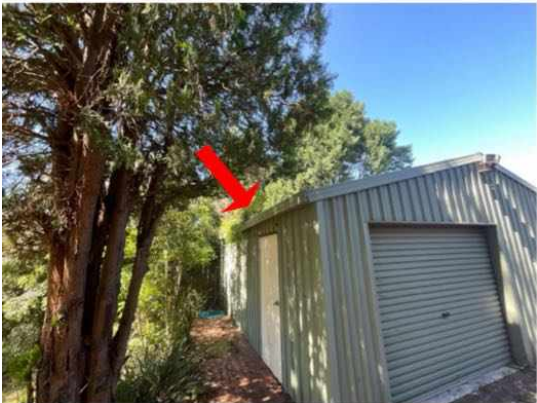
### Finding 3.03

Building:	Main Building
Location:	Pergola & Shed
Finding:	Roof Plumbing – Blocked Gutters and Downpipes.
Information:	Observation

Roof plumbing elements, including the guttering and downpipe systems, were observed to contain accumulated debris at the time of inspection. These components are designed to maintain continuous and unobstructed water flow from the roof to the stormwater discharge system. Any obstruction in these systems compromises their intended performance.

- All debris should be removed from gutters and downpipes immediately to restore proper drainage performance.
- Homeowners or a suitably competent handyperson may carry out basic cleaning works as an interim measure.
- A licensed plumber should be engaged to undertake a full assessment of the roof plumbing system, confirm whether any components have been damaged due to sustained moisture exposure, and provide recommendations for required remedial works.
- Where gutter guard is installed, a routine maintenance program should be implemented to ensure debris does not accumulate and impede the system's operation.

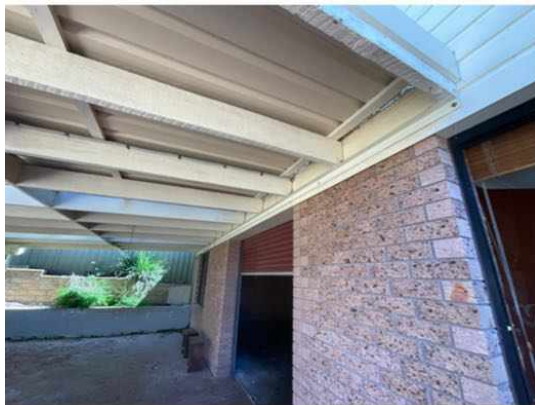
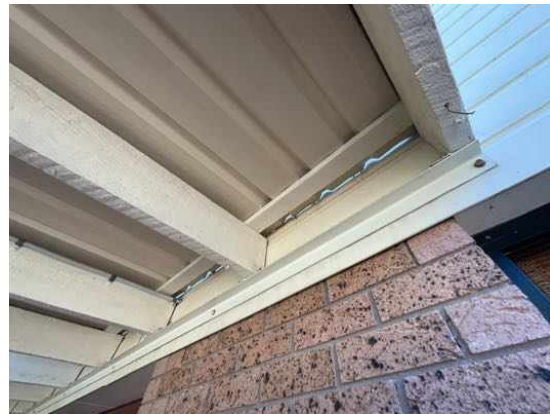
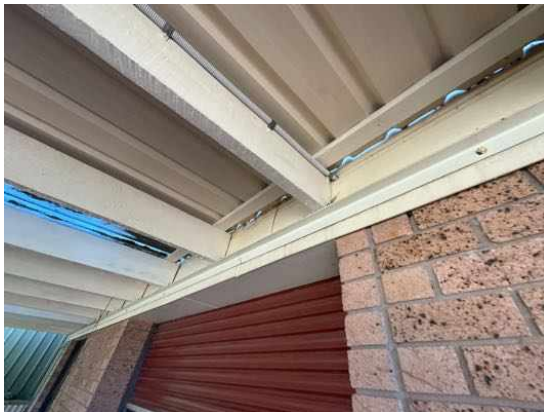
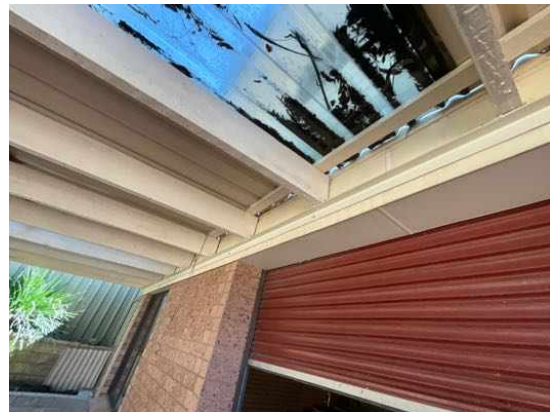
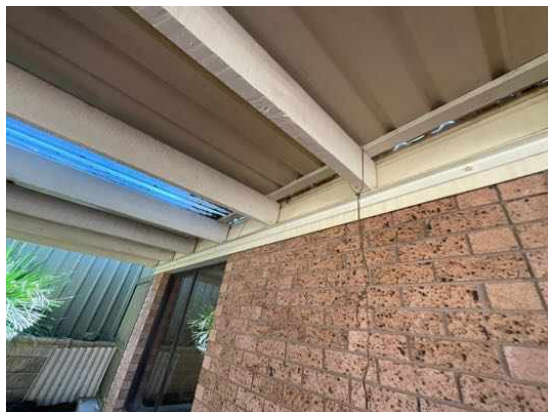
**Finding 3.04**

Building: Main Building  
Location: Pergola  
Finding: Roof Plumbing – Missing Flashings (Minor Defect)  
Information: Observation:

It was observed that flashings have not been installed at the junction where the pergola roof abuts the main building structure. In typical construction, flashings are required at these intersections to provide a weatherproof seal and prevent water ingress during rainfall events.

The absence of appropriate flashings may allow water to penetrate at the junction between the pergola and the dwelling, particularly during periods of heavy or wind-driven rain. While no significant water ingress or damage was evident at the time of inspection, this condition may result in minor leaks, localised moisture ingress, or deterioration of adjacent building materials over time if not addressed. The issue is currently considered a nuisance-type defect rather than an immediate structural concern.

Rectification is not considered urgent; however, installation of suitable flashings is recommended to improve weatherproofing. A licensed roofing plumber may be engaged to assess the junction and install appropriate flashing in accordance with standard building practices. Investigation and rectification may be undertaken at the client's discretion.

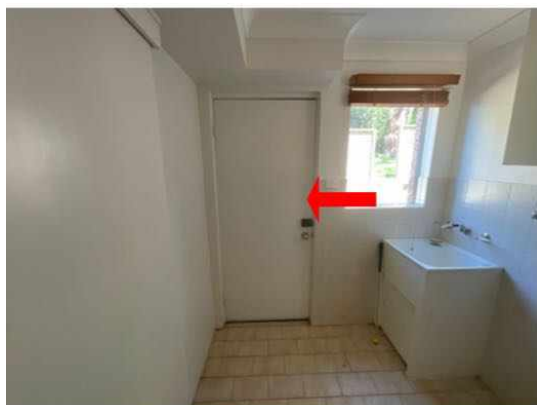
Building:	Main Building
Location:	Laundry
Finding:	Door - Binding and/or Jamming.
Information:	Functional Defect Identified

- If the issue appears to be related to major structural movement, it is recommended that a registered builder with experience in re-stumping or subfloor repairs be engaged to assess the extent of the movement and provide a quotation for necessary remedial works.
- Where the issue is minor in nature, a qualified carpenter or general handyperson may be appointed to carry out corrective works at the client's discretion.

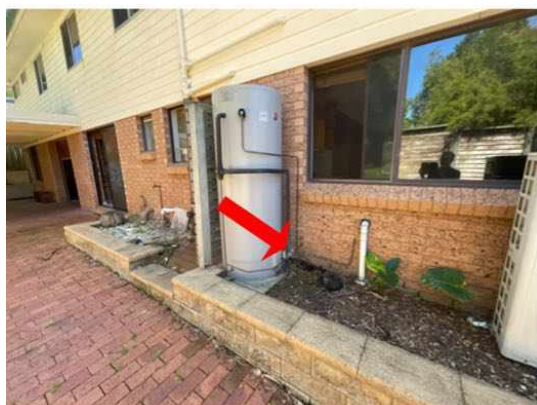
### Finding 6.03

Building:	Main Building
Location:	All External Areas
Finding:	Overflow Management – Risk of Termite Activity..
Information:	Observation: Water Pooling from HWS and Air Conditioning Overflows

It is highly recommended that all overflows from the HWS and air conditioning units be redirected away from the building, preferably via fixed drainage or extension piping, to prevent water accumulation near the structure.

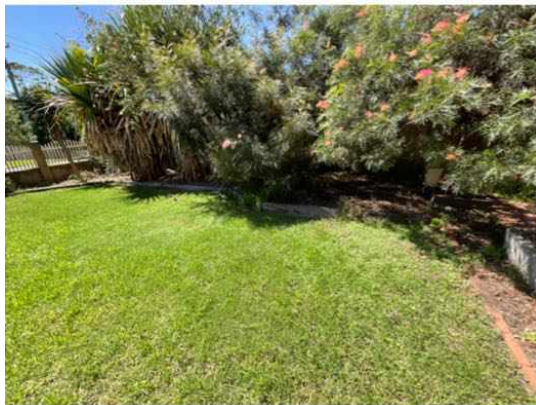
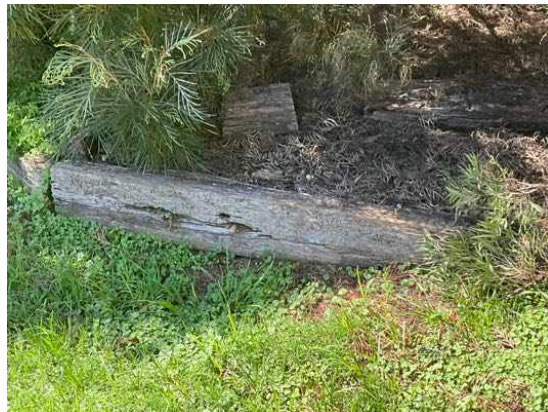
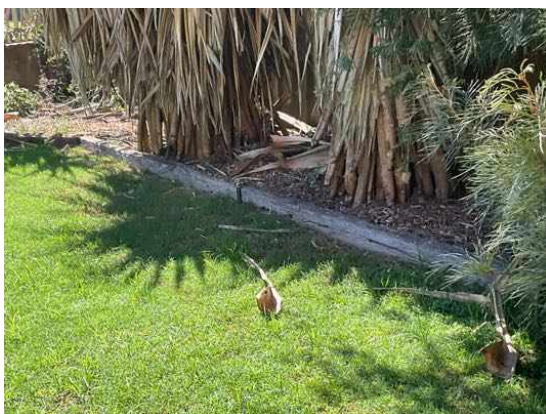
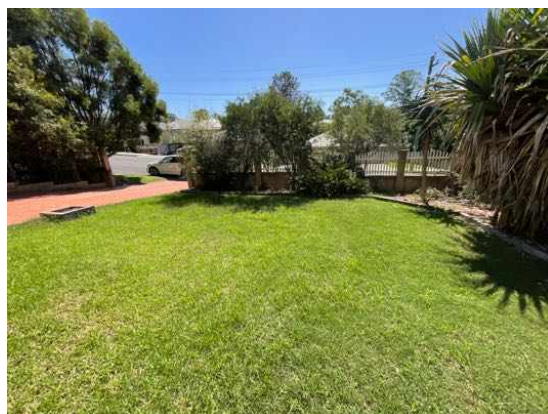
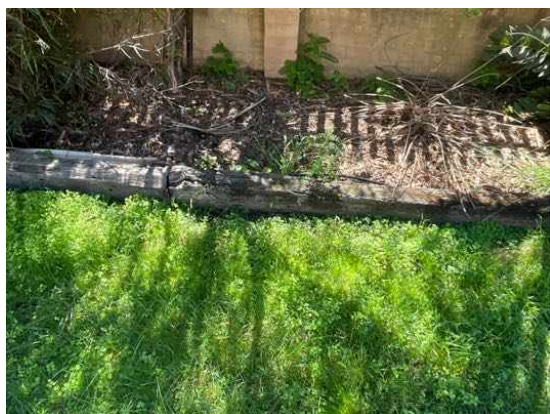
**Finding 6.04**

Building:	Main Building
Location:	Yard
Finding:	Conductive Conditions – Untreated or Non-Durable Timbers in Hazardous Environments
Information:	Observation:

Where untreated or non-durable timbers have been identified in such conditions, it is strongly recommended that these elements be replaced as soon as possible.
