Building Inspection Report

Inspection Date: Tue, 27 Jan 2026

Property Address: unit 2/142 Pound Rd, Hampton Park VIC
3976, Australia

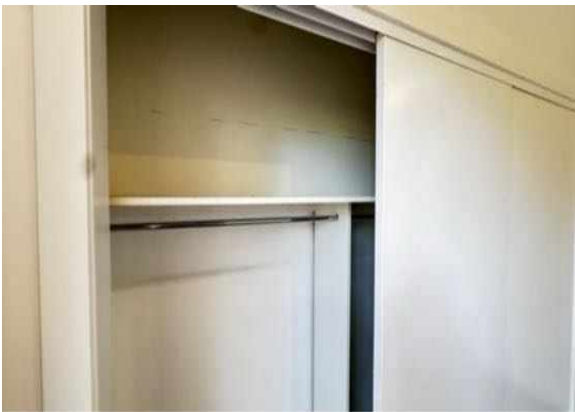
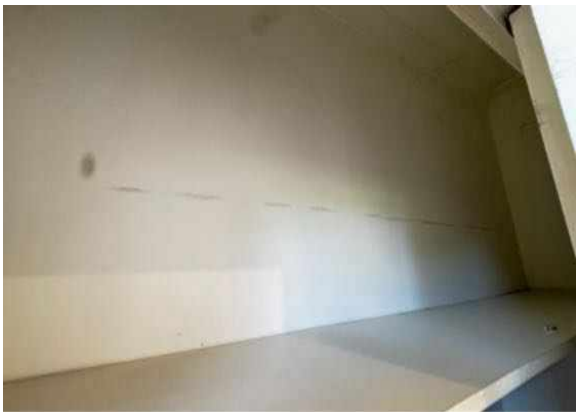
Defects 3.03

Information: The walls were inspected for paint condition, and discolouration was observed. While primarily a cosmetic issue, deteriorated paint may indicate poor surface preparation, or age-related wear.

Possible causes include age-related wear and impact damage.

A qualified painter should be engaged when practical to prepare and repaint affected areas. Addressing paint deterioration improves aesthetics and protects wall materials from further wear.

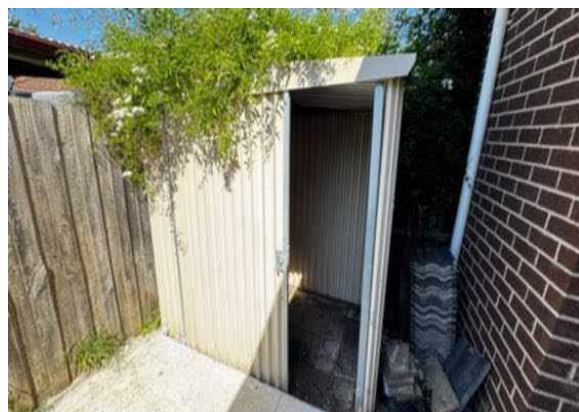
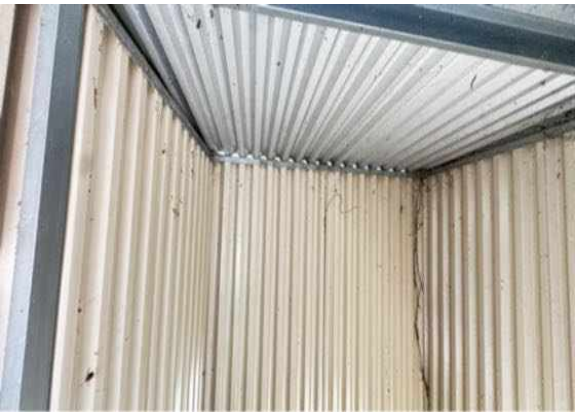
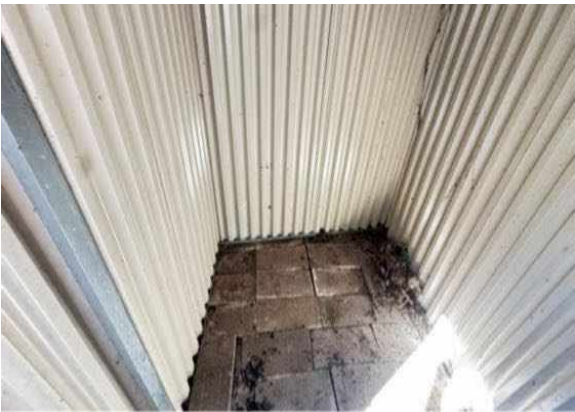
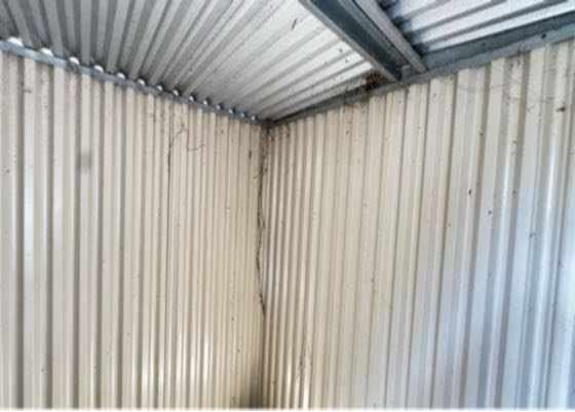
Defects 3.18

Building: Main Building
 Location: All External Areas > Rear
 Finding: Garden Shed - General Condition
 Information: The garden shed was inspected visually. The shed structure shows signs of age-related deterioration, including corrosion of roofing and walls and weathered components.

The shed does not appear to compromise the primary dwelling structure but may reduce usability, weatherproofing, and amenity. This deterioration is likely due to age, exposure to weather, and a lack of regular maintenance.

When practical, a competent hand man should be engaged to repair or replace damaged, missing, or weathered components. Rectification will restore functionality, durability, and weatherproofing of the shed.

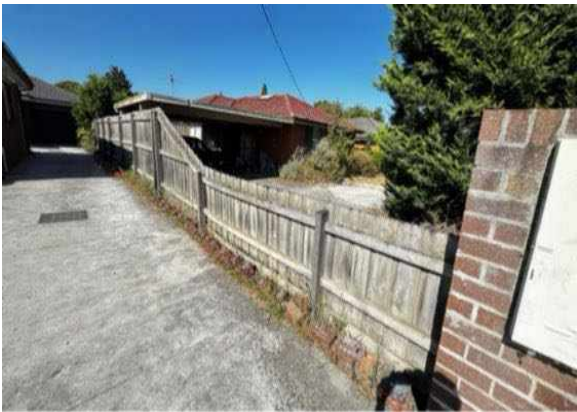
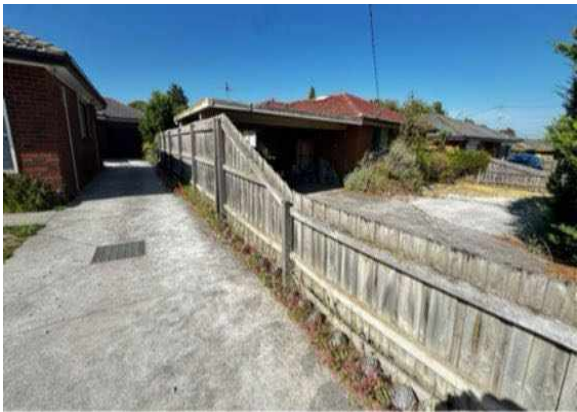
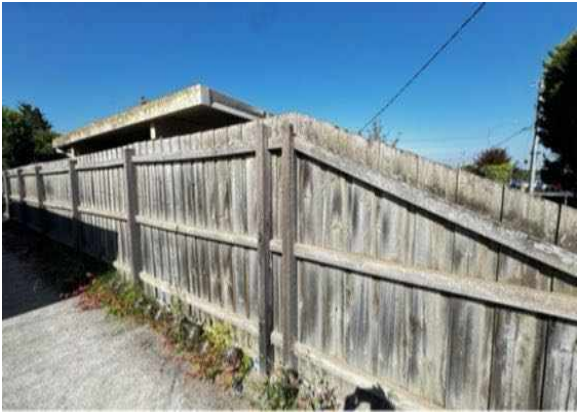
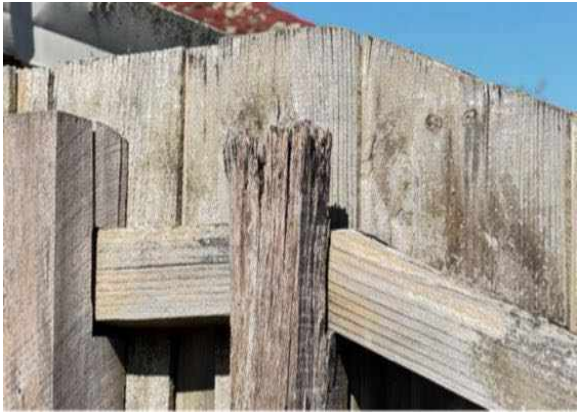
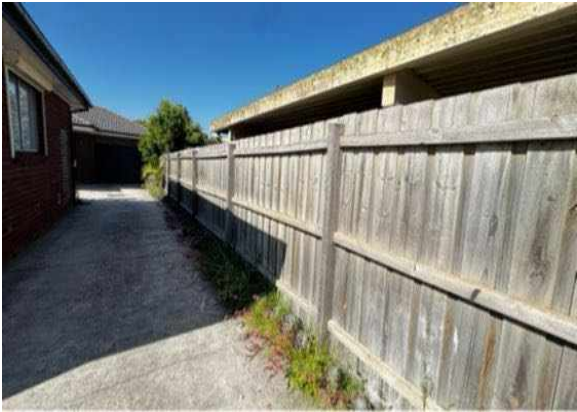
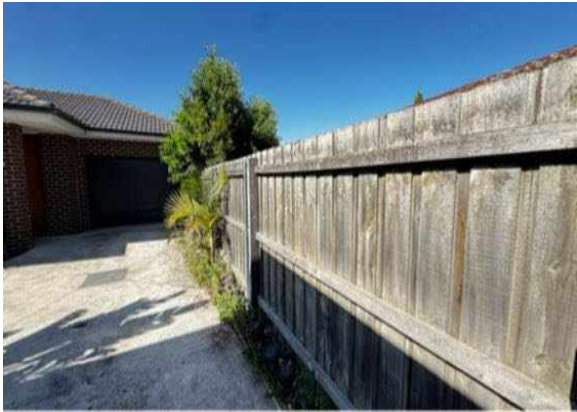
Defects 3.19

Building: Main Building
Location: Fencing All Areas
Finding: Fencing - Deteriated
Information: Timber fencing was inspected and deterioration was observed in this area. Deteriorated fencing can compromise structural stability, reduce privacy, and may allow pest ingress or accelerated decay if left unaddressed.

Possible causes include age-related timber decay, prolonged exposure to moisture or sunlight, poor maintenance, or impact damage.

When practical, a qualified carpenter or fencing specialist should be engaged to repair or replace affected sections, and a qualified painter should be engaged to restore protective finishes. Prompt rectification will maintain structural performance, improve appearance, and extend the lifespan of the fencing.
