Building and Timber Pest Inspection Report

Inspection Date: Thu, 19 Feb 2026

Property Address: 30 Aloomba St, Chadstone VIC 3148,
Australia

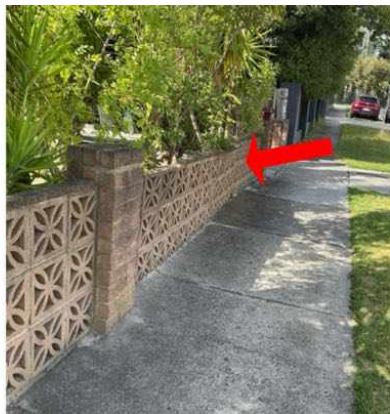
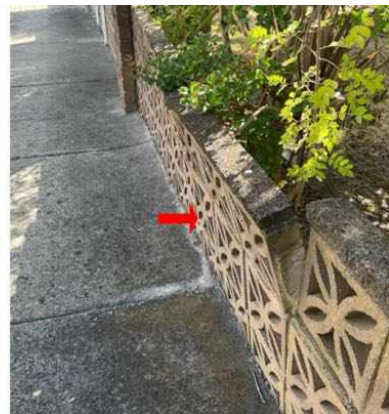
Building:	Main Building
Location:	Fencing
Finding:	Front fence – severe leaning (safety hazard)
Information:	The front fence is significantly out of plumb/leaning.

There is an increased risk of collapse, which may cause injury to pedestrians.

Arrange urgent repair or replacement by a qualified fencing contractor and restrict access to the area until made safe.

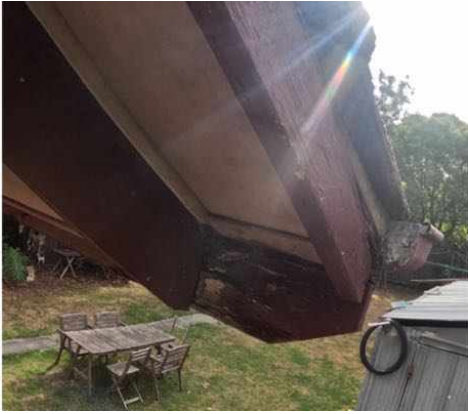
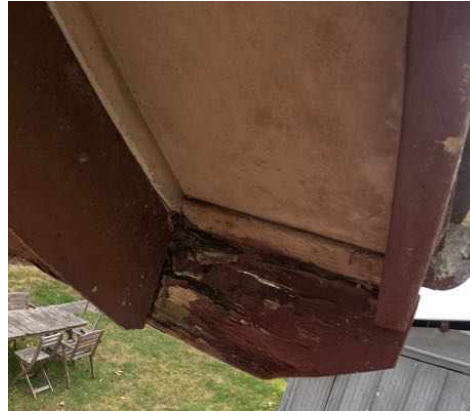
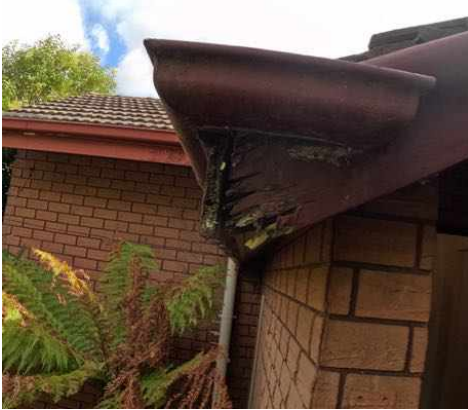
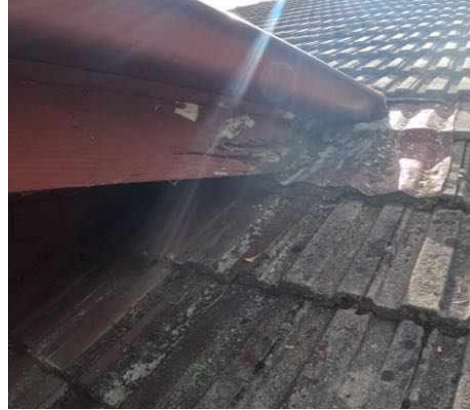
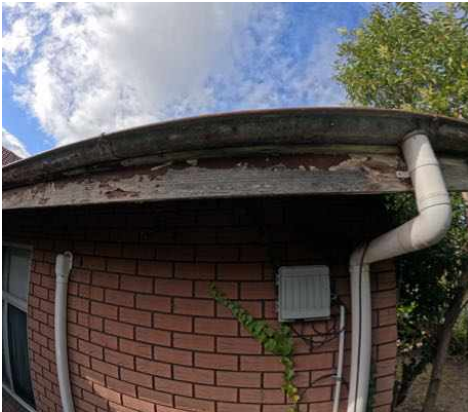
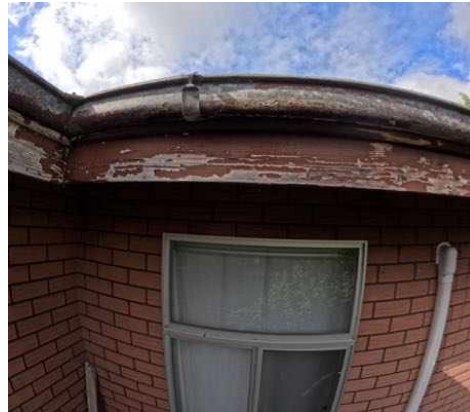
Building:	Main Building
Location:	Roof Exterior
Finding:	Fascias - Wood rot
Information:	Wood rot was found to be affecting fascias and bargeboards in this area, evidenced by the presence of mould on the surface in some areas. Wood rot, also known as Fungal Decay, occurs when timbers and other cellulose building materials are exposed to damp conditions on an ongoing basis.

It is likely that this wood rot has developed as a result of faults in the roof plumbing, creating excessive moisture in this areas. Frequent exposure to rain and other weather conditions also make fascias and bargeboards susceptible to accelerated deterioration.

Early intervention and regular maintenance will prolong the useful life of these building elements. Prior to any works being performed, the cause of the moisture that has created the visible wood rot should be identified and addressed in a suitable manner.

It is advised that a roof plumber be appointed to inspect all roof plumbing and subsequently identify the cause of the wood rot. Replacement of affected fascias and bargeboards may then be a necessary step in protecting surrounding building elements from such deterioration.

A qualified plumber may be appointed to assess the cause of excessive moisture and to provide advice on any remedial works as required. A qualified carpenter or registered builder may also be required to replace affected building materials.

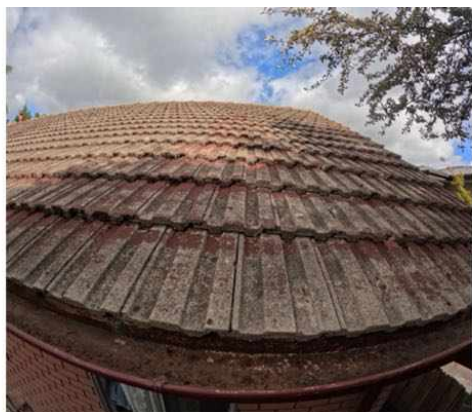
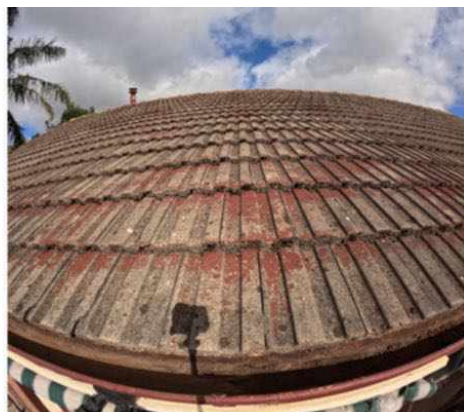
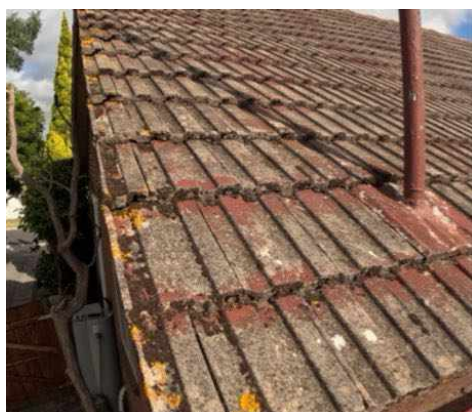
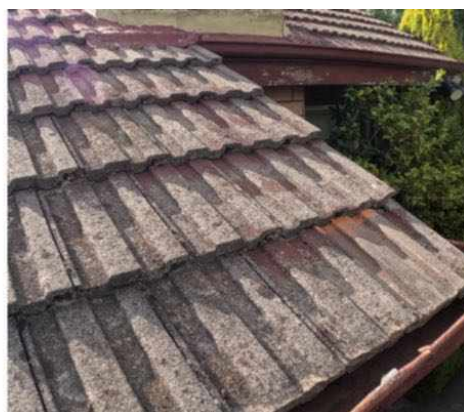
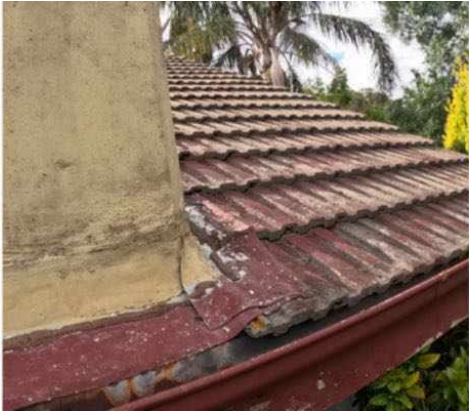
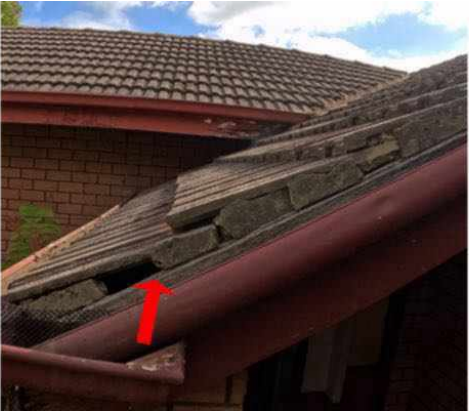
Finding 3.02

Building: Main Building
 Location: Roof Exterior
 Finding: Roof tiles - Weathered
 Information: Upon inspection of the exterior roofing, the majority of roof tiles were considered to be in a fair condition. While weathering of the tiles is consistent with the age of the property, maintenance works are required.

Isolated areas of mortar have come loose in the valleys and minor cracking is also present. Re-pointing and re-sealing the may be considered as an interim solution by the client to help preserve and extend the life span of the tiles.

Where left unmanaged, deteriorating roof tiles are likely to lead to a number of secondary defects, including minor water leaks and weather exposure to internal roofing structures.

Efflorescence was observed on the underside of the roofing material. This is identified by the white, powdery staining that forms when moisture within the material dissolves salts, which are then carried to the surface and deposited as the water evaporates.

While efflorescence itself is not structurally damaging, it indicates that moisture is penetrating or accumulating in the roof covering. If left unaddressed, ongoing moisture exposure may contribute to deterioration of roofing materials and encourage timber decay or corrosion of fixings.

It is recommended to monitor the area for signs of active leaks and ensure roof drainage and ventilation are adequate. If moisture ingress persists, a licensed roofing contractor should be engaged to investigate and carry out necessary rectification works.

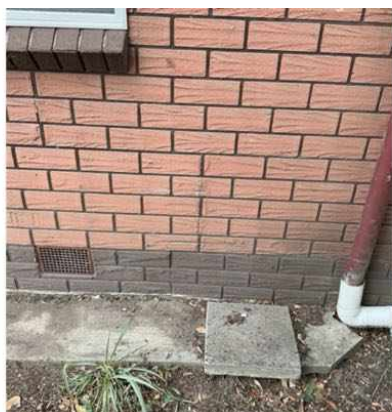
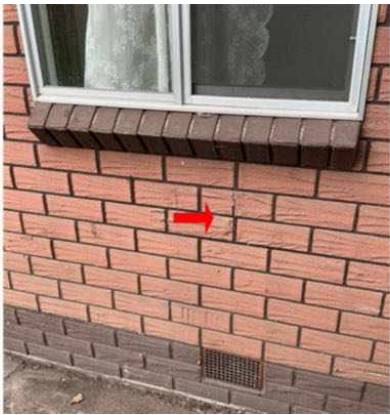
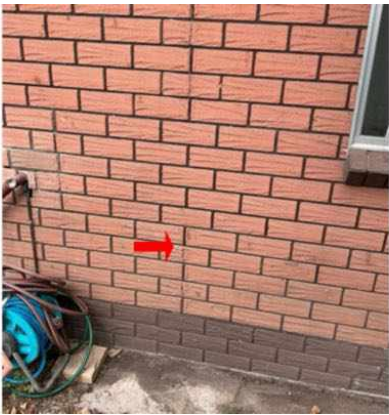
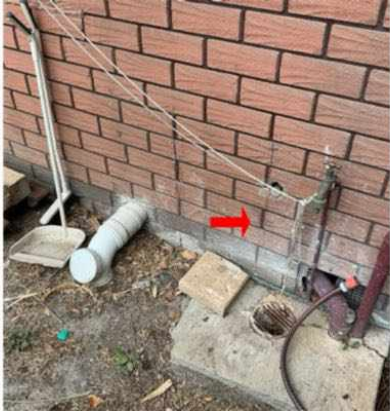
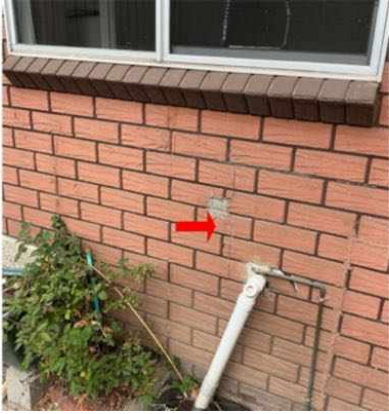
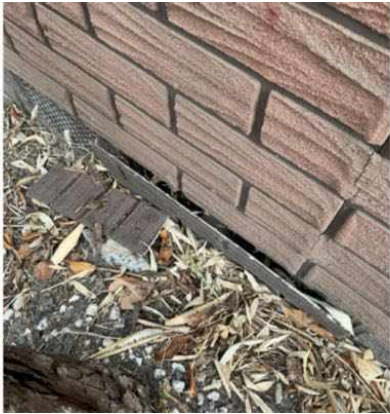
Finding 3.03

Building:	Main Building
Location:	Walls
Finding:	External wall cladding – cracking observed (various locations)
Information:	Cracking was noted to the external wall cladding at multiple areas around the property. This may be associated with minor building movement/settlement and normal thermal expansion and contraction.

While generally considered a minor defect, cracking may allow moisture entry and progressive deterioration if left unattended. Due to the less common cladding profile/finish, matching materials and completing repairs may be more difficult and potentially higher cost than standard cladding systems.

Engage a qualified builder/renderer to assess the extent and cause of cracking and to provide a repair method and cost estimate (including matching). Client is advised to factor potential repair costs into their overall purchase decision.

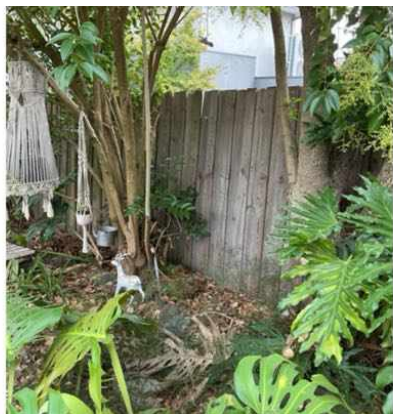
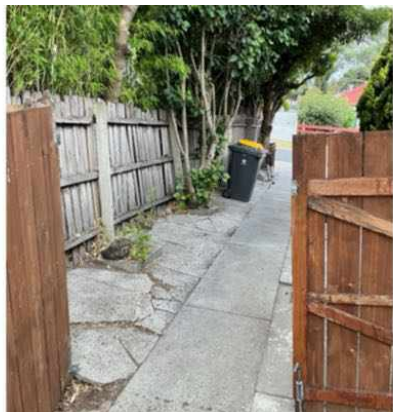
Finding 3.04

Information: Sections of the fence were observed to be leaning and out of alignment. This may be due to footing movement, poor anchoring, or gradual deterioration over time. Although no immediate structural failure was noted, the leaning condition may worsen and could eventually compromise stability or appearance.

Recommend monitoring the fence over time. If further movement occurs or stability becomes a concern, engage a qualified fencing contractor or builder to assess and undertake appropriate rectification work.

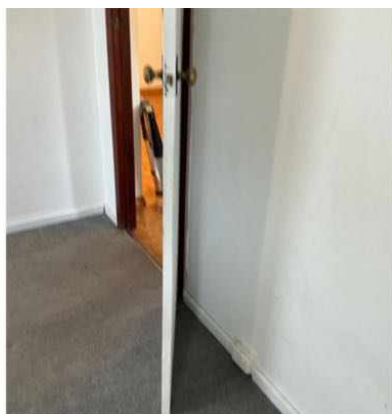
Finding 3.05

Building:	Main Building
Location:	Bedroom
Finding:	Door stop - Missing
Information:	The door stop is missing or is inadequate to stop the door handle from damaging the wall. Although some building elements may seem irrelevant or unnecessary, all building elements play a key role in the operation and function of the overall structure and its performance.

Re-installation or replacement of the door stop is advised as soon as possible to prevent any subsequent damage to the door or associated structures. A general handyman may be appointed to perform these works at client discretion.

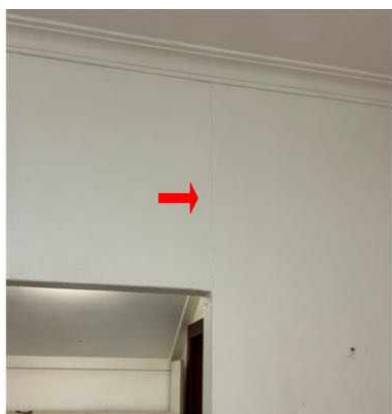
Finding 3.06

Finding: Brickwork - Cracking [Fine]

Information: Although fine cracks are quite noticeable, they are often only considered to be an appearance defect and usually do not indicate any structural damage. Generally, the cause of a fine crack is indicative of a separation between brickwork and mortar throughout the structure, but single bricks may also show cracks of this nature.

Cracking of this nature can generally be repaired with minor filling and should be conducted by a qualified bricklayer.

Always contact a building inspector should cracks widen lengthen or become more numerous.

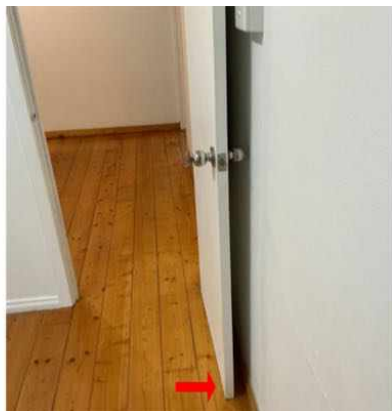
Finding 3.07

Finding: Door stop - Missing

Information: The door stop is missing or is inadequate to stop the door handle from damaging the wall. Although some building elements may seem irrelevant or unnecessary, all

building elements play a key role in the operation and function of the overall structure and its performance.

Re-installation or replacement of the door stop is advised as soon as possible to prevent any subsequent damage to the door or associated structures. A general handyman may be appointed to perform these works at client discretion.

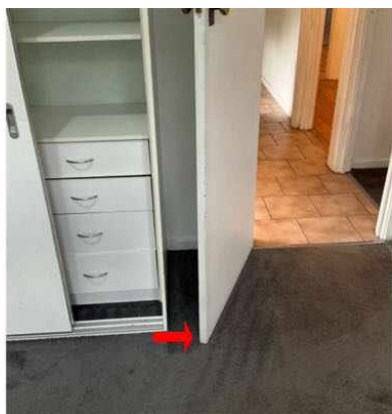
Finding 3.08

Building:	Main Building
Location:	Bedroom 3
Finding:	Door - Binding/jamming
Information:	Binding and/or jamming of this door is evident during standard operation. This defect inhibits the functionality of the affected door as well as creating potential for secondary defects to associated building elements, such as damage to the floor covering.

A door that binds to flooring or to the associated door frame may have several causes, ranging from minor defects, such as poor installation of the door or deteriorated hinges, through to major structural issues, such as damage to subfloor structures.

Where door binding/jamming appears to indicate major structural issues, a registered builder specialising in re-stumping should be appointed to provide an estimate on the cost of rectification.

For minor causes, a qualified carpenter or general handyman should be appointed to perform minor rectification works at client discretion.

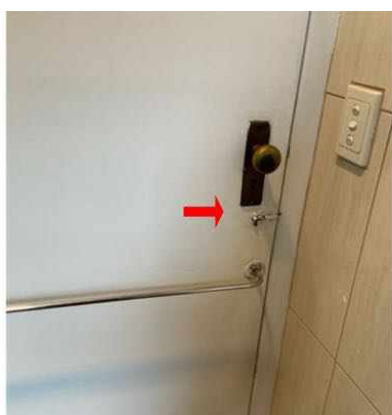
Finding 3.09

Information: It was noted that the door in this area was not latching during operation at the time of inspection. Whilst detracting from the functionality of this building element, this minor defect may also be a security risk, and may therefore have serious implications if left unattended.

It is suspected that this defect has occurred due to minor issues with the associated hinges. Such damage is identified as general wear and tear, which is expected for building elements of this age.

A qualified carpenter or general handyperson may be appointed to perform rectification works as necessary, at client discretion. If left unattended, further functional impairment is likely to occur.

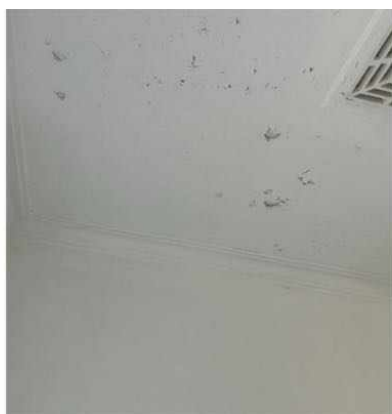
Building: Main Building
 Location: Bathroom
 Finding: Peeling paint was observed to the bathroom ceiling finish. Condensation
 Information: Peeling paint was observed to the bathroom ceiling finish.

This is commonly associated with ongoing high humidity/condensation and may indicate intermittent moisture exposure, which can lead to further paint failure and potential mould growth over time.

Improve ventilation (confirm exhaust fan is present and operating) and have the ceiling surface prepared and repainted with a suitable bathroom-grade moisture-resistant system after confirming no active moisture source is present.

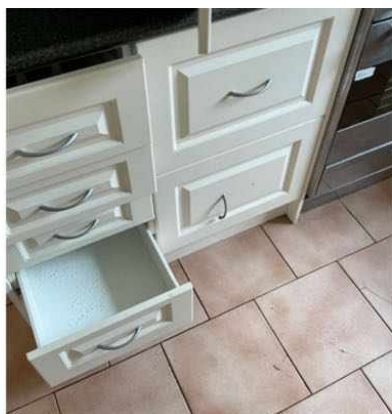
Building: Main Building
 Location: Kitchen
 Finding: Fitting or fixture - Loose
 Information: The fitting in this area is loose and requires adjustment to tighten.

If left unmanaged, the fitting may further deteriorate, causing potential for the development of other minor secondary defects.

A relevant tradesperson should be appointed to perform these rectification works at discretion of the client.

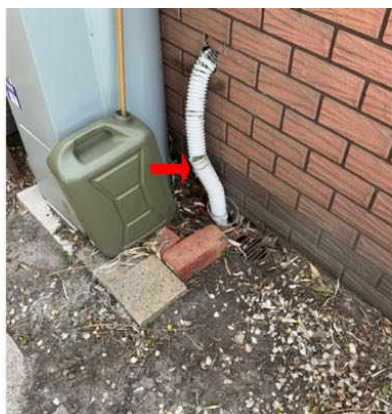
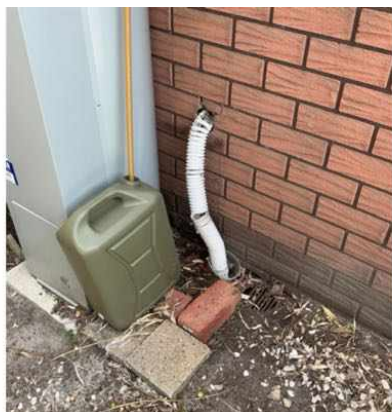
Finding 3.14

Building: Main Building
 Location: Laundry
 Finding: Broken pipe
 Information: When the laundry tap was turned on, water was observed leaking from a damaged external drain/pipe. This ongoing leakage can raise moisture levels in the surrounding area, which may adversely affect the footing/foundation over time, and may also allow moisture to enter the wall cavity and cause concealed damage. The elevated moisture conditions are also conducive to termite activity.

Engage a licensed plumber to investigate and repair/replace the damaged pipework and confirm all joints/connections are watertight. After repairs, monitor the area for continued dampness and consider further investigation (and a timber pest assessment if concerns persist) to check for any moisture-related damage or termite risk.

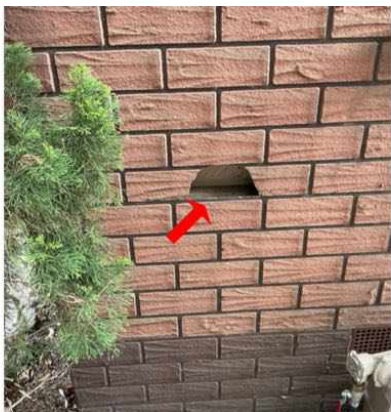
Building:	Main Building
Location:	Walls
Finding:	External wall cladding hole with timber borer damage
Information:	An opening/hole was noted in the external wall cladding, exposing internal timber. The exposed timber shows evidence consistent with wood borer activity (multiple small pin-holes).

The damaged timber may continue to deteriorate and the opening may allow moisture and pest/termite entry into the wall cavity.

Arrange a licensed timber pest inspector to assess the extent of borer activity and recommend treatment/rectification, then repair/replace affected timber as required and reinstate the cladding to fully close and seal the opening.

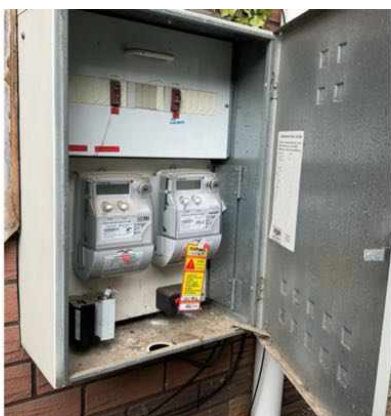
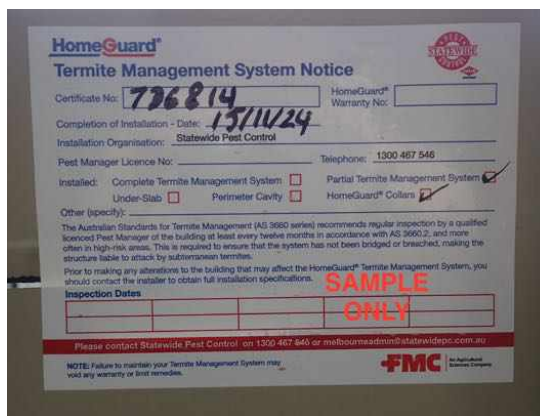
Finding 6.01

Building: Main Building
 Location: Electrical switchboard
 Finding: Termite Management System - no evidence of a chemical installation
 Information: The application of a post-construction chemical termite barrier is highly recommended for all properties, particularly if live termite activity has been found on the site previously. Such barriers are highly effective in preventing termite attack on any timber building elements throughout the property.

A durable notice should be placed in the switchboard unit to indicate current termite barriers. At the time of inspection, it appeared as though no termite management system has been installed, with no evidence to suggest preventative works taking place.

The client may consider gaining further advice from a pest controller as to the costs and procedures involved with this application. It is recommended that obtaining such advice be a short-term priority.

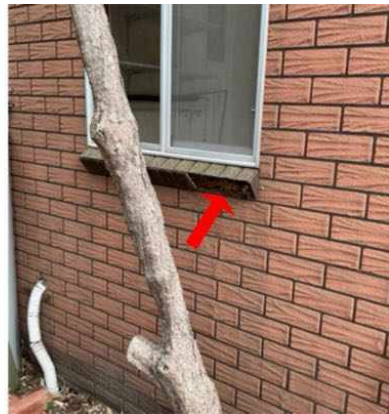
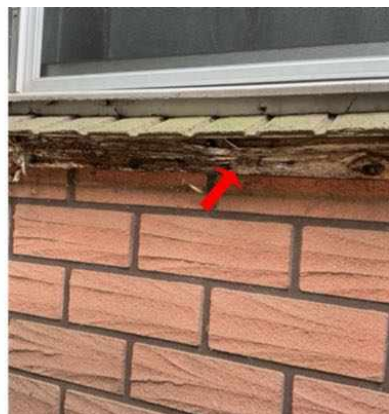
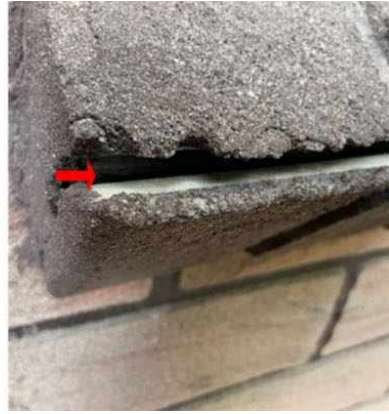
Finding 7.01

Building:	Main Building
Location:	Walls
Finding:	Window sill / lower cladding—severe deterioration and wood decay
Information:	The window sill/lower cladding shows severe damage with advanced timber decay, likely due to prolonged moisture exposure.

Deteriorated cladding can allow further moisture entry and progressive decay, and rectification may be costly even if not currently structural.

Engage a qualified carpenter/builder to replace the deteriorated sections and investigate/rectify the moisture source contributing to the decay, and factor the likely repair cost into your purchase decision.

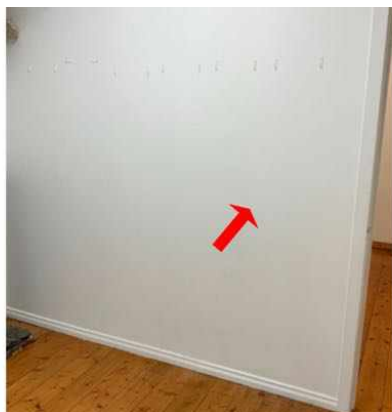
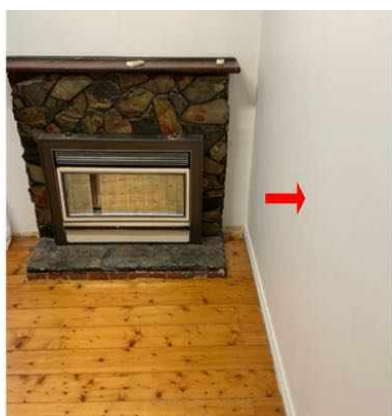
If the wall is not adequately supported, differential movement may occur, which can lead to settlement and cracking over time.

Monitor the wall for any signs of movement (e.g., noticeable settlement, new or widening cracks, sticking doors/windows). If movement is observed, engage a qualified builder/structural engineer promptly to assess and carry out repairs as required.

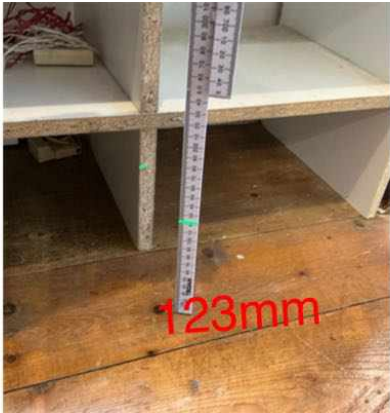
Building:	Main Building
Location:	All Areas
Finding:	floor unevenness - v4
Information:	The standard laser level was positioned 125 mm above the floor, as shown in the photo. The measured floor deviation across the room ranges from the lowest point to the highest point by approximately 10mm
