## Building Inspection Report

Inspection Date: Thu, 22 Jan 2026

Property Address: 19A Gloucester Ave, MERRYLANDS, NSW,  
2160, Australia

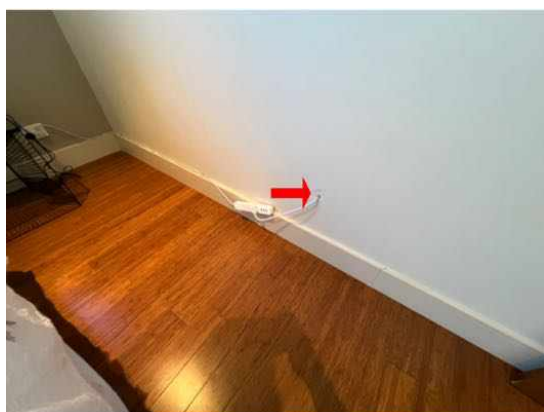
#### Defects 1.01

Building:	Main Building
Location:	Bedroom 4
Finding:	Exposed Electrical Cable to Internal Wall
Information:	An exposed electrical cable was observed protruding from the internal wall surface, with a power board connected externally.

Exposed electrical wiring presents a potential safety hazard, as it increases the risk of electric shock, accidental damage to the cable, and non-compliant electrical installation practices. The absence of a proper wall plate or conduit protection means the wiring is vulnerable to mechanical damage and does not appear to meet current electrical safety standards.

It is recommended that this issue be rectified as a priority by a licensed electrician. The cable should be correctly terminated within an approved outlet, conduit, or wall plate to ensure compliance and to eliminate potential safety risks. Repairs should be undertaken as soon as practicable.

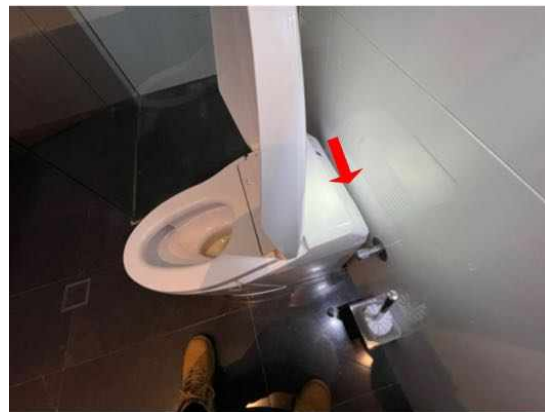
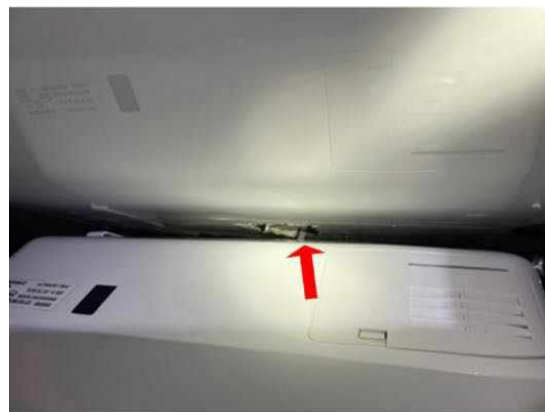
#### Defects 1.02

Building:	Main Building
Location:	Bathroom 2
Finding:	Unsecured Electrical Wiring Behind Toilet
Information:	An electrical cable was observed unsecured and inadequately protected behind the toilet cistern.

is present in close proximity to plumbing fixtures and moisture-prone surfaces.

Unsecured electrical wiring poses a potential safety risk, particularly within wet areas. The lack of proper fixing, mechanical protection, or enclosure increases the risk of damage to the cable, potential electric shock, and does not appear to comply with current electrical safety standards. The location behind the toilet also restricts visibility and access, increasing the likelihood of the issue remaining unnoticed.

It is recommended that this matter be rectified as a priority by a licensed electrician. The wiring should be properly secured, enclosed, and terminated in accordance with current electrical regulations to eliminate safety risks. Repairs should be carried out as soon as practicable.

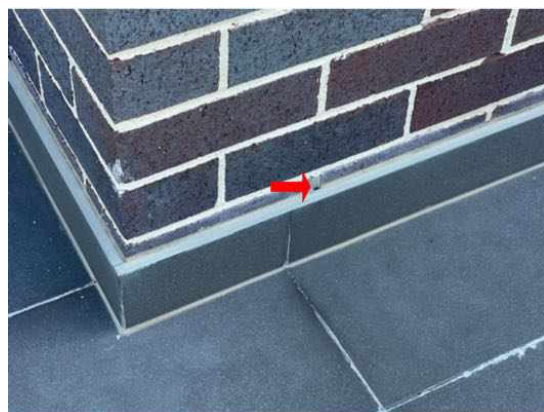
### Defects 3.03

Building: Main Building  
 Location: Balcony - Master bedroom  
 Finding: Weep holes - Blocked  
 Information: It was noted during the time of inspection that some of the weep holes to the brickwork were blocked. Weep holes are designed to allow water from leaks or seepages in brickwork to be directed to the external environment, prior to entering the wall cavity or associated building materials. Weep holes should therefore be kept clean and free of debris or blockages.

Blocked weep holes are likely to result in the presence of excessive moisture within the brickwork and associated structures, creating potential for water damage and moisture problems.

Depending on the nature of the blockage, the homeowner may be able to undertake remedial works to remove blockages. Alternatively, appointment of a registered builder may be required to remove blockages. Preventative works are necessary in ensuring the structural integrity of the affected brickwork and should be performed as soon as possible.

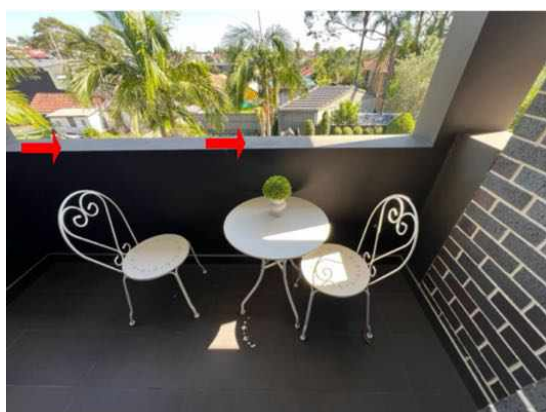
### Defects 3.04

Building: Main Building  
 Location: Balcony - Bedroom 2

Finding: Cracking to Bedroom 2 Balcony Walls

Information: Cracking was observed to the rendered masonry surfaces forming the Bedroom 2 balcony walls. The cracking appears to be hairline to minor in width and is typical of movement or shrinkage within rendered finishes.

The cracking is located along sections of the balcony wall, including the top edge and vertical wall surfaces adjacent to the balcony area of Bedroom 2.

Rendered masonry elements are susceptible to cracking due to thermal movement, differential movement between materials, building settlement, or shrinkage of the render over time. While the cracking observed is minor at the time of inspection and does not appear to be structural in nature, it may allow moisture penetration if left unsealed, particularly given the exposed nature of balcony areas.

It is recommended that the cracks be monitored and sealed with an appropriate flexible exterior sealant and redecorated as required to maintain weather resistance. If cracking increases in width, length, or becomes recurrent after repairs, further assessment by a suitably qualified builder or structural engineer may be warranted. Repairs should be carried out within a reasonable timeframe as part of ongoing maintenance.

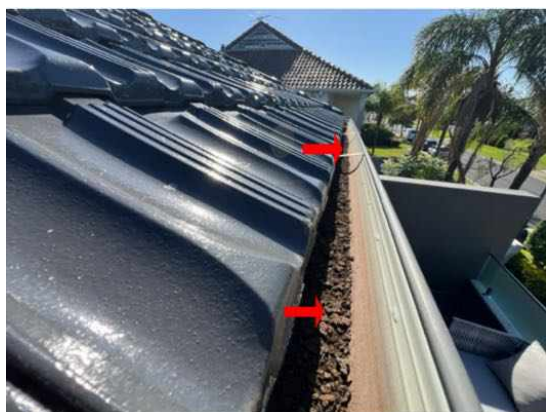
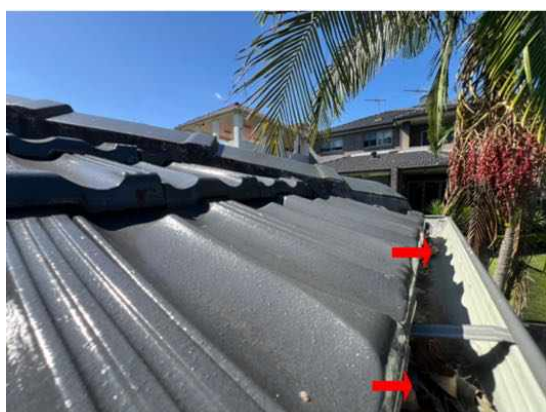
### Defects 3.05

Location: Roof Exterior  
 Finding: Debris Accumulation to Gutters  
 Information: Accumulated debris was observed within sections of the roof gutters at the time of inspection.

Debris accumulation within gutters can restrict the free flow of rainwater, increasing the risk of water overflow, which may lead to moisture damage to fascia boards, eaves, and external wall surfaces. Prolonged blockage can also contribute to premature deterioration of the guttering system.

It is recommended that the gutters be cleaned and cleared of debris as part of routine property maintenance. Ongoing periodic cleaning is advised, particularly in areas subject to leaf litter, to ensure the guttering system continues to function as intended.

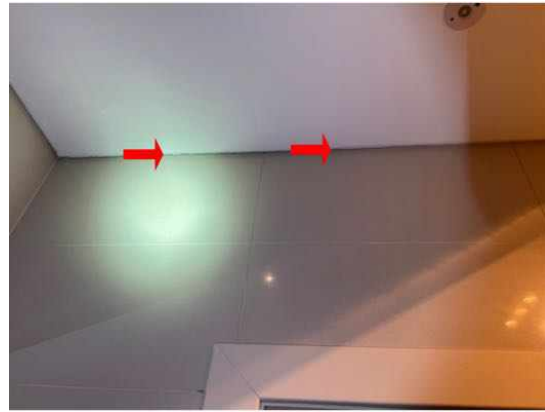
### Defects 3.07

Building:	Main Building
Location:	All Internal Areas
Finding:	Hairline Cracking to Upstairs Ceilings
Information:	Hairline cracking was observed to the ceiling linings in the upstairs areas of the dwelling.

The cracking is located along ceiling junctions and joint lines, including areas adjacent to cornices.

Hairline cracking to plasterboard ceilings is common and typically results from minor building movement, thermal expansion and contraction, or natural settlement over time. The cracking observed is cosmetic in nature and does not appear to indicate a structural issue at the time of inspection.

No immediate action is required other than ongoing monitoring. If the cracking increases in width, length, or is accompanied by sagging, staining, or moisture-related indicators, further assessment by a suitably qualified tradesperson or building

professional may be warranted.

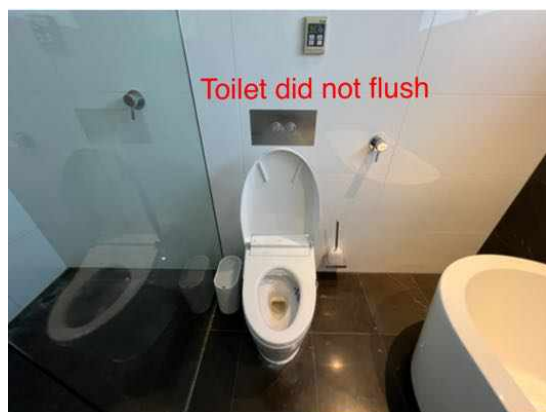
### Defects 3.12

Information: The toilet located within the bathroom did not flush at the time of inspection. As a result, the fixture was not operating as intended. This issue may be due to an internal cistern component fault, an adjustment issue, or a problem with the water supply to the toilet. No further investigation was carried out beyond the scope of this visual inspection.

This condition is considered a minor defect; however, it impacts the normal use of the bathroom. It is recommended that a suitably qualified plumber inspect the toilet and carry out any necessary repairs or adjustments to restore correct operation. Repairs should be undertaken in the short term.

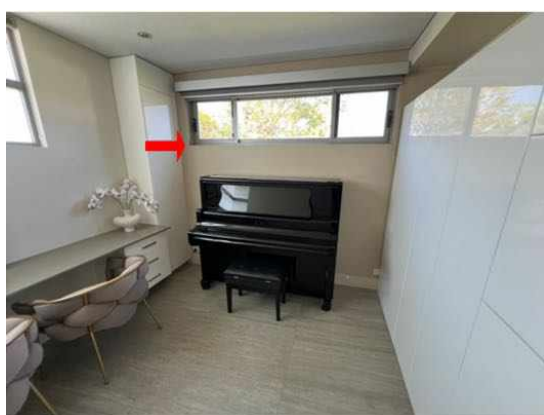
### Defects 3.17

**Finding:** Minor Cracking to Wall at Window Reveal  
**Information:** Minor cracking was observed to the internal wall lining adjacent to the window reveal. The cracking is located at the lower corner of the window opening, where the wall lining meets the window frame. This type of cracking is commonly associated with minor building movement, thermal expansion and contraction, or normal settlement of materials over time.

At the time of inspection, the cracking appeared minor and cosmetic in nature, with no signs of structural distress or moisture penetration noted. While this is not considered a major defect, it may worsen over time if left unattended. It is recommended that the cracking be monitored and repaired as part of routine maintenance by a qualified painter or plasterer, with repairs undertaken as required to maintain the internal finishes of the property.

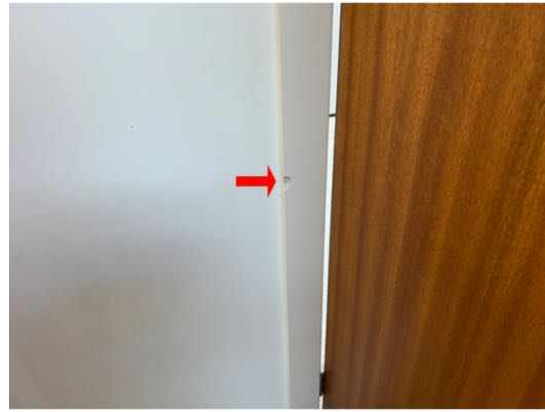
### Defects 3.18

**Building:** Main Building  
**Location:** Foyer  
**Finding:** Damage to Door Architrave  
**Information:** Minor damage was observed to the internal door architrave, with localised chipping and surface damage noted to the painted finish. The damage is located along the vertical edge of the architrave adjacent to the door leaf and is consistent with impact damage or general wear and tear over time.

At the time of inspection, the damage appeared cosmetic in nature and did not affect the operation of the door or indicate any structural concern. While this is considered a minor defect, it detracts from the internal presentation of the property. Repair by a qualified painter or carpenter is recommended as part of routine maintenance, with repairs to be undertaken at a suitable time to maintain internal finishes.

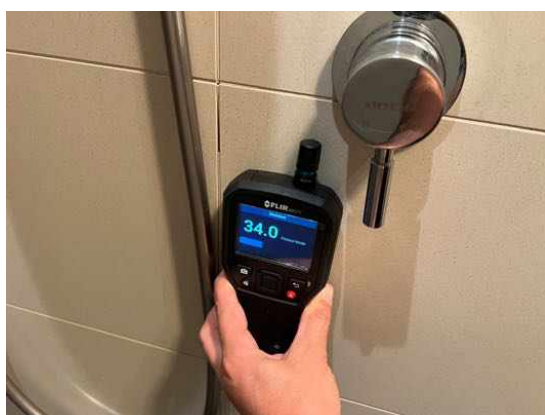
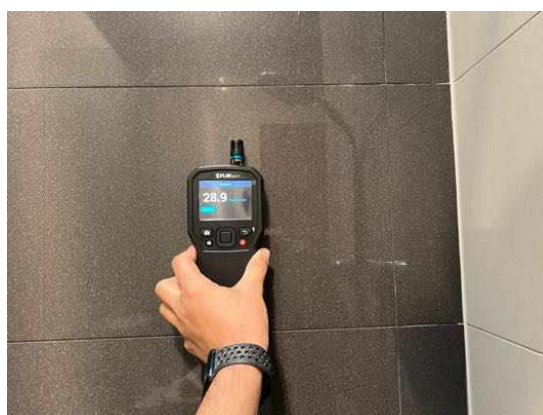
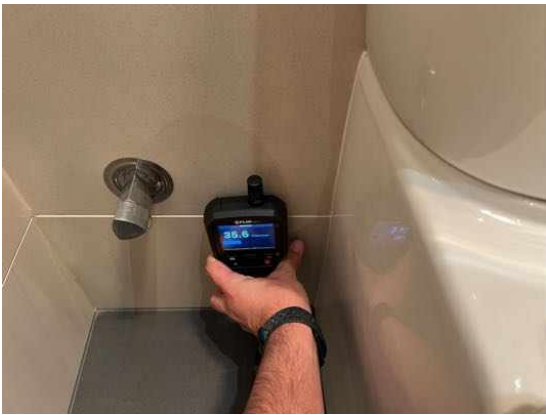
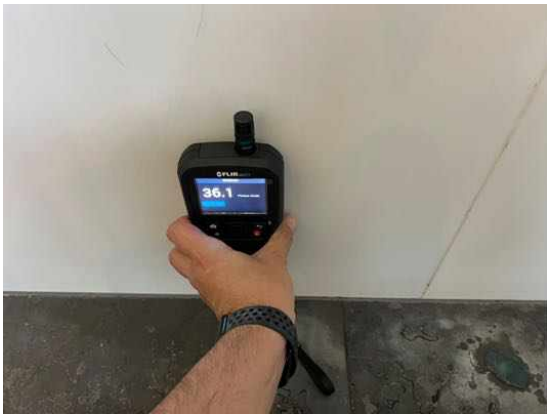
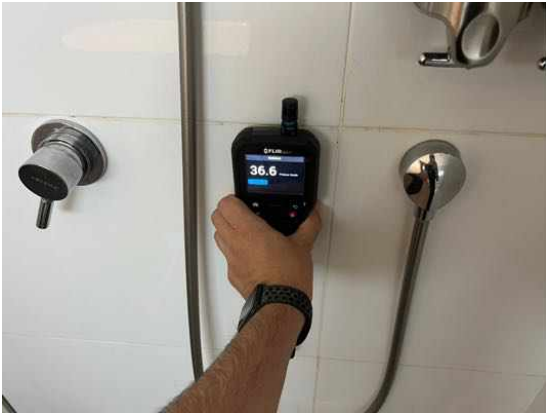
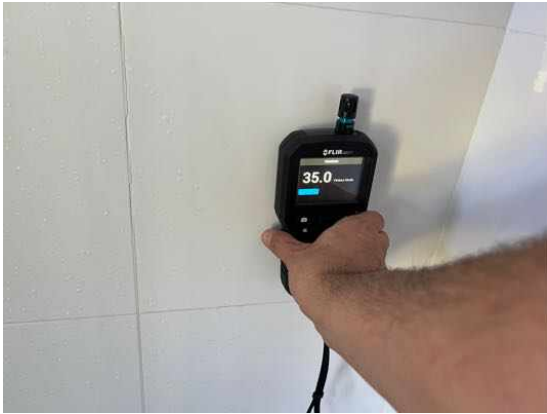
Building: Main Building  
Location: All Areas  
Finding: Moisture metre readings  
Information: Moisture testing was undertaken to selected accessible internal surfaces using a non-invasive moisture meter at the time of inspection. Readings obtained provide an indicative assessment only and are intended as a guide to assist in identifying areas that may warrant further investigation.

No invasive testing was carried out, and moisture readings can be influenced by a range of factors including material type, surface finishes, environmental conditions, and recent use of wet areas. As such, the results are provided for information purposes only and do not constitute a definitive assessment of concealed moisture conditions. Concealed defects may exist that were not evident at the time of inspection.

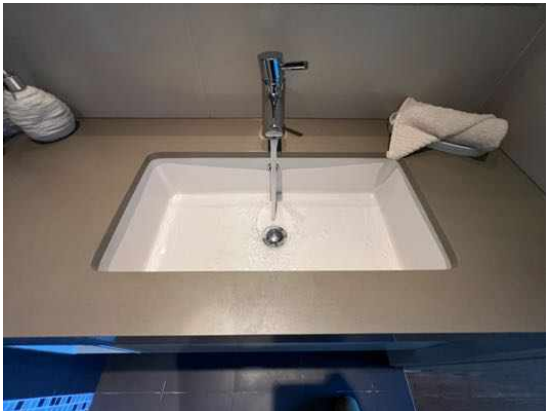
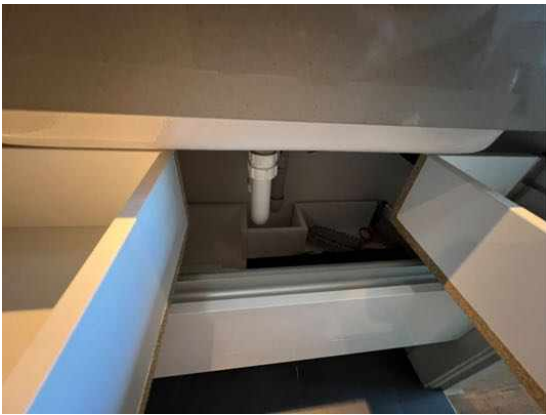
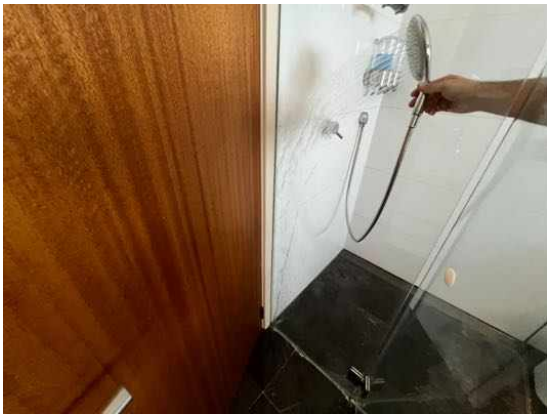
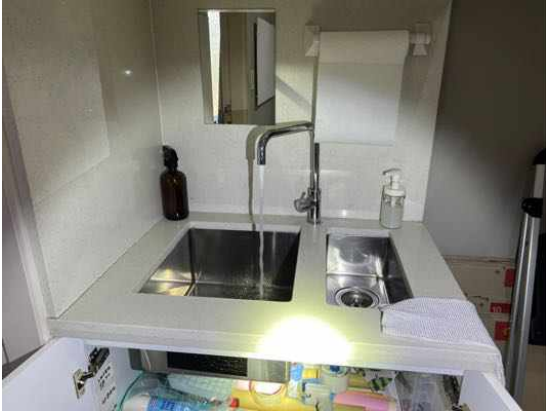
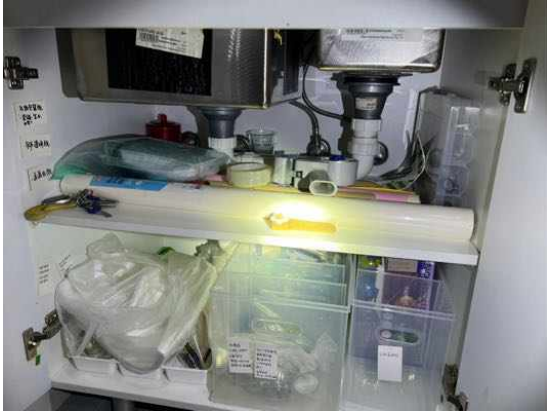
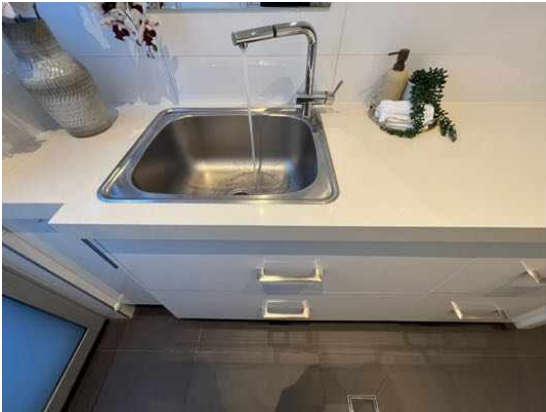
Noted Item

Building: Main Building  
Location: All Wet Areas  
Finding: Waterproofing  
Information: All taps, mixers, and toilets were tested for correct operation, except where access was restricted. The shower recess waterproofing was assessed by conducting non-invasive moisture readings to the walls in and around the shower recess. No abnormal or significant moisture variations were detected within the areas tested. In addition, a visual inspection of the surrounding wall surfaces did not reveal any visible signs of recent or ongoing water damage where inspection was possible.

Based on the above observations, there is no conclusive evidence to suggest the presence of an active shower recess leak at the time of inspection, other than any issues already identified elsewhere in this report. It is therefore reasonable to assume that the shower waterproofing is currently performing as intended. However, it should be noted that if the shower has not been used for an extended period prior to the inspection, moisture readings may not accurately reflect underlying conditions and may result in misleading outcomes. As this inspection is limited to visual and non-invasive methods in accordance with pre-purchase inspection standards, it is not possible to definitively confirm the absence of leaks. If a higher level of certainty is required, a specialist invasive inspection is recommended.

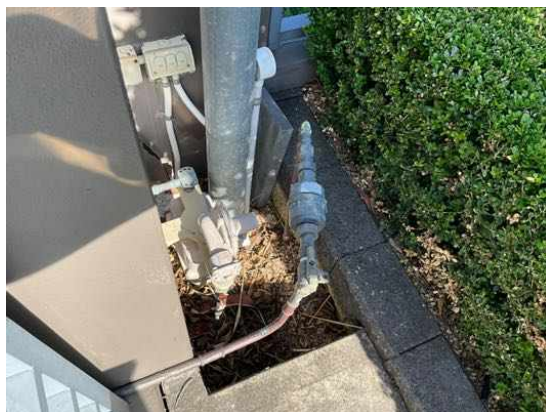
Clients are advised that servicing, testing, maintenance, and certification of electrical

and gas installations fall outside the scope of this inspection. Any concerns regarding the condition, operation, or compliance of these services should be referred to appropriately licensed electricians, gas fitters, or service authorities as required.
