Building Inspection Report

Inspection Date: Thu, 5 Feb 2026

Property Address: 7 Twilight Dr, Mudgeeraba QLD 4213,
Australia

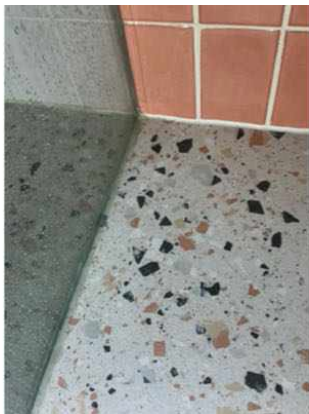
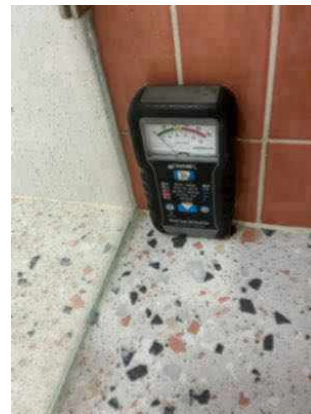
Defects 3.01

Building: Main Building
 Location: Bathroom > Rear Right
 Finding: Shower screen- leaks
 Information: At the time of inspection it was noted that the shower screen has minor leak.

Although minor leaks to shower screens may seem insignificant, they may cause damage to other fixtures such as grout ,vanities

And create mould damage which may become costly.

Re-Sealing of screen is recommended to be rectified as soon as possible to stop further deterioration.

A handyman may be required to rectify this condition.

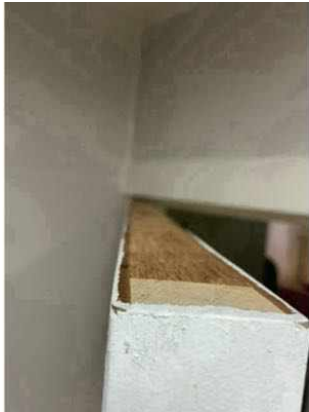
Defects 3.02

Building: Main Building
 Location: Bathroom > Front
 Finding: Door edge sealing - defective

Information: It was observed that there are areas where the door leaves do not have all sides top and / or bottom edges sealed. The edges of doors must be sealed to prevent moisture ingress and to comply with Standards and Tolerances

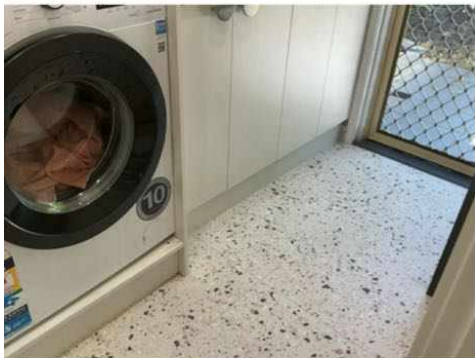
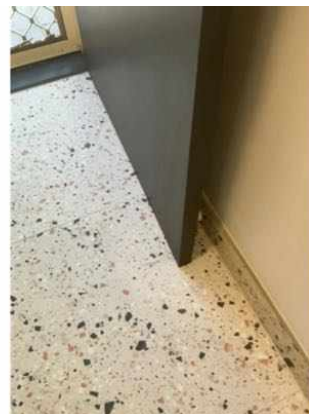
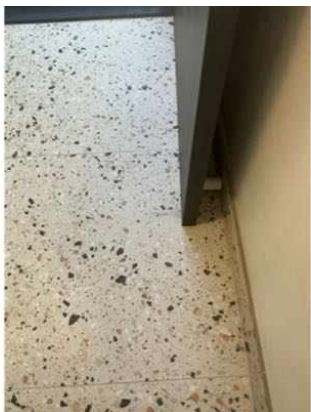
Defects 3.03

Building: Main Building

Location: Laundry > Rear

Finding: Door - Binding

Information: Binding of this door is evident during standard operation. This defect inhibits the functionality of the affected door as well as creating potential for secondary defects to associated building elements, such as damage to the door jamb.

For minor causes, a qualified carpenter or general handyman should be appointed to perform minor rectification works at client discretion.

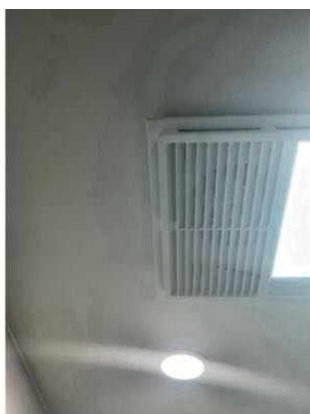
Building: Main Building
Location: Bathroom > Front Left
Finding: Installation - substandard or incomplete - exhaust
Information: The installation of this fan appears to have been completed to a substandard level of workmanship or is incomplete. Generally substandard repairs or installation are related to poor workmanship, the use of inappropriate materials, or a failure to complete installation to a suitable standard.

Where installation is substandard and/or incomplete, the client should contact the responsible trade to undertake rectification. Unfinished and substandard building works are likely to degrade more quickly and may create potential for secondary defects to associated building elements.
