Building and Timber Pest Inspection Report

Inspection Date: Thu, 5 Mar 2026

Property Address: 32/538 Woodville Rd, Guildford NSW 2161,
Australia

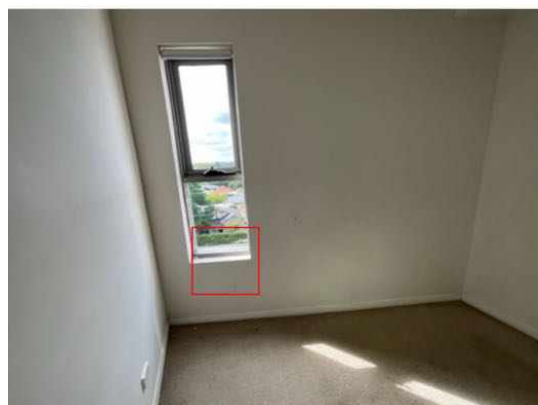
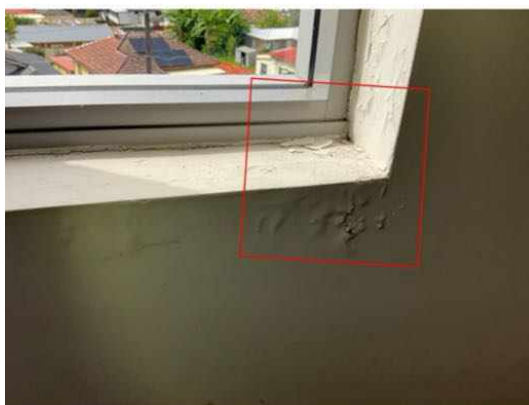
Finding 2.01

Building:	Main Building
Location:	Bedroom 2
Finding:	Rain penetration suspected
Information:	Rain penetration (also known as penetrating damp) is a common form of dampness that can occur through walls, roofs or openings (e.g. windows).

Common causes include faulty or missing flashing, cracked tiles, degraded pointing, lack of sealant and blocked weep holes. Rain penetration can also occur when water tracks horizontally under the lip of eaves and roof linings with insufficient angles, or by tracking across wall ties.

Rain penetration is suspected around the window to bedroom 2. A roof restoration specialist or a licensed roofing plumber must be appointed urgently for assessment and repair.

The cause of the water leak should be addressed immediately to prevent further damage. It is recommended that the water leak be resolved prior to any repairs of the damaged area, which may require localised replacement of building materials and refinishing.

Trades responsible for such works may include roofing restoration specialists or licensed roofing plumbers.

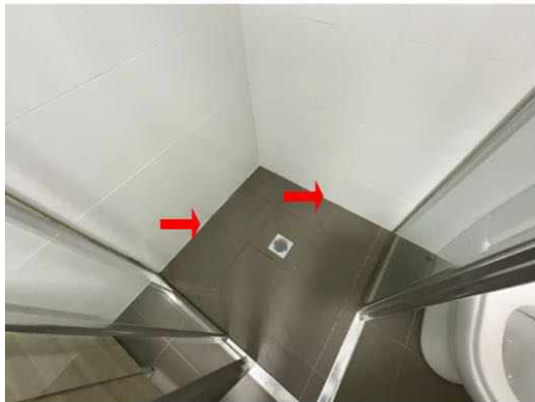
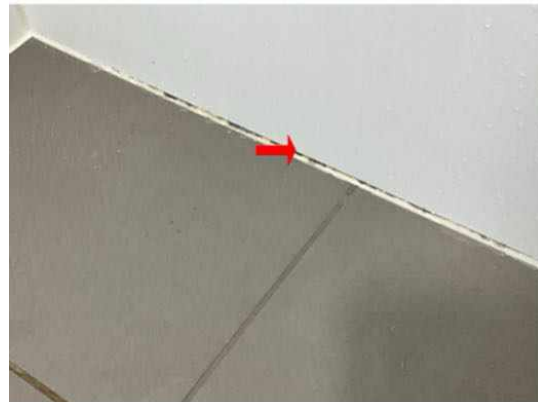
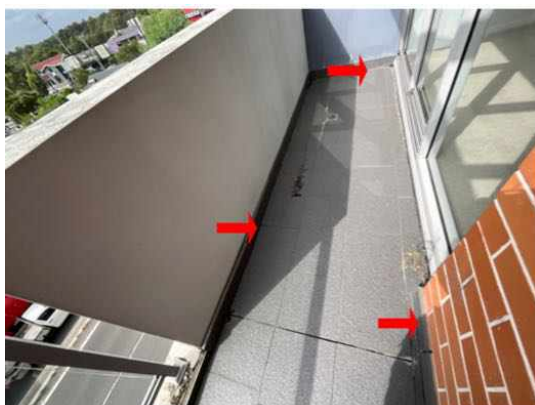
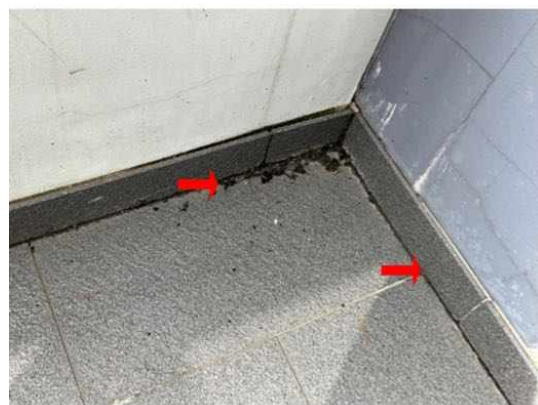
Finding 3.01

Building: Main Building
Location: All Wet Areas
Finding: Sealant and grouting - Missing or damaged
Information:

It was noted on inspection that sealant or grout is degraded to this area.

Different materials and floor areas move at different rates, generally causing cracking to grout or sealant at this point. A flexible sealant is required to allow for expected expansion and contraction, while keeping the joint water tight and protective of all associated building materials.

Flexible and mould resistant materials should be applied to affected areas to prevent any subsequent water damage that is likely to occur. Regular maintenance and replacement of damage or missing or damaged sealant and grout is highly recommended to the wet areas, as this is a regular wear and tear defect. Sealant and grouting in areas that come into regular contact with water should be maintained for the long term care of your property.

A sealant specialist should be appointed to complete these works as soon as possible.

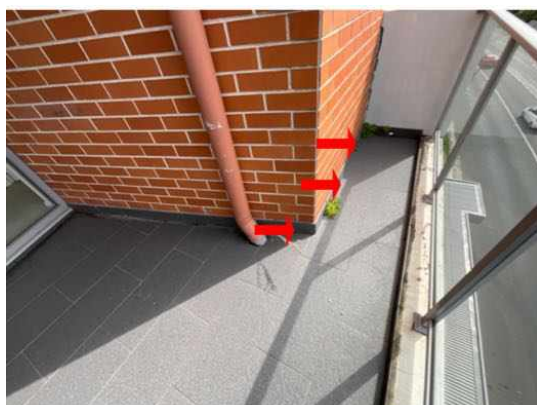
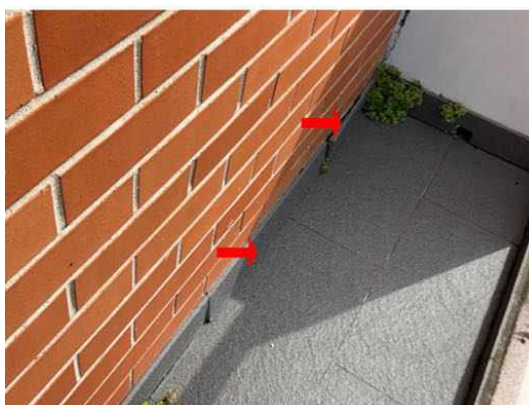
Finding 3.02

Building: Main Building

Location: Balcony
 Finding: Tiles - Drummy
 Information: Drummy tiled areas were identified at the time of inspection. The term 'drummy' refers to tiles that have become detached from their fixing, despite otherwise being in relatively good condition. Such defects are generally caused by physical or moisture damage to the area. Drummy tiled areas may also be a direct result of poor workmanship during the construction process.

Tiled areas may swell and shrink with changes in air humidity if the area has sustained moisture damage. Any exposure to moisture is capable of causing tiled areas to become drummy and/or cracked over a prolonged period of time. Drummy tiled areas generally require removal and replacement of affected tiles, with adequate sealant and grouting.

Specialist trades are available for these types of services. A licensed tiling contractor may be appointed to perform works as necessary.

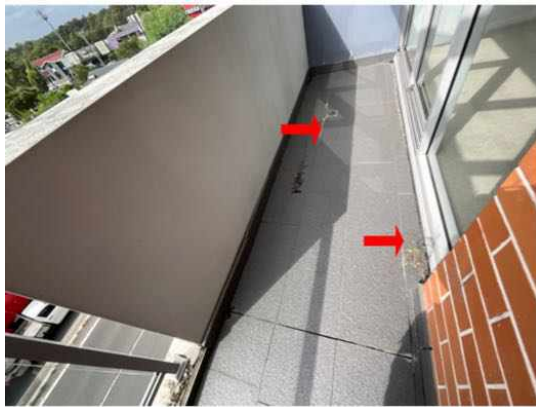
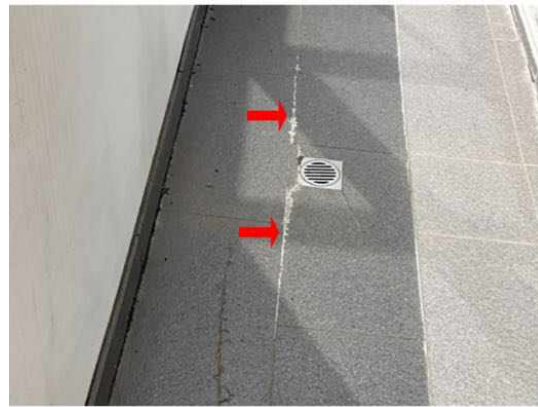
Finding 3.03

Building: Main Building
 Location: Balcony
 Finding: Efflorescence
 Information: Efflorescence appears to be affecting the brickwork, concrete or tiles in this area. Efflorescence typically occurs when excess salts within the concrete or cement mortar is leached to the surface due to water transfer.

It is typically seen as white salt deposits on the surfaces of concrete pavement or mortar between bricks or tiles. While detracting from the overall appearance of the affected area, efflorescence is not likely to develop into secondary damage if left unmanaged.

Generally, soluble salt deposits can be removed by dry brushing with a stiff-bristled brush. Repeated dry brushing is an ideal treatment for eliminating this forming of efflorescence. A cleaning contractor or general handyperson may be appointed to

perform these works at the discretion of the client.

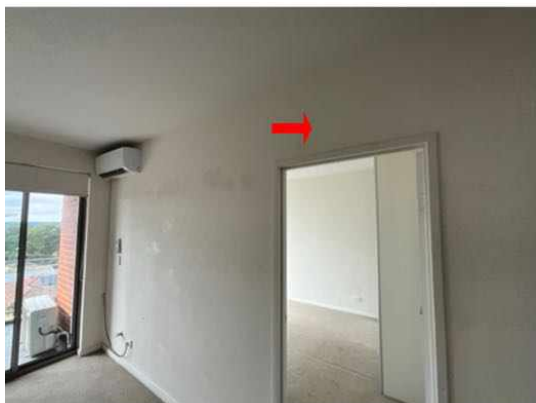
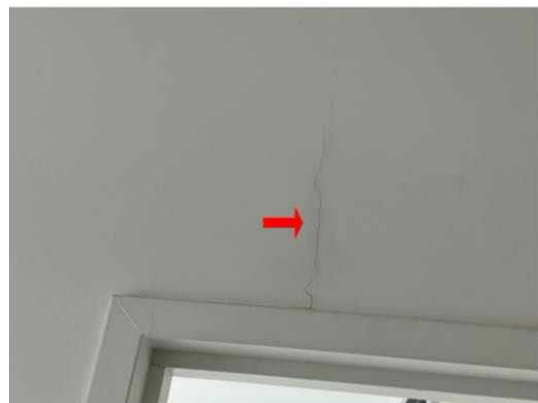
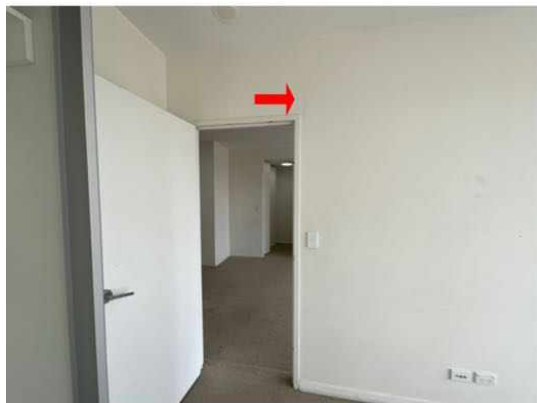
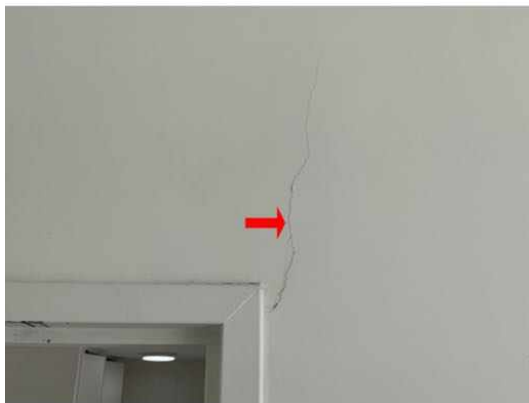
Finding 3.04

Building:	Main Building
Location:	Bedroom - Master
Finding:	Cracking - Damage Category 1 - Fine (up to 1mm)
Information:	Although fine cracks are quite noticeable, they are often only considered to be an appearance defect, and usually do not indicate any structural damage. Generally, the cause of a fine crack is indicative of a separation between building materials and finishes (e.g. paint, plaster, etc.) along joints.

Cracking of this nature can generally be repaired with minor sanding, filling and/or repainting. Such works should be performed by a qualified painter or a general handyman.

Monitoring of all cracking should be conducted frequently. Always contact a building inspector should cracks widen, lengthen, or become more numerous.

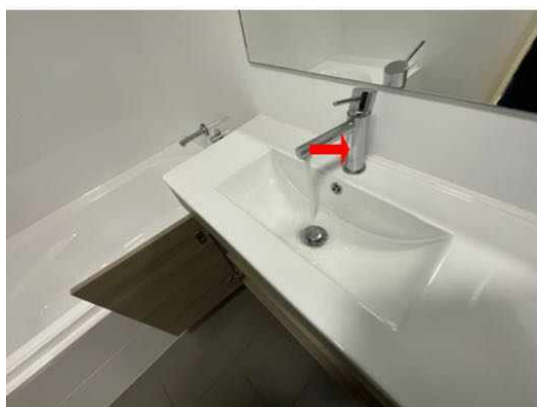
Finding 3.05

Building: Main Building
 Location: Bathroom
 Finding: Plumbing fitting or fixture - Loose
 Information:

The fitting in this area is loose and requires adjustment to tighten.

If left unmanaged, the fitting may further deteriorate, causing potential for the development of other minor secondary defects.

A licensed plumber should be appointed to perform these rectification works at discretion of the client.

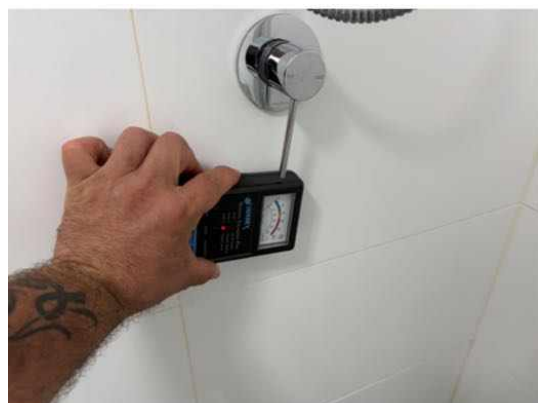
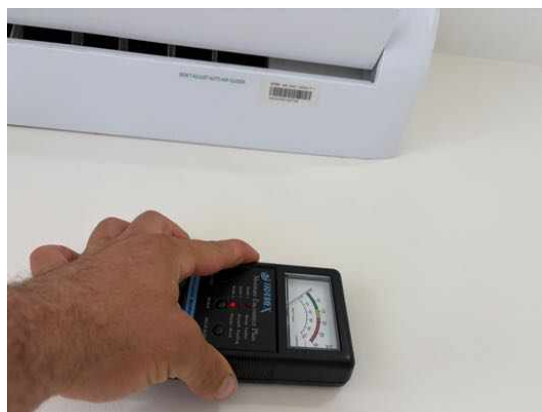
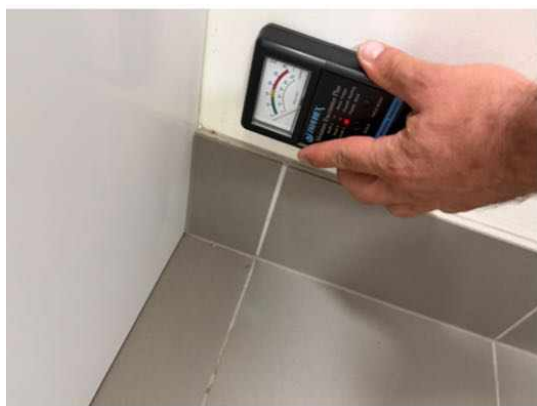
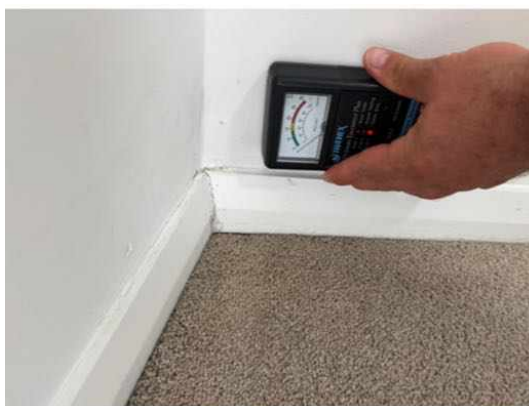
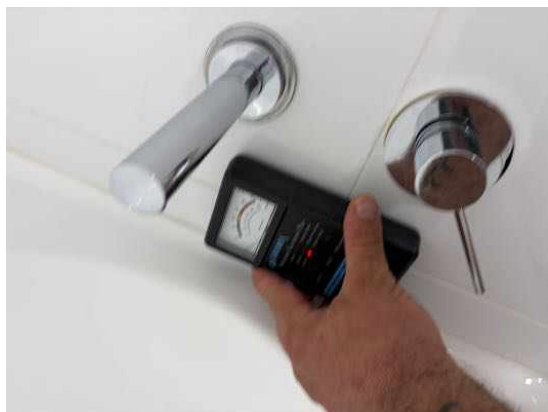
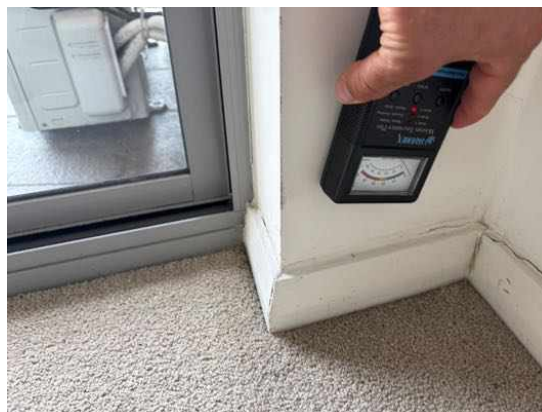
Building: Main Building
 Location: All Areas
 Finding: Moisture metre
 Information: During the inspection the property was checked for moisture using a moisture metre.

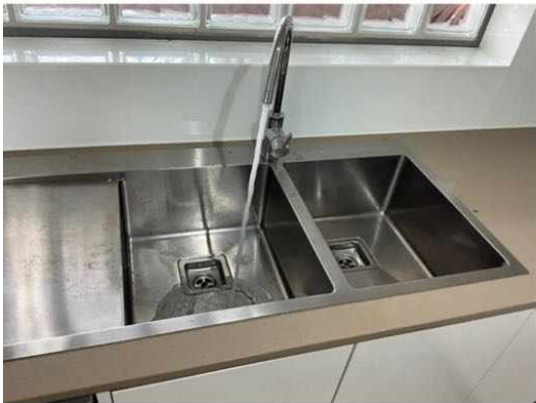
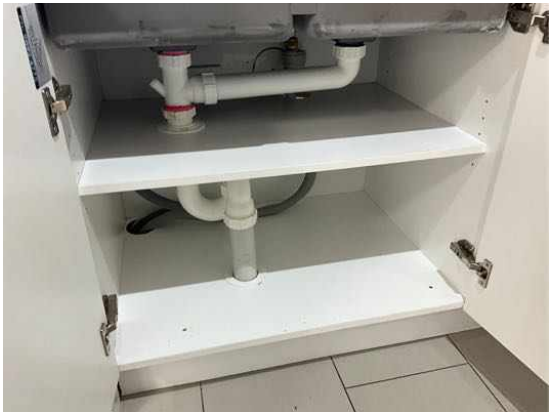
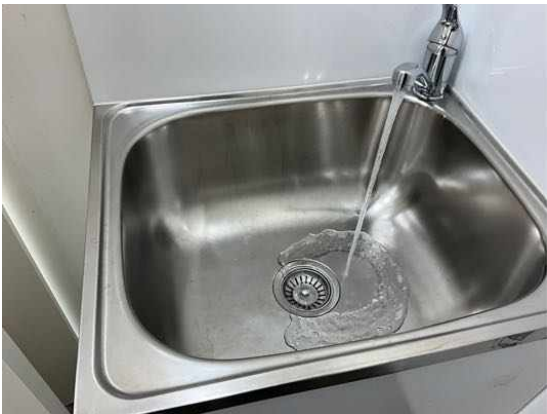
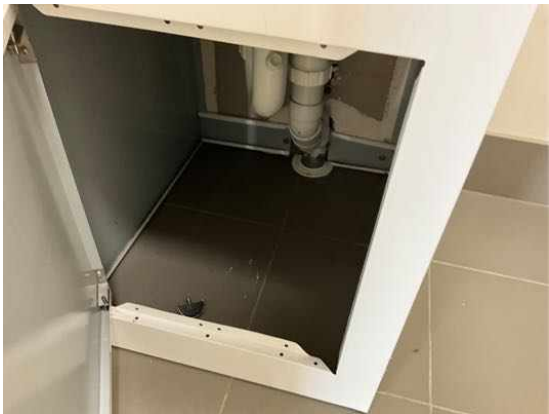
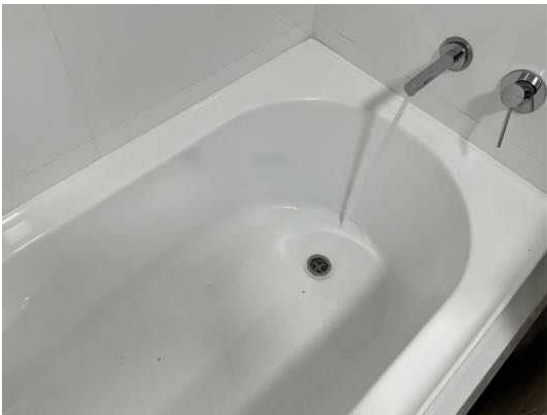
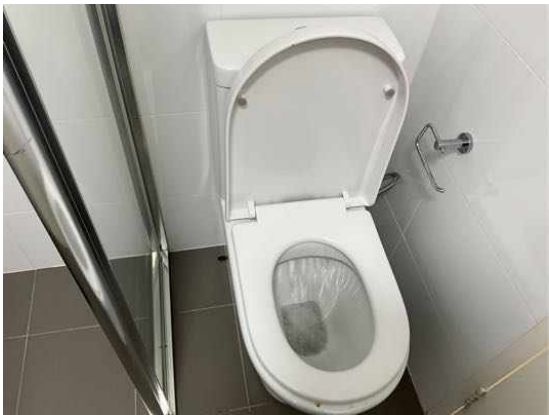
Building: Main Building
 Location: All Wet Areas
 Finding: Waterproofing
 Information:

All taps, mixers and toilets were tested for operation, except for those obstructed. The waterproofing to the shower recess was assessed by checking the walls in and around the shower recess for varying moisture content. There were no significant variations across the tested areas. No sign of recent water damage was evident upon a visual inspection of the surrounding walls, where the visual nature of the inspection was possible.

Consequently, there is no conclusive evidence of any current shower recess leakage other than those which may have already been mentioned earlier in this report. It is reasonable to assume the shower waterproofing is sound. Note that if the shower is not used, or has not been used for some time, moisture readings would not vary significantly and this can lead to erroneous results. It is not possible under the visual inspection criteria (under which a prepurchase inspection is carried out) to categorically determine if there are leaks. If a more accurate assessment is required, a special purpose inspection should be requested. Alternatively, the assumption should be made that the shower may leak.

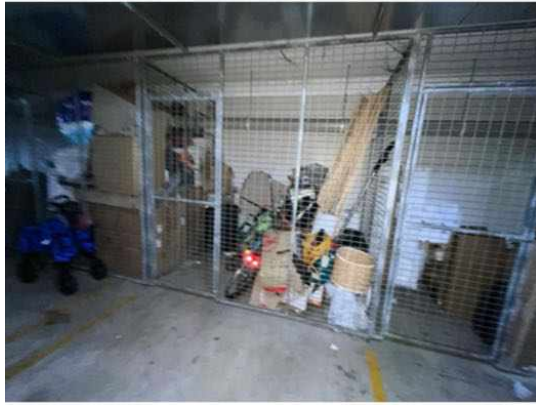
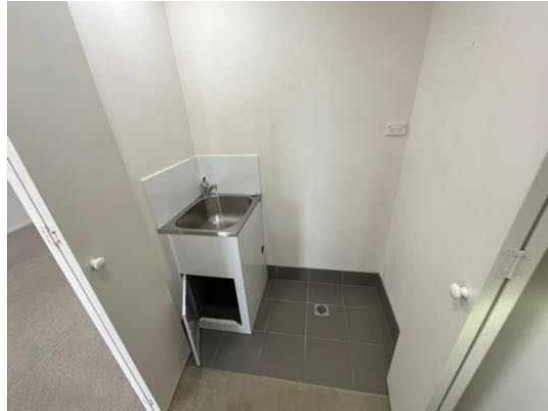
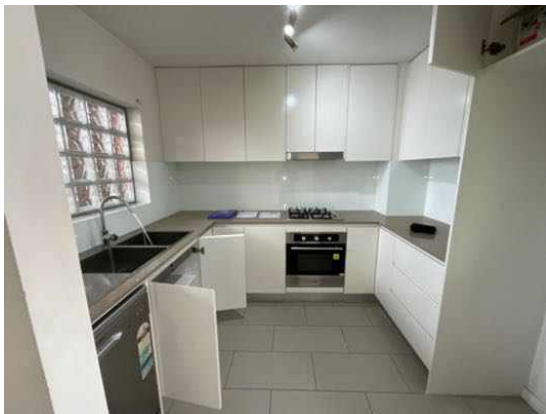
Building: Main Building
 Location: All Areas

Finding: Additional Photos - Obstructions and Limitations

These photographs are an indication of the obstructions and limitations which impeded full inspection of the property at the time of inspection. These obstructions can hide an array of defects and should be removed to allow full inspection to be carried out. A re-inspection is recommended once the areas are made accessible.
