Building and Timber Pest Inspection Report

Inspection Date: Fri, 27 Feb 2026

Property Address: 572 Iluka Cres, Lavington NSW 2641,
Australia

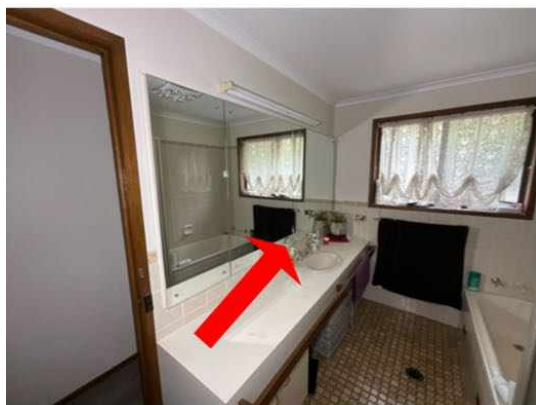
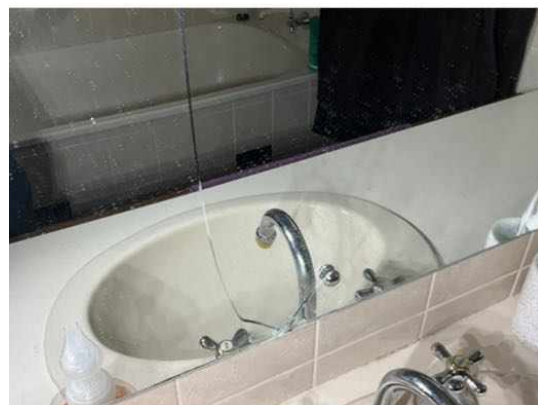
Finding 1.01

Building: Building 1
 Location: Bathroom
 Finding: Mirror - Cracked
 Information: Cracks were identified in the mirror in this area. Cracking in mirrors is generally the result of impact damage, and is likely to develop further when left unmanaged.

Cracking affects the use and quality of the mirror and may cause damage to surrounding structures (e.g. tiling ingress of moisture) if the initial damage is not fixed or managed. The increased likelihood of the mirror further cracking and/or shattering also poses a safety hazard in the area.

A qualified mirror or glass repair service may be required to repair the damage. Where damaged extensively, replacement of the mirror may be required. Alternatively, a carpenter or handyman can remove and rehang mirrors into built in cabinetry.

Please be advised that any persons coming into contact with the cracked mirror should do so with due caution to avoid any personal injury that may ensue.

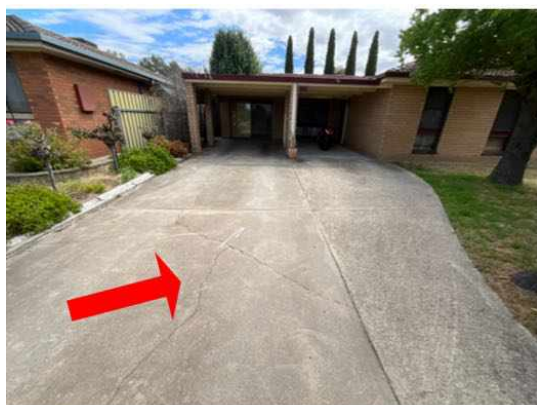
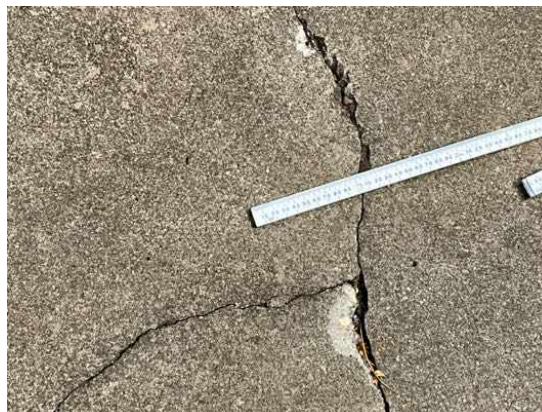
Finding 3.01

Location:	Driveway
Finding:	Cracking - External Concrete Paving Damage Category 3 - Wide Cracks (2mm - 4mm)
Information:	Wide cracks were identified in external concrete paving. Wide cracks are significant and are likely to lead to the development of safety hazards and secondary defects if left unmanaged.

General age and expected deterioration of the paved areas is a common cause of this type of cracking. However, expansion and contraction of the slab may also have occurred due to environmental factors. Such factors include variable moisture and weather conditions, the presence of trees and their roots having a settling or lifting affect on the soil, or the effect of load bearing, e.g. heavy vehicles over a sustained period of time.

Cracking to this degree may also be due to poor original installation of the concrete. Factors such as poor compaction of the sub surface and/or inadequate reinforcing of the slab may create cracking and other secondary defects. Wide cracks may also have a more significant structural cause, such as subsidence of soils.

Where the crack is located adjacent to structural elements of the building, the advice of a Structural Engineer is advisable before undertaking repairs. Significant repair and likely replacement of the concrete paving is probable.

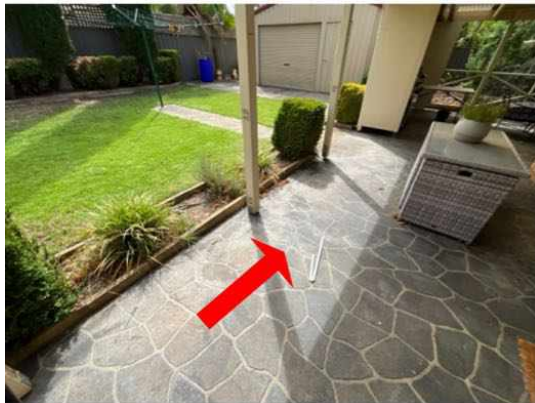
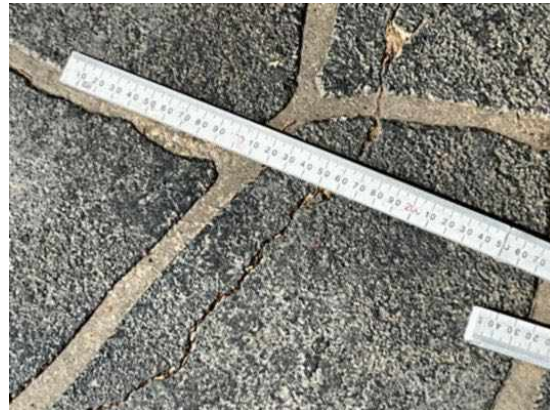
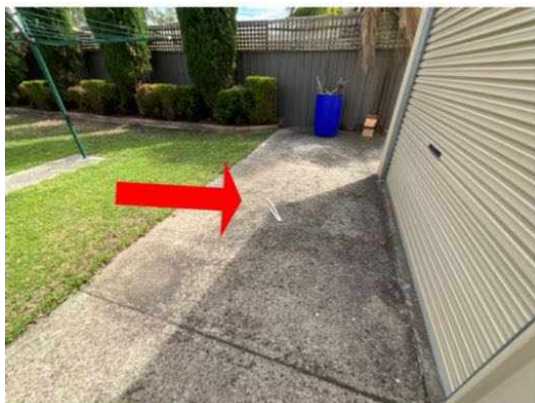
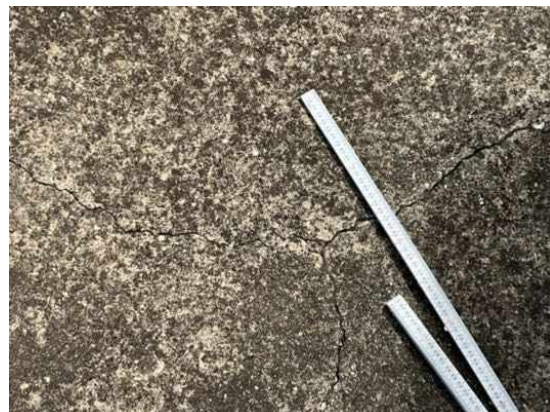
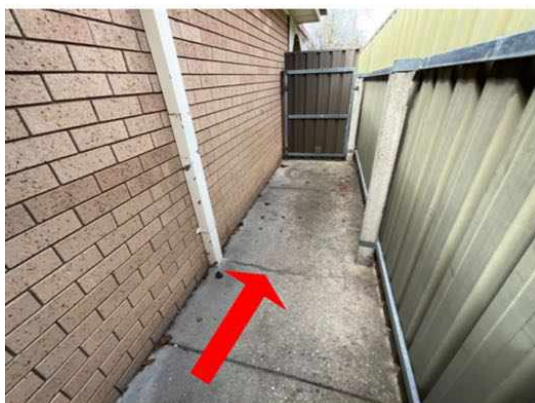
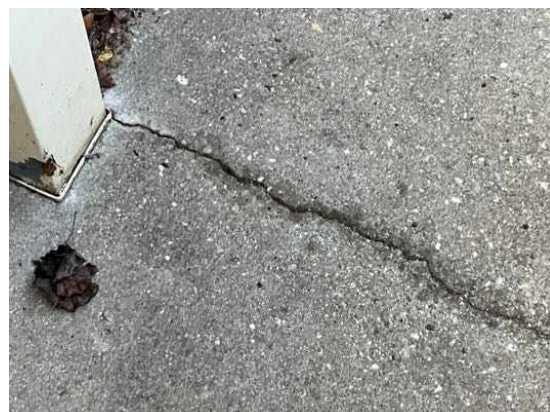
Finding 3.02

Building:	Building 1
Location:	Alfresco, yard- back
Finding:	Cracking - External Concrete Paving Damage Category 1 - Fine (less than 2mm)
Information:	Fine cracks were identified in external concrete paving. Although fine cracks are quite noticeable, they are often only considered to be an appearance defect, and usually do not indicate any structural damage. To be considered a Category 1 or fine crack, the crack is found to be less than 2mm in width.

Generally the cause of a hairline crack in existing concrete paving such as driveways and pathways is indicative of the expansion and contraction of the concrete. Such

causes are generally due to environmental factors, such as moisture levels, weather conditions, root systems of nearby trees or the soil types on which they are laid.

Fine cracks may also be due to poor original installation of the concrete. Factors such as poor compaction of the sub surface and/or inadequate reinforcing of the slab may create cracking and other secondary defects.

Monitoring of all cracking should be conducted frequently. Always contact a building inspector should cracks widen, lengthen, or become more numerous.

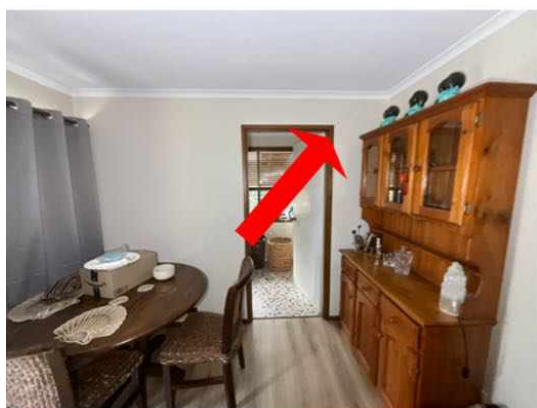
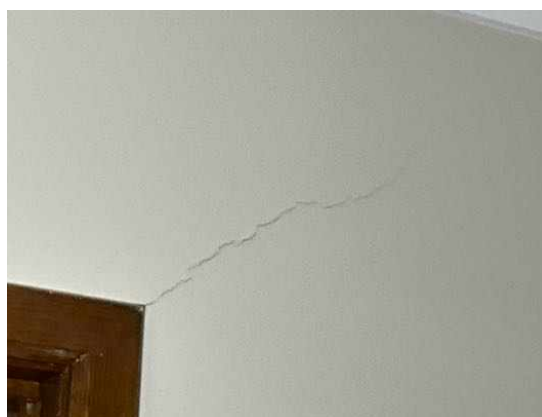
Finding 3.03

Location: Dining Room

Finding: Cracking - Damage Category 1 - Fine (up to 1mm)

Information: Although fine cracks are quite noticeable, they are often only considered to be an appearance defect, and usually do not indicate any structural damage. Generally, the cause of a fine crack is indicative of a separation between building materials and finishes (e.g. paint, plaster, etc.) along joins.

Cracking of this nature can generally be repaired with minor sanding, filling and/or repainting. Such works should be performed by a qualified painter or a general handyman.

Monitoring of all cracking should be conducted frequently. Always contact a building inspector should cracks widen, lengthen, or become more numerous.

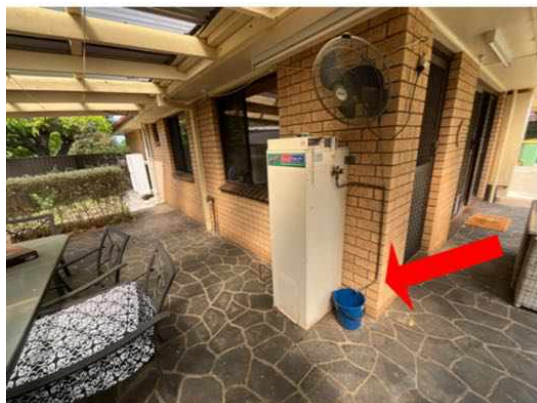
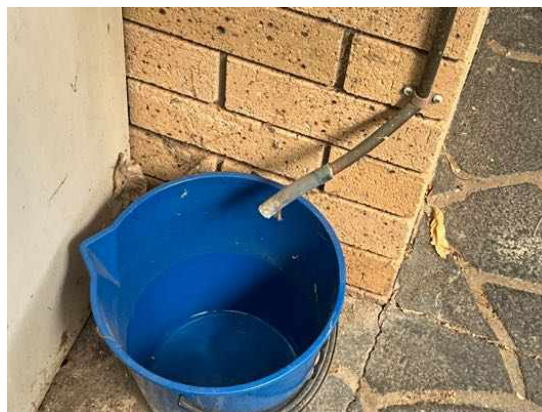
Finding 6.01

Location: Alfresco

Finding: HWS Overflow - Not Connected

Information: The Hot Water System (HWS) overflow was found to be disconnected from storm water drainage and is creating excessive moisture in the surrounding area.

These damp conditions can lead to secondary defects such as rot, rust or corrosion

of associated building elements, the formation of fungal decay, or even the creation of potential slip hazards. When coupled with poor site drainage, pooling of water may also attract termite activity to this area.

It is highly recommended that a licensed plumber be appointed to connect the HWS overflow in order to prevent such an environment from being created. These minor works should be carried out as soon as possible.

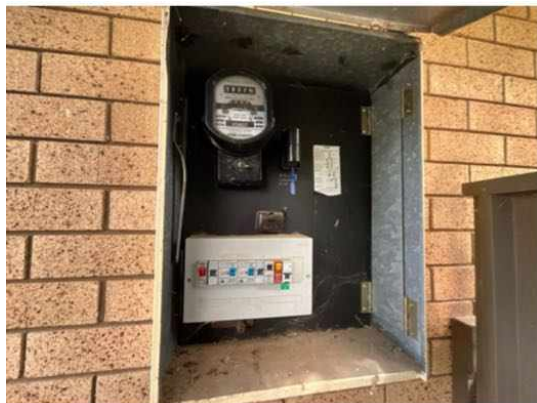
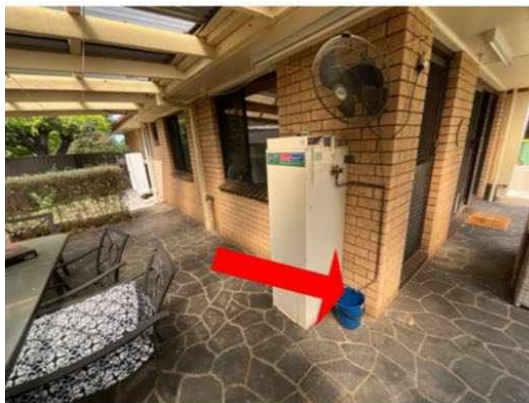
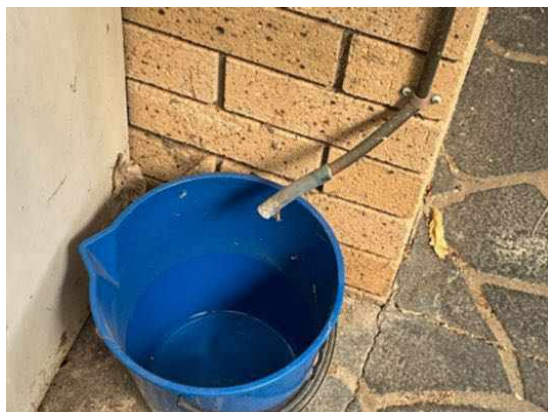
Finding 6.02

Building:	Building 1
Location:	All External Areas
Finding:	Termite Management System - no evidence of a chemical installation
Information:	The application of a post-construction chemical termite barrier is highly recommended for all properties, particularly if live termite activity has been found on the site previously. Such barriers are highly effective in preventing termite attack on any timber building elements throughout the property.

A durable notice should be placed in the switchboard unit to indicate current termite barriers. At the time of inspection, it appeared as though no termite management system has been installed, with no evidence to suggest preventative works taking place.

The client may consider gaining further advice from a pest controller as to the costs and procedures involved with this application. It is recommended that obtaining such advice be a short-term priority.

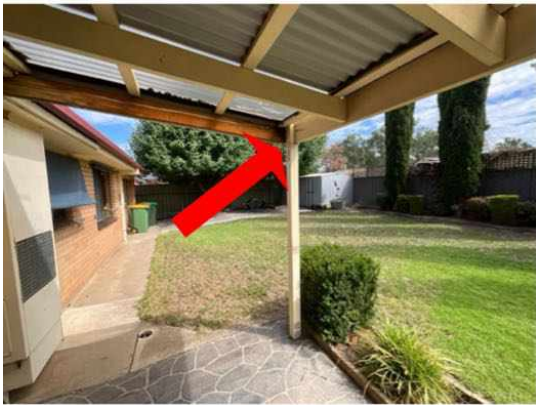
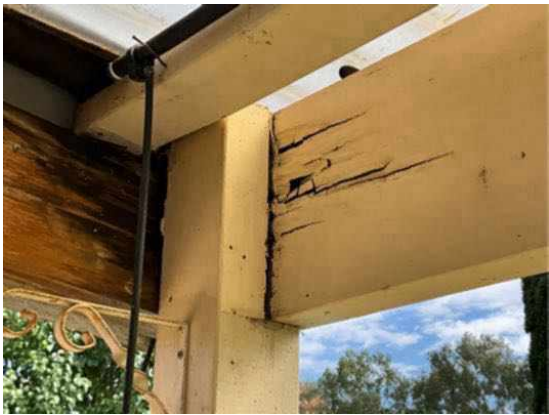
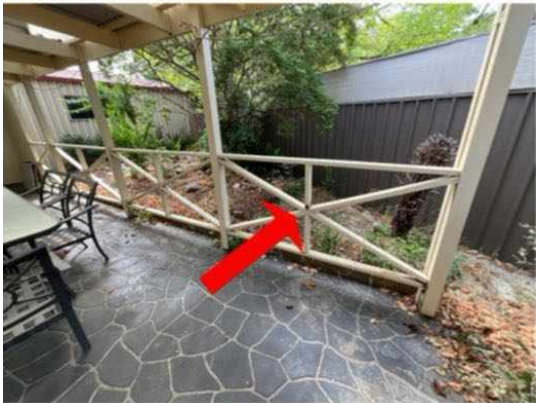
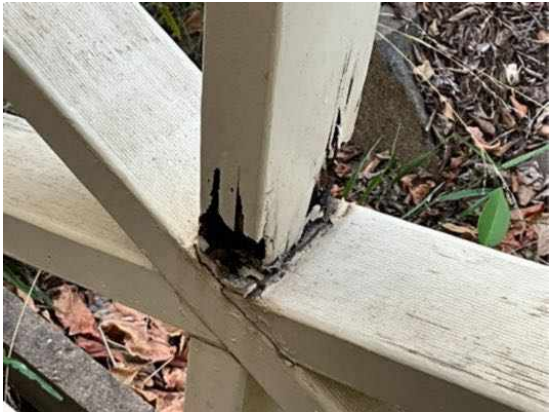
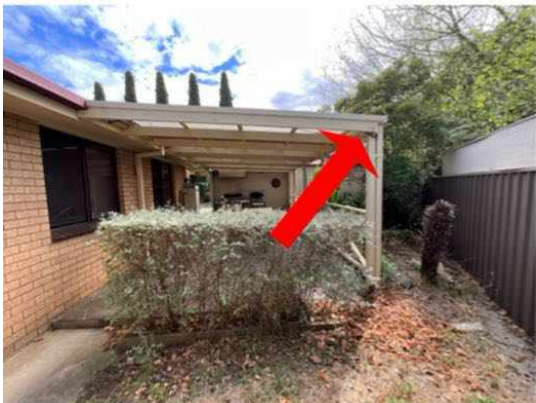
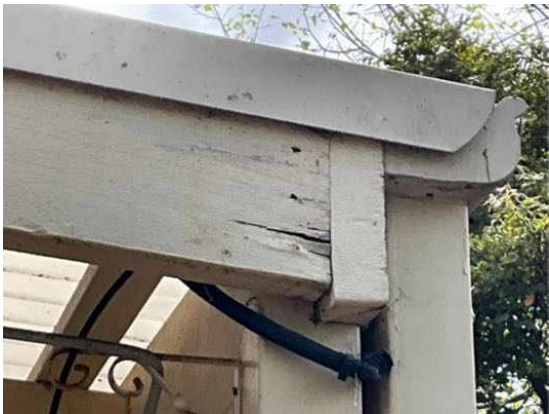
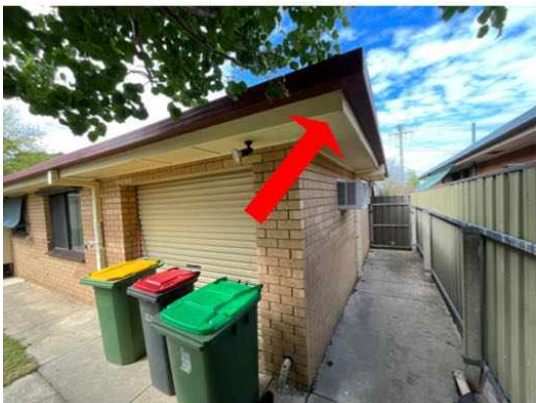
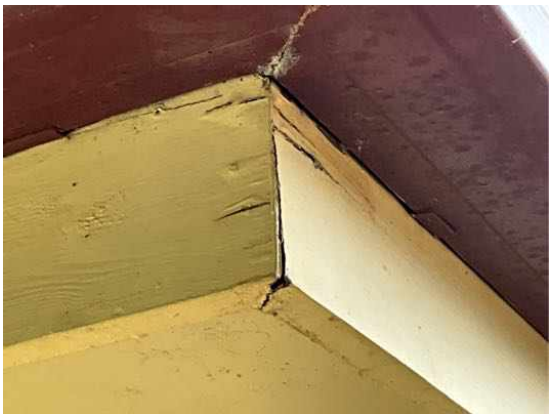
Finding 7.01

Building:	Building 1
Location:	Alfresco, eaves
Finding:	Fungal decay - present (localised)
Information:	Fungal decay also known as wood decay or wood rot generally refers to the deterioration of timber elements when in contact with excessive levels of moisture for a prolonged period of time.

The development of fungal decay is accelerated by temperatures in the range of 5degreeC to 40degreeC as well as the presence of oxygen. Generally fungal decay develops on timber elements that are in use in an external environment which are exposed to rain penetration.

In this case although the affected timber element is in a decaying state the extent of any visible damage appears to be localised to a specific area and is yet to spread to other parts of the building element or affect adjoining structures. The fungal decay is therefore likely to be of a relatively superficial nature with minimal impact on the structural integrity or tensile strength of the timber element.

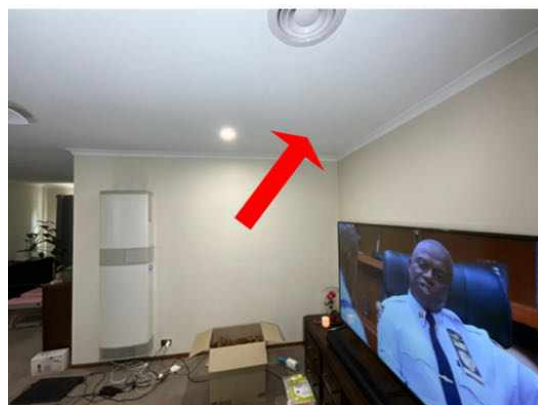
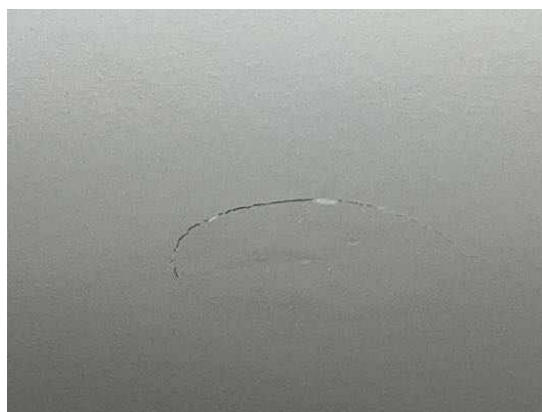
Building: Building 1
 Location: Living Room
 Finding: Cracking - Damage Category 1 - Fine (up to 1mm)
 Information: Although fine cracks are quite noticeable, they are often only considered to be an appearance defect, and usually do not indicate any structural damage. Generally, the cause of a fine crack is indicative of a separation between building materials and finishes (e.g. paint, plaster, etc.) along joins.

Cracking of this nature can generally be repaired with minor sanding, filling and/or repainting. Such works should be performed by a qualified painter or a general handyman.

Monitoring of all cracking should be conducted frequently. Always contact a building inspector should cracks widen, lengthen, or become more numerous.

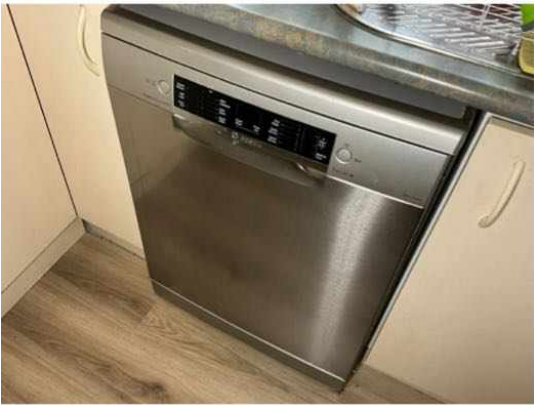
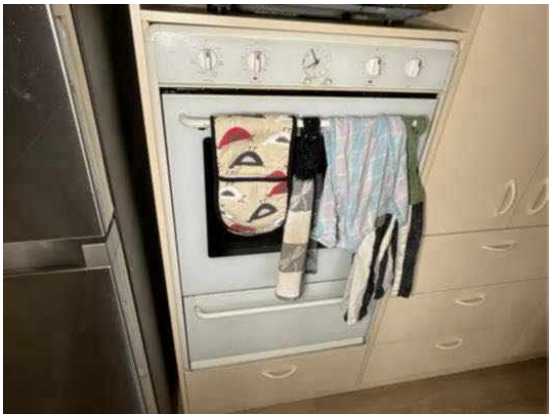
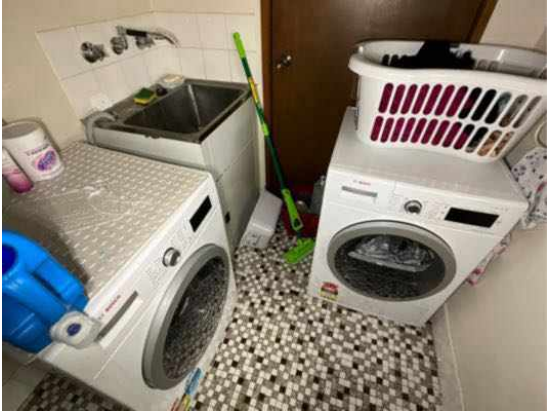
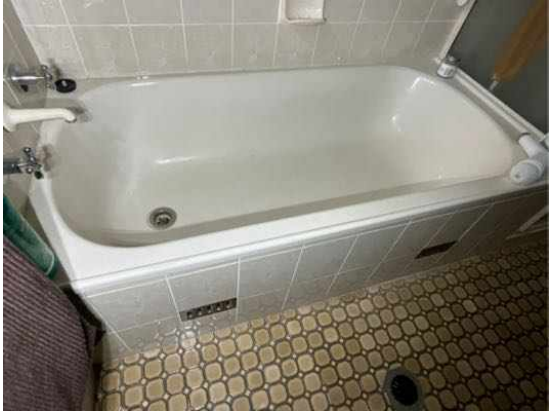
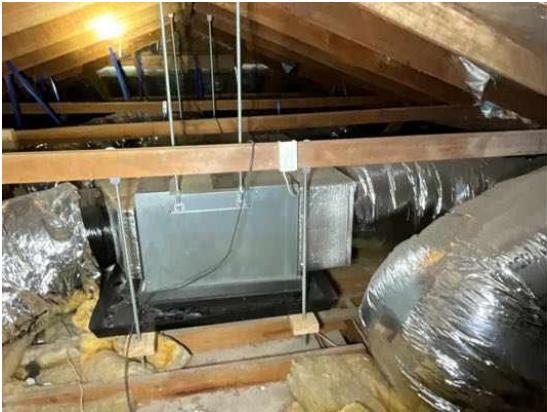
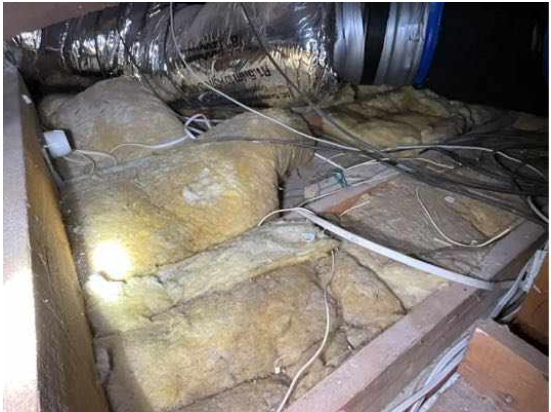
Building: Building 1
 Location: All Areas
 Finding: Additional Photos - Obstructions and Limitations
 Information: These photographs are an indication of the obstructions and limitations which impeded full inspection of the property at the time of inspection. These obstructions can hide an array of defects and should be removed to allow full inspection to be carried out. A re-inspection is recommended once the areas are made accessible.
