# Building and Timber Pest Inspection Report

Inspection Date: Tue, 10 Feb 2026

Property Address: 25 Birkdale Terrace, West Wodonga VIC  
3690, Australia

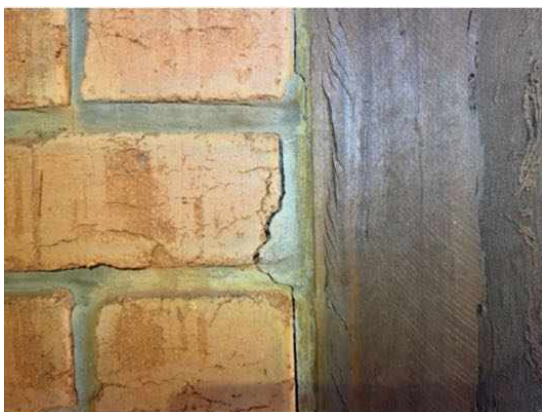
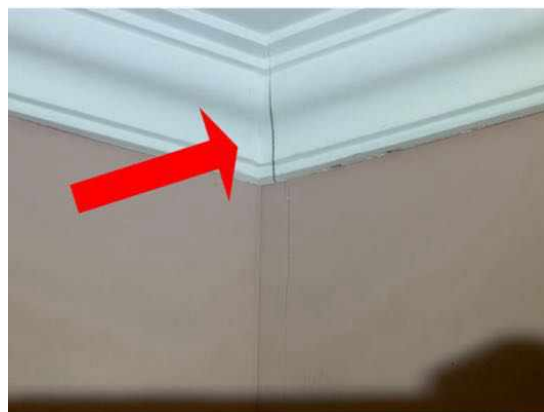
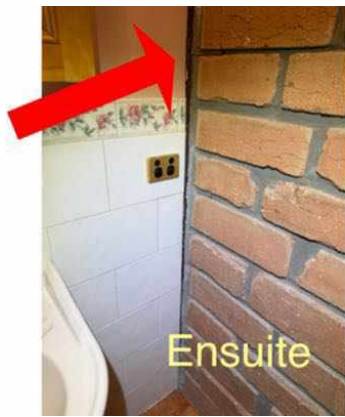
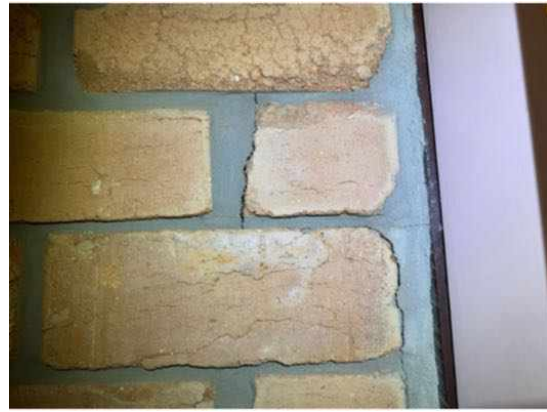
#### Finding 3.01

Building: Main Building  
Location: Brickwork, Internal walls  
Finding: Cracking & Signs of General Movement - External & Internal  
Information: Cracking was identified to some areas of the brickwork and internal walls at the time of inspection. Cracking has a variety of possible causes, however, the most common is general movement of adjacent footings and/or expansion / contraction of building materials.

Cracking is a relatively common defect, and is most likely to occur adjacent to windows, doors and other openings.

Areas of internal and external cracking and signs of movement were identified at, but not limited to the rear retaining wall, some internal areas and areas of the brickwork. The client should monitor these areas to identify any further movement. Should further movement become apparent, a structural engineer should be engaged for further evaluation.

The client should monitor the cracking. Should the cracking lengthen, widen or become more numerous, the client should consult with a structural engineer promptly to provide further advice.

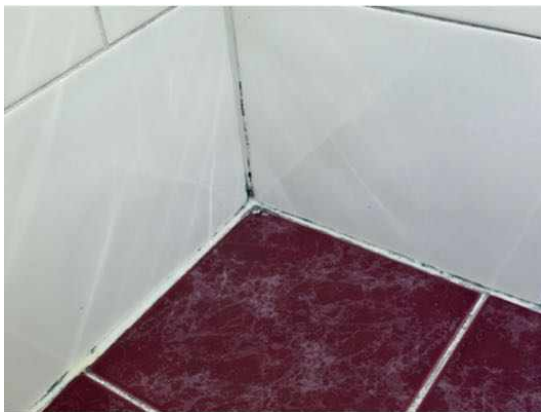
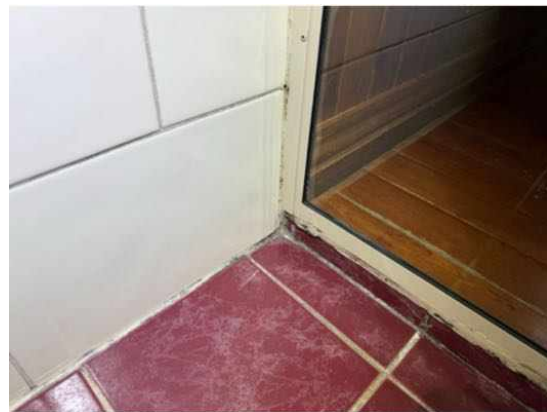
### Finding 3.02

Building:	Main Building
Location:	Tiled Areas
Finding:	Sealant / grouting - deteriorated or missing & Cracked Tiles
Information:	It appears that the sealant and grout has deteriorated in some tiled areas, a common defect in buildings of a similar age. Areas of cracked tiles were also noted, which can allow for moisture ingress behind the tiles, if neglected.

Sealant and grouting in areas that come into regular contact with water should be maintained for the long term care of your property.

Recommend engaging a licensed tiling contractor in the short term, to provide maintenance works where necessary.

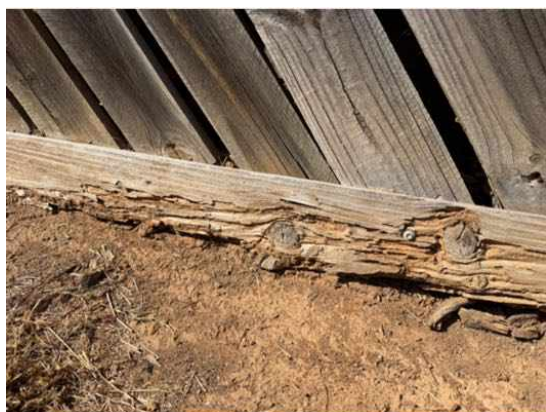
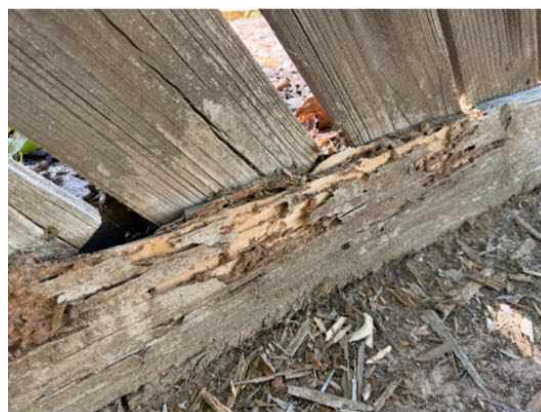
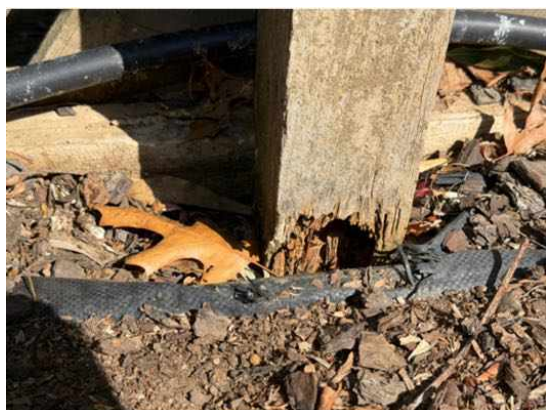
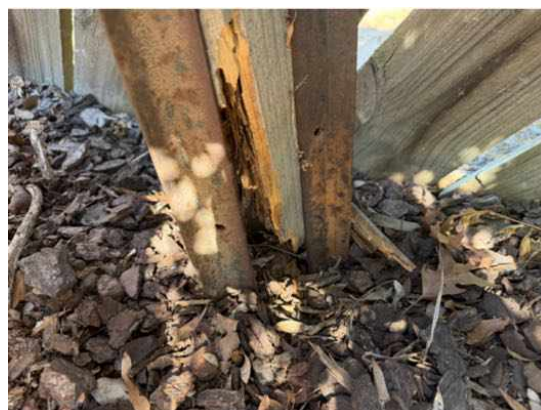
### Finding 5.01

Building:	Main Building
Location:	Rear Fencing
Finding:	Evidence of termite workings & damage
Information:	Evidence of previous termite damage & workings were identified at, but not limited to, areas of the rear fencing.

As the previous treatment has expired, it is advised that the client engage a licensed pest controller to provide further advice regarding installation of a termite treatment. 12 monthly ongoing termite inspections, conducted by a qualified termite inspector, are also recommended

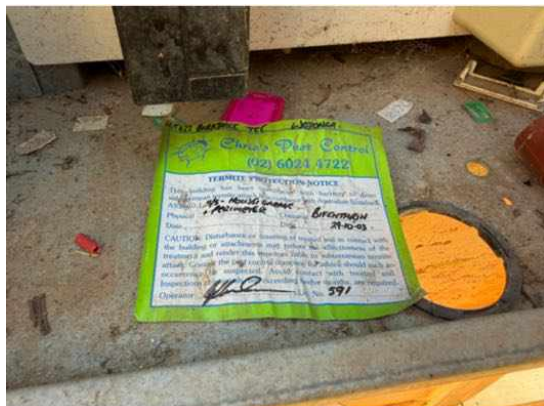
### Finding 6.01

Building:	Main Building
Location:	Switchboard
Finding:	Expired Termite Treatment
Information:	A durable notice has been installed in the meter box, indicating that a previous termite management system has been installed.

The sticker indicates that the year of installation was 2003, meaning the chemical

barrier has now expired.

Such barriers are highly effective in preventing termite attack on the building and therefore should be installed. The client should engage a licensed pest controller to provide further advice regarding application of a termite treatment.

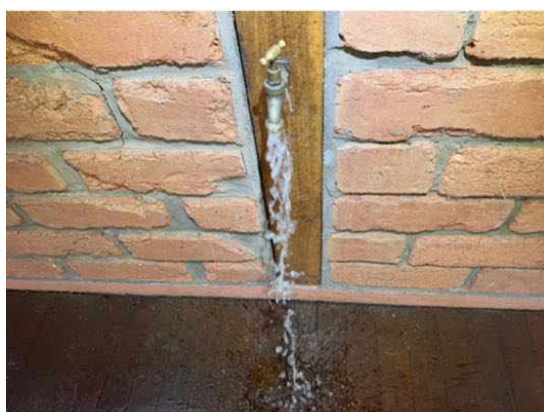
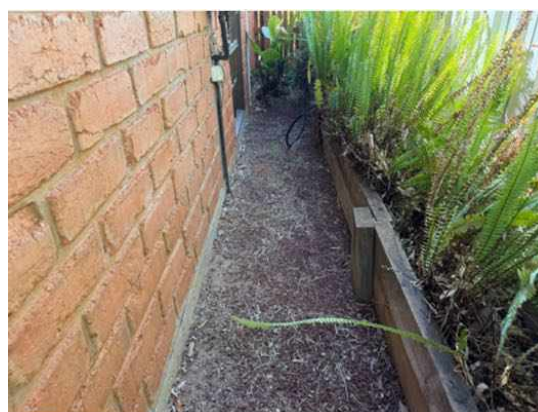
### Finding 6.02

Building:	Main Building
Location:	Tap, Side house
Finding:	Potential Water pooling - against property
Information:	Potential areas of water pooling around the perimeter of the property were identified. Where insufficient drainage of taps, and garden beds against the house are present, water pooling is likely to occur, and can create areas conducive to timber pests.

Recommend consulting with a licensed plumber and/or landscaping contractor to provide further advice.

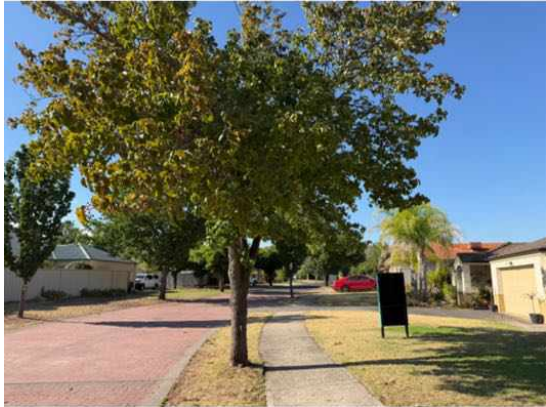
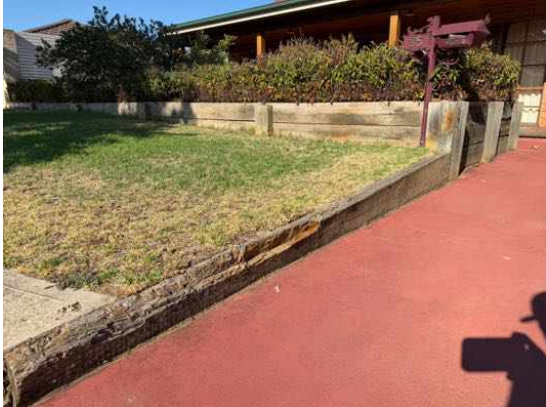
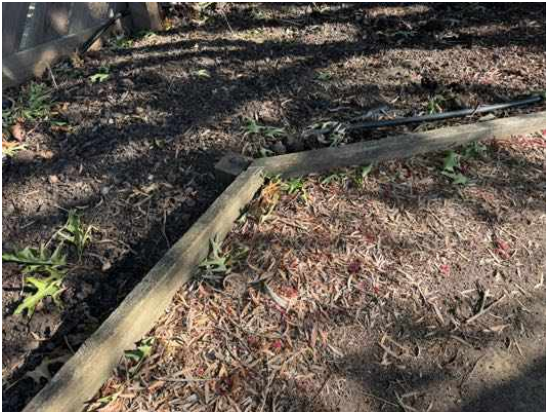
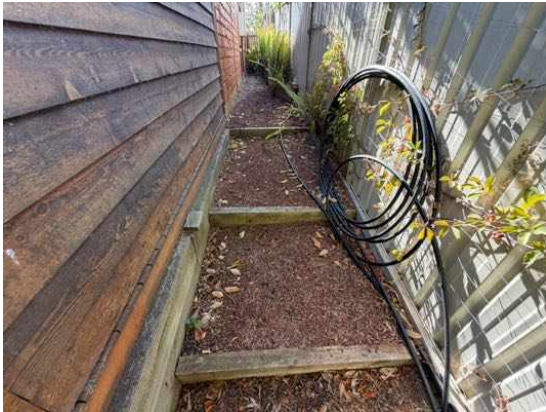
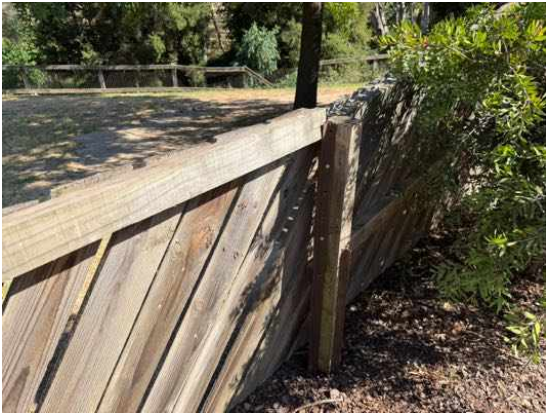
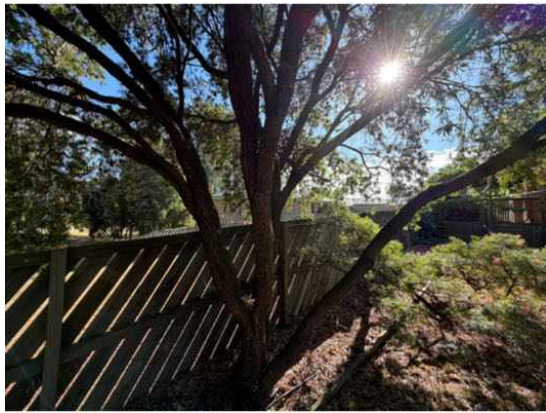
### Finding 6.03

Building:	Main Building
Location:	All External Areas
Finding:	Timber in direct ground contact & trees - conducive to termites

Where timber materials are in direct contact with the ground and consequently moisture, they become conducive to termite activity. The tree stumps, timber debris in the subfloor, and trees surrounding the building create an environment conducive to termite infestation.

Where feasible, it is advised any timbers in direct contact with the ground should be removed and any trees in close proximity to the building should be removed or inspected at least annually to reduce the risk of termite infestation & detect any early signs of termite activity.

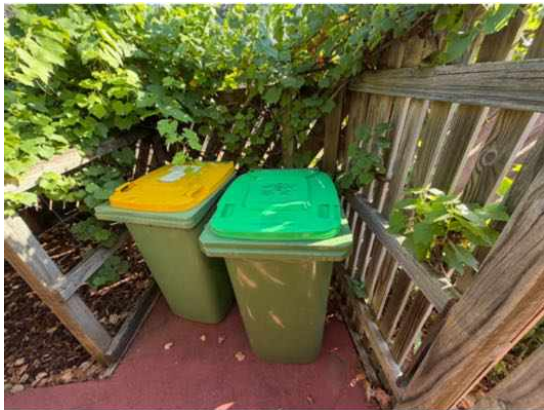
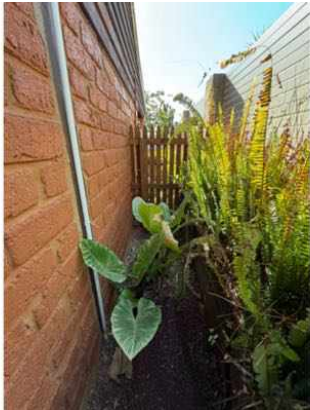
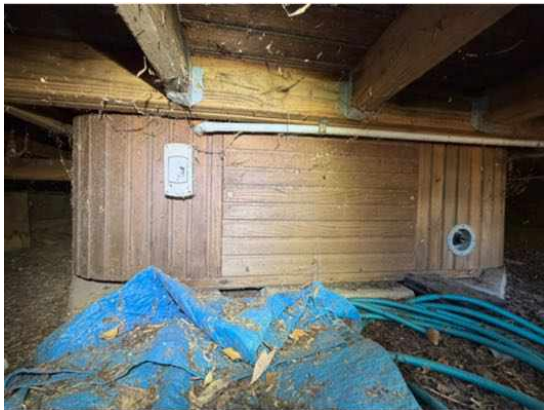
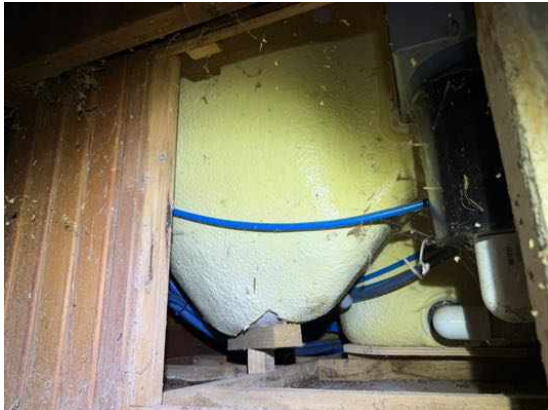
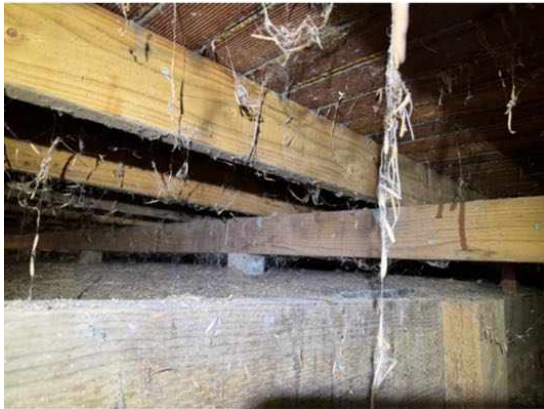
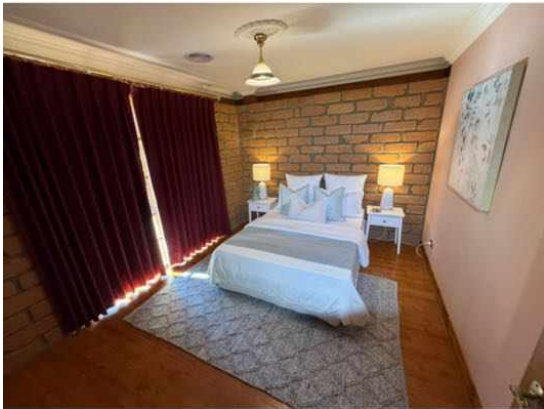
Building: Main Building  
Location: All Areas  
Finding: Additional Photos - Obstructions and Limitations  
Information: These photographs are an indication of the obstructions and limitations which impeded full inspection of the property at the time of inspection. These obstructions can hide an array of defects and should be removed to allow full inspection to be carried out. A re-inspection is recommended once the areas are made accessible.

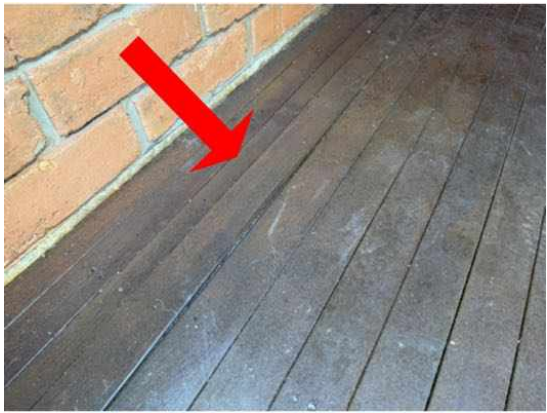
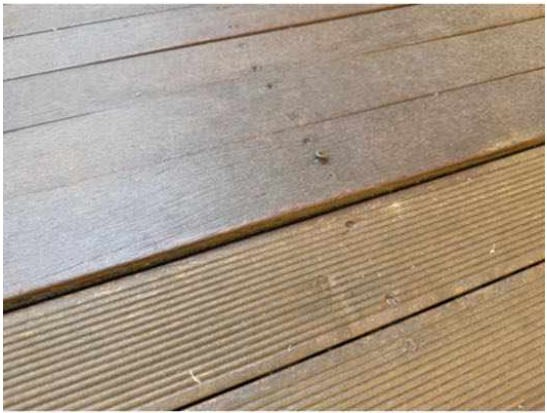
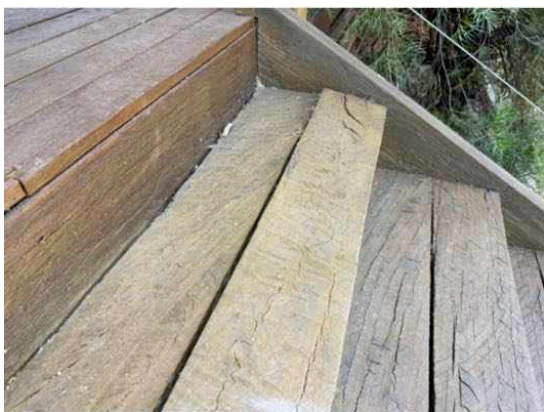
Building: Main Building  
Location: Rear Decking & Steps  
Finding: Decking Maintenance  
Information: It appears that some decking boards & steps of the rear deck are slightly loose, a common defect in building of a similar age. Recommend engaging a licensed carpenter to provide maintenance works where necessary to ensure the decking & associated screws are secure.

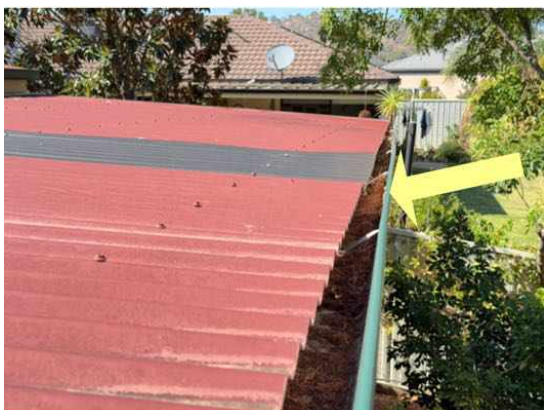
Building: Main Building  
 Location: Guttering  
 Finding: Debris in Gutters  
 Information: It appears that there is some debris in the gutters. Accumulation of debris can lead to blockages of the gutters & water overflows, if neglected.

Recommend engaging a general handyman to remove all debris from the gutters to prevent overflows & blockages.

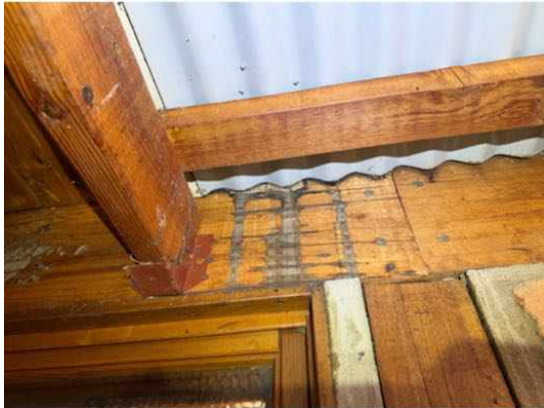
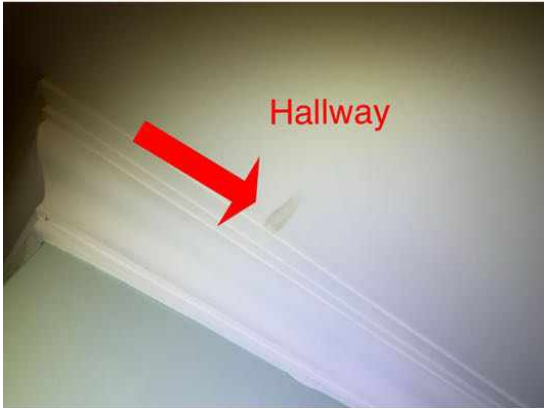
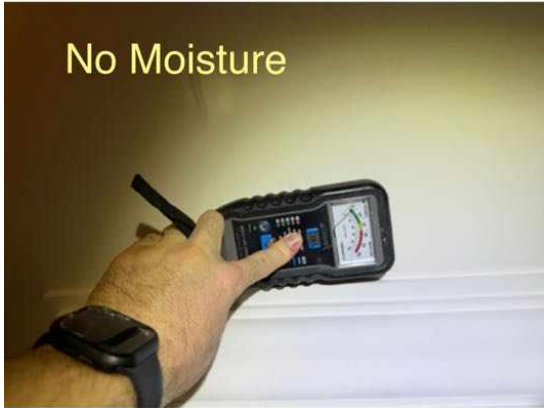
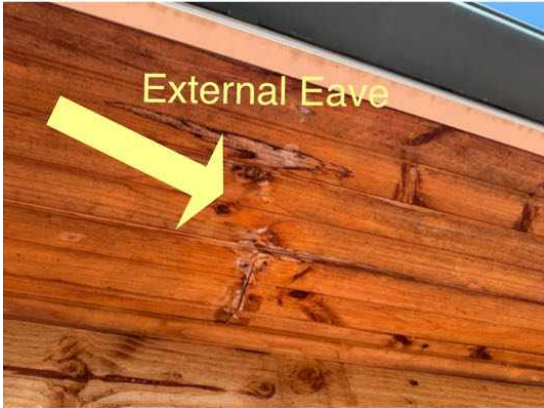
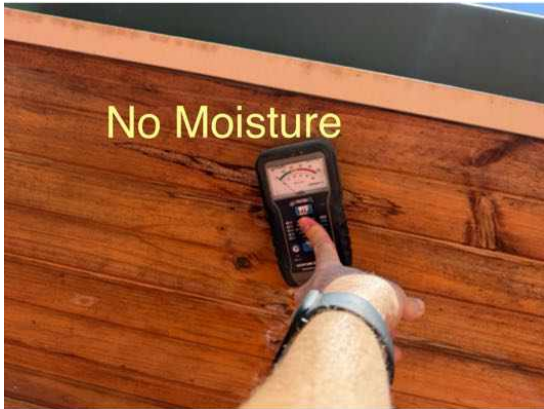
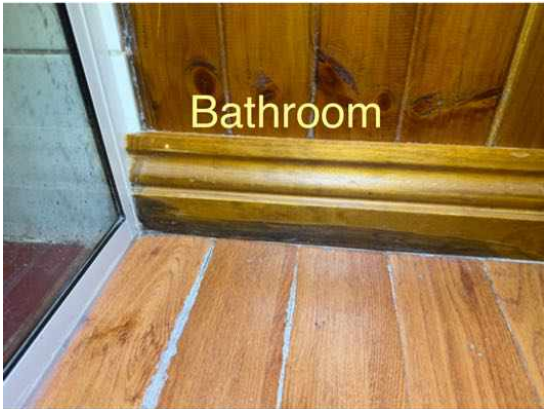
Some areas of water staining were identified at, but not limited to the verandah framing, front timber eave, hallway ceiling and outside the shower areas on the floor. No high moisture was present in these areas at the time of inspection. It is advised that the client monitor these areas.

Building: Main Building  
 Location: Eave, Verandah, Hallway  
 Finding: Water Staining Present  
 Information: It appears that water staining was present at but not limited to, the hallway ceiling, front timber eave, outside the shower areas and rear patio beam. Potential causes of leaking include deteriorated roof cladding or damaged plumbing fittings and fixtures. No high moisture was evident in these areas at the time of inspection.

It is recommended that the client monitor these areas and engage a licensed plumber, should the leak persist or return.

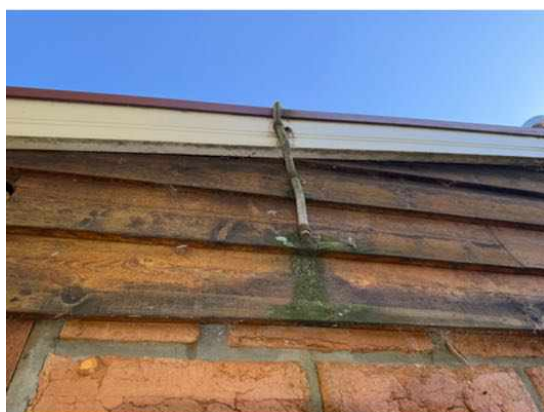
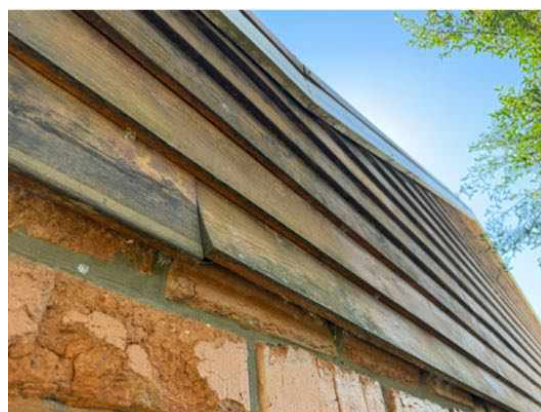
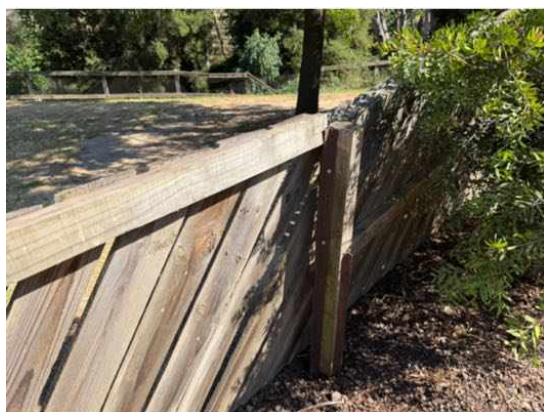
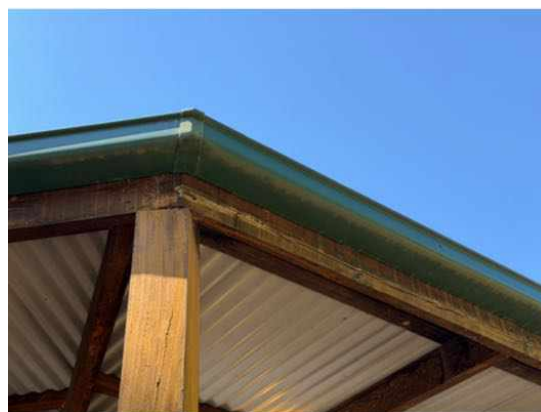
Building: Main Building  
 Location: Fencing, Weatherboard's  
 Finding: External Timbers - General Weathering  
 Information: Some external timbers at, but not limited to the fencing & weatherboard cladding had areas of general weathering. This is a common defect in buildings of a similar age.

Recommend engaging a licensed painting contractor in the short term to provide additional protection to the external timbers. Regular maintenance of external timbers will extend the useful life of the materials.

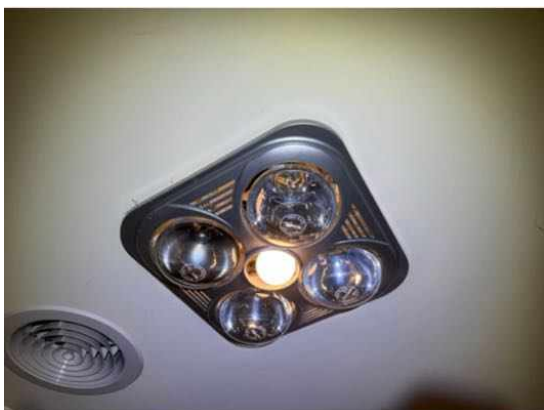
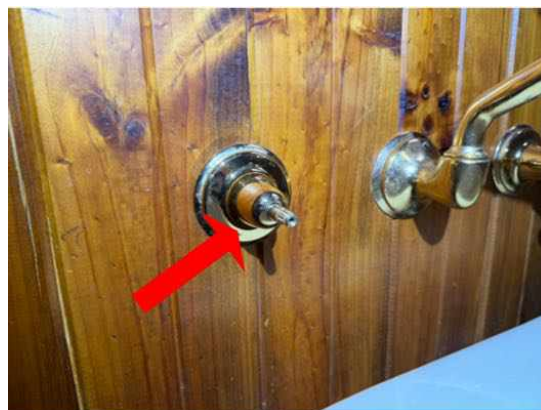
Building: Main Building  
 Location: Main Bathroom  
 Finding: Maintenance Items - Exhaust Fan Noisy & Bath Tap Missing  
 Information: It appears that the exhaust fan of the main bathroom was noisy when operating, at the time of inspection. One of the bath taps was also found to be missing. The client can engage a licensed electrician and plumber at their discretion to provide maintenance works where necessary.

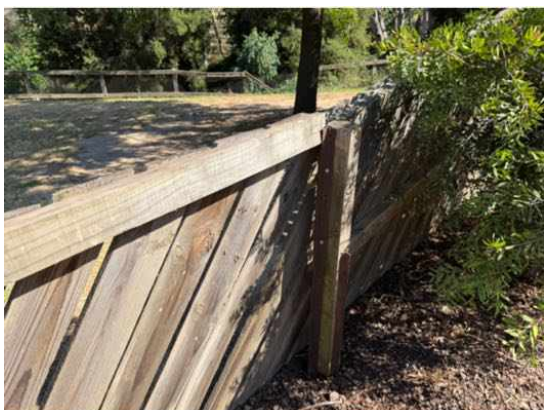
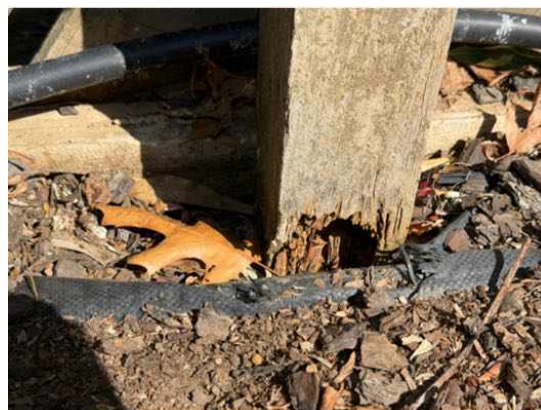
Building:	Main Building
Location:	Fencing
Finding:	Fencing - Deteriorated
Information:	It was noted at the time of inspection that sections of the fencing have deteriorated. A licensed fencing contractor can be appointed at clients discretion, to provide remedial works where necessary.

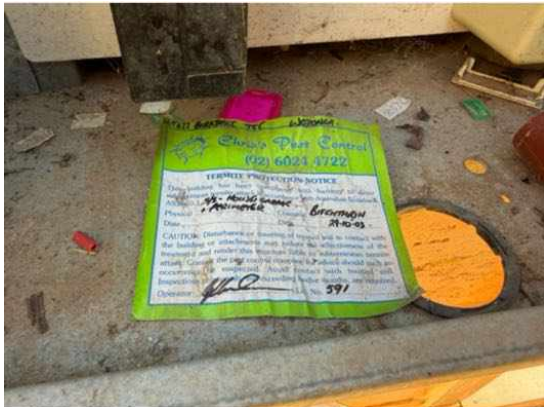
Building:	Main Building
Location:	Switchboard
Finding:	Evidence of a previous termite management system (meter box - expired)
Information:	A durable notice has been installed in the meter box, indicating that a previous termite management system has been installed.

The sticker indicates that the year of installation was 2004, meaning the chemical barrier has expired. Therefore, a termite treatment is strongly recommended.

The client should engage a licensed pest controller to provide further advice regarding application of a termite treatment.
