Building and Timber Pest Inspection Report

Inspection Date: Sat, 28 Feb 2026

Property Address: 2/510 Butson Ave, South Albury NSW 2640,
Australia

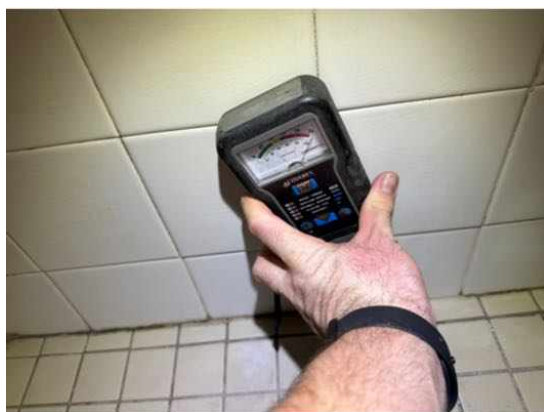
Finding 3.01

Building: Main Building
 Location: Shower
 Finding: Shower - High Moisture
 Information: It appears that high moisture is present at but not limited to, the base of the shower wall. Potential causes of leaking include but are not limited to loose or damaged plumbing fittings and fixtures, and/or deteriorated seals or waterproofing.

Evidence of high moisture was identified at, but not limited to the base of the shower wall. Recommend engaging a licensed plumber and/or tiling contractor promptly, to identify the cause of the moisture & provide remedial works where necessary.

Areas of leaking and high moisture create an environment conducive to termite activity and therefore should not be neglected. Recommend engaging a licensed plumber and/or tiling contractor promptly, to provide remedial works where necessary.

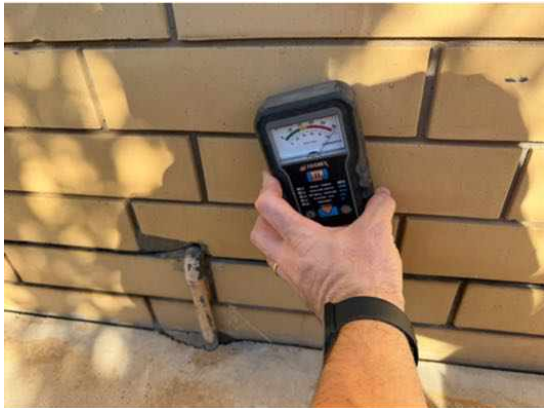
Finding 3.02

Building: Main Building
 Location: Rear Elevation
 Finding: High Moisture - Brickwork
 Information: It appears moist conditions are present above the damp proof course at, but not limited to the rear elevation of the unit. Potential causes of moisture above the DPC include associated leaking from pipework and/or deterioration of the DPC and water pooling against the building allowing for rising damp.

It appears high moisture was present above the damp proof course at, but not limited to the rear elevation of the unit. Recommend consulting with a licensed plumber to provide further advice and remedial works.

Recommend consulting with a licensed plumber in the short term to provide further advice & remedial works where necessary.

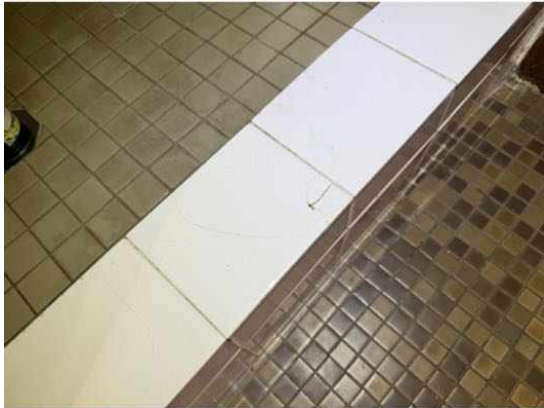
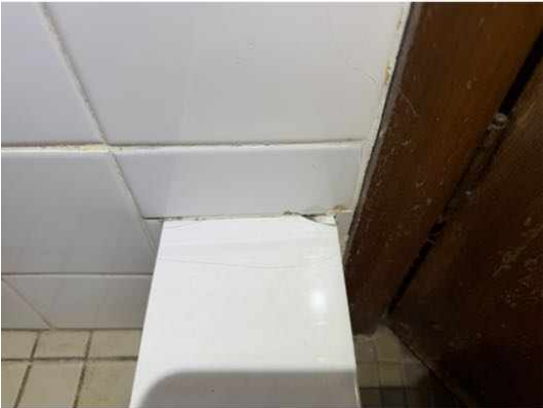
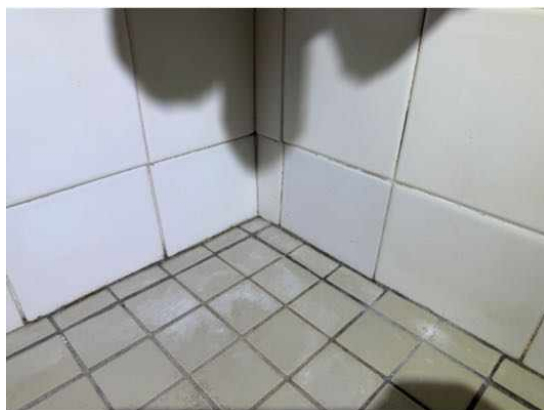
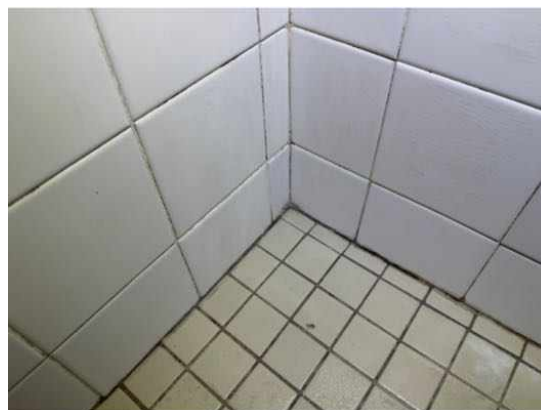
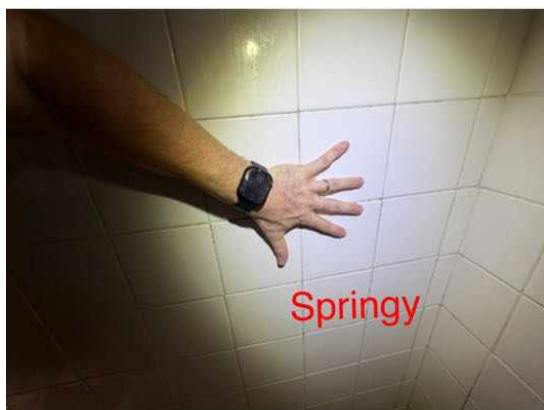
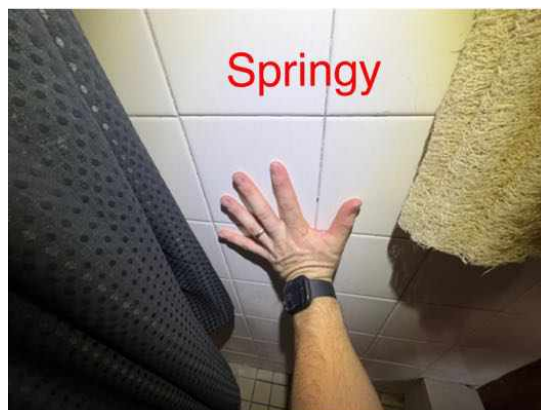
Finding 3.03

Building: Main Building
Location: Tiled Areas
Finding: Sealant / grouting - deteriorated or missing & Cracked Tiles, Springy Shower Walls
Information: It appears that the sealant and grout has deteriorated in some tiled areas, a common defect in buildings of a similar age. Areas of cracked tiles were also noted, which can allow for moisture ingress behind the tiles, if neglected. Some shower walls also appeared to be springy.

Sealant and grouting in areas that come into regular contact with water should be maintained for the long term care of your property.

- areas of cracked tiling and deteriorated sealant & grout were noted. Springy shower walls were also present. Recommend engaging a licensed tiling contractor to provide remedial works to these areas.

Recommend engaging a licensed tiling contractor in the short term, to provide remedial works where necessary.

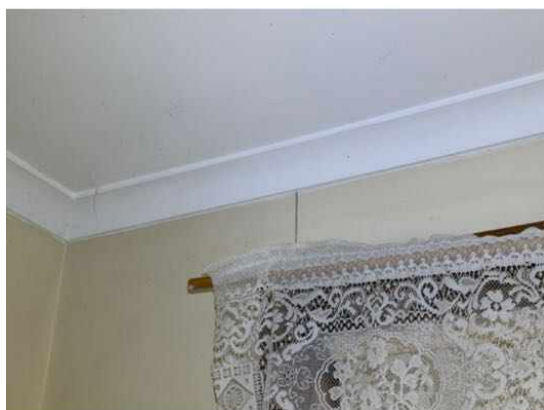
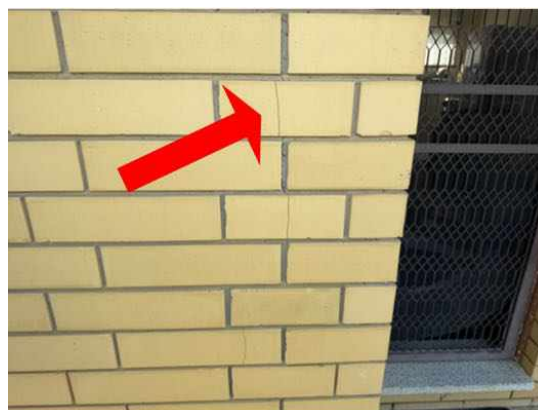
Finding 3.04

| Location: | Kitchen, Brickwork |
| Finding: | Cracking - External & Internal |
| Information: | Cracking was identified to some areas of the brickwork and internal wall linings at the time of inspection. Cracking has a variety of possible causes, however, the most common is general movement of adjacent footings and/or expansion / contraction of building materials. |

Cracking is a relatively common defect, and is most likely to occur adjacent to windows, doors and other openings.

The client should monitor the cracking. Should the cracking lengthen, widen or become more numerous, the client should consult with a structural engineer promptly to provide further advice.

All areas of internal and external cracking should be monitored to identify any further movement. Should cracking lengthen, widen, or become more numerous, a structural engineer should be engaged promptly, for further evaluation.

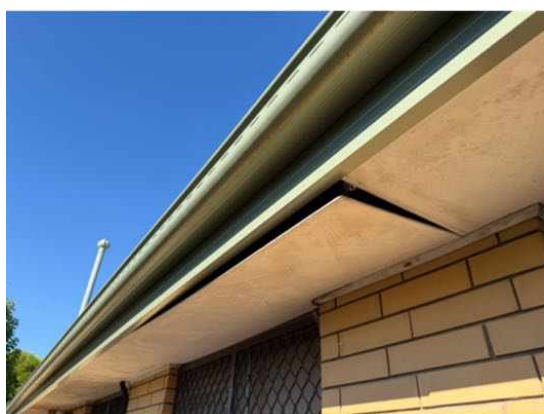
Finding 3.05

Location: Rear

Finding: Eaves - Sagging

Information: It appears that the eaves at but not limited to the rear elevation, were found to be sagging at the time of inspection. Sagging of eaves generally indicates that the fixings (e.g. nails or glue) have become loose and require refixing.

Where minor sagging is evident, remedial works such as re-fixing of the eaves may be required. Such works could be performed by relevant tradespeople, such as a licensed carpenter or a general handyman at clients discretion.

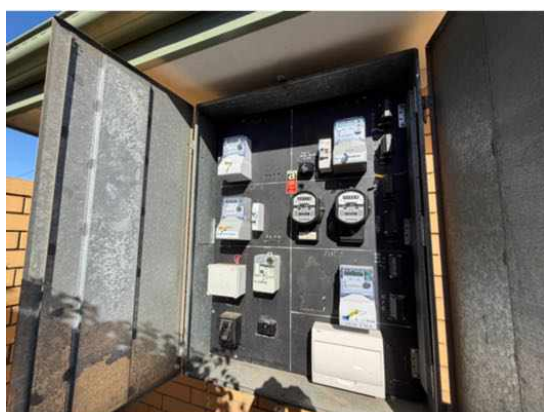
Finding 6.01

Building: Main Building
 Location: Switchboard
 Finding: Termite Management System - no evidence of a chemical installation
 Information: The application of a termite barrier is strongly recommended, as it appears no termite management system has been installed, with no evidence or durable notice to suggest works taking place. Generally, a durable notice is placed in the meter box to indicate current termite barriers.

Such barriers are highly effective in preventing termite attack on the building and therefore should be installed.

Recommend seeking further advice from a licensed pest controller.

Installation of a termite barrier is recommended as there was no evidence of installation of a previous termite management system. 12 monthly termite inspections, conducted by a qualified termite inspector are also advised. Recommend engaging a licensed pest controller, to provide further advice.

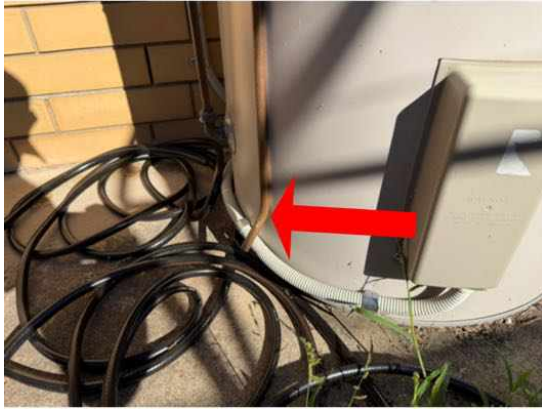
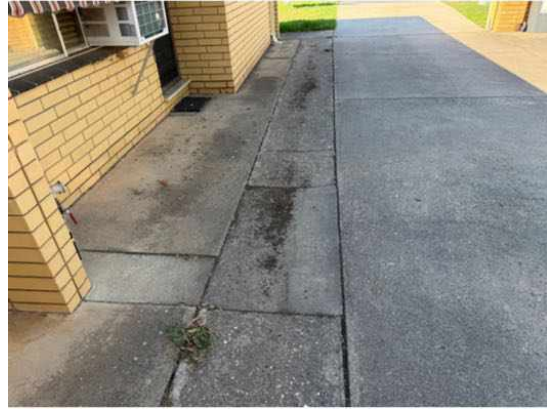
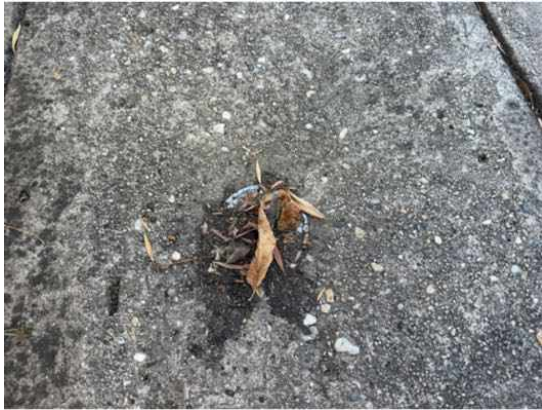
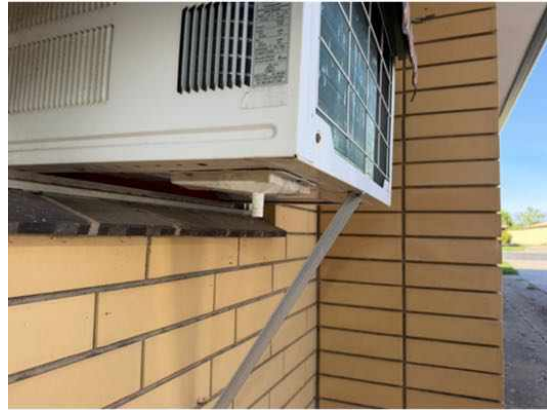
Finding 6.02

Building: Main Building
 Location: All external areas
 Finding: Potential Water pooling - against property
 Information: Potential areas of water pooling around the perimeter of the property were identified. It appears that the drain that was present in front of the unit appeared to be blocked. Recommend consulting with a licensed plumber to provide further advice, to ensure sufficient stormwater drainage has been installed.

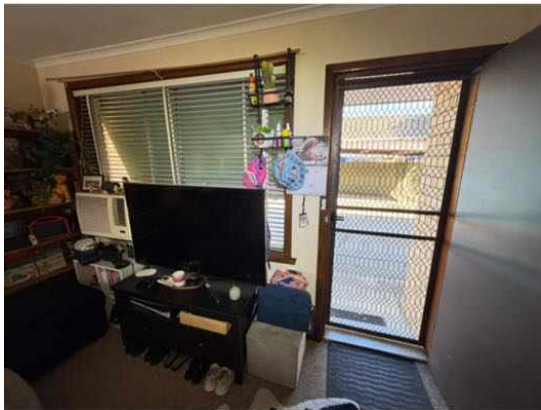
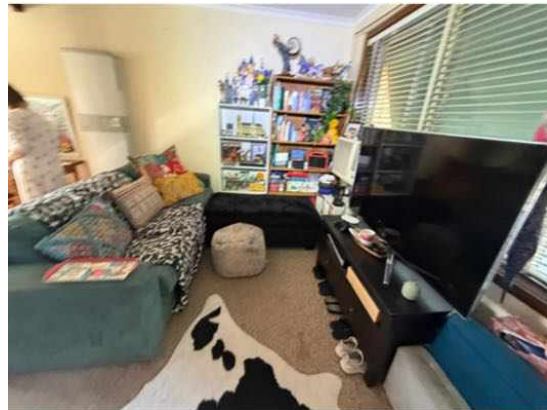
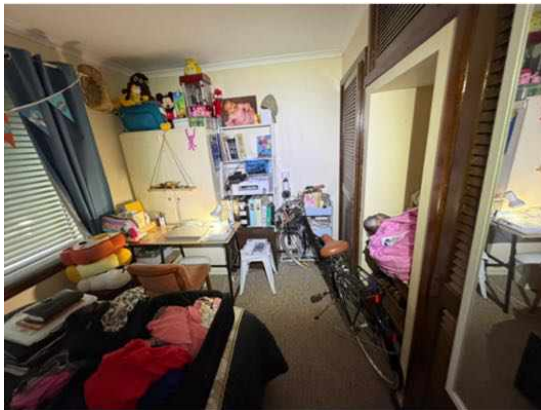
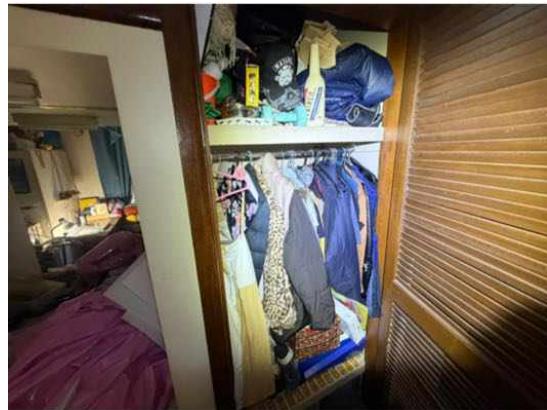
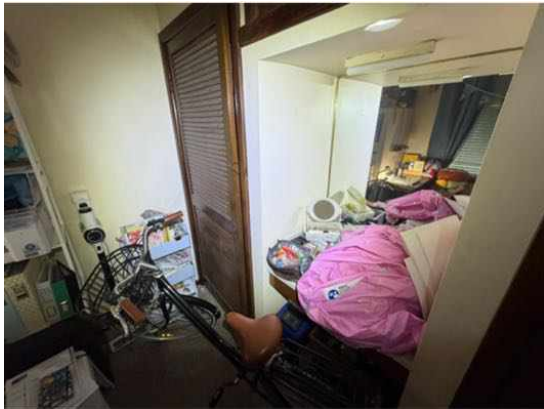
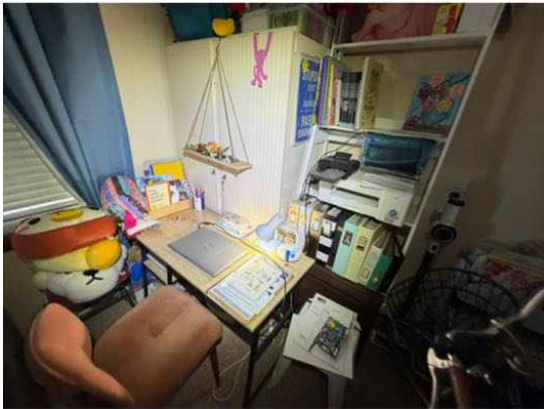
be removed, and a further inspection should be performed. The roof void was unable to be fully inspected due to areas of low roof pitch, loose fill insulation, and pipework. Indicative images below depict some of the obstructions encountered.

Building: Main Building
Location: All Areas
Finding: Additional Photos - Obstructions and Limitations
Information: These photographs are an indication of the obstructions and limitations which impeded full inspection of the property at the time of inspection. These obstructions can hide an array of defects and should be removed to allow full inspection to be carried out. A re-inspection is recommended once the areas are made accessible.

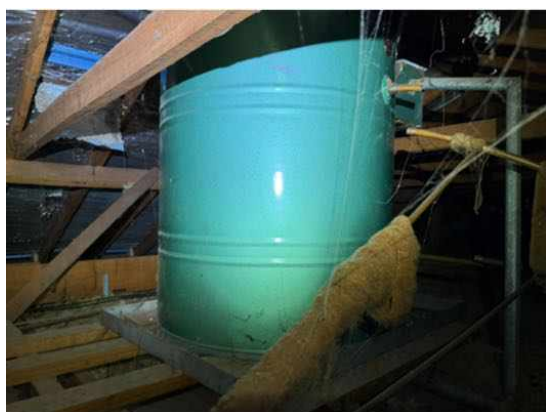
Building: Main Building
Location: Roof Void
Finding: Gravity-Fed HWS - Disconnected
Information: A disconnected gravity-fed hot water system (HWS) remains in the roof void.

Despite this plumbing system being unused, it may contain residual water. If neglected, rust of the system overtime, may lead to residual water leaking.

Recommend that the client either monitor the condition of the system or get the system drained by a licensed plumber to prevent any potential future leaks.

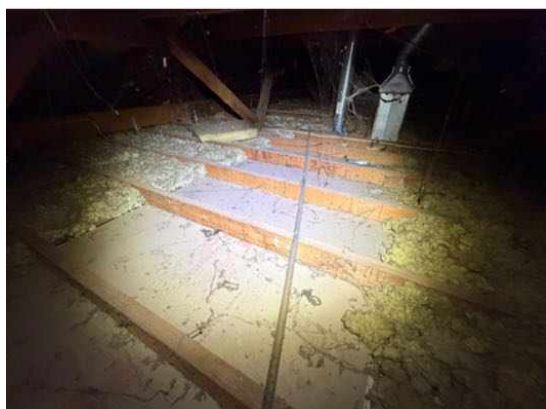
Building: Main Building
Location: Roof Void
Finding: Insulation - Missing
Information: Some areas of missing insulation were identified to the roof void. Insufficient or missing insulation may reduce the energy efficiency of the home.

Installation of adequate insulation is advised and can be conducted by an insulation contractor at clients discretion.

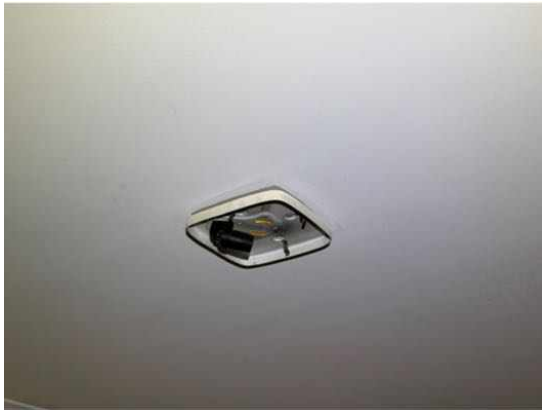
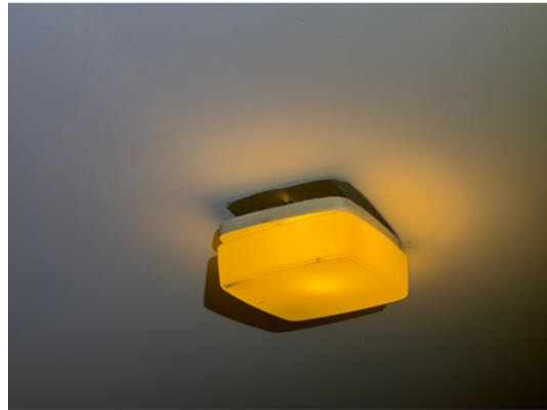
Location: Bedrooms

Finding: Light fitting - Missing & loose

Information: The light fitting of the front bedroom was found to be missing at the time of inspection and the light in the second bedroom appeared to be loose.

Recommend engaging a licensed electrician, to provide maintenance works, at clients discretion.
