Building and Timber Pest Inspection Report

Inspection Date: Thu, 5 Feb 2026

Property Address: 159 Leicester St, Fitzroy VIC 3065, Australia

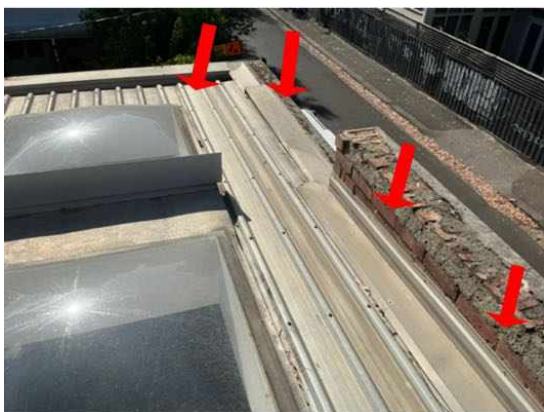
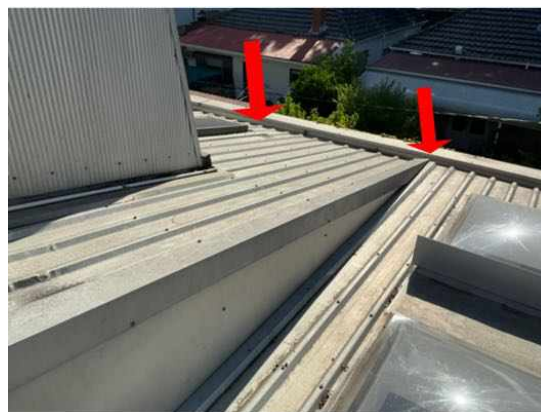
Building: Main Building
 Location: Study/Outside
 Finding: Fall Hazard/ Study/ Outside
 Information: During the inspection, it was observed that guardrails are installed on the perimeter of the building. This poses a significant risk of individuals falling from a height exceeding three metres.

The construction of the guardrails must be carried out by a Registered Builder or Carpenter.

It is strongly recommended that this matter be addressed as expeditiously as possible.

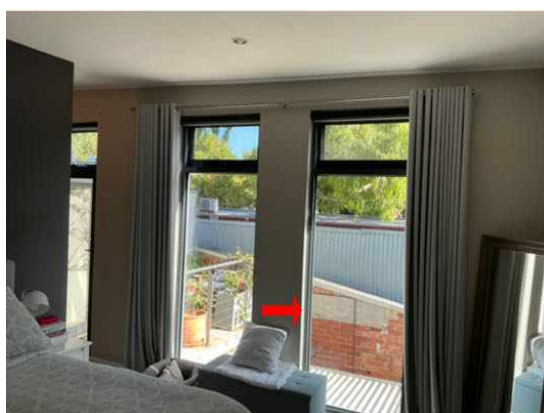
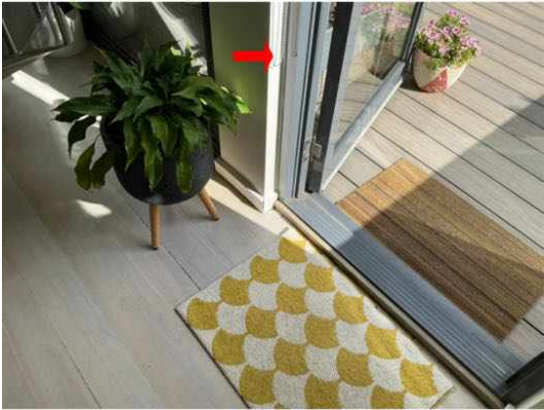
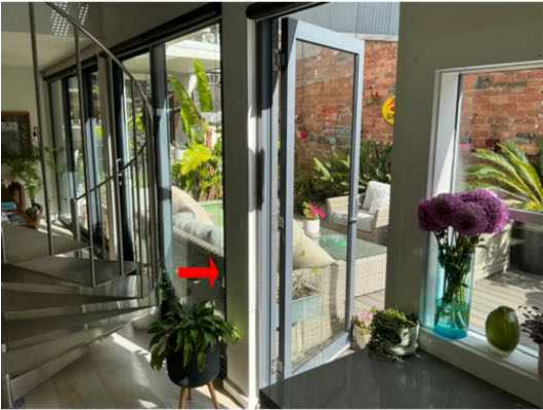
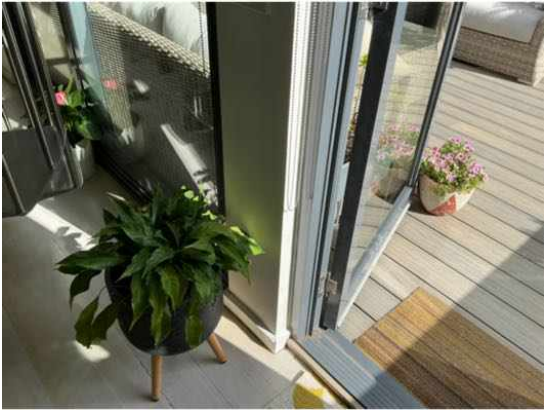
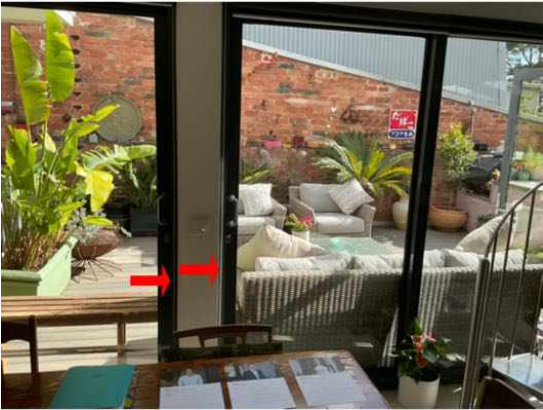
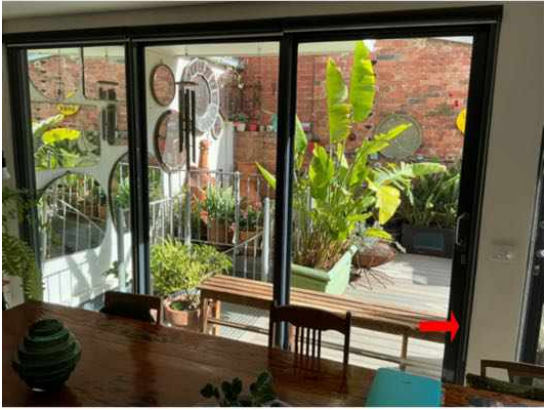
Finding 1.02

Building: Main Building
 Location: All Areas

Information: Looped curtain and blind cords pose a significant strangulation hazard for children as they can place the loop over their head and/or get tangled in the loose cords.

Check all the rooms in your house for any blinds or curtains with long cords that are either loose or looped. This includes any cords that are within children's reach at floor level or near furniture they can climb on.

Secure any loose or looped cords with cleats or tension devices – these can be purchased from your local curtain and blind retailer or hardware store. Do not put furniture such as cots, beds, highchairs, playpens, couches, chairs, tables or bookshelves near a window where children can reach the blind or curtain cord.

It is recommended that this defect be resolved immediately to avoid harm to occupants.

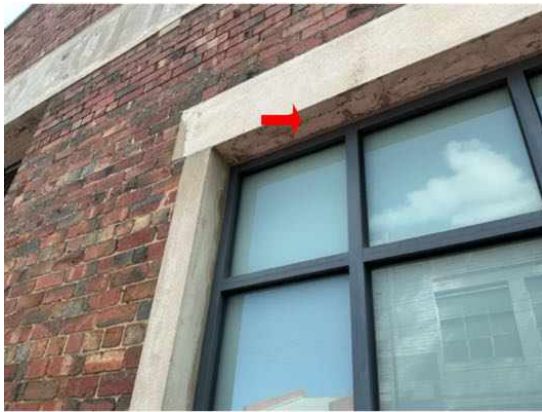
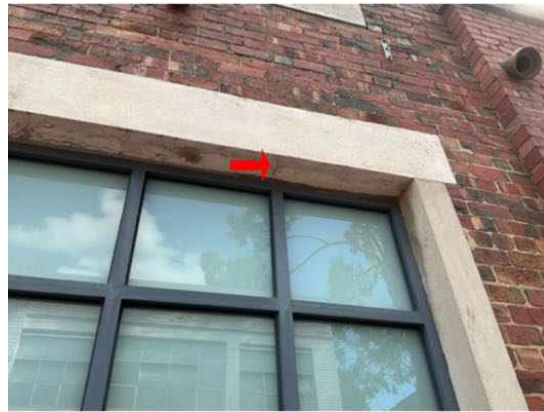
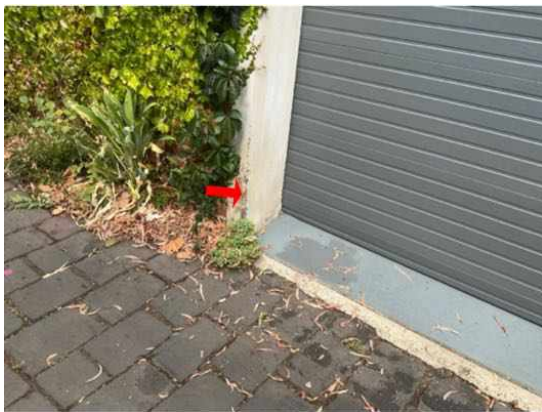
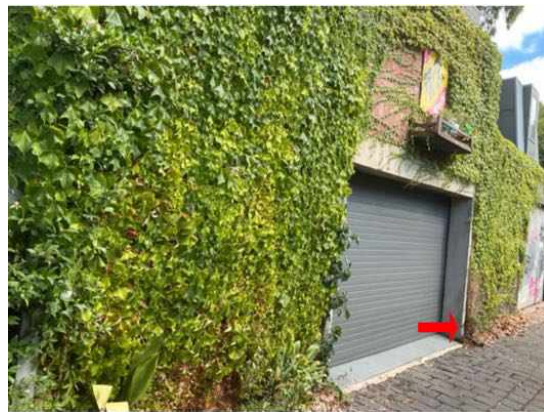
Building: Main Building
Location: All Areas
Finding: Cracks to external render - Category 1

Information: It has been observed that cracking to the external rendered surfaces has occurred. The degree of damage falls within Category 1, described as fine cracks that do not need repair and which are less than 1.0mm in width limit.

Although fine cracks are quite noticeable, they are often only considered to be an appearance defect, and usually do not indicate any structural damage. Generally, the cause of a fine crack is indicative of a separation between building materials and finishes (e.g. paint, plaster, render etc.) along joins.

Cracking of this nature can generally be repaired with filling or rendering. Such works should be performed by a qualified Renderer or a general Handyman.

Monitoring of all cracking should be conducted frequently. Always contact a Building Inspector should cracks widen, lengthen, or become more numerous.

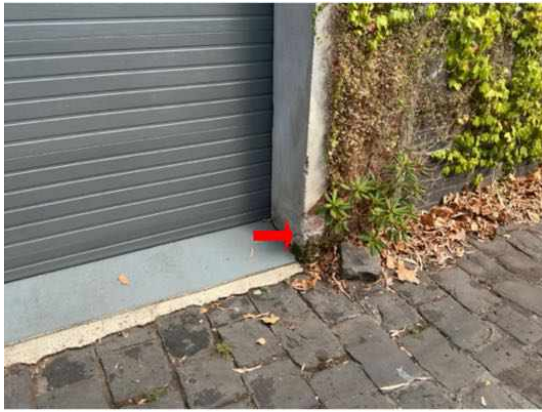
Finding 3.02

Building:	Main Building
Location:	All Areas
Finding:	Cracking - Damage Category 1 - Fine (up to 1mm)
Information:	Although fine cracks are quite noticeable, they are often only considered to be an appearance defect, and usually do not indicate any structural damage. Generally, the cause of a fine crack is indicative of a separation between building materials and finishes (e.g. paint, plaster, etc.) along joins.

In this instance client have indicate that these cracks become visible after roof leaks. However the leaks have been repaired, and hence no change in terms of sizes.

Cracking of this nature can generally be repaired with minor sanding, filling and/or repainting. Such works should be performed by a qualified Painter or a general Handyman.

Monitoring of all cracking should be conducted frequently. Always contact a Building Inspector should cracks widen, lengthen, or become more numerous.

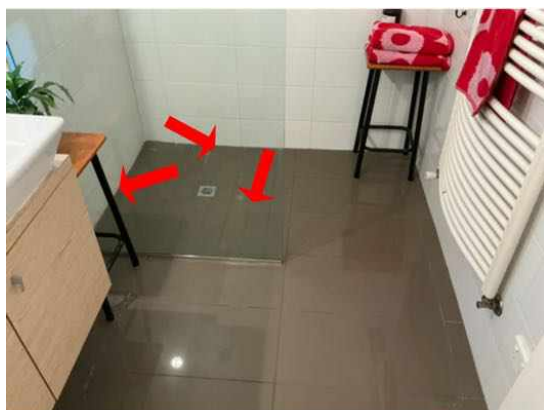
Building:	Main Building
Location:	Bathroom 2
Finding:	Sealant and grouting - Missing or damaged
Information:	It was noted on inspection that sealant or grout is degraded to the tiled shower alcove and or other areas of the bathroom . A flexible sealant is required to allow for expected expansion and contraction, while keeping the joint water tight and protective of all associated building materials.

The lack of sealant between tiles can cause water damp to the wall behind it.

Unmanaged damp in the bathroom area is likely to facilitate the formation and development of mould and fungi growth, decaying associated building materials and compromising their structural integrity of associated elements. It is important to address damp conditions , as the World Health Organisation notes that excess moisture leads - on almost all indoor materials - to growth of microbes such as moulds, fungi and bacteria, which subsequently emit spores and other matter into the indoor air. Exposure to these contaminants is associated with a wide range of respiratory and other health-related problems. Damp conditions also create a conducive environment for termite infestation.

Regular maintenance and replacement of damage or missing or damaged sealant and grout is highly recommended to the wet areas, as this is a regular wear and tear defect. Sealant and grouting in areas that come into regular contact with water should be maintained for the long term care of your property.

Consultation with a sealant specialist is advised immediately to perform remedial works as required.

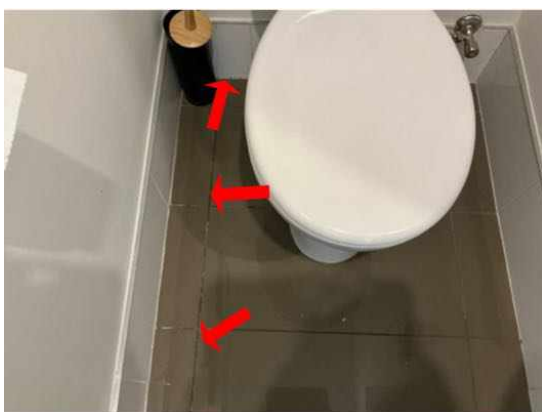
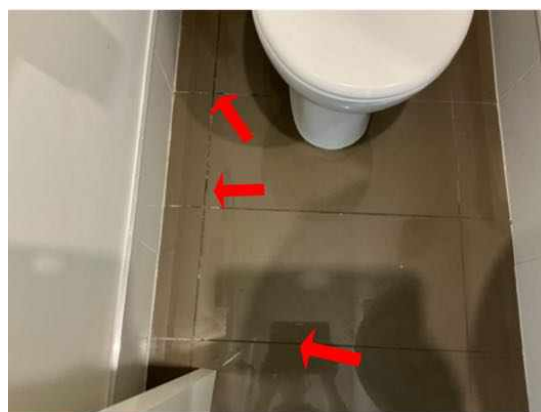
Building:	Main Building
Location:	Toilet (WC)
Finding:	Sealant and grouting -WC- Missing or damaged
Information:	During inspection, it was observed that sealant or grout is absent from the water cistern.

To prevent any potential water damage, flexible and mould-resistant materials should be applied to the affected areas. Regular maintenance and replacement of damaged or missing sealant and grout are strongly recommended for wet areas, as this is a common wear-and-tear issue. Sealant and grouting in areas frequently exposed to water should be maintained to ensure the long-term maintenance of your property.

It is advisable to appoint a sealant specialist or tiling contractor to complete these repairs as soon as possible.

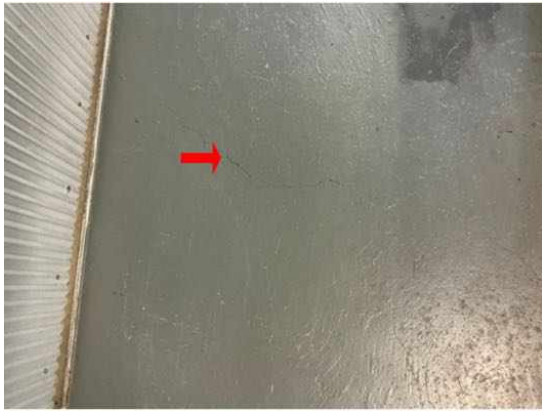
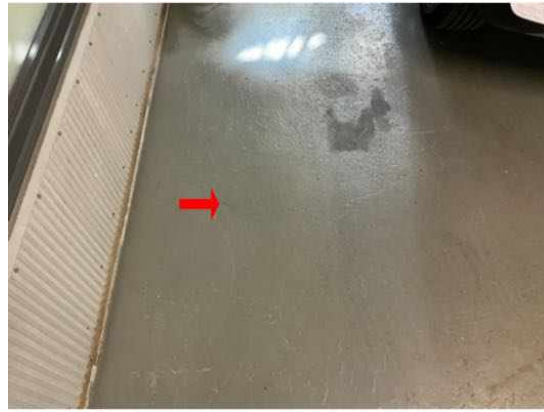
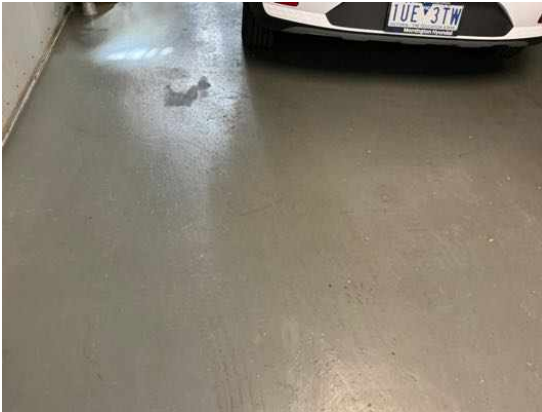
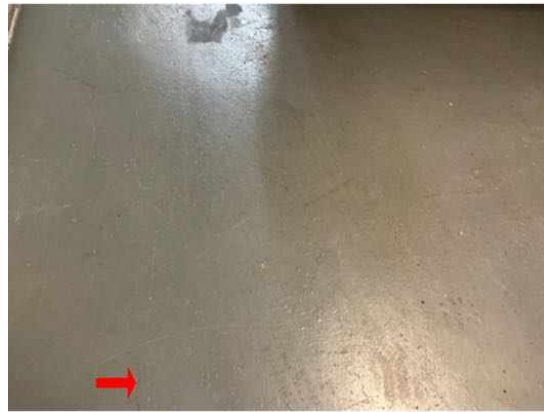
Finding 3.07

Building:	Main Building
Location:	Garage
Finding:	Crack in concrete slab - Category 1
Information:	A crack coded as Category 1 was identified in the slab. A Category 1 crack is

described as a fine but noticeable crack, with the slab at an otherwise reasonable level.

To be considered Category 1, the approximate width of the crack is less than 1.0mm, or a less than 10mm change in offset when a 3m straight edge is placed over the defect.

Category 1 cracks should be monitored for a period of 12 months. At the end of the monitoring period, identified cracks that are rated greater than Category 2 are considered defects, and require rectification.

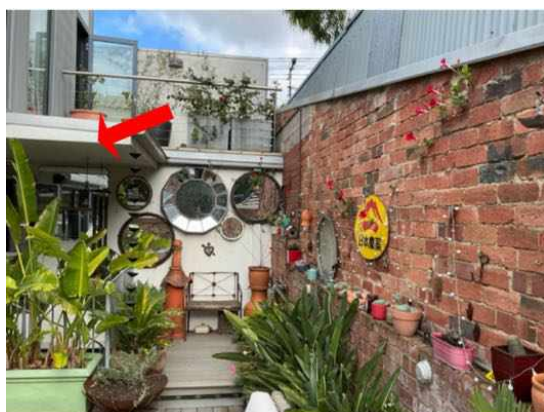
Building:	Main Building
Location:	Verandah
Finding:	Ceiling - Water Damage
Information:	Water Damage to ceiling linings in this area was evident at the time of inspection. Water damage indicates that surfaces have been exposed to excessive moisture over time.

While mostly an appearance defect, water damage can be indicative of more serious defects, which may be currently concealed by interior ceilings.

Where water damage is active, a Licensed Plumber must be consulted to identify the cause of the damage and to provide advice on any reparation works that may be required. Replacement of any damaged structures is advised.

Conversely, where water damage is old and inactive, affected building materials may be repaired or replaced at client discretion.

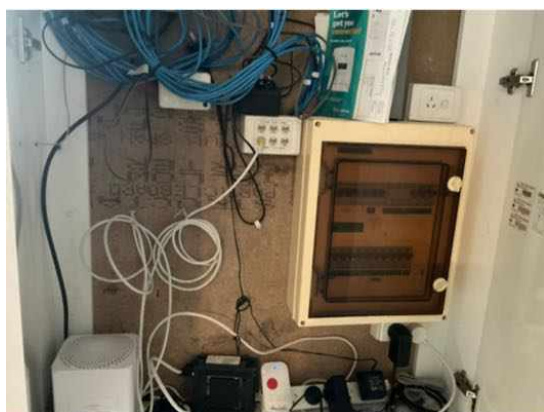
Information: The application of a post-construction chemical termite barrier is highly recommended for all properties, particularly if live termite activity has been found on the site previously. Such barriers are highly effective in preventing termite attack on any timber building elements throughout the property.

A durable notice should be placed in the switchboard unit to indicate current termite barriers. At the time of inspection, it appeared as though no termite management system has been installed, with no evidence to suggest preventative works taking place.

The client may consider gaining further advice from a pest controller as to the costs and procedures involved with this application. It is recommended that obtaining such advice be a short-term priority.

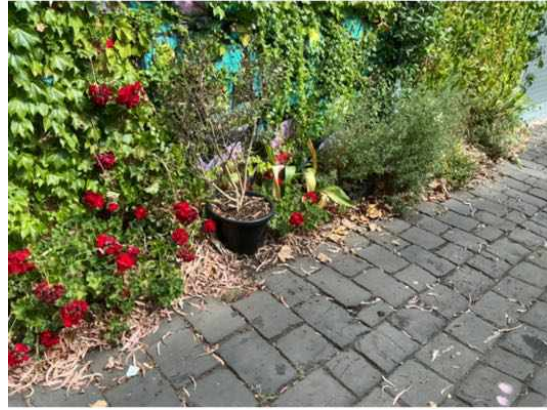
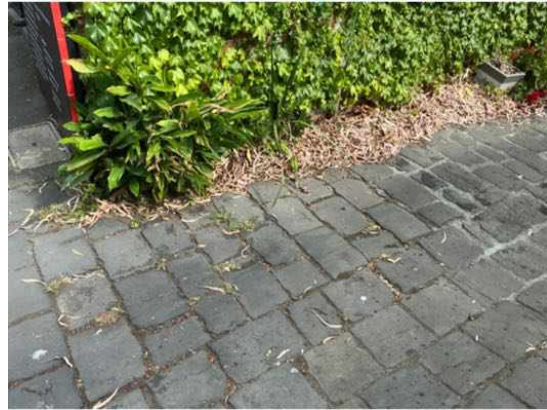
Finding 6.02

Finding: Garden Beds - Conditions Conducive to Termite Attack

Information: Garden beds were found to be evident in close proximity to the building. Garden beds immediately adjacent to the perimeter of the building block the visual inspection of these areas, providing a concealed termite entry point.

Garden beds can include untreated timber and a combination of moisture from watering, which produce conditions conducive to termite activity and ingress.

Further advice from a Timber Pest Technician is required to ensure appropriate Termite Management systems are implemented.
