Building and Timber Pest Inspection Report VR

Inspection Date: Mon, 12 Jan 2026

Property Address: 4 Grevillea St, Ormiston QLD 4160,
Australia

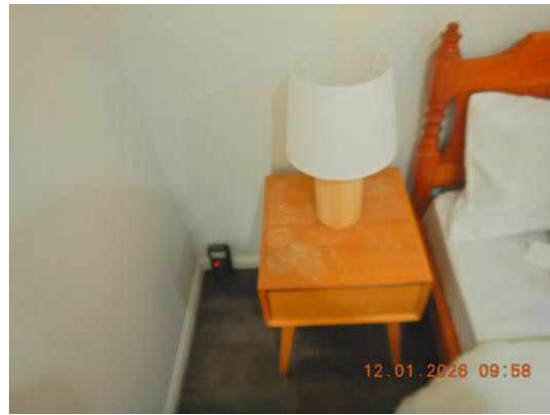
Building: Main Building
Location: Bedroom - Master > Rear Right
Finding: moisture meter readings
Information: There was a high moisture meter reading of between 22/30 % in the master bedroom/ ensuite shower wall area, with identified movement and moisture damage in the base of this wall at the time of this inspection. This can be caused by water ingress into the wall cavity from external sources or a possible plumbing leak . Wet areas can also have a potential failure to the water proofing membrane causing potential water issues. A licensed plumbing contractor or waterproofing contractor should inspect this area and report .

Repair works may be required to the wall framing in this area.

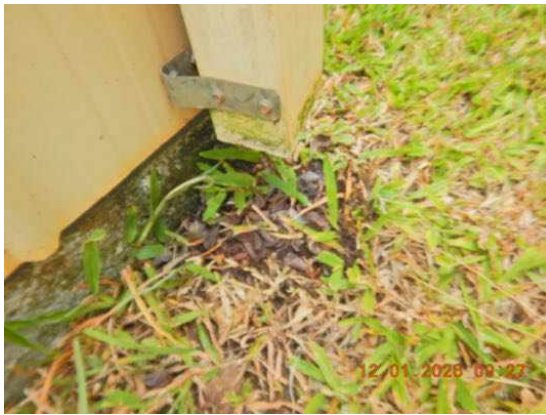
Information: The down pipes to the rear alfresco and detached garden shed in this property are not connected to the storm water line to the street. At present the down pipes are depositing water to the ground, this may over a period of time contribute to possible subsidence and structural foundation issues and may contribute to the development of mould and mildew, as well as being conducive to termite activity.

The services of a licensed plumbing contractor could be engaged to carry out this task.

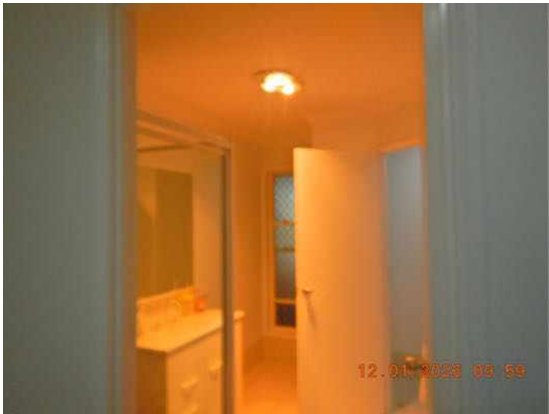
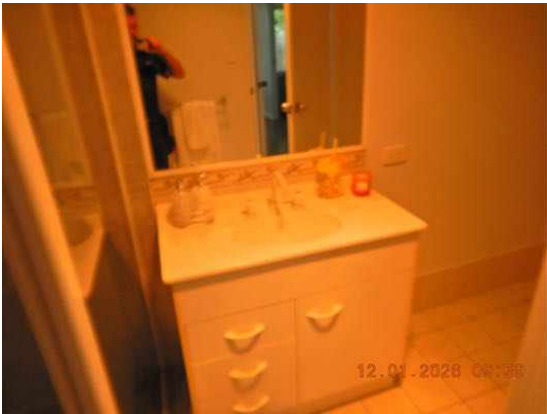
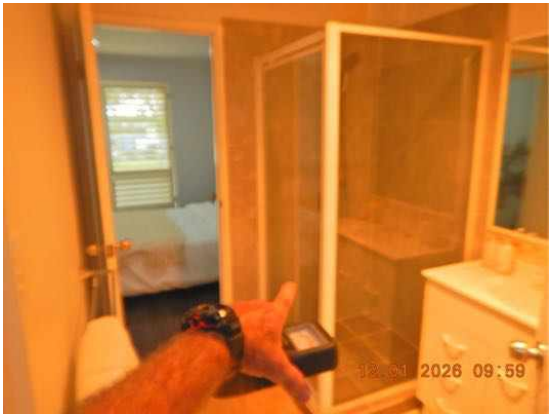
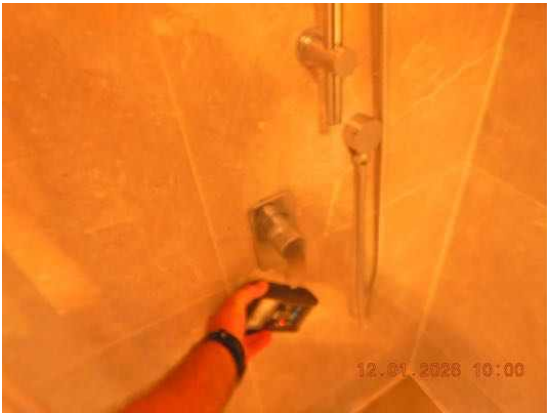
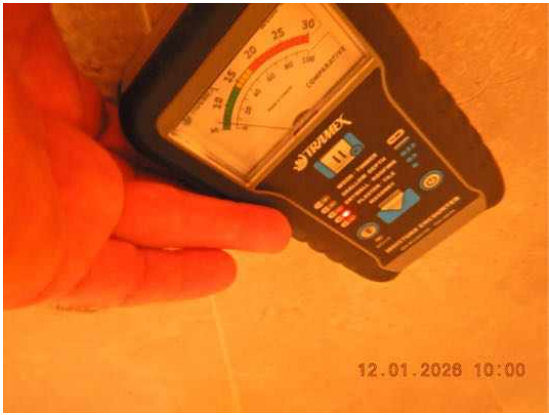
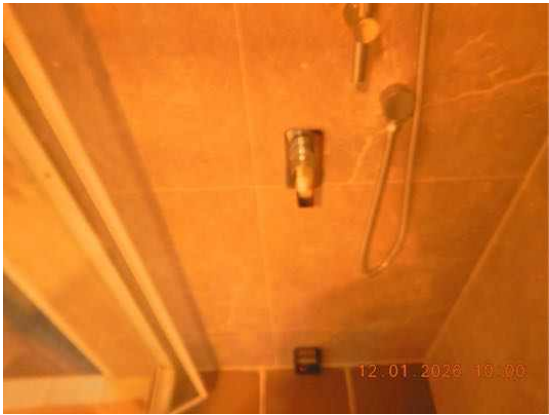
Building:	Main Building
Location:	Bedroom - Master/ Ensuite > Front Left
Finding:	Tap bodies not sealed in wall cavity
Information:	The master bedroom ensuite/bathroom shower wall mixer tap was found to not be sealed in the wall cavity at the time of this inspection.

This will allow unwanted moisture penetration into the wall and floor cavity and may cause unwanted moisture damage to occurring to other areas of this building.

It appears that this shower base has been re tiled over the original shower floor tiles and waste, and the New wall tiles were found to be unsealed along the top and side edges.

Installation of an appropriate sanitary grade sealant to all tap areas should be completed as soon as possible to reduce the risk of any further moisture damage occurring.

Sealing the top and side edge will reduce the risk of condensation getting behind the wall tiles.

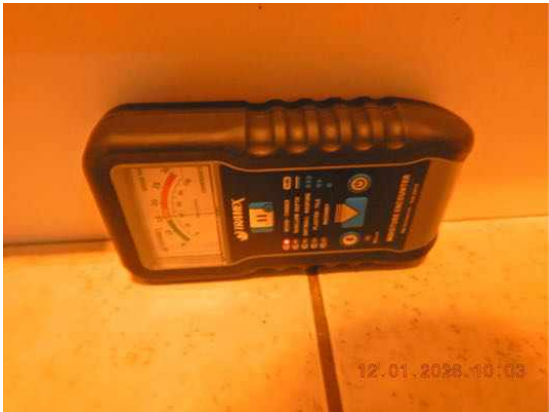
Finding 3.10

Location: Bedroom - Master/ Ensuite > Rear Left
Finding: Tiles - Drummy
Information: Drummy floor tiled areas were identified at the rear left master bedroom ensuite/bathroom floor area at time of inspection. The term 'drummy' refers to tiles that have become detached from their fixing, despite otherwise being in relatively good condition. Such defects are generally caused by physical or moisture damage to the area. Drummy tiled areas may also be a direct result of poor workmanship during the construction process.

Tiled areas may swell and shrink with changes in air humidity if the area has sustained moisture damage. Any exposure to moisture is capable of causing tiled areas to become drummy and/or cracked over a prolonged period of time. Drummy tiled areas generally require removal and replacement of affected tiles, with adequate sealant and grouting.

Specialist trades are available for these types of services. Otherwise, it is advised that a tiling contractor be appointed to perform works as necessary at the clients discretion to ensure that no further damage is sustained in the affected area.

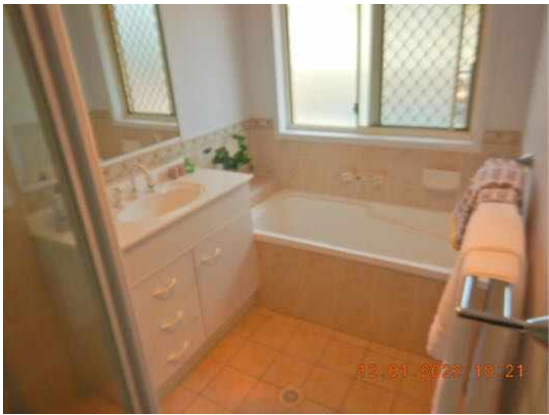
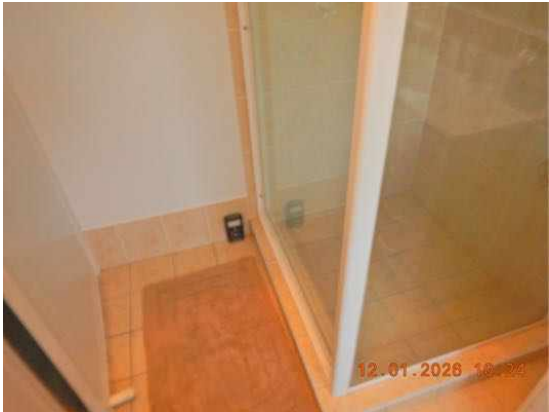
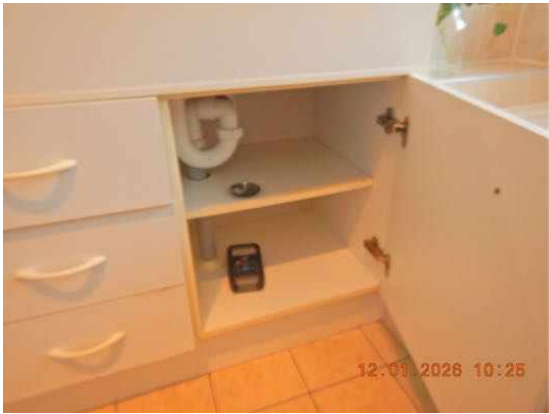
Building: Main Building
 Location: Bathroom > Rear Left
 Finding: Shower screen leak
 Information: The shower screen in this bathroom was found to have a leak at the base of the screen.

As this is not a new screen this is usually the result of insufficient or deteriorating sealant ,and will require re sealing.

There is an active leak in the vanity basin waste pipe that will require repair as soon as possible to reduce the risk of water damage to this vanity unit .

A plumbing contractor or handyman can complete this job.

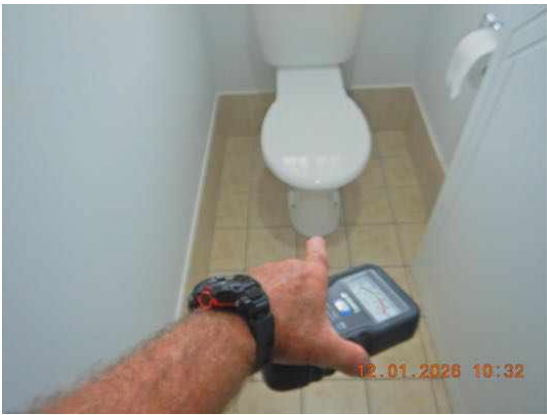
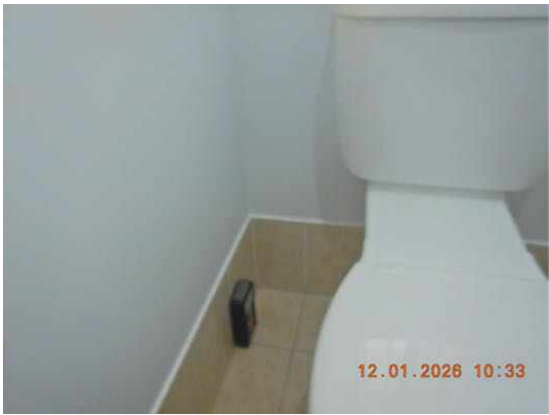
Building: Main Building
Location: Toilet (WC) > Rear
Finding: Toilet pan not secured correctly
Information: The main toilet pan was found to be loose and not secured to the floor correctly at the time of this inspection.

This may pose a potential safety hazard to anyone who may be using this unit if the unit moves or breaks when used.

Installation of an adequate silicone sealant will reduce the minor movement in the toilet pan.

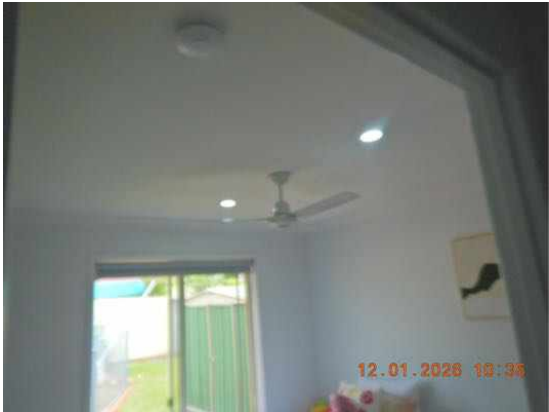
Finding 3.16

Building: Main Building
Location: Bedroom 3 > Front Right
Finding: Robe door damaged
Information: The bedroom-3 robe sliding door in this room was found to have sustained impact damage to the back face and will require repair or replacement.

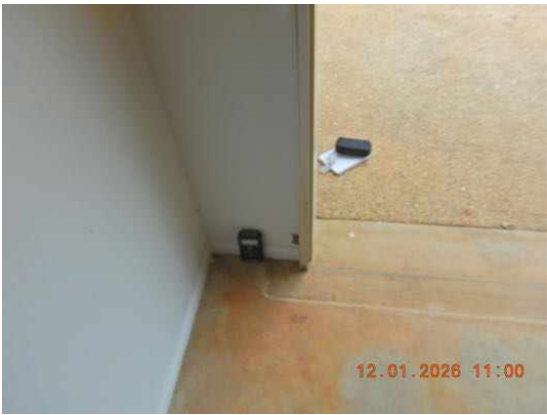
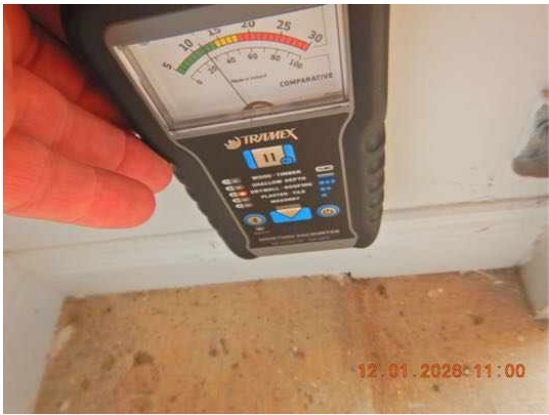
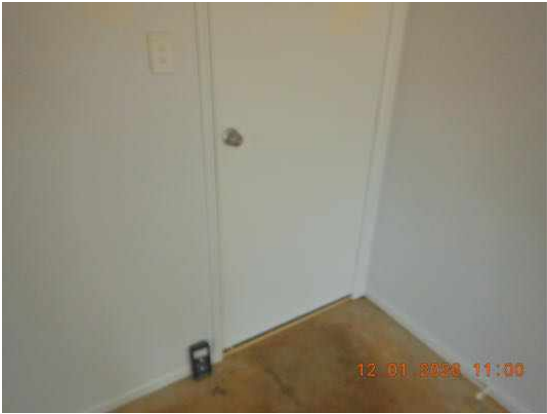
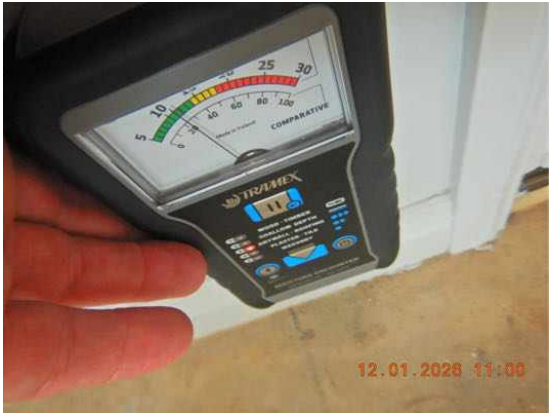
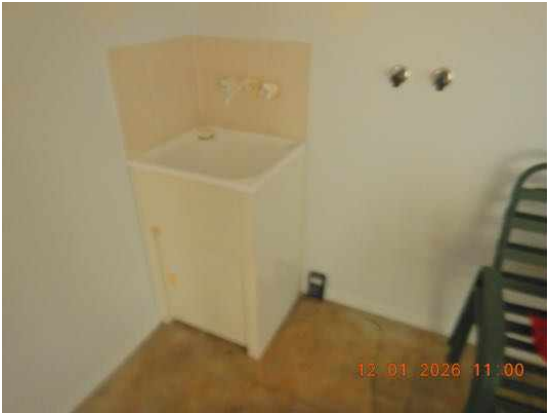
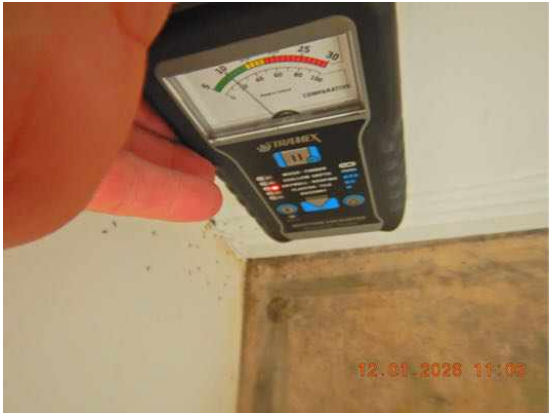
Finding 3.17

Building: Main Building
 Location: Garage > Centre Right
 Finding: Wood rot
 Information: The right side garage wall timber skirting evidence of minor wood rot.

This area backs onto the master bedroom ensuite/bathroom shower area, and is suspected to be old damage.

Wood rot, also known as Fungal Decay, occurs when timbers and other cellulose building materials are exposed to damp conditions on an ongoing basis. This could be the result of exposure to weathering over a prolonged period of time, or the attraction

of excessive moisture from other abutting building materials. Contributing factors also include poor air ventilation in the area.

Wood rot is often associated with general damp problems and is evidenced by a 'musty' smell or mould and mildew occurring on surfaces. If left unmanaged, damp conditions can lead to further health problems and the decay of timbers will continue.

Early intervention and regular maintenance, particularly of exterior timbers, will prolong the useful life of these building elements. Prior to any works being performed, the cause of the moisture that has created the visible wood rot should be identified and addressed in a suitable manner. Replacement of affected timbers may then be a necessary step in protecting surrounding building elements from such deterioration.

A qualified plumber may be appointed to assess the cause of excessive moisture and to provide advice on any remedial works as required. A qualified carpenter or registered builder may also be required to replace affected building materials.

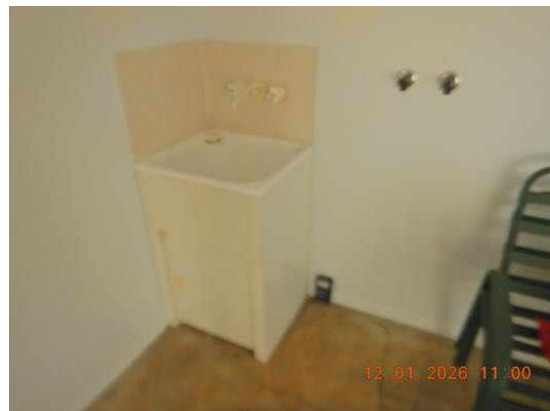
Building: Main Building
 Location: Garage/ Laundry > Rear Left
 Finding: Tap bodies not sealed in wall cavity
 Information: The garage /laundry wall taps were found to not be sealed in the wall cavity at the time of this inspection.

This will allow unwanted moisture penetration into the wall and floor cavity and may cause unwanted moisture damage to occurring to other areas of this building.

Installation of an appropriate sanitary grade sealant to all tap areas should be completed as soon as possible to reduce the risk of any further moisture damage occurring.

A plumbing contractor or handyman could complete the job.

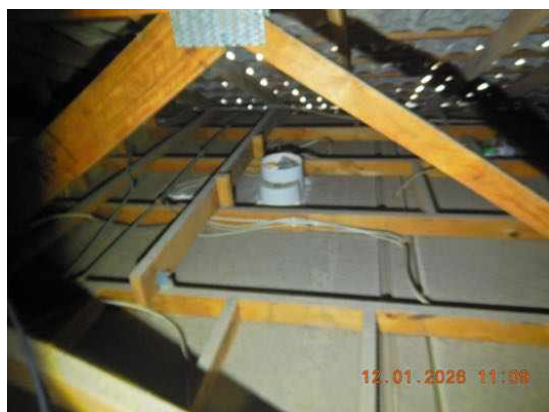
Finding 3.20

Building:	Main Building
Location:	Roof Void > All Areas
Finding:	Insulation - Missing
Information:	Upon inspection of the roof void it was noted that insulation is not present.

Where insulation is absent, the area does not meet current Australian Standards. Installation of adequate insulation is recommended and should be conducted at the client's discretion.

Ceiling Insulation was not required to be installed under the building code at the time of this buildings construction .

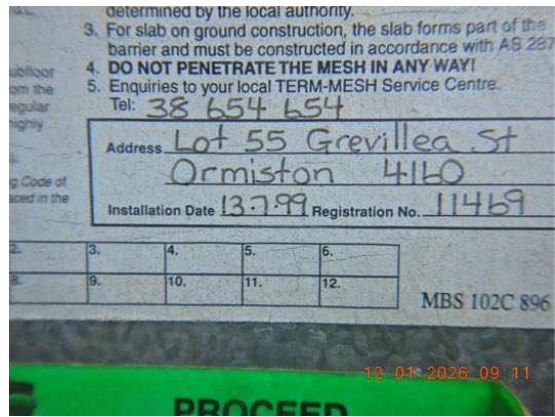
There was evidence found to indicate that this property has been inspected and treated for general pest, and visually inspected for timber pest (Termites) within the past 12 months as recommended.

The application of a post-construction chemical termite barrier is highly recommended for all properties, particularly if live termite activity has been found on the site previously. Such barriers are highly effective in preventing termite attack on any timber building elements throughout the property.

A chemical termite barrier is recommended as soon as possible.

The client may consider gaining further advice from a pest controller as to the costs and procedures involved with this application. It is recommended that obtaining such advice be a short-term priority.
