Building and Timber Pest Inspection Report

Inspection Date: Thu, 9 Apr 2026

Property Address: 9 Alverna St, Rooty Hill NSW 2766,
Australia

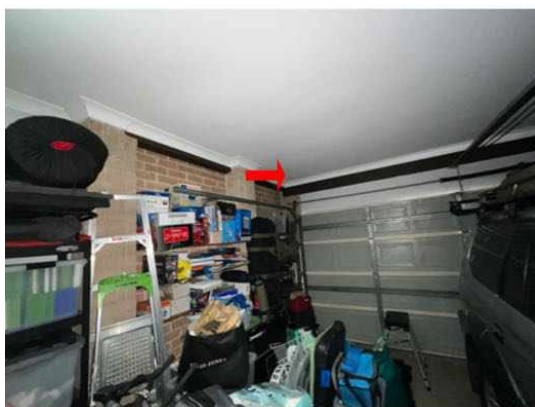
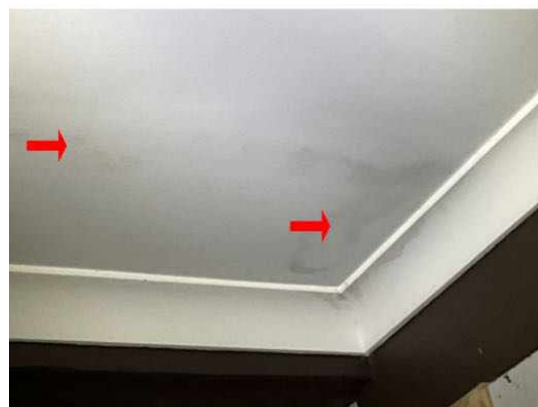
Building:	Main Building
Location:	Garage
Finding:	Ceiling - Water damaged
Information:	Water damage to the ceiling lining is generally an indication of excessive moisture being present in the roof void, usually via a leak to the roof covering.

Where water damage is evident to the ceiling, the primary requirement is to identify and rectify the source of the leak. A licensed roofing plumber should be appointed as soon as possible to identify the leak and perform rectification works as necessary, ensuring the water damage is restricted.

Once the leak is repaired, consultation with relevant tradespeople, including plasterers and painters, is advised. Rectification works may include replacement of ceiling lining or minor repainting, depending on the extent of the damage.

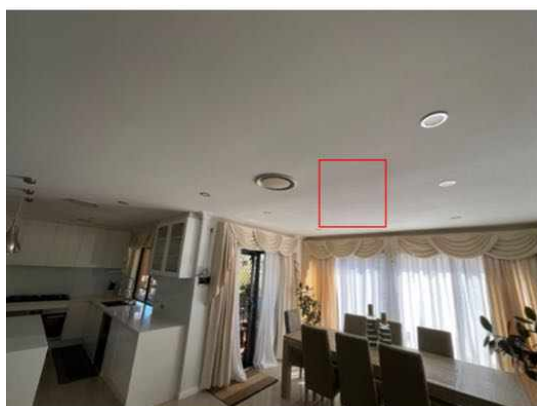
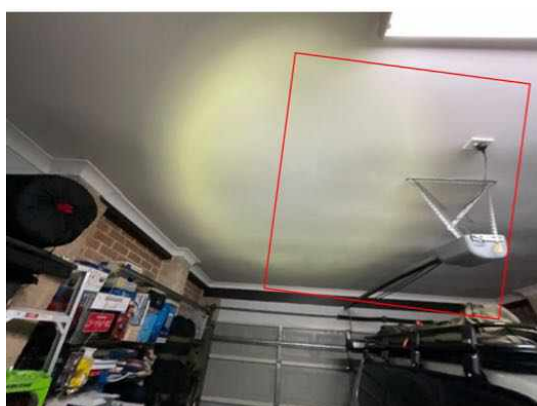
Finding 3.01

Building:	Main Building
Location:	Dining Room, garage
Finding:	Ceiling - Sagging
Information:	Sections of the ceiling were found to be sagging at the time of inspection. Sagging to the fixed ceiling structure generally indicates that the building materials have swollen, due to contact with water, or that fixings (e.g. nails or glue) have become loose and require reattachment.

Where minor sagging is evident, comparatively minor works, such as re-gluing of ceiling sheets, may be required. Such works may be performed by relevant tradespeople, such as plasterers and painters. Where excessive moisture has caused the roofing structure to swell and sag, the source of the water leak should primarily be identified prior to any remedial works being performed.

The appropriate action should be taken by the client as soon as possible to ensure that any potential further damage is limited.

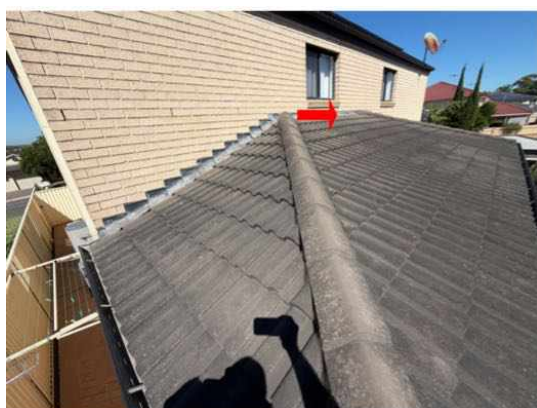
Finding 3.02

Building:	Main Building
Location:	Dining Room

Finding: Roof plumbing - Flashing cracked
 Information: Water leaks generally occur when a particular area of the property is not weather or water tight. Cracks were evident to the roof flashing in this area at the time of inspection.

Regardless of the location, if left unmanaged, even minor leaks can lead to serious damage of associated building elements, potentially resulting in the need for replacement of building materials. Damage to ceilings, wood rot, mould and other hazards, such as electrical hazards, may also arise if left unmanaged.

Further inspection and repair by a roof specialist or a licensed roof plumber is advised to adequately rectify the potential leak.

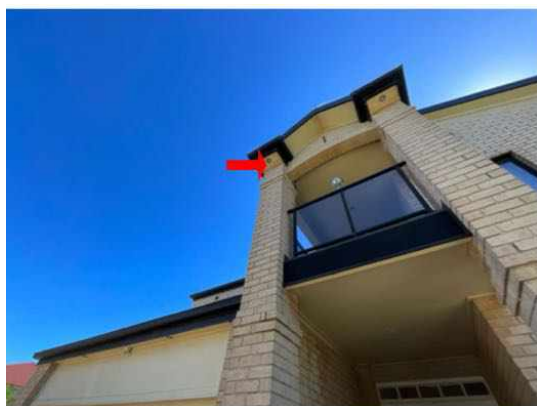
Finding 3.03

Building: Main Building
 Location: Front Elevation
 Finding: Eaves/Roof plumbing -- water damages
 Information: Water damage is generally an indication of excessive moisture being present, usually via a leak. It is suspected that gutter blockages causing stormwater to backflow into the eaves causing water damages. This is additionally conducive to termite activity due to the damp conditions.

Where water damage is evident, the primary requirement is to identify and rectify the source of the leak. Gutters must be kept clear of any blockages moving forward. A roofing plumber should be appointed for further assessment if the problem persists.

Once the leak is repaired, consultation with relevant tradespeople, including carpenters, plasterers and painters, is advised.

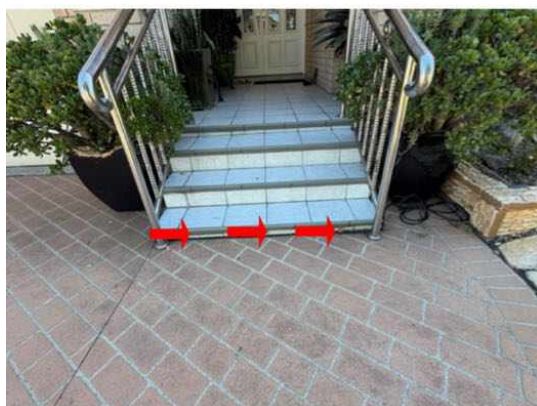
Building:	Main Building
Location:	Porch, balcony
Finding:	Tiles - Drummy
Information:	Drummy tiled areas were identified at the time of inspection. The term 'drummy' refers to tiles that have become detached from their fixing, despite otherwise being in relatively good condition. Such defects are generally caused by physical or moisture damage to the area. Drummy tiled areas may also be a direct result of poor workmanship during the construction process.

Tiled areas may swell and shrink with changes in air humidity if the area has sustained moisture damage. Any exposure to moisture is capable of causing tiled areas to become drummy and/or cracked over a prolonged period of time. Drummy tiled areas generally require removal and replacement of affected tiles, with adequate sealant and grouting.

Specialist trades are available for these types of services. A licensed tiling contractor may be appointed to perform works as necessary.

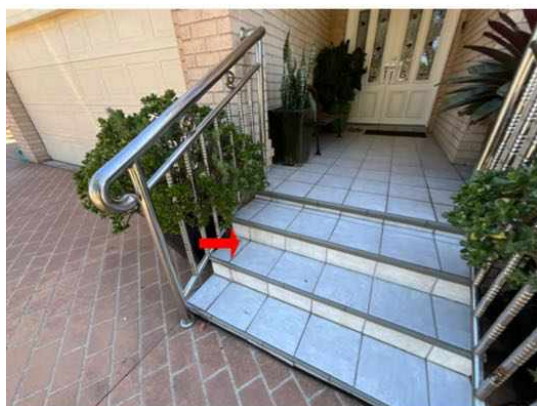
Finding 3.07

Building: Main Building
 Location: Porch
 Finding: Cracked floor tiles
 Information:

Cracking in the floor tiles was evident in this area at the time of inspection. It is suspected that this cracking has occurred as a result of minor settlement or shrinkage.

Cracked tiles throughout the household detract from the overall appearance of the affected areas however it is unlikely to create or lead to any secondary defects.

While not considered a matter of urgency, replacement of cracked floor tiles is recommended at the clients discretion. A licensed tiling contractor may be appointed to perform these works. Where cracks become more numerous, contact a licensed building inspector for further investigation.

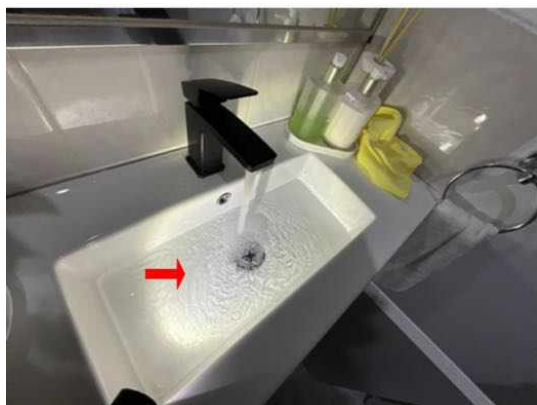
Finding 3.08

Building: Main Building
 Location: Powder room
 Finding: Sink/basin - slow draining
 Information:

The sink/basin drain appeared to be partially blocked at the time of inspection. Blockages here are usually caused by hair and other debris. If left unmanaged, a lack of general maintenance may lead to the development of more significant defects, such as water damage to surrounding building materials.

A licensed plumber should be appointed to remove the blockage at the client discretion.

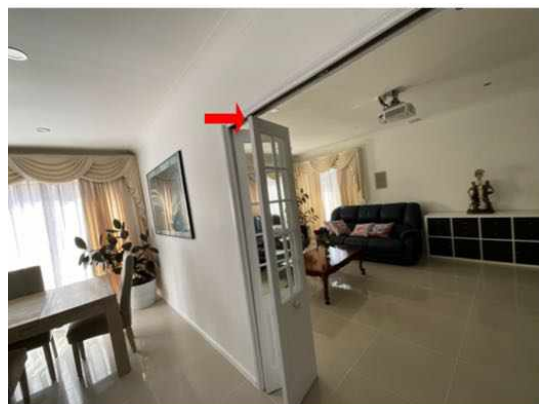
Finding 3.09

Building: Main Building
 Location: Media room
 Finding: Door - Stiff to slide
 Information:

The door in this area was jammed and difficult to slide along the associated tracks at the time of the inspection. Restricted function of the affected door may pose as a potential safety hazard if required for emergency egress from the building.

maintenance are the usual causes for this type of defect.

Replacement of door hardware or tracks may be required, as well as minor repairs and cleaning. A licensed carpet will be required to repair the affected doors.

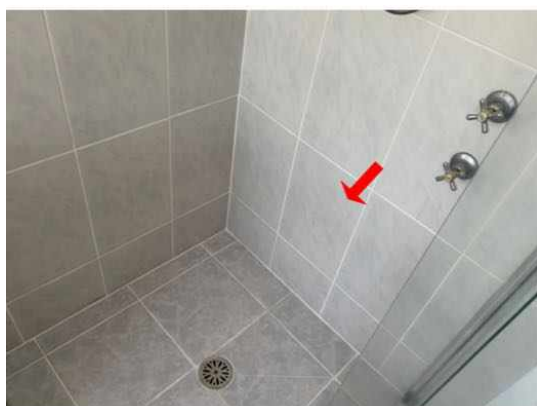
Finding 3.10

Building:	Main Building
Location:	Ensuite, bathroom
Finding:	Shower damp - Monitor
Information:	Damp is evident to the lower 400mm of wall to the shower alcove. There is no high reading around the taps nor are there high readings transferring to the other side of the wall. Sealant appears to have been repaired recently and both sealant and grout appear in acceptable condition at present.

This defect is quite common, and is suspected to have been caused by moisture permeating or leaching through the grouting and perhaps gaps in the sealant prior to repair.

Unmanaged damp in the shower recess is likely to facilitate the formation and development of mould and fungi growth, decaying associated building materials and compromising their structural integrity. It is important to address damp conditions, as the World Health Organisation notes that excess moisture leads - on almost all indoor materials - to growth of microbes such as moulds, fungi and bacteria, which subsequently emit spores and other matter into the indoor air. Exposure to these contaminants is associated with a wide range of respiratory and other health-related problems.

Monitoring the area is advised and if any visual signs of excessive moisture appear (peeling paint, mould) then consultation with a qualified plumber or bathroom specialist

would be advised to identify the cause of damp and to perform remedial works as required.

Always ensure that sealant and grout is in good condition to prevent any moisture issues occurring in the future.

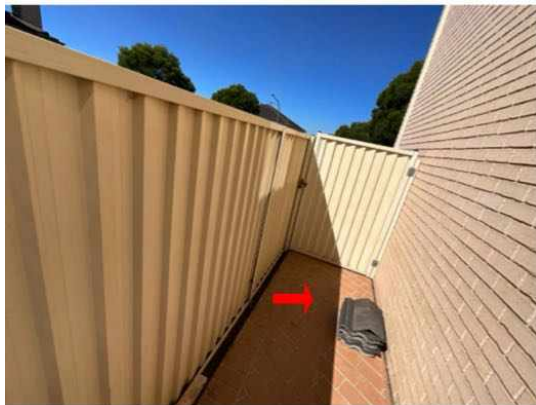
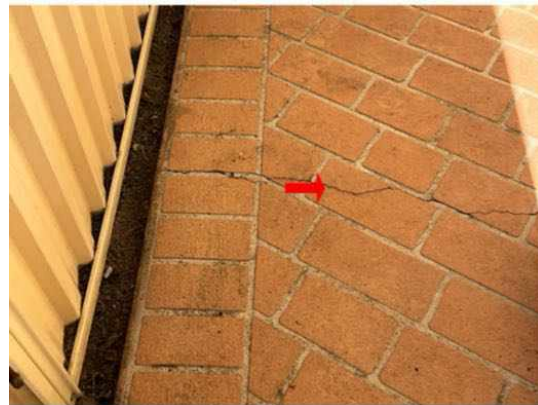
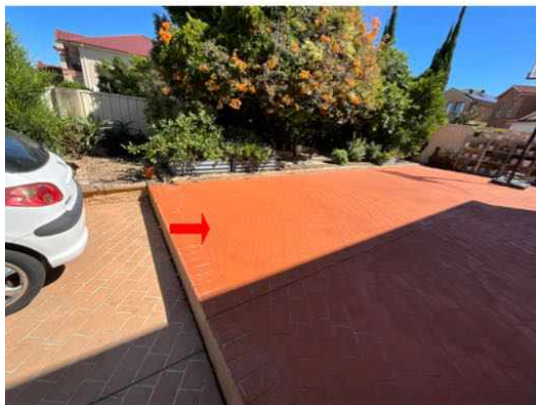
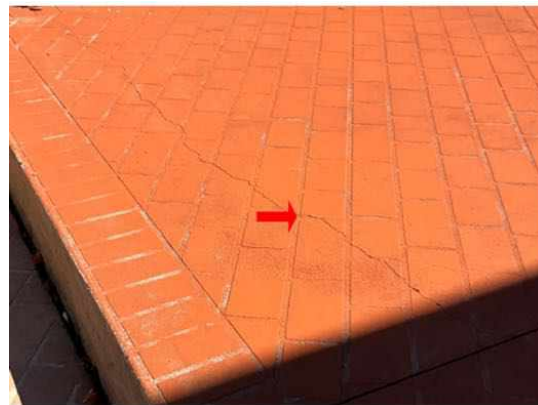
Finding 3.11

Building:	Main Building
Location:	Multiple areas
Finding:	Cracking - External Concrete Paving Damage Category 1 - Fine (less than 2mm)
Information:	Fine cracks were identified in external concrete paving. Although fine cracks are quite noticeable, they are often only considered to be an appearance defect, and usually do not indicate any structural damage. To be considered a Category 1 or fine crack, the crack is found to be less than 2mm in width.

Generally the cause of a hairline crack in existing concrete paving such as driveways and pathways is indicative of the expansion and contraction of the concrete. Such causes are generally due to environmental factors, such as moisture levels, weather conditions, root systems of nearby trees or the soil types on which they are laid.

Fine cracks may also be due to poor original installation of the concrete. Factors such as poor compaction of the sub surface and/or inadequate reinforcing of the slab may create cracking and other secondary defects.

Monitoring of all cracking should be conducted frequently. Always contact a building inspector should cracks widen, lengthen, or become more numerous.

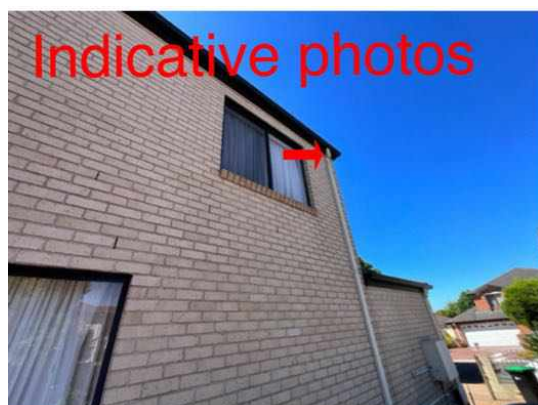
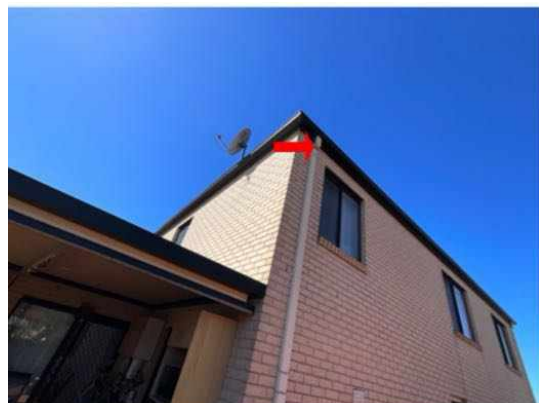
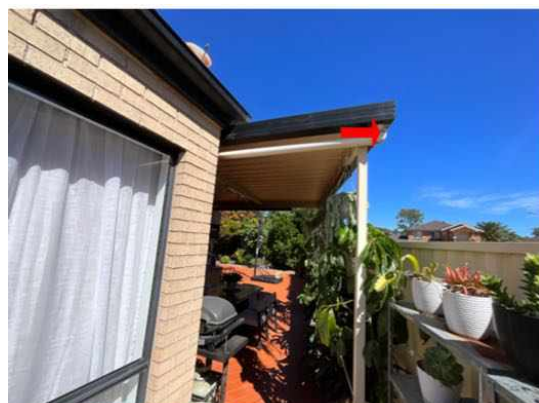
Building:	Main Building
Location:	Multiple areas of roof plumbing
Finding:	Water leak - External
Information:	Water leaks were found to be present to exterior plumbing work. Leaks are generally caused by deterioration of the plumbing elements over time, due to exposure to weather conditions, but may have also been caused by minor impact damage.

Such leaking creates damp conditions in the affected area, causing potential for water pooling and subsequent water damage if left unattended. These conditions may also attract termite attack, particularly if the area is subject to minimal levels of sun throughout daylight hours.

It is highly advised that a licensed plumber be appointed to rectify any water leaks that may be present. Areas of repair and replacement of plumbing fittings and fixtures may be required and, as such, a quotation should be sought.

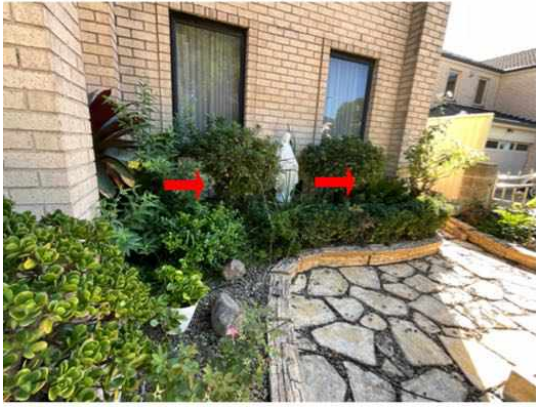
Finding 6.05

Building:	Main Building
Location:	Vegetation
Finding:	Vegetation - Abutting property
Information:	Vegetation against external wall may have an invasive root system. If there are weak points in the brick work or concrete slab, it is possible for the roots to gain entry into these areas. Once the roots have gained entry, it is possible for termites to gain concealed entry via these roots. It is recommended to remove the vegetation and root system where possible.
