# Building and Timber Pest Inspection Report

Inspection Date: Wed, 11 Mar 2026

Property Address: 131 Doonside Cres, Woodcroft NSW 2767,  
Australia

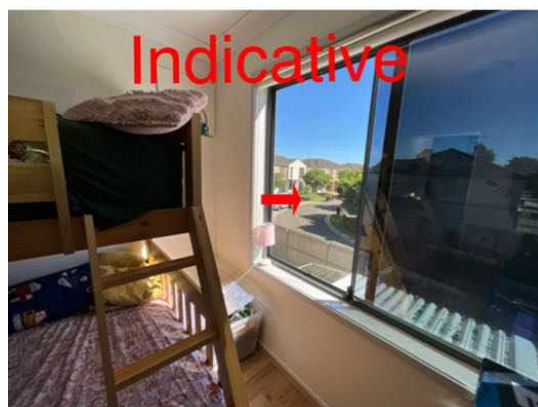
Building:	Main Building
Location:	Upstairs Windows
Finding:	Window restrictions - Missing
Information:	Window restrictors were found to be missing.

The National Construction Code (NCC) requirements apply to all openable bedroom windows in residential buildings, including hotels, motels and for all windows in early childhood centres.

Windows need to be locked at 12.5cm when the devices are engaged. The safety devices must be robust and child proof. The alternative is security screens such as bars or grills on the windows so long as they have gaps no bigger than 12.5cm. Flyscreens do not comply unless they are the reinforced security type and capable of resisting the very strong outward pressure which would prevent a child falling through. The laws apply to openable windows in a building within 1700mm of the internal floor and if the internal floor is more than 2m above the ground floor outside.

Windows upstairs lack appropriate child locks, creating a safety hazard. Window restrictors must be installed on these Windows immediately for added safety.

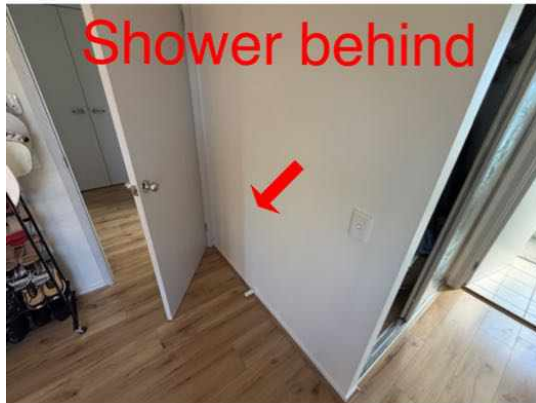
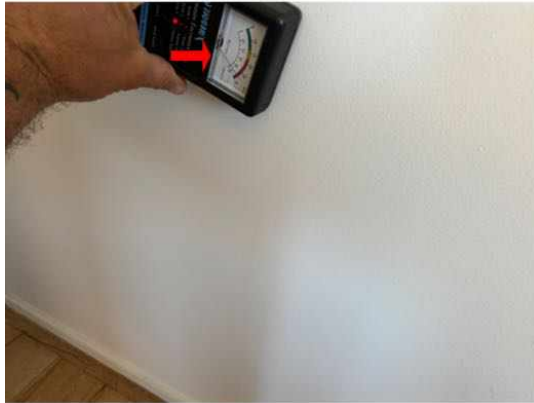
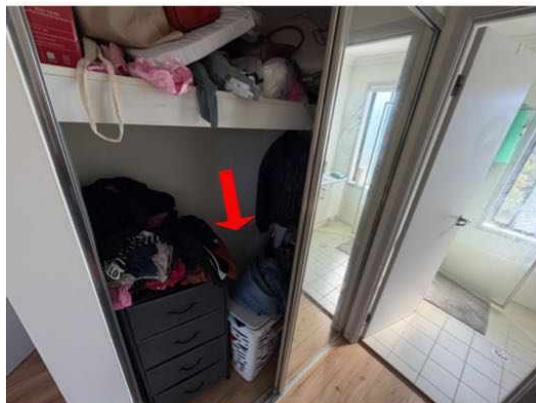
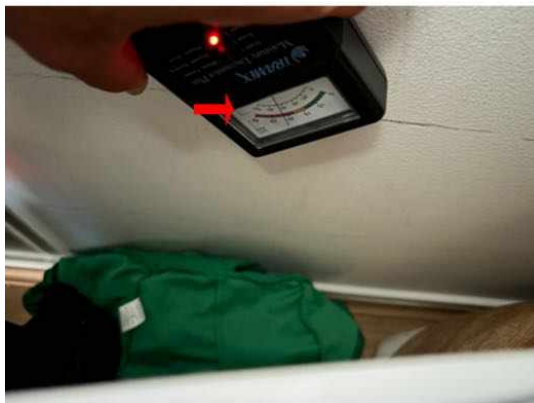
#### Finding 2.01

Building:	Main Building
Location:	Bathroom
Finding:	Water leak suspected - Internal
Information:	A water leak is suspected in this area at the time of inspection. Internal water leaks can be detrimental to surrounding building elements; their potential causes include damage to plumbing fittings and fixtures, through to water damage and deterioration

Rust, corrosion, decay and water damage are potential outcomes where a minor water leak is left unattended. More serious defects may also result, such as electrical hazards, or water damage to structural building elements.

In extreme cases, structural damage may develop due to a prolonged water leak. It is highly advised that a bathroom specialist be appointed urgently for assessment and repairs.

Excess moisture was also identified to the walls behind the main bathroom shower. A bathroom specialist must be appointed immediately for further assessment and repairs as this indicates that the waterproofing membrane may have failed.

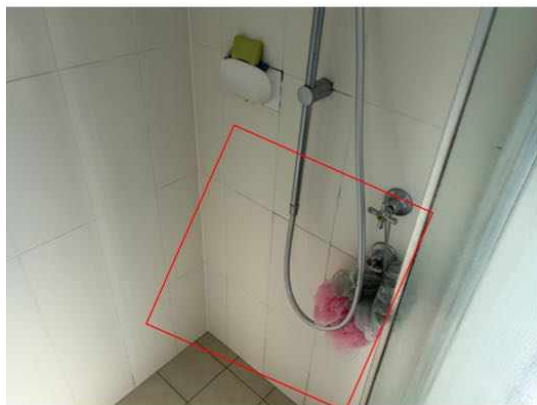
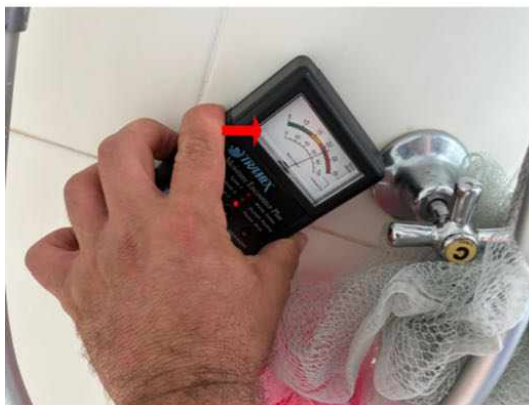
## Finding 2.02

Building:	Main Building
Location:	Ensuite
Finding:	Water leak - Suspected
Information:	A water leak is suspected in this area as excessive moisture was detected at the time of inspection. Another potential cause maybe moisture ingress behind the tiles from around the wall fittings and penetrations.

Internal water leaks can be detrimental to surrounding building elements; their potential causes include damage to plumbing fittings and fixtures, through to water damage and deterioration of associated building elements.

Attracting termites, corrosion, mould, decay and water damage are potential

outcomes where a minor water leak is left unattended. More serious defects may also result, such as electrical hazards, or water damage to structural building elements.

In extreme cases, structural damage may develop due to a prolonged water leak. It is highly advised that internal water leaks be addressed by a licensed plumber as a matter of relative urgency.

Excessive moisture was identified to the walls in the ensuite shower. There maybe a water leak OR otherwise moisture maybe penetrating around the fittings. A licensed plumber must be appointed urgently for further assessment and repairs.

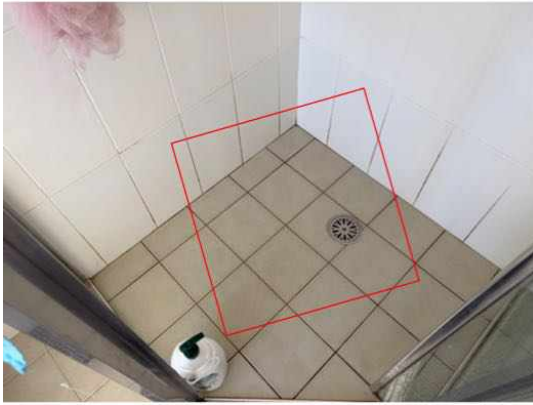
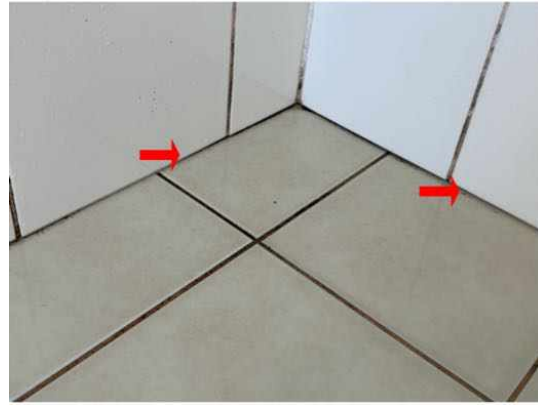
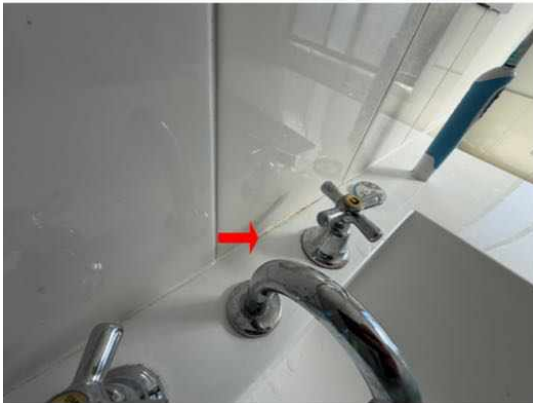
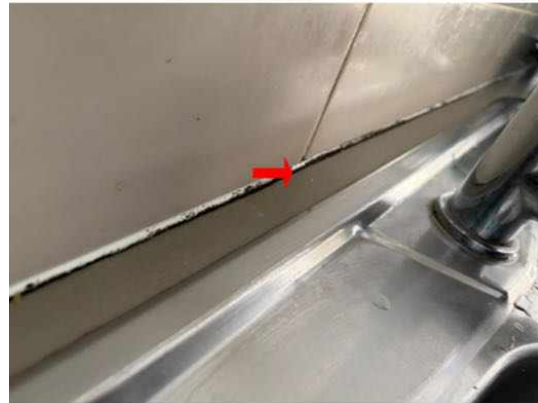
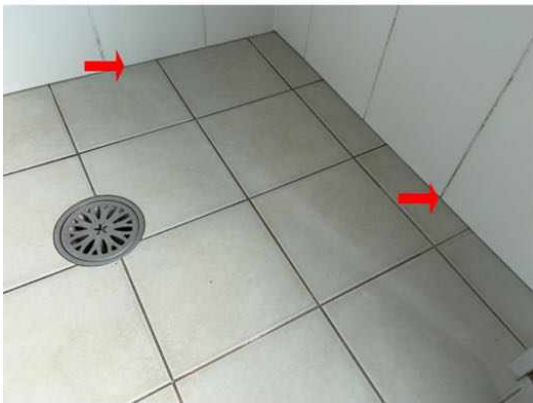
### Finding 3.01

Building: Main Building  
 Location: All Wet Areas  
 Finding: Sealant and grouting - Missing or damaged  
 Information:

It was noted on inspection that sealant or grout is degraded to this area.

Different materials and floor areas move at different rates, generally causing cracking to grout or sealant at this point. A flexible sealant is required to allow for expected expansion and contraction, while keeping the joint water tight and protective of all associated building materials.

Flexible and mould resistant materials should be applied to affected areas to prevent any subsequent water damage that is likely to occur. Regular maintenance and replacement of damage or missing or damaged sealant and grout is highly recommended to the wet areas, as this is a regular wear and tear defect. Sealant and grouting in areas that come into regular contact with water should be maintained for the long term care of your property.

A sealant specialist should be appointed to complete these works as soon as possible.

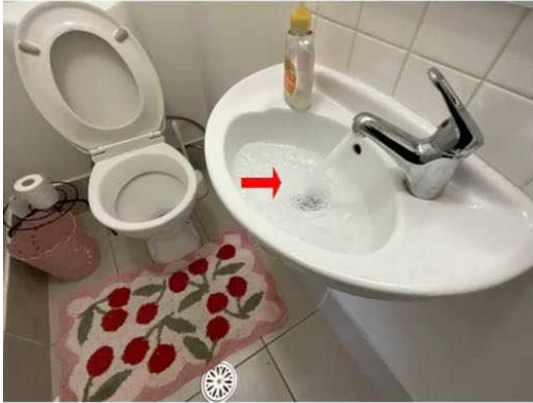
### Finding 3.02

Building: Main Building  
 Location: Powder room  
 Finding: Sink/basin - slow draining  
 Information:

The sink/basin drain appeared to be partially blocked at the time of inspection. Blockages here are usually caused by hair and other debris. If left unmanaged, a lack of general maintenance may lead to the development of more significant defects, such as water damage to surrounding building materials.

A licensed plumber should be appointed to remove the blockage at the client discretion.

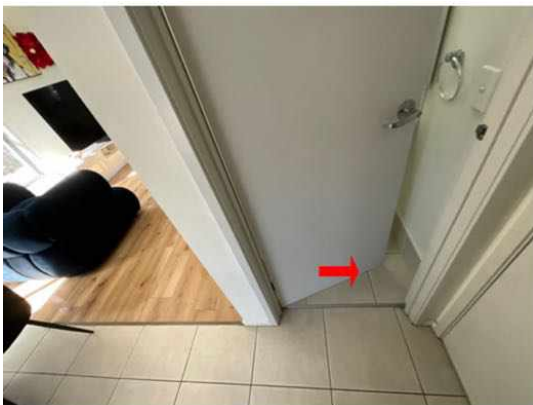
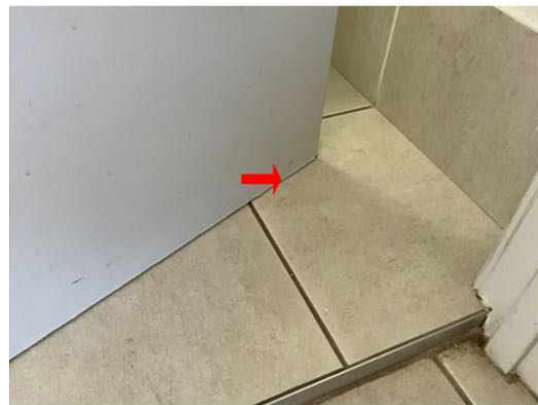
### Finding 3.03

Building: Main Building  
 Location: Powder room  
 Finding: Door - Binding/jamming  
 Information:

Binding and/or jamming of this door is evident during standard operation. This defect inhibits the functionality of the affected door as well as creating potential for secondary defects to associated building elements, such as damage to the floor covering or adjacent frame.

A door that binds to flooring or to the associated door frame may have several causes, ranging from minor defects, such as poor installation of the door or deteriorated hinges.

A licensed carpenter should be appointed to perform minor rectification works at client discretion.

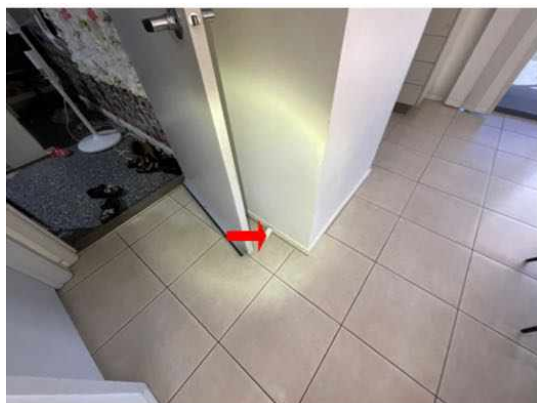
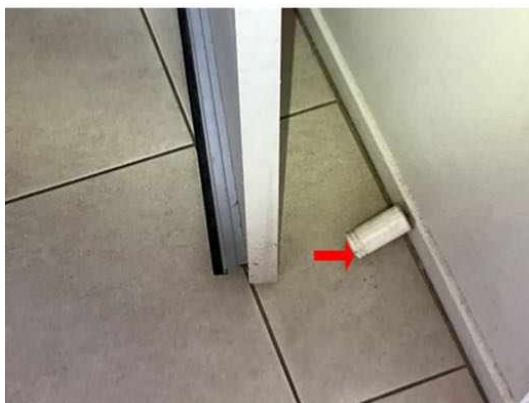
### Finding 3.04

Building: Main Building  
 Location: Garage

Finding: Door stop - damaged  
 Information: The door stop is inadequate to stop the door handle from damaging the wall. Although some building elements may seem irrelevant or unnecessary, all building elements play a key role in the operation and function of the overall structure and its performance.

Re-installation or replacement of the door stop is advised as soon as possible to prevent any subsequent damage to the door or associated structures. A general handyman may be appointed to perform these works at client discretion.

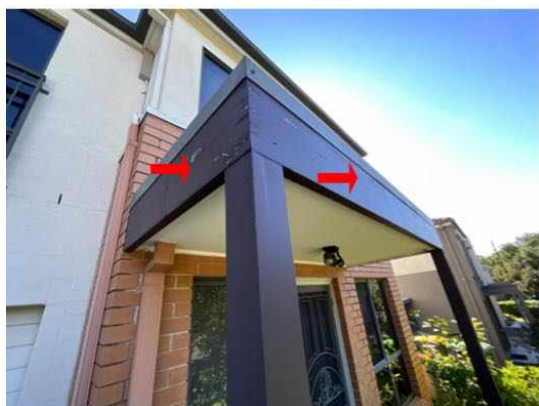
### Finding 3.05

Building: Main Building  
 Location: Porch  
 Finding: External painting deteriorated  
 Information: The external paintwork in this area has been neglected and require attention to prepare and re-paint.

Whilst incomplete or missing paint finish is generally an appearance defect, it can also lead to the development of secondary building defects over time. Incomplete areas of paint finish expose the area to moisture, potentially accelerating the deterioration of underlying building materials.

Degraded paint finishes should be sanded back, filled, leveled and painted, as applicable. Where inadequate or missing paint protection has led to the deterioration of the associated building element, repair and/or replacement of this building element may be required.

A painting contractor should be appointed as soon as possible to perform necessary works to aid the appearance of the affected area and to ensure the area is protected against further deterioration. Alternatively, the homeowner following manufacturer instructions may perform these works.

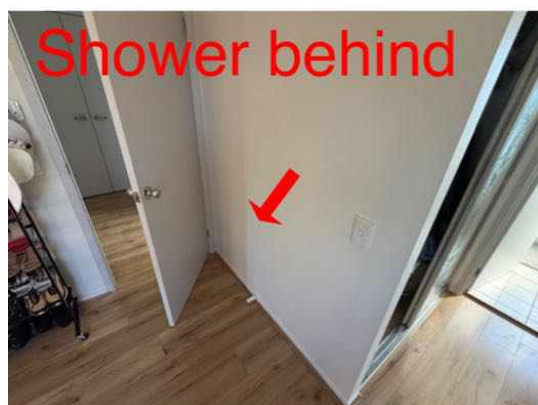
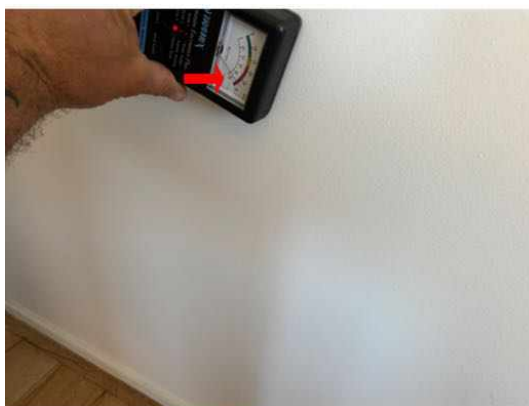
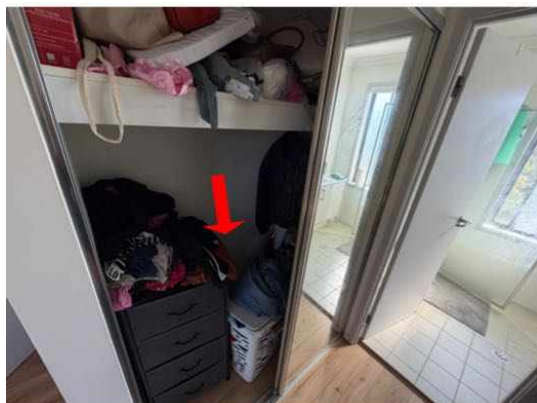
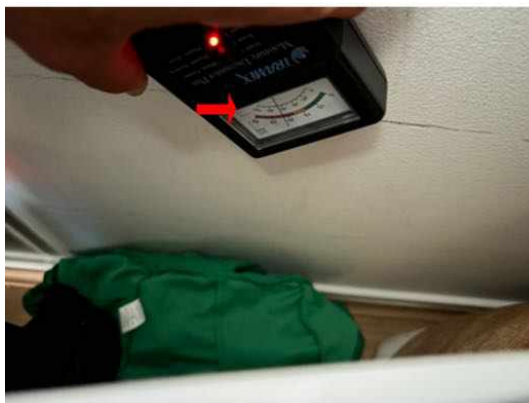
Building:	Main Building
Location:	Bathroom
Finding:	Water leak suspected - Internal
Information:	A water leak is suspected in this area at the time of inspection. Internal water leaks can be detrimental to surrounding building elements; their potential causes include damage to plumbing fittings and fixtures, through to water damage and deterioration of associated building elements.

Rust, corrosion, decay and water damage are potential outcomes where a minor water leak is left unattended. More serious defects may also result, such as electrical hazards, or water damage to structural building elements.

In extreme cases, structural damage may develop due to a prolonged water leak. It is highly advised that a bathroom specialist be appointed urgently for assessment and repairs.

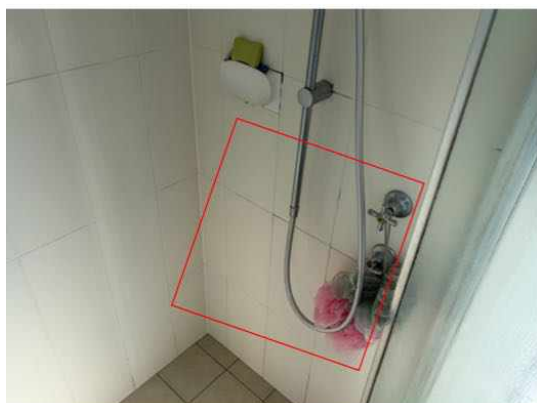
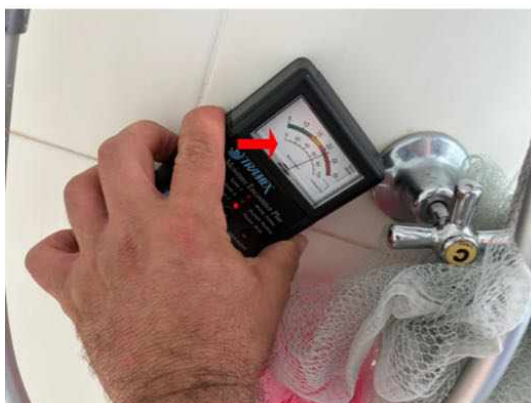
### Finding 6.02

Building:	Main Building
Location:	Ensuite
Finding:	Water leak - Suspected
Information:	A water leak is suspected in this area as excessive moisture was detected at the time of inspection. Another potential cause maybe moisture ingress behind the tiles from around the wall fittings and penetrations.

Internal water leaks can be detrimental to surrounding building elements; their potential causes include damage to plumbing fittings and fixtures, through to water damage and deterioration of associated building elements.

Attracting termites, corrosion, mould, decay and water damage are potential outcomes where a minor water leak is left unattended. More serious defects may also result, such as electrical hazards, or water damage to structural building elements.

In extreme cases, structural damage may develop due to a prolonged water leak. It is highly advised that internal water leaks be addressed by a licensed plumber as a matter of relative urgency.

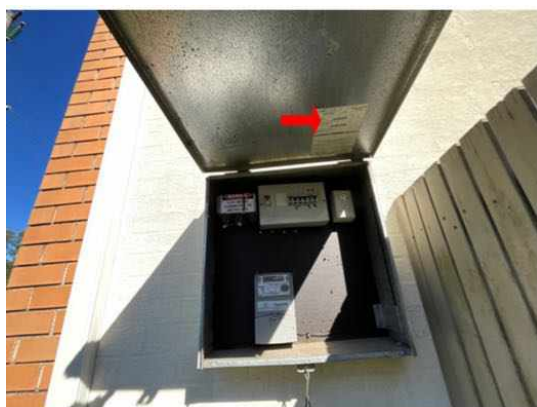
### Finding 6.03

Building: Main Building  
 Location: Slab penetrations  
 Finding: Service penetrations  
 Information: Services into home can allow for concealed termite entry without additional or adequate termite protection.

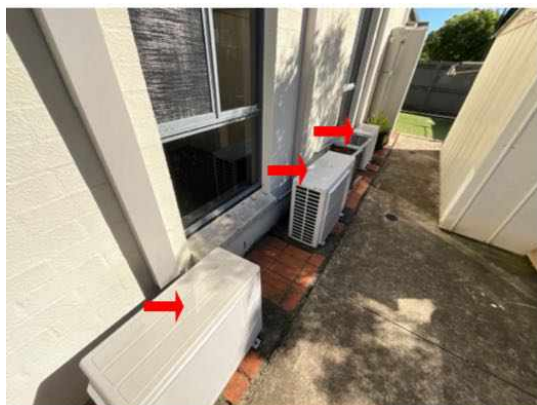
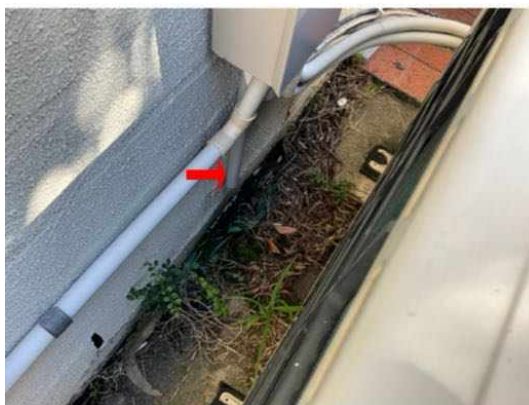
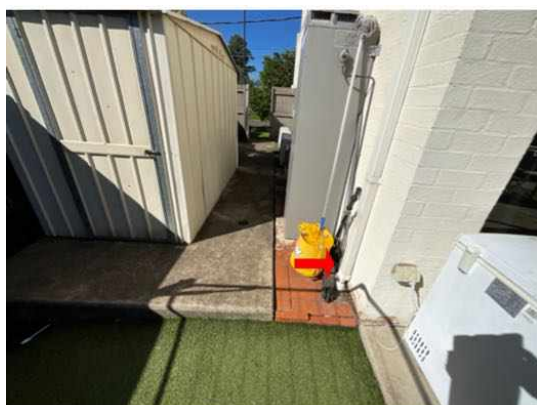
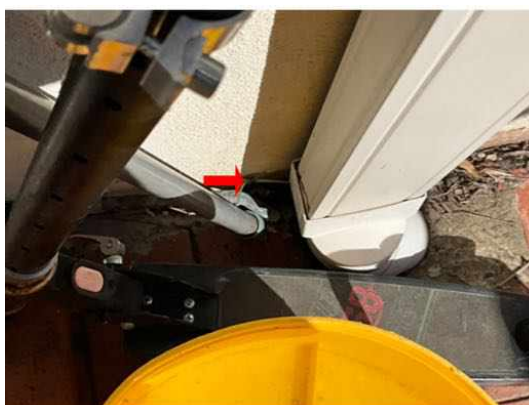
### Finding 6.04

Building: Main Building  
 Location: Yard - Side  
 Finding: Overflow - Not plumbed for drainage  
 Information: The overflow is not plumbed or connected to suitable drainage, which can result in the surrounding area becoming excessively damp.

These damp conditions can lead to secondary defects such as rot, rust or corrosion of associated building elements, the formation of fungal decay, or even the creation of potential slip hazards. When coupled with poor site drainage, pooling of water may also attract termite activity to this area.

It is highly recommended that a licensed plumber be appointed to install adequate drainage to the overflow. These works will ensure that the area remains dry and free of

any secondary defects.

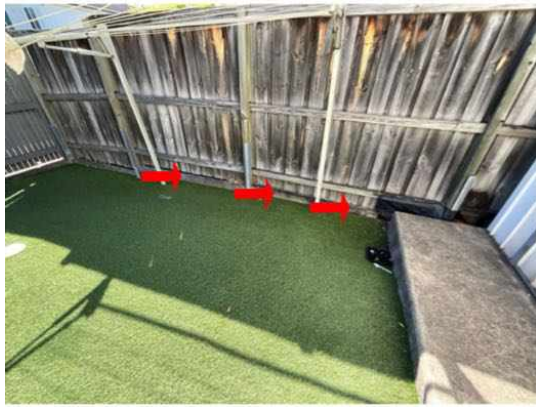
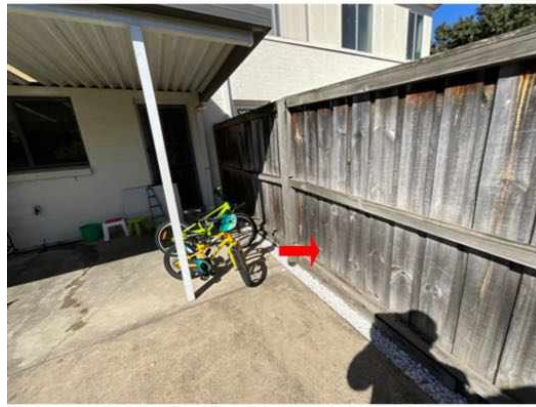
### Finding 6.05

Building:	Main Building
Location:	Fencing & Landscaping
Finding:	Building materials in direct ground contact - conducive to termites
Information:	Where timber elements are in direct contact with the ground and consequently moisture or dampness they become conducive to termite activity. Whether timber is used as a building element part of a fencing structure or stored as an unused item they can provide an environment that is attractive to termite infestation.

When met with excessive moisture timber begins to decay and develop wood rot. Any timbers that are in direct contact with external grounds especially if left untreated or non-durable also provide ingress for subterranean termites into that particular element.

The removal of any such materials that may be conducive to termite activity should be removed as soon as possible to minimise the risk of termite attack.

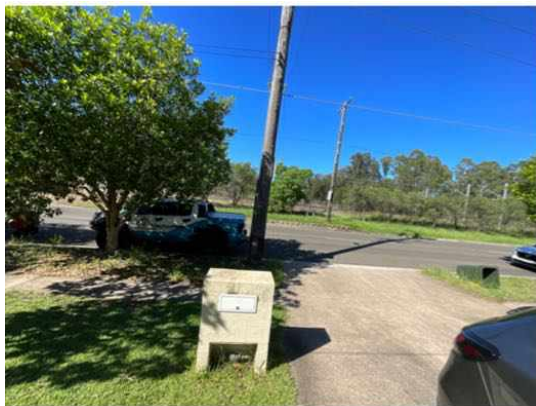
### Finding 6.06

Finding: Surrounding bushland - Conductive

Information: Home and or building is situated in a high risk area for termite activity, due to close proximity to surrounding bushland.

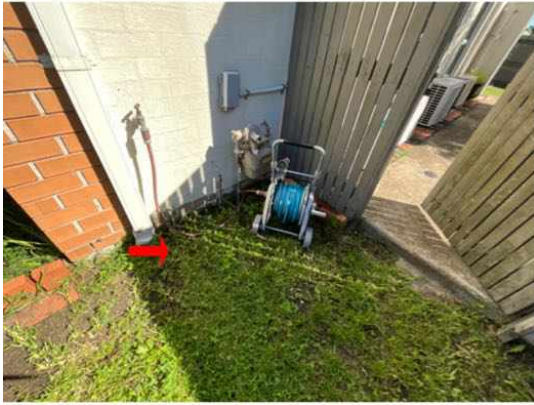
### Finding 6.07

Information: The external tap in this area was noted to have no drain at the time of inspection.

This keeps the surrounding surfaces damp while using the tap, which becomes conducive to termite activity.

A licensed plumber must be appointed to ensure an appropriate drain is installed.
