## Building Inspection Report

Inspection Date: Thu, 22 Jan 2026

Property Address: 41 Orelia Ave, Orelia WA 6167, Australia

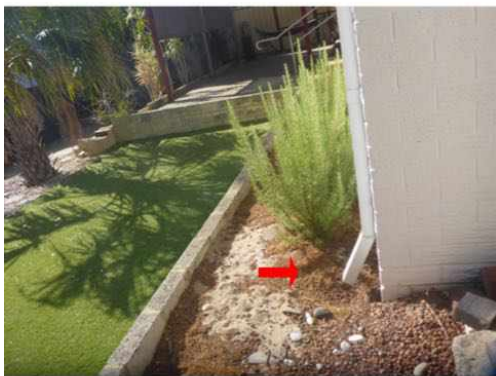
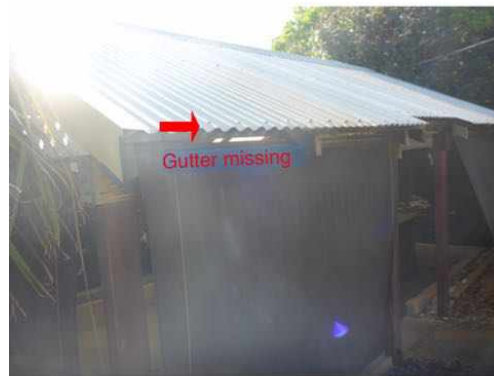
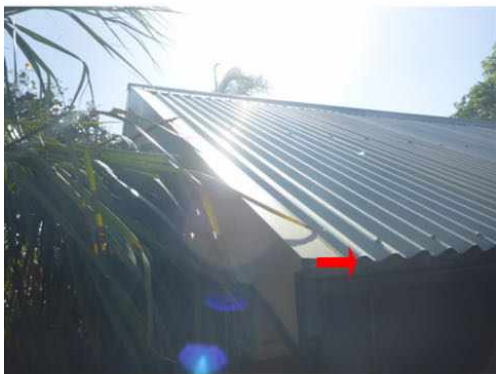
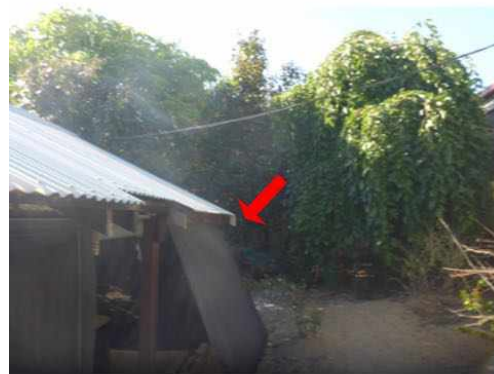
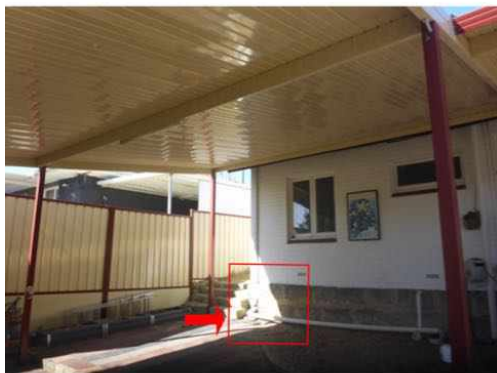
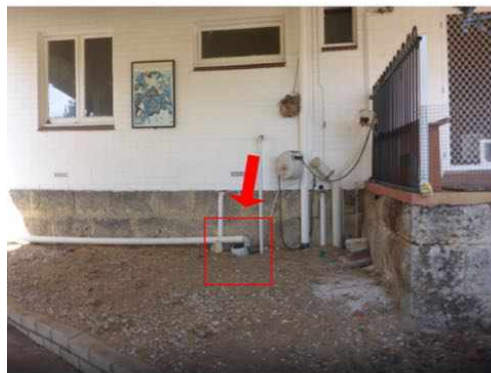
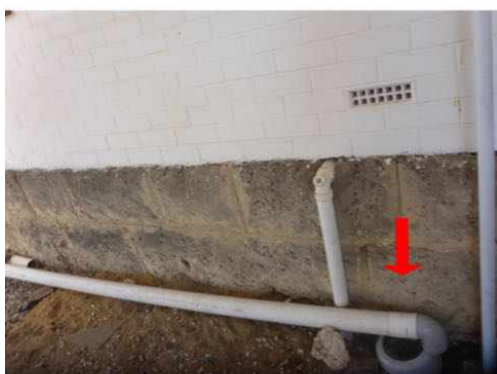
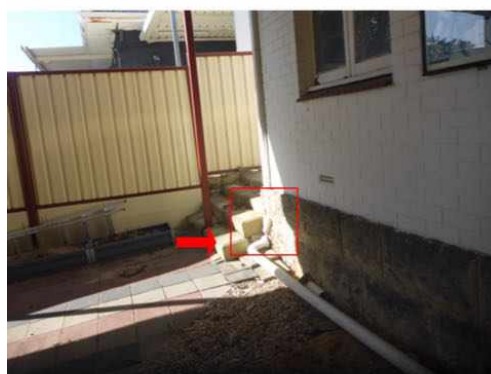
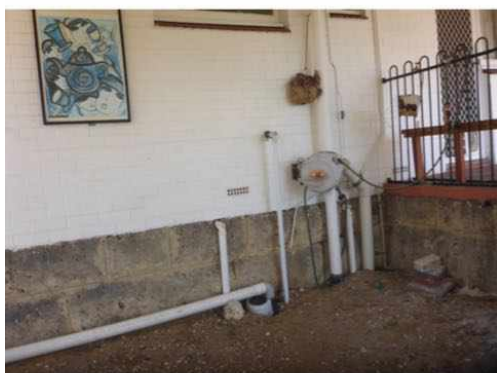
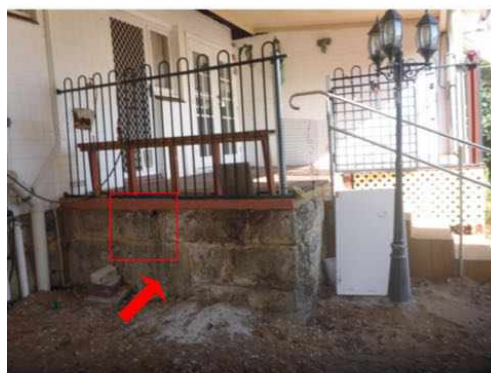
#### Defects 2.01

Building: Main Building  
 Location: Roof Exterior > Existing  
 Finding: Stormwater drain - Not connected  
 Information: The roof plumbing is not adequately connected to stormwater drainage on the site. This disconnection negatively impacts the functional capacity of the roof plumbing.

Where roof plumbing doesn't drain adequately, the area at the base perimeter can become excessively damp, potentially creating an environment that is susceptible to rust and corrosion of surrounding building elements, as well as attracting termites and other pests.

It is highly recommended that a plumber be appointed to further inspect the area and to install adequate drainage equipment where necessary.

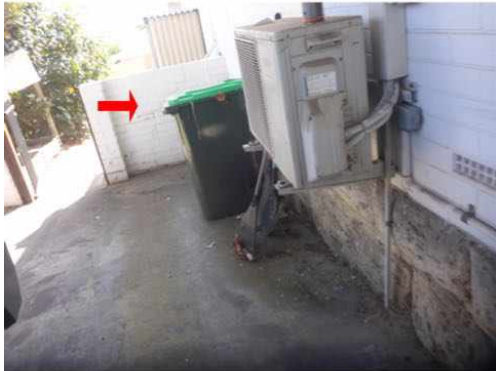
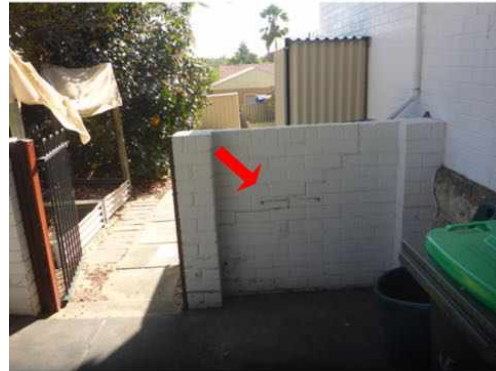
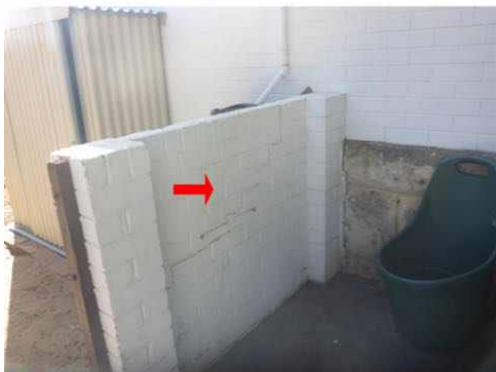
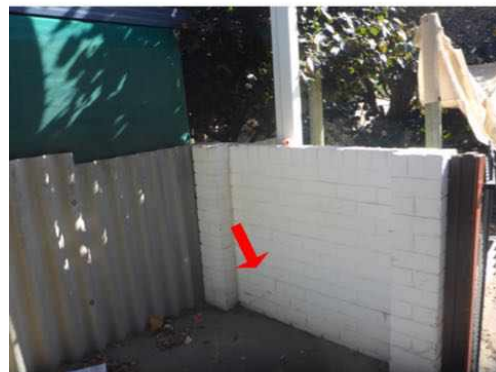
### Defects 3.01

Building:	Main Building
Location:	Entry > Existing
Finding:	Brickwork - Step cracking
Information:	Step cracking was identified to the brickwork in this area at the time of inspection. Step cracking, which is similar to other forms of cracking, has a variety of possible causes. However, the most common is the subsidence of adjacent footings.

Step cracking is a relatively common defect, and is most likely to occur adjacent to windows, doors and other openings. Mortar failure in the gaps between affected bricks indicates the stresses and tensions affecting the wall.

Where step cracking is extensive or severe, the client is advised to consult a structural engineer. Minor step cracking can be used as a warning sign to address factors causing stress to the wall, which can include the effect of surrounding trees, water leaks, soil erosion, or even the presence of reactive soils in the surrounding area.

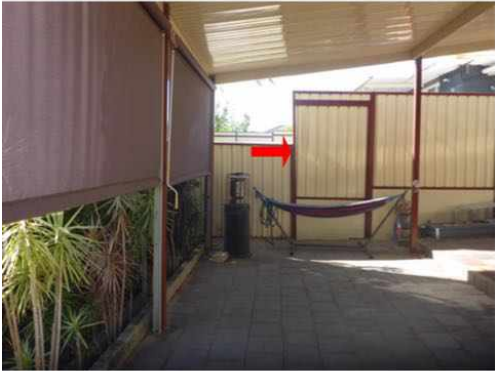
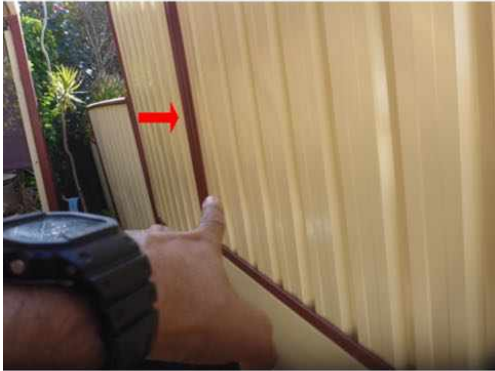
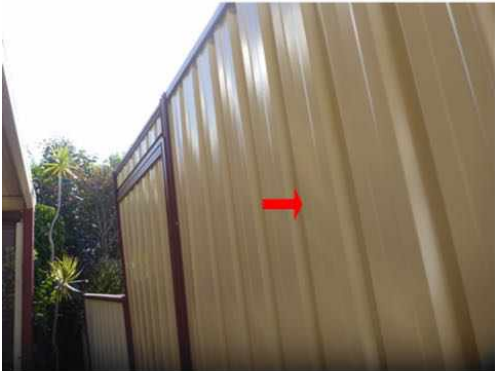
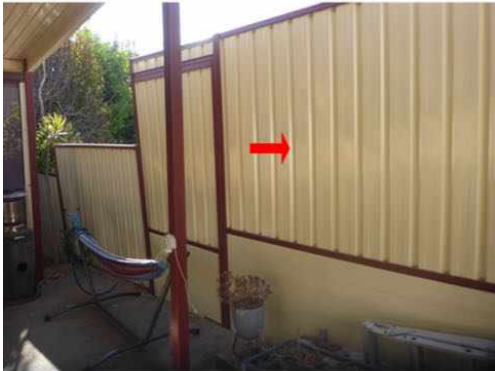
### Defects 3.02

Building:	Main Building
Location:	Exterior walls - right side > Existing
Finding:	Fence Leaning & Broken
Information:	Fence leaning & Broken

At the time of inspection we observed that fence is leaning & Broken.

A relevant tradesperson should be appointed to repair or replace the affected building element prior to any subsequent damage being caused.

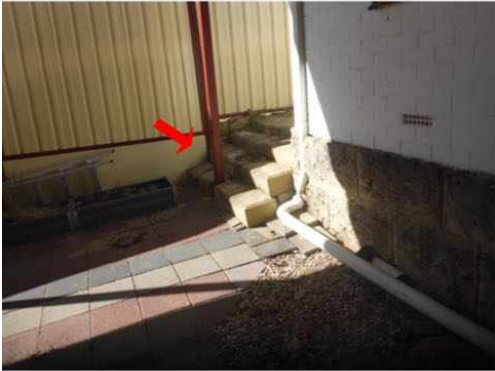
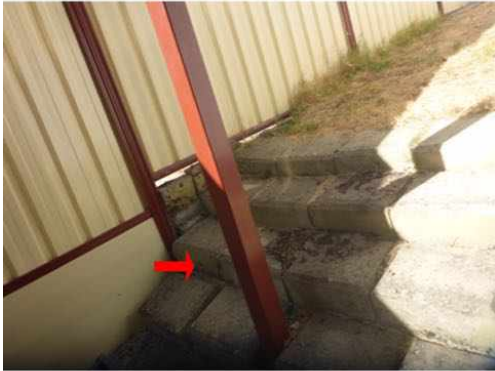
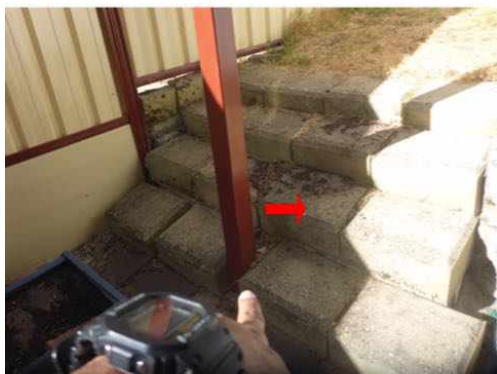
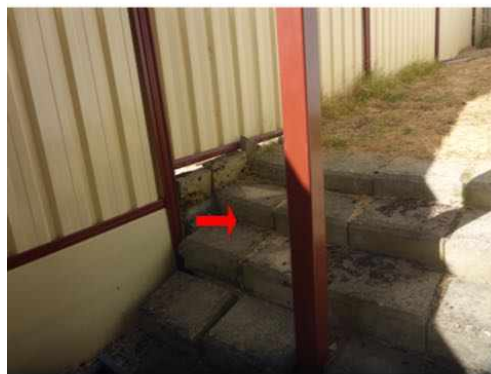
**Defects 3.03**

Building: Main Building  
Location: Rear Elevation > Existing  
Finding: Stairs - Uneven heights  
Information: The stairs were found to be of varying heights, creating a potential trip hazard for users of the staircase. According to normal building practices, all stairs should be measured and levelled to exact heights so as to prevent tripping.

Although retrospective works may not be relevant or cost-efficient, re-levelling of the uneven stairs is otherwise advisable. Consultation with a qualified carpenter as to the cost of potential solutions is recommended as soon as possible.

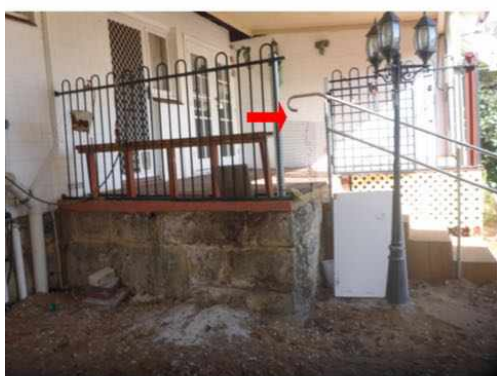
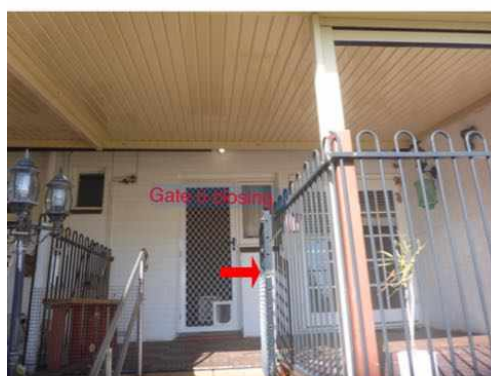
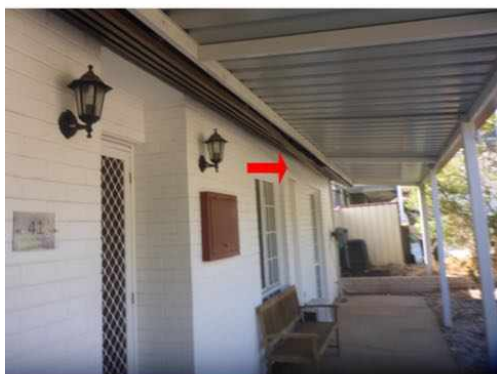
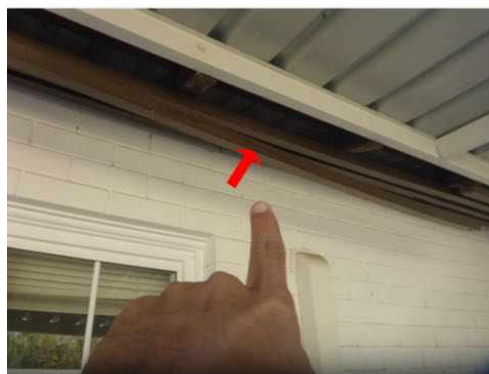
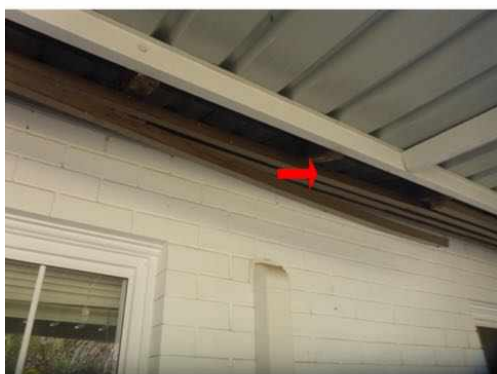
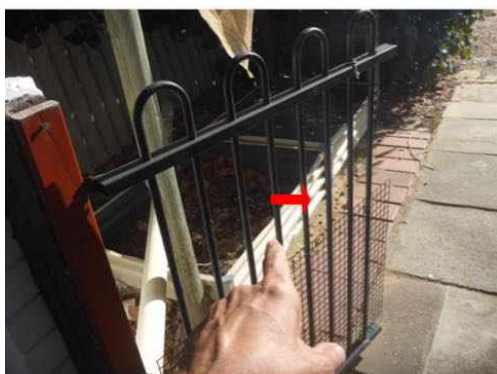
### Defects 3.04

Building: Main Building  
 Location: Kitchen > Existing  
 Finding: Building element - Broken  
 Information: Breakage occurs generally when the building materials have either aged and decayed, or as a result of damage (accidental or deliberate).

Repair and/or replacement of broken elements is advised to ensure that additional secondary defects do not arise as a consequence. Such works are necessary, as all building elements play a key role in the operation and function of the overall structure and its performance.

A relevant tradesperson should be appointed to repair or replace the affected building element prior to any subsequent damage being caused.

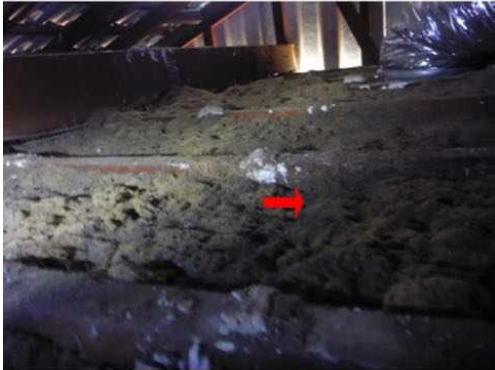
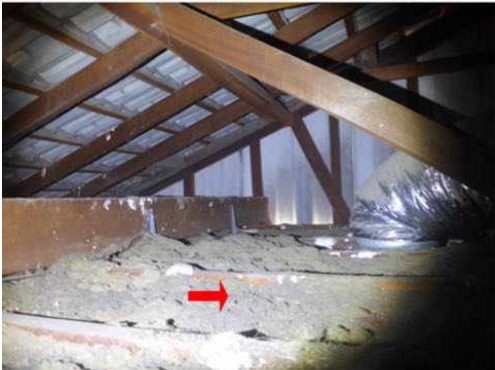
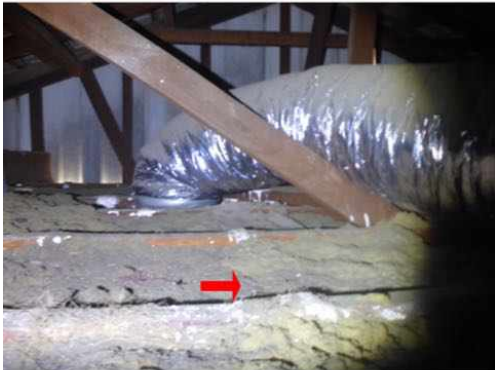
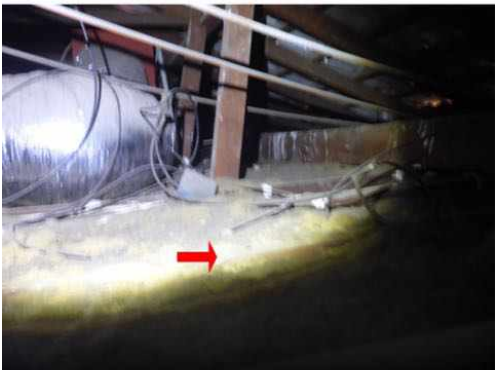
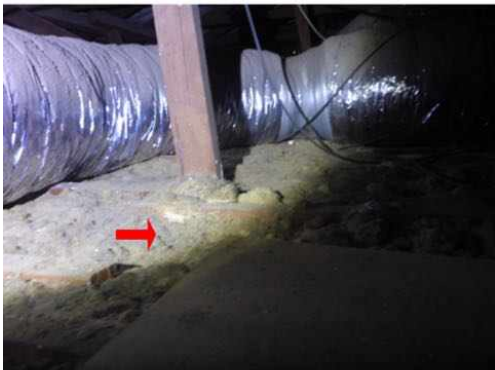
### Defects 3.05

Building: Main Building  
 Location: Roof Void > Existing  
 Finding: Insulation - Reduced in volume  
 Information: Insul-fluff is common in many older homes and is a loose form of insulation that is 'blown' into roof voids. While this type of insulation was considered effective at the time of installation, modern materials have surpassed it as the preferred insulator.

This type of insulation is susceptible to settling and reducing in volume, detracting from its effectiveness and resulting in an overall loss of energy within the household. Additionally, the reduction in volume has led to an uneven distribution of insulation within the ceiling void, further detracting from its effectiveness.

It is highly advised that this insulation be removed and replaced with a more appropriate material. This will ensure that the property is adequately insulated and will promote an increase in energy efficiency within the property. An insulation contractor should be appointed to provide further advice on replacement options and to perform works as necessary.

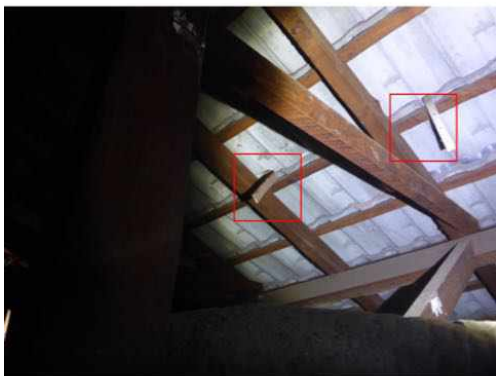
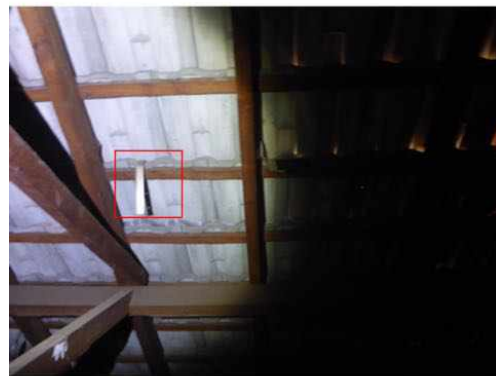
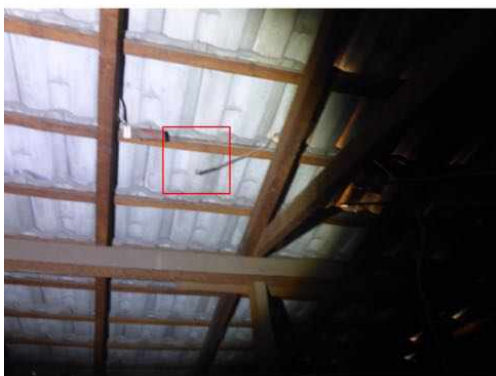
**Defects 3.06**

Building: Main Building  
Location: Roof Void > Existing  
Finding: Roof structure - Connections missing

Information: The roofing connection was found to be missing or broken in certain sections at the time of inspection. Upon closer inspection within the ceiling void, it is suspected that the loose connections is a direct result of inadequate connections, which appear to have deteriorated over a prolonged period of time.

roof structures are likely to create strain on associated building elements, creating potential for secondary damage.

It is critical to ensure that the fastenings holding important roof elements together remain structurally sound (i.e. not corroded) and tightly fastened. Any failure in fastenings can lead to movement of roof members, which is likely to result in an uneven or sagged appearance of the roof exterior. Improper nailing at the point where the ceiling joist connects to the bottom of the rafter may also cause sagging.

Remedial works are highly advised and should be performed by a registered builder or roofing contractor. Please note that at the time of construction it was not required but it is not as per current code of practice.

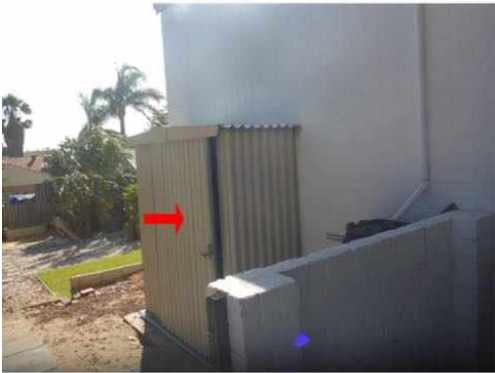
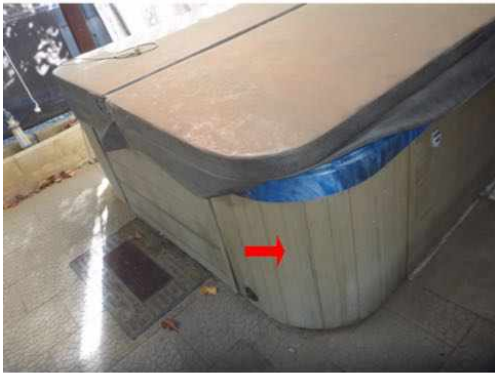
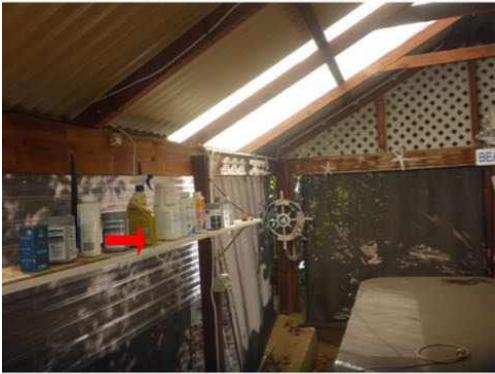
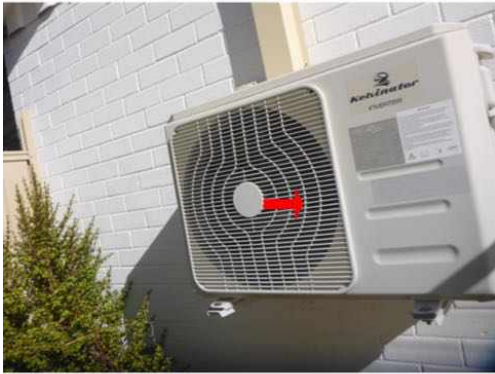
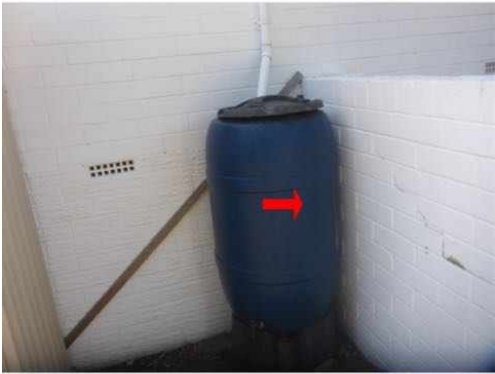
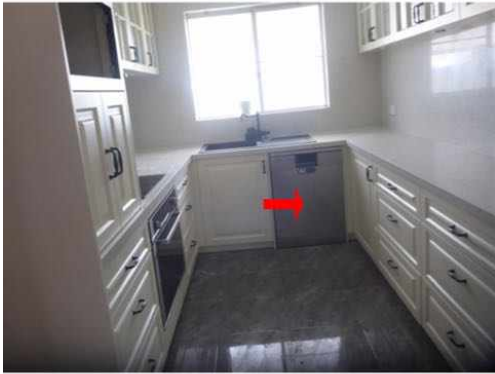
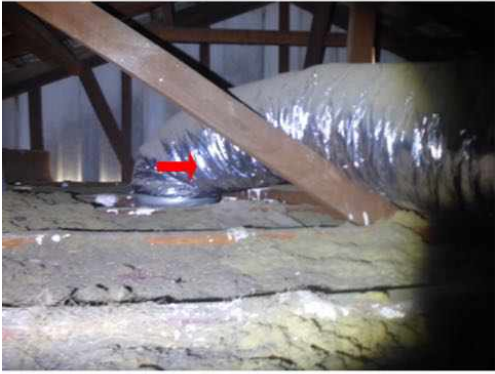
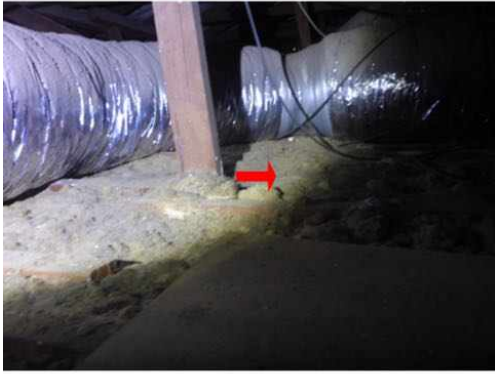
Building:	Main Building
Location:	All External & Internal Areas > Existing
Finding:	Additional Photos - Obstructions and Limitations
Information:	These photographs are an indication of the obstructions and limitations which impeded full inspection of the property at the time of inspection. These obstructions can hide an array of defects and should be removed to allow full inspection to be carried out. A re-inspection is recommended once the areas are made accessible.

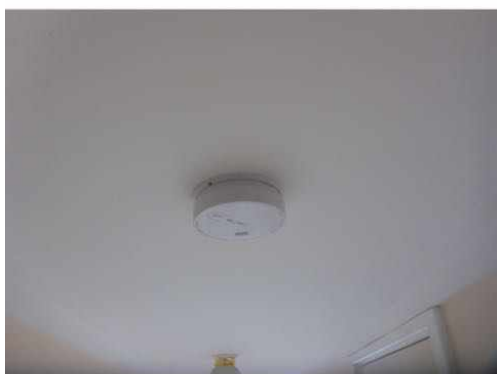
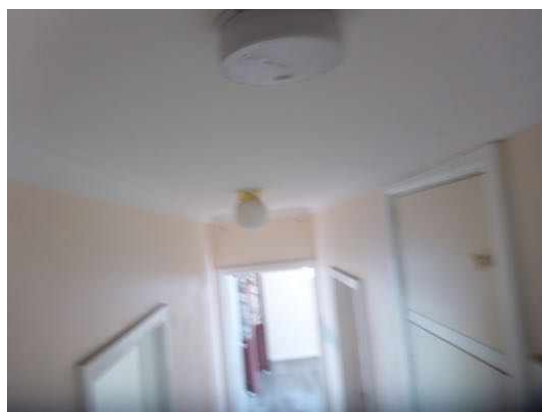
Building:	Main Building
Location:	
Finding:	Smoke Detectors and Alarms
Information:	<p>At the time of inspection we observed smoke alarm is installed. However the evaluation of smoke detectors or alarms including hard wired systems and their legislative requirement is outside the scope of the inspection. This caution is mentioned to raise the awareness only. Additional inspection and advisory service are necessary to determine the sufficiency , type, and location of all smoke detectors and to test their functionality.</p> <p>It is highly recommended that all electrical items undergo evaluation by licences electrician and that the new homeowner received an electrical certificate for enhanced safety-assurance. additionally, how owners should test all smoke detectors monthly for added safety.</p>

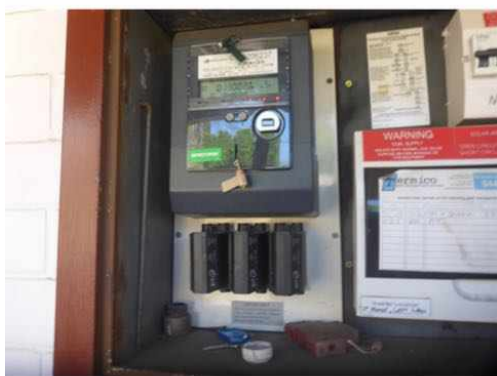
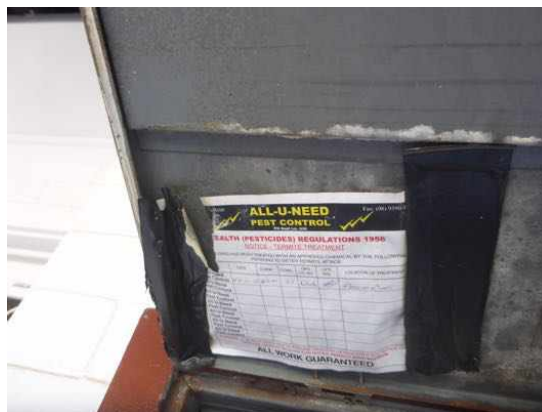
Building:	Main Building
Location:	
Finding:	Termite Management System -
Information:	<p>The application of a post-construction chemical termite barrier is highly recommended for all properties, particularly if live termite activity has been found on the site previously. Such barriers are highly effective in preventing termite attack on any timber building elements throughout the property.</p>

A durable notice should be placed in the switchboard unit to indicate current termite barriers. At the time of inspection, it appeared as though no termite management system has been installed, with no evidence to suggest preventative works taking place.

There is no durable notice in place.

The client may consider gaining further advice from a pest controller as to the costs and procedures involved with this application. It is recommended that obtaining such

advice be a short-term priority.

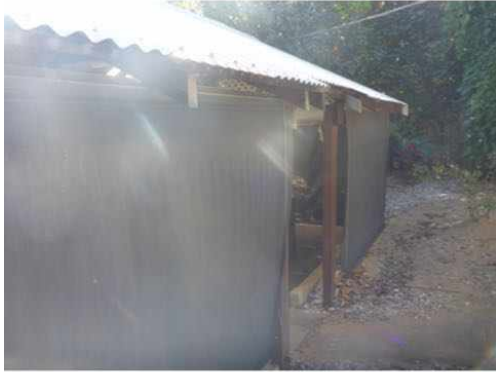
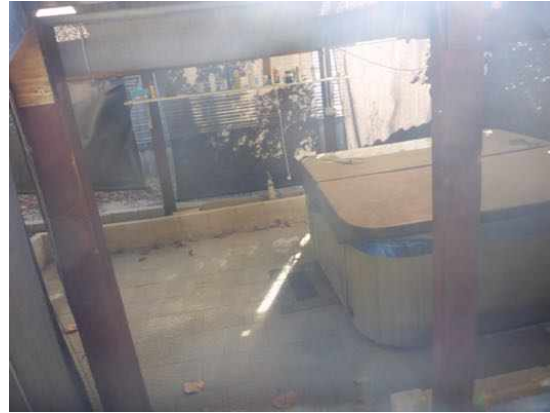
Building: Main Building  
 Location:  
 Finding: Pool fencing - Inspection required  
 Information: It is suspected that areas of the pool fencing do not to comply with Australian Standards and do not appear to be safe. Assessment of the pool area is required.

Please note that this inspection does not cover pool fencing and other pool fittings and fixtures. It is highly advised that a specialist be appointed to inspect the pool and

surrounding area and provide advice on rectification works that may be required.

Note; Buyers needs obtained Spa/ Pool inspection report from the owner or local authority.
