Building and Timber Pest Inspection Report

Inspection Date: Wed, 11 Feb 2026

Property Address: 29 Roseby St, Marrickville NSW 2204,
Australia

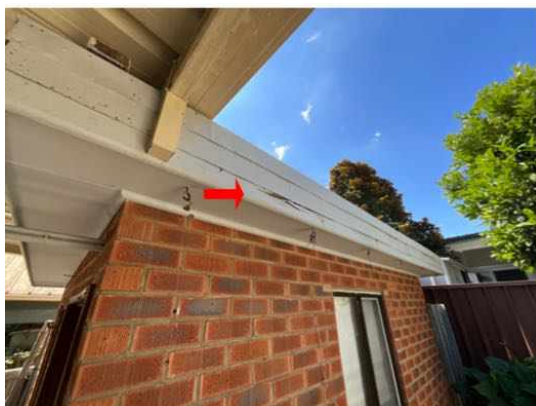
Building:	Main Building
Location:	External Areas
Finding:	Wood rot
Information:	This building element shows evidence of wood rot. Wood rot, also known as Fungal Decay, occurs when timbers and other cellulose building materials are exposed to damp conditions on an ongoing basis. This could be the result of exposure to weathering over a prolonged period of time, or the attraction of excessive moisture from other abutting building materials.

Early intervention and regular maintenance, particularly of exterior timbers, will prolong the useful life of these building elements. Prior to any works being performed, the cause of the moisture that has created the visible wood rot should be identified and addressed in a suitable manner. Replacement of affected timbers may then be a necessary step in protecting surrounding building elements from such deterioration.

A qualified carpenter or registered builder may also be required to replace affected building materials.

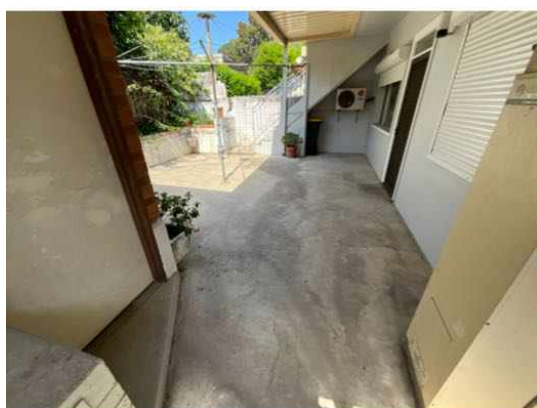
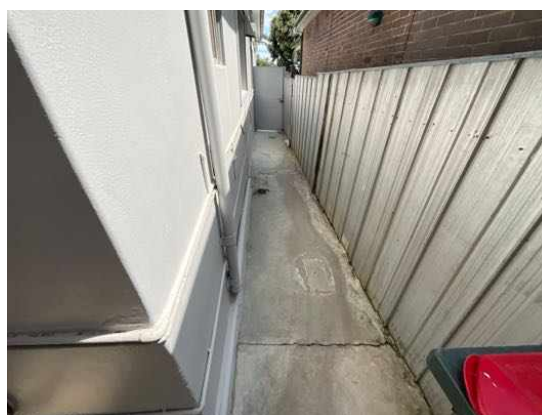
Finding 3.02

Building:	Yard
Location:	The Site
Finding:	Site drainage - Inadequate
Information:	The site drainage in this area was found to be inadequate at the time of inspection, creating potential for subsequent water damage to associated building elements.

It is important that water does not lie against the base of walls; surrounding paths and ground levels should be sloped to drain water away from walls.

Where site drainage is inadequate, installation of drains may be required. A qualified plumber should be appointed to further inspect the property and perform any remedial works as necessary. Water damage and secondary defects are likely to occur if left unmanaged.

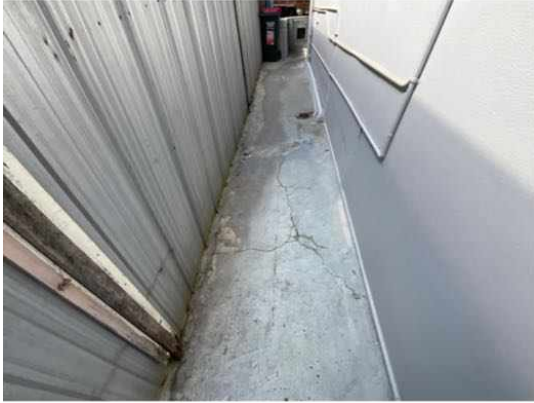
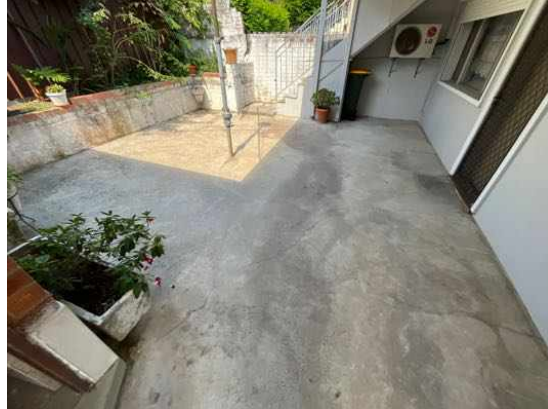
Finding 3.03

Building:	Yard
Location:	Pathway
Finding:	Cracking - External Concrete Paving Damage Category 1 - Fine (less than 2mm)
Information:	Fine cracks were identified in external concrete paving. Although fine cracks are quite noticeable, they are often only considered to be an appearance defect, and usually do not indicate any structural damage. To be considered a Category 1 or fine crack, the crack is found to be less than 2mm in width.

Generally the cause of a hairline crack in existing concrete paving such as driveways and pathways is indicative of the expansion and contraction of the concrete. Such causes are generally due to environmental factors, such as moisture levels, weather conditions, root systems of nearby trees or the soil types on which they are laid.

Fine cracks may also be due to poor original installation of the concrete. Factors such as poor compaction of the sub surface and/or inadequate reinforcing of the slab may create cracking and other secondary defects.

Monitoring of all cracking should be conducted frequently. Always contact a building inspector should cracks widen, lengthen, or become more numerous.

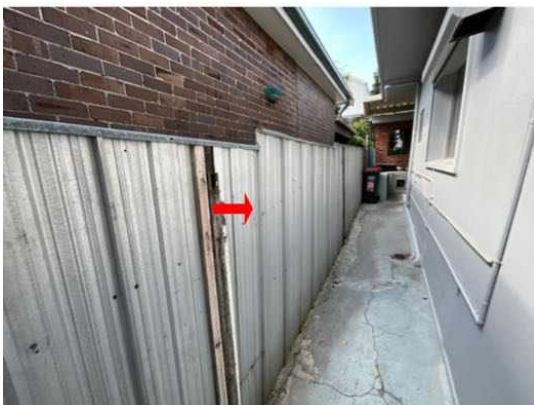
Finding 3.04

Building:	Yard
Location:	Fencing
Finding:	Fencing - Deteriorated
Information:	It was noted at the time of inspection that sections of the fencing throughout the property have deteriorated. Typically fencing deteriorates due to age and or wear, rot and or rust which is generally expected for a structure of this age, due to prolonged exposure to weather conditions. Sometimes inadequate installation or maintenance can be to blame.

If left unattended, it is likely that further damage will occur. It is suspected that repair of several elements of the fencing may be required however replacement may be a consideration of the client also.

A licensed fencing contractor should be appointed to provide further advice and perform rectification works as necessary.

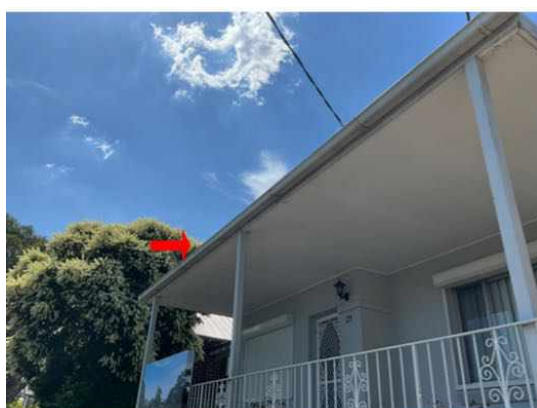
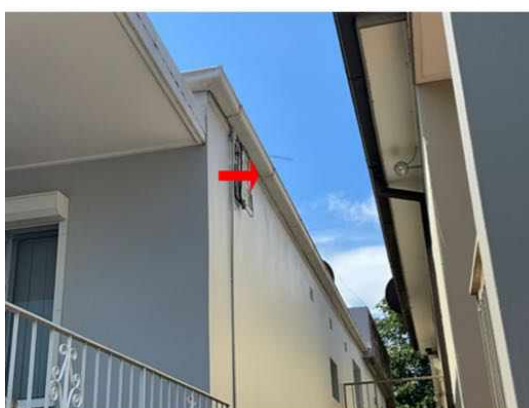
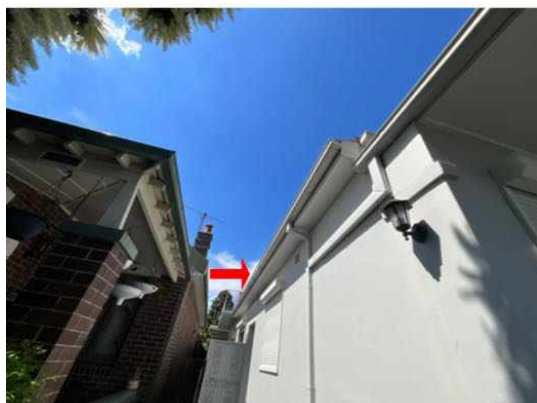
Finding 3.05

Building:	Main Building
Location:	Roof Exterior

Finding: Gutter Clips - Rusted or corroded
 Information: This building element shows evidence of rusting and corrosion, which is likely to have developed as a result of excessive exposure to moisture and or inadequate coatings.

As surface rust provides no protection to the underlying iron, the deteriorating condition is likely to worsen if not addressed in the short-term future.

Where possible, the use of galvanized (treated) metals or aluminium coated metals aid in rust prevention, as does regular general maintenance. Rust formation can be controlled with coatings, such as paint, that isolate the iron from the environment.

Rusting and corrosion should be managed by ideally removing or limiting the affected surface from exposure to moisture.

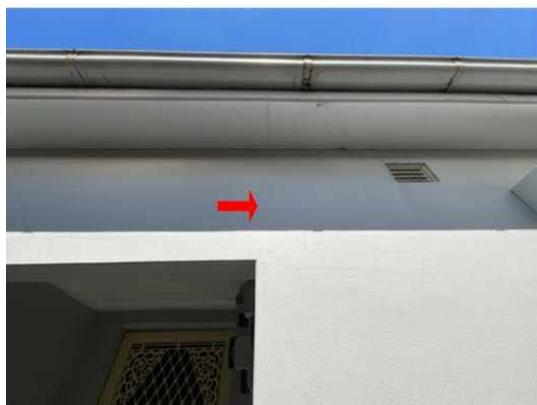
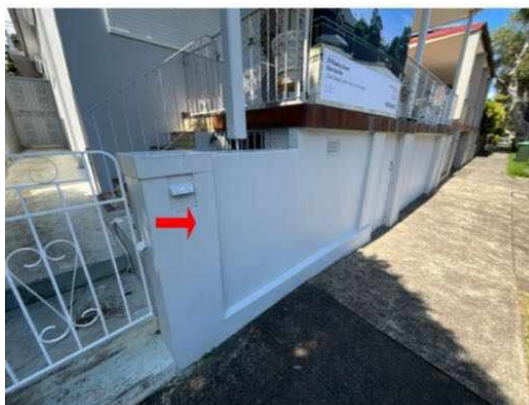
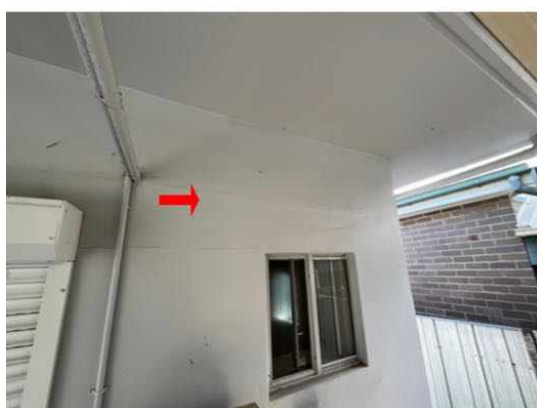
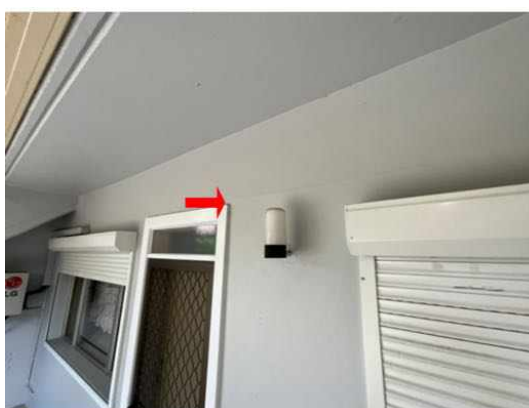
Finding 3.06

Building: Main Building
 Location: Exterior walls
 Finding: Cracking - Damage Category 2 - Noticeable (up to 5mm)
 Information: Noticeable cracks are a common occurrence as a result of many primary defects. Such causes may include age, general wear and tear, expected building movement, general expansion/contraction of building materials in different weather conditions, and/or minor failings in the installation or application of building materials.

I recommend monitoring and if further cracking is evident appoint a bricklayer to see what works are required.

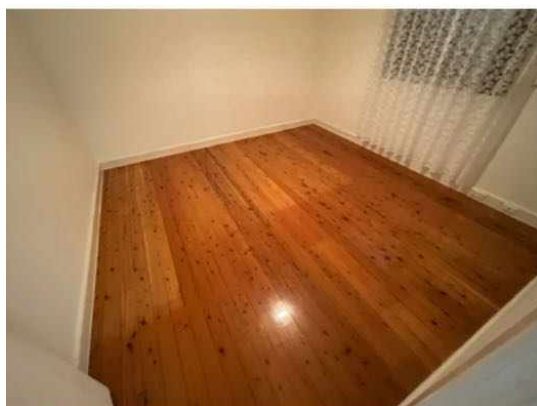
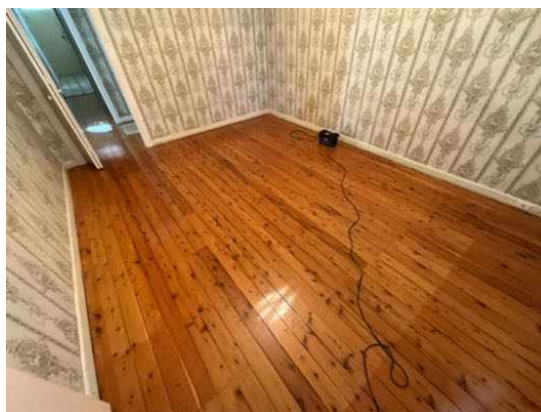
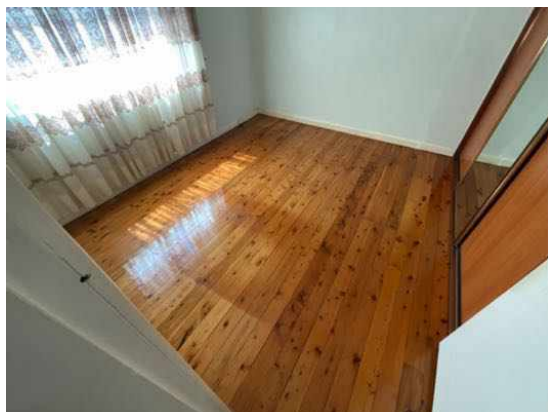
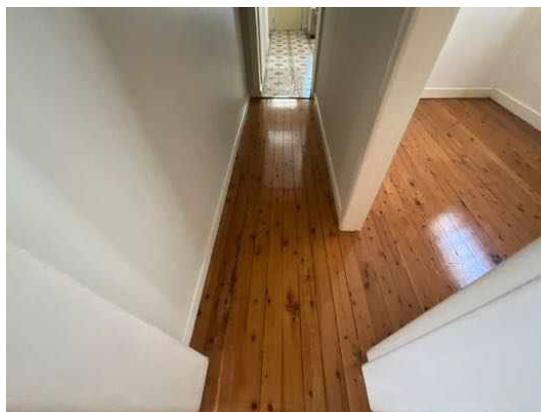
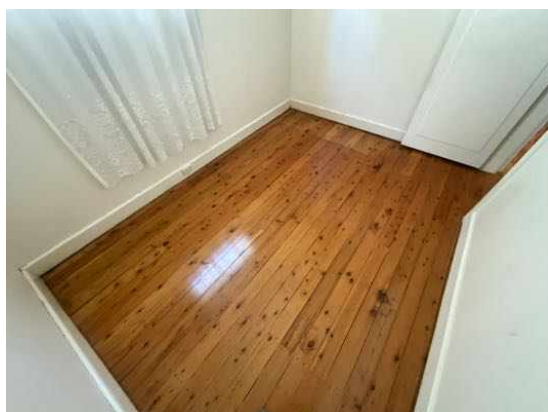
Finding 3.07

Building:	Main Building
Location:	Floors throughout
Finding:	Floors - bouncy
Information:	The internal flooring in this area was identified as being bouncy at the time of inspection. A bouncy floor surface generally presents as a discernible change in level as they are walked across, in noisy or creaking flooring, or in consequent movement of surrounding furniture and fixtures.

Bouncy floors generally indicate that the floorboards or the subfloor structures are coming loose from the joists that they are installed on. Bouncy flooring may also be the result of gaps between flooring and joist structures, which require packing.

On further inspection it was noted that there was termite damage found throughout the subfloor structure.

The client is advised to seek quotations for required repairs from a Registered Builder. Replacement of the floors are most likely required throughout the property.

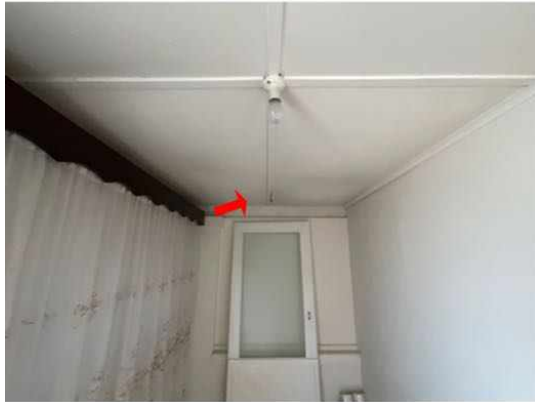
Finding 3.08

Building:	Main Building
Location:	Study
Finding:	Ceiling - Water stained
Information:	Water staining to ceiling linings in this area was evident at the time of inspection. Water staining indicates that surfaces have been exposed to excessive moisture over time. The minerals and other elements in the water lead to staining, which may graduate to corrosion and deterioration if left unmanaged.

Although there was no moisture detected in the ceiling I would recommend monitoring and acting on one of the following.

Where water staining is active, a licensed plumber must be consulted to identify the cause of the staining and to provide advice on any reparation works that may be required. Replacement of any damaged structures is advised.

Conversely, where water staining is old and inactive, affected building materials may be repaired or replaced at client discretion.

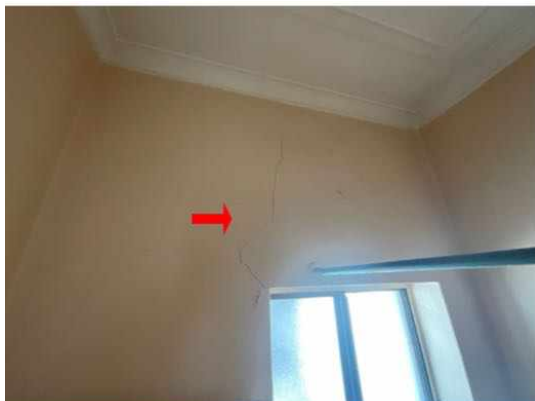
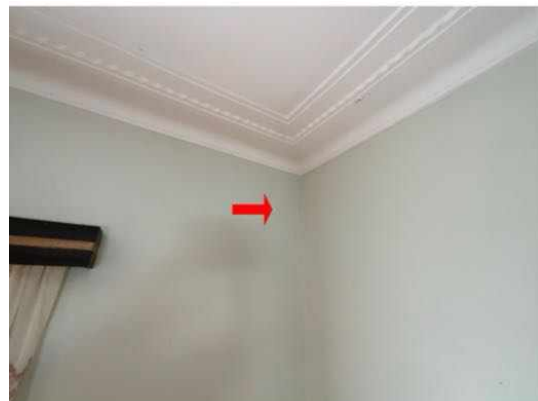
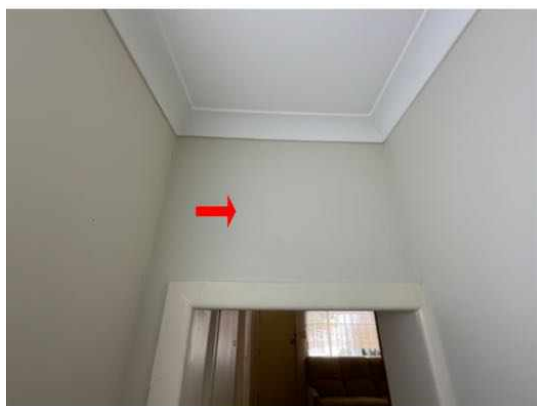
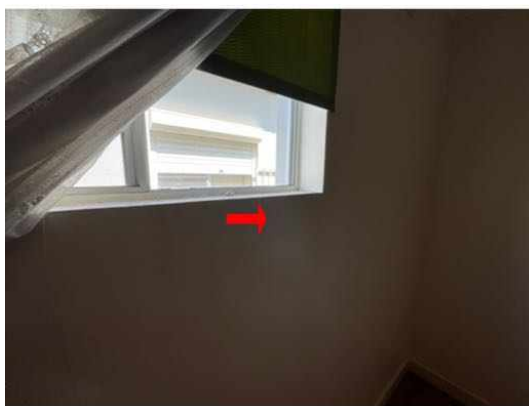
Finding 3.09

Building:	Main Building
Location:	Internal Areas
Finding:	Cracking - Damage Category 2 - Noticeable (up to 5mm)
Information:	Noticeable cracks are a common occurrence as a result of many primary defects. Such causes may include age, general wear and tear, expected building movement, general expansion/contraction of building materials in different weather conditions, and/or minor failings in the installation or application of building materials.

I recommend monitoring and if further cracking is evident appoint a bricklayer to see what works are required.

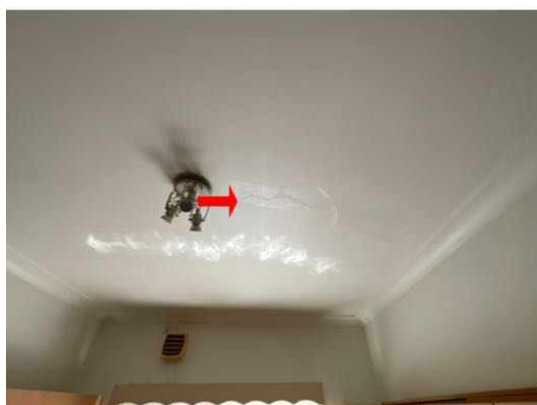
Finding 3.10

Building:	Main Building
Location:	Internal Areas
Finding:	Cracking - Damage Category 1 - Fine (up to 1mm)
Information:	Although fine cracks are quite noticeable, they are often only considered to be an appearance defect, and usually do not indicate any structural damage. Generally, the cause of a fine crack is indicative of a separation between building materials and finishes (e.g. paint, plaster, etc.) along joins.

Cracking of this nature can generally be repaired with minor sanding, filling and/or repainting. Such works should be performed by a qualified painter or a general handyman.

Monitoring of all cracking should be conducted frequently. Always contact a building inspector should cracks widen, lengthen, or become more numerous.

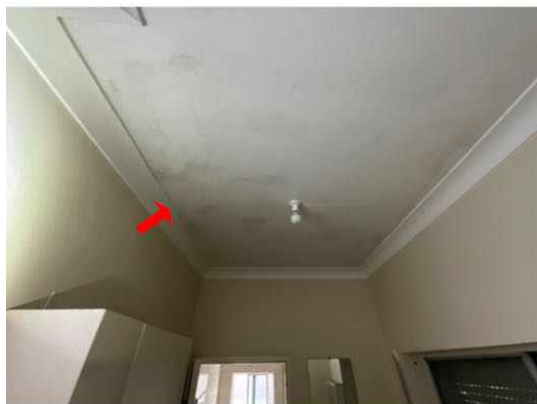
Finding 3.11

Building:	Main Building
Location:	Laundry
Finding:	Mould - Present
Information:	Generally, the client is advised to ensure that the general environment is free of

moisture and humidity to aid in the prevention of mould formation and development.

Any mould found during the inspection should be cleaned by a cleaning contractor or the homeowner as applicable.

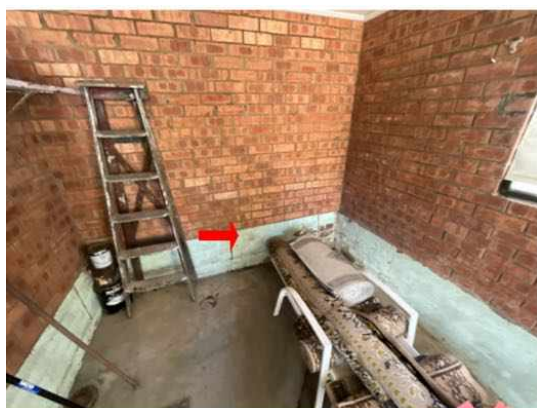
Finding 3.12

Building:	Shed
Location:	Shed
Finding:	Interior walls - Lateral damp
Information:	Lateral penetrating damp refers to the sideways movement of moisture. The implications of unmanaged damp range from mould fungi growth, wood rot and decaying building materials, to finishes including lifting, bubbling, peeling and staining of paint, plaster and wallpaper.

Structural waterproofing barriers or tanking barriers are often used to protect internal surfaces against the affects of lateral penetrating dampness. These types of work are generally undertaken where the source of the penetrating damp cannot be prevented.

Consultation with a damp proofing contractor is advised to address the cause of the damp and to perform remedial works as necessary.

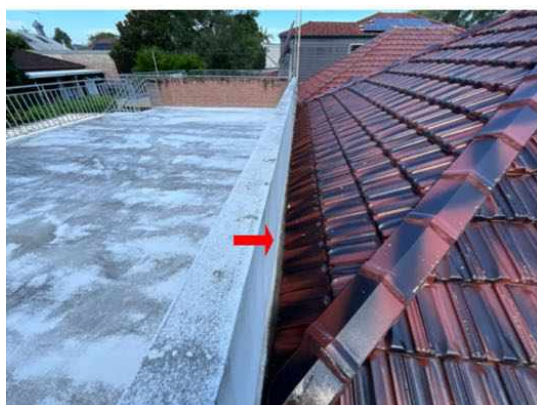
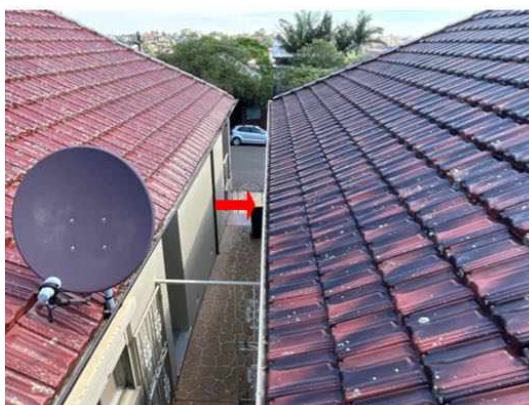
Finding 3.13

Building:	Main Building
Location:	Roof Exterior
Finding:	Gutters - Blocked
Information:	Roof plumbing structures, such as guttering and downpipes, should be free of all debris to prevent blockages. Blockages of the guttering and downpipes will lead to pooling and accumulated water overflows, which is likely to subsequently flood eaves and exterior walls.

Blocked gutters are likely to lead to high levels of moisture in the affected areas. Such moisture will not only cause rust and decay of the associated building materials, but can also provide conditions that are conducive to termite and timber pest activity. Blockages in gutters should therefore be removed to ensure dry conditions are maintained.

Consult a Licensed Plumber for further specific advice on remedial works that may be required. In the interim, it is highly advised that blocked gutters be removed by the homeowner or a general handyman as a matter of urgency.

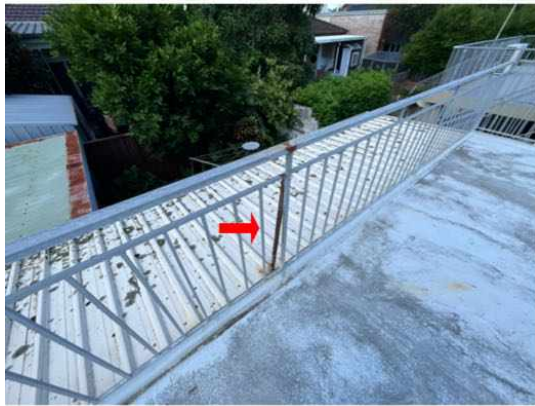
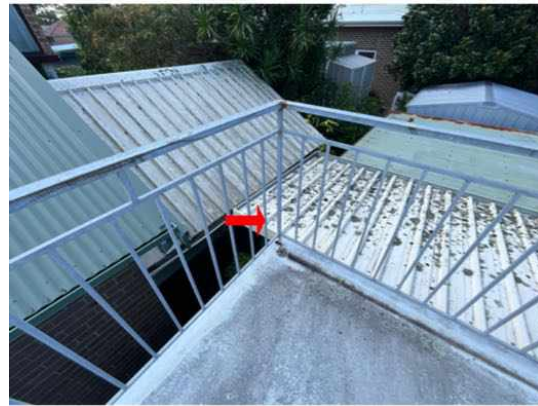
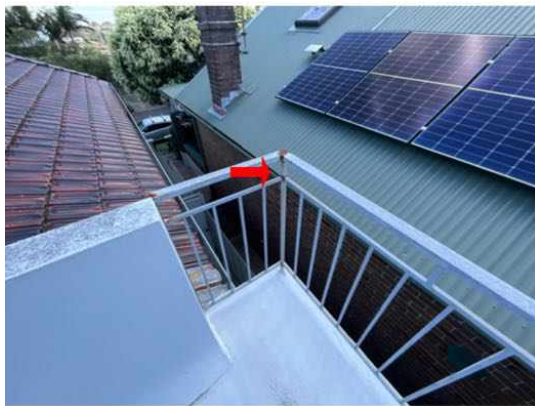
Finding 3.14

Building:	Main Building
Location:	Roof Top Terrace
Finding:	Building element - Rusted or corroded
Information:	This building element shows evidence of rusting and corrosion, which is likely to have developed as a result of excessive exposure to moisture and or inadequate coatings.

As surface rust provides no protection to the underlying iron, the deteriorating condition is likely to worsen if not addressed in the short-term future.

Where possible, the use of galvanized (treated) metals or aluminium coated metals aid in rust prevention, as does regular general maintenance. Rust formation can be controlled with coatings, such as paint, that isolate the iron from the environment.

Rusting and corrosion should be managed by ideally removing or limiting the affected

surface from exposure to moisture.

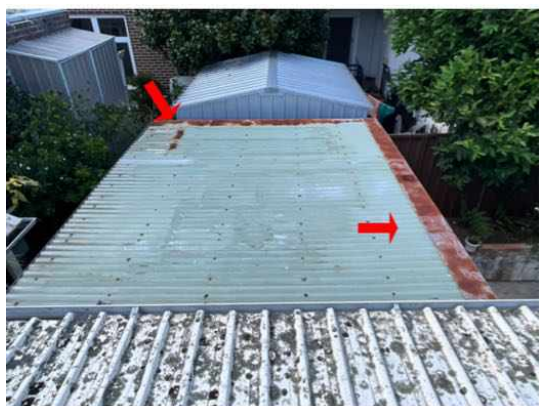
Finding 3.15

Building:	Shed
Location:	Roof Exterior
Finding:	Roof sheets - Rusted
Information:	Metal roofs generally comprise numerous individual sheets, which join and overlap. These intersections are particularly prone to lift at the edge and consequently rust at these points.

Upon inspection of the exterior roofing structure, evidence of rust to these sections was identified.

A roofing contractor should be appointed to assess the damage to the roofing sheets and to perform remedial works as necessary.

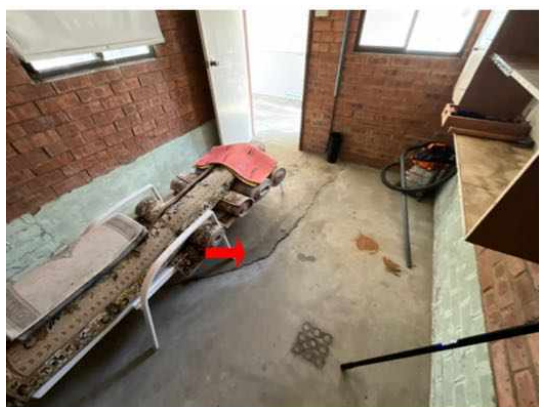
Finding 3.16

Building: Shed
 Location: Shed
 Finding: Crack in concrete slab - Category 2
 Information: A crack coded as Category 2 was identified in the slab. A Category 2 crack is described as a distinct crack, with the slab being noticeably curved or changed in level.

To be considered Category 2, the approximate width of the crack is less than 2.0mm, or a change in offset of less than 15mm when a 3m straight edge is placed over the defect.

Category 2 cracks to slabs should be monitored for a period of 12 months. At the end of the monitoring period, cracks rated greater than Category 2 are considered defects that require rectification.

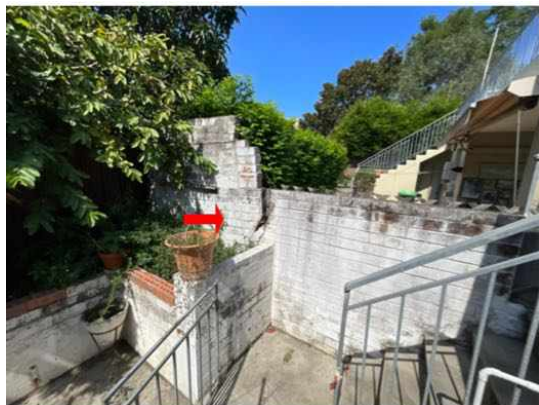
Finding 3.17

Building: Yard
 Location: Yard - Back
 Finding: Brickwork - Cracking noticeable
 Information: There were several cracks and or crack repairs evident to external brickwork.

Noticeable cracks are a common occurrence in external brickwork and are a likely result of age expected building movement, general expansion, and/or contraction of building materials in different weather conditions.

It is highly advised that a qualified bricklayer be appointed to provide necessary works to cracked brickwork to prevent any further damage.

Always monitor these cracks and contact a building inspector should cracks widen, lengthen, or become more numerous.

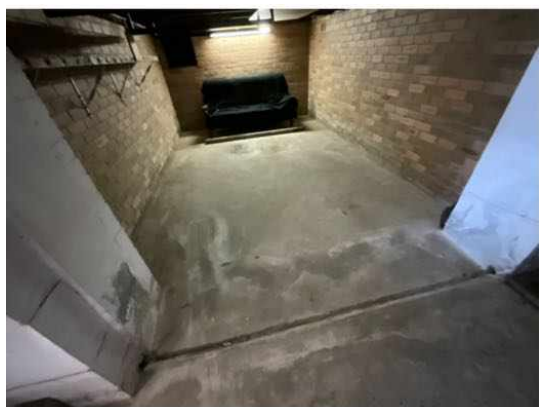
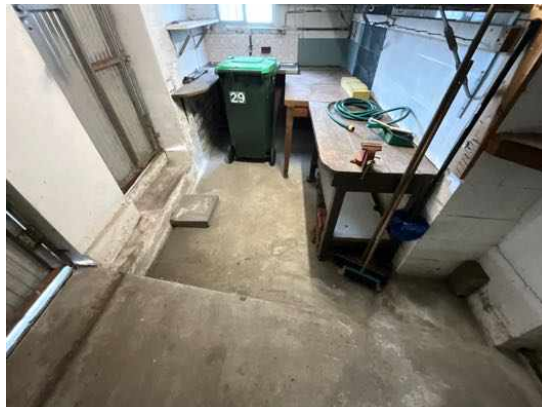
Finding 3.18

Building:	Main Building
Location:	Basement
Finding:	Sump Pump - Missing
Information:	Although some building elements may seem irrelevant or unnecessary, all building elements play a key role in the operation and function of the overall structure and its performance.

I recommend appointing a plumber to see what necessary works are required to install a sump pump at the property.

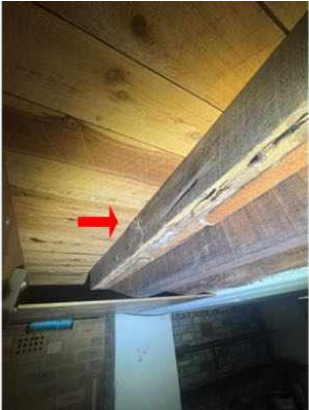
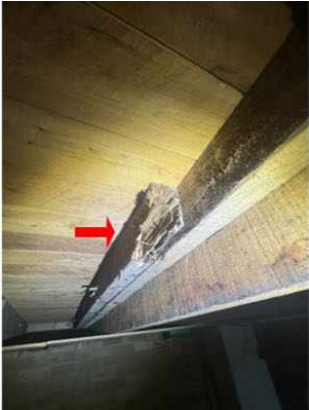
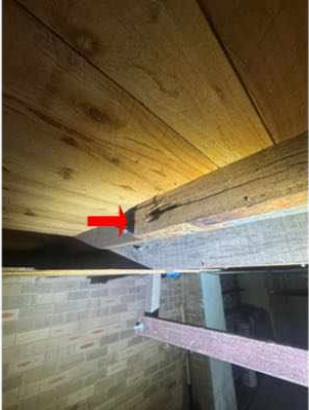
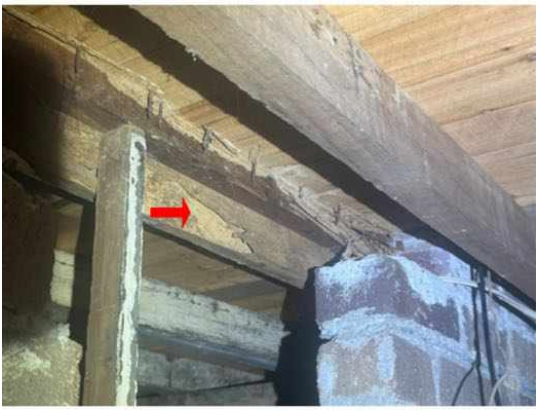
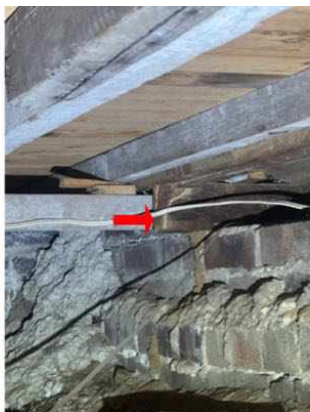
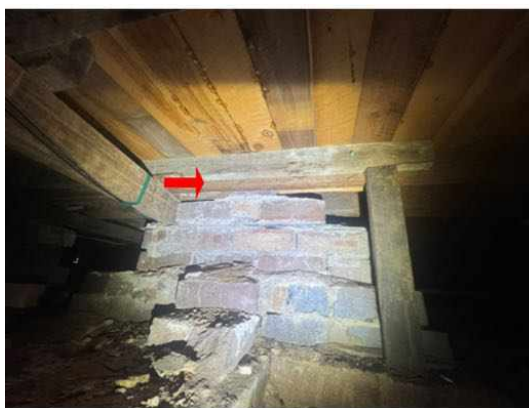
Building: Main Building
Location: Subfloor
Finding: Termite - damage identified
Information: Despite no live termite or timbered pest activity being indicated, termite damage was found to have affected this area.

A building contractor should be appointed to provide a further invasive inspection and to see what necessary works are required.

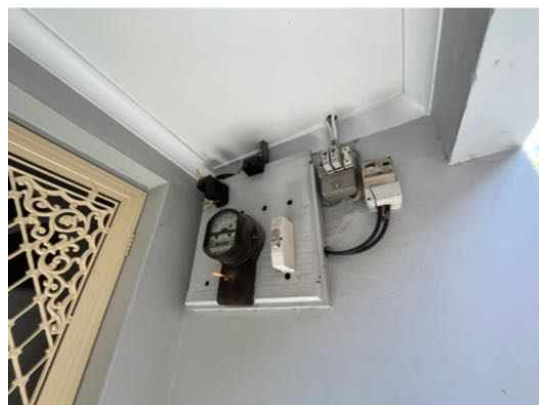
Finding 6.01

Building:	Main Building
Location:	All Areas
Finding:	Termite Management System - no evidence of a chemical installation
Information:	The application of a post-construction chemical termite barrier is highly recommended for all properties, particularly if live termite activity has been found on the site previously. Such barriers are highly effective in preventing termite attack on any timber building elements throughout the property.

The client may consider gaining further advice from a pest controller as to the costs and procedures involved with this application. It is recommended that obtaining such advice be a short-term priority.

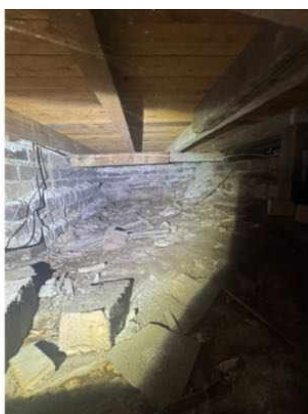
Finding 6.02

Building:	Main Building
Location:	Subfloor
Finding:	Subfloor - Debris
Information:	An array of debris was found in the subfloor area at the time of inspection. Debris in this area restricts subfloor ventilation and creates potential for concealed pest entry. Stored timbers and other materials may also make the area susceptible to termite activity and wood rot.

A clear and empty subfloor will be better ventilated and easier to maintain in a dry condition. The removal of any timber debris is vital in minimising the risk of termite or wood borer activity.

Debris in the subfloor should be removed as soon as possible. Depending on the location and amount of debris and stored items, the homeowner may elect to undertake this task. Alternatively there are a large number of rubbish removal subcontractors that could undertake these works.

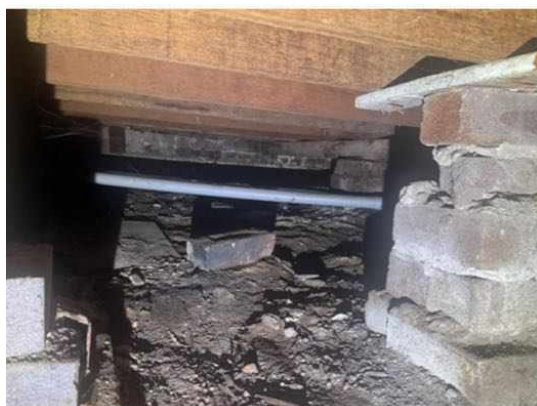
Finding 6.03

Building:	Main Building
Location:	Subfloor
Finding:	Subfloor - Lack of ventilation
Information:	It was noted at the time of inspection that the subfloor area lacks adequate ventilation. Ventilation can be restricted by a variety of minor defects, including obstructions in the subfloor space, a lack of vents or a low clearance.

A well ventilated subfloor aids in maintaining dry conditions, preventing secondary damage such as wood rot and pest activity, as well as preventing the development of mould and mildew (which can lead to respiratory safety hazards for occupants).

The client may also consider mechanical ventilation (powered fans) to improve subfloor airflow.

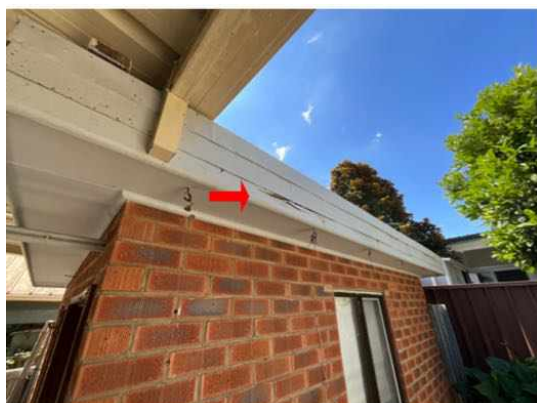
Finding 7.01

Building:	Main Building
Location:	External Areas
Finding:	Fungal decay - present (localised)
Information:	Fungal decay also known as wood decay or wood rot generally refers to the deterioration of timber elements when in contact with excessive levels of moisture for a prolonged period of time.

The development of fungal decay is accelerated by temperatures in the range of 5degreeC to 40degreeC as well as the presence of oxygen. Generally fungal decay develops on timber elements that are in use in an external environment which are exposed to rain penetration.

In this case although the affected timber element is in a decaying state the extent of any visible damage appears to be localised to a specific area and is yet to spread to other parts of the building element or affect adjoining structures. The fungal decay is therefore likely to be of a relatively superficial nature with minimal impact on the structural integrity or tensile strength of the timber element.
