Building Inspection Report

Inspection Date: Thu, 9 Apr 2026

Property Address: 53 Mary St, Unley SA 5061, Australia

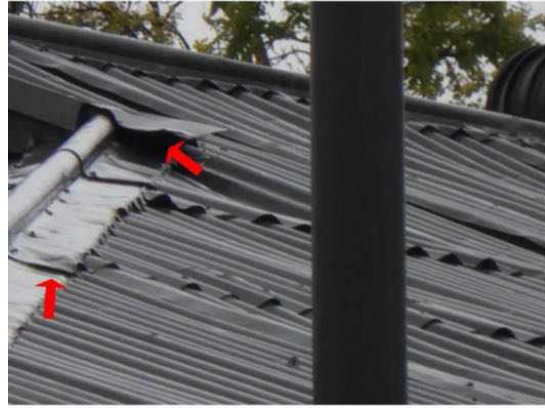
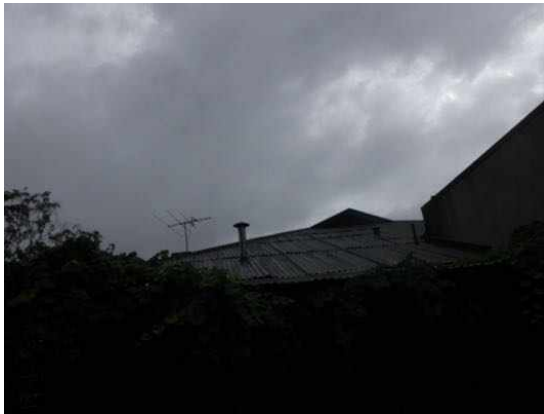
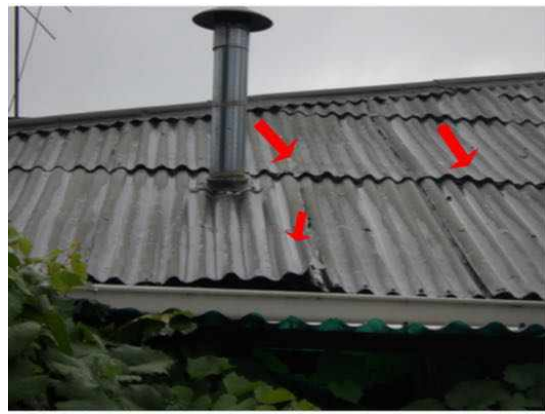
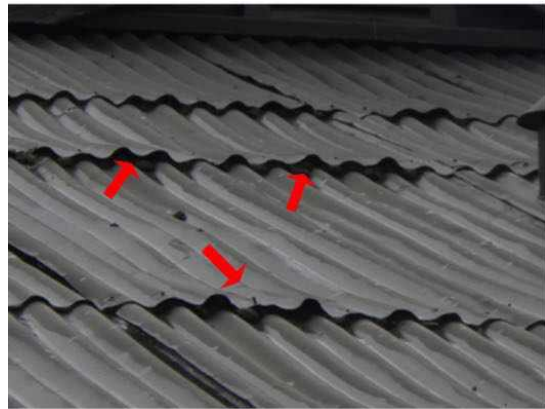
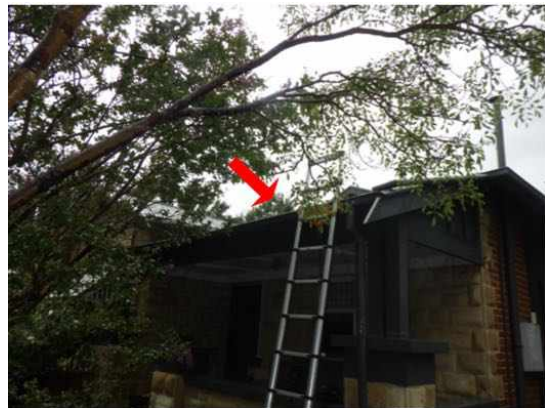
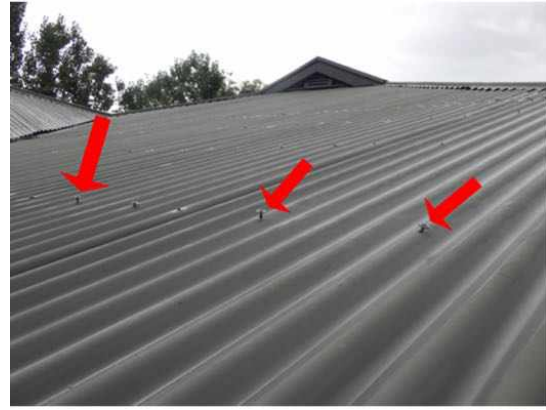
Defects 2.01

Building: Building 1
Location: All External Areas
Finding: Roof sheets - Not secure / Loose from its original fixing
Information: Upon inspection of the exterior roofing it was found that the roof sheets have not been adequately secured to the adjoining roof structure.

Loose roof sheets are susceptible to water penetration, exposing the surrounding associated area to internal roof leaks and water damage.

Adequate fixing of all loose roof sheets should be conducted as soon as possible to ensure no further damage is incurred during the construction process. The builder on site should be notified of this defect as soon as possible in order to engage the appropriate tradesperson to perform necessary works.

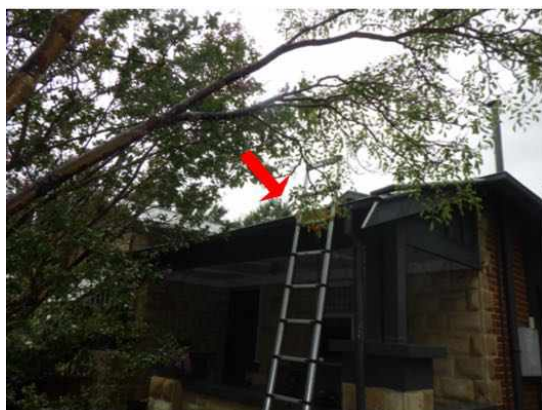
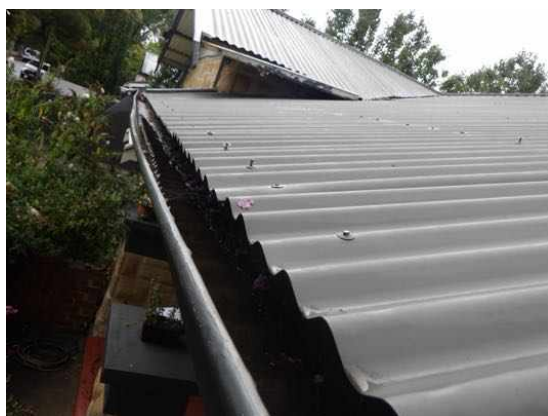
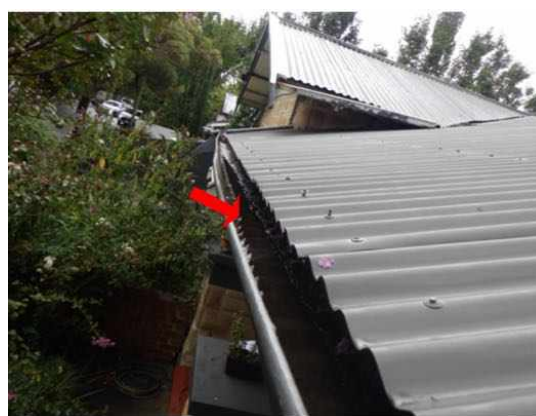
Defects 2.02

Building:	Building 1
Location:	All External Areas
Finding:	Gutters - Blocked
Information:	At the time of inspection it was noticed that gutters were blocked in few sections around the property. Gutters have to be cleaned in regular intervals.

Blocked gutters are likely to lead to high levels of moisture in the affected areas. Such moisture will not only cause rust and decay of the associated building materials, but can also provide conditions that are conducive to termite and timber pest activity. Blockages in gutters should therefore be removed immediately to ensure dry conditions are maintained.

Consult a Licensed Plumber for further specific advice on remedial works that may be required. In the interim, it is highly advised that blocked gutters be removed by the homeowner or a general handyperson as a matter of urgency.

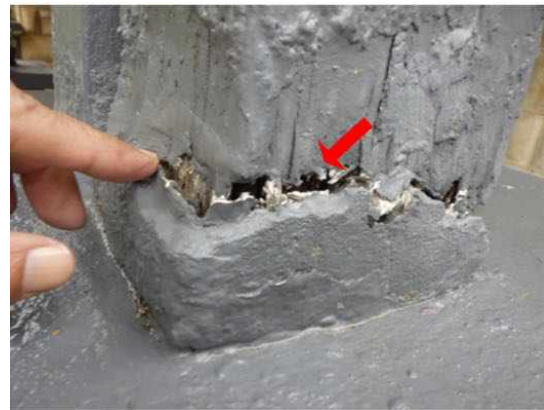
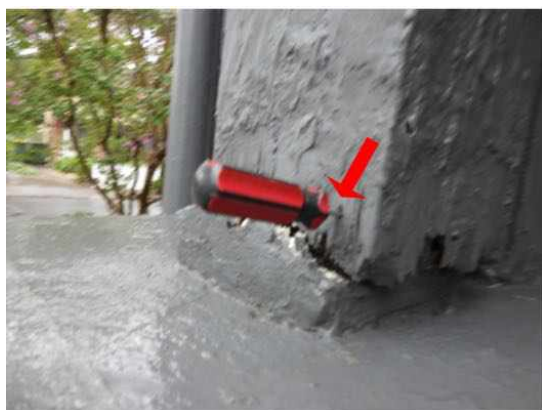
Defects 2.03

Building:	Building 1
Location:	All External Areas
Finding:	Entry Area - Post - Wood Rot / Damaged
Information:	At the time of inspection it was noticed that this building element shows evidence of wood rot and result of that structural integrity has been compromised . Wood rot, also known as Fungal Decay, occurs when timbers and other cellulose building materials are exposed to damp conditions on an ongoing basis. This could be the result of exposure to weathering over a prolonged period of time, or the attraction of excessive

moisture from other abutting building materials. Contributing factors also include poor air ventilation in the area.

Wood rot is often associated with general damp problems and is evidenced by a 'musty' smell or mould and mildew occurring on surfaces. If left unmanaged, damp conditions can lead to further health problems and the decay of timbers will continue.

Early intervention and regular maintenance, particularly of exterior timbers, will prolong the useful life of these building elements. Prior to any works being performed, the cause of the moisture that has created the visible wood rot should be identified and addressed in a suitable manner. Replacement of affected timbers may then be a necessary step in protecting surrounding building elements from such deterioration.

A qualified plumber may be appointed to assess the cause of excessive moisture and to provide advice on any remedial works as required. A qualified carpenter or registered builder may also be required to replace affected building materials.

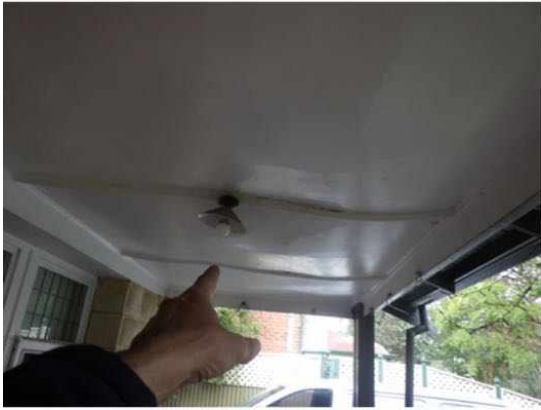
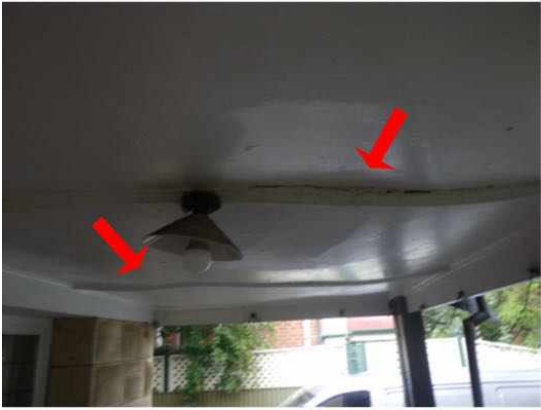
Defects 2.04

Building:	Building 1
Location:	All External Areas
Finding:	Porch Ceiling - Sagging
Information:	At the time of inspection it was noticed that sections of the ceiling were found to be sagging in this entry / porch area. Sagging to the fixed ceiling structure generally indicates that the building materials have swollen, due to contact with water, or that fixings (e.g. nails or glue) have become loose and require reattachment.

In some cases, sagging ceiling linings may also indicate that there are structural issues, causing surfaces to warp, twist or sag. Where sagging appears to be major, appointment of a structural engineer is advised to further inspect the property and identify the source and rectification works required.

Where minor sagging is evident, comparatively minor works, such as re-gluing of ceiling sheets, may be required. Such works may be performed by relevant tradespeople, such as plasterers and painters. Where excessive moisture has caused the roofing structure to swell and sag, the source of the water leak should primarily be identified prior to any remedial works being performed.

The appropriate action should be taken by the client as soon as possible to ensure that any potential further damage is limited.

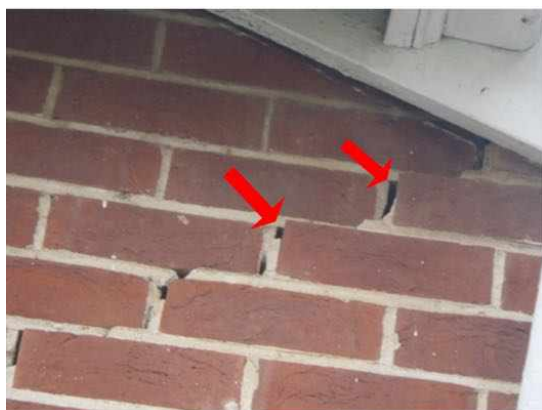
Defects 2.05

Building: Building 1
Location: All External Areas
Finding: Brickwork - Cracking [Repair required]
Information: Major cracking was identified to the brickwork in this area. Cracks of this type are likely to have been caused by minor expected movement of building elements, but may also have a structural cause that is more significant.

A crack of this size may be repaired by extensive filling. Additionally, further remedial works to associated building elements, such as eave sheeting or external door frames, is likely to be required.

A qualified bricklayer should be contacted immediately to estimate and perform repair and restoration works. Consultation with a structural engineer may be required where structural instability is found to be the underlying cause of the cracking.

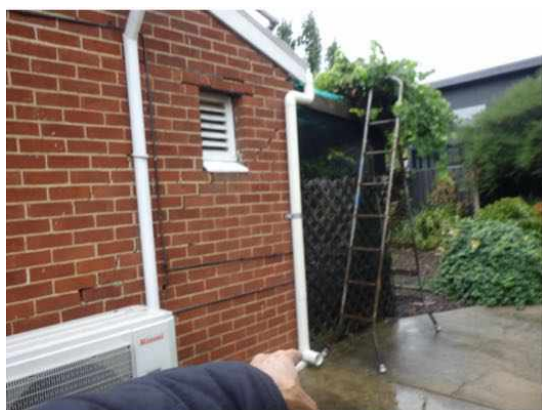
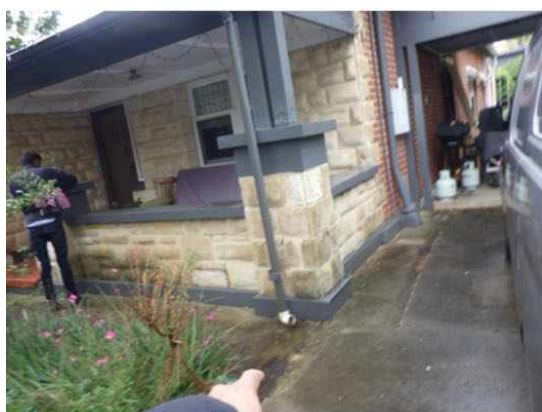
Defects 2.07

Building:	Building 1
Location:	All External Areas
Finding:	Site drainage - Inadequate
Information:	The site drainage in this area was found to be inadequate at the time of inspection, creating potential for subsequent water damage to associated building elements.

It is important that water does not lie against the base of walls; surrounding paths and ground levels should be sloped to drain water away from walls. Downpipes should not discharge stormwater onto lower walls or plinths. Stormwater should be carried away by large, regularly cleaned drains. Ground levels may need to be lowered to expose a buried DPC.

Where site drainage is inadequate, installation of an Agricultural (Aggie) Drain may be required. A qualified plumber should be appointed to further inspect the property and perform any remedial works as necessary. Water damage and secondary defects are likely to occur if left unmanaged.

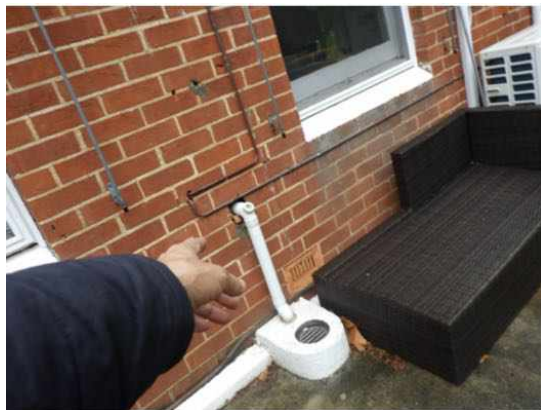
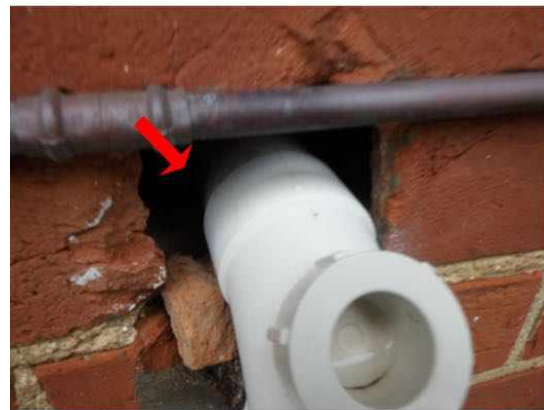
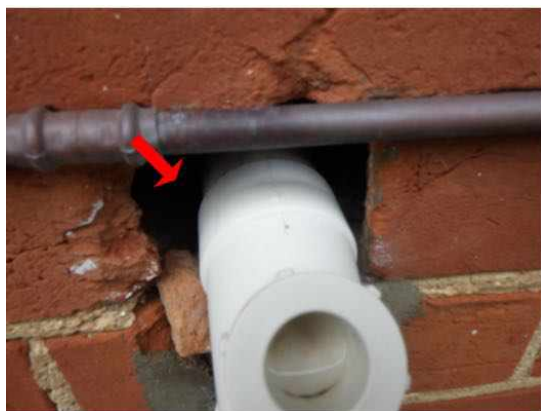
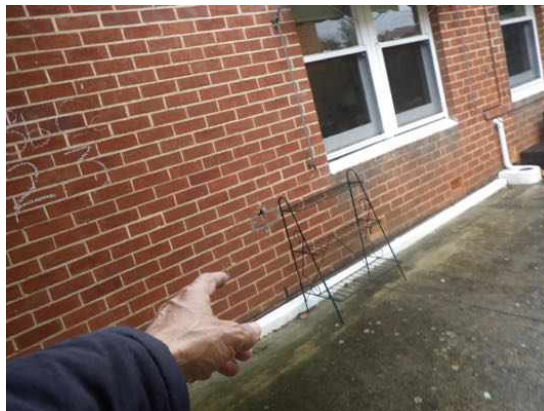
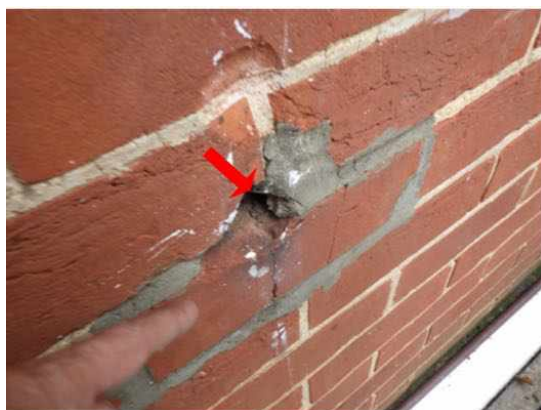
Defects 2.08

Building:	Building 1
Location:	All External Areas
Finding:	External walls - Holes
Information:	Significant holes were identified around pipe penetrations in this wall section. It is

Gaps and holes around pipework makes the area susceptible to insect and vermin ingress, as well as allowing water penetration to the cavity wall. As such, associated building elements are likely to deteriorate at an accelerated rate, and major implications are expected if holes around the pipework are left unmanaged.

All excessive holes, gaps or cracks should be adequately filled by a suitable sealant or trimmings as soon as possible to prevent any further damage. Such works may be conducted by a general handyman or licensed plumber.

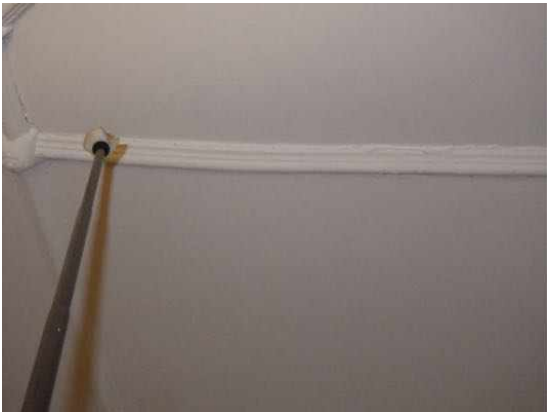
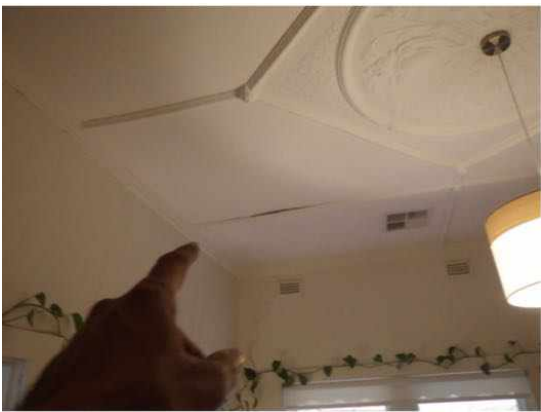
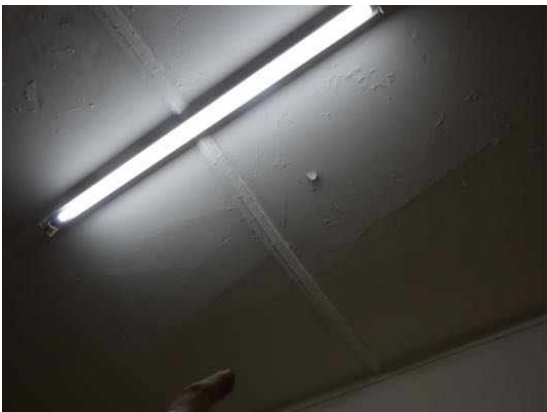
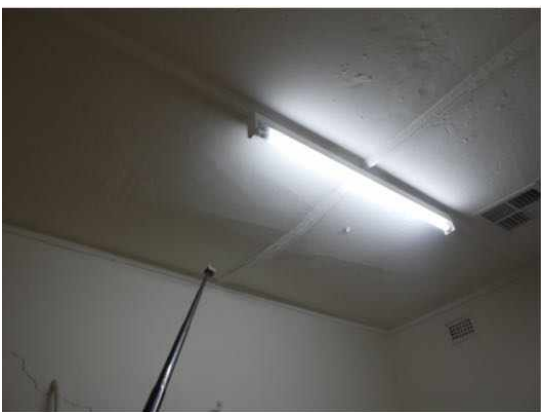
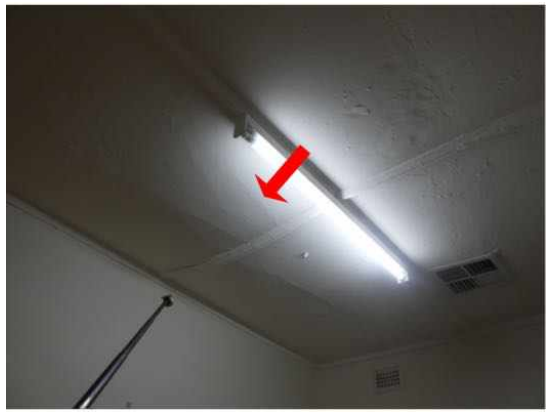
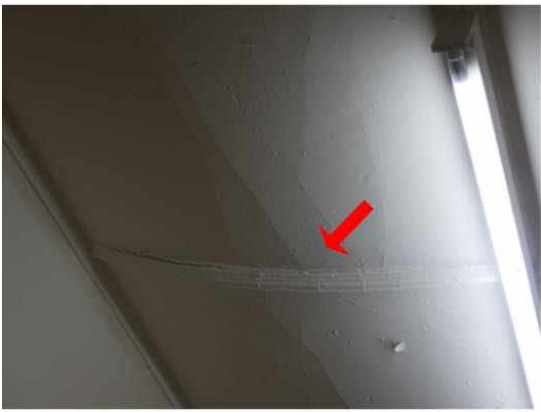
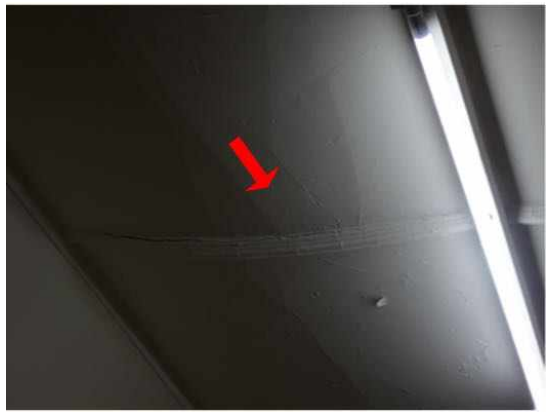
Defects 2.09

Building:	Building 1
Location:	All Internal Areas
Finding:	Internal Ceiling - Sagging
Information:	Sections of the ceiling were found to be sagging at the time of inspection. Sagging to the fixed ceiling structure generally indicates that the building materials have swollen, due to contact with water, or that fixings (e.g. nails or glue) have become loose and require reattachment.

Where minor sagging is evident, comparatively minor works, such as re-gluing of ceiling sheets, may be required. Such works may be performed by relevant tradespeople, such as plasterers and painters. Where excessive moisture has caused the roofing structure to swell and sag, the source of the water leak should primarily be identified prior to any remedial works being performed.

The appropriate action should be taken by the client as soon as possible to ensure that any potential further damage is limited.

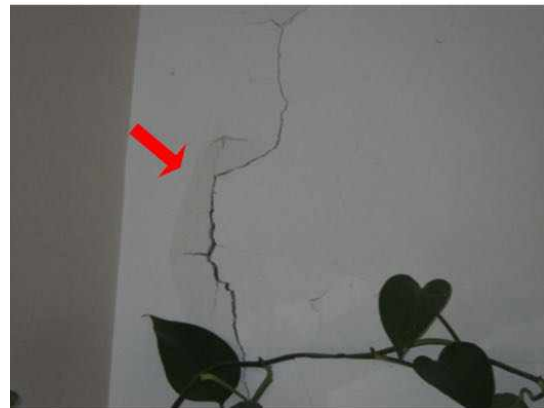
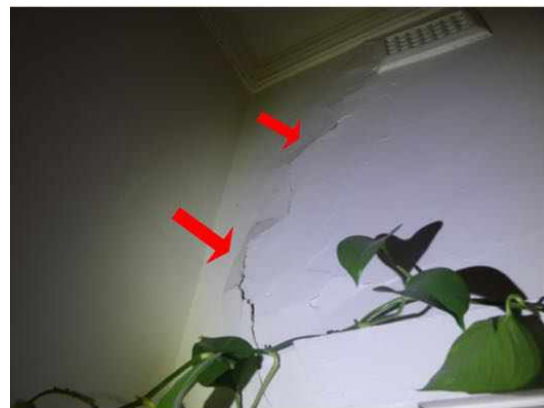
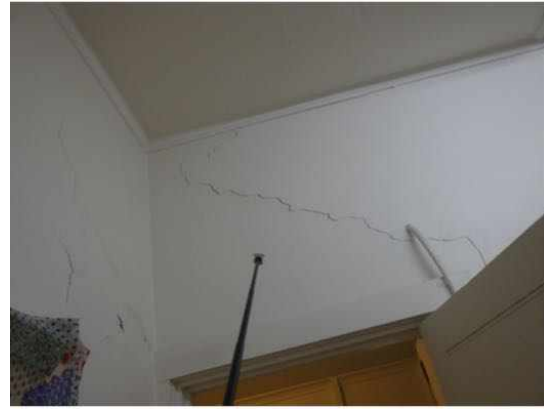
Defects 2.10

Building: Building 1
Location: All Internal Areas
Finding: Plaster - Drummy
Information: Sections of plaster sheeting in this toilet/ laundry, living, kitchen area and other areas around the property appear to be drummy. The term `drummy` is used to describe plaster which, whilst solid, has become detached from its original fixing.

The most common causes of plaster failure are physical damage and moisture damage. Moisture causes plaster to swell and shrink as the humidity of the air changes, or as a consequence of leaks, which can be enough to create drumminess or cracking.

Drummy plaster generally needs chemical re-adhesion or to be screwed back to the substrate, with minor consequent patching and painting required.

Ensure that the general environment is free of moisture and humidity to aid in the prevention of drummy plaster and plaster damage. Appointment of a qualified plasterer is advised as soon as possible in order to complete remedial works as necessary.

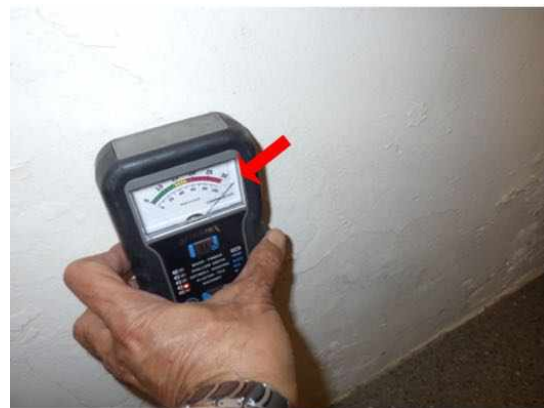
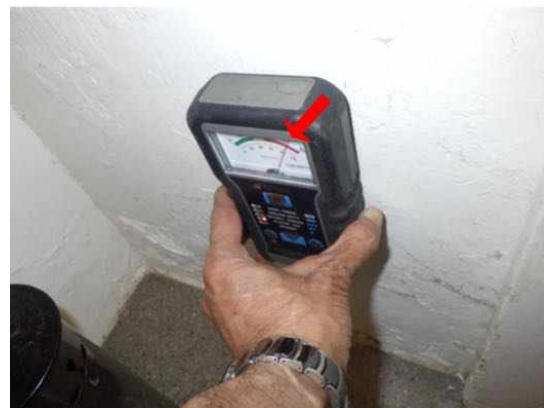
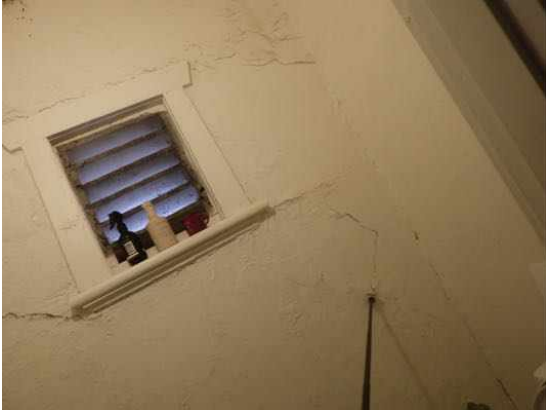
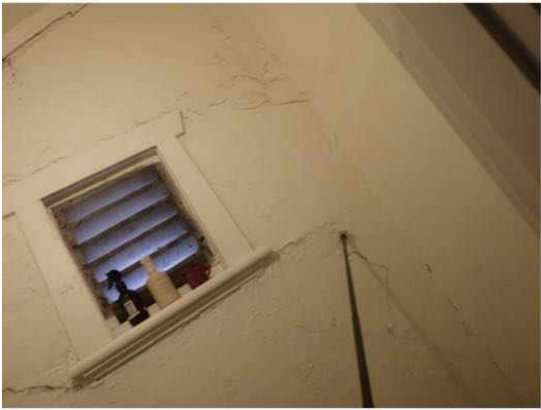
Defects 2.11

Building:	Building 1
Location:	All Internal Areas
Finding:	Internal walls - Damp
Information:	At the time of inspection it was noticed that high moisture readings were noted in few sections of internal walls around the property .

Damp (or structural damp) refers to the presence of unwanted moisture in the structure of a building, either as the result of intrusion from outside, or condensation from within the structure. Generally, structural damp is caused by rain penetration, rising damp, and leaks from plumbing pipes.

Unmanaged damp facilitates the formation and development of mould, fungi growth and wood rot, decaying associated building materials and compromising their structural integrity. Damage to finishes is also likely to occur, including lifting, bubbling, peeling and staining of paint, plaster and wallpaper.

The first step in addressing damp is to diagnose the cause. The identified cause should be addressed first prior to repairing the appearance and other defects which have resulted from the rising damp. If the original cause is not resolved, further cases of damp are likely to ensue, resulting in secondary defects.

Consultation with a qualified plumber is advised immediately to identify the cause of damp and perform remedial works as required. Where excessive mould growth is present, further inspection by a specialist environmental health inspector should also be considered.

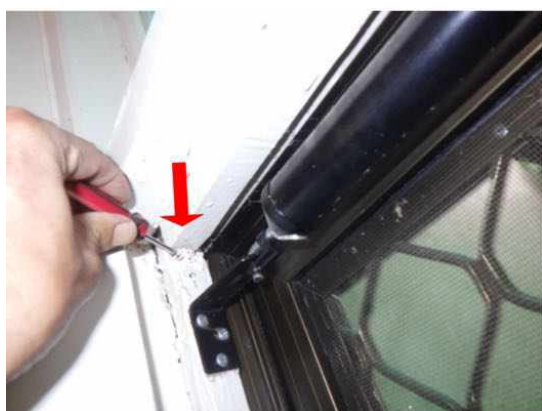
Defects 3.03

Building: Building 1
Location: All Internal Areas
Finding: Building element - Broken
Information: Breakage occurs generally when the building materials have either aged and decayed, or as a result of damage (accidental or deliberate).

Repair and/or replacement of broken elements is advised to ensure that additional secondary defects do not arise as a consequence. Such works are necessary, as all building elements play a key role in the operation and function of the overall structure and its performance.

A relevant tradesperson should be appointed to repair or replace the affected building element prior to any subsequent damage being caused.

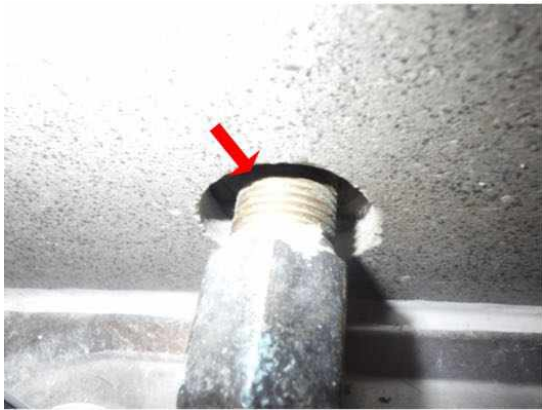
Defects 3.05

Building: Building 1
Location: All Internal Areas
Finding: Grout - Missing
Information: Grout is missing in this laundry area. Grout is used to protect gaps and crevices in building materials to ensure that they are water-tight and prevent water penetration to the associated structures.

Where grout is missing, a tiling contractor should be appointed immediately to apply grout and re-apply any silicone where necessary. Failure to do so is likely to lead to water damage to the surrounding area.

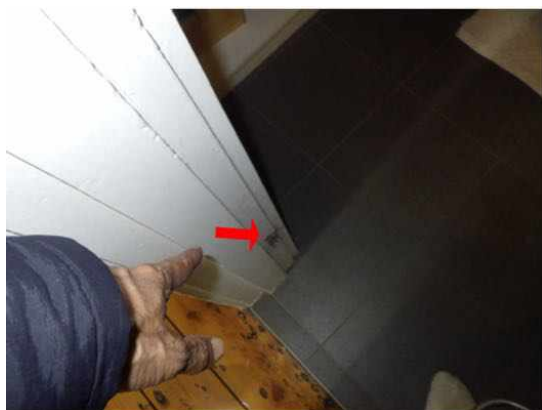
Defects 3.06

Building: Building 1
Location: All Internal Areas
Finding: Building element - Missing
Information: At the time of inspection it was noticed door is missing from this bathroom area. Although some building elements may seem irrelevant or unnecessary, all building elements play a key role in the operation and function of the overall structure and its performance.

Replacement of any missing building element should be conducted as soon as possible to ensure that no damage or functional issues occur to associated building materials.

The appropriate tradesperson should be appointed as soon as possible to replace the missing building element.

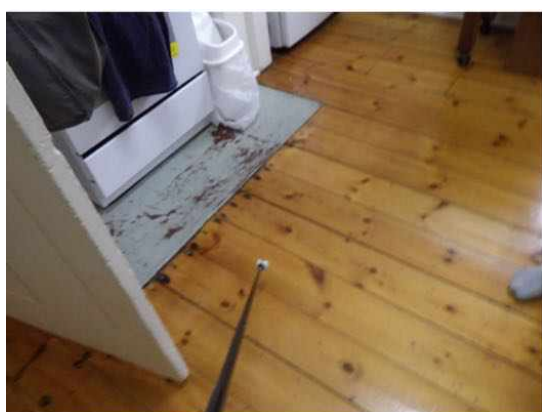
Defects 3.07

Building:	Building 1
Location:	All Internal Areas
Finding:	Floors - bouncy
Information:	The internal flooring in this area was identified as being bouncy at the time of inspection. A bouncy floor surface generally presents as a discernible change in level as they are walked across, in noisy or creaking flooring, or in consequent movement of surrounding furniture and fixtures.

Bouncy floors generally indicate that the floorboards or the subfloor structures are coming loose from the joists that they are installed on. Bouncy flooring may also be the result of gaps between flooring and stumps or joist structures, which require packing.

The client is advised to seek quotations for required repairs from a Registered Builder specialising in re-stumping. The potential resolution may range from packing gaps in subfloor structures through to replacement of subfloors stumps and refixing of flooring.

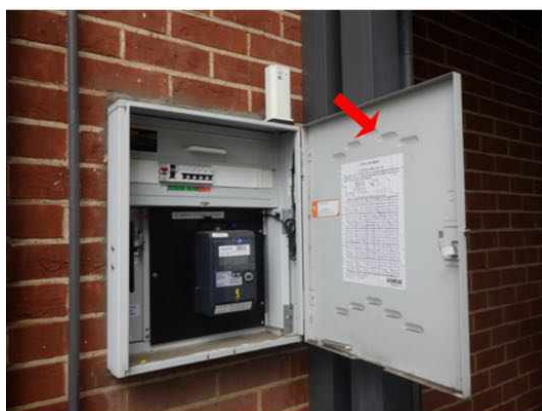
Noted Item

Building: Building 1
 Location: All External Areas >
 Finding: Termite Management System - No evidence of a chemical installation
 Information: The application of a post-construction chemical termite barrier is highly recommended for all properties, particularly if live termite activity has been found on the site previously. Such barriers are highly effective in preventing termite attack on any timber building elements throughout the property.

A durable notice should be placed in the switchboard unit to indicate current termite barriers. At the time of inspection, it appeared as though no termite management system has been installed, with no evidence to suggest preventative works taking place.

The client may consider gaining further advice from a pest controller as to the costs and procedures involved with this application. It is recommended that obtaining such advice be a short-term priority.
