## Building Inspection Report

Inspection Date: Wed, 1 Apr 2026

Property Address: 58 London St, Bentleigh VIC 3204, Australia

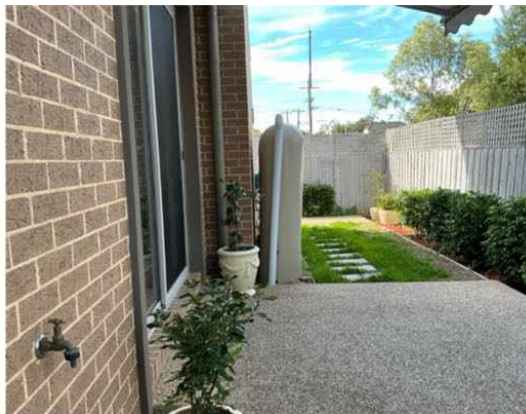
#### Defects 1.01

Building: Main Building  
Location: Rear Elevation  
Finding: Additional Photos  
Information: It appears the water tank is showing signs of subsidence as the water tank is on an angle and not secure.

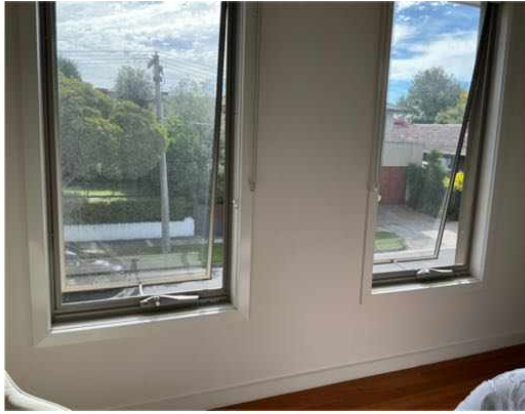
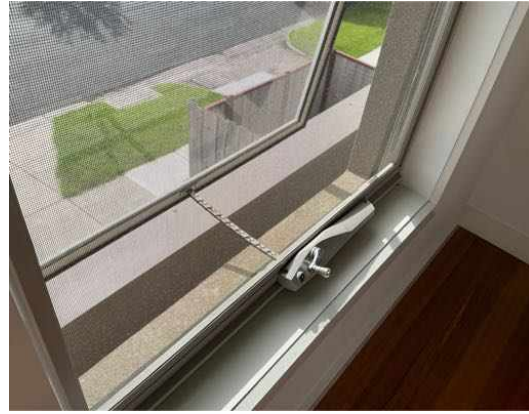
#### Defects 1.02

Building: Main Building  
Location: Upstairs  
Finding: Windows not restricted opening  
Information: Second story windows in buildings constructed after 2013 must be fitted with devices to restrict the window opening more than 12.5cm to prevent falls. Even if this property was constructed prior to this date it is a safety hazard not to have restricting devices installed.

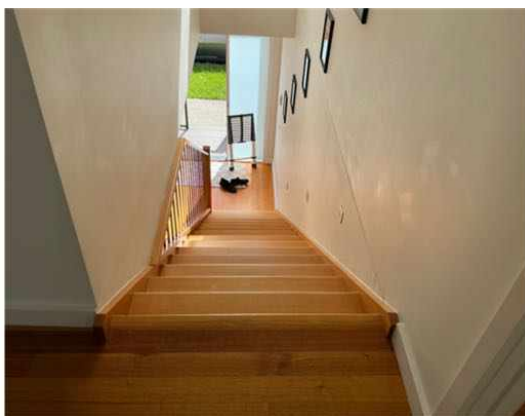
### Defects 1.03

Building:	Main Building
Location:	Stairs - Internal
Finding:	Balustrade - Suspected Non-Compliance
Information:	The balustrade was measured and found to be less than the present building regulation requirement of 1000mm high. Additionally the gaps between the balustrade cladding were found to be greater than the present building regulation requirement of 125mm.

This defect creates a potential safety hazard and should be rectified as soon as possible to ensure the safety of the area and to meet present building standards and regulations.

A registered builder should be contacted to discuss possible rectification solutions.

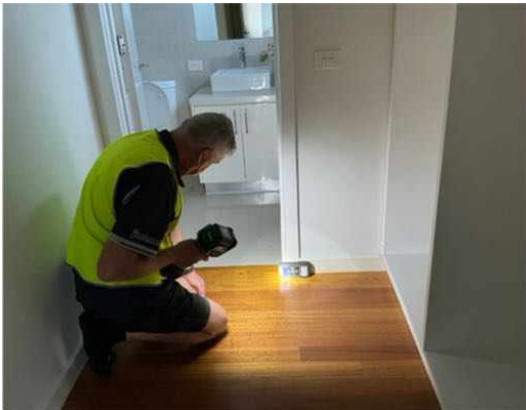
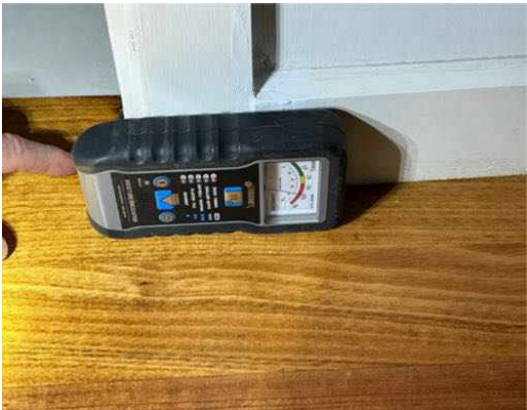
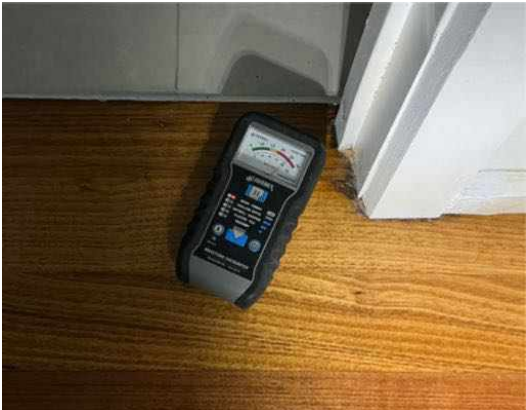
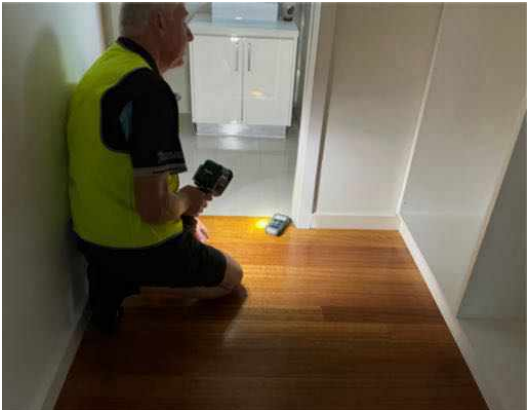
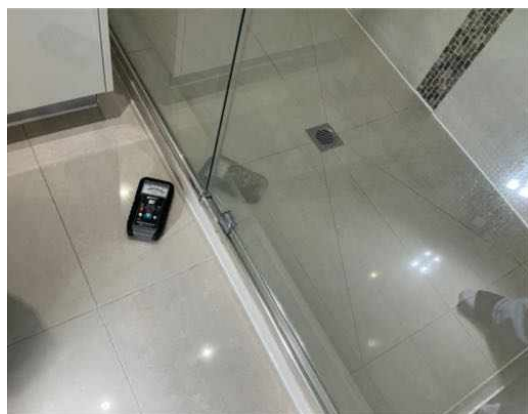
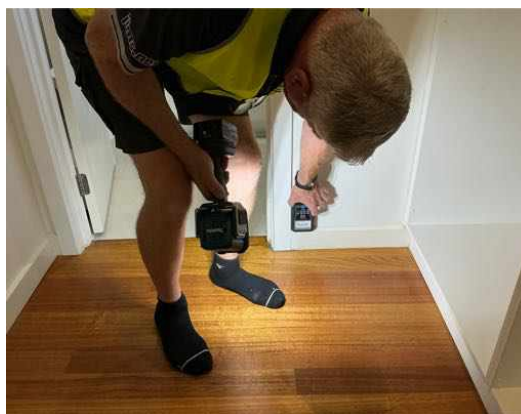
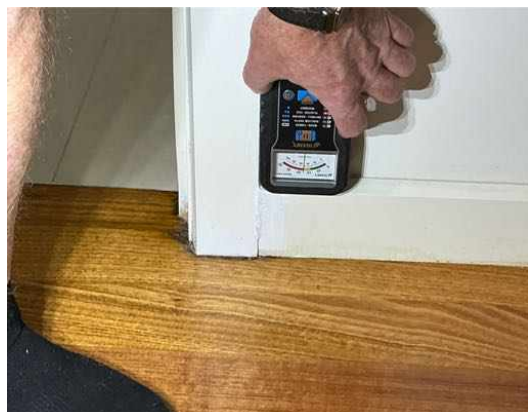
**Defects 2.01**

Building: Main Building  
Location: Ensuite - Master  
Finding: Shower - Leaking  
Information: Leaking was evident to the shower area at the time of inspection as shown in photos with the moisture meter. It is suspected that the leaking has occurred as a result of general ageing of the building elements.

Leaking from the shower base, where left unattended, is likely to lead to water damage to adjoining flooring and walls. Leaking can lead to water damage and necessitate extensive remedial works being required. Active water leaks may also create an environment that is susceptible to the formation and development of mould.

The downstairs en-suite bathroom was found to leaking as evidenced by swollen door frame and vanity unit as well as excess moisture found with a moisture meter . This is considered a major effect for immediate rectification as without immediate attention associated building elements may continue to degrade.

Appointment of a tiling contractor is required to replace the shower the bathroom waterproofing and tiling. Such works should be performed as soon as possible to ensure that no further damage occurs.

A qualified Tiler and Registered Builder should be engaged in order to replace this bathroom tiling and waterproofing prior to any further use. The other bathrooms showed no sign of excess moisture however it is possible they have not been used for an extended period of time therefore moisture may not be present at the time of inspection..

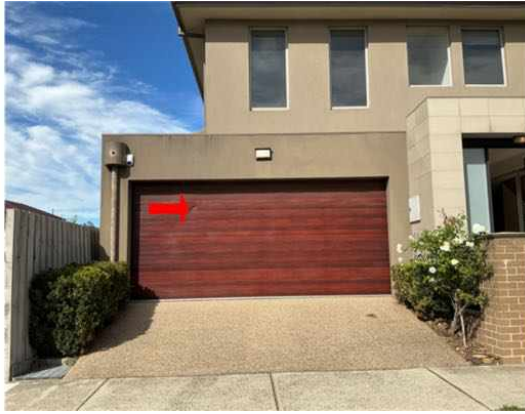
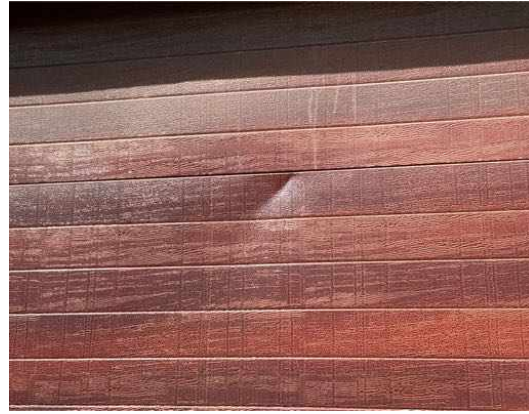
### Defects 3.01

Building:	Main Building
Location:	Garage
Finding:	Garage door - Superficial markings
Information:	The garage roller door has a number of marks and dents likely to have resulted from impact damage be it accidental or deliberate impact at sometime.

Garage roller doors can fail when the building materials have aged but may be indicative of impact damage (accidental or deliberate). While superficial markings detract from the aesthetics of the building element, the functionality has not been hindered in any way.

Repair and/or replacement of the two garage doors would improve the condition of the garage but certainly not an urgent item

A qualified roller door installer or supplier should be engaged to check out the operation and overall condition of the doors to determine if repair is an option otherwise replacement may need to be considered.

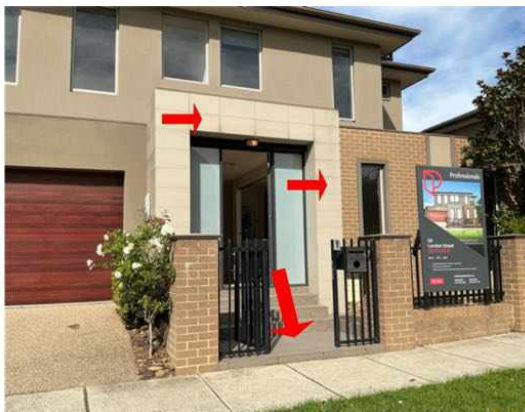
### Defects 3.02

Building:	Main Building
Location:	Front Elevation
Finding:	Tiles - Drummy
Information:	Drummy tiled areas were identified at the time of inspection. The term 'drummy' refers to tiles that have become detached from their fixing, despite otherwise being in relatively good condition. Such defects are generally caused by physical or moisture damage to the area. Drummy tiled areas may also be a direct result of poor workmanship during the construction process.

Tiled areas may swell and shrink with changes in air humidity if the area has sustained moisture damage. Any exposure to moisture is capable of causing tiled areas to become drummy and/or cracked over a prolonged period of time. Drummy tiled areas generally require removal and replacement of affected tiles, with adequate sealant and grouting.

Specialist trades are available for these types of services. A registered builder may be required to undertake works if damage is extensive or if secondary building defects have resulted. Otherwise, it is advised that a tiling contractor be appointed to perform works as necessary. Immediate action is recommended to ensure that no further damage is sustained in the affected area.

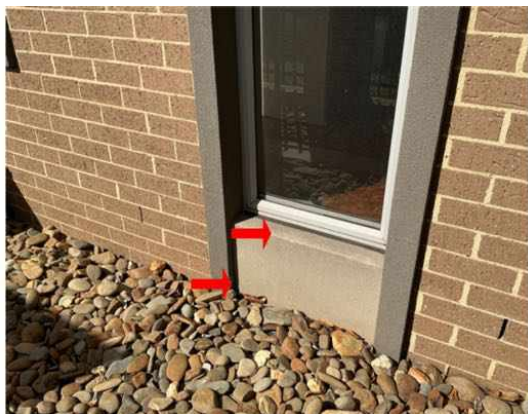
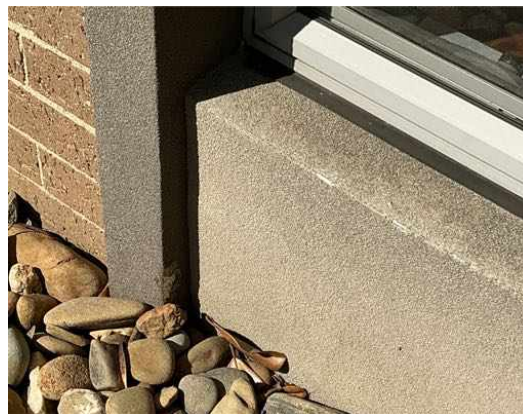
### Defects 3.03

Building:	Main Building
Location:	Render
Finding:	Render chipped - defective
Information:	Chips or any other blemish which is obvious from a normal viewing position is considered a defect with reference to Standards and Tolerances.

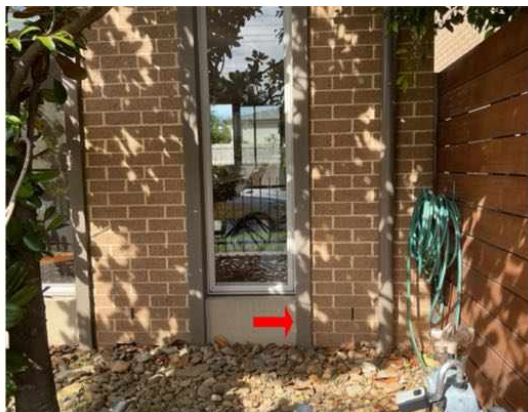
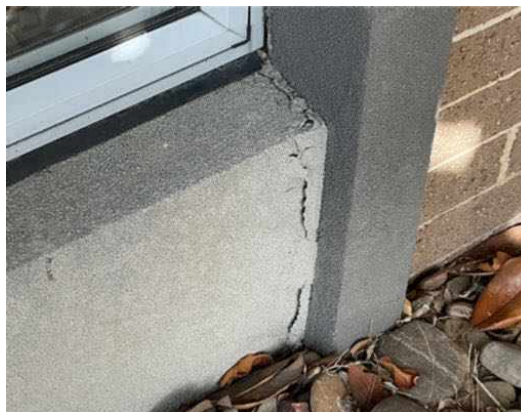
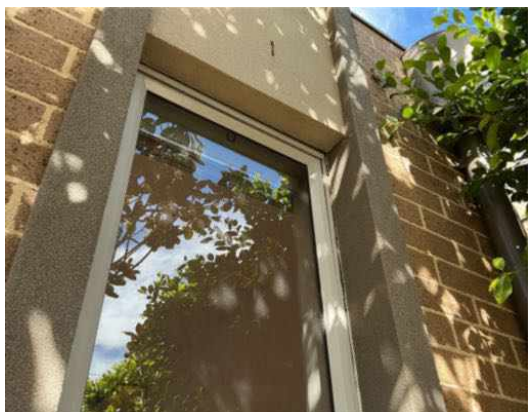
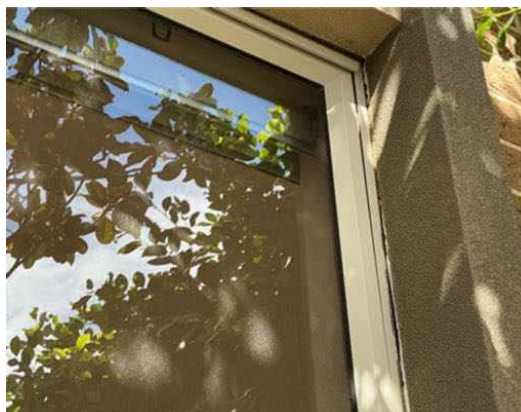
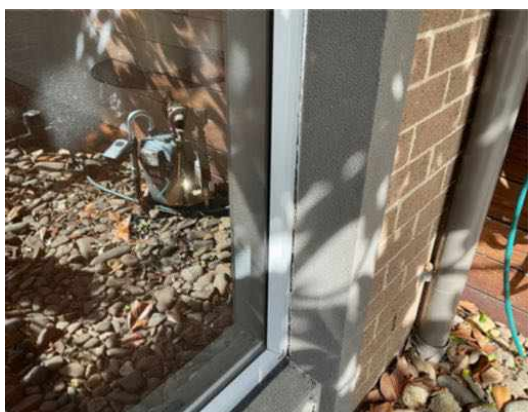
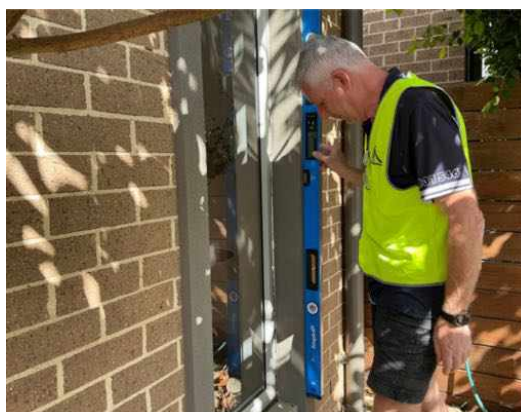
### Defects 3.04

Building:	Main Building
Location:	Front Elevation
Finding:	Cracks to render - Category 2
Information:	It has been observed that cracking to rendered surfaces has occurred. The degree of damage falls within Category 2, described as noticeable cracks which are easily filled. Cracking of this size are generally less than 5mm in width.

Category 2 damage is required to be monitored for a period of 12 months. After the monitoring period, a crack rated at Category 2 or above is considered a defect requiring rectification.

Always contact your building inspector should cracks widen, lengthen, or become more numerous.

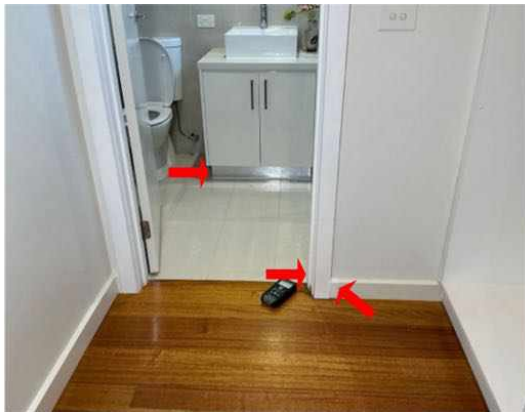
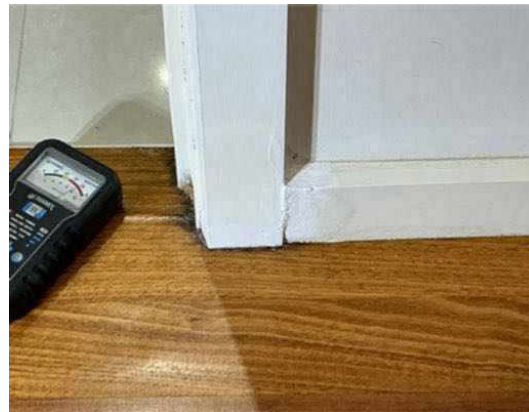
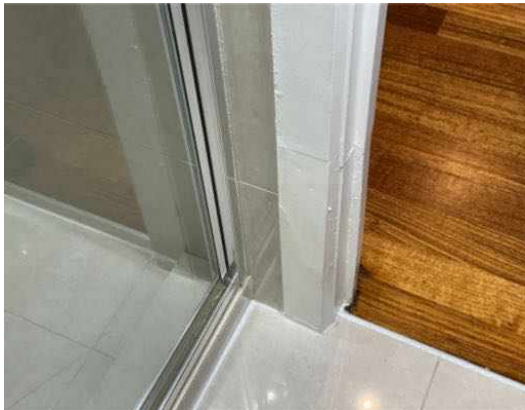
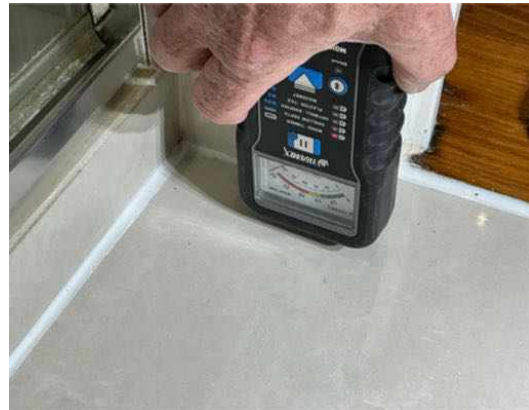
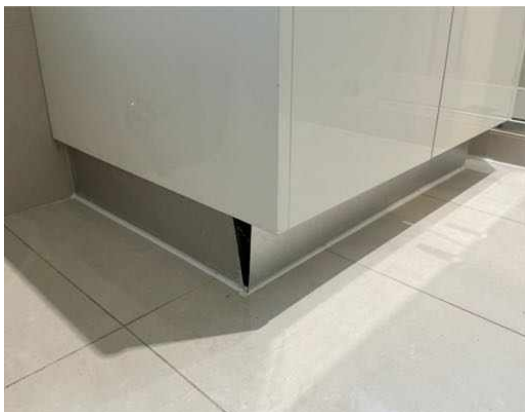
### Defects 3.05

Building:	Main Building
Location:	Walk In Robe and en-suite
Finding:	Building element - Swollen
Information:	Swollen building elements generally indicate that the building materials have been affected by excessive moisture over a prolonged period of time, and have swollen as a result. The formation and development of mould/fungi or mildew is also a likely consequence of excessive moisture, which may pose major respiratory issues for occupants, particularly the elderly, the very young and those with existing illnesses and could be potential health safety hazards. In these cases an appropriately qualified inspector/tester should also be contacted for advice and/or technical assistance.

The structural integrity of swollen building elements can not be guaranteed, and further damage is likely to develop if left unmanaged. Excessive moisture is likely to lead to the development of secondary damage to any associated building elements, which may necessitate major repair works if prolonged.

Rectification of the cause of the water leak should be addressed prior to any remedial works to the swollen building elements. A licensed plumber should be appointed immediately to identify the cause of the leak and provide advice on remedial works as necessary, Repair and/or replacement of swollen building elements should be conducted as a matter of urgency by a registered builder or qualified carpenter.

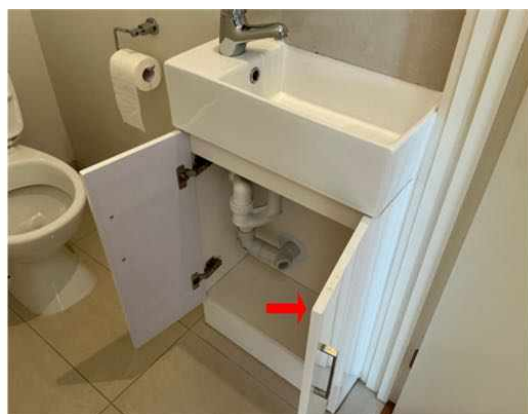
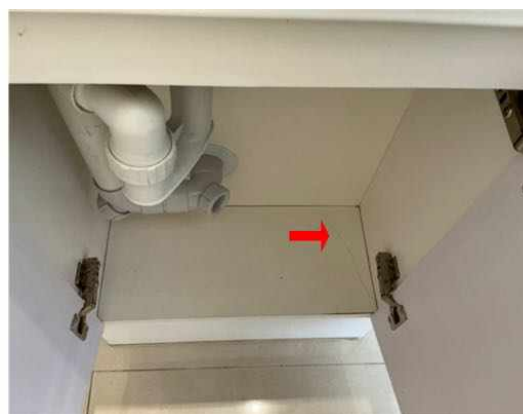
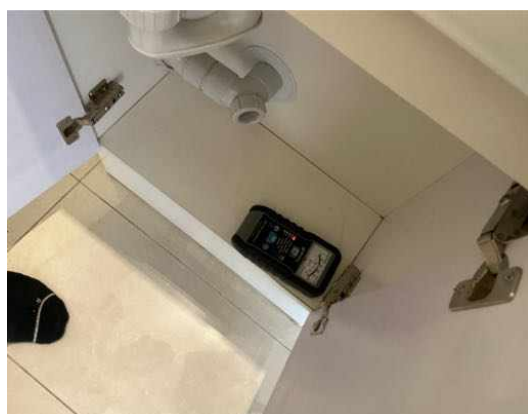
### Defects 3.06

Building: Main Building  
Location: Powder Room  
Finding: Building element - Swollen  
Information: Swollen building elements generally indicate that the building materials have been affected by excessive moisture over a prolonged period of time, and have swollen as a result. The formation and development of mould/fungi or mildew is also a likely consequence of excessive moisture, which may pose major respiratory issues for occupants, particularly the elderly, the very young and those with existing illnesses and could be potential health safety hazards. In these cases an appropriately qualified inspector/tester should also be contacted for advice and/or technical assistance.

The structural integrity of swollen building elements can not be guaranteed, and further damage is likely to develop if left unmanaged. Excessive moisture is likely to lead to the development of secondary damage to any associated building elements, which may necessitate major repair works if prolonged.

Rectification of the cause of the water leak should be addressed prior to any remedial works to the swollen building elements. A licensed plumber should be appointed immediately to identify the cause of the leak and provide advice on remedial works as necessary, Repair and/or replacement of swollen building elements should be conducted as a matter of urgency by a registered builder or qualified carpenter.

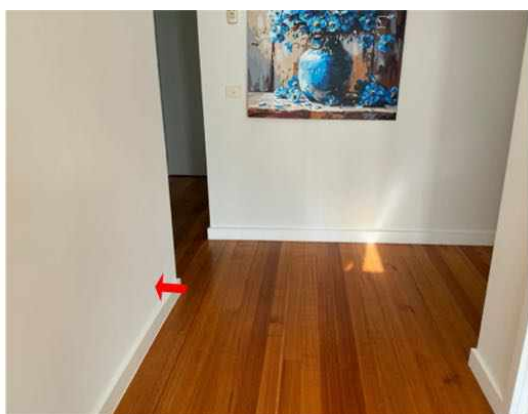
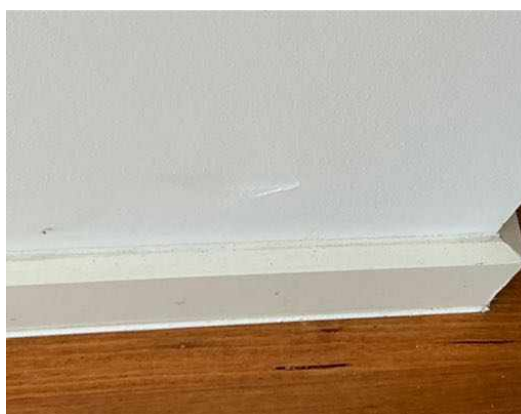
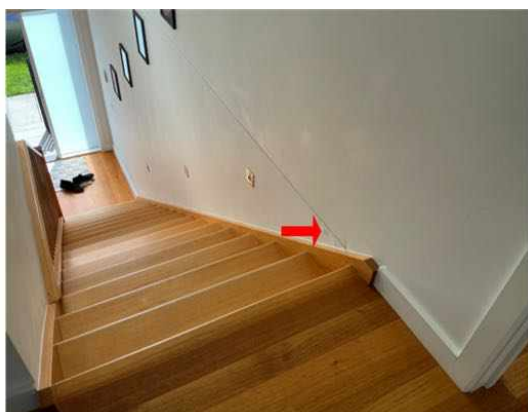
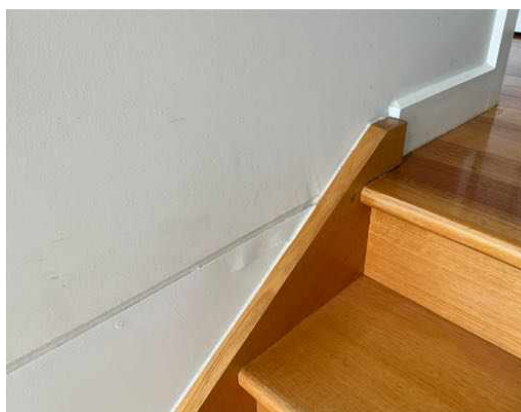
### Defects 3.07

Building: Main Building  
 Location: Entry and stairs  
 Finding: Plaster - Damaged  
 Information: Damage from flooding to the internal plaster was identified in this area at the time of inspection.

The plaster damage is approximately as shown in the photos provided at the time of inspection.

This should be monitored frequently to identify whether further cracking results.

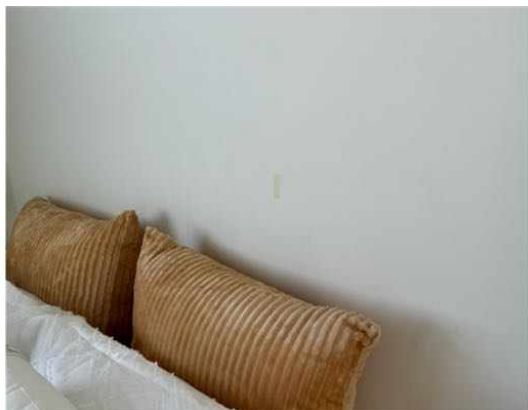
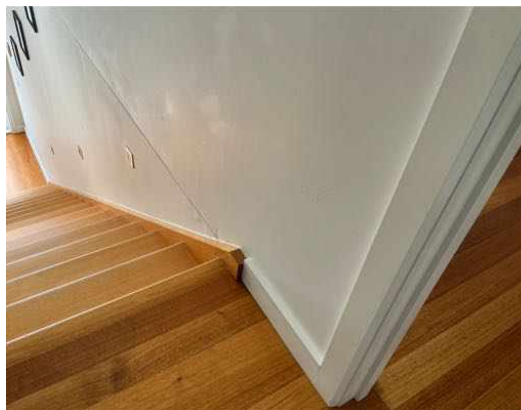
### Defects 3.08

Building: Main Building  
 Location: All Areas  
 Finding: Walls - Scuffed  
 Information: Superficial scuff marks were noted to the internal walls in this area at the time of inspection. Marked and scuffed surfaces, while detracting from the overall appearance of the affected building element, do not indicate any operational or structural damage. This degree of surface damage is consistent with general wear and tear.

Marked surfaces may be left at client discretion, as no repair/replacement is necessarily required. Marked surfaces are unlikely to result in the development of

secondary damage; however, the client may wish to seek quotations for the cost to refurbish or replace the affected wall linings.

A general handyman or cleaning contractor may be appointed to rectify marked or scuffed surfaces at the client's discretion.

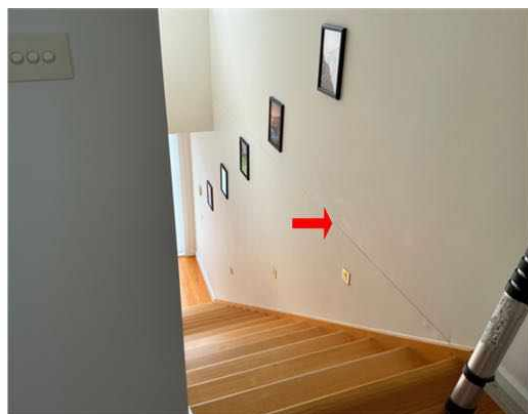
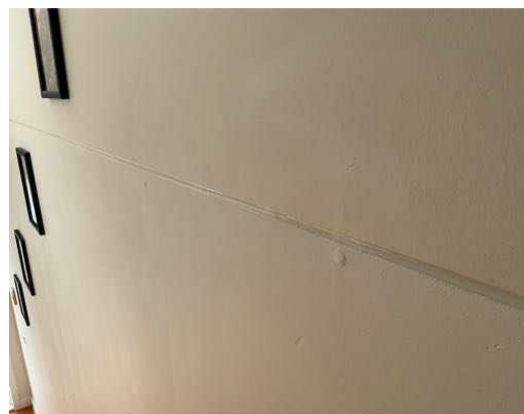
### Defects 3.09

Building:	Main Building
Location:	Stairs - Internal
Finding:	Nails - Popping
Information:	Numerous popped nails were identified at the time of inspection. Nails and screws are held by the friction between them and the surface that they are applied to. Over time, the nails and screws can back out, which is often a result of general ageing and deterioration of the building structure.

If left unmanaged, internal wall and ceiling sheeting may become loose and unstable, increasing the rate of deterioration of these building elements and creating potential for the development of secondary defects.

Re-fastening of popped nails will help to maintain the stability of these, and associated, building elements. Such minor works will also help to improve the appearance of the affected area and secure the linings. These works should be performed by a qualified carpenter or plasterer at client discretion.

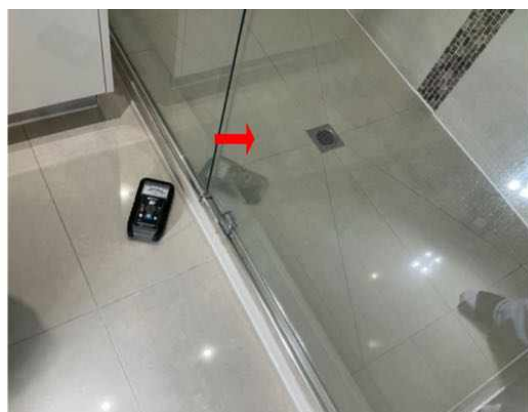
### Defects 3.10

Building:	Main Building
Location:	Ensuite - Master
Finding:	Tiles - Rummy (Shower base)
Information:	Drummy tiled areas were identified at the time of inspection. The term 'drummy' refers to tiles that have become detached from their fixing, despite otherwise being in relatively good condition. Such defects are generally caused by physical or moisture damage to the area. Drummy tiled areas may also be a direct result of poor workmanship during the construction process.

Tiled areas may swell and shrink with changes in air humidity if the area has sustained moisture damage. Any exposure to moisture is capable of causing tiled areas to become drummy and/or cracked over a prolonged period of time. Drummy tiled areas generally require removal and replacement of affected tiles, with adequate sealant and grouting.

Specialist trades are available for these types of services. A registered builder may be required to undertake works if damage is extensive or if secondary building defects have resulted. Otherwise, it is advised that a tiling contractor be appointed to perform works as necessary. Immediate action is recommended to ensure that no further damage is sustained in the affected area.

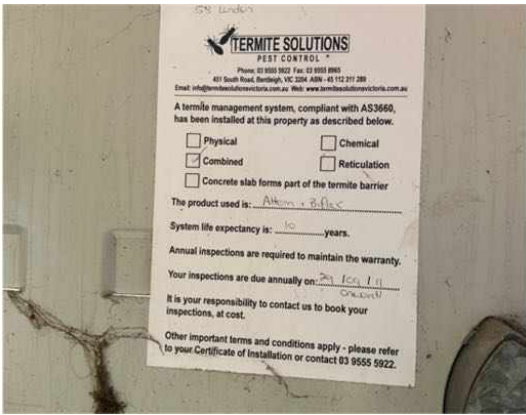
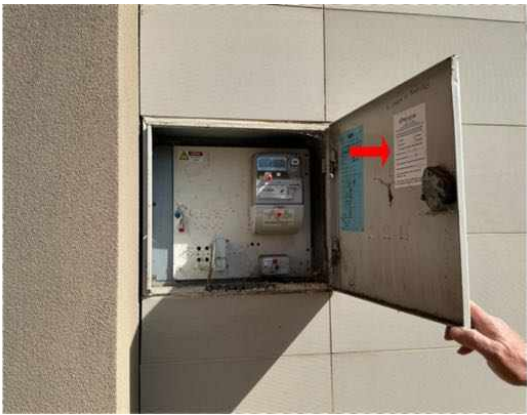
### Noted Item

Building:	Main Building
Location:	Electrical Switchboard
Finding:	Evidence of a chemical treated zone barrier was identified
Information:	During inspection of the property, it was noted that works to install a chemical treated zone barrier had previously been completed. A chemical treated zone barrier is likely to ensure effective protection against termites.

However, we strongly recommend annual inspections of the barrier and surrounding areas as there are several factors that can lead to deterioration of the barrier and decrease its effectiveness.

Where a Termite Management System has been identified, the client should identify to the type of barrier, date of installation, warranty conditions and any documentation provided by a builder or past owner. Consult the company who installed the barrier to confirm whether the system is still under warranty.
