Building Inspection Report

Inspection Date: Fri, 16 Jan 2026

Property Address: 58-60 Mariners Reef Rd, MARYBOROUGH,
VIC, 3465, Australia

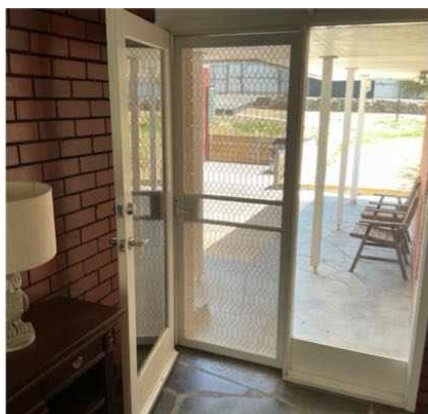
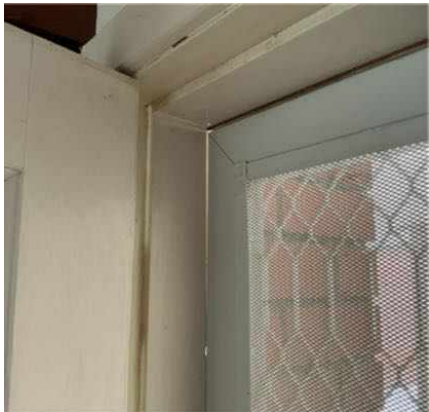
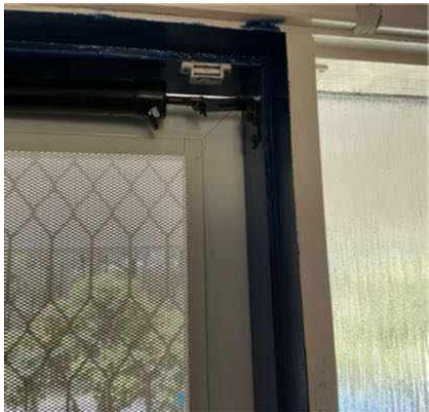
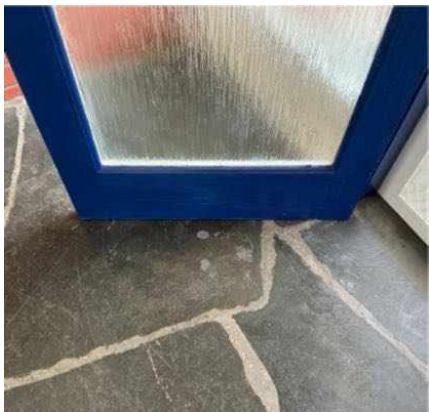
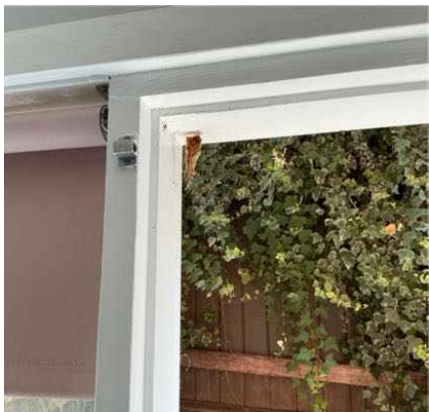
Defects 3.01

Building:	Main Building
Location:	All External Doors
Finding:	All external door seals - not installed
Information:	External perimeter door seals and bottom Raven door seals are essential components of a home's weatherproofing system. These seals serve as a protective barrier against external weather conditions, preventing rain, wind, dust, and pests from entering the home. Additionally, they play a critical role in maintaining indoor temperatures, improving energy efficiency, and reducing heating and cooling costs.

During the inspection, it was observed that these seals were missing from all the external doors of the property. The absence of door seals leaves the home vulnerable to several issues, including:

- It is highly recommended to engage a skilled handyperson or tradesperson to install external perimeter door seals and bottom Raven door seals on all external doors. These seals should be selected and installed based on the specific needs of the homeowner and the property's design.

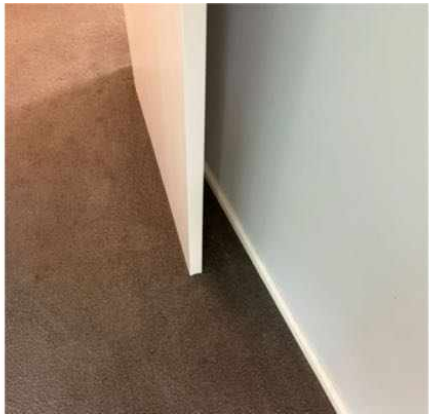
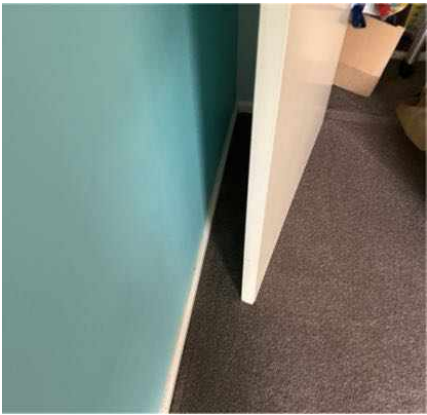
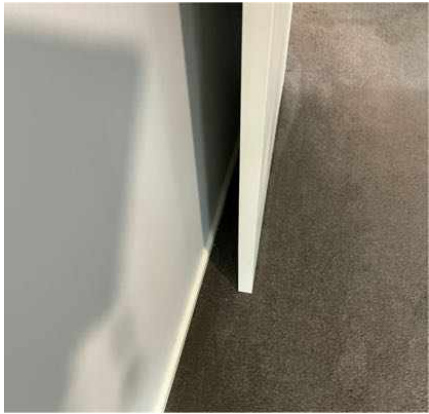
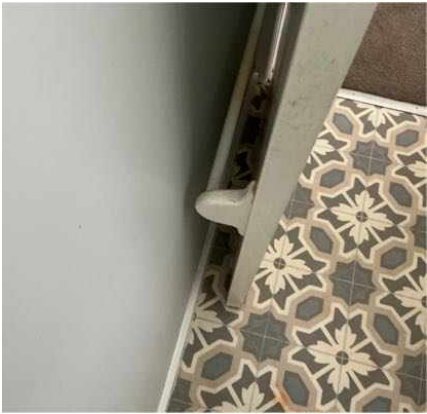
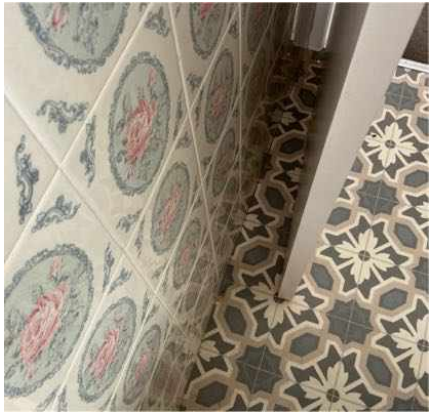
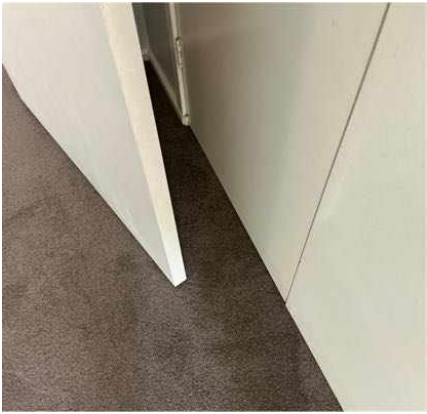
Defects 3.02

Building:	Main Building
Location:	All Internal Areas
Finding:	Missing or Damaged Door Stops
Information:	Several door stops were observed to be either missing or damaged throughout the property. Door stops serve a critical function in protecting walls, skirting boards, doors, and surrounding fixtures from impact damage caused by the door swinging too far.

- Risk of damage to walls, architraves, and door hardware due to uncontrolled door movement.
- Repetitive contact may result in indentations, chipped paint, or structural cracking.
- Reduced functionality and premature wear to doors and frames.

- Engage a qualified tradesperson or handyperson to install or replace door stops where required.
- Ensure the selected stops are appropriate for the type and swing of the door (e.g.

- Check nearby surfaces and door components for any damage already caused, and carry out repairs as needed.

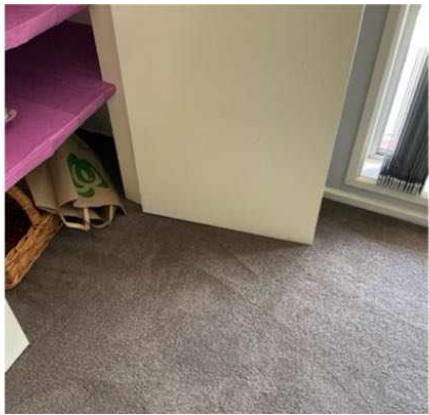
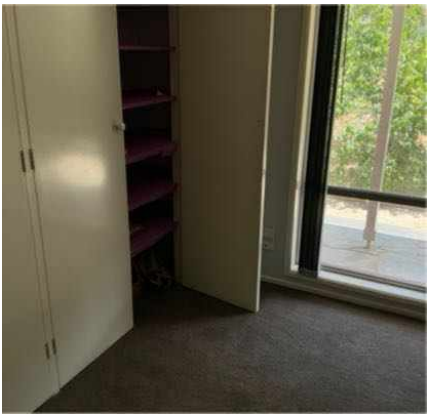
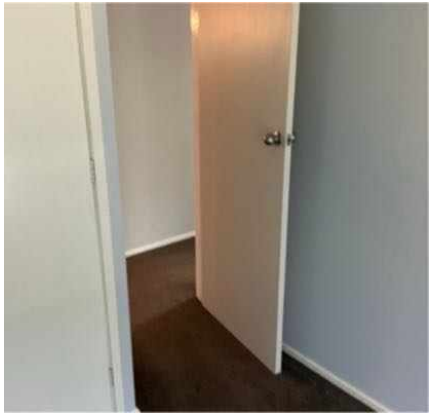
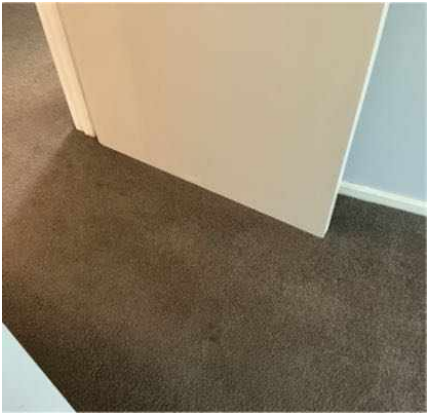
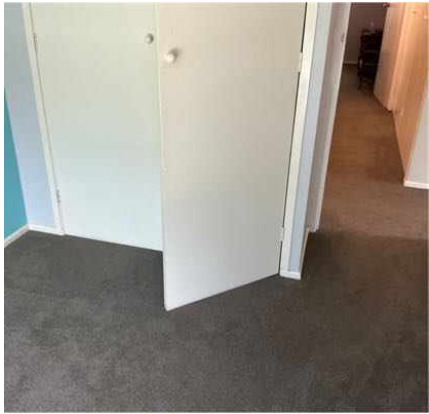
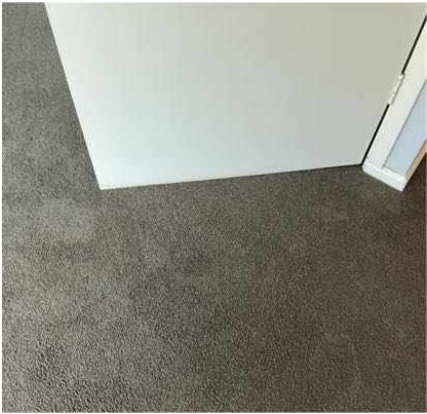
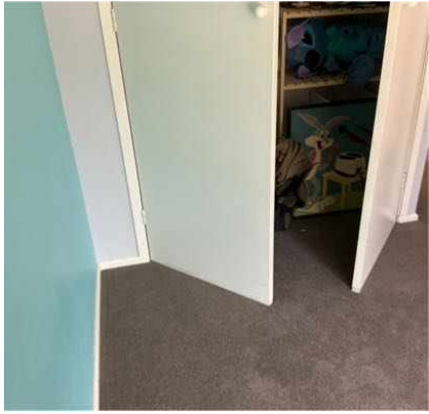
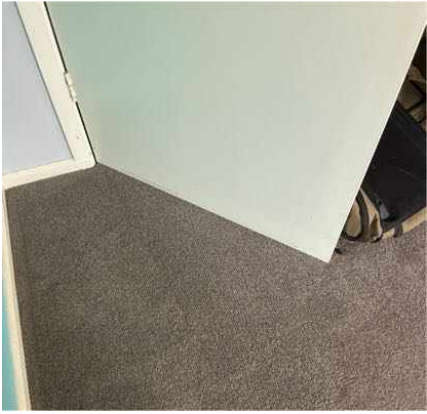
Defects 3.03

Building:	Main Building
Location:	Internal Areas
Finding:	Internal Doors Binding on Carpet
Information:	During the inspection, it was observed that one or more internal doors were binding at the base due to contact with the carpet. This condition restricts proper door operation and places undue pressure on the floor covering.

- Restricted door operation and reduced functionality.
- Increased risk of damage to carpet fibres and floor finishes.
- Potential for accelerated wear to door edges and door hardware.
- Reduced overall finish quality and usability of the affected areas.

This condition affects normal usability and finish quality and should be rectified to prevent ongoing damage and ensure proper door operation throughout the dwelling.

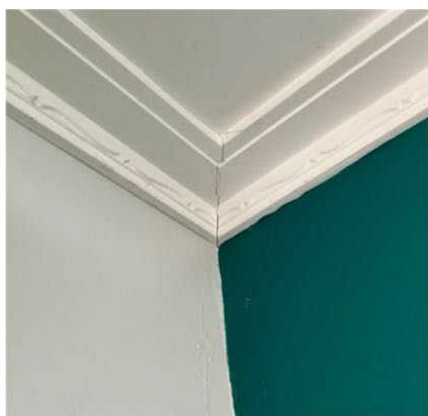
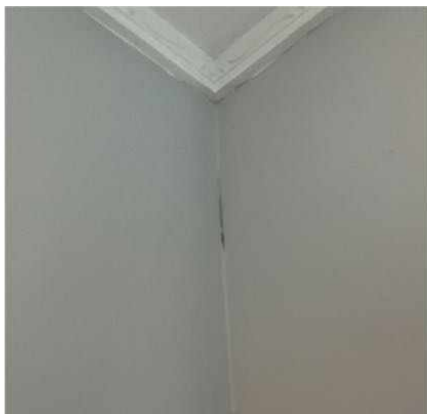
Defects 3.04

Building: Main Building
Location: Internal Areas
Finding: Cracking to Internal Wall Linings
Information: Cracking was observed to internal wall linings during the inspection. These types of cracks are generally considered common and are typically the result of natural building movement, age-related wear, thermal expansion and contraction, or minor installation-related issues in plasterboard or supporting framing members.

The cracking noted is typical of minor building movement and does not currently present as structural. Regular monitoring and cosmetic repair will assist in preserving the internal presentation and allow early intervention if future issues arise.

- Engage a qualified plasterer to repair cracks and consider installing expansion joints if necessary to accommodate ongoing building movement.
- Arrange for repainting by a qualified painter following any plaster repairs.
- Monitor cracks over time for signs of progression (e.g. widening, lengthening, or new cracks forming).
- If deterioration continues or operational issues with doors/windows arise, seek further assessment from a building inspector or structural engineer.

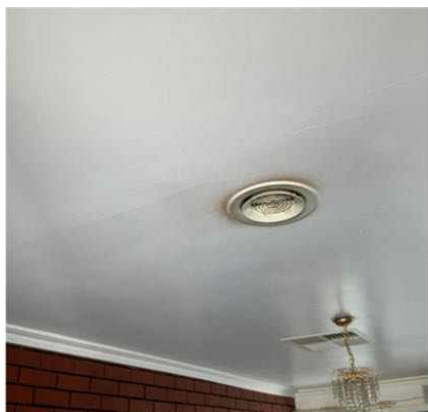
Defects 3.05

Building:	Main Building
Location:	Entry
Finding:	Cracking and Staining to Ceiling Finishes Adjacent to Heating Duct
Information:	At the time of inspection, cracking to the ceiling lining and paint finish was observed in the vicinity of the heating duct within the entry area. Localised brown discolouration and staining were also present around the duct penetration. The cracking appears to radiate from and around the duct opening, indicating movement, thermal expansion, or moisture-related stress to the ceiling lining at this location.

- The cracking indicates ongoing movement or stress to the ceiling lining, which may continue to worsen over time.
- The staining suggests possible past or current moisture presence, condensation, or air leakage around the duct penetration.
- If moisture is present, there is an increased risk of ceiling lining deterioration, mould growth, and hidden damage to framing or insulation.
- The condition reduces the overall presentation of the entry area and may indicate broader performance issues with duct sealing or roof space moisture control.

- The duct penetration should be inspected to confirm whether moisture, condensation, or air leakage is occurring.
- Any gaps around the duct should be properly sealed to prevent air and moisture transfer.
- The affected ceiling area should be repaired by a qualified tradesperson, including stabilising the substrate, re-finishing, and repainting.

- If moisture is confirmed, further investigation of roof space ventilation, insulation, and duct insulation may be required.

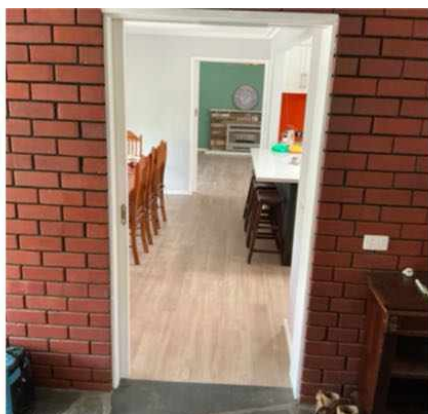
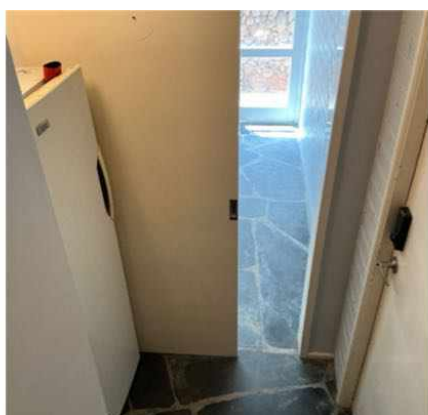
Defects 3.06

Building:	Main Building
Location:	Dining Room & Laundry
Finding:	Internal Sliding Door - Stiff
Information:	During the inspection, one or more internal sliding doors were noted to operate stiffly or not slide smoothly along their tracks. This condition is commonly caused by minor misalignment, debris accumulation within the tracks, or deterioration of rollers and fittings over time.

- Reduced ease of use and impaired door functionality.
- Increased wear to door tracks, rollers, or fittings if left unaddressed.
- Possible difficulty achieving full closure, affecting privacy or security.

- Clean and inspect the upper and lower tracks to remove dust or debris.
- Lubricate all moving components to improve operation.
- Engage a qualified carpenter or handyman to adjust, realign, or replace worn rollers and fittings as required.

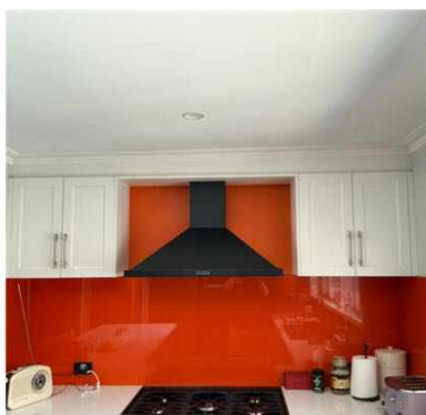
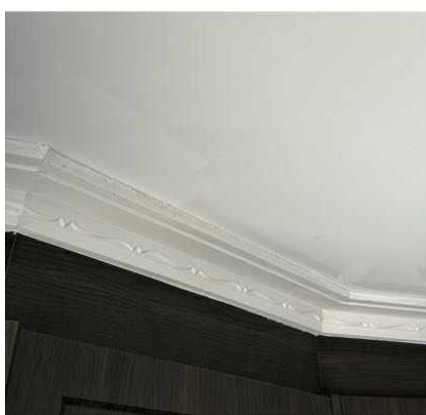
Defects 3.07

Building: Main Building

- Visual inconsistency affecting finish quality.
- Potential for further ceiling movement or plasterboard cracking.
- Possible underlying structural or support-related concerns requiring investigation.

- Rectify the sag by reinforcing or adjusting ceiling support as necessary and reattaching or replacing the affected cornice.
- Monitor the area for signs of worsening sag or plaster cracking if immediate repair is not undertaken.

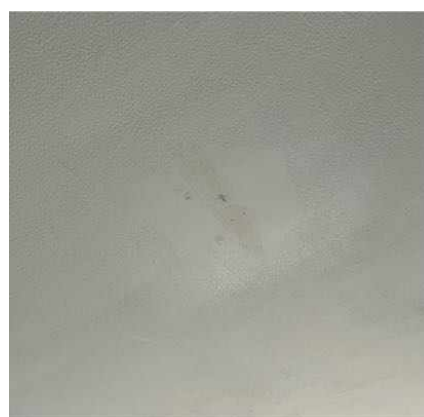
Defects 3.08

Building:	Main Building
Location:	Bedroom
Finding:	Ceiling Patching Visible in Multiple Areas
Information:	Ceiling surfaces in several rooms were noted to contain visible patching, likely resulting from prior repairs or attempted cosmetic improvements. The affected areas exhibit inconsistent texture, slight protrusions, or visible outlines that detract from a uniform ceiling finish.
Implications:

- Patching may indicate past water damage, movement, or ceiling lining failure
- Potential underlying structural or moisture issues may not be fully resolved
- Poor visual finish detracts from presentation and may require further cosmetic repair

- Obtain clarification from the vendor regarding the reason for previous patching
- Engage a licensed plasterer to assess the ceiling condition and provide remedial works where needed
- Consider further investigation to rule out active water ingress or ceiling lining deterioration

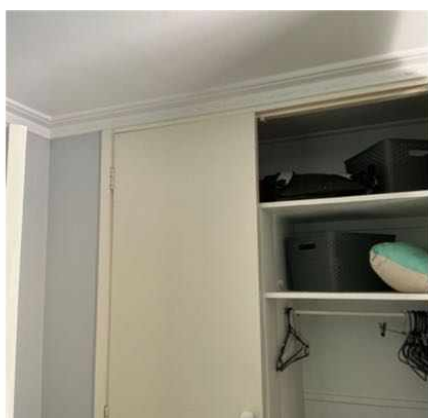
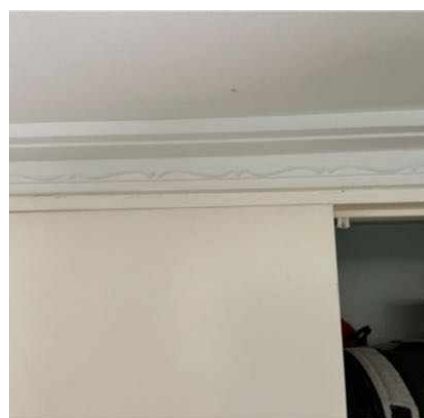
Defects 3.09

Building:	Main Building
Location:	Built In Robe
Finding:	Binding Doors on Frame
Information:	During the inspection, one or more internal doors were noted to be binding against the door frames, making them difficult to open and close. This condition is typically caused by poor initial installation, deterioration of hinges, or movement in the surrounding structure due to minor settlement or environmental factors.

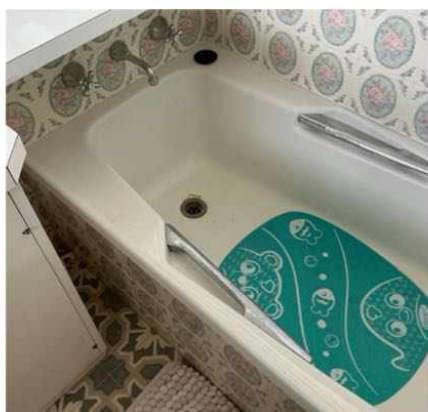
Defects 3.10

Building:	Main Building
Location:	Bathroom
Finding:	Peeling Enamel Coating to Bathtub Waste Area
Information:	At the time of inspection, the enamel coating to the bathtub was observed to be peeling and deteriorated around the waste outlet area. The exposed substrate beneath the enamel is visible, indicating loss of protective surface coating and ongoing material breakdown at a high-use and high-moisture location.

In summary, the peeling enamel around the bath waste area represents an active deterioration issue that will continue to worsen if not addressed, and rectification is recommended to restore durability, hygiene, and functional performance.

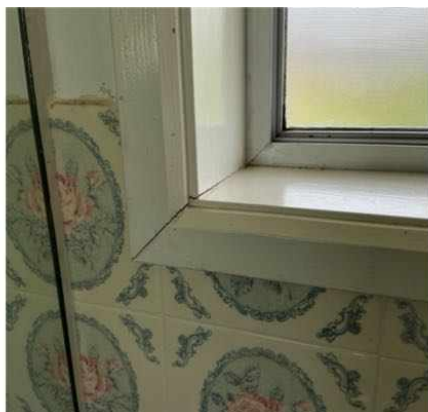
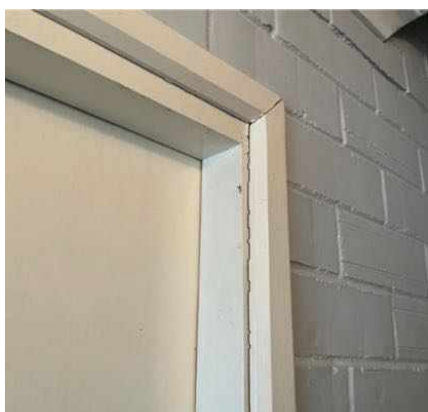
Defects 3.11

Building:	Main Building
Location:	Bathroom
Finding:	Cracking to Painted Architraves and Skirting Boards
Information:	Cracks were observed opening up in various sections of the painted architraves and skirting boards. These cracks may be associated with minor building movement, timber shrinkage, or inadequate surface preparation prior to painting.

This condition is not uncommon following recent painting, particularly in timber joinery, and is typically considered a maintenance item unless associated with significant structural movement.

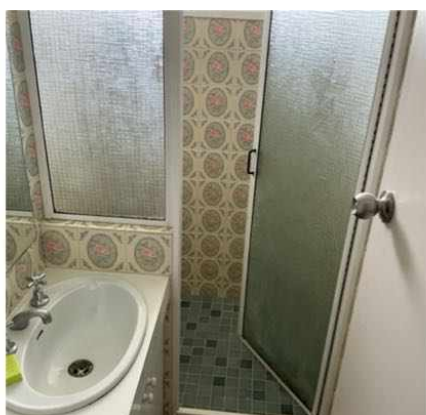
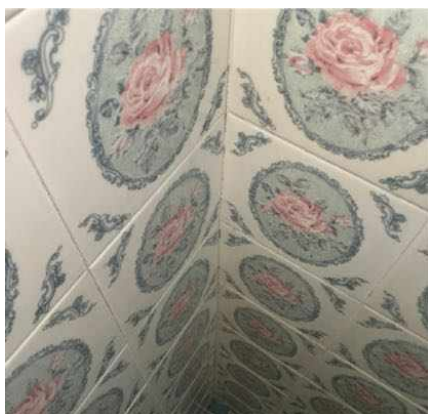
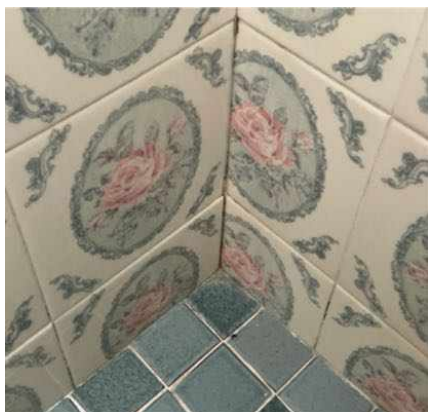
Defects 3.12

Building:	Main Building
Location:	Shower
Finding:	Missing Sealant to Shower Intersection Joints
Information:	At the time of inspection, it was observed that the shower intersection joints (including wall-to-wall and wall-to-floor junctions) have not been sealed with flexible waterproof sealant. Although this installation method was commonly accepted at the time the dwelling was constructed, it does not align with current best practice for wet area detailing. The absence of sealant leaves these junctions vulnerable to water penetration during normal shower use.

In summary, the absence of caulking to the shower intersection joints represents an increased risk of concealed water ingress and progressive damage, and rectification is recommended to improve moisture control, durability, and long-term performance of the wet area.

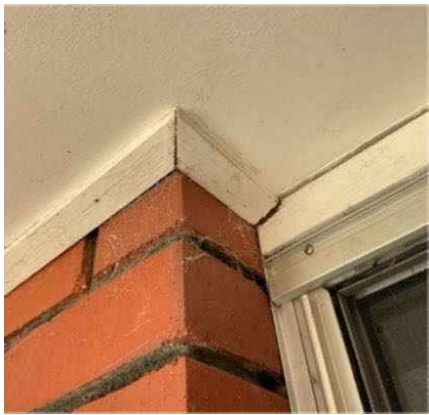
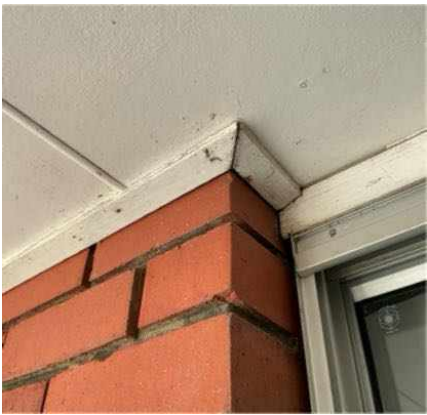
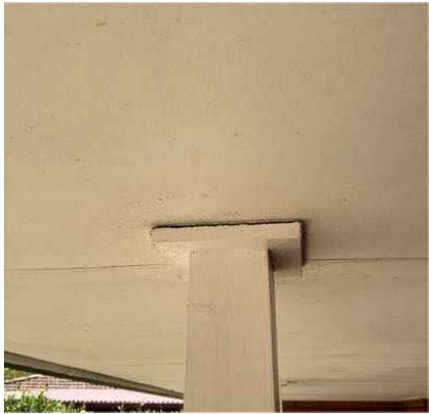
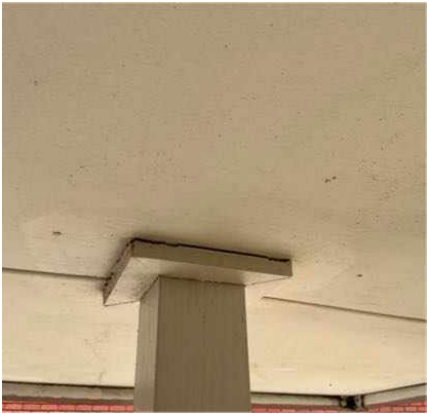
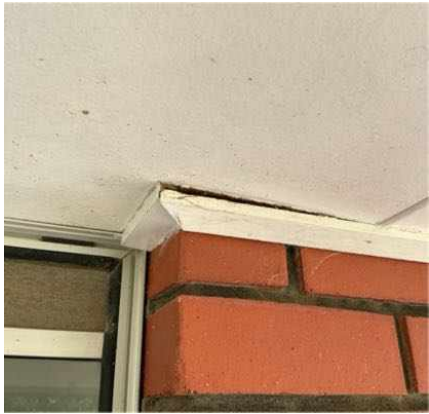
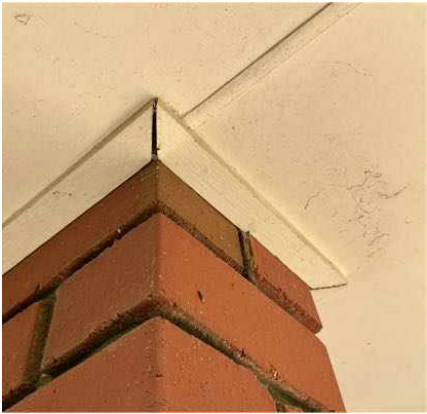
Defects 3.13

Building:	Main Building
Location:	All External Areas
Finding:	Cracking and Separation of Timber Quad Moldings at Eaves
Information:	During the inspection, cracking and separation was noted at the mitre joints of timber quad moldings installed around the eaves in multiple locations. This condition is common in aging properties and is typically associated with natural movement and environmental exposure over time.

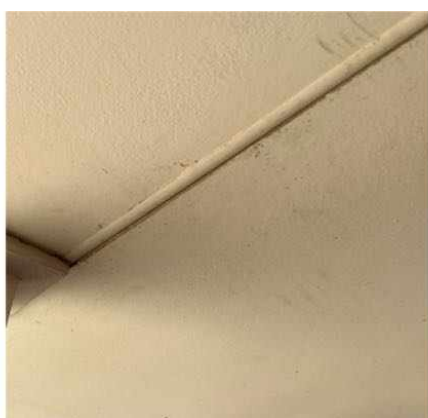
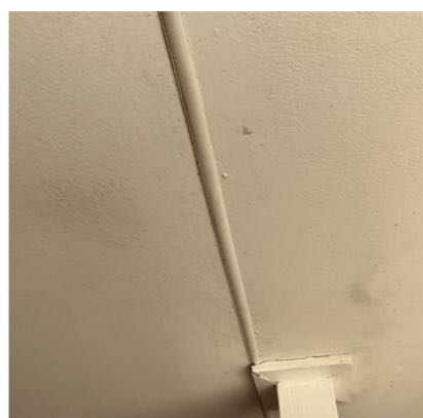
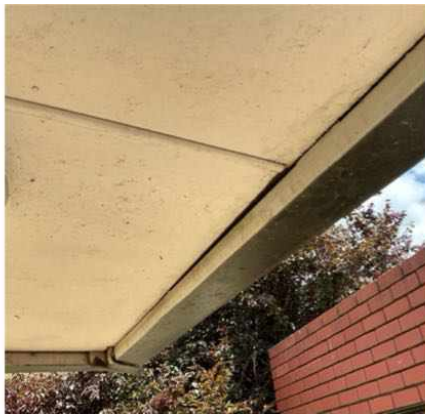
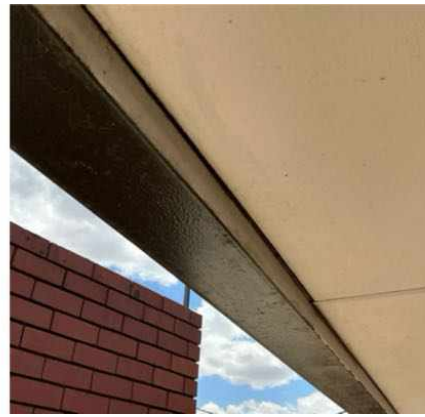
Defects 3.14

Building: Main Building
Location: All External Areas
Finding: Separation of Eave Lining from Joining Strips and Gutter/Fascia
Information: At the time of inspection, sections of the eave lining were observed to be separating from the joining strips and the adjacent gutter and fascia components. Visible gaps were present along multiple sheet junctions and perimeter edges, indicating loss of fixing integrity and/or ongoing movement within the eave lining system. The condition is consistent with ageing materials, moisture exposure, and fixings losing holding capacity over time.
Implications:

In summary, the separation of the eave lining from the joining strips and gutter/fascia represents a progressive durability and weather-resistance defect that will continue to worsen if left unaddressed, and rectification is recommended to restore enclosure integrity, protect the roof space, and maintain the long-term performance of the building envelope.

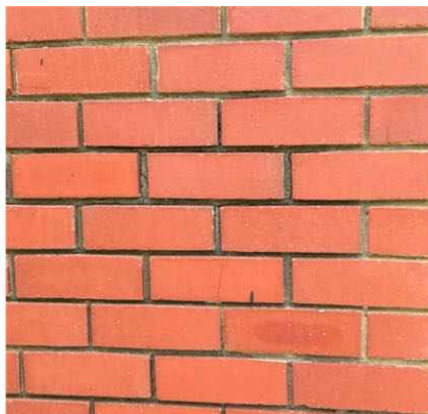
Defects 3.15

Building:	Main Building
Location:	Facade Near Garage
Finding:	Deteriorated Mortar Bedding to Brickwork
Information:	During the inspection, sections of mortar bedding to the brickwork were observed to be deteriorated in various areas. Mortar plays a critical role in bonding bricks together, maintaining wall stability, and providing a weather-resistant seal against moisture ingress. The level of deterioration observed is generally consistent with the age and construction type of the dwelling; however, it still represents a material defect that requires maintenance.

In summary, while the mortar deterioration is consistent with the age of the dwelling, it represents a progressive maintenance defect that will continue to worsen if not addressed, and rectification is recommended to preserve the structural integrity, durability, and long-term performance of the masonry walls.

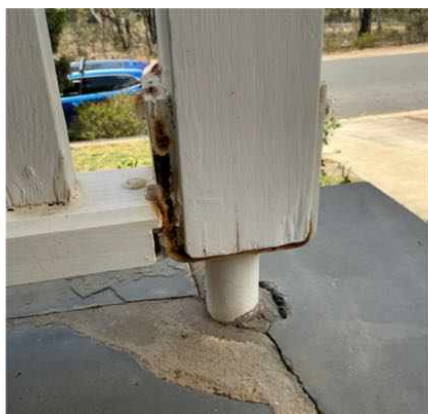
Defects 3.16

Building:	Main Building
Location:	Porch
Finding:	Corroded Steel Post Stirrup to Verandah Post
Information:	At the time of inspection, the steel stirrup supporting the verandah post was observed to be heavily corroded. Rust staining and section loss were evident along the stirrup, particularly at the junction between the post, fixing plate, and concrete footing. Cracking and deterioration to the surrounding concrete at the post base were also noted, indicating long-term moisture exposure and ongoing degradation of the support detail.

In summary, the rusted steel stirrup represents a structural durability defect that will continue to deteriorate if left unaddressed, and rectification is recommended to restore the integrity and safety of the verandah post support.

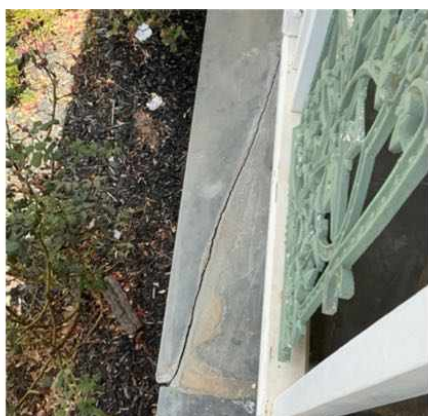
Defects 3.17

Building:	Main Building
Location:	Porch
Finding:	Cracking Along Mortar Joint to Porch Paving
Information:	At the time of inspection, a continuous crack was observed following the mortar joint line within the porch paving. The cracking runs longitudinally through the joint and indicates separation between adjacent paving units rather than an isolated surface blemish. This condition suggests movement or loss of bonding within the paved surface.

In summary, the cracking along the mortar joint to the porch paving indicates movement and joint failure that will continue to deteriorate if not addressed, and rectification is recommended to restore surface stability, durability, and safe use of the porch area.

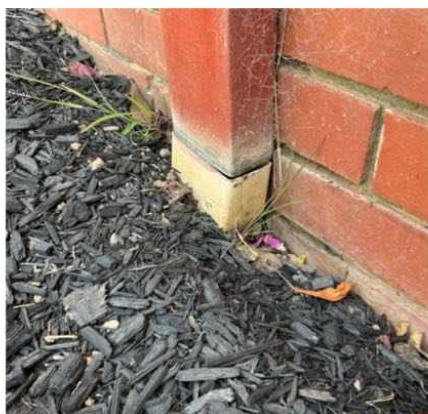
Defects 3.18

Building:	Main Building
Location:	Left-hand Side
Finding:	Downpipes Short and Not Fully Connected to Stormwater
Information:	During inspection, it was observed that one or more downpipes terminate above the stormwater connection point rather than being fully extended into the system. As a result, rainwater may not be effectively directed into the drainage system and can instead discharge around the base of the dwelling.

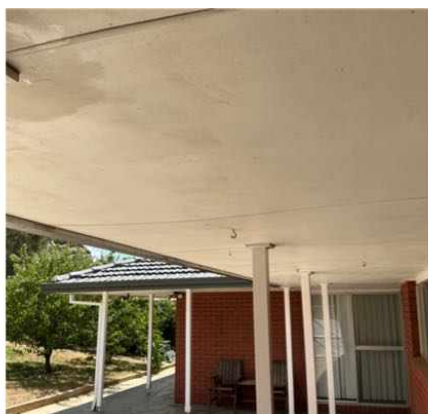
Defects 3.19

Building:	Main Building
Location:	Rear Porch
Finding:	Eave sheets - Sagging
Information:	Visible sagging of the eave sheeting was noted around the entire perimeter of the dwelling. This is a common condition in older homes, where prolonged exposure to weathering, moisture ingress, and general material fatigue can cause the eaves to detach or fall out from the fascia boards. In this case, it was observed that the eave sheets are inadequately supported and appear to be temporarily held in place by nails driven into the fascia, which is not a compliant or durable method of fixing.

The observed sagging and makeshift fixing of the eave sheets indicate material degradation and improper support, which is consistent with age-related wear in older properties. These conditions present both visual and functional issues that, if left unaddressed, may worsen over time. Prompt attention from a qualified tradesperson is recommended to restore the integrity of the eave structures and prevent further deterioration or associated damage.

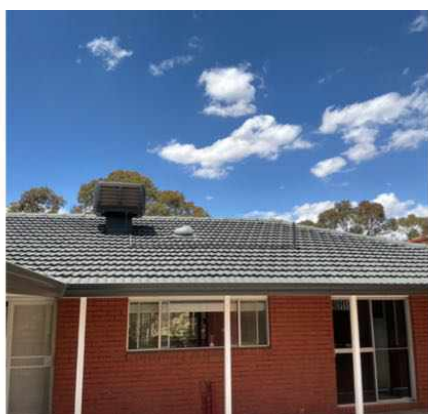
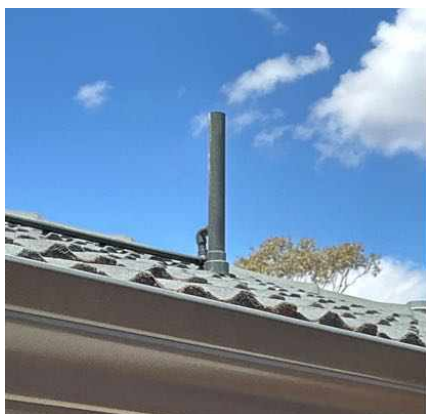
Defects 3.20

Building:	Main Building
Location:	Roof Exterior
Finding:	Evaporative Cooler Overflow Discharging Into Sanitary Vent
Information:	At the time of inspection, the roof-mounted evaporative cooling system was observed to have its overflow pipe connected into a vertical sanitary vent pipe. Based on the visible pipe configuration, the overflow discharge appears to enter the sanitary plumbing system rather than being directed to a stormwater or approved external discharge point.

In summary, the evaporative cooler overflow appears to discharge into a sanitary vent pipe, which is not considered best practice and may represent a plumbing compliance and hygiene concern. Rectification is recommended to ensure correct discharge, prevent cross-contamination, and maintain safe system operation.

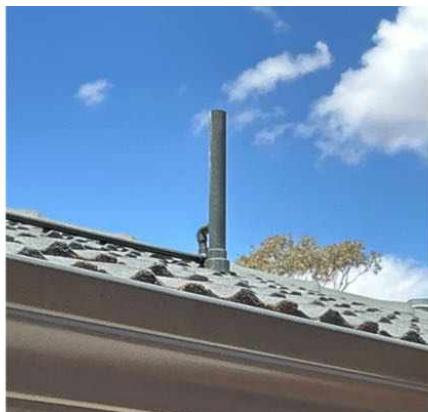
Defects 3.21

Building:	Main Building
Location:	Roof Exterior
Finding:	Sanitary Vent Pipes – Unprotected Open Terminations
Information:	The sanitary vent pipes servicing the drainage system were observed to terminate open above the roof line without vented caps or protective cowls. While vent pipes are required to remain open to atmosphere for correct system operation, the absence of vented protective terminals leaves the pipe openings exposed to rainwater entry, debris accumulation, insects, and birds.

Although the vent pipes are required to remain open to atmosphere, the addition of compliant vented caps or cowls is recommended to improve system protection, reliability, and long-term performance.

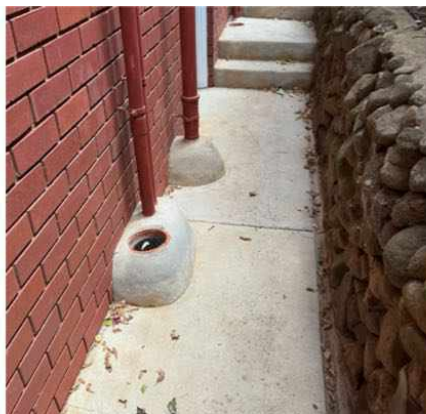
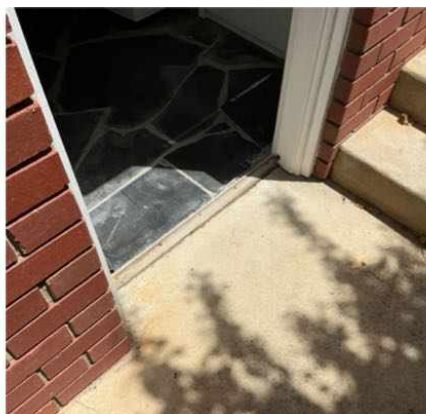
Building: Main Building
Location: Right-hand Side

In summary, while water ingress could not be confirmed at the time of inspection, the external ground and step configuration presents a potential future moisture risk to the laundry doorway and should be monitored and rectified if water entry is observed.

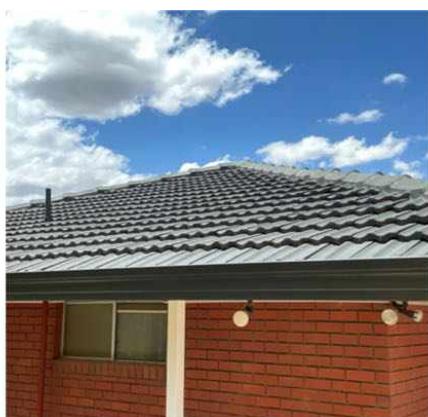
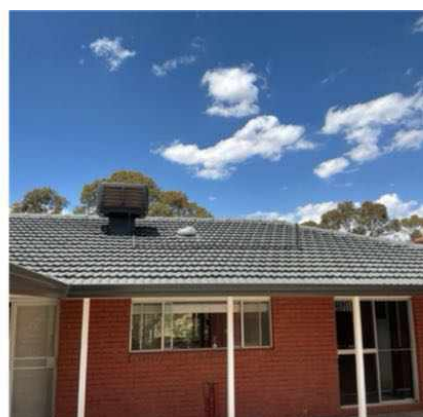
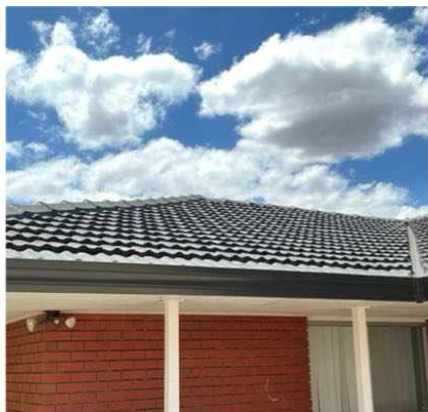
Building: Main Building
Location: Roof Exterior
Finding: Roof Tiles – Evidence of Restoration

The roof restoration has improved the visual presentation of the roof and may extend its service life, provided ongoing maintenance and inspection are conducted to address wear as the coating ages.
