Building and Timber Pest Inspection Report

Inspection Date: Sat, 14 Feb 2026

Property Address: 20/300C Burns Bay Rd, Lane Cove NSW
2066, Australia

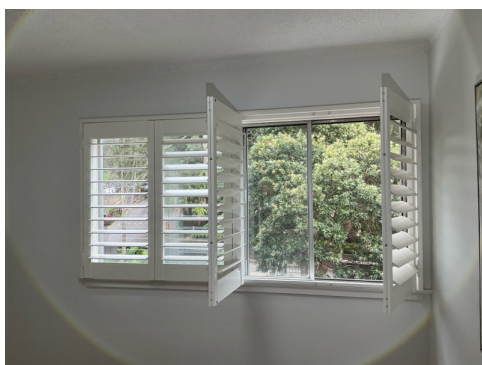
Finding: Window Restrictors - Recommended

Information: Upstairs windows did not have window restrictors installed. Although not a requirement at the time of construction, it is advisable to install window opening restrictors on all second storey windows with sill heights below 1.7 meter and potential fall of 2 meters or more.

If you live in a strata scheme, window safety devices must be installed on all applicable windows by 13 March 2018. Residents with safety devices installed can still fully open their windows but it's recommended that devices be engaged whenever children are present, to prevent falls.

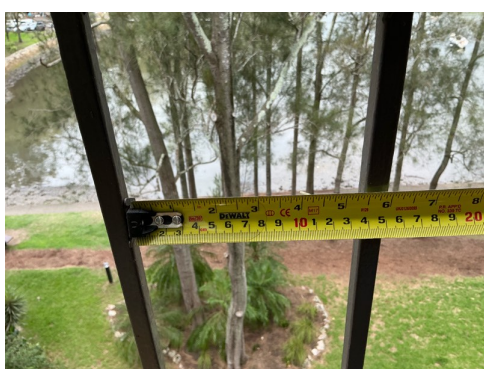
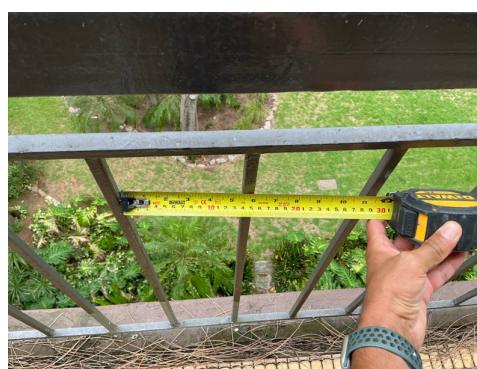
Finding 1.02

This exceeds the maximum allowable spacing as per Australian safety standards, posing a potential safety hazard, particularly for young children who may be at risk of falling through or getting trapped in the gap.

☒ The excessive spacing of more than 125 mm between the railings fails to comply with the above standards, creating a risk of injury or entrapment, particularly for young children. This defect could allow a child to slip through the gap or get their head or limbs stuck, leading to potential injury or a fall from height.

☒ To rectify this defect, the spacing between the railings should be reduced to 125 mm or less. This can be achieved by installing additional balusters or a secondary barrier (such as a mesh or panel) to close the gap. Any modifications should be carried out in accordance with the NCC and relevant Australian Standards, and a qualified professional should be consulted to ensure compliance.

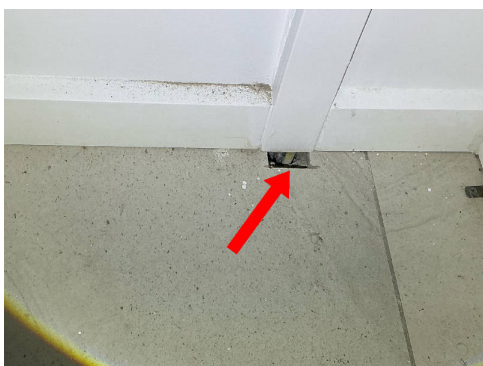
Finding 1.03

Finding: Electrical Wires - Exposed

Information: During the inspection, exposed electrical wires were noted. This condition poses a significant safety hazard, as it increases the risk of electrical shock, short circuits, and potential fire. It is imperative that a qualified electrician addresses this issue immediately by properly insulating the exposed wires and ensuring all electrical connections comply with safety standards. Prompt action will mitigate the risks associated with exposed wiring and maintain the safety and integrity of the property's electrical system.

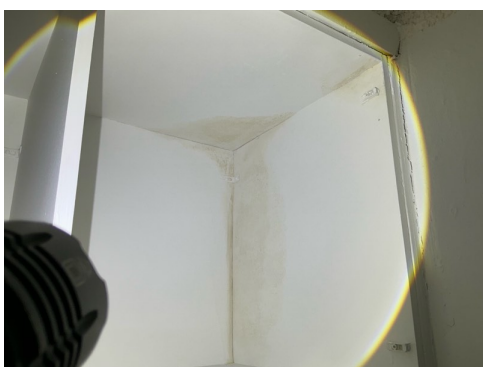
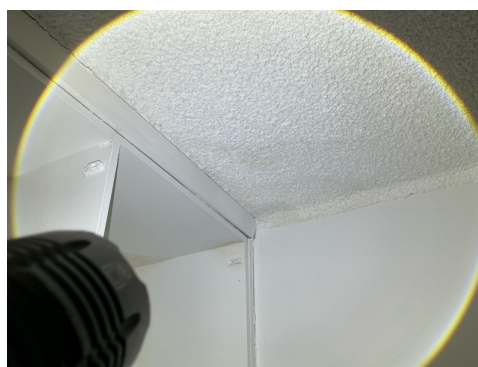
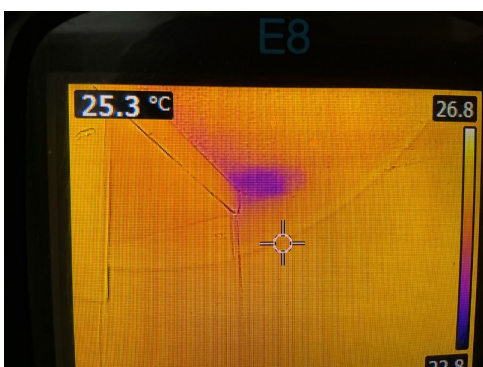
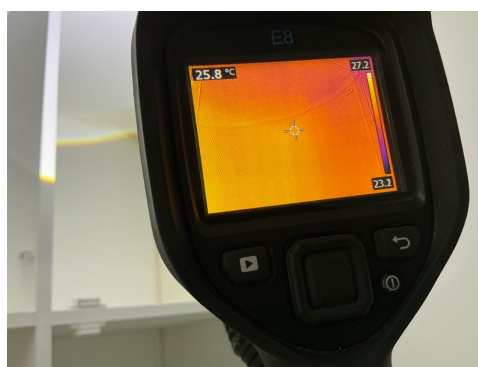
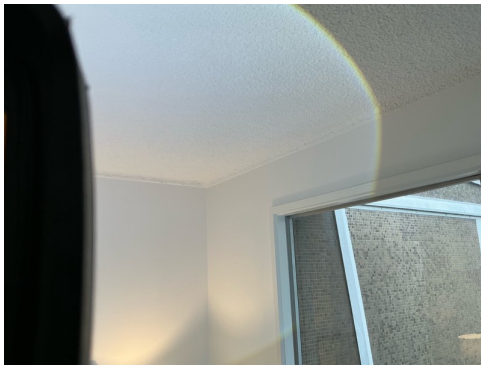
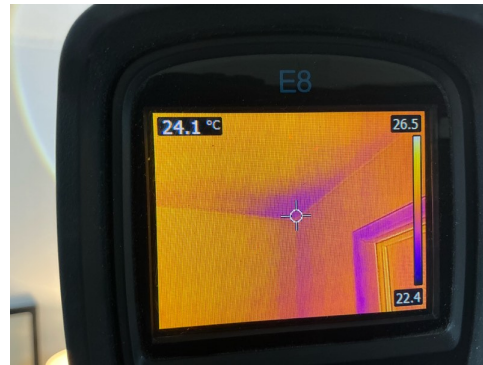
Finding 2.01

Finding: Active Moisture – Ceiling Areas (Bedrooms and Closet)

At the time of inspection, active moisture was detected to the ceiling areas within both bedrooms and the adjoining closet. Thermal imaging and moisture testing identified temperature differentials and elevated moisture readings consistent with ongoing water ingress. Visible signs of dampness and discolouration were also noted to ceiling surfaces.

The presence of active moisture indicates that the issue is current and not historical. If left unaddressed, continued water penetration may result in deterioration of plasterboard, mould growth, insulation damage, and potential structural timber decay.

Immediate investigation and rectification are required. As this appears to be associated with building elements that may fall under common property (such as roofing, external walls, or plumbing services), the client is strongly advised to notify and involve Strata Management without delay. A licensed plumber and/or roofing contractor should be engaged to identify and rectify the source of ingress, followed by appropriate repairs to affected internal finishes once the leak has been fully resolved.

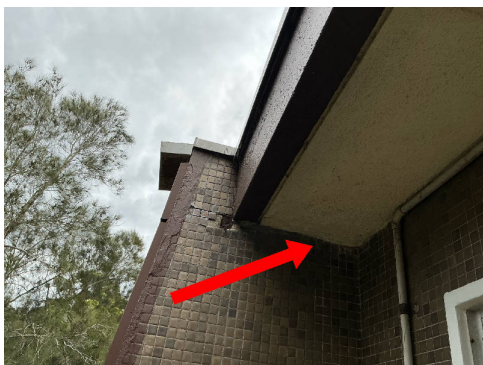
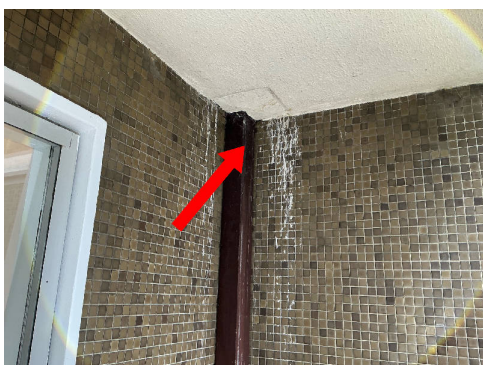
Finding 3.02

Building: Main Building
Location: Balcony
Finding: Eaves - Water stained

Water staining to eaves linings in this area was evident at the time of inspection. Water staining indicates that surfaces have been exposed to excessive moisture over time. The minerals and other elements in the water lead to staining, which may graduate to corrosion and deterioration if left unmanaged.

While mostly an appearance defect, water staining can be indicative of more serious defects, which may be currently concealed by interior ceilings.

Where water staining is active, a licensed plumber must be consulted to identify the cause of the staining and to provide advice on any reparation works that may be required. Replacement of any damaged structures is advised. The client is advised to engage strata management as well.

Conversely, where water staining is old and inactive, affected building materials may be repaired or replaced at client discretion.

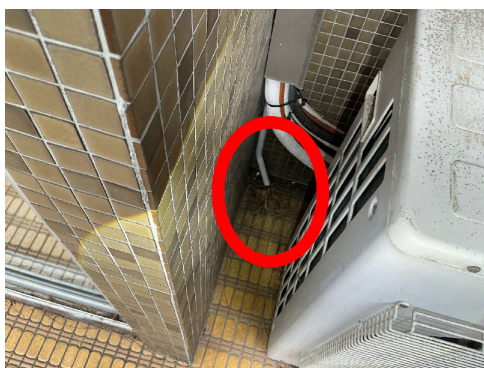
**Finding 3.03**

Finding: Air conditioner - Disconnected overflow

Information: The Air Conditioner (A/C) overflow was found to be disconnected from storm water drainage and is creating excessive moisture in the surrounding area.

Such leaking creates an environment which is conducive to an array of defects, including water damage to associated building elements and the attraction of termite or timber pest infestation.

It is highly recommended that a licensed plumber be appointed to connect the A/C overflow in order to prevent such an environment from being created. These minor works should be carried out as soon as possible.

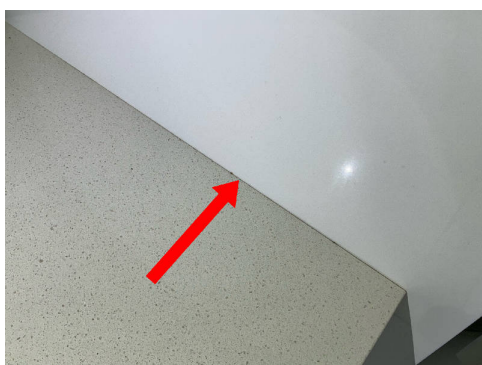
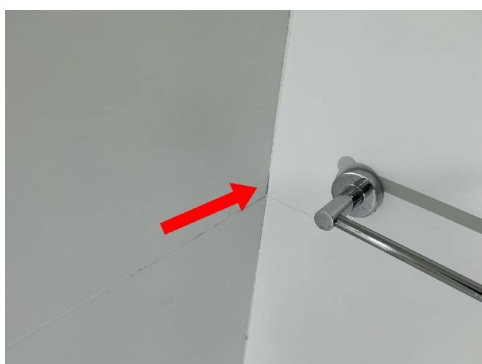
Finding 3.04

Finding: Sealant and Grouting - Missing or Damaged

It was noted on inspection that sealant or grout is degraded/missing to these areas.

Different materials and floor areas move at different rates, generally causing cracking to grout or sealant at this point. A flexible sealant is required to allow for expected expansion and contraction, while keeping the joint water tight and protective of all associated building materials.

Flexible and mould resistant materials should be applied to affected areas to prevent any subsequent water damage that is likely to occur. Regular maintenance and replacement of damage or missing or damaged sealant and grout is highly recommended to the wet areas, as this is a regular wear and tear defect. Sealant and grouting in areas that come into regular contact with water should be maintained for the long term care of your property.

A sealant specialist or tiling contractor should be appointed to complete these works as soon as possible

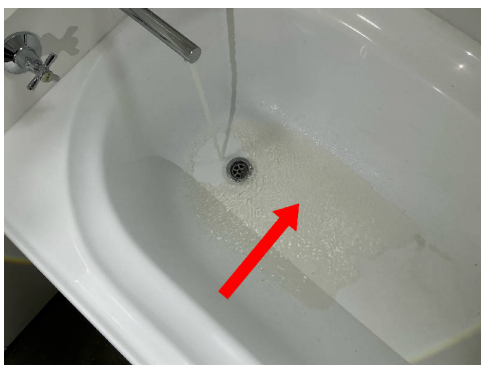
Finding 3.05

Finding: Tap - Rust in water

Information: The water emitting from the tap in this area is rusty-coloured and undiluted. It is suspected that this is a direct result of the erosion and deterioration of associated pipework, which is contaminating the water as it passes through the affected sections.

While this is a common defect and is relatively expected in a property of this age and condition, eroding pipework can have damaging implications to associated building elements if left unmanaged.

Replacement of this pipework appears to be necessary. A licensed plumber should be appointed to further inspect the pipework and provide any remedial works as required.

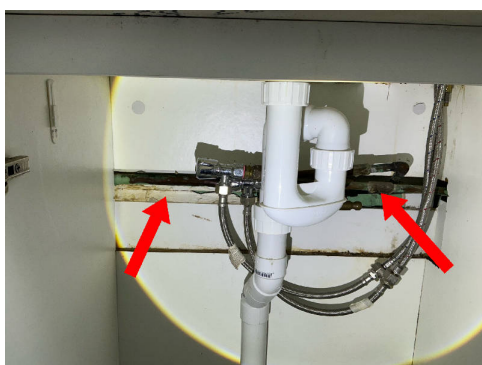
Finding 3.06

Finding: Minor Corrosion to Plumbing Pipes and Cabinet Water Damage

Information: At the time of inspection, minor corrosion was noted to sections of the older copper plumbing pipes beneath the bathroom basin. The corrosion and surface oxidation appear consistent with age-related deterioration and possible past minor leakage. Associated minor water damage and deterioration were observed to the internal cabinet surfaces, including staining and swelling to the base panels.

No active leak was detected at the time of inspection; however, corrosion of this nature can weaken pipe integrity over time and may result in future leakage if left unaddressed.

The client is advised to consider upgrading the older plumbing pipework with new compliant materials to minimise the risk of future leaks. In addition, due to the moisture-related deterioration noted to the cabinet, replacement of the affected bathroom cabinet is recommended to prevent further deterioration.

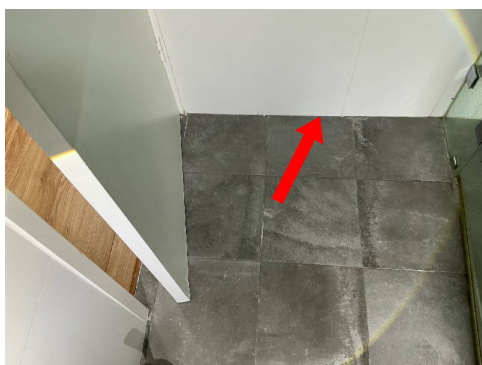
Finding: Door Stopper(s) - Missing

Information: At the time of inspection, it was noted that a door stopper was missing in this area.

The absence of a door stopper can lead to potential damage to the door, wall, or surrounding finishes, as the door may swing open too far and impact the wall or adjacent objects. Over time, this can cause dents, scuffs, or even structural damage to the wall or door. It is recommended that a door stopper be installed to prevent further damage and ensure the protection of both the door and the surrounding area.

The client is advised to engage services of a handyman to install the door stopper.

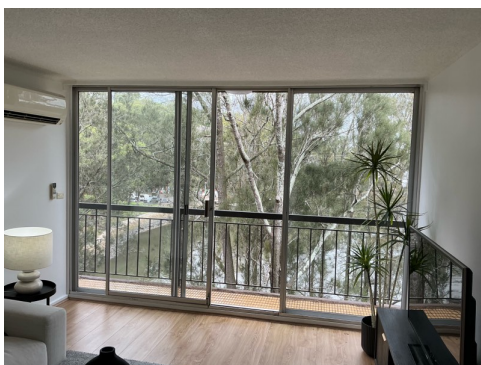
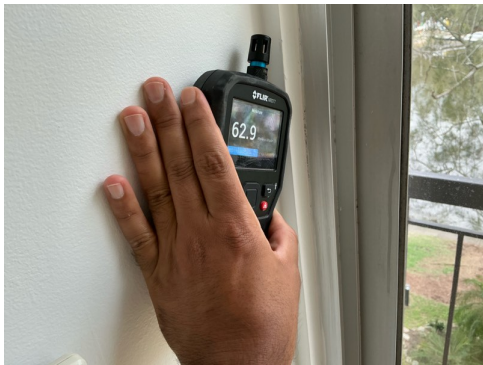
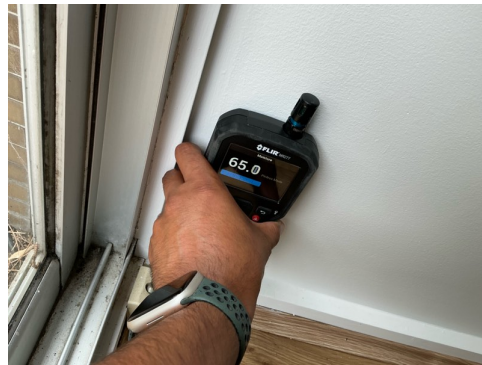
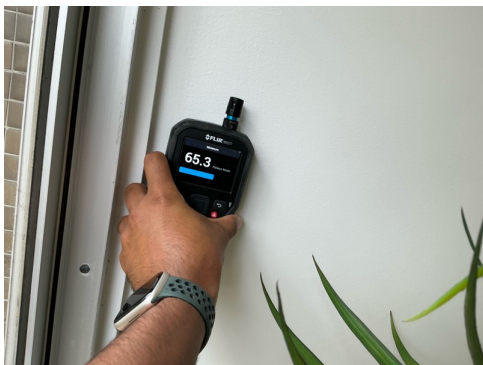
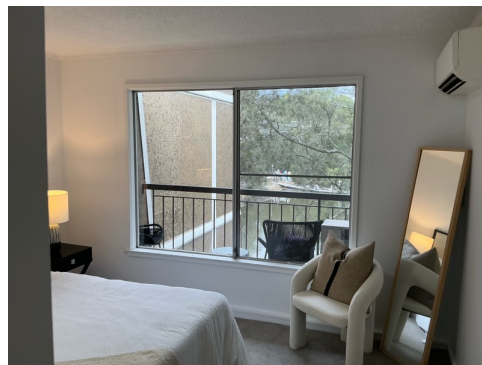
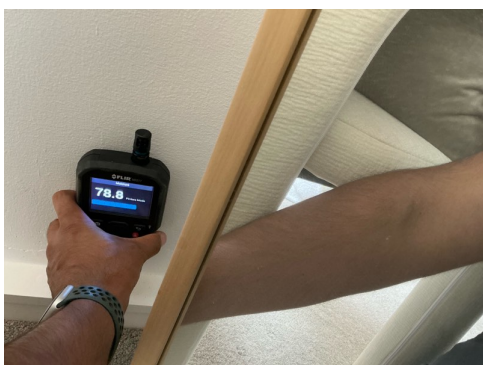
Finding 3.11

Finding: Excessive Moisture - Walls

Information: Excessive moisture was observed in the walls at the time of inspection, indicating potential underlying issues that could be contributing to this condition.

One possible cause is rising damp, where moisture from the ground seeps up through the brickwork due to a compromised waterproofing. Another potential factor could be water ingress from faulty, leaking or blocked gutters, roof and downpipes, which may be allowing water to overflow and penetrate the wall.

The client is advised to engage services of a professional plumber and strata management to fix the issue of roof leaks and also monitor the area over 12 months for any further deterioration.

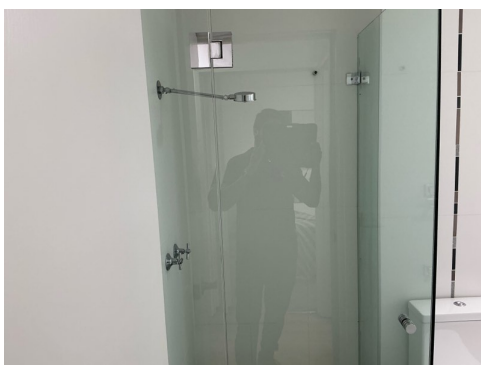
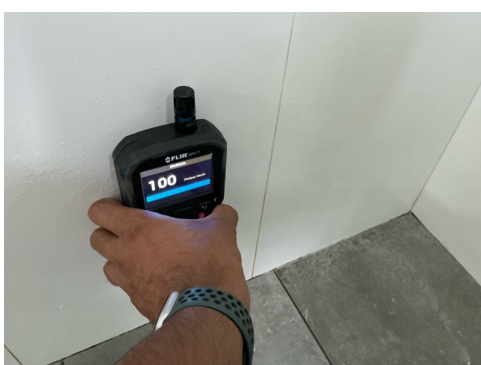
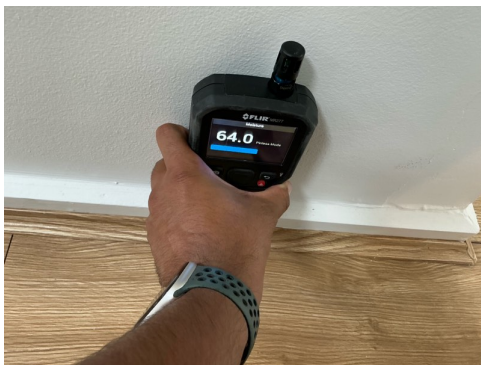
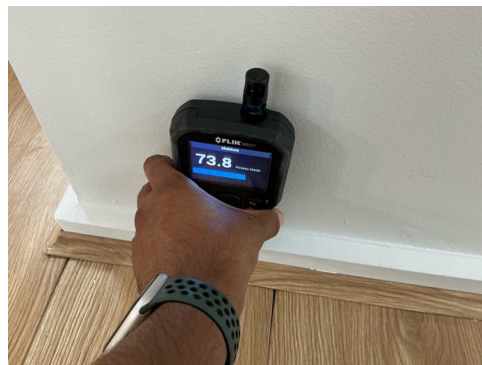
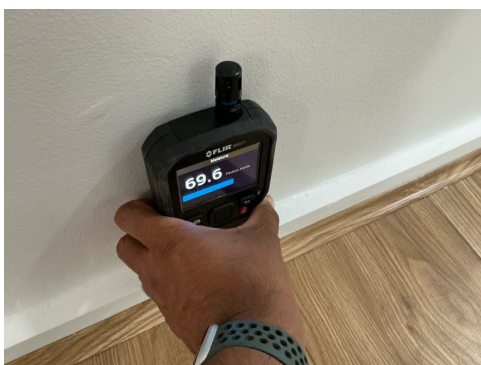
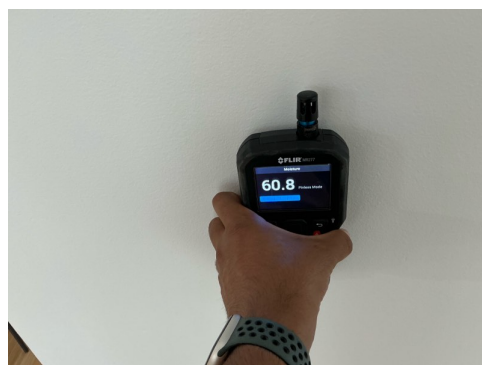
Finding 3.12

Information: At the time of inspection, elevated moisture levels were detected on the wall adjacent to the shower area. While no visible water damage or deterioration was noted, the presence of moisture suggests possible seepage or condensation associated with regular shower use.

At this stage, no immediate action is required. However, the area should be monitored over the next 12 months for any signs of deterioration such as staining, bubbling paint, or mould growth. It should be noted that moisture ingress of this nature does not generally resolve without intervention, and at some point remedial works are likely to be required. Should conditions worsen, the client is advised to engage services of a licensed plumber or waterproofing specialist to rectify the issue of moisture before this minor defect turns into major defect.

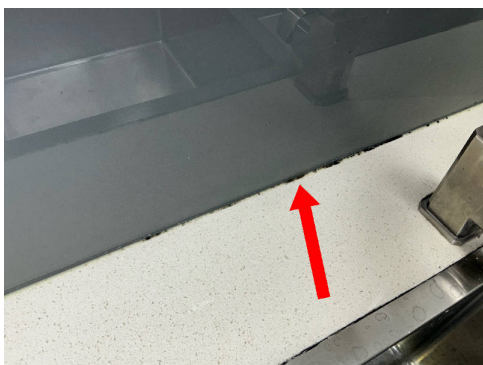
Information: At the time of inspection, mould growth was observed on the sealant within the wet areas, indicating prolonged moisture exposure and inadequate ventilation. Mould can deteriorate the integrity of the sealant over time and pose hygiene concerns.

The affected sealant should be removed and replaced with a high-quality mould-resistant silicone, and the area should be thoroughly cleaned and treated to remove existing mould. Adequate ventilation should be maintained to prevent recurrence.
