# Building and Timber Pest Inspection Report

Inspection Date: Tue, 3 Feb 2026

Property Address: 16 Brigalow Ct, Thurgoona NSW 2640,  
Australia

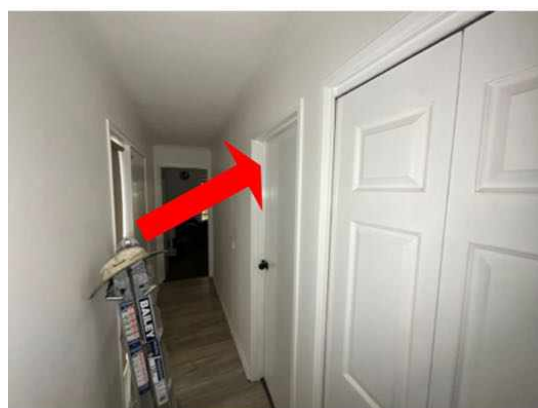
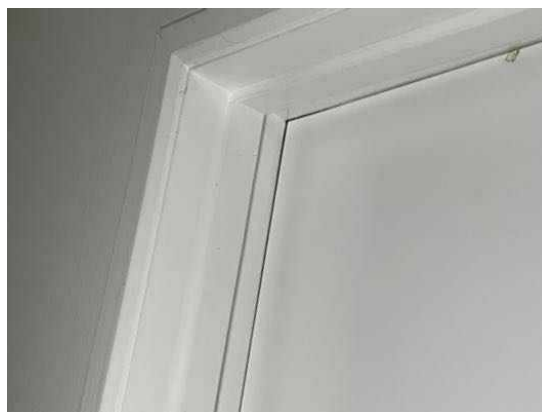
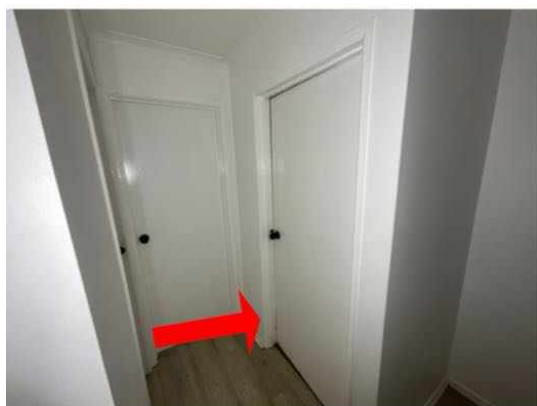
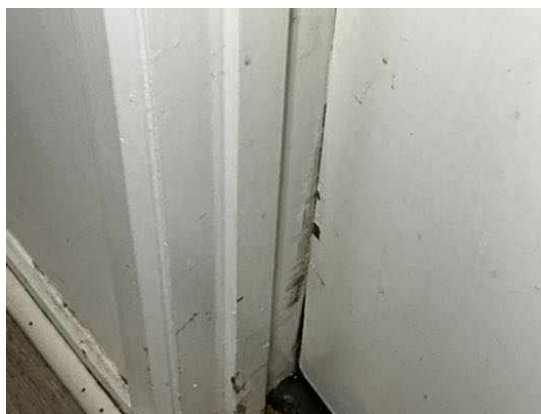
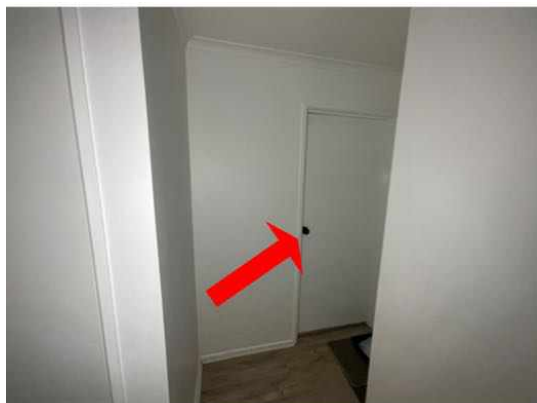
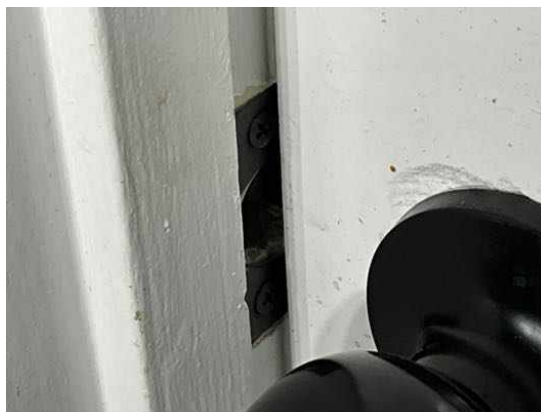
#### Finding 3.01

Building: Building 1  
Location: Bedroom 2, 3, laundry  
Finding: Door- Binding/jamming  
Information: Binding and/or jamming of this door is evident during standard operation. This defect inhibits the functionality of the affected door as well as creating potential for secondary defects to associated building elements, such as damage to the floor covering.

A door that binds to flooring or to the associated door frame may have several causes, ranging from minor defects, such as poor installation of the door or deteriorated hinges, through to major structural issues, such as damage to subfloor structures.

A qualified carpenter or general handyperson should be appointed to perform minor rectification works at client discretion.

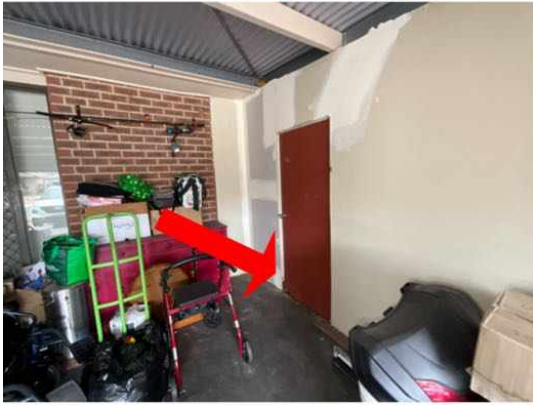
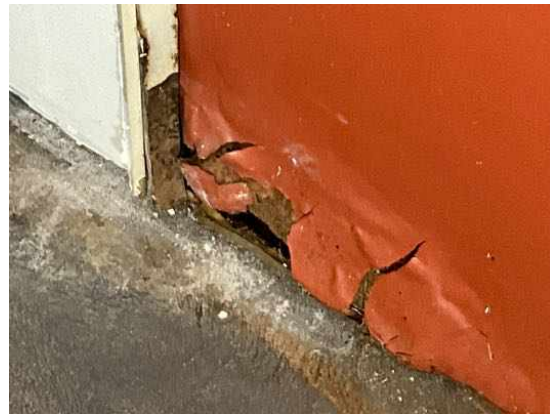
### Finding 3.02

Building: Building 1  
 Location: Garage  
 Finding: MDF- Moisture affected  
 Information: The Particle board (MDF) in this area has been affected by excess moisture. This moisture has caused swelling of the material. A lack of effective paint or other coating has probably allowed the moisture to penetrate and deteriorate the material over time.

In cases of minor swelling a painter or Handy person could re-paint and restore the area.

In cases where the material is structurally compromised a carpenter or General handy person could be contacted to replace the damaged elements and complete all needed restoration.

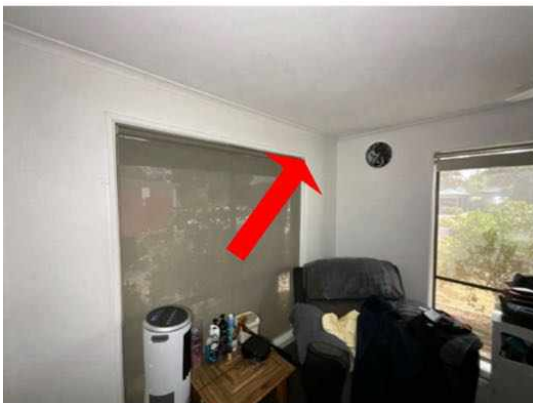
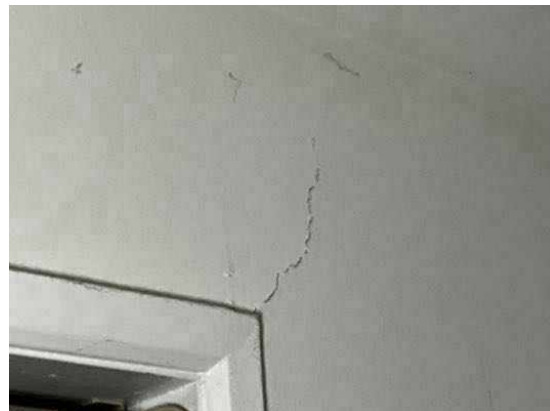
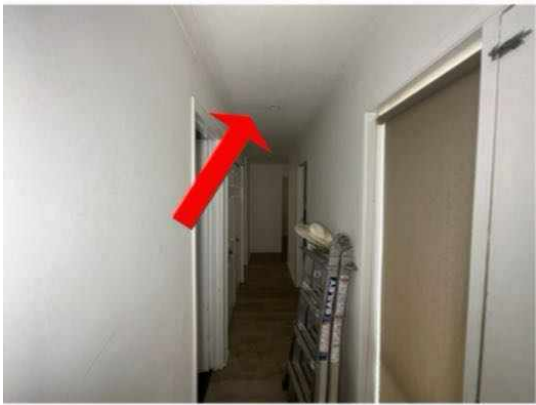
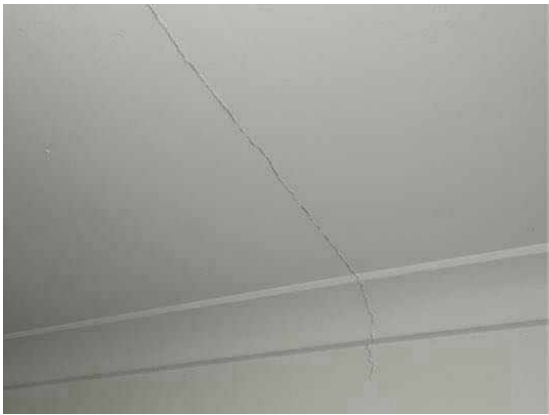
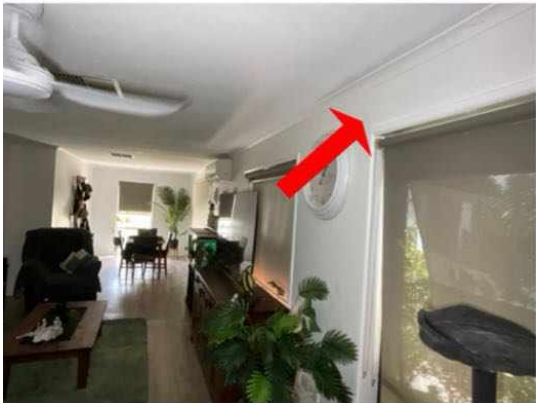
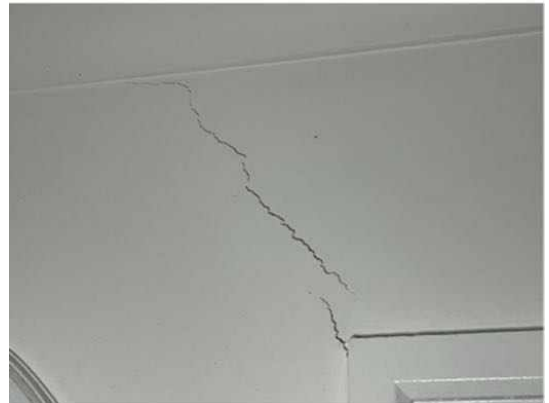
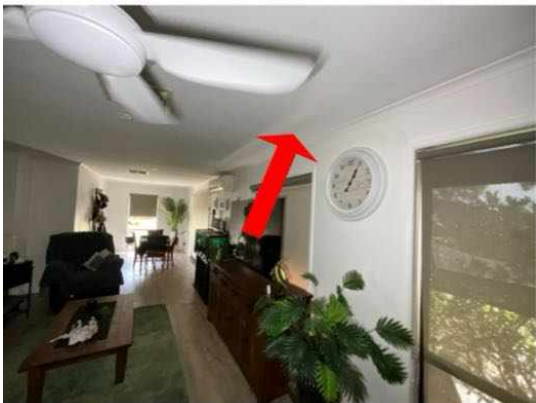
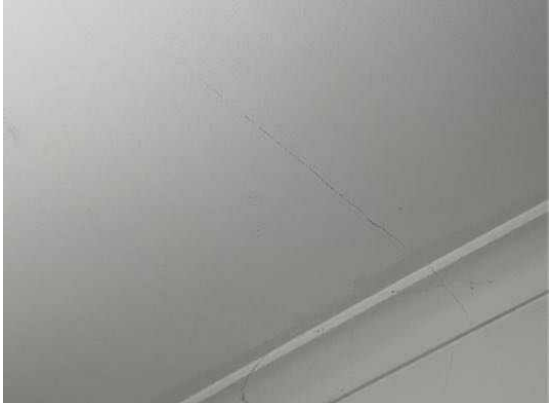
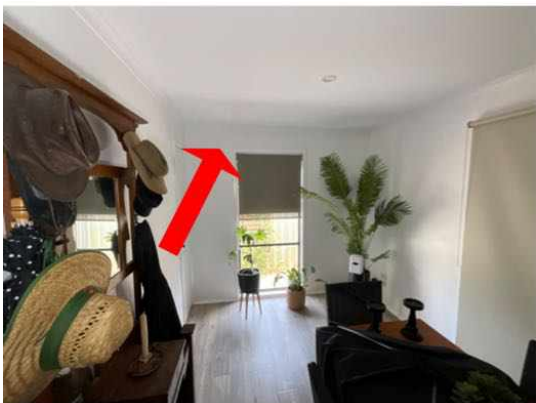
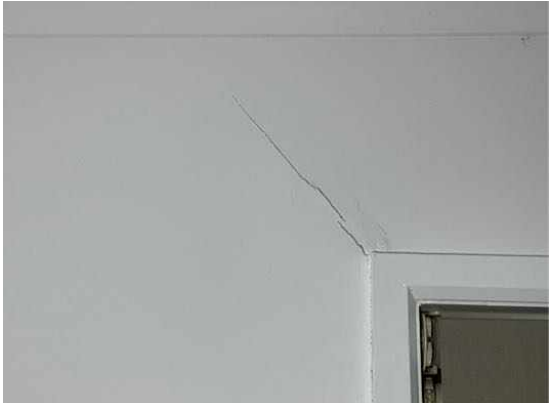
### Finding 3.03

Building:	Building 1
Location:	Bedroom 1 hall, living
Finding:	Cracking - Damage Category 1 - Fine (up to 1mm)
Information:	Although fine cracks are quite noticeable, they are often only considered to be an appearance defect, and usually do not indicate any structural damage. Generally, the cause of a fine crack is indicative of a separation between building materials and finishes (e.g. paint, plaster, etc.) along joints.

Cracking of this nature can generally be repaired with minor sanding, filling and/or repainting. Such works should be performed by a qualified painter or a general handyman.

Monitoring of all cracking should be conducted frequently. Always contact a building inspector should cracks widen, lengthen, or become more numerous.

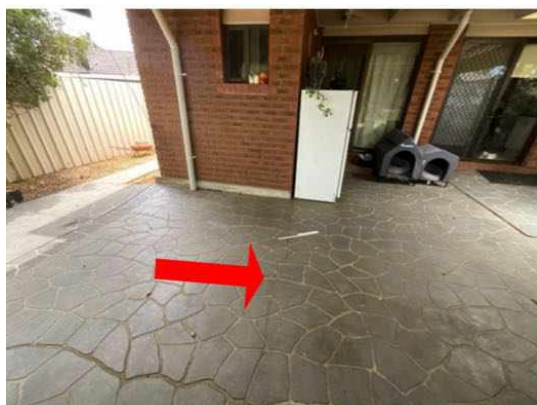
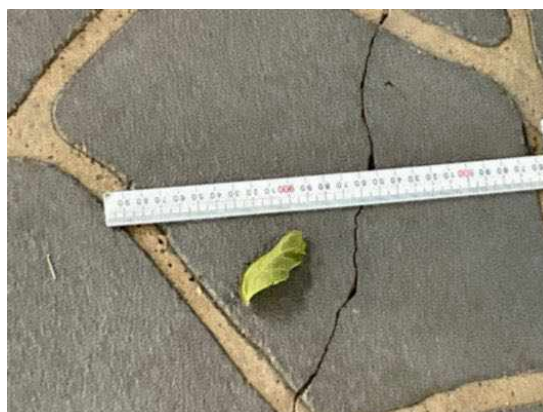
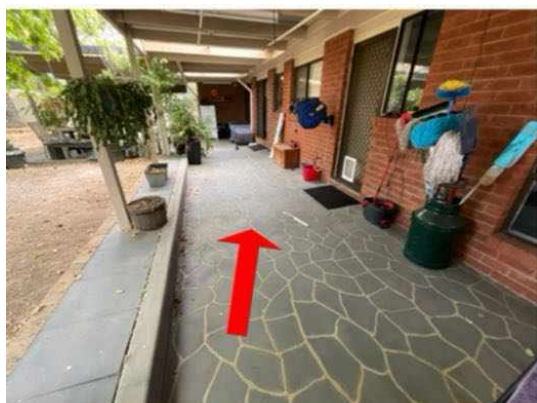
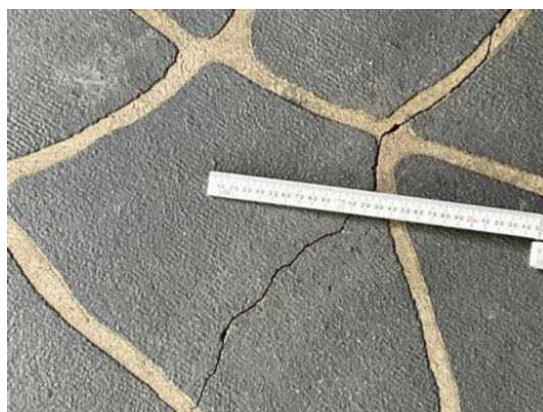
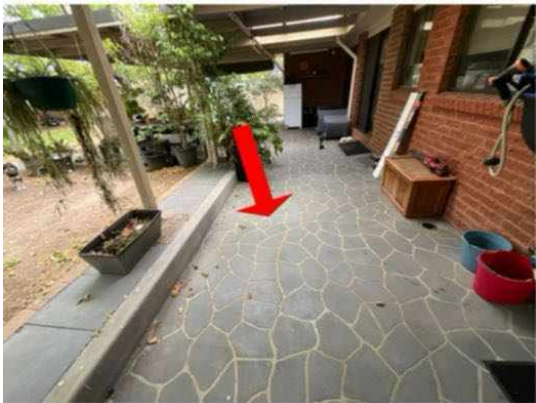
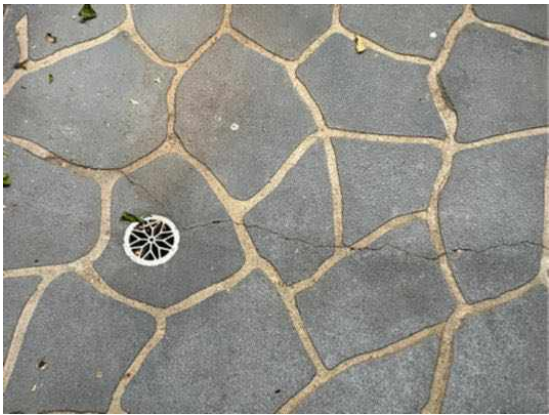
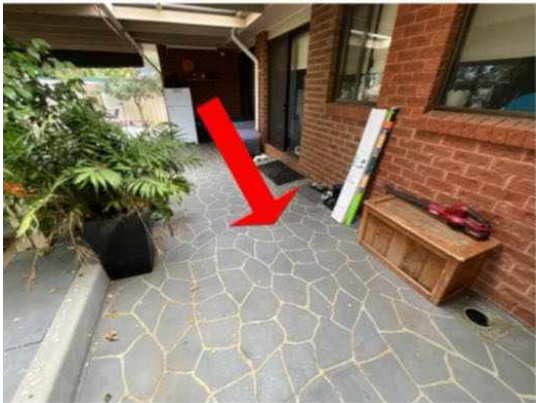
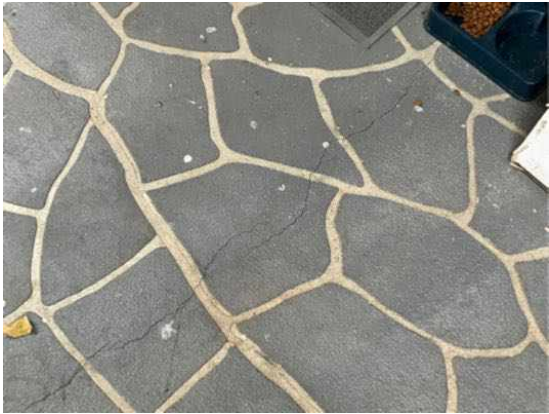
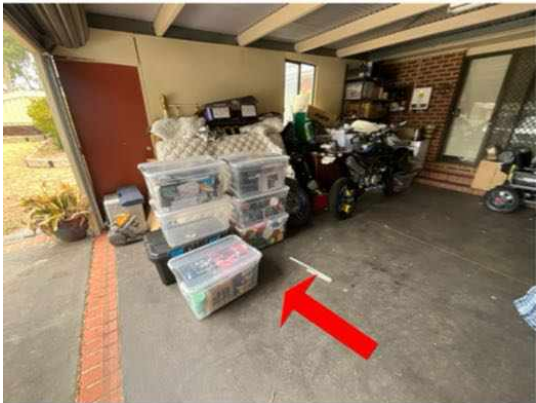
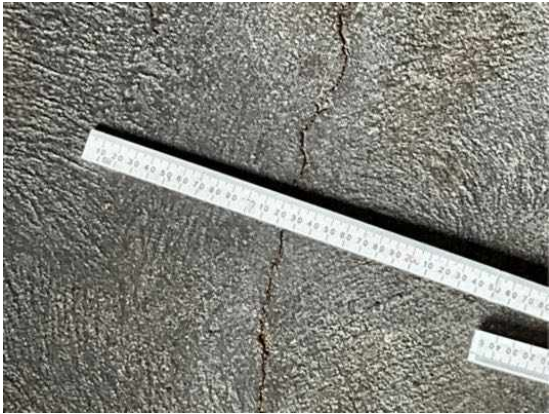
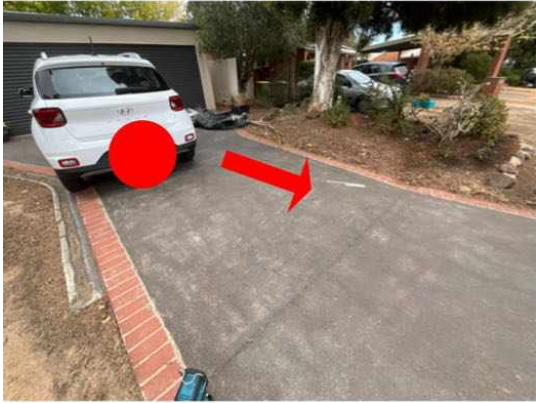
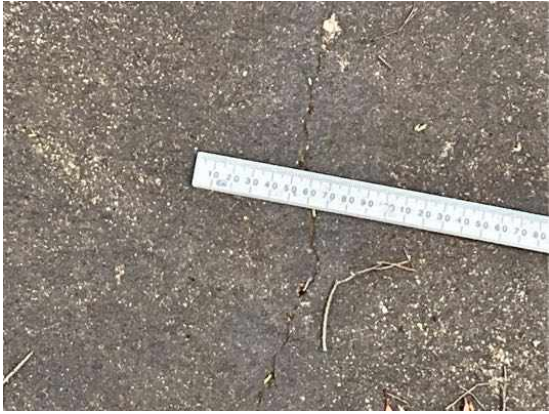
Finding 3.04

Building:	Building 1
Location:	Alfresco, garage, driveway
Finding:	Cracking - External Concrete Paving Damage Category 1 - Fine (less than 2mm)
Information:	Fine cracks were identified in external concrete paving. Although fine cracks are quite noticeable, they are often only considered to be an appearance defect, and usually do not indicate any structural damage. To be considered a Category 1 or fine crack, the crack is found to be less than 2mm in width.

Generally the cause of a hairline crack in existing concrete paving such as driveways and pathways is indicative of the expansion and contraction of the concrete. Such causes are generally due to environmental factors, such as moisture levels, weather conditions, root systems of nearby trees or the soil types on which they are laid.

Fine cracks may also be due to poor original installation of the concrete. Factors such as poor compaction of the sub surface and/or inadequate reinforcing of the slab may create cracking and other secondary defects.

Monitoring of all cracking should be conducted frequently. Always contact a building inspector should cracks widen, lengthen, or become more numerous.

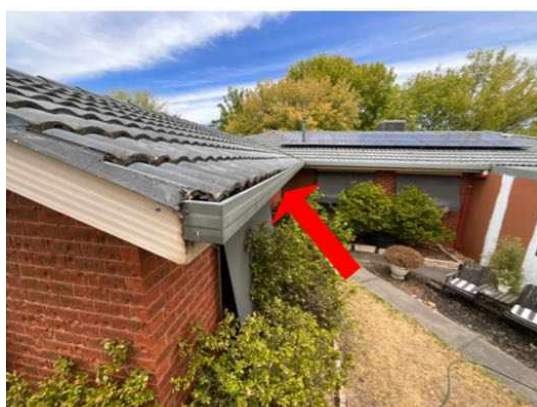
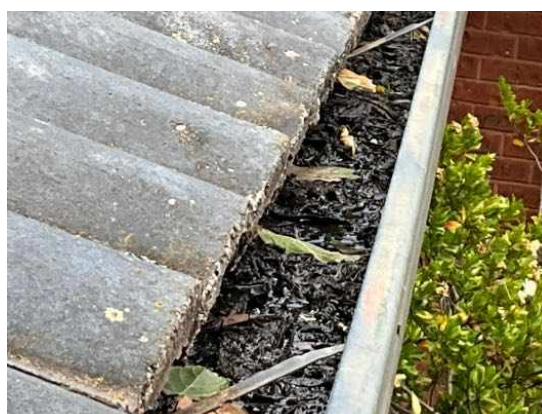
### Finding 6.01

Building: Building 1  
 Location: Eaves  
 Finding: Gutters- Blocked  
 Information: Roof plumbing structures, such as guttering and downpipes, should be free of all debris to prevent blockages. Blockages of the guttering and downpipes will lead to pooling and accumulated water overflows, which is likely to subsequently flood eaves and exterior walls.

Blocked gutters are likely to lead to high levels of moisture in the affected areas. Such moisture will not only cause rust and decay of the associated building materials, but can also provide conditions that are conducive to termite and timber pest activity. Blockages in gutters should therefore be removed immediately to ensure dry conditions are maintained.

Consult a Licensed Plumber for further specific advice on remedial works that may be required. In the interim, it is highly advised that blocked gutters be removed by the homeowner or a general handyperson as a matter of urgency.

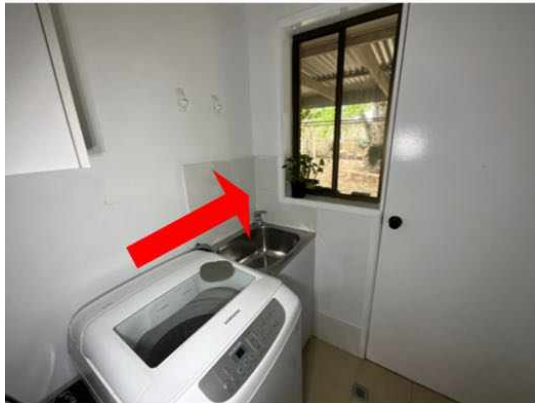
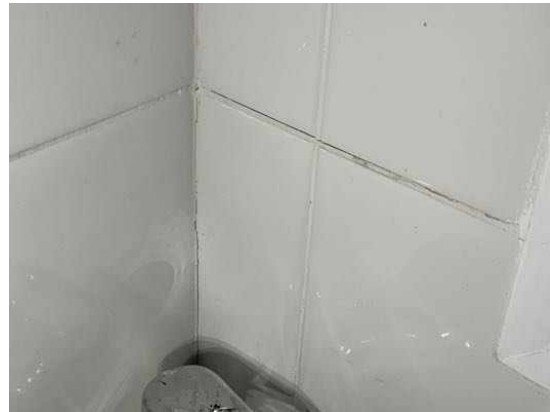
### Finding 6.02

Building: Building 1  
 Location: Laundry

Finding: Inadequate sealant or Grout  
 Information: This area has a lack of effective Sealant or Grout. This is allowing the ingress of water to the structure inside the wall.

The presence of water encourages Termite attack, Mould and Fungal Decay.

A Tiler or General Handy person must be contacted as soon as possible to effect repairs and prevent further deterioration.

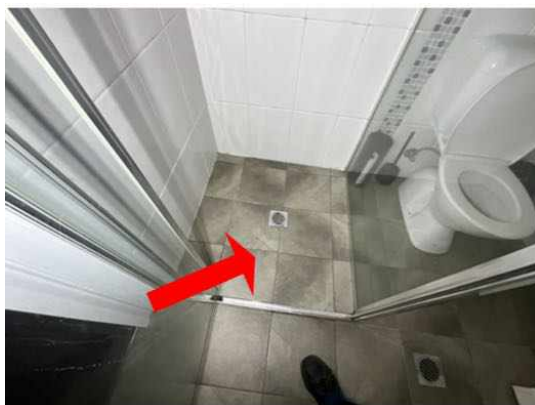
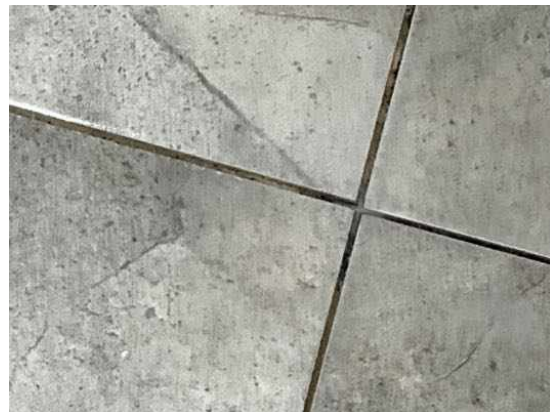
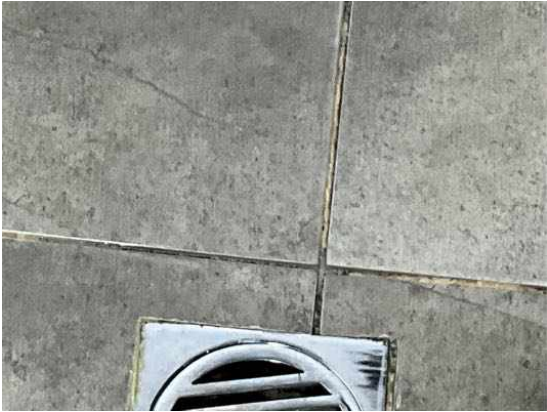
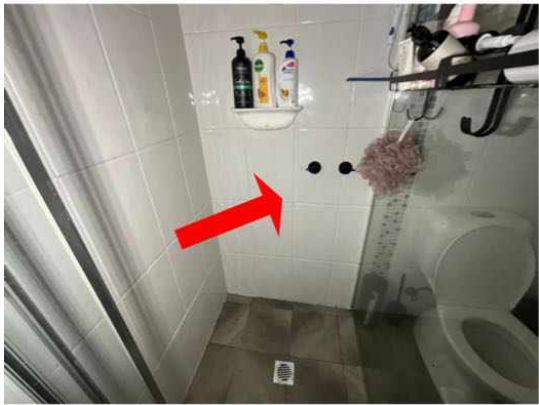
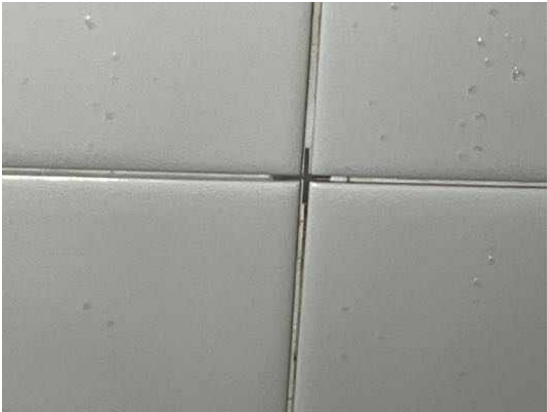
### Finding 6.03

Building: Building 1  
 Location: Ensuite  
 Finding: Inadequate sealant or Grout  
 Information: This area has a lack of effective Sealant or Grout. This is allowing the ingress of water to the structure inside the wall.

The presence of water encourages Termite attack, Mould and Fungal Decay.

A Tiler or General Handy person must be contacted as soon as possible to effect repairs and prevent further deterioration.

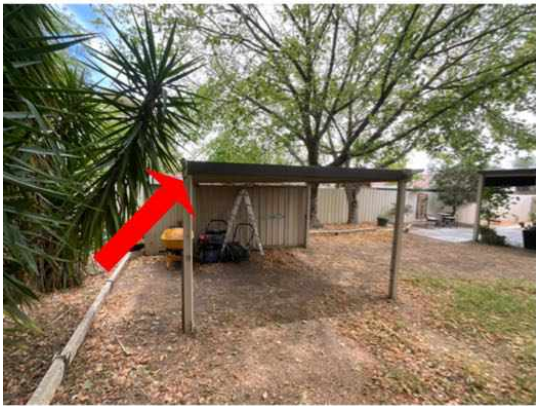
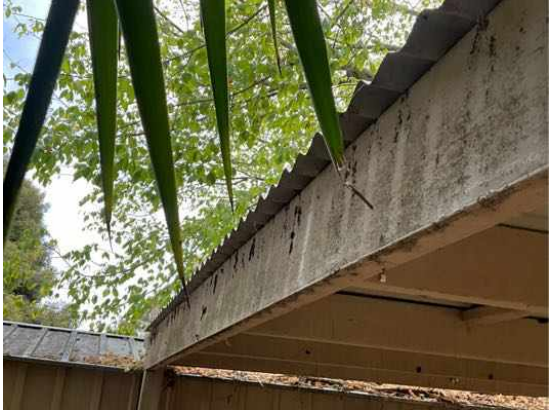
**Finding 6.04**

Building: Building 1  
 Location: Shed  
 Finding: Guttering Missing  
 Information: The Guttering in this area was missing at the time of inspection. Guttering, Downpipes and Stormwater drainage are vital to protect the integrity of the structure and to prevent an environment conducive to Timber Pest attack.

A Plumber should be contacted as soon as possible to replace and connect to drainage the missing Guttering.

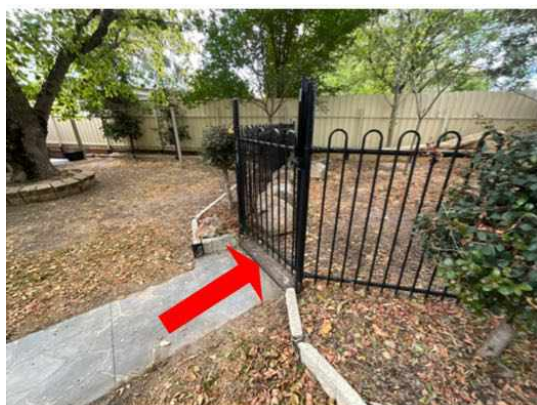
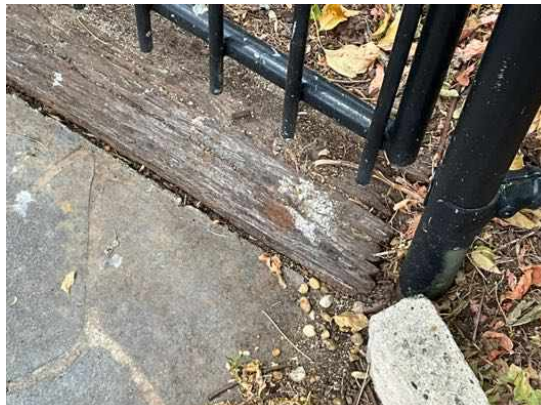
## Finding 6.05

Building:	Building 1
Location:	Yard - Back
Finding:	Untreated or non-durable timbers in a hazardous environment
Information:	To reduce the risk of timber pest attack it is essential that timber used in a hazardous environment (e.g. in direct contact with the ground or frequently exposed to damp conditions) is of sufficient durability and/or is adequately preservative treated.

Untreated timbers in direct contact with the ground are likely to develop severe wood rot and/or fungal decay if left unattended creating attraction for subterranean termites to infest the timbers from surrounding areas.

If untreated or non-durable timbers are found to be in a hazardous environment it is highly advised that replacement of these building elements be performed as soon as possible to aid the protection of the property against termite / timber pest attack.

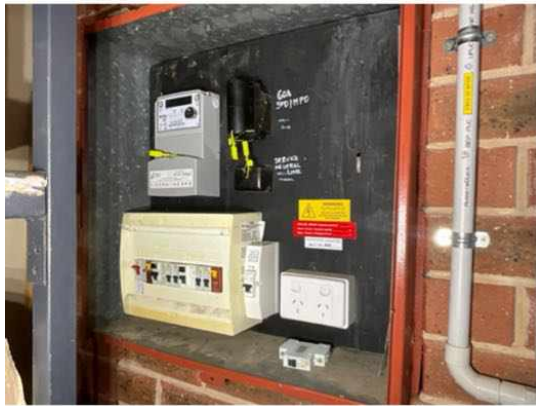
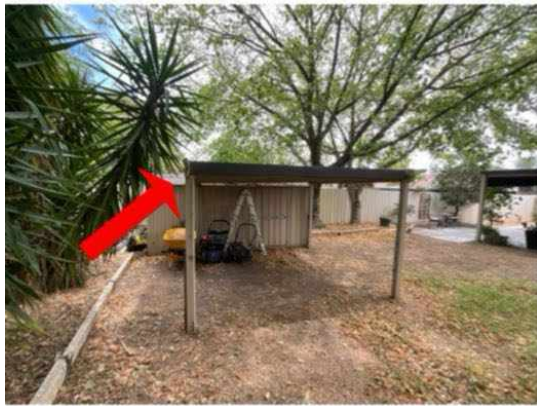
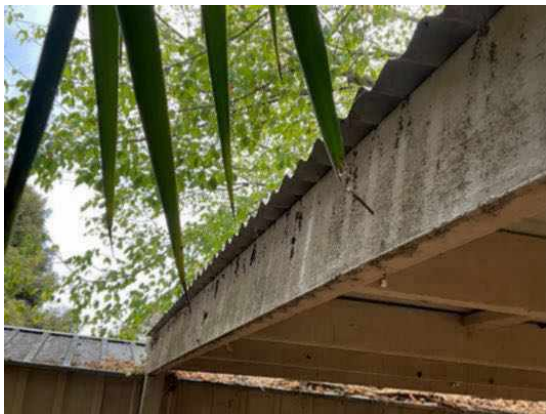
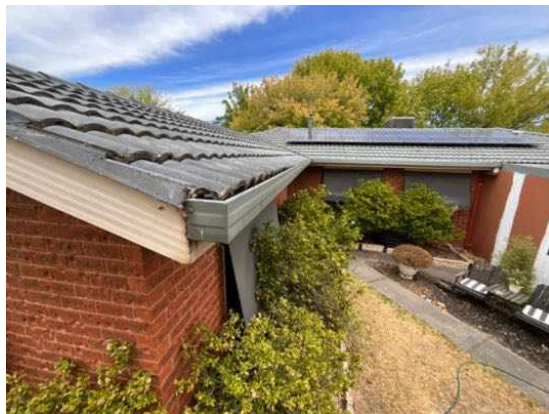
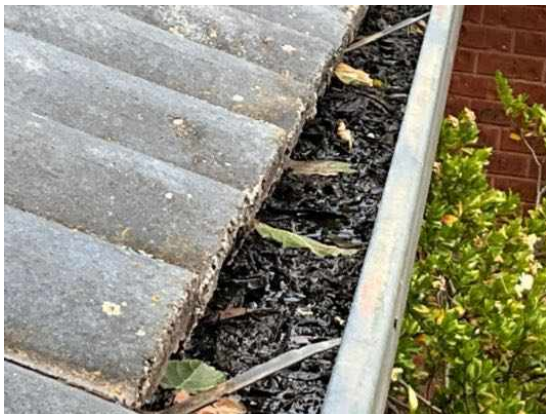
## Finding 6.06

Building:	Building 1
Location:	All External Areas
Finding:	Termite Management System - no evidence of a chemical installation
Information:	The application of a post-construction chemical termite barrier is highly recommended for all properties, particularly if live termite activity has been found on the site previously. Such barriers are highly effective in preventing termite attack on any timber building elements throughout the property.

A durable notice should be placed in the switchboard unit to indicate current termite barriers. At the time of inspection, it appeared as though no termite management system has been installed, with no evidence to suggest preventative works taking place.

There is no evidence of previous Termite Management services. The property has factors that are Conducive to Termite attack. A Licensed Pest controller should be contacted soon to advise on a Termite Management Plan and avoid potentially costly repairs.

The client may consider gaining further advice from a pest controller as to the costs and procedures involved with this application. It is recommended that obtaining such

advice be a short-term priority.

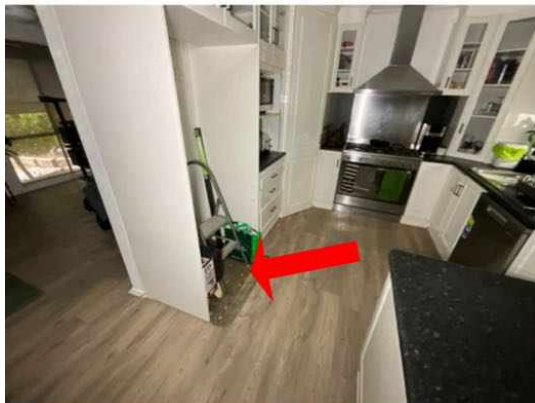
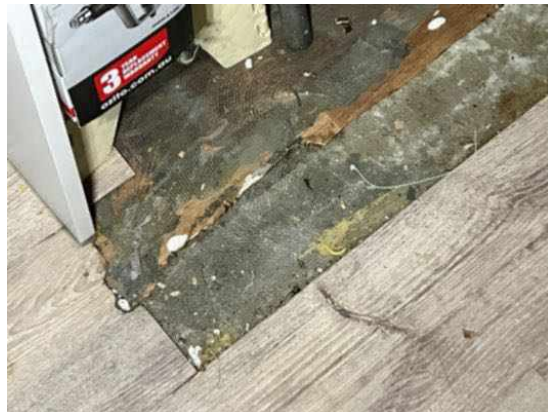
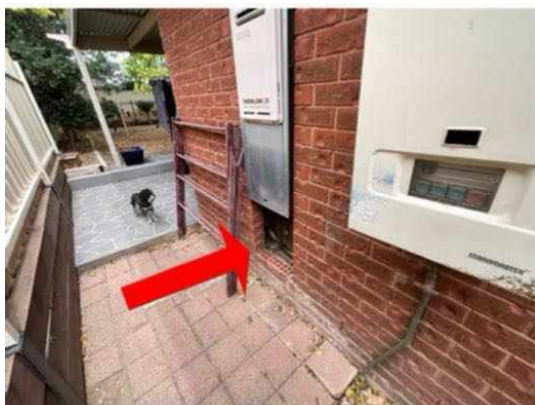
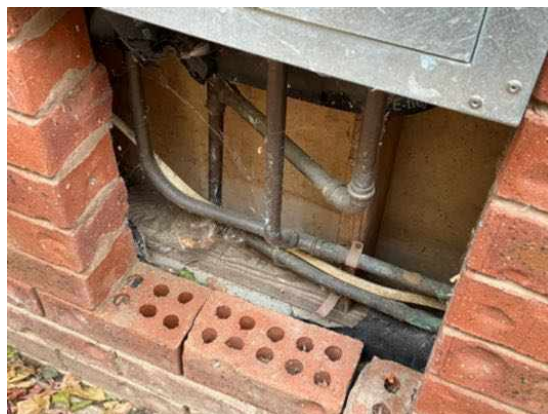
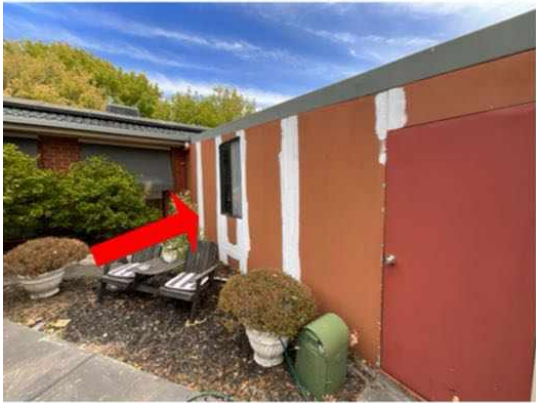
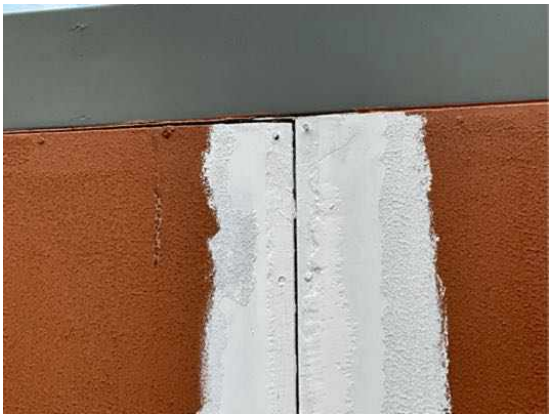
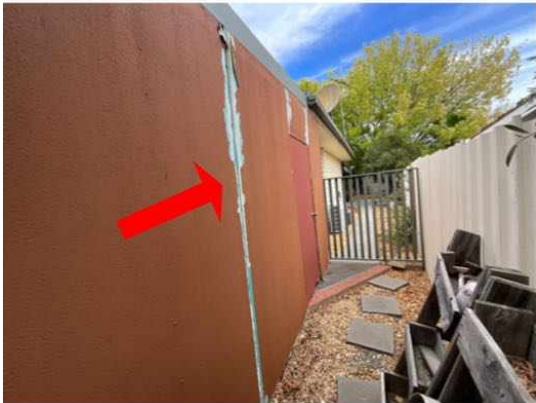
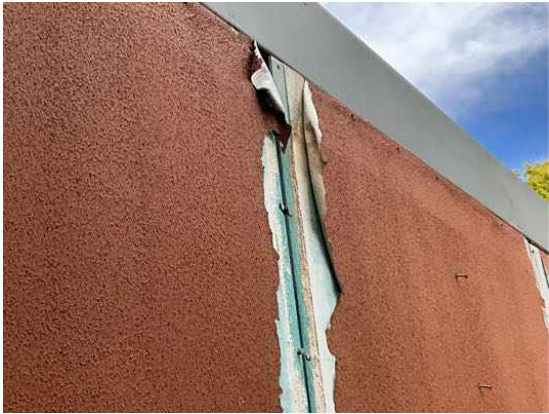
#### Noted Item

Building: Building 1  
Location: Kitchen, side wall, garage  
Finding: Installation - substandard or incomplete  
Information: The installation of this building element appears to have been completed to a substandard level of workmanship or is incomplete. Generally substandard repairs or installation are related to poor workmanship, the use of inappropriate materials, or a failure to complete installation to a suitable standard.

Where installation is substandard and/or incomplete, the client should contact the responsible trade to undertake rectification. Unfinished and substandard building works are likely to degrade more quickly and may create potential for secondary defects to associated building elements.

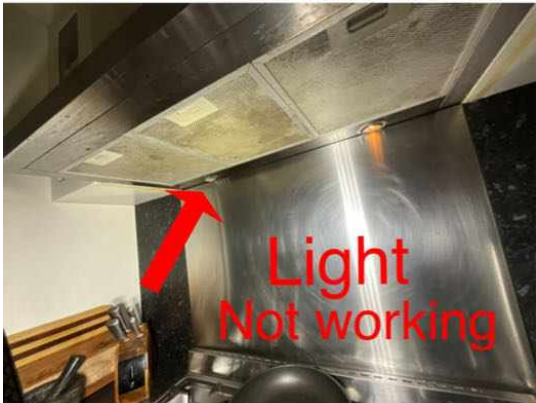
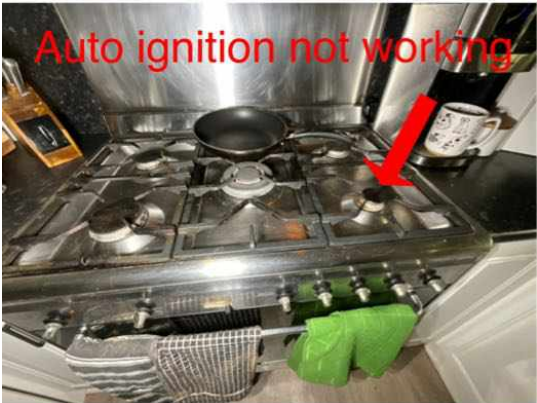
**Noted Item**

Stove/oven and rangehood - see defect

Building: Building 1  
 Location: Kitchen  
 Finding: Stove and rangehood  
 Information: The stove ignition is not working on the front right burner.  
 The left light under the range hood is not working.

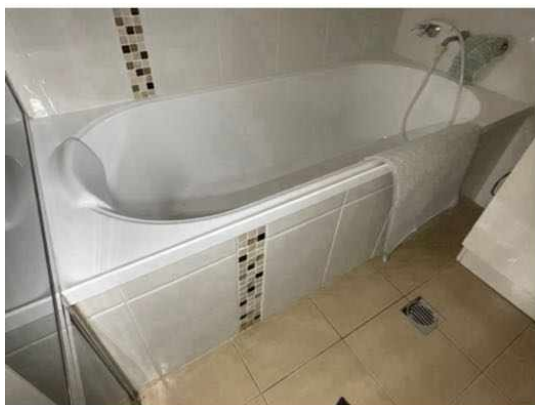
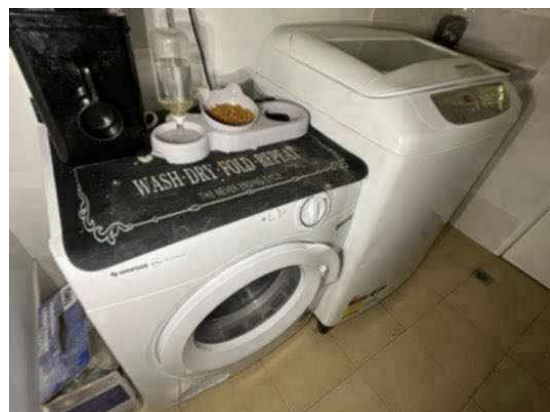
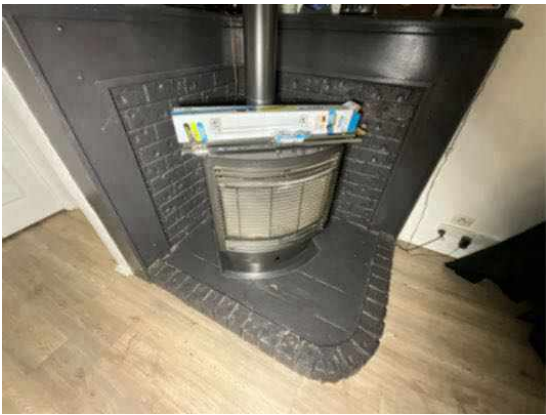
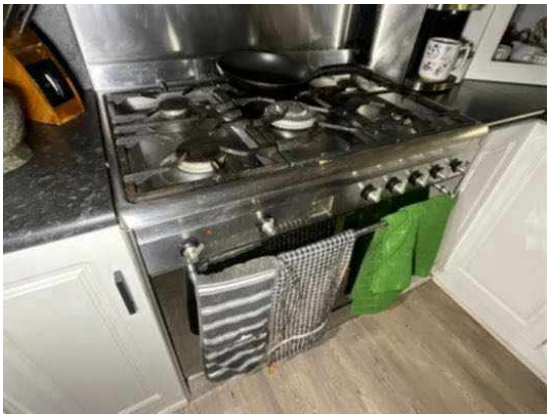
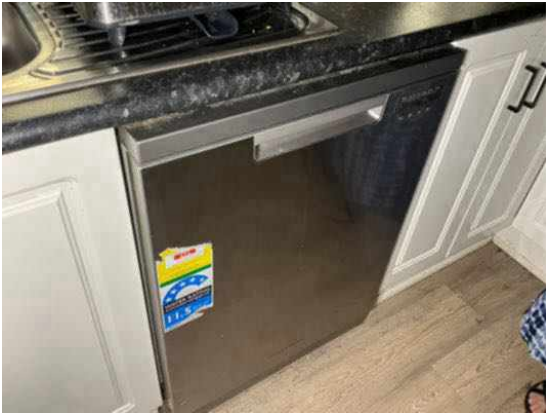
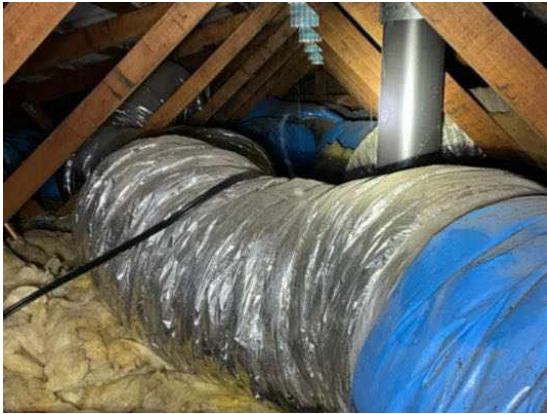
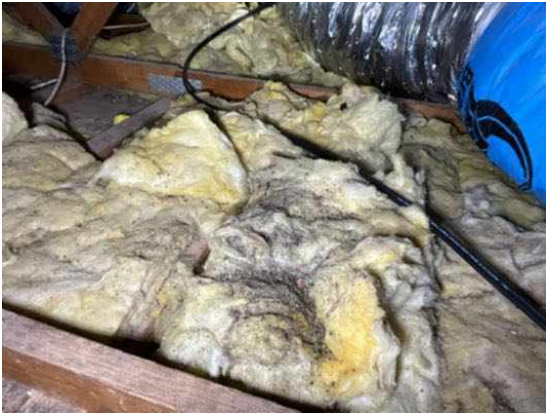
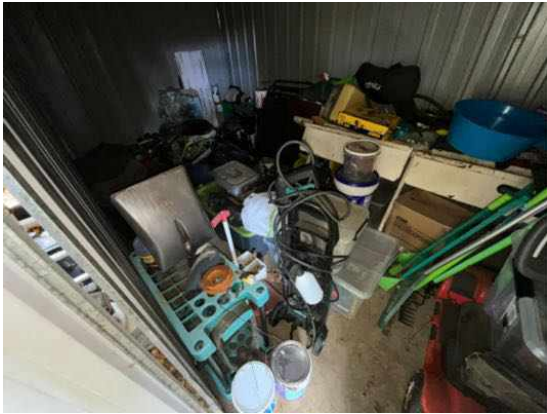
### Noted Item

Building: Building 1  
 Location: All Areas  
 Finding: Additional Photos - Obstructions and Limitations  
 Information: These photographs are an indication of the obstructions and limitations which impeded full inspection of the property at the time of inspection. These obstructions can hide an array of defects and should be removed to allow full inspection to be carried out. A re-inspection is recommended once the areas are made accessible.
