Building and Timber Pest Inspection Report

Inspection Date: Tue, 17 Feb 2026

Property Address: 14 Gallina Dr, Spring Farm NSW 2570,
Australia

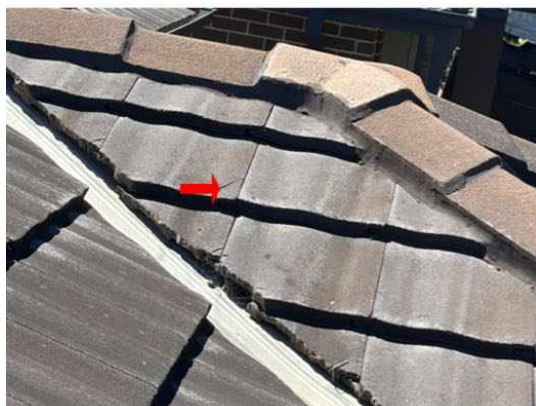
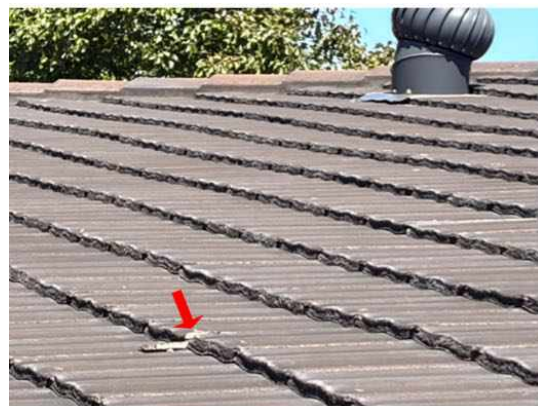
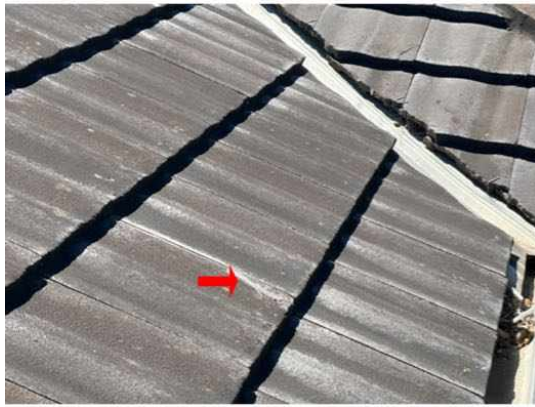
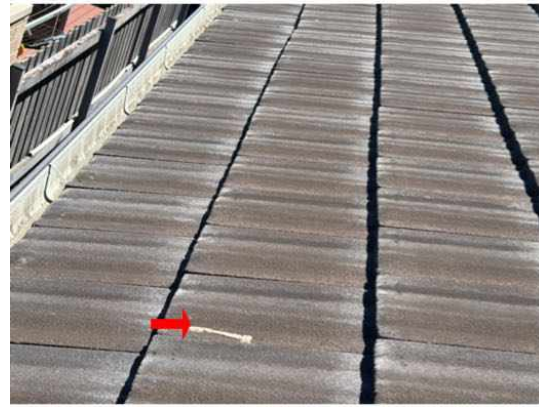
Finding 3.01

Location: Roof Exterior

Finding: Roof tiles - Broken

Information: Upon inspection of the exterior roof covering, broken roofing tiles were identified. Broken and friable roof tiles are generally the result of ageing and weathering of what is essentially a porous material. Cracked roofing tiles were also noted to have been sealed. This handyman work appears to have been completed to a substandard level and does not comply with regular building practices.

If left to further deteriorate, broken and brittle roof tiles are likely to lead to water penetration via the roof into the ceiling space, causing secondary damage to ceiling linings, insulation and roof structures. Broken roof tiles are also likely to detract from the effectiveness of the roof drainage system, creating potential for secondary damage to the exterior roof covering and roof plumbing.

Replacement of broken tiles is required and should be performed by a roofing contractor as soon as possible.

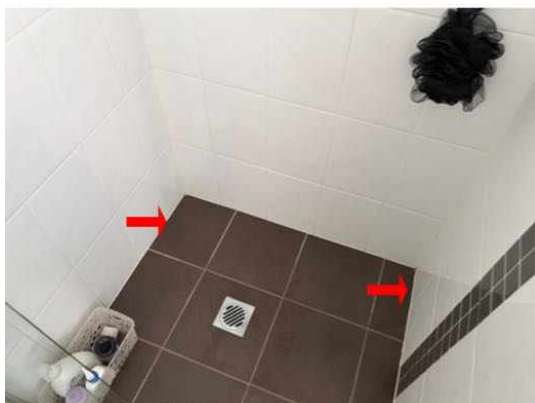
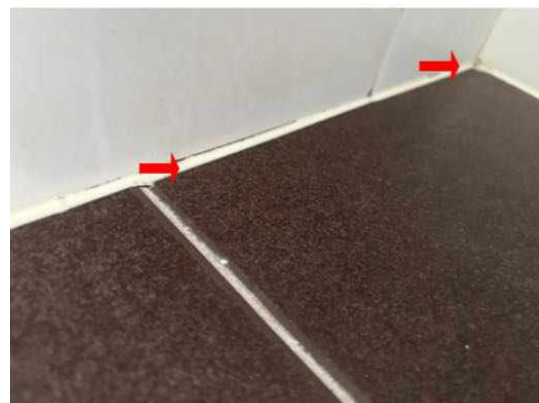
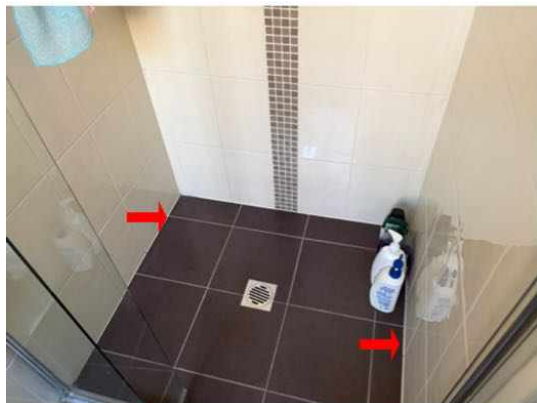
Finding 3.02

Building:	Main Building
Location:	All Wet Areas
Finding:	Sealant and grouting - Missing or damaged
Information:

It was noted on inspection that sealant or grout is degraded to this area.

Different materials and floor areas move at different rates, generally causing cracking to grout or sealant at this point. A flexible sealant is required to allow for expected expansion and contraction, while keeping the joint water tight and protective of all associated building materials.

Flexible and mould resistant materials should be applied to affected areas to prevent any subsequent water damage that is likely to occur. Regular maintenance and replacement of damage or missing or damaged sealant and grout is highly recommended to the wet areas, as this is a regular wear and tear defect. Sealant and grouting in areas that come into regular contact with water should be maintained for the long term care of your property.

A sealant specialist should be appointed to complete these works as soon as possible.

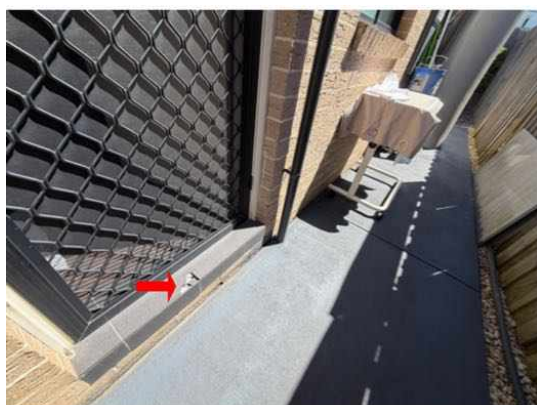
Finding 3.03

Building: Main Building
 Location: Laundry
 Finding: Cracked floor tiles
 Information:

Cracking in the floor tiles was evident in this area at the time of inspection. It is suspected that this cracking has occurred as a result of minor settlement or shrinkage.

Cracked tiles throughout the household detract from the overall appearance of the affected areas however it is unlikely to create or lead to any secondary defects.

While not considered a matter of urgency, replacement of cracked floor tiles is recommended at the clients discretion. A licensed tiling contractor may be appointed to perform these works. Where cracks become more numerous, contact a licensed building inspector for further investigation.

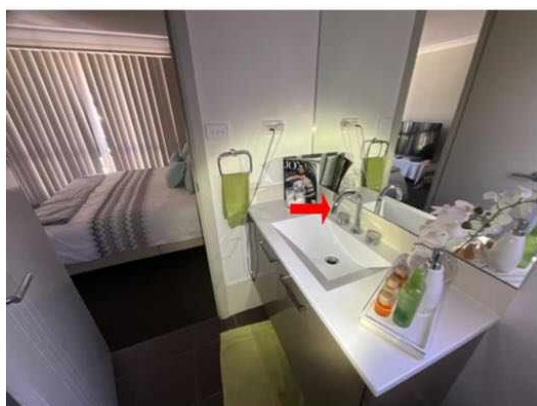
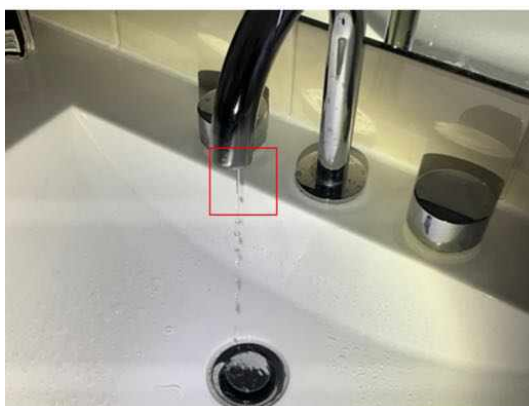
Finding 3.04

Building: Main Building
 Location: Ensuite
 Finding: Washers - Degraded
 Information:

The washers on the taps in this area appear to have degraded as a result of general

ageing. Degraded washers generally result in slow, persistent leakage from taps and plumbing hardware.

Replacement of washers will ensure that water wastage does not occur and that the persistent water leak does not result in secondary damage to surrounding structures. Such damage may range from rust and corrosion to damage of surfaces, e.g. bench tops, etc.

A qualified plumber should be appointed to replace degraded washers and to further inspect associated plumbing fixtures and fittings. Where water damage has occurred, a carpenter or cabinet maker may be appointed to replace affected building elements.

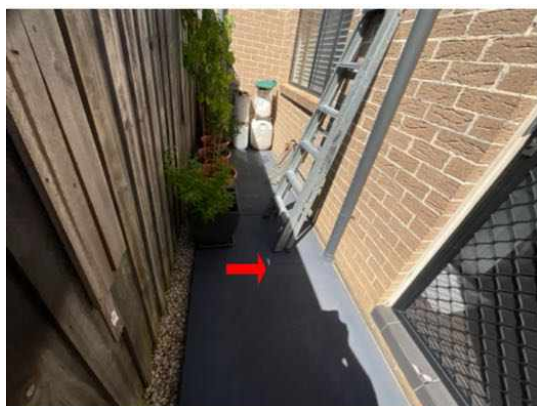
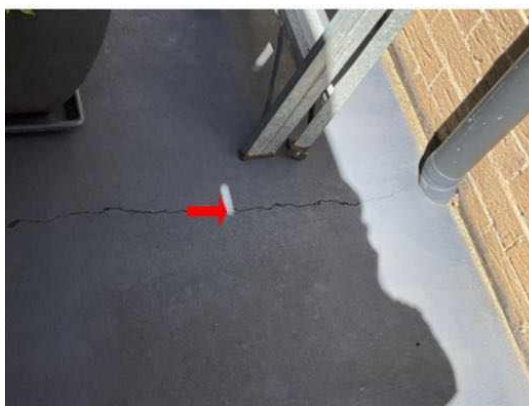
Finding 3.05

Building:	Main Building
Location:	Yard LHS
Finding:	Cracking - External Concrete Paving Damage Category 1 - Fine (less than 2mm)
Information:	Fine cracks were identified in external concrete paving. Although fine cracks are quite noticeable, they are often only considered to be an appearance defect, and usually do not indicate any structural damage. To be considered a Category 1 or fine crack, the crack is found to be less than 2mm in width.

Generally the cause of a hairline crack in existing concrete paving such as driveways and pathways is indicative of the expansion and contraction of the concrete. Such causes are generally due to environmental factors, such as moisture levels, weather conditions, root systems of nearby trees or the soil types on which they are laid.

Fine cracks may also be due to poor original installation of the concrete. Factors such as poor compaction of the sub surface and/or inadequate reinforcing of the slab may create cracking and other secondary defects.

Monitoring of all cracking should be conducted frequently. Always contact a building inspector should cracks widen, lengthen, or become more numerous.

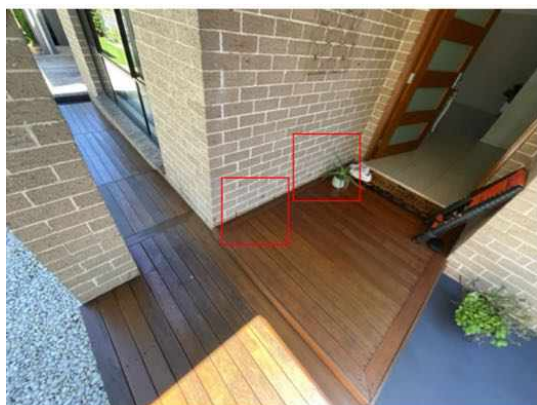
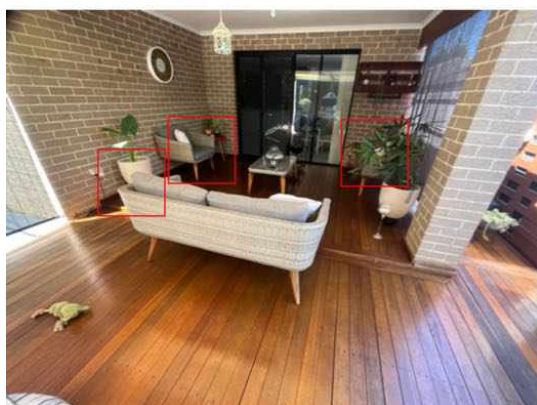
Finding 6.01

Building: Main Building
 Location: Porch, alfresco
 Finding: Bridging or breaching of termite barriers - weep holes
 Information: Bridging is the spanning of a termite barrier or inspection zone so that subterranean termites are provided with passage over or around that barrier.

Weep holes in the exterior brickwork of the property are designed to allow condensation that may build up between the brickwork and subsequent timber framework to drain from within the wall hence preventing any deterioration of the timber building elements.

Additionally build-up of moisture is likely to occur if weep holes are covered further attracting termite activity to these areas.

It is highly recommended that weep holes are left exposed in all areas throughout the

external property. Therefore if any termite activity leading into weep holes becomes easily detectable during frequent pest inspections. A landscaper must be appointed urgently for this work.

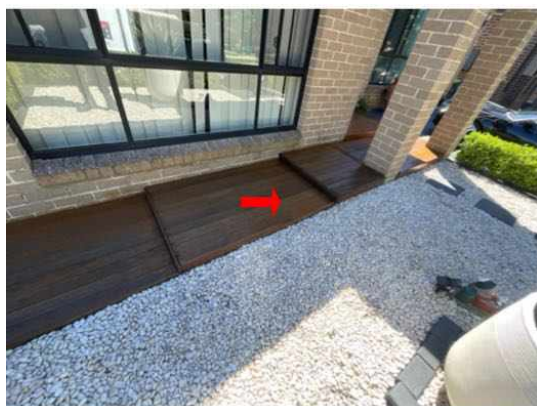
Finding 6.02

Building:	Main Building
Location:	Fencing & Landscaping
Finding:	Building materials in direct ground contact - conducive to termites
Information:	Where timber elements are in direct contact with the ground and consequently moisture or dampness they become conducive to termite activity. Whether timber is used as a building element part of a fencing structure or stored as an unused item they can provide an environment that is attractive to termite infestation.

When met with excessive moisture timber begins to decay and develop wood rot. Any timbers that are in direct contact with external grounds especially if left untreated or non-durable also provide ingress for subterranean termites into that particular element.

The removal of any such materials that may be conducive to termite activity should be removed as soon as possible to minimise the risk of termite attack.

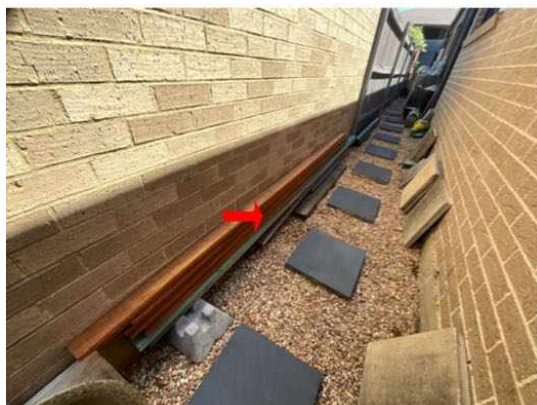
Finding 6.03

Location: Yard

Information: The storing of timbers in the subfloor space or around the external property increases the risk of termite activity being present. As they are likely to come into contact with weather conditions or excessive moisture wood rot is likely to develop on timbers that are not treated.

It is highly recommended that any stored timbers be immediately removed from areas in which they may attract any termite / timber pest attack. Minimisation of risk / prevention of termite attack is far more adequate than dealing with the presence of termite activity.

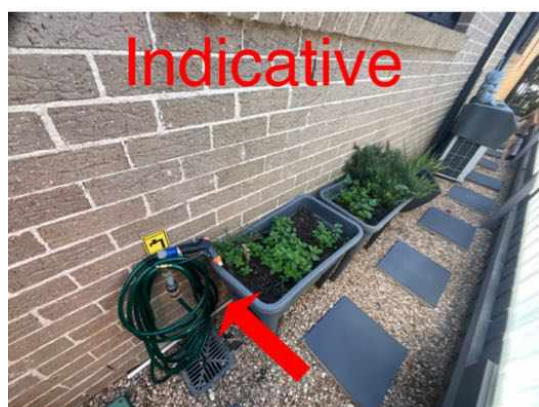
Finding 6.04

Location: Perimeter

zone of at least 75mm should be maintained to permit detection of termite entry. The concrete edge should not be concealed by render, tiles, cladding, flashings, adjoining structures, paving, soil, turf or landscaping etc. Where this is the case you should arrange to have the slab edge exposed for inspection. Concealed termite entry may already be taking place but could not be detected at the time of the inspection. This may have resulted in concealed timber damage. Does the slab edge inspection zone fully comply?

Not able to comment. A very high proportion of termite attacks are over the edge of both Infill and other concrete slabs types. Covering the edge of a concrete slab makes concealed termite entry easy. Infill slab type construction has an even higher risk of concealed termite ingress as the slab edge is concealed due to the construction design and cannot be exposed. The type of slab may only be determined by assessment of the construction plans by a qualified person e.g. Builder, Architect. Construction Plans may be obtainable by your local Council or Builder. Termite activity and or damage may be present in concealed timbers of the building. We strongly recommend frequent regular inspections in accordance with AS 3660.2. Where the slab edge is not fully exposed or the slab is an infill slab or the slab type cannot be determined then we strongly recommend inspections every 3 to 6 months in accordance with AS 3660.2 or AS 4349.3.

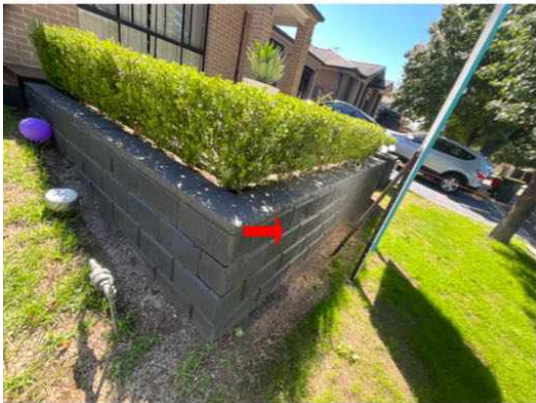
Building:	Main Building
Location:	Retaining walls
Finding:	Retaining walls
Information:	At the time of inspection the retaining walls were checked and no defects were observed other than those which May have been mentioned earlier in this report. AS4349.1-2007 requires all retaining walls in excess of 700mm to be inspected by a licensed and practicing structural engineer.
