## Building Inspection Report

Inspection Date: Thu, 22 Jan 2026

Property Address: 361 Waterfall Gully Rd, Rosebud VIC 3939,  
Australia

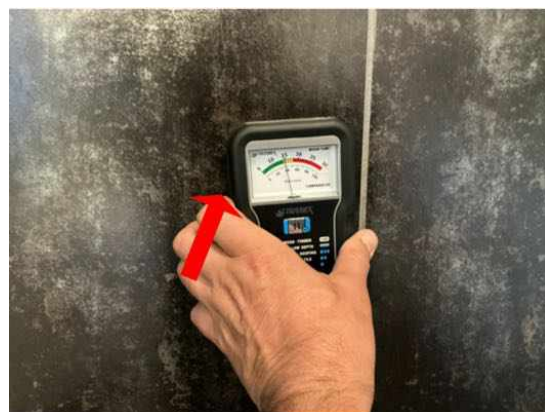
Always ensure that sealant and grout is in good condition to prevent any moisture issues occurring in the future

It is advised to engage an epoxy grout specialist to remove and replace the grout with epoxy grout and install epoxy to all floor wall corner joints.

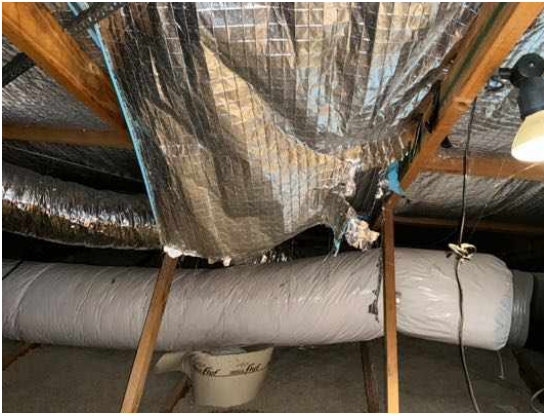
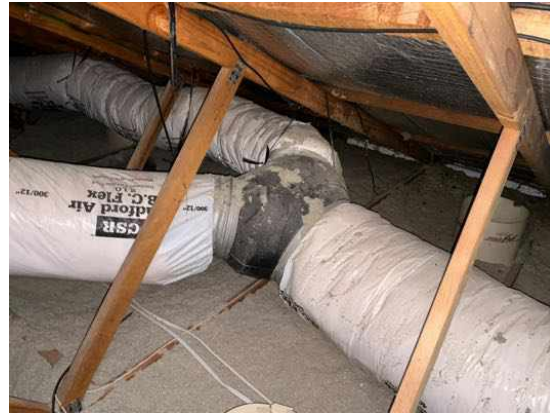
### Defects 3.17

Building: Main Building  
 Location: Roof Void  
 Finding: Roof Void - Limited Access

NOTE: Unless all insulation is removed from the roof space a full inspection is never possible, timber pest or termite activity and/or damage may not be visible.

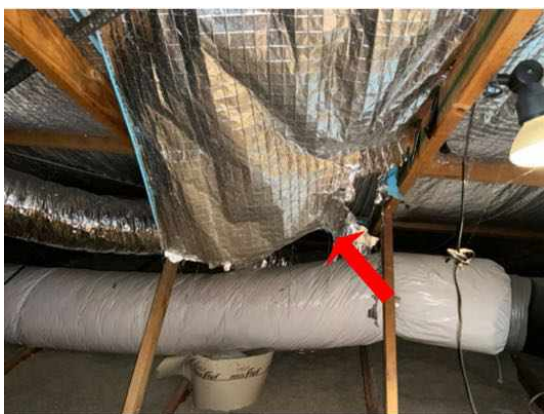
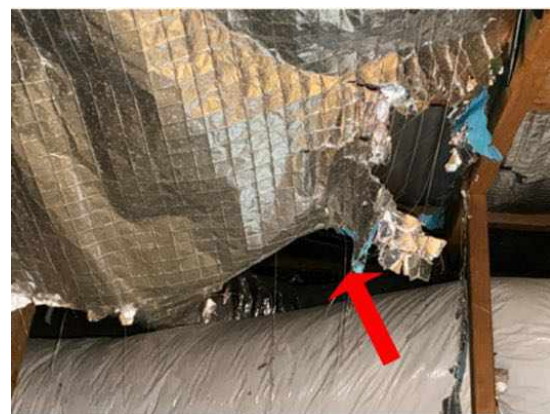
### Defects 3.18

This has likely occurred due to age-related deterioration, poor installation, or minor structural movement. Damaged roof coverings can reduce thermal efficiency, allow water to enter the building, and, in severe cases, compromise structural integrity or fire safety.

A registered builder or qualified insulation specialist is required to inspect and repair the damaged components. This should be rectified immediately to seal gaps, restore thermal and structural performance, and reduce the risk of water damage.

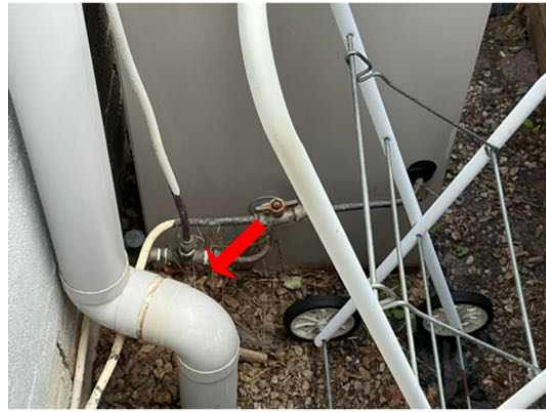
When not properly connected, discharged water can create damp conditions around the HWS, potentially leading to secondary defects such as timber rot, corrosion of nearby metal components, mould growth, or slip hazards. Prolonged exposure to moisture in this area may also attract termite activity and contribute to long-term deterioration of surrounding building elements.

A licensed plumber should be engaged immediately to connect the T&P discharge pipe to a suitable stormwater outlet or floor waste. Prompt rectification will ensure safe operation of the HWS, protect surrounding structures, and reduce potential health and safety risks.

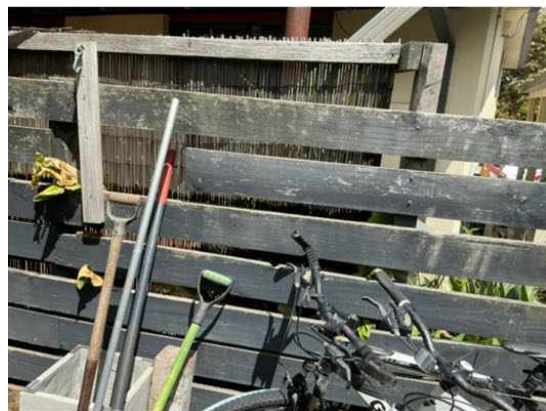
### Defects 3.23

Building:	Main Building
Location:	Fencing All Areas
Finding:	Fencing - Deteriated
Information:	Timber fencing was inspected and deterioration was observed in this area. Deteriorated fencing can compromise structural stability, reduce privacy, and may allow pest ingress or accelerated decay if left unaddressed.

Possible causes include age-related timber decay, prolonged exposure to moisture or sunlight, poor maintenance, or impact damage.

When practical, a qualified carpenter or fencing specialist should be engaged to repair or replace affected sections, and a qualified painter should be engaged to restore protective finishes. Prompt rectification will maintain structural performance, improve appearance, and extend the lifespan of the fencing.

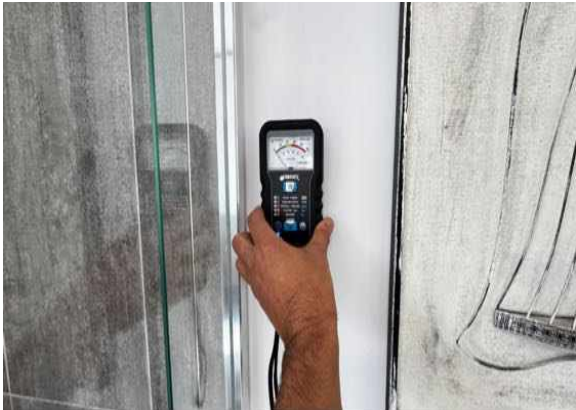
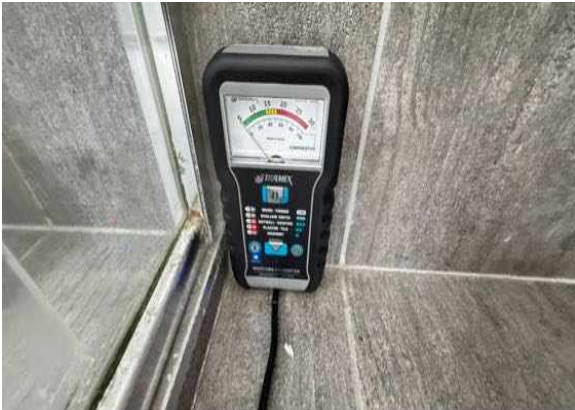
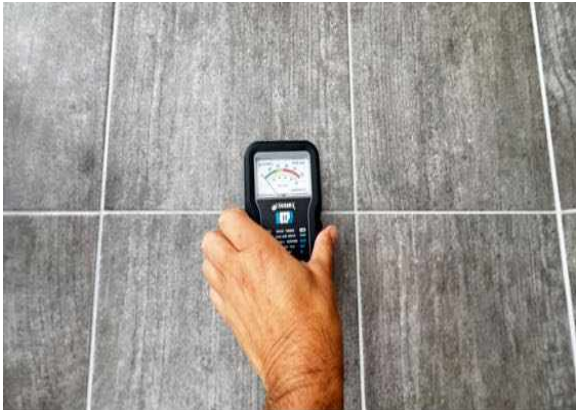
Noted Item

Building: Main Building  
Location: All Areas Interior & Exterior  
Finding: Moisture Levels - Advisory - No Elevated Moisture Levels Present  
Information: At the time of inspection, no elevated moisture levels were detected in these areas. Moisture readings were taken (using a Tramex Moisture Meter) and non-invasive testing methods and reflect conditions present at the time of inspection only. This item is noted for advisory purposes and should not be relied upon as a guarantee that moisture issues are not present elsewhere or may not occur in the future.

It is important to note that moisture levels can fluctuate due to weather conditions, plumbing usage, seasonal changes, or intermittent leaks. Concealed moisture within wall cavities, subfloor areas, or other inaccessible locations may not be detected during a visual or limited moisture assessment.

Ongoing monitoring of the property is recommended, and further investigation by a qualified tradesperson should be considered if signs of water ingress, dampness, staining, mould growth, or material deterioration become apparent.

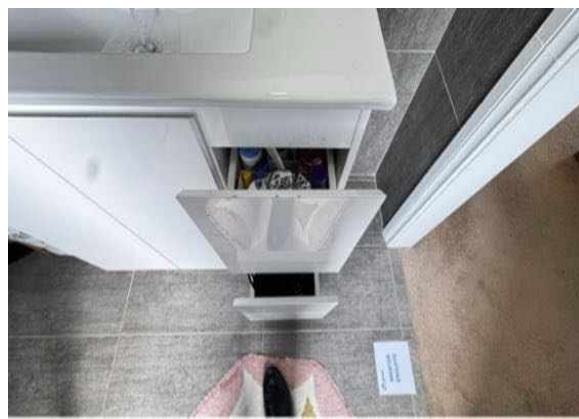
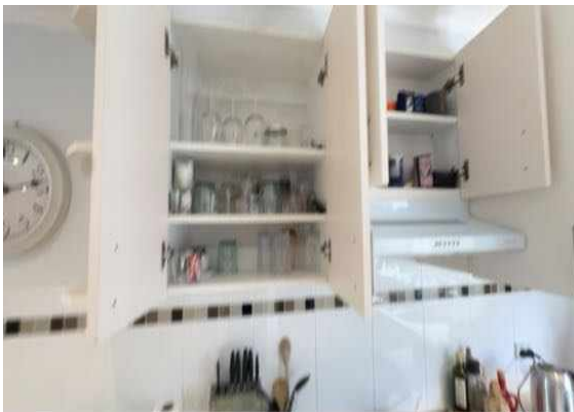
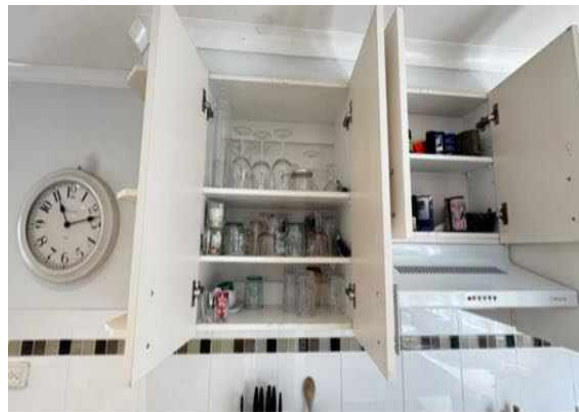
## Noted Item

Building:	
Location:	All Areas
Finding:	Additional Photos - Obstructions & Limitations
Information:	These photographs provide evidence of obstructions and restrictions that prevented full access to certain areas of the property at the time of inspection. Such obstructions may include stored goods, furniture, floor coverings, stored building materials, dense vegetation, vehicles, or fixed finishes.

It is strongly recommended that obstructions be removed and concealed areas made fully accessible immediately. A re-inspection should then be carried out to allow a complete assessment of the property's condition. This is particularly important prior to purchase, as defects in concealed areas can carry significant rectification costs.
