Building and Timber Pest Inspection Report

Inspection Date: Mon, 19 Jan 2026

Property Address: 4 Park Ln, Wodonga VIC 3690, Australia

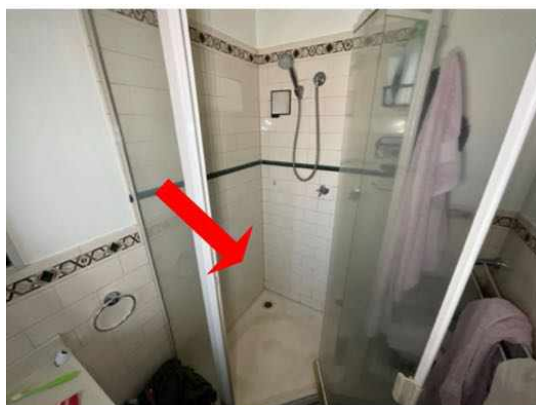
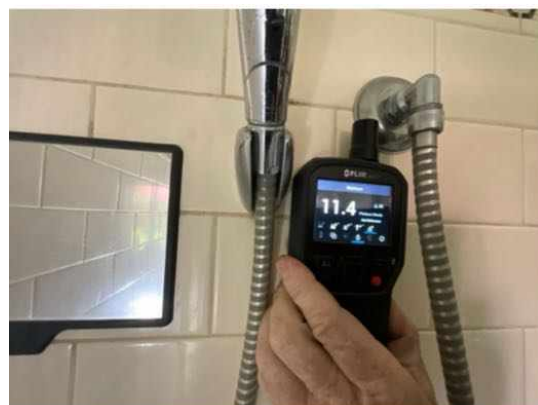
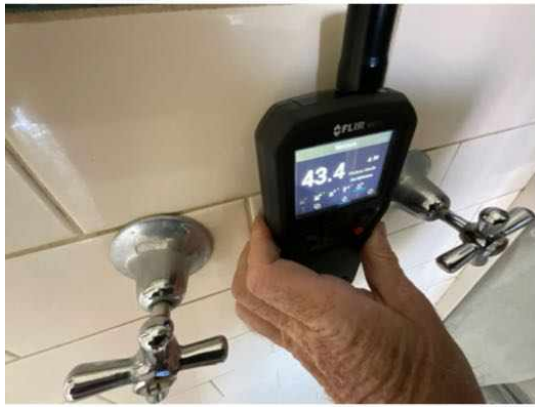
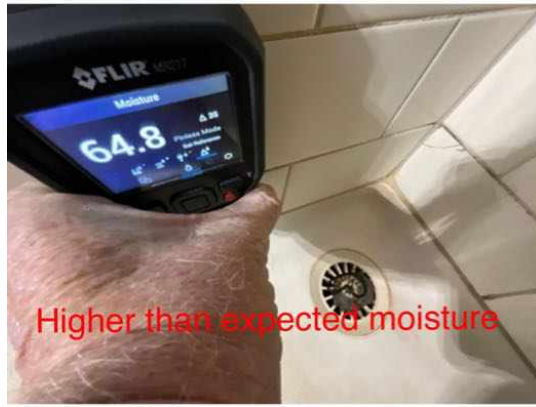
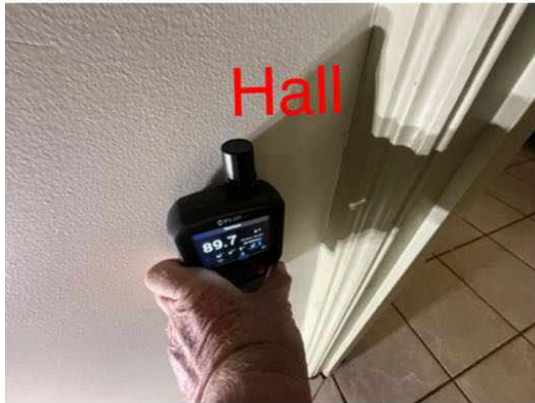
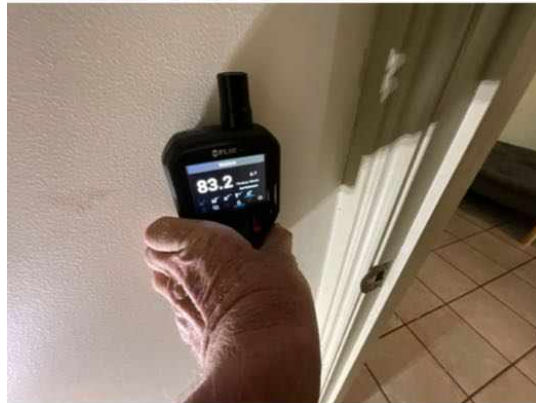
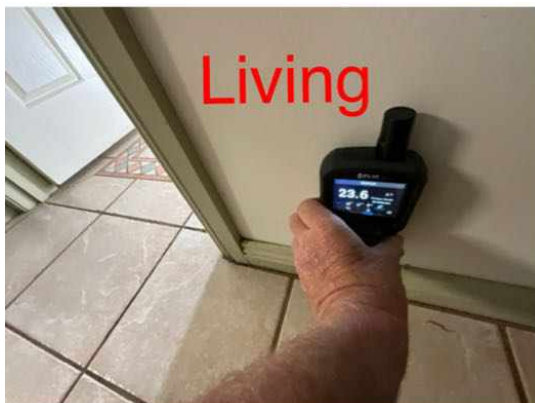
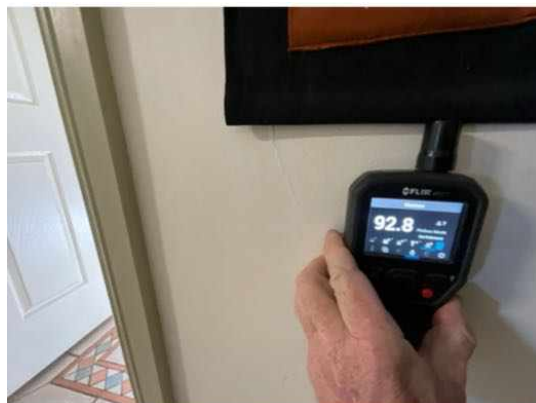
Finding 2.01

Building: Building 1
Location: Ensuite
Finding: Shower Damp- Major
Information: Damp is evident to the lower 300mm of wall to the Shower Alcove. This is suspected to have been caused by moisture permeating through the grouting in this area, which shows evidence of deterioration.

High levels of moisture were observed on the outside of the shower walls in the opposite wall.

Damp (or structural damp) refers to the presence of unwanted moisture in the structure of the building, either as a result of intrusion from outside, or condensation from within the structure. In the Shower area, internal water leaks or other sources of excessive moisture are generally the cause of damp.

Consultation with a qualified Plumber or Bathroom Specialist is advised immediately to identify the cause of damp and to perform remedial works as required.

Always ensure that sealant and grout is in good condition to prevent any moisture issues occurring in the future.

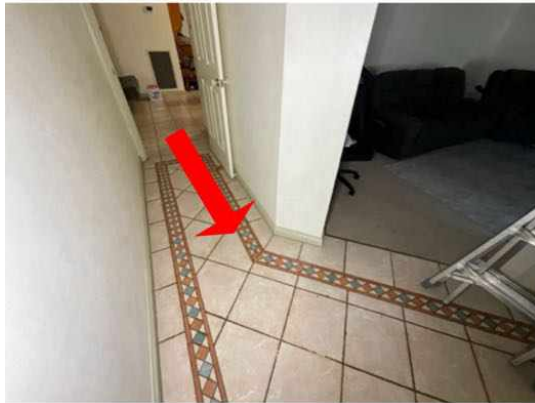
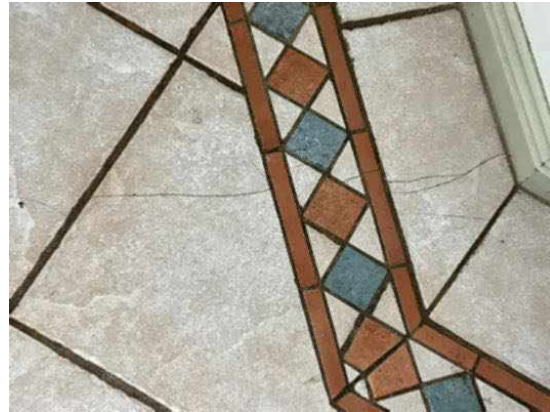
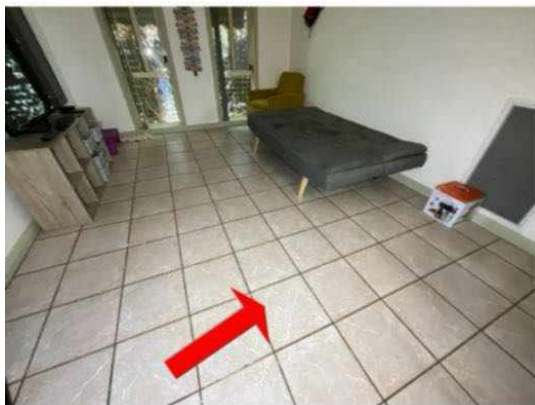
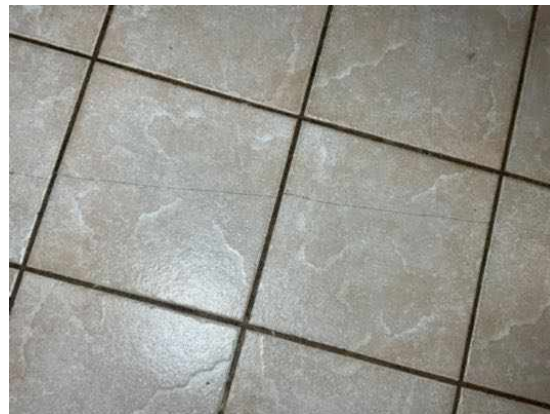
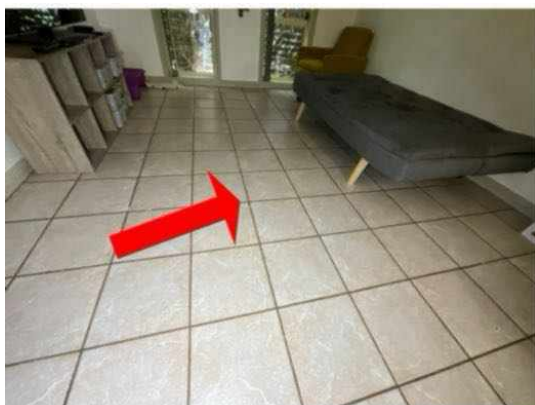
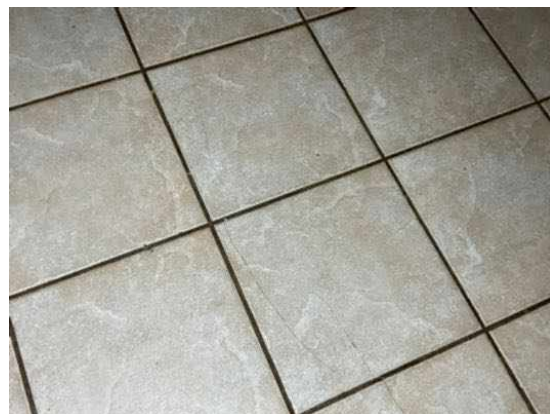
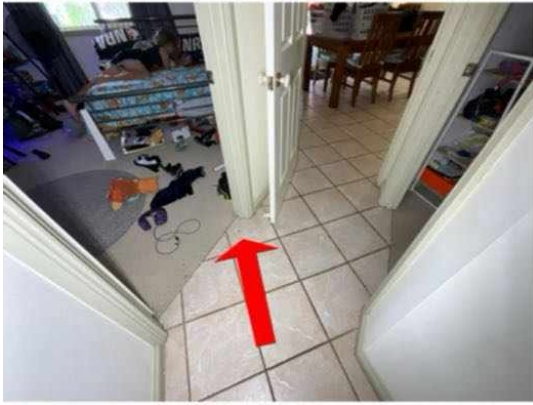
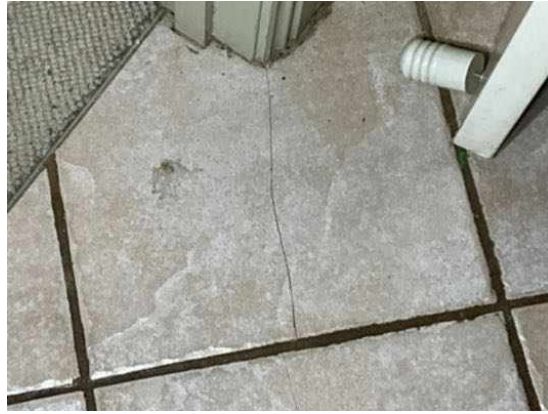
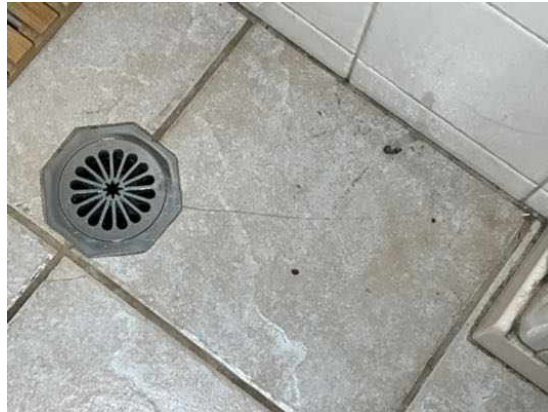
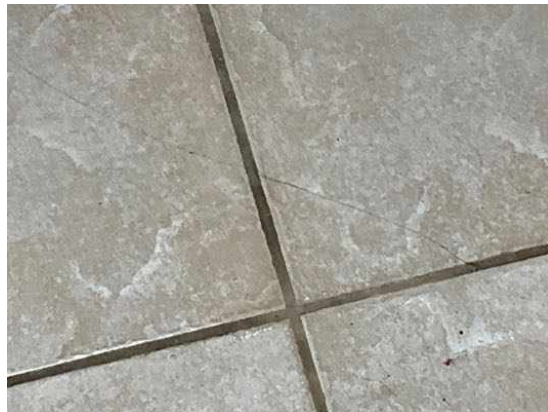
Finding 3.01

Building:	Building 1
Location:	Hall, dining, hall 2, bathroom,
Finding:	Cracked floor tiles
Information:	Cracking in the floor tiles was evident in this area at the time of inspection. It is suspected that this cracking has occurred as a result of minor settlement or impact damage.

Cracked tiles throughout the household detract from the overall appearance of the affected areas however it is unlikely to create or lead to any secondary defects.

While not considered a matter of urgency, replacement of cracked floor tiles is recommended at the clients discretion. A tiling contractor may be appointed to perform these works. Where cracks become more numerous, contact a licensed building inspector for further investigation.

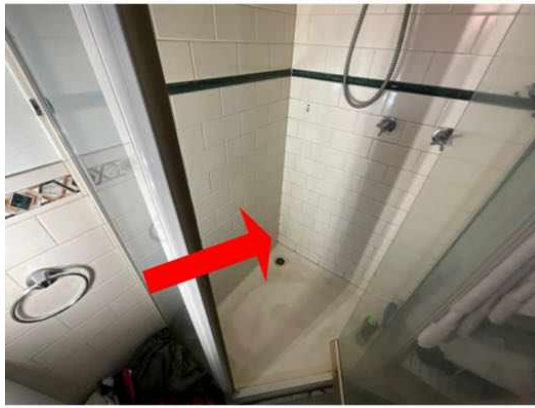
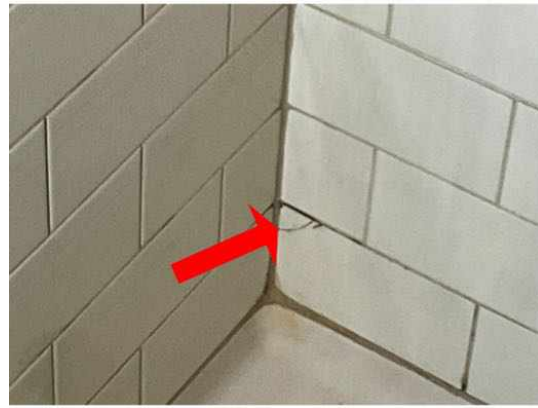
Finding 3.02

Building:	Building 1
Location:	Ensuite
Finding:	Wall Tiles- Cracked
Information:	Cracked tiles within the household detract from the overall appearance of the affected areas, as well as creating potential for water penetration to adjoining building elements. If left unmanaged, water damage may occur as a result of constant water penetration over a prolonged period of time.

While not considered a matter of urgency, replacement of tiles is advised as a solution. A Tiling Contractor may be appointed to perform these works at client discretion.

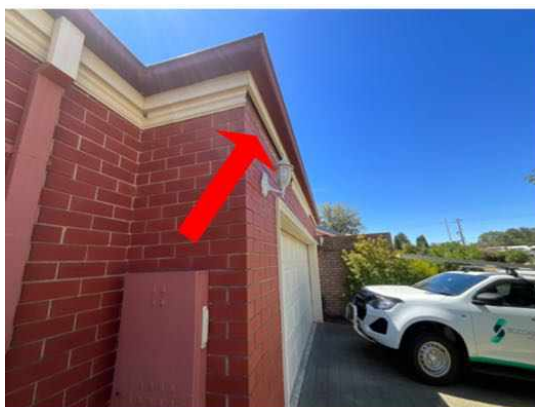
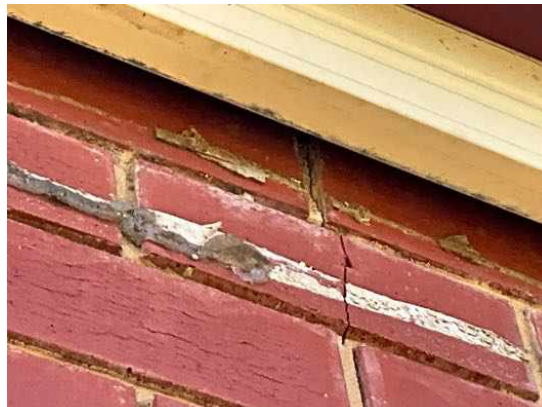
Finding 3.03

Finding: Brickwork - Cracking [Fine]

Information: Although fine cracks are quite noticeable, they are often only considered to be an appearance defect and usually do not indicate any structural damage. Generally, the cause of a fine crack is indicative of a separation between brickwork and mortar throughout the structure, but single bricks may also show cracks of this nature.

Cracking of this nature can generally be repaired with minor filling and should be conducted by a qualified bricklayer.

Always contact a building inspector should cracks widen lengthen or become more numerous.

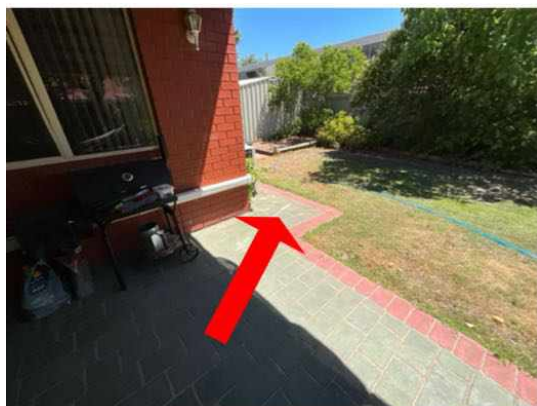
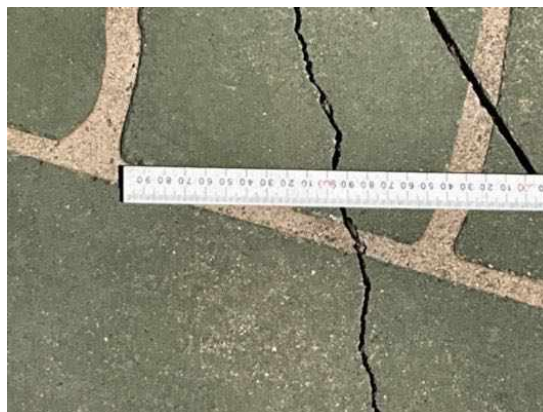
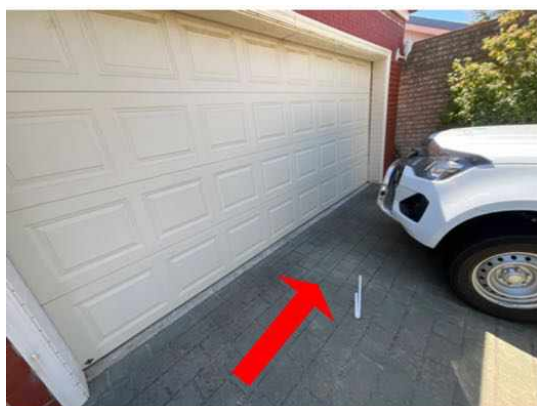
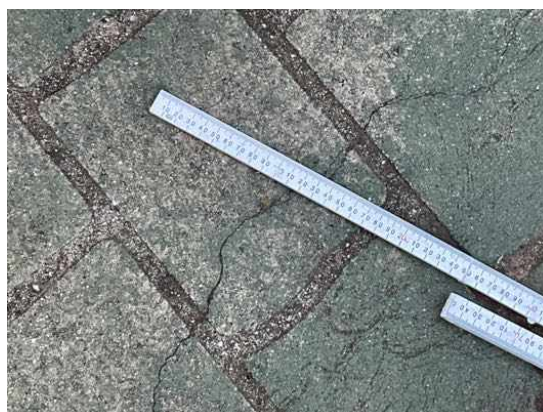
Finding 3.04

Finding: Cracking - External Concrete Paving Damage Category 2 - Distinct (less than 3mm)

Information: Distinct cracks were identified in external concrete paving. Distinct cracks are generally found in older concrete paving, and may also present as a trip hazard as

consequence of an uneven or curved surface.

General age and expected deterioration of the paved areas is a common cause of this type of cracking. However, expansion and contraction of the slab may also have occurred due to environmental factors. Such factors include variable moisture and weather conditions, the presence of trees and their roots having a settling or lifting affect on the soil, or the effect of load bearing, e.g. heavy vehicles over a sustained period of time.

Cracking to this degree may also be due to poor original installation of the concrete. Factors such as poor compaction of the sub surface and/or inadequate reinforcing of the slab may create cracking and other secondary defects.

Repairs are likely to be required to prevent further cracking and to reduce hazards associated with cracking, such as tripping. Monitoring of all cracking should be conducted frequently. Always contact a building inspector should cracks widen, lengthen, or become more numerous.

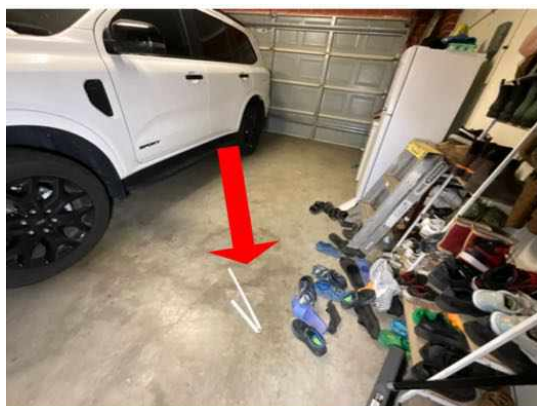
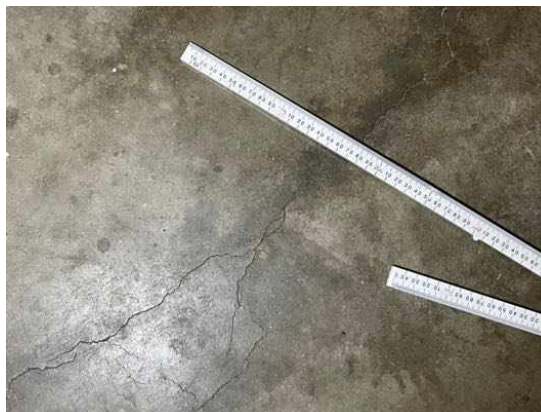
Finding 3.05

Building:	Building 1
Location:	Garage
Finding:	Crack in concrete slab - Category 1
Information:	A crack coded as Category 1 was identified in the slab. A Category 1 crack is

described as a fine but noticeable crack, with the slab at an otherwise reasonable level.

To be considered Category 1, the approximate width of the crack is less than 1.0mm, or a less than 10mm change in offset when a 3m straight edge is placed over the defect.

Category 1 cracks should be monitored for a period of 12 months. At the end of the monitoring period, identified cracks that are rated greater than Category 2 are considered defects, and require rectification.

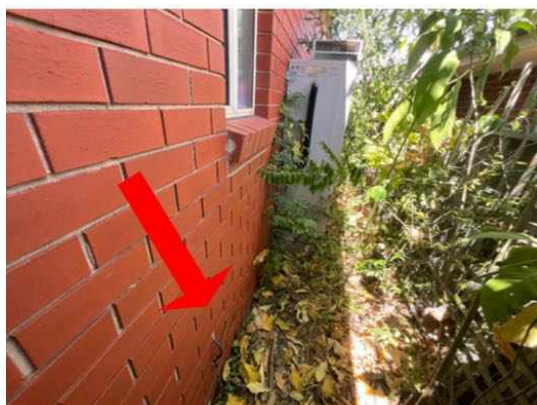
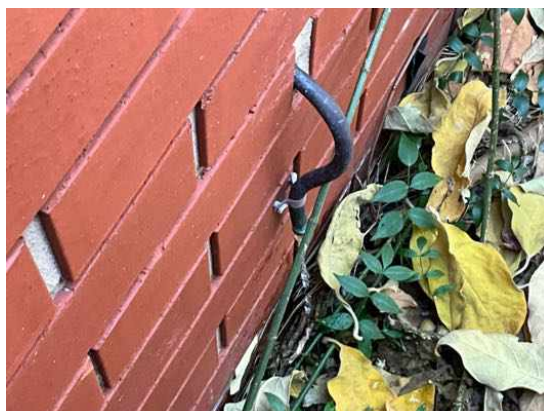
Finding 6.01

Building:	Building 1
Location:	Yard - Side
Finding:	HWS Overflow - Not Connected
Information:	The Hot Water System (HWS) overflow was found to be disconnected from storm water drainage and is creating excessive moisture in the surrounding area.

These damp conditions can lead to secondary defects such as rot, rust or corrosion of associated building elements, the formation of fungal decay, or even the creation of potential slip hazards. When coupled with poor site drainage, pooling of water may also attract termite activity to this area.

It is highly recommended that a licensed plumber be appointed to connect the HWS overflow in order to prevent such an environment from being created. These minor works should be carried out as soon as possible.

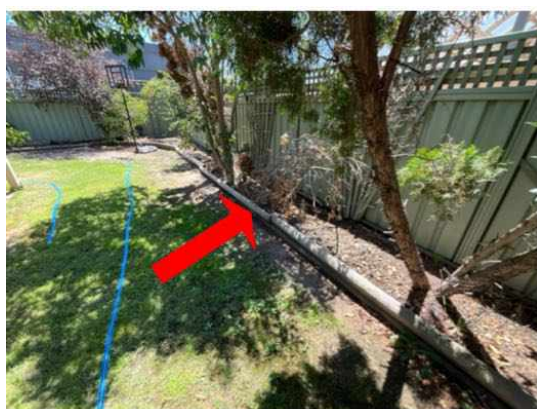
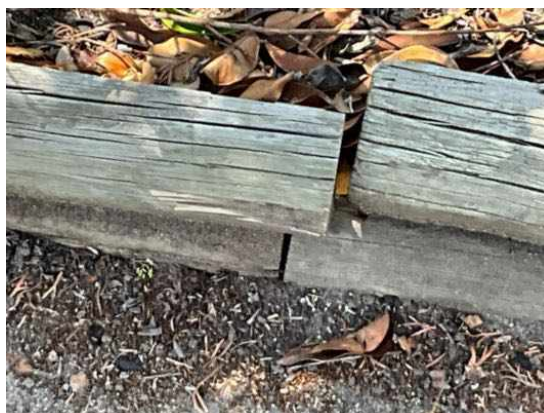
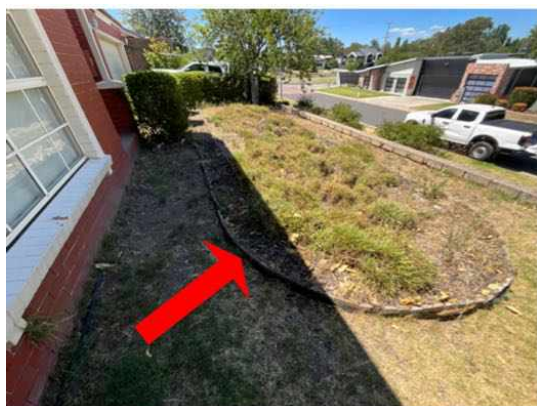
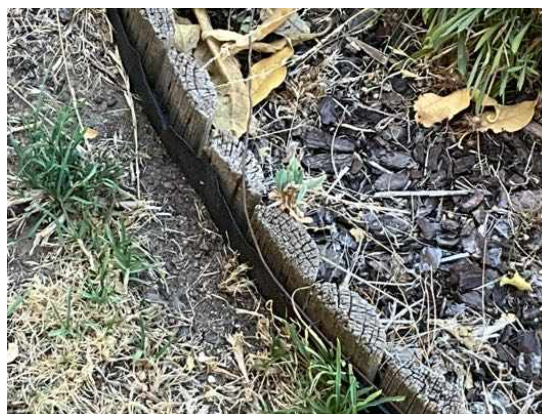
Finding 6.02

Building: Building 1
Location: Yard - Back, front
Finding: Untreated or non-durable timbers in a hazardous environment
Information: To reduce the risk of timber pest attack it is essential that timber used in a hazardous environment (e.g. in direct contact with the ground or frequently exposed to damp conditions) is of sufficient durability and/or is adequately preservative treated.

Untreated timbers in direct contact with the ground are likely to develop severe wood rot and/or fungal decay if left unattended creating attraction for subterranean termites to infest the timbers from surrounding areas.

If untreated or non-durable timbers are found to be in a hazardous environment it is highly advised that replacement of these building elements be performed as soon as possible to aid the protection of the property against termite / timber pest attack.

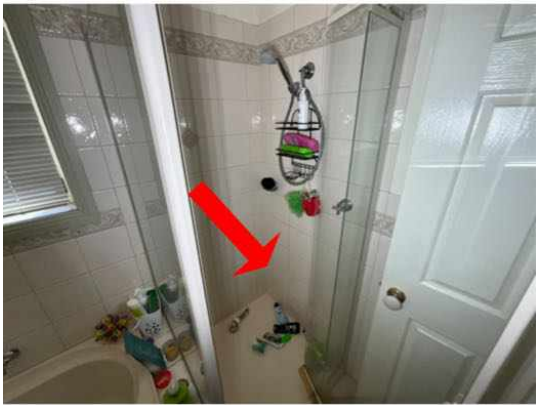
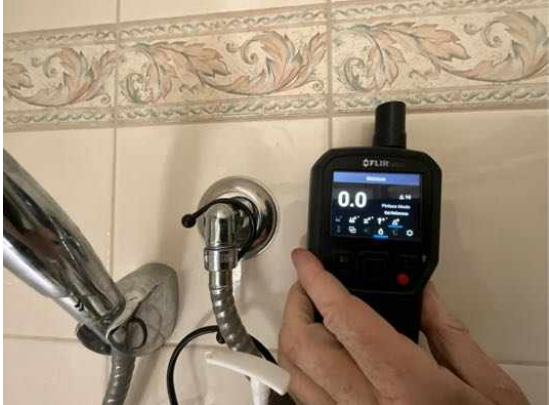
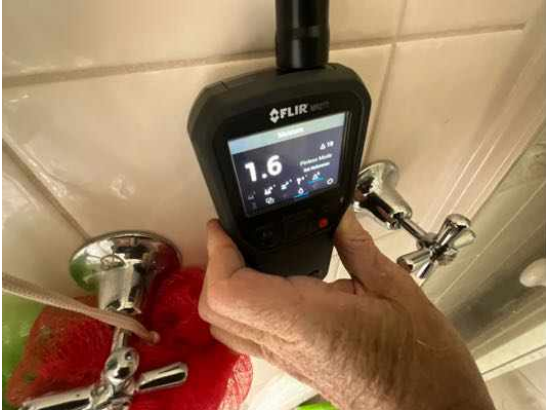
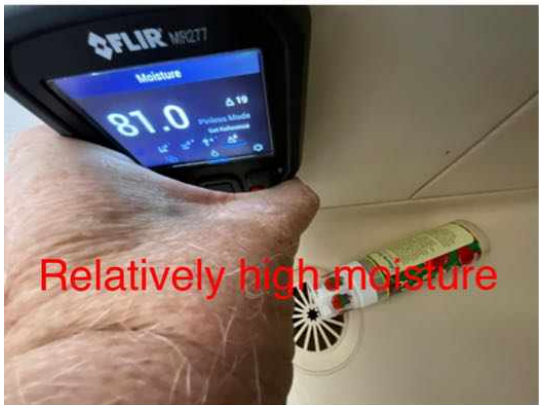
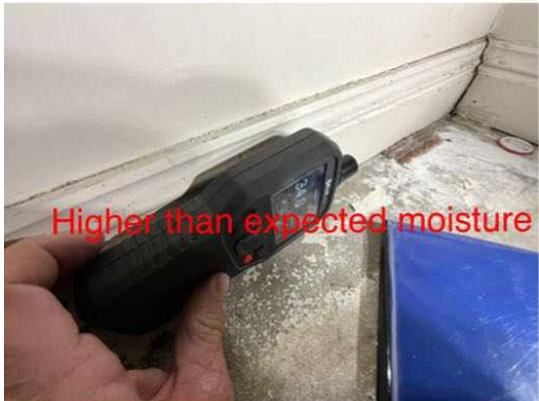
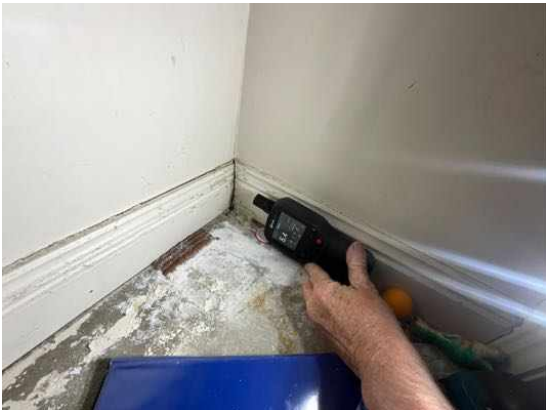
Finding 6.03

Building:	Building 1
Location:	Bathroom
Finding:	Shower damp- Monitor
Information:	Damp is evident to the lower 400mm of wall to the shower alcove. There is no high reading around the taps nor are there high readings transferring to the other side of the wall.

This defect is quite common, and is suspected to have been caused by moisture permeating or leaching through the grouting and perhaps gaps in the sealant prior to repair.

Damp (or structural damp) refers to the presence of unwanted moisture in the structure of a building, either as the result of intrusion from outside, or condensation from within the structure. In the shower area, internal water leaks or other sources of excessive moisture are generally the cause of damp.

Unmanaged damp in the shower recess is likely to facilitate the formation and development of mould and fungi growth, decaying associated building materials and compromising their structural integrity. It is important to address damp conditions, as the World Health Organisation notes that excess moisture leads - on almost all indoor materials - to growth of microbes such as moulds, fungi and bacteria, which subsequently emit spores and other matter into the indoor air. Exposure to these contaminants is associated with a wide range of respiratory and other health-related problems.

Monitoring the area is advised and if any visual signs of excessive moisture appear (peeling paint, mould) then consultation with a qualified plumber or bathroom specialist would be advised to identify the cause of damp and to perform remedial works as required.

Always ensure that sealant and grout is in good condition to prevent any moisture issues occurring in the future.

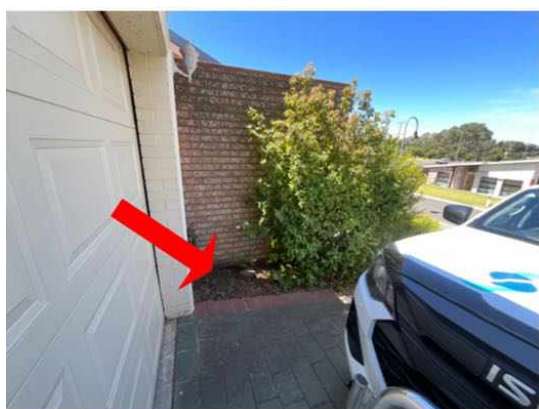
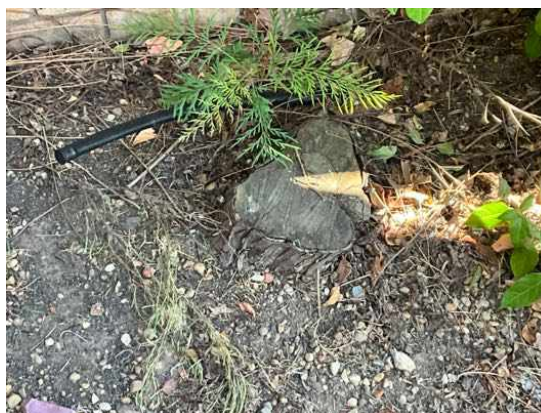
Finding 6.04

Building:	Building 1
Location:	Driveway
Finding:	Tree Stump in Ground
Information:	Any tree stumps in the yard not removed during the tree removal process provides the opportunity for Termite infestation and is likely to be subject to decay from damp conditions against the stump.

All tree stumps should be removed by professional tree removal services where possible. Meanwhile regular inspections are advised to identify any termite activity in the areas identified.

Services for tree stump removal should be contacted as soon as possible to reduce the risk of timber pest attack.

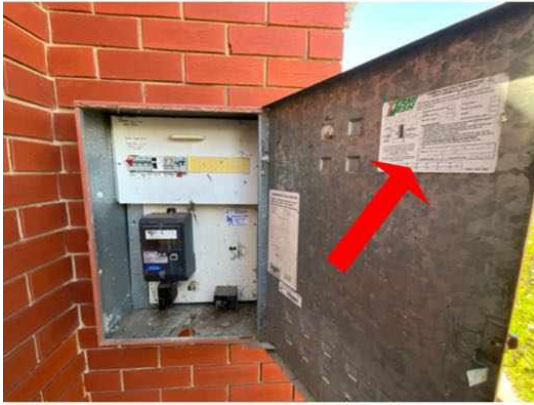
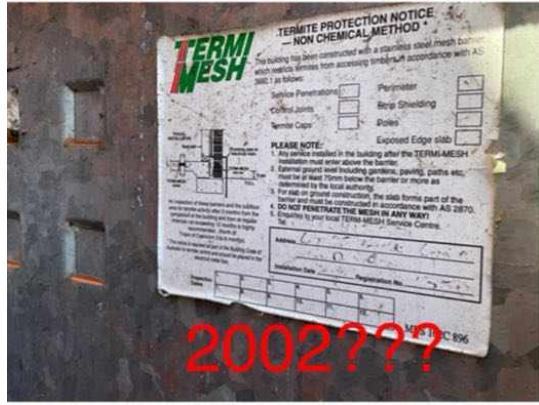
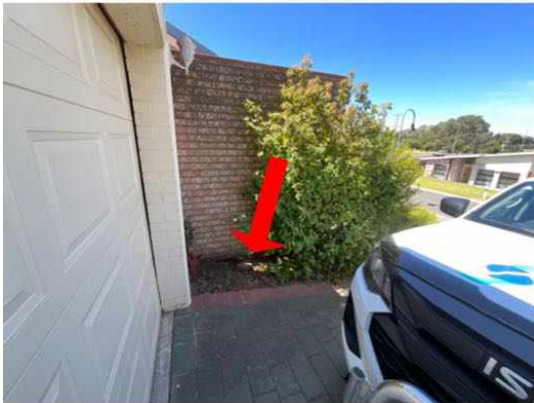
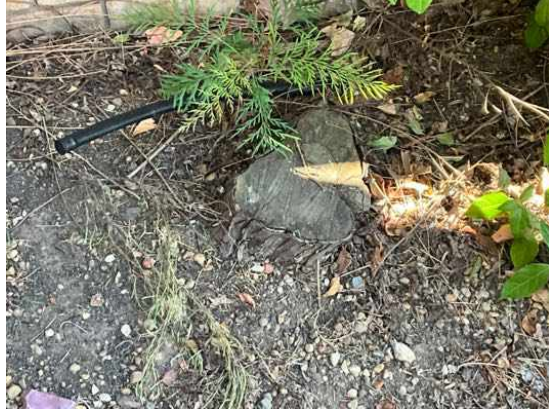
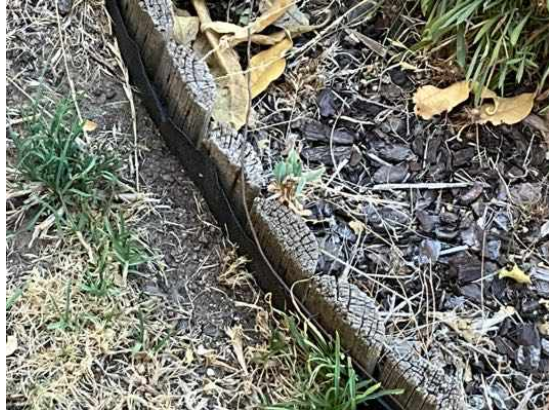
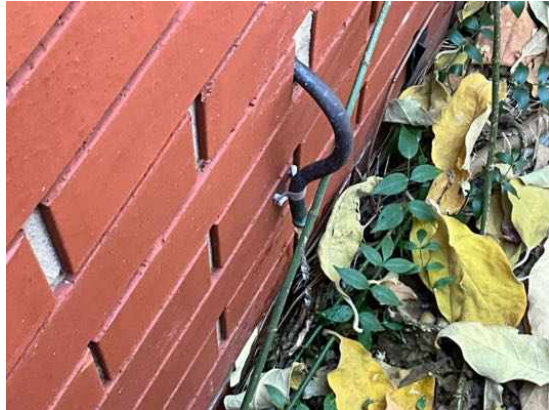
Finding 6.05

Building:	Building 1
Location:	All External Areas
Finding:	Termite Management System - no evidence of a chemical installation
Information:	The application of a post-construction chemical termite barrier is highly recommended for all properties, particularly if live termite activity has been found on the site previously. Such barriers are highly effective in preventing termite attack on any timber building elements throughout the property.

A durable notice should be placed in the switchboard unit to indicate current termite barriers. At the time of inspection, it appeared as though no termite management system has been installed, with no evidence to suggest preventative works taking place.

The client may consider gaining further advice from a pest controller as to the costs and procedures involved with this application. It is recommended that obtaining such advice be a short-term priority.

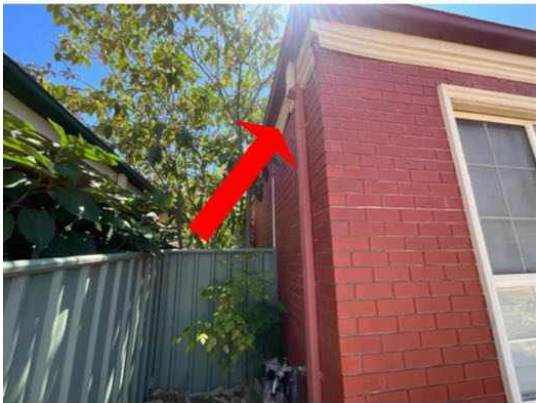
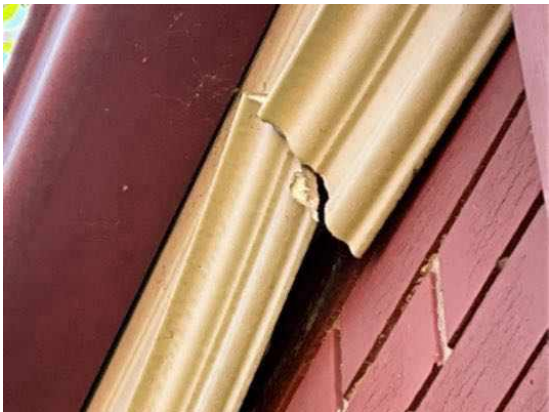
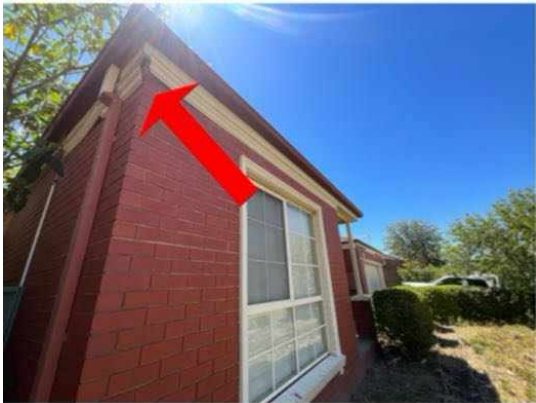
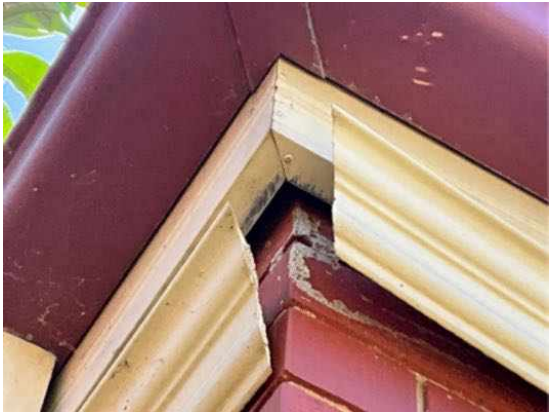
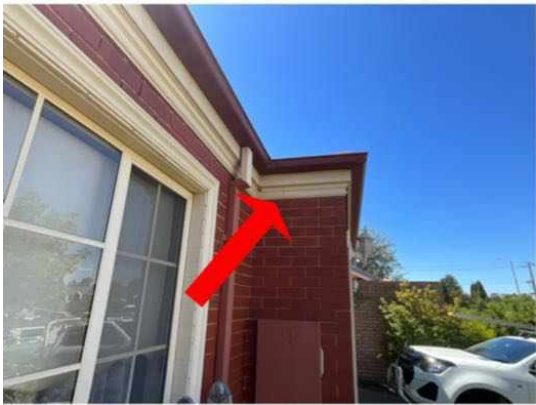
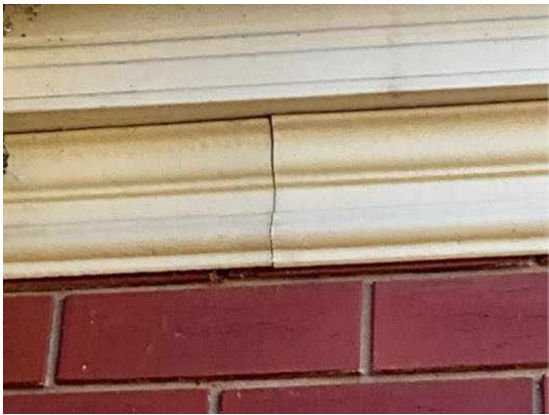
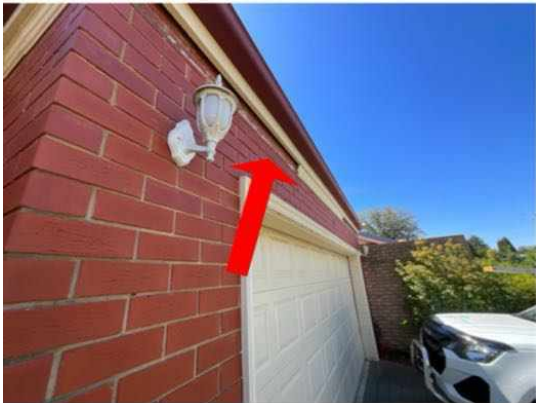
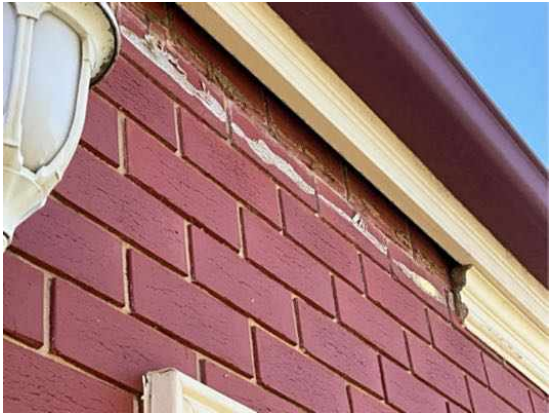
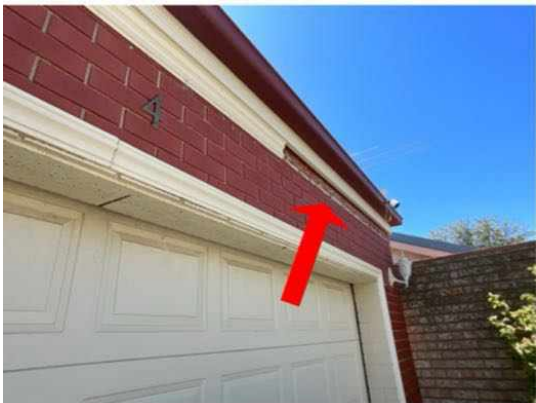
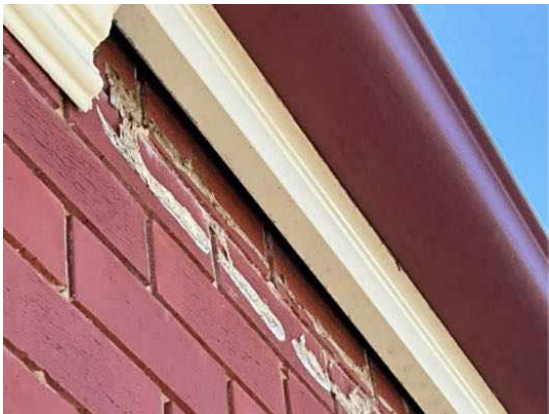
Building: Building 1
Location: Yard - Front
Finding: Building element - Damaged
Information: Breakage occurs generally when the building materials have either aged and decayed, or as a result of damage (accidental or deliberate).

Repair and/or replacement of broken elements is advised to ensure that additional secondary defects do not arise as a consequence. Such works are necessary, as all building elements play a key role in the operation and function of the overall structure and its performance.

A relevant tradesperson should be appointed to repair or replace the affected building element prior to any subsequent damage being caused.

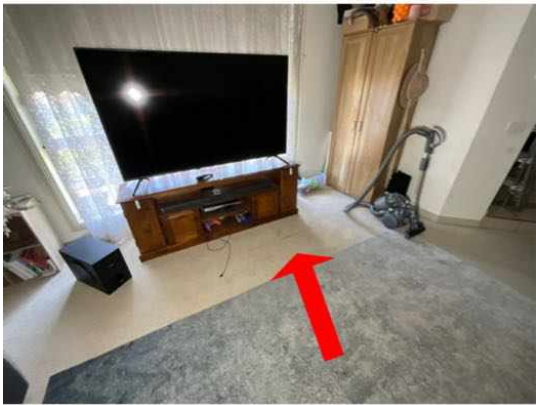
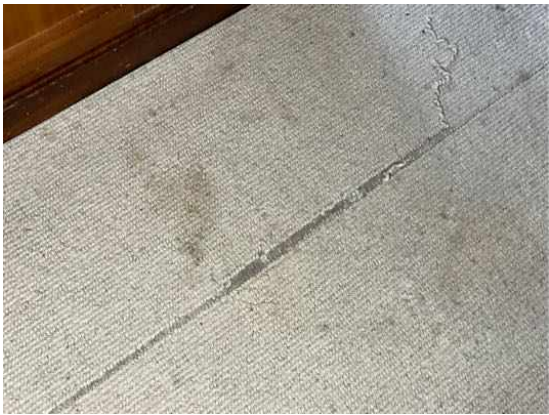
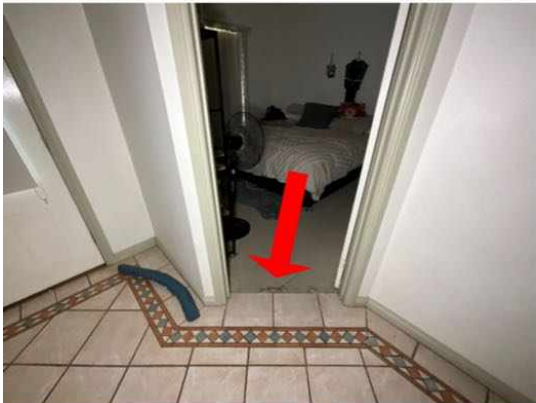
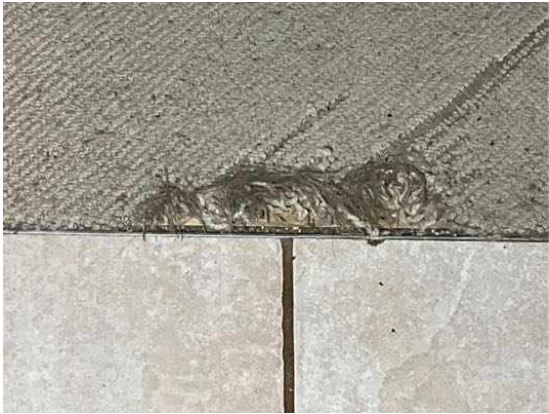
Building: Building 1
Location: Carpet
Finding: Carpet -deterioration
Information: The carpet in these areas is deteriorated. Sections can be seen to be frayed or worn.

A carpet specialist should be contacted at the discretion of the client to make any improvements and prevent further deterioration.

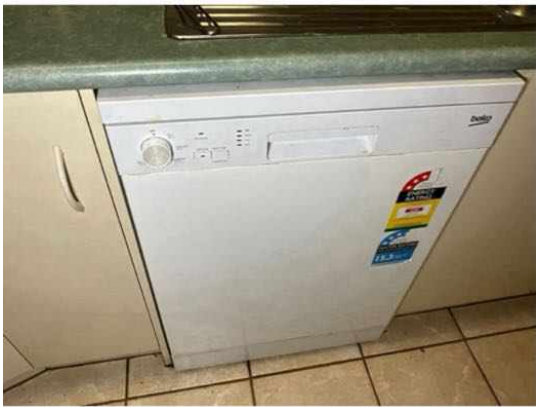
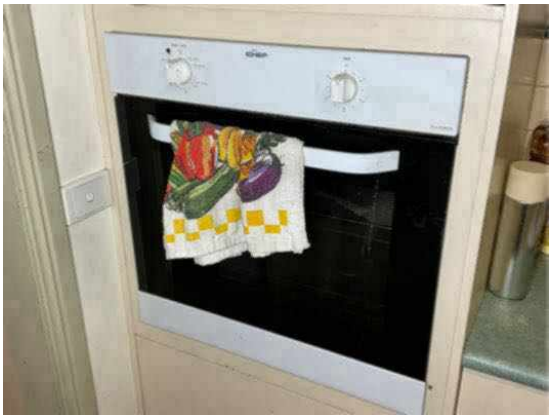
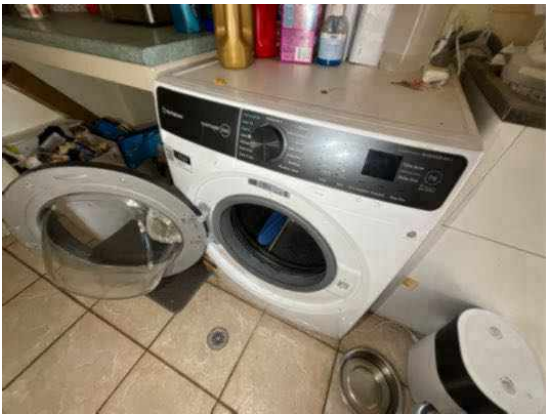
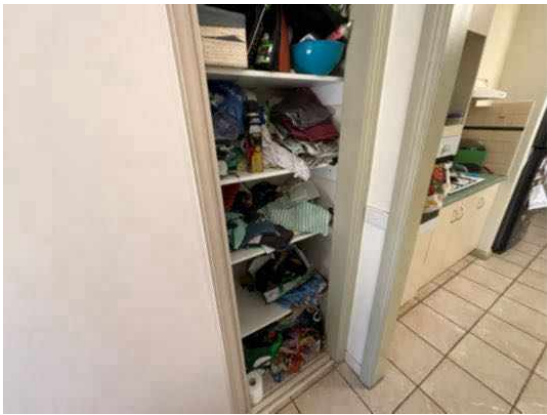
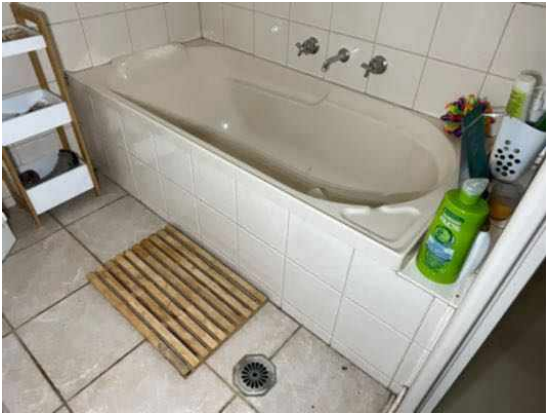
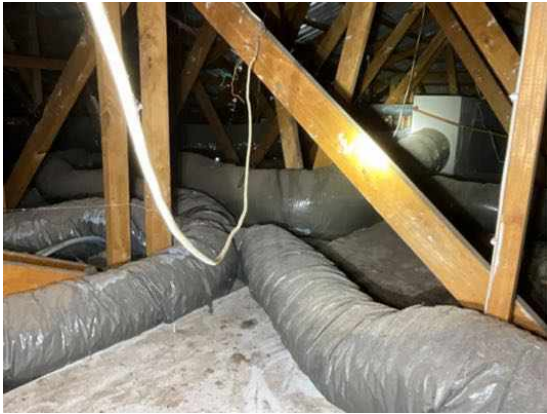
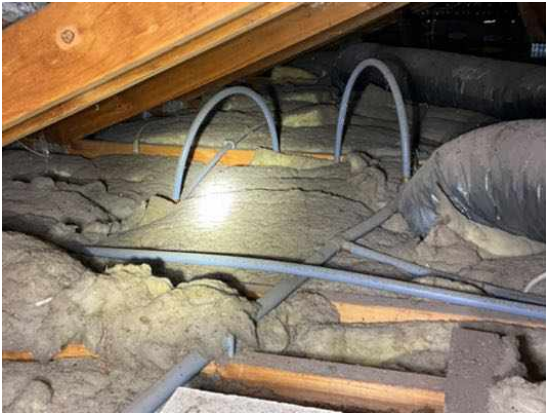
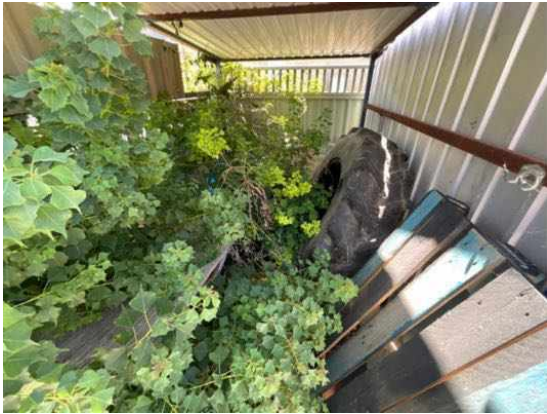
Building: Building 1
Location: All Areas
Finding: Additional Photos - Obstructions and Limitations
Information: These photographs are an indication of the obstructions and limitations which impeded full inspection of the property at the time of inspection. These obstructions can hide an array of defects and should be removed to allow full inspection to be carried out. A re-inspection is recommended once the areas are made accessible.
