Building and Timber Pest Inspection Report

Inspection Date: Mon, 12 Jan 2026

Property Address: 17 Kobina Avenue Glenmore Park NSW
2745

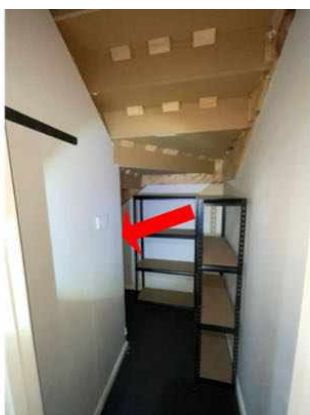
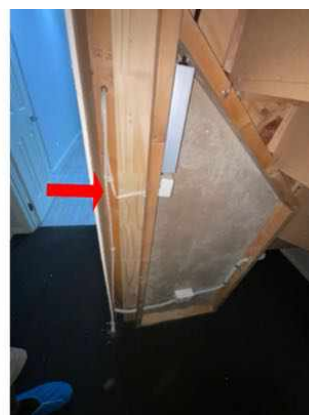
Exposed or substandard electrical wiring presents a safety hazard. Wiring that is not suitably enclosed is susceptible to mechanical damage over time and increases the risk of electric shock, short-circuiting, or potential fire hazards. There is also a risk of inadvertent contact by occupants or persons accessing the area, which may result in injury. The condition does not align with accepted electrical safety standards and good trade practice.

It is strongly recommended that a suitably licensed electrician be engaged as a matter of urgency to further inspect the installation and carry out the necessary repairs. Works should include the installation of appropriate conduit or replacement of the wiring to ensure it is adequately protected, compliant, and safe for ongoing use. Further investigation may be required to confirm that no additional electrical defects are present.

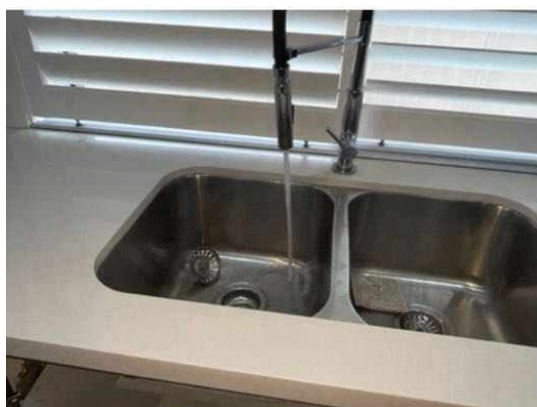
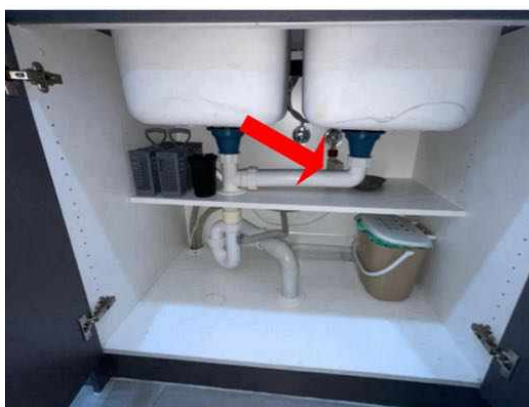
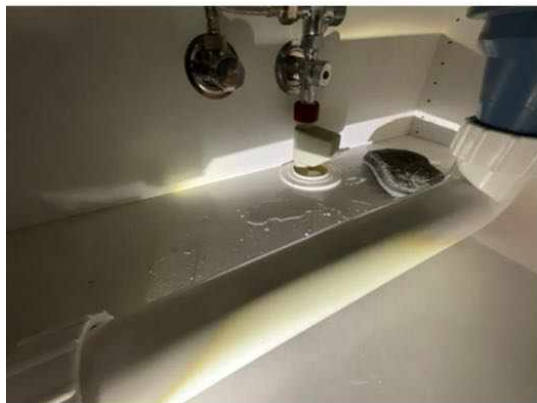
Building: Main Building
Location: Kitchen
Finding: Water leak - Internal.
Information: Observation

A water leak was identified at a plumbing fixture located beneath the sink at the time of inspection. The leak was active at the time of assessment. No visible water damage, swelling, or deterioration to the surrounding cabinetry or cupboard base was observed at the time of inspection.

If left unattended, ongoing leakage may result in moisture ingress to adjacent cabinetry, flooring, or wall linings. Prolonged exposure to moisture can lead to material deterioration, mould growth, and potential concealed damage that may not be immediately visible. Plumbing leaks also have the potential to worsen over time, increasing the risk of secondary damage.

It is strongly recommended that the leak be rectified as a matter of relative urgency by a suitably licensed plumber. Following repairs, the affected area should be monitored to confirm the leak has been successfully resolved and that no subsequent water damage develops.

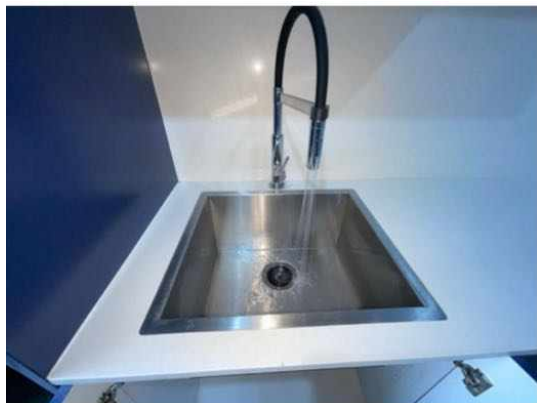
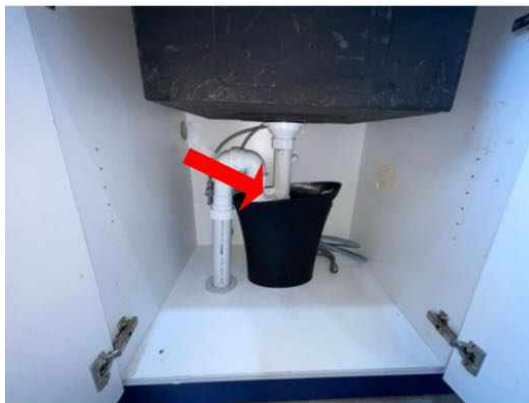
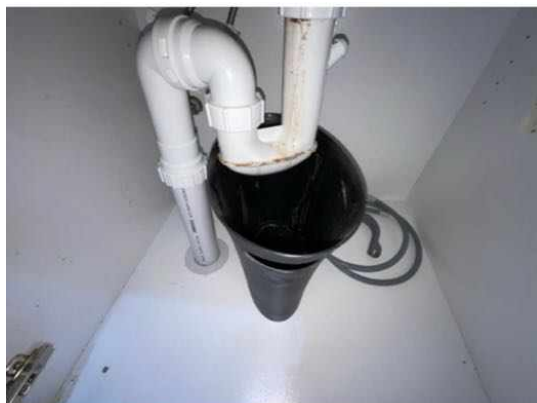
Finding 3.02

Building:	Main Building
Location:	Laundry
Finding:	Water leak - Internal.
Information:	Observation

A water leak was identified at a plumbing fixture located beneath the basin at the time of inspection. The leak was active at the time of assessment. No visible water damage, swelling, or deterioration to the surrounding cabinetry or cupboard base was observed at the time of inspection.

If left unattended, ongoing leakage may result in moisture ingress to adjacent cabinetry, flooring, or wall linings. Prolonged exposure to moisture can lead to material deterioration, mould growth, and potential concealed damage that may not be immediately visible. Plumbing leaks also have the potential to worsen over time, increasing the risk of secondary damage.

It is strongly recommended that the leak be rectified as a matter of relative urgency by a suitably licensed plumber. Following repairs, the affected area should be monitored to confirm the leak has been successfully resolved and that no subsequent water damage develops.

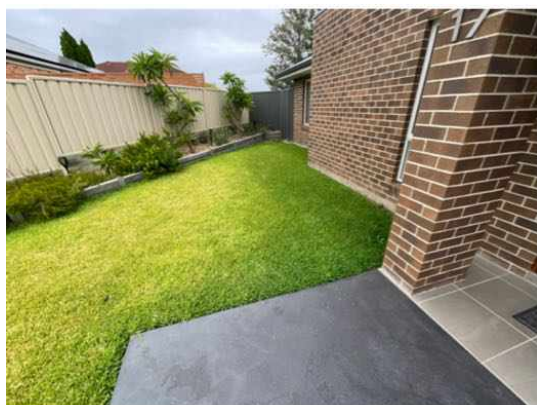
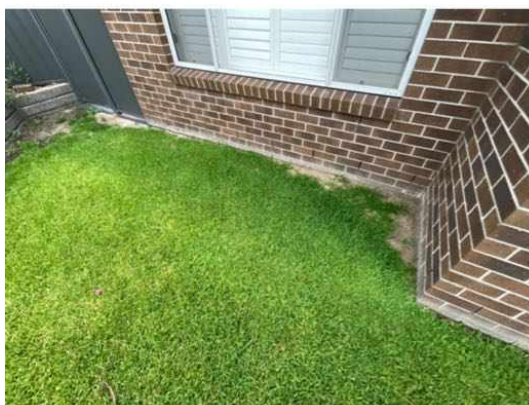
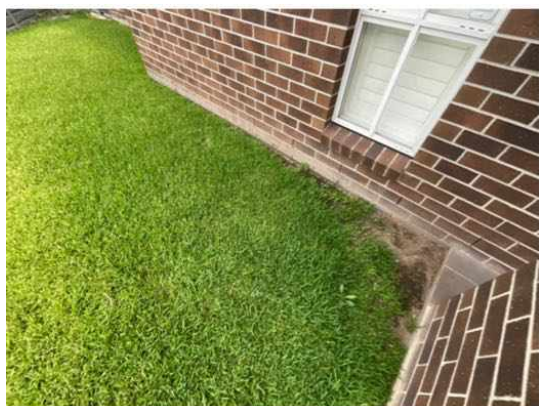
Finding 3.03

Building:	Main Building
Location:	Yard - Front
Finding:	Site/Yard Drainage - Assessment.
Information:	At the time of inspection, the site drainage to the rear of the property was observed to be inadequate, posing a concern. Specifically, the ground levels in this area slope towards the dwelling, rather than away from it, which is contrary to standard drainage practices. No evidence of surface drainage infrastructure (such as ag drains, strip drains, or surface channels) was noted in the affected area. As a result, this configuration has the potential to allow surface water to pool near the base of the structure, particularly during periods of heavy rainfall.

This condition elevates the risk of several building-related issues, including:

- Water ingress into the subfloor or lower sections of the building,
- Compromised foundation integrity due to prolonged moisture exposure,
- Timber pest activity, especially from termites attracted to damp environments,
- Accelerated deterioration of building materials in contact with or near retained moisture.

Failure to implement proper drainage gradients may contribute to chronic moisture issues that can be costly to remediate and may affect the long-term durability of the structure.

- Regrading of the site at the front of the property is recommended to achieve appropriate falls away from the building.
- Installation of surface drainage systems, such as grated drains or ag lines connected to the stormwater system, should be considered to effectively capture and redirect surface runoff.
- It is critical to ensure that all water runoff is directed to approved stormwater discharge points, in compliance with local council regulations.
- A qualified licensed plumber and/or landscaping contractor should be engaged to assess the site in detail and carry out any necessary remedial work.
- Ongoing maintenance of the drainage system is advised to prevent future issues.

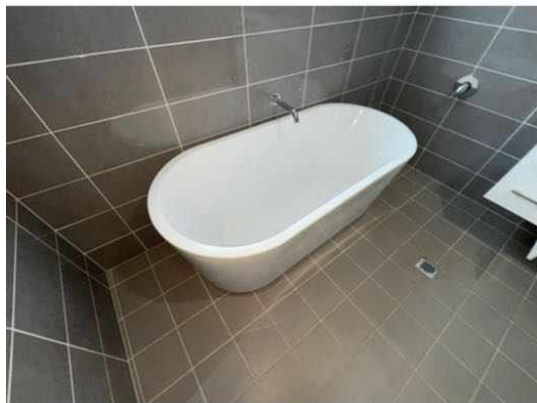
Finding 3.04

Building:	Main Building
Location:	Ensuite
Finding:	Bathtub - Not secured.
Information:	Defect – Freestanding Bathtub Not Secured

The freestanding bathtub was found to be unsecured to the floor at the time of inspection. The tub is capable of movement when pressure is applied, indicating that it has not been mechanically or adhesively fixed. Freestanding baths require stabilisation and proper sealing to ensure safe and compliant use. Without adequate fixing, plumbing connections may also be placed under strain.

An unsecured bathtub presents several functional and safety risks. Movement during use can cause shifting or tipping, creating a hazard for occupants. Ongoing movement may stress or partially dislodge the waste outlet or other plumbing connections, increasing the likelihood of concealed water leakage. Water escaping beneath the tub can lead to moisture accumulation, mould development, and deterioration of flooring or subfloor materials. Over time, this can escalate into significant repair costs and potential microbial health risks.

Engage a licensed plumber to secure the bathtub in accordance with manufacturer guidelines and relevant plumbing standards. Acceptable methods typically include mechanical fixing or the application of a flexible, mould-resistant adhesive sealant to stabilise the unit and ensure a watertight junction with the flooring. The plumber should also confirm that all waste and overflow connections are sound and compliant. Proper fixing and sealing will improve safety, protect plumbing integrity, and reduce the risk of moisture-related damage.

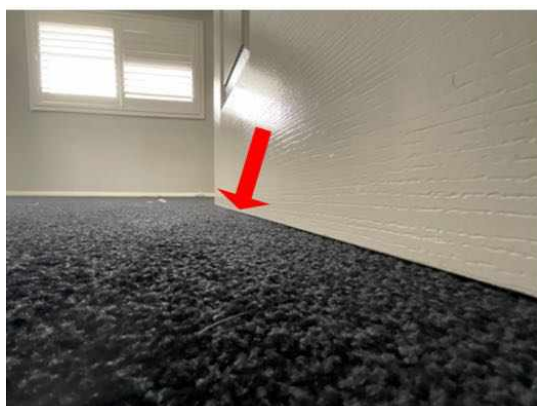
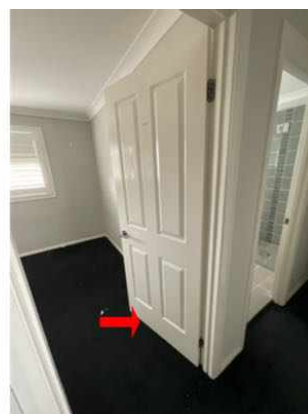
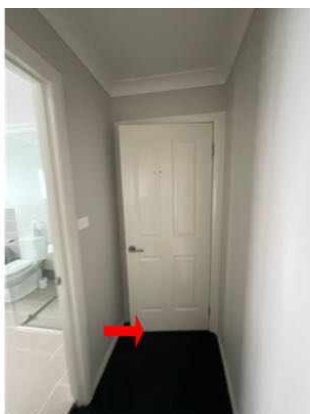
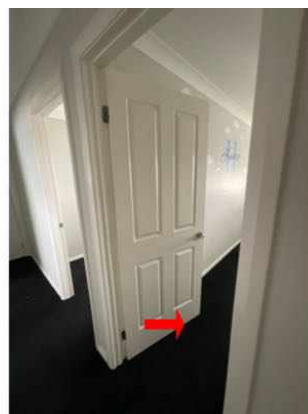
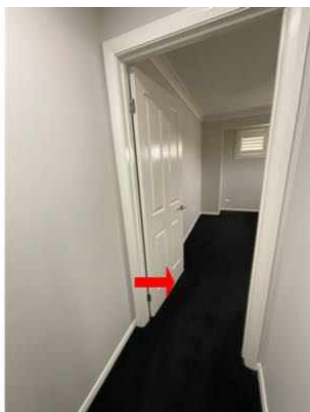
Finding 3.05

Building: Main Building
 Location: All Areas > Upstairs
 Finding: Door(s) – Binding Due to Insufficient Clearance.
 Information: Defect:

Binding or rubbing was observed during standard operation of one or more internal doors, caused by insufficient clearance between the door and frame or floor surface.

This condition impairs the functionality of the affected door and may lead to secondary damage to adjoining components such as door frames, architraves, or floor finishes.

Planing and resealing the bottom edge of the affected doors is recommended to allow for proper clearance and operation.

Minor rectification can be undertaken by a qualified carpenter or general handyman at the client's discretion.

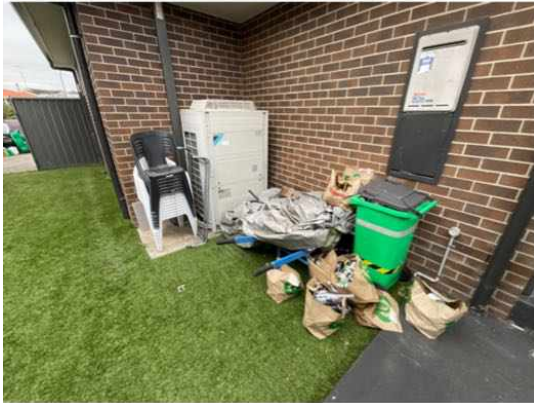
Such areas are also more likely to retain moisture or dampness, creating conducive conditions for termite activity. Obstructions against or very close to the building can provide cover, shade, and a favourable environment for infestation.

- Remove all obstructions and stored materials located against or near the building.

- Arrange a follow-up inspection to assess previously inaccessible areas and reduce the risk of undetected termite activity.

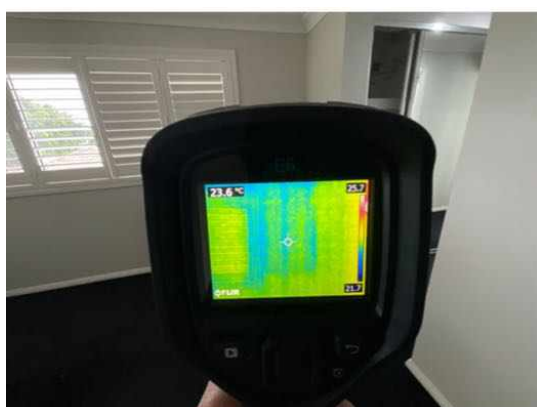
At the time of the inspection, no abnormalities indicating live termite activity were observed. However, it's important to note that various factors—such as obstructions, ambient temperature, and wall material/thickness—can impact the accuracy of thermal readings. In cases where surfaces are visually restricted or obstructed, a comprehensive thermal scan may not always be feasible.

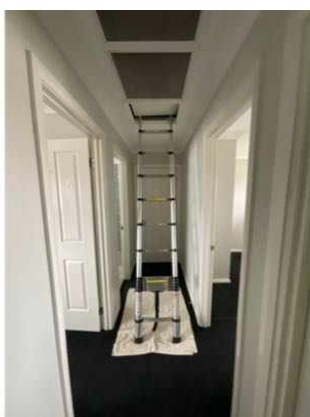
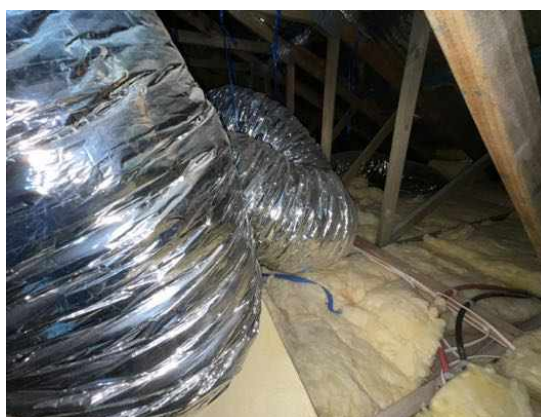
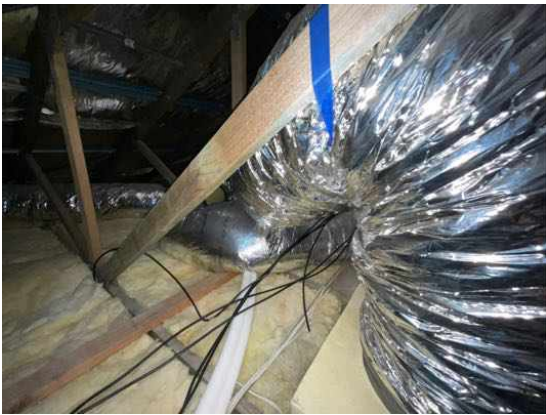
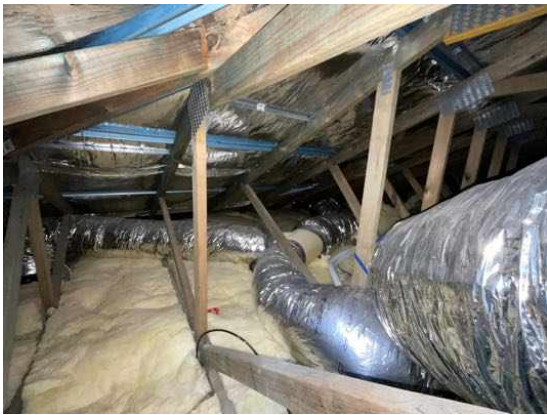
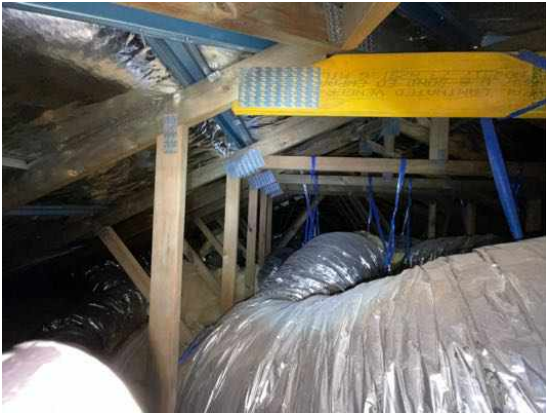
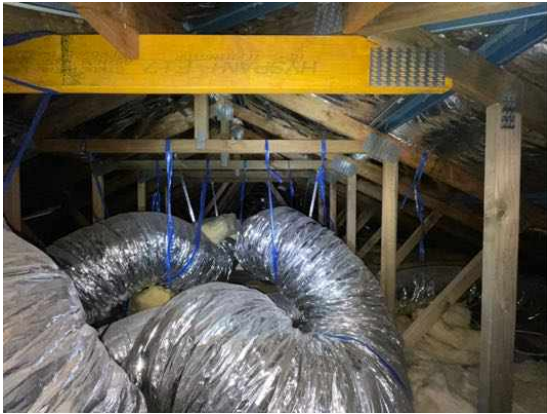
Building:	Main Building
Location:	Roof Void
Finding:	Roof Void – Limited Accessibility..

Installation of an additional manhole is recommended to facilitate a re-inspection and enable a more thorough assessment of the roof void in the future. This will help ensure that all structural elements and concealed areas are properly evaluated.
