Building and Timber Pest Inspection Report

Inspection Date: Mon, 23 Mar 2026

Property Address: 114 Hindmarsh St, Cranebrook NSW 2749,
Australia

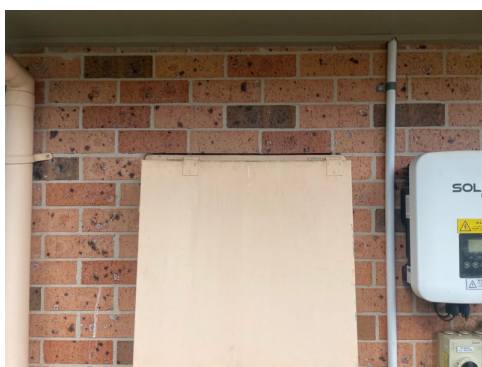
Information: During the inspection, a visible gap was noted between the wall surface and the top of the electrical switchboard enclosure. The switchboard did not appear to be neatly fitted or fully sealed at this location, resulting in an unfinished junction between the box and the surrounding wall lining.

This condition may allow dust, moisture, insects or vermin to enter the cavity around the switchboard and may also indicate poor finishing or incomplete installation. While the internal electrical components were not dismantled or tested as part of this visual inspection, gaps around electrical fittings are undesirable and should be properly assessed to confirm the enclosure is securely installed and suitably sealed.

A licensed electrician should be engaged immediately to inspect the switchboard installation and carry out any necessary rectification or sealing works as required. This item should be attended to as an immediate safety and maintenance matter.

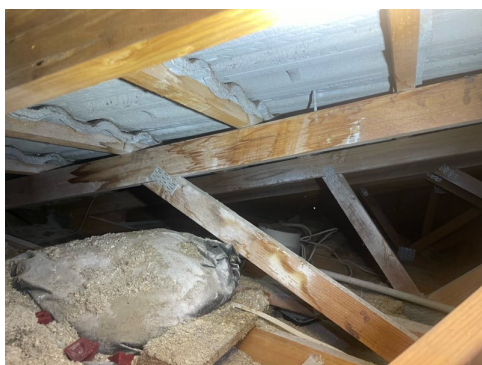
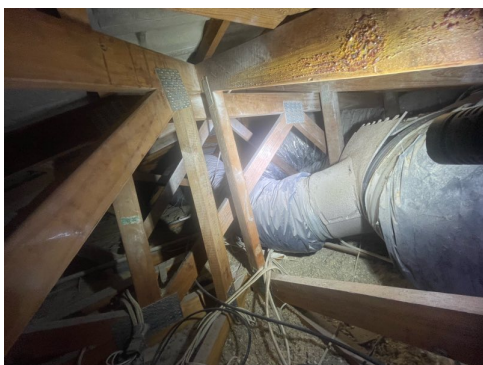
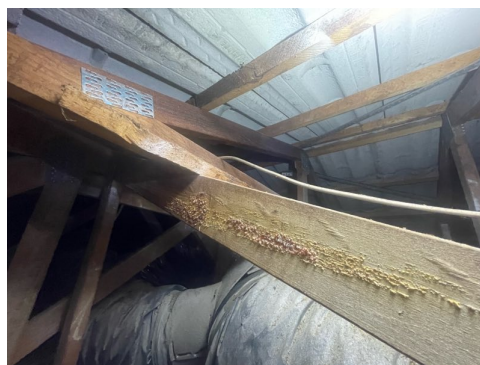
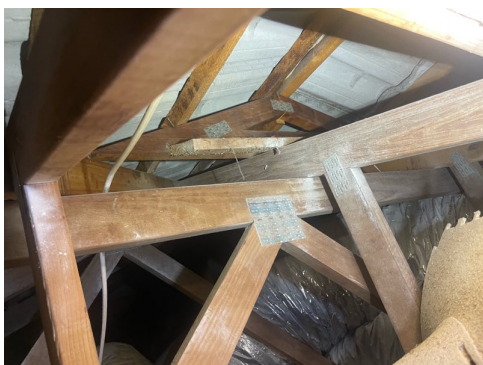
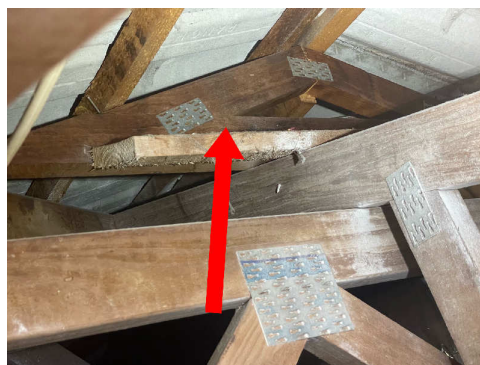
Finding 2.01

Finding: Roof Framing – Water Staining Beneath Solar Panel Fixings

Information: During the roof inspection, water staining was observed to sections of the timber framing beneath the solar panel fixing screws. The staining appears consistent with past or ongoing moisture entry at or around the roof penetrations associated with the solar panel installation.

This condition may indicate that the fixings, seals, or flashing details around the solar panel mounting points are not fully weatherproof, allowing water to track through the roof covering and affect the underlying timber members. Continued moisture ingress can contribute to deterioration of timber elements, damage to surrounding materials, and possible concealed defects if not addressed.

A suitably qualified roofing contractor and/or licensed solar installer should be engaged to assess the solar panel fixing penetrations and carry out repairs as required. The affected timber framing should also be monitored and further investigated if signs of active leakage, deterioration, or moisture persistence are identified.

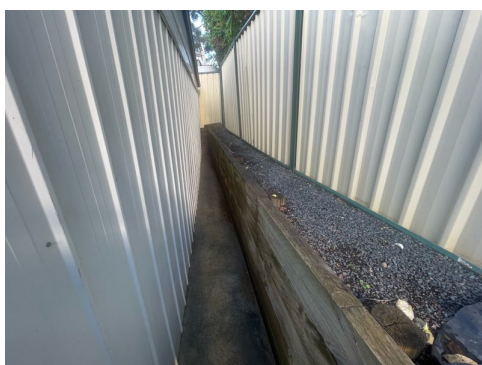
Finding 2.02

Information: During the inspection, the timber retaining wall was observed to be significantly out of plumb and leaning from its intended vertical alignment. The extent of the movement suggests that the wall may no longer be performing as intended and that visible deformation has occurred over time.

A retaining wall that is significantly leaning may indicate structural movement, inadequate support, deterioration of timber components, excessive soil pressure, poor drainage, or a combination of these factors. If left unattended, this condition may lead to further movement, loss of retaining function, and possible localised collapse of the wall and retained ground.

A suitably qualified contractor or structural engineer should be engaged to assess the retaining wall and determine the extent of movement and any necessary remedial works. This defect should be treated as a significant issue and addressed without delay.

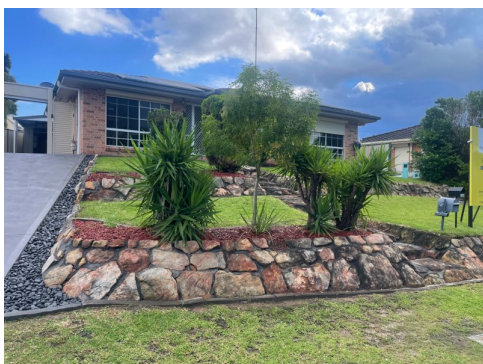
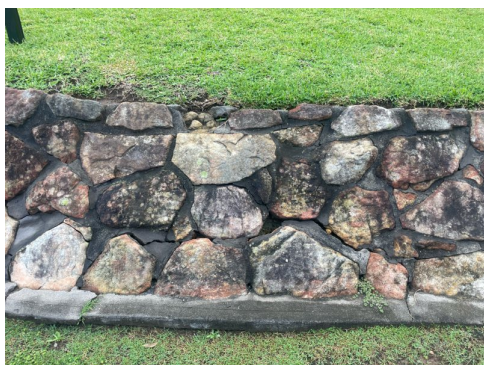
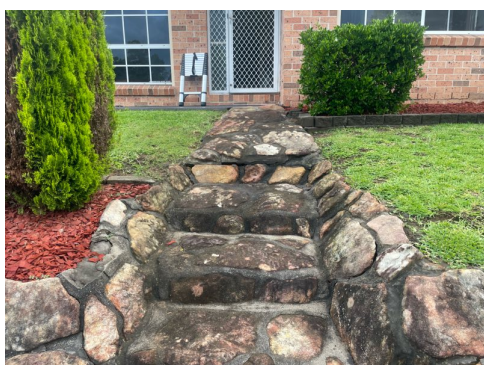
Finding 3.01

Building: Main Building
Location: Front Elevation
Finding: Stone retaining wall - Deteriorated mortar joints

The stone retaining wall located within the external landscaped area of the property was observed to have deteriorated mortar joints in several sections. The issue was more evident along the upper and exposed wall surfaces where the mortar has worn away between the stones.

The mortar joints were found to be cracked, eroded, and in some places missing, which reduces the bond strength between stones and exposes the wall to moisture entry. While the overall alignment of the wall remains satisfactory, the deterioration affects both the visual presentation and long-term durability.

The likely cause of the deterioration is prolonged exposure to weather conditions such as rain, sun, and temperature variations over time. These environmental factors gradually weaken the mortar matrix, leading to surface erosion and separation. No movement or displacement was noted at the time of inspection, indicating the wall's structure remains stable.

It is recommended that the property owner engage a qualified stonemason or landscaper to repoint and repair the affected mortar joints. Using compatible mortar materials and workmanship appropriate for stone construction will ensure durability and consistent appearance.

Although the condition is considered minor at this stage, early intervention will help prevent further weathering and potential water penetration that may eventually compromise the wall's structural performance. Regular maintenance of stone retaining walls is advised to prolong service life and maintain an acceptable standard of appearance.

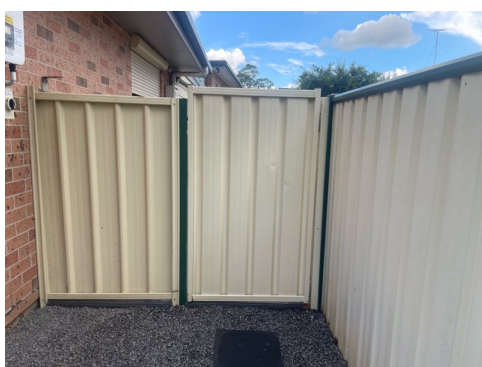
Finding 3.04

Building: Main Building
Location: Fencing
Finding: Perimeter Fence – Impact Damage

Information: During inspection, the perimeter fence, constructed from a steel frame with corrugated steel infill panels, was noted to have sustained damage due to an impact load. The affected section shows distortion and misalignment, with visible bending that reduces both its presentation and structural integrity.

The damaged area appears consistent with force applied directly to the panels and frame. This has resulted in an uneven surface and compromised finish, detracting from the overall appearance of the boundary structure.

This defect was identified along the perimeter fence during the inspection. It is recommended that a competent contractor be engaged to assess the extent of the damage and carry out necessary repairs or replacement to restore the fence to a serviceable and presentable condition.

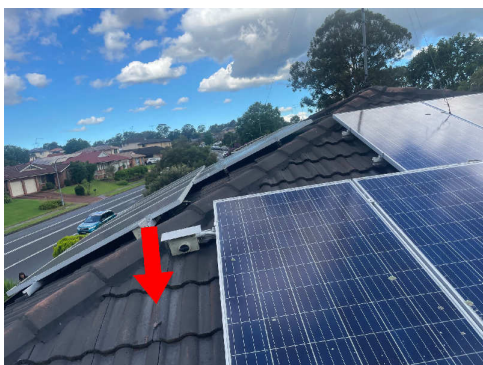
Finding 3.05

Finding: Roof tiles - Broken

Information: Upon inspection of the exterior roof covering, broken roofing tiles were identified. Broken and friable roof tiles are generally the result of ageing and weathering of what is essentially a porous material.

If left to further deteriorate, broken and brittle roof tiles are likely to lead to water penetration via the roof into the ceiling space, causing secondary damage to ceiling linings, insulation and roof structures. Broken roof tiles are also likely to detract from the effectiveness of the roof drainage system, creating potential for secondary damage to the exterior roof covering and roof plumbing.

Replacement of broken tiles is required and should be performed by a roofing contractor as soon as possible.

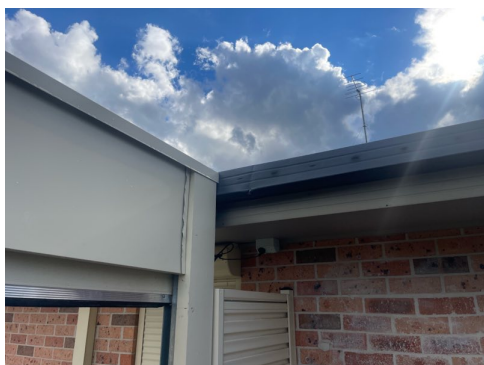
Finding 3.06

Finding: Damaged Gutters

Information: The damaged gutter at the corner junction was observed during the inspection. This issue was identified as the gutter no longer functions as intended, showing signs of deterioration that may affect stormwater drainage.

The defect is located at the corner junction of the roofline, where water flow is most concentrated. If the damage is not rectified in a timely manner, it may cause overflow and moisture ingress, leading to potential secondary defects in surrounding building elements.

It is recommended that a licensed roofing or guttering contractor be engaged to carry out the repair or replacement. Addressing this issue promptly will ensure the guttering system remains functional and helps protect the property from future water damage.

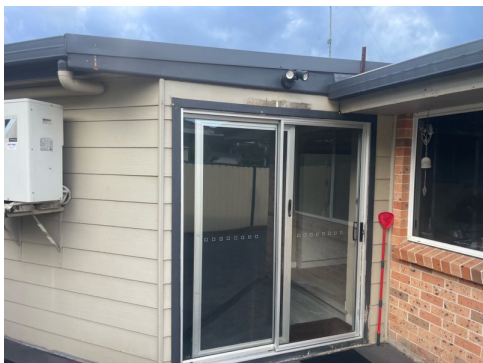
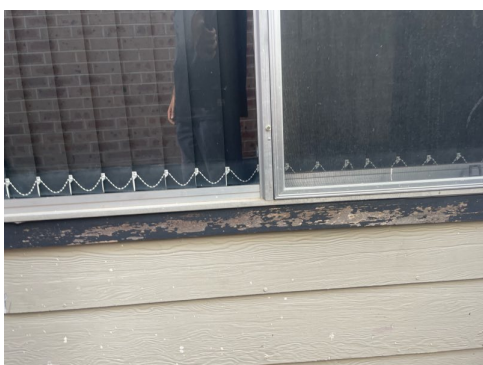
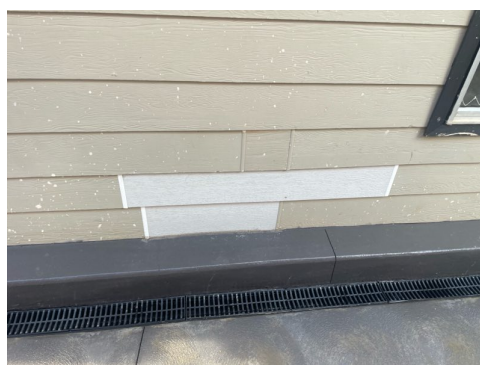
Finding 3.07

Finding: Exterior Paint – Deterioration

It is recommended that routine maintenance be carried out by a qualified painter or tradesperson to prepare and repaint the affected areas. Regular upkeep of external paintwork helps preserve the building's appearance and maintain protection against weathering.

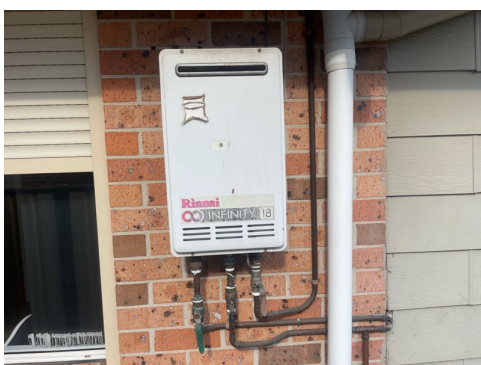
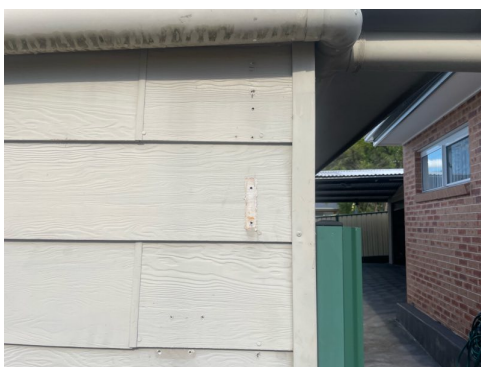
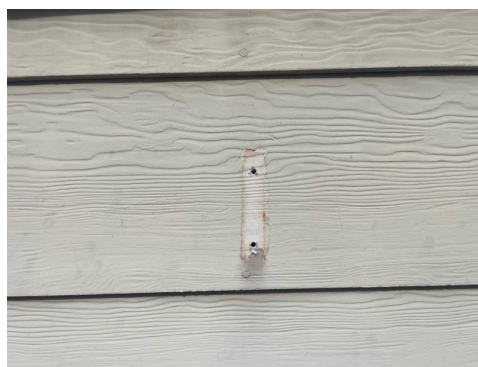
Finding 3.08

Building: Main Building
Location: Exterior walls - right side
Finding: Sealant – Damaged / Displaced

A suitably qualified contractor should be engaged to assess the affected area and replace the defective sealant as required. This item is considered a maintenance issue that should be attended to in the near future.

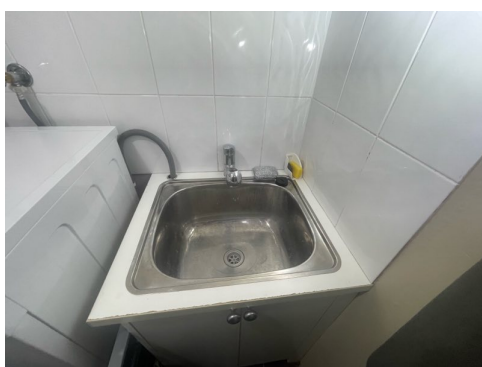
Finding 3.09

Finding: Cabinetry – Missing or Deteriorated Corner Sealant

This matter is considered a maintenance defect. It is recommended that the affected cabinetry corners be re-sealed by a suitably qualified tradesperson to restore protection and appearance.

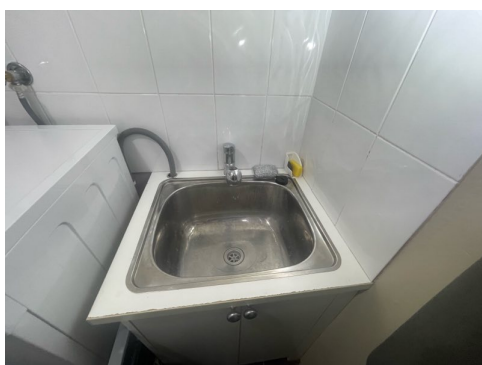
Finding 3.10

Finding: Laundry Vanity – Damaged (Scratches, Wear & Tear)

It is recommended that the client arrange further assessment and repair or replacement of the affected vanity components as required to restore function and reduce the risk of further deterioration. If water staining is active or worsening, it is also recommended that the plumbing and surrounding junctions (basin waste, taps, silicone seals, and adjacent wall/floor interfaces) be checked to confirm there is no ongoing leak contributing to the damage.

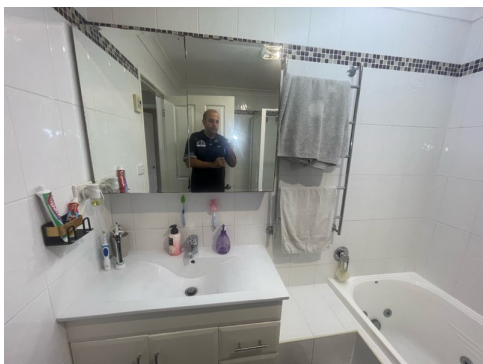
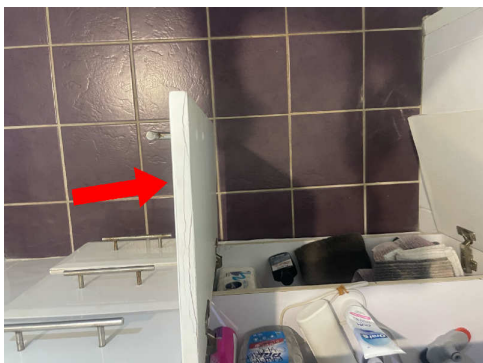
Finding 3.11

Building: Main Building
Location: Bathroom
Finding: Bathroom Vanity – Damaged (Scratches, Water Staining, Wear & Tear)

It is recommended that the client arrange further assessment and repair or replacement of the affected vanity components as required to restore function and reduce the risk of further deterioration. If water staining is active or worsening, it is also recommended that the plumbing and surrounding junctions (basin waste, taps, silicone seals, and adjacent wall/floor interfaces) be checked to confirm there is no ongoing leak contributing to the damage.

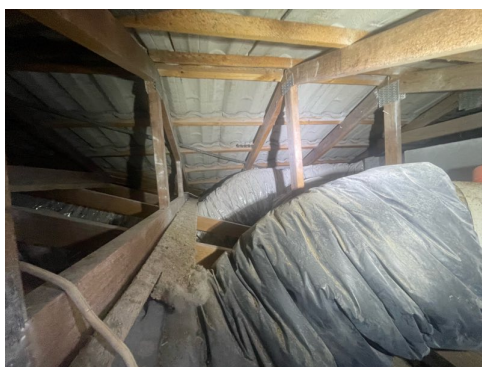
Finding 3.15

Building: Main Building
Location: Roof Void
Finding: Sarking - Missing

Sarking may be retrospectively fitted by a registered builder at the discretion of the client.

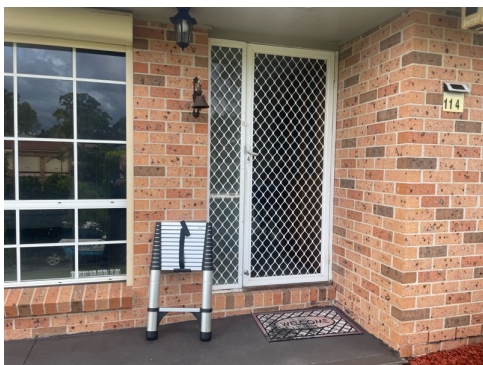
Finding 3.16

Building: Main Building
Location: Entry
Finding: Security Door - Deteriorated and Damaged Flyscreen

It is recommended that a licensed tradesperson or security door specialist be engaged to repair or replace the damaged components. Replacement of the flyscreen and servicing or replacement of the top locking jack will restore the door's functionality, appearance, and safety.

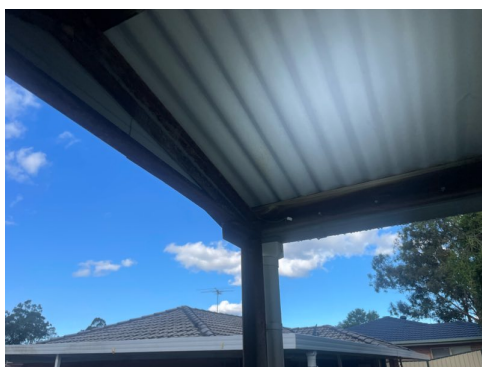
Finding 3.17

Building: Main Building
Location: Shed
Finding: Building element - Rusted or corroded

Rusting and corrosion should be managed by ideally removing or limiting the affected surface from exposure to moisture. A registered builder may be appointed to replace any building elements that have been severely affected by rust or water damage.

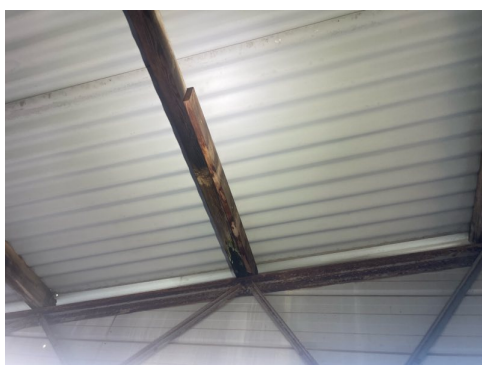
Finding 3.18

Building: Main Building
Location: Shed
Finding: Water leak - Active

It is highly advised that the cause of the leak be identified and resolved immediately by a licensed plumber to prevent any further damage. Depending on the extent of the damage previously sustained, repair and/or replacement of any affected building materials may be required.

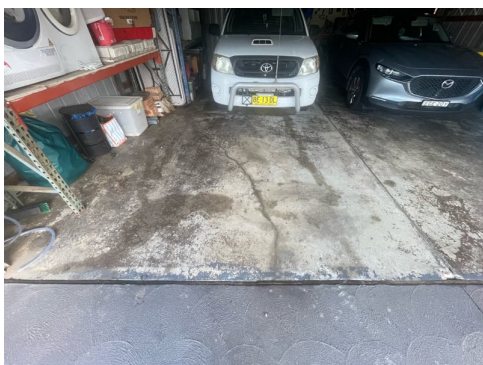
Finding 3.19

Category 1 cracks should be monitored for a period of 12 months. At the end of the monitoring period, identified cracks that are rated greater than Category 2 are considered defects, and require rectification.

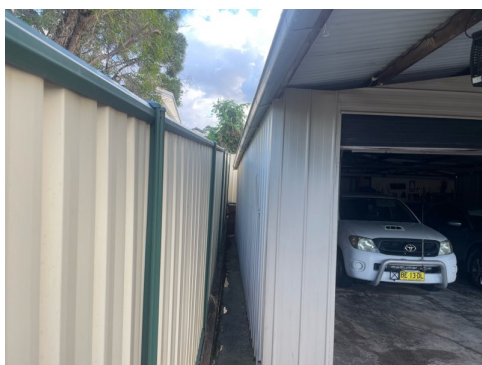
Finding 3.21

Building: Main Building
Location: Shed
Finding: Damaged Gutters

It is recommended that a licensed roofing or guttering contractor be engaged to carry out the repair or replacement. Addressing this issue promptly will ensure the guttering system remains functional and helps protect the property from future water damage.

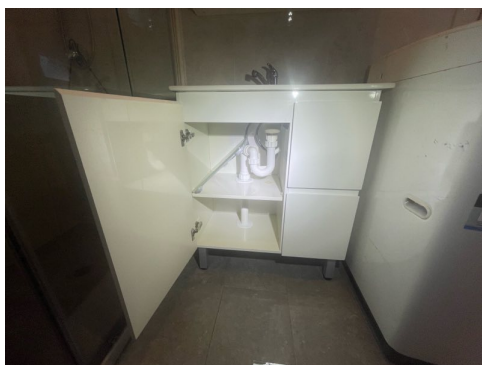
Finding 3.25

Building:	Granny-Flat
Location:	Bathroom
Finding:	Bathroom Vanity – Damaged (Water Staining, Wear & Tear)
Information:	The bathroom vanity was observed to be in a damaged condition at the time of inspection, including visible scratches to the vanity surfaces, water staining, general wear and tear. This condition affects both presentation and serviceability of the fixture.

It is recommended that the client arrange further assessment and repair or replacement of the affected vanity components as required to restore function and reduce the risk of further deterioration. If water staining is active or worsening, it is also recommended that the plumbing and surrounding junctions (basin waste, taps, silicone seals, and adjacent wall/floor interfaces) be checked to confirm there is no ongoing leak contributing to the damage.

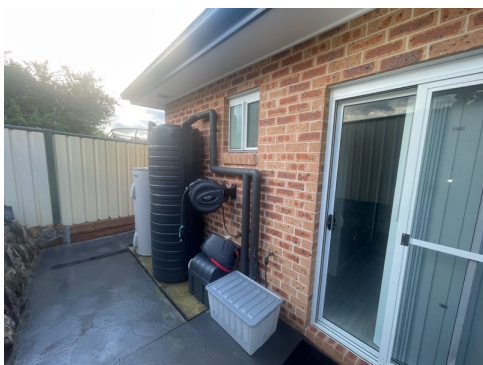
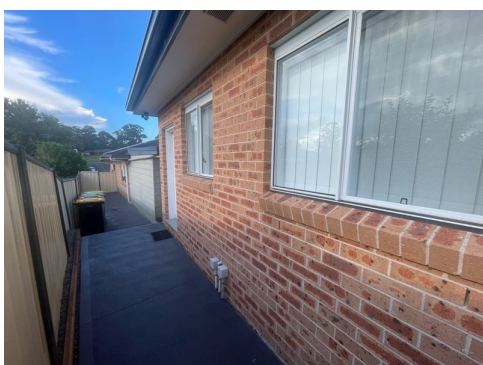
Finding 6.03

Building:	Main Building
Location:	All Areas - Slab Edge
Finding:	Slab Edge - Exposure
Information:	An inspection zone of at least 75mm in relation to the exposed slab edge, between the bottom brick and the perimeter pavement, is required. This inspection zone should be maintained in order to force termites into the open where they can be detected more readily during regular inspections. The slab edge should not be concealed by anything that may prevent inspection of the area, including render, landscaping, soil, turf, paving, concrete cladding or other structures.

Where the slab edge cannot be properly inspected, it is highly recommended that termite or timber pest inspections be carried out every 6-12 months to aid protection of the property against infestation.

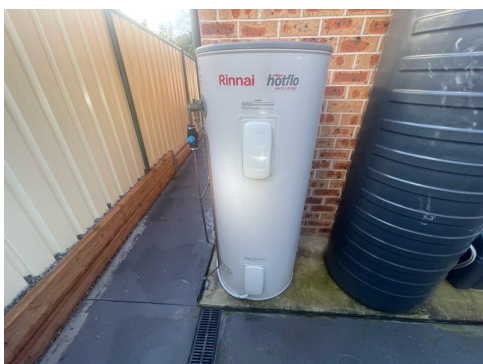
Finding 6.09

Building:	Granny-Flat
Location:	Hotwater Unit
Finding:	Overflows not plumbed to drainage
Information:	The overflow is not plumbed or connected to suitable drainage, which has resulted in the surrounding area becoming excessively damp.

It is highly recommended that a qualified plumber be appointed to install adequate drainage to the overflow. These works will ensure that the area remains dry and free of any secondary defects.

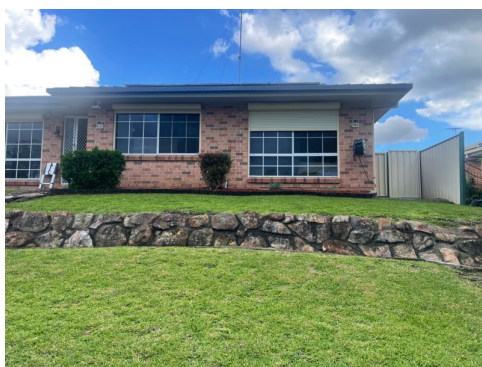
Finding 6.10

Building:	Main Building
Location:	Exterior walls - front
Finding:	Weep Holes Obstructed - Vegetation/Wood Chips/Mulch/Soil
Information:	<p>During the inspection, vegetation, wood chips, mulch, and soil were observed built up against the external brickwork, blocking the wall weep holes. These openings are critical for providing ventilation and drainage to the wall cavity, allowing any internal moisture to escape and preventing damp conditions.</p> <p>When weep holes are obstructed, airflow and drainage are reduced, causing moisture to become trapped within the wall cavity. Over time, this can lead to dampness, deterioration of materials, and potential mould development.</p> <p>Such moist and concealed conditions also create a conducive environment for termite activity, as termites are attracted to areas with constant moisture and limited visibility.</p> <p>It is a short-term priority to clear all vegetation, wood chips, mulch, and soil from around the wall base. A minimum clearance of approximately 75 mm below the lowest brick course should be maintained to restore ventilation, drainage, and visibility for ongoing termite inspection and moisture management.</p>

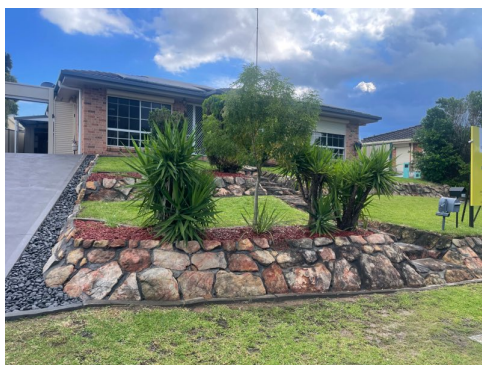
Finding 6.11

Building:	Main Building
Location:	Yard
Finding:	Large trees/stumps within 30m of house

Regular inspections are recommended. Consider test drilling any large trees. A pest controller can be contacted to carry out such testing at the owners discretion.
