Building and Timber Pest Inspection Report

Inspection Date: Thu, 19 Mar 2026

Property Address: 5/40 Liddiard St, Hawthorn VIC 3122,
Australia

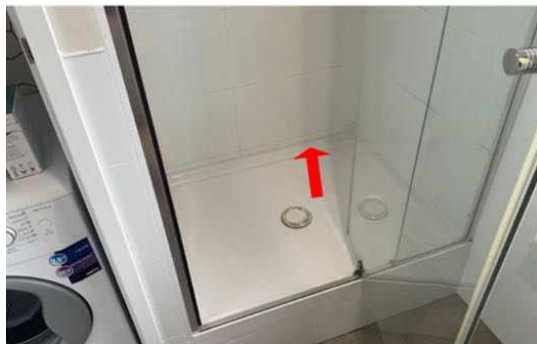
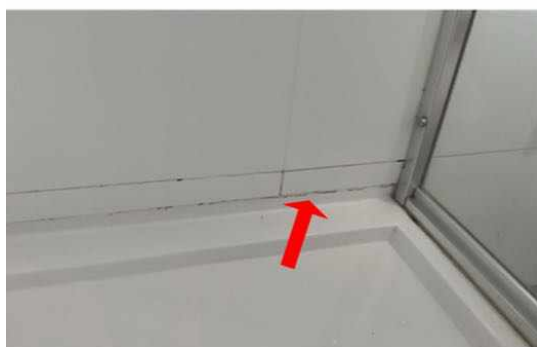
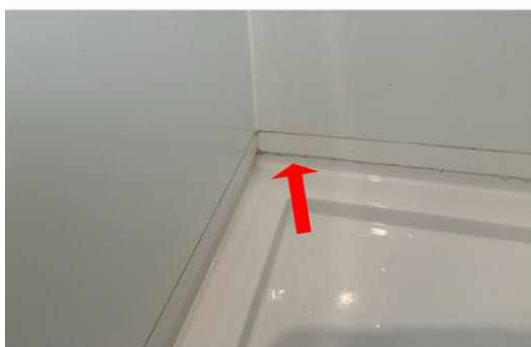
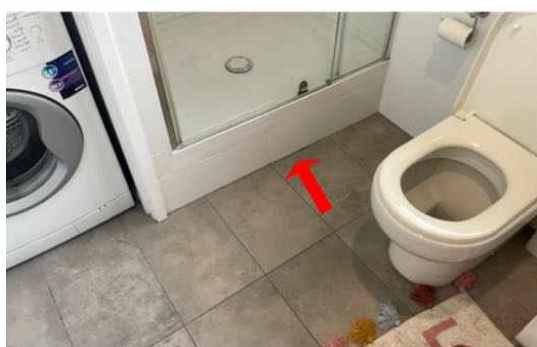
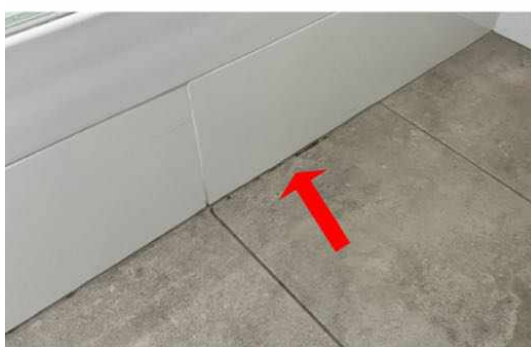
Finding: Grout and sealant - degraded within the bathroom area

Information: It was noted on inspection that grout or sealant is degraded to the shower and other areas within the bathroom.

Different materials move at different rates, generally causing cracking to grout at this point. Build up of moisture in the bathroom can also cause grout and sealants to degrade and become mouldy.

Any damaged or degraded materials should be scraped out and flexible and mould resistant materials should be applied to affected areas to prevent any subsequent water damage that may occur. Regular maintenance and replacement of damaged or missing grout/ sealant is highly recommended to the wet areas, as this is a regular wear and tear defect. Both grout and sealant in areas that come into regular contact with water should be maintained for the long term care of your property.

A bathroom specialist or tiling contractor should be appointed to complete these works as a priority.

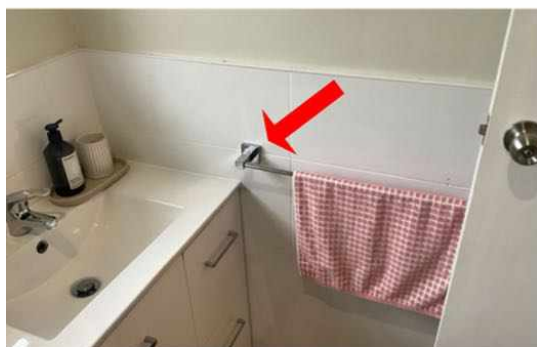
Finding 3.02

Finding: Towel rail loose

Information: At the time of inspection , the towel rail within the bathroom was loose and requires tightening.

This may be undertaken by a competent handyman.

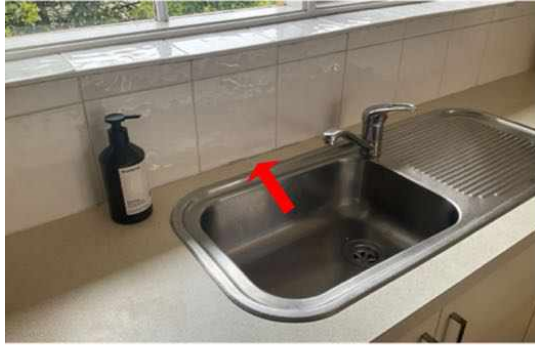
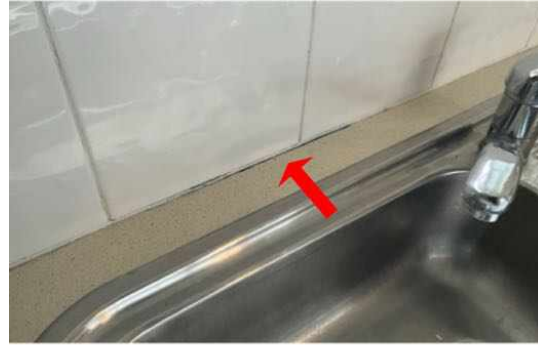
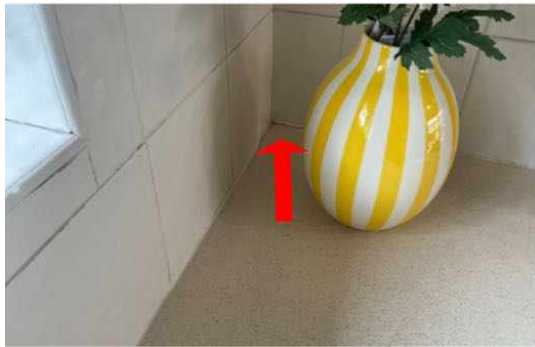
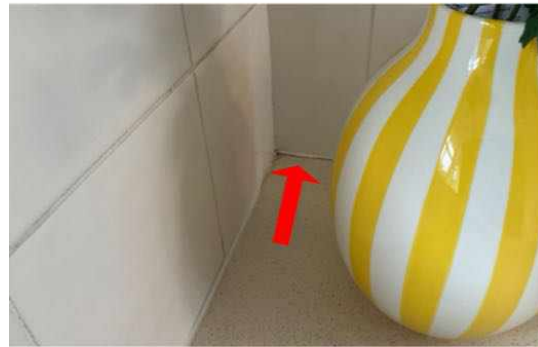
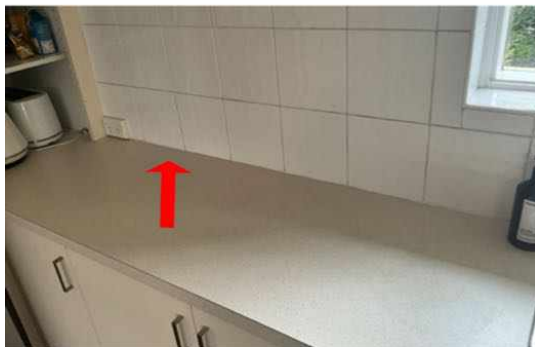
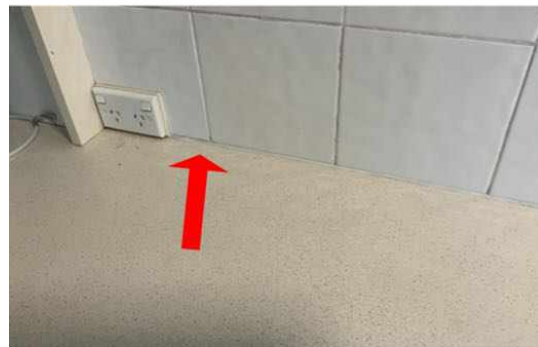
Finding: Sealant - Degraded or Missing

Information: Sealant is degraded in this area. Sealant is used to protect gaps and crevices in building materials to ensure that they are water-tight and prevent water penetration to the associated structures.

Failure to do so may lead to further deterioration of the sealant which in turn can lead to water damage to the surrounding area.

Where sealant is missing or degraded, a competent handyman may be appointed to scrape out and re-apply any silicone where necessary.

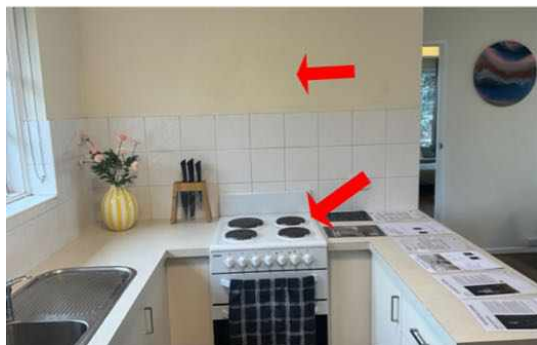
Finding 3.05

Finding: Rangehood missing

Rangehood extract steam and cooking vapours either through the roof void and outside or are filtered through charcoal filters back within the kitchen. The lack of a rangehood can cause condensation issues within the area and result in secondary moisture damage and a build up of cooking grease on ceilings

Even though this may be difficult and costly , the homeowner should look to have a rangehood installed by a licensed electrician.

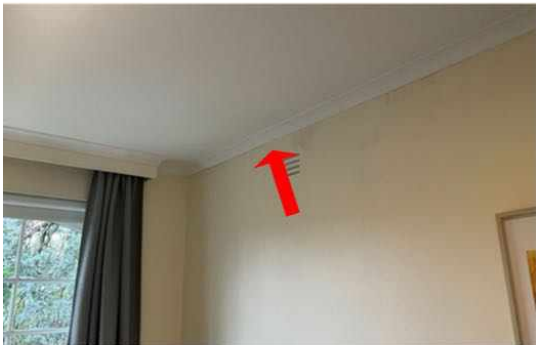
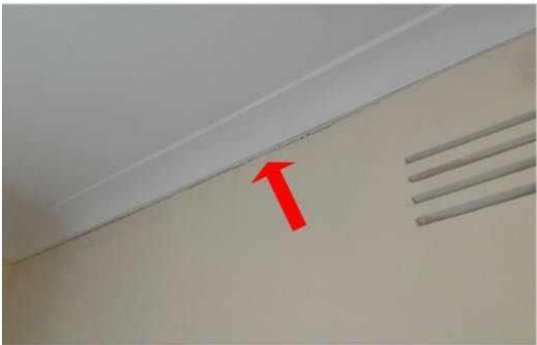
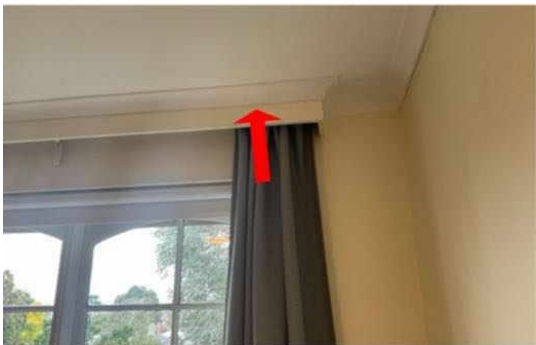
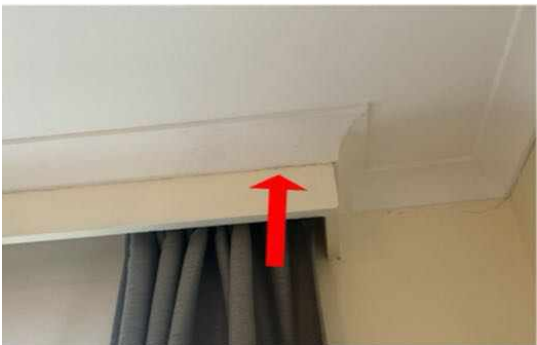
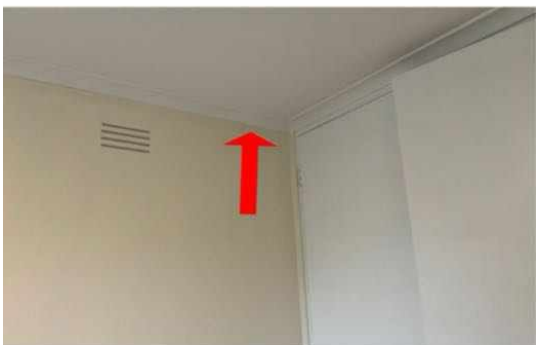
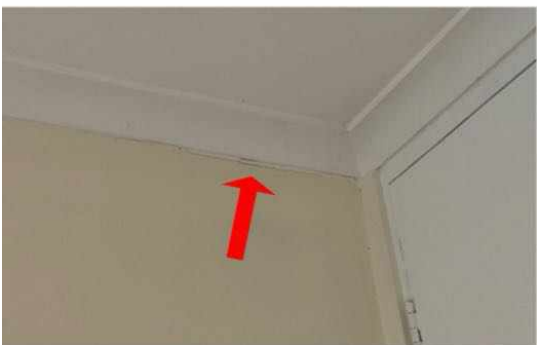
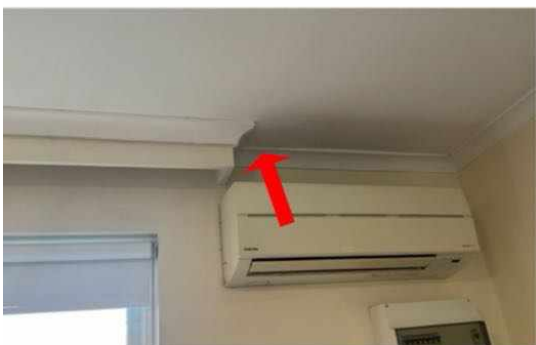
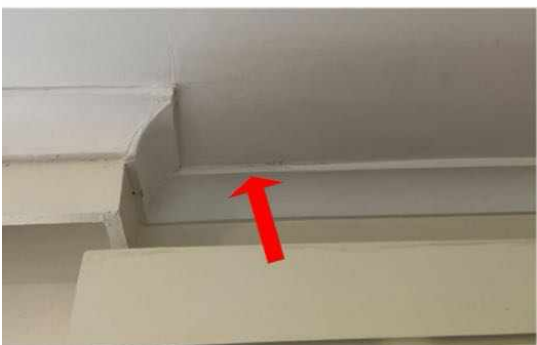
Finding 3.06

Finding: Cracking - fine

Information: Some fine cracking was noted throughout the property.

Although fine cracks are quite noticeable, they are often only considered to be an appearance defect, and usually do not indicate any structural damage. Generally, the cause of a fine crack is indicative of a separation between building materials and finishes (e.g. paint, plaster, etc.) along joints.

Cracking of this nature can generally be repaired with minor sanding, filling and/or repainting. Such works should be performed by a qualified painter or a general handyman.

Monitoring of all cracking should be conducted frequently. Always contact a building inspector should cracks widen, lengthen, or become more numerous.

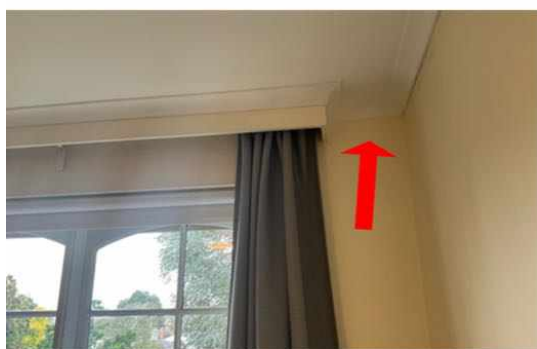
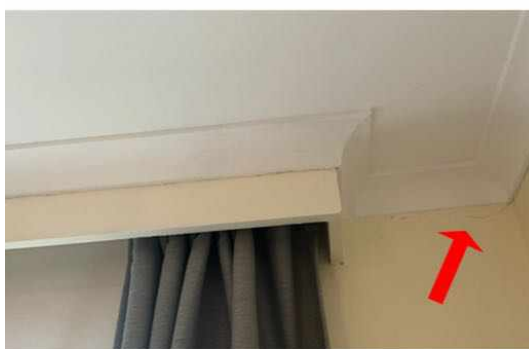
Finding 3.07

Building:
 Location: Bedroom
 Finding: Cracks to internal solid walls
 Information: It was observed that fine cracking to the solid internal wall has occurred eg where the wall meets the ceiling.

Generally, the cause of fine cracking to solid surfaces is indicative of a slight movement of the building and is very common.

Monitoring of all cracking should be conducted and should no further cracking occur, repairs may be undertaken. Cracking of this nature can generally be repaired with minor scraping, filling and/or repainting. Such works may be performed by a qualified painter or a general handyman.

Always contact a building inspector should cracks widen, lengthen, or become more numerous.

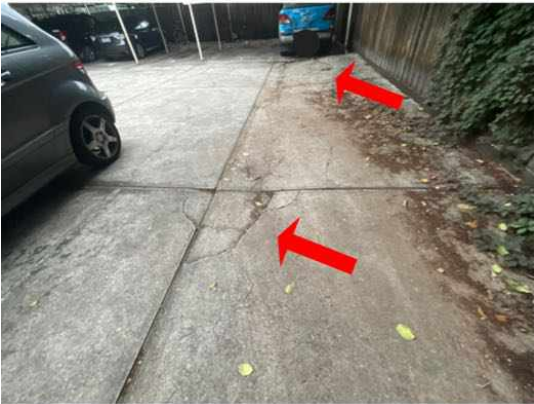
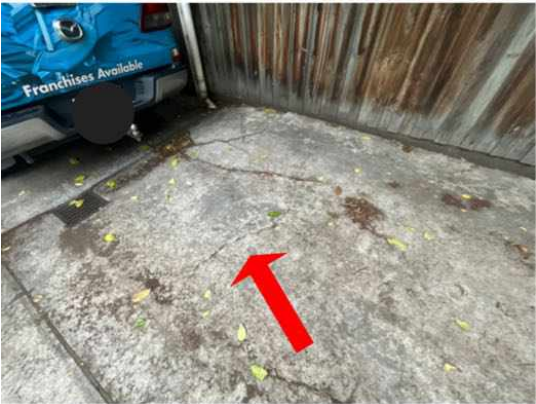
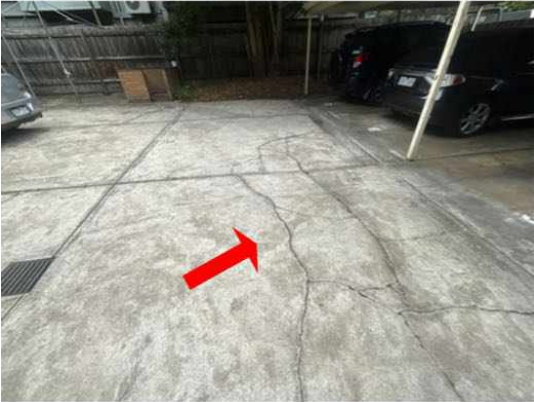
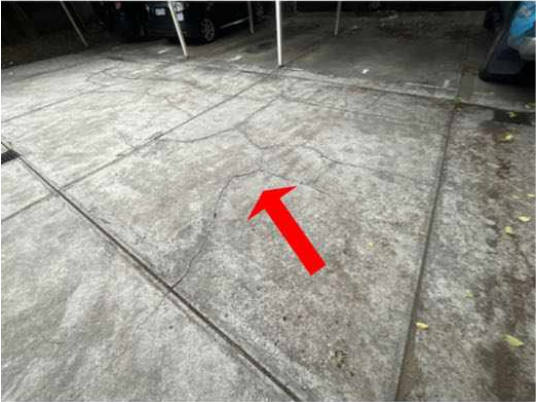
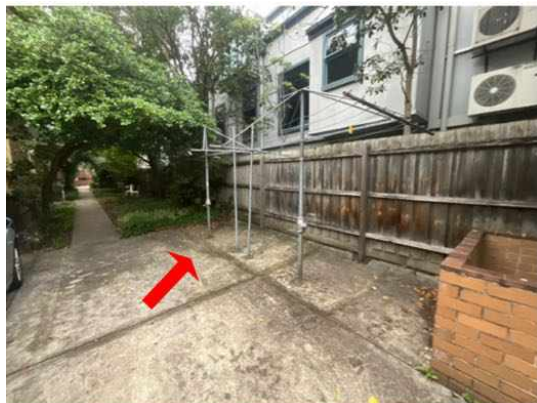
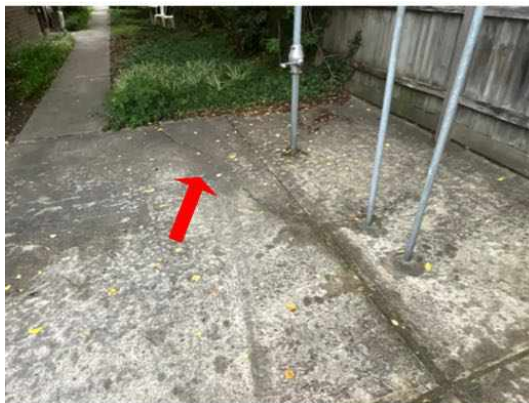
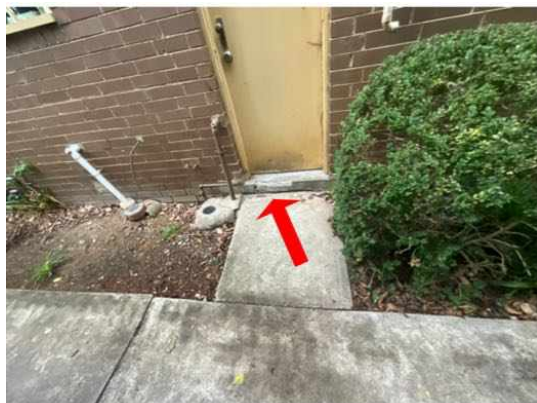
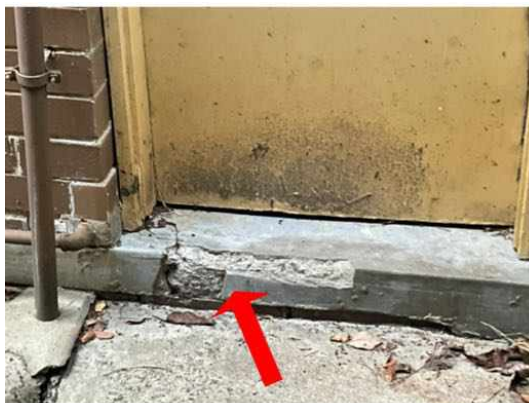
Finding 3.08

Building:
 Location: Driveway
 Finding: Cracking - Noticeable cracking to driveway paving (probable owners corporation issue)
 Information: Noticeable cracks were identified in the concrete paving of the driveway. These noticeable cracks may lead to the development of tripping hazards and secondary defects if they develop further.

General age and expected deterioration of the paved areas is a common cause of this type of cracking. However, expansion and contraction of the driveway may also have occurred due to environmental factors. Such factors include variable moisture and weather conditions, the presence of trees and their roots having a settling or lifting affect on the soil, or the effect of load bearing, e.g. heavy vehicles over a sustained

Cracking to this degree may also be due to poor original installation of the driveway. Factors such as poor compaction of the sub surface and/or inadequate reinforcing of the slab may create cracking and other secondary defects. Noticeable cracks may also be due to subsidence of soils.

The area should be monitored for any changes that may occur and potentially cause tripping hazards. Should this occur, repair or replacement of the concrete paving may be necessary.

Please note: it is suspected this would be covered by the owners corporation. Your own enquiry should be made to determine whether this is the case.

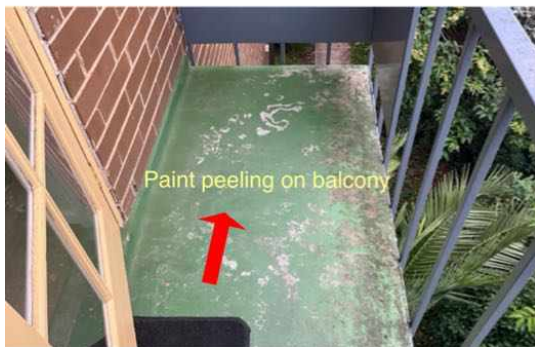
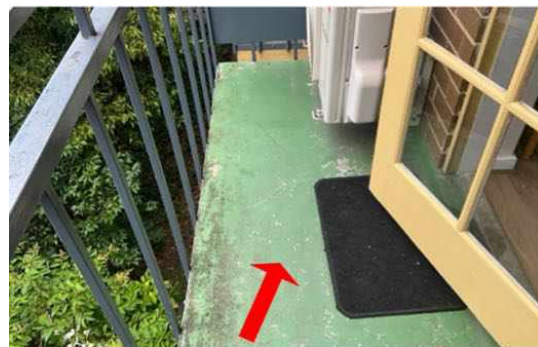
Finding: Additional Photos - minor defects

Information: Additional photos are provided for your general reference. Arrows have been included where necessary to highlight areas of importance.

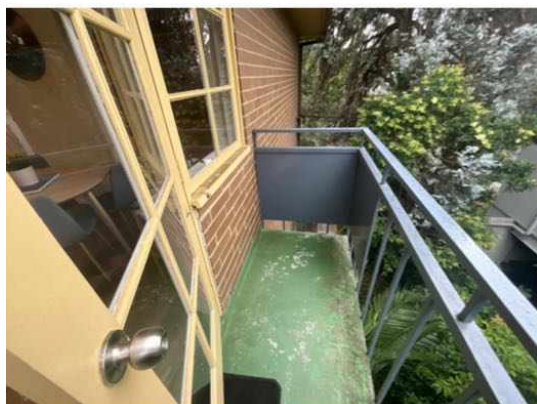
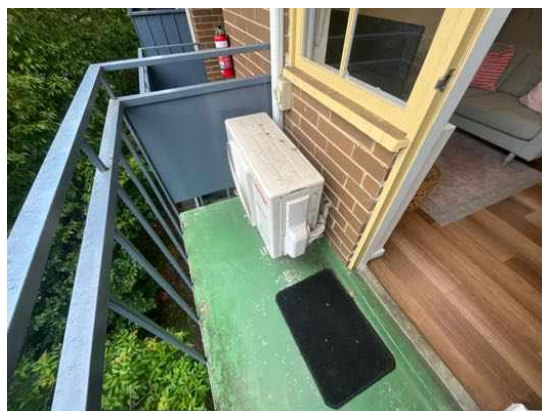
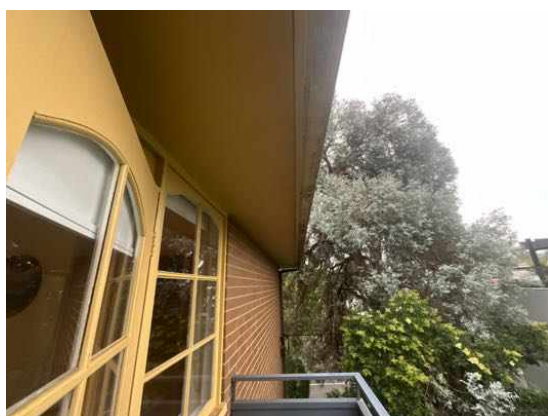
Building:
Location: Balcony
Finding: Area presented in a fair condition

Information: At the time of inspection, the area presented in a fair condition when compared with properties of a similar age.

There was some slight unevenness to the floor in this area.
