Building Inspection Report

Inspection Date: Wed, 1 Apr 2026

Property Address: 5/16-24 Merriwa St, GORDON, NSW, 2072,
Australia

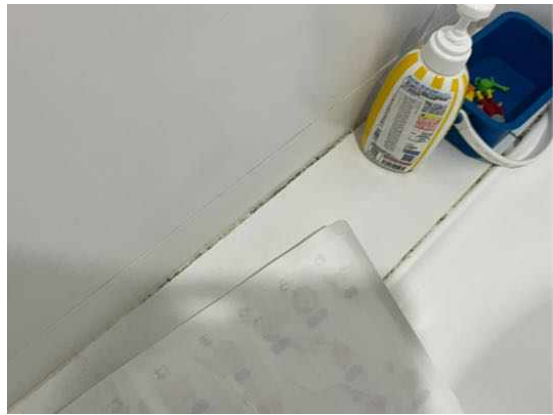
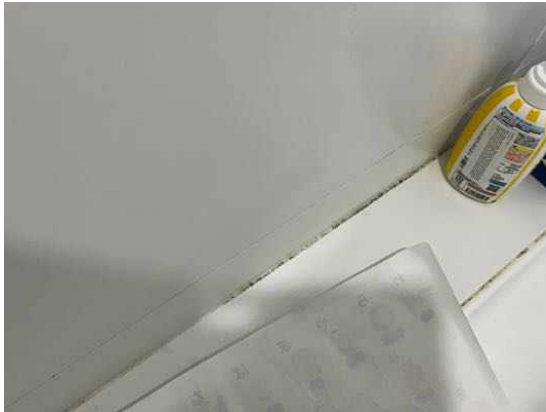
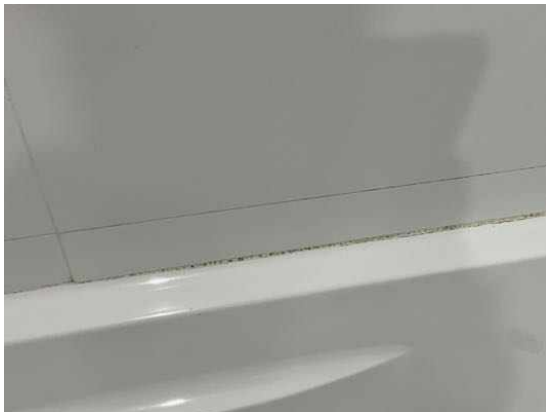
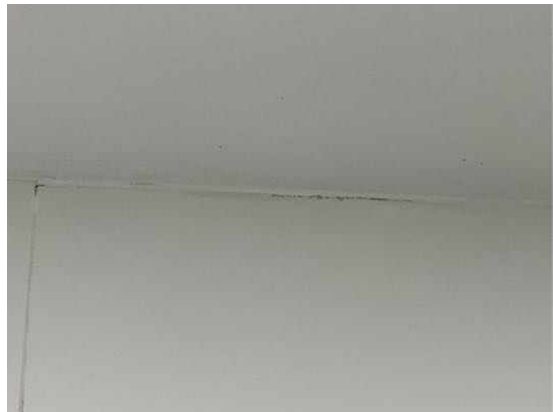
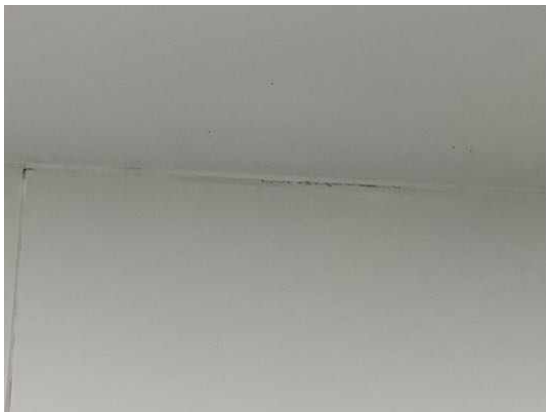
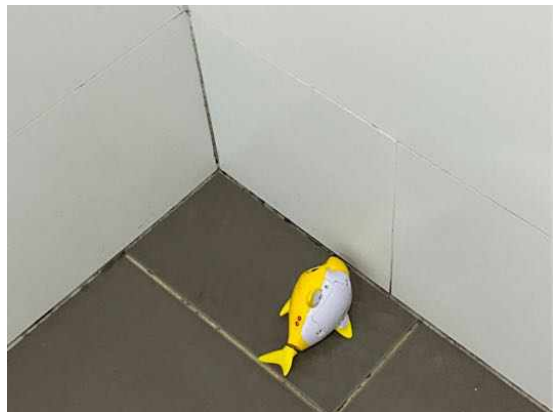
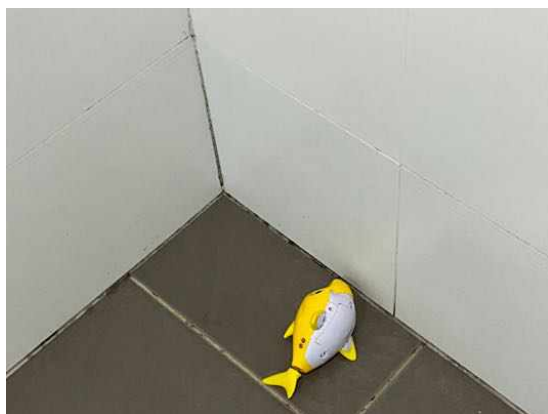
Defects 1.01

Building: Main Building
Location: Bathroom
Finding: Mould - Present
Information: Mold growth is present throughout the property, primarily due to inadequate ventilation. Poor airflow and moisture accumulation within the house have created ideal conditions for mold to thrive.

- **Health Hazards**: Mold growth can pose serious health risks to occupants, particularly those with allergies, asthma, or other respiratory conditions. Prolonged exposure to mold spores can cause respiratory issues, skin irritation, and other allergic reactions.
- **Structural Damage**: Mold can degrade building materials over time, leading to rot and weakening of the structural components such as timber, drywall, and insulation, which can result in costly repairs.
- **Decreased Property Value**: The presence of mold can significantly reduce the value of the property, as it indicates underlying moisture and ventilation issues that need addressing.

A licensed mold remediation specialist should be engaged to remove the mold and treat affected areas. In addition, a ventilation expert or builder should assess and improve the house's ventilation system, possibly installing exhaust fans, vents, or mechanical ventilation systems to ensure adequate airflow and prevent future mold growth.

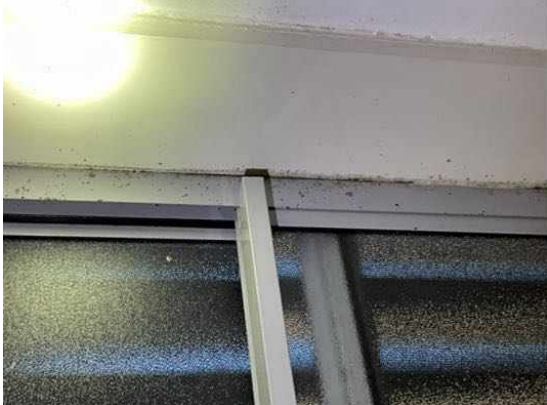
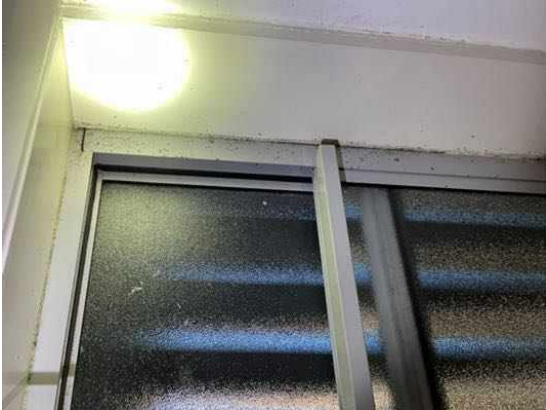
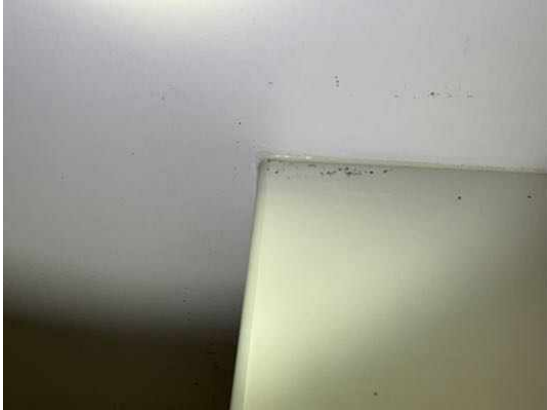
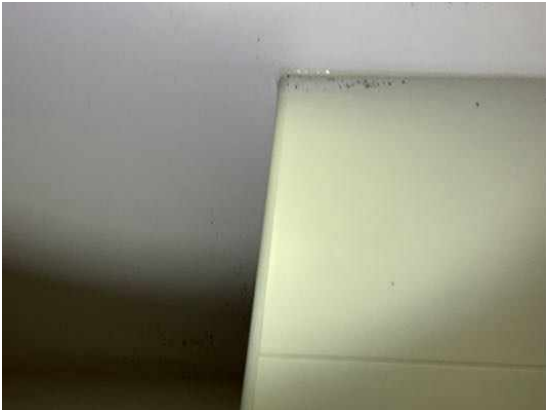
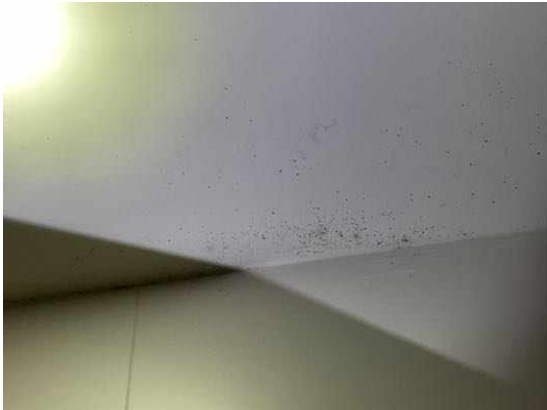
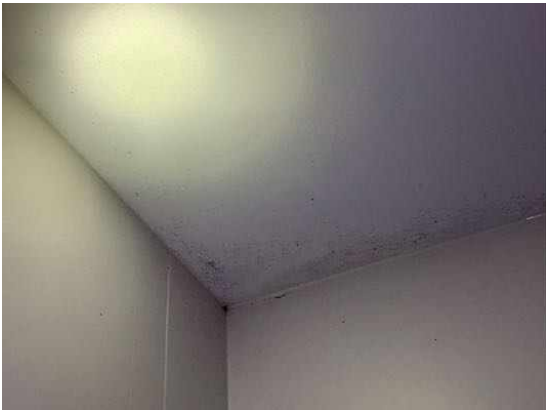
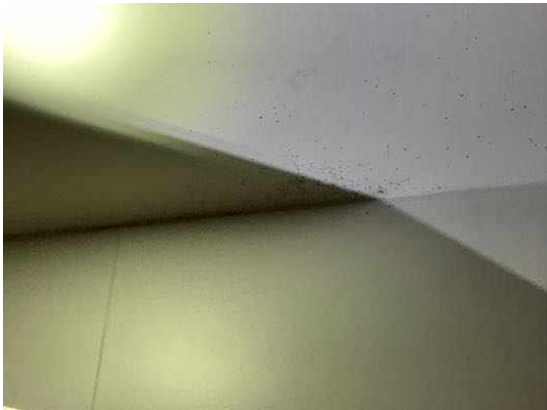
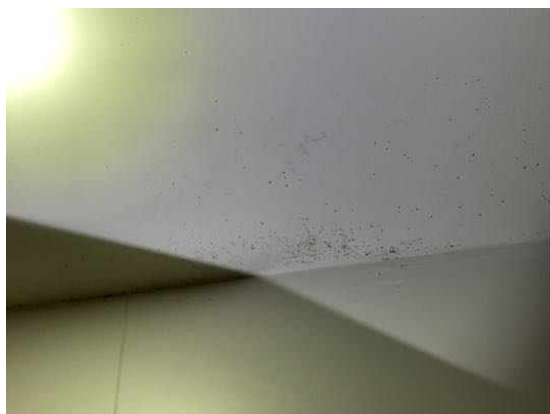
Defects 1.02

Building:	Main Building
Location:	Ensuite - Master
Finding:	Mould - Present
Information:	Mold growth is present throughout the property, primarily due to inadequate ventilation. Poor airflow and moisture accumulation within the house have created ideal conditions for mold to thrive.

- ****Health Hazards****: Mold growth can pose serious health risks to occupants, particularly those with allergies, asthma, or other respiratory conditions. Prolonged exposure to mold spores can cause respiratory issues, skin irritation, and other allergic reactions.
- ****Structural Damage****: Mold can degrade building materials over time, leading to rot and weakening of the structural components such as timber, drywall, and insulation, which can result in costly repairs.
- ****Decreased Property Value****: The presence of mold can significantly reduce the value of the property, as it indicates underlying moisture and ventilation issues that need addressing.

A licensed mold remediation specialist should be engaged to remove the mold and treat affected areas. In addition, a ventilation expert or builder should assess and improve the house's ventilation system, possibly installing exhaust fans, vents, or mechanical ventilation systems to ensure adequate airflow and prevent future mold growth.

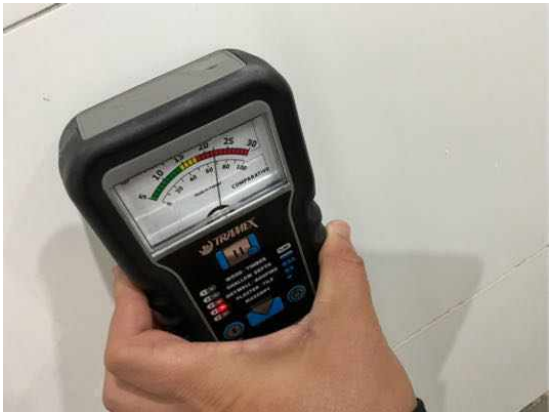
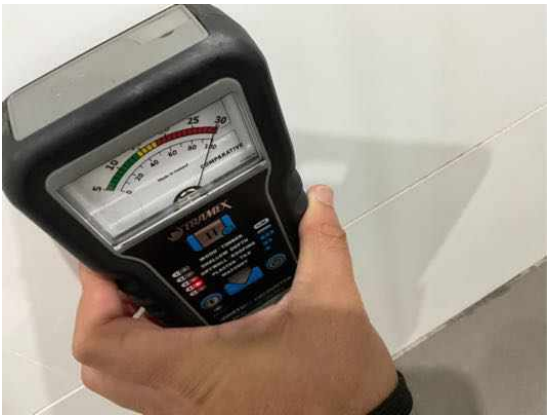
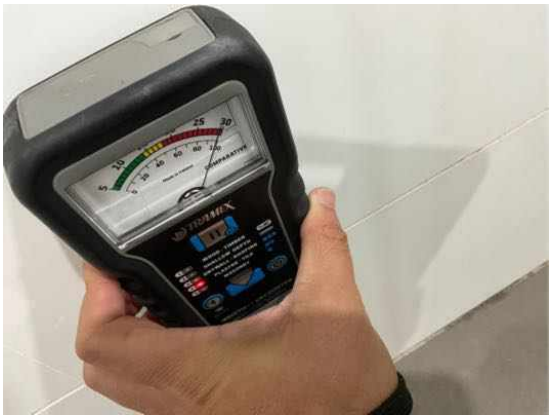
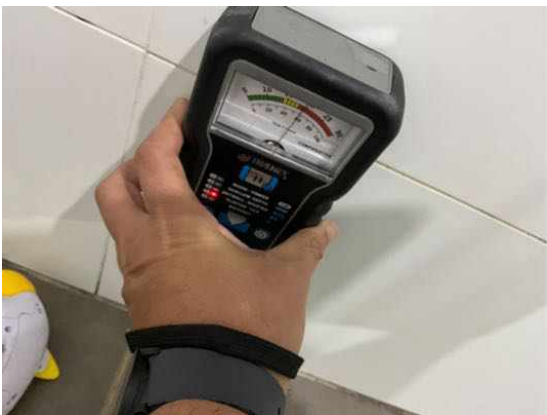
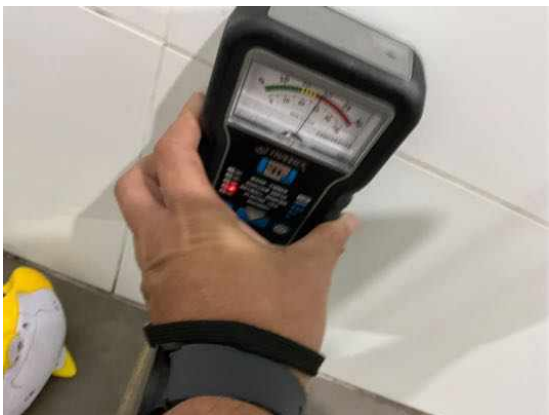
Defects 2.01

Building: Main Building
 Location: Bathroom
 Finding: Evidence of excessive moisture was present at the time of inspection
 Information: Excessive moisture is present behind the bathroom tiles, indicating a potential water leakage issue within the wall.

The prolonged presence of moisture can lead to mold growth, deteriorate the

structure, and create an environment conducive to health hazards. Additionally, it may compromise the adhesive holding the tiles, leading to their detachment.

A licensed plumber or a qualified contractor specializing in water damage remediation should investigate the source of the moisture, fix any leaks, and address the damage. Additionally, replacing affected tiles and ensuring proper waterproofing are crucial to preventing future issues.

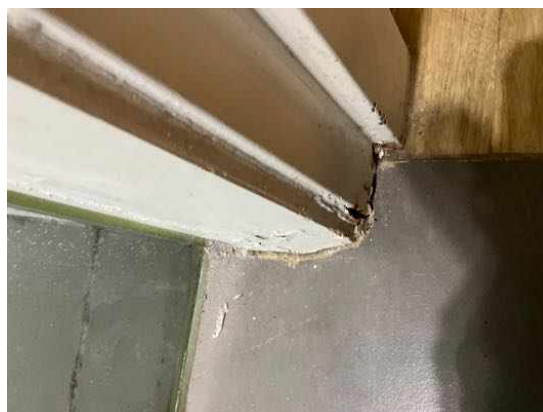
Defects 2.02

Building: Main Building
Location: Bathroom
Finding: Door Water damage
Information: The door in the area has sustained water damage, resulting in swelling and discoloration of the wood, as well as potential structural issues. This damage compromises both the aesthetic and functional aspects of the vanity."

1. **Carpenter or Woodworker:** They can assess and repair the damage to the vanity, potentially replacing any irreparable parts.
2. **Plumber:** If the water damage is due to plumbing issues, a plumber can fix leaks and ensure there are no further water-related problems.
3. **General Contractor:** If the damage is extensive and affects the surrounding area, a general contractor can coordinate the repair work, including both the vanity and any related structural or cosmetic repairs.

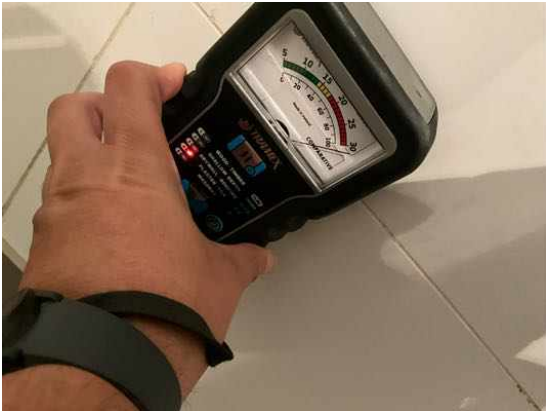
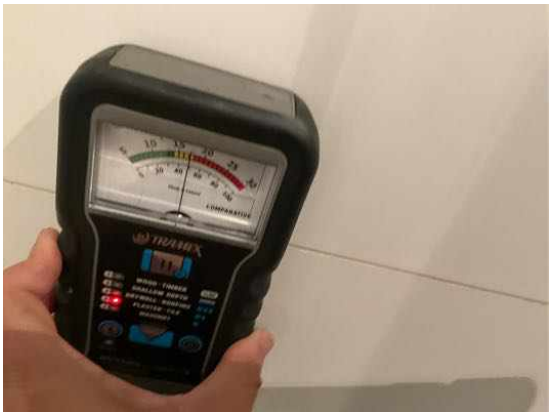
Defects 2.03

Building: Main Building
Location: Ensuite - Master
Finding: Evidence of excessive moisture was present at the time of inspection
Information: Excessive moisture is present behind the bathroom tiles, indicating a potential water leakage issue within the wall.

The prolonged presence of moisture can lead to mold growth, deteriorate the structure, and create an environment conducive to health hazards. Additionally, it may compromise the adhesive holding the tiles, leading to their detachment.

A licensed plumber or a qualified contractor specializing in water damage remediation should investigate the source of the moisture, fix any leaks, and address the damage. Additionally, replacing affected tiles and ensuring proper waterproofing are crucial to preventing future issues.

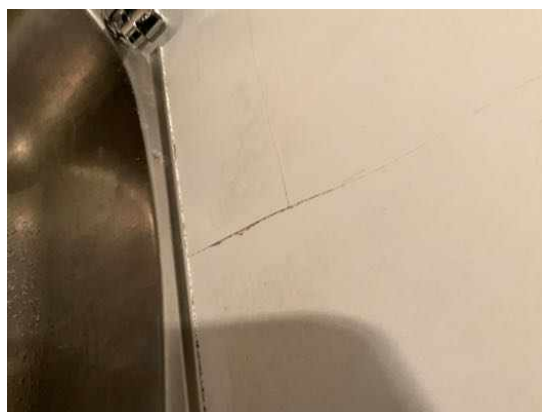
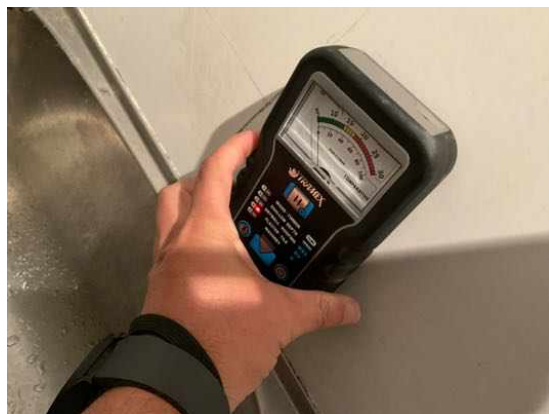
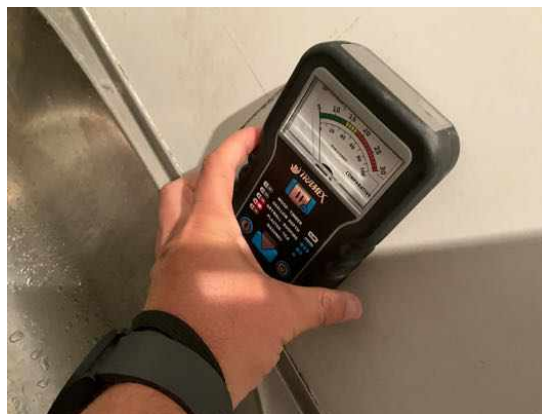
Defects 3.02

Building: Main Building
 Location: Laundry
 Finding: Tiles - Cracked or damaged
 Information: Cracking was evident to the tiling in this area at the time of inspection. While the

cracking appears to be minor, this area is frequently exposed to water, allowing potential for water penetration into adjoining sections of walls or flooring.

If left unmanaged, water penetration to these areas may lead to subsequent water damage, which is likely necessitate repair work to affected building elements.

A tiling contractor should be appointed to ensure that no further water damage occurs. The re-application of silicone and grouting throughout remaining tile work is also advised, to further protect the area against water penetration.

Where water penetration has led to water damage, appointment of a relevant tradesperson may be required to repair damaged building elements.

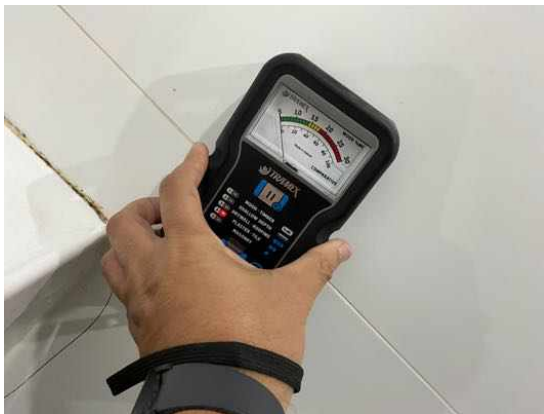
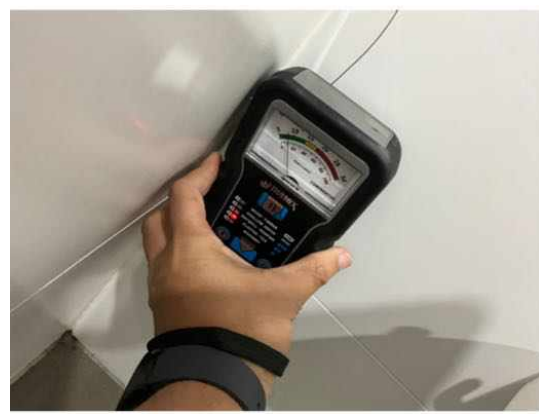
Defects 3.03

Building:	Main Building
Location:	Bathroom
Finding:	Tiles - Cracked or damaged
Information:	Cracking was evident to the tiling in this area at the time of inspection. While the cracking appears to be minor, this area is frequently exposed to water, allowing potential for water penetration into adjoining sections of walls or flooring.

If left unmanaged, water penetration to these areas may lead to subsequent water damage, which is likely necessitate repair work to affected building elements.

A tiling contractor should be appointed to ensure that no further water damage occurs. The re-application of silicone and grouting throughout remaining tile work is also advised, to further protect the area against water penetration.

Where water penetration has led to water damage, appointment of a relevant tradesperson may be required to repair damaged building elements.

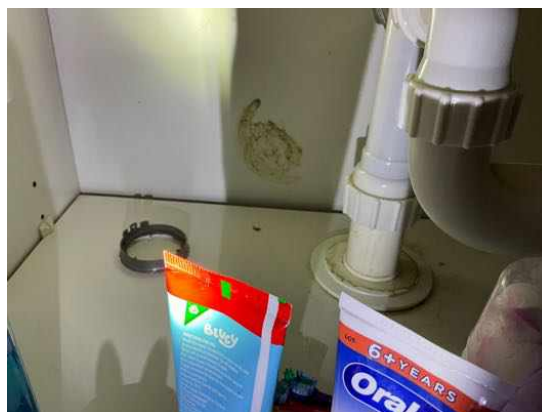
Defects 3.04

Building:	Main Building
Location:	Bathroom
Finding:	Water Stains in Vanity
Information:	“Water stains observed in the vanity area, compromising its appearance and potentially causing damage.”

Continued water exposure may lead to material damage, mold growth, and diminished aesthetic appeal.

A licensed plumber or maintenance professional should assess and fix any leaks contributing to the water stains, while a cleaning or restoration service may be needed to address the visible stains and prevent further damage.

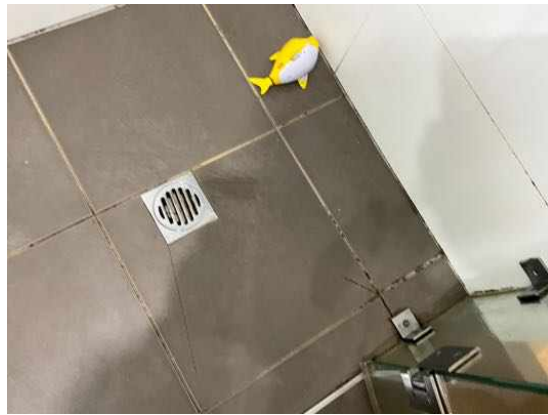
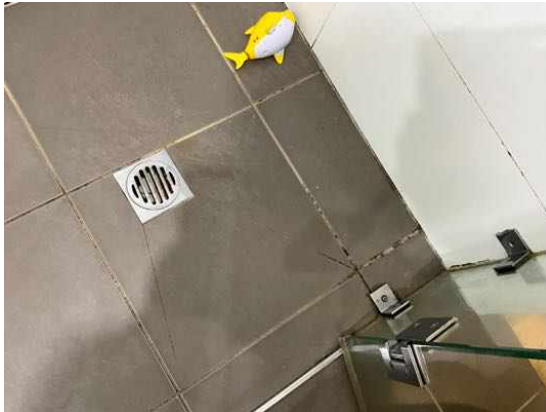
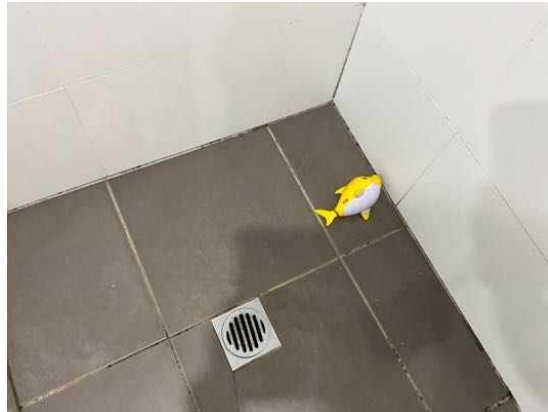
Defects 3.05

Building:	Main Building
Location:	Bathroom
Finding:	Sealant and grouting - Missing or damaged
Information:	It was noted on inspection that sealant or grout is degraded to the tiled shower alcove and or other areas of the bathroom.

Different materials and floor areas move at different rates, generally causing cracking to grout or sealant at this point. A flexible sealant is required to allow for expected expansion and contraction, while keeping the joint water tight and protective of all associated building materials.

There appears to be excessive mould to the sealant and grout which will likely require scraping out and replacement.

Flexible and mould resistant materials should be applied to affected areas to prevent any subsequent water damage that is likely to occur. Regular maintenance and replacement of damage or missing or damaged sealant and grout is highly recommended to the wet areas, as this is a regular wear and tear defect. Sealant and grouting in areas that come into regular contact with water should be maintained for the long term care of your property.

A sealant specialist or tiling contractor should be appointed to complete these works as soon as possible

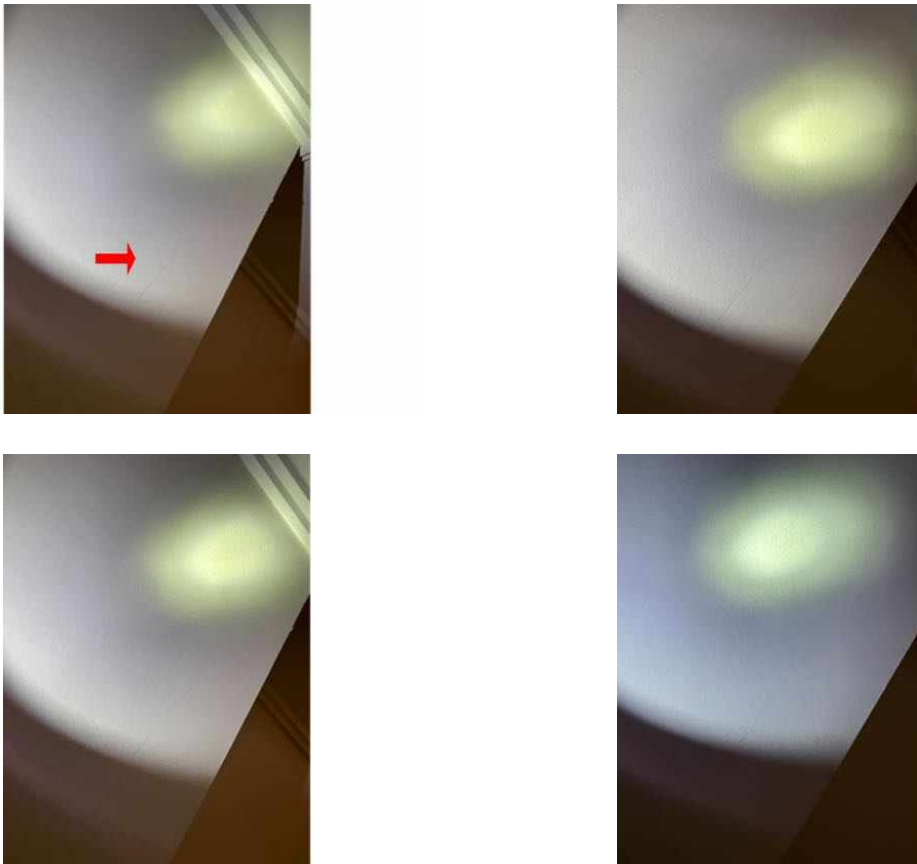
Defects 3.06

Finding: Brickwork - Cracking [Fine]

Information: Although fine cracks are quite noticeable, they are often only considered to be an appearance defect and usually do not indicate any structural damage. Generally, the cause of a fine crack is indicative of a separation between brickwork and mortar throughout the structure, but single bricks may also show cracks of this nature.

Cracking of this nature can generally be repaired with minor filling and should be conducted by a qualified bricklayer.

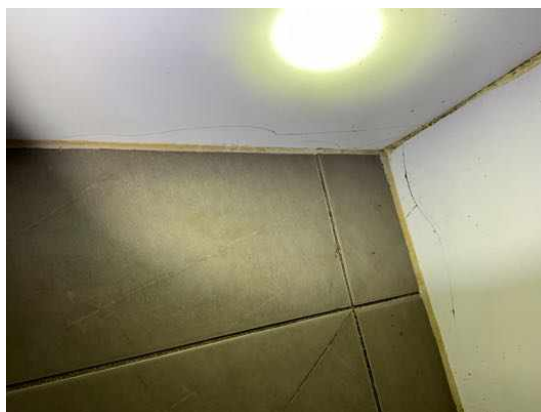
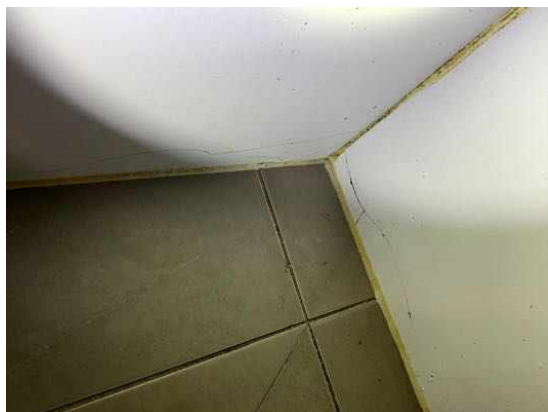
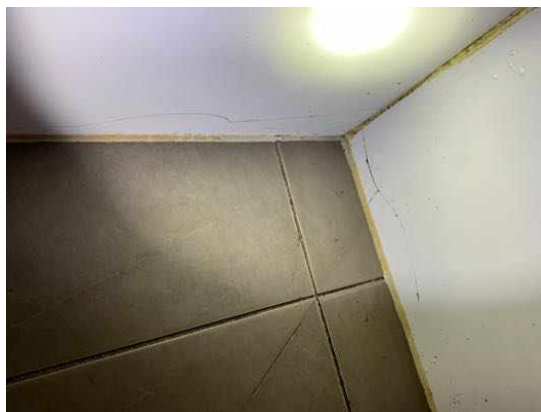
Defects 3.07

Building:	Main Building
Location:	Ensuite - Master
Finding:	Tiles - Cracked or damaged
Information:	Cracking was evident to the tiling in this area at the time of inspection. While the cracking appears to be minor, this area is frequently exposed to water, allowing potential for water penetration into adjoining sections of walls or flooring.

If left unmanaged, water penetration to these areas may lead to subsequent water damage, which is likely necessitate repair work to affected building elements.

A tiling contractor should be appointed to ensure that no further water damage occurs. The re-application of silicone and grouting throughout remaining tile work is also advised, to further protect the area against water penetration.

Where water penetration has led to water damage, appointment of a relevant tradesperson may be required to repair damaged building elements.

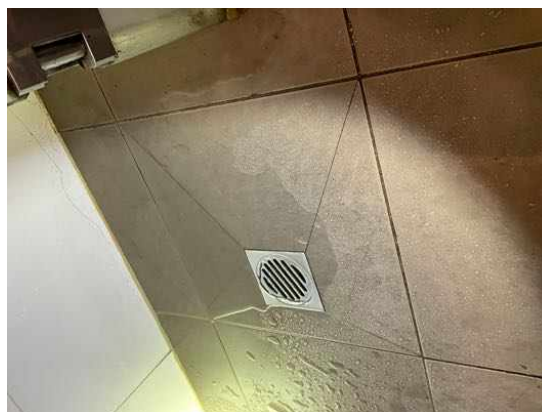
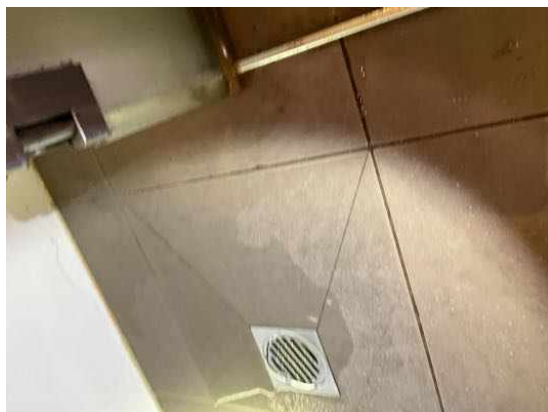
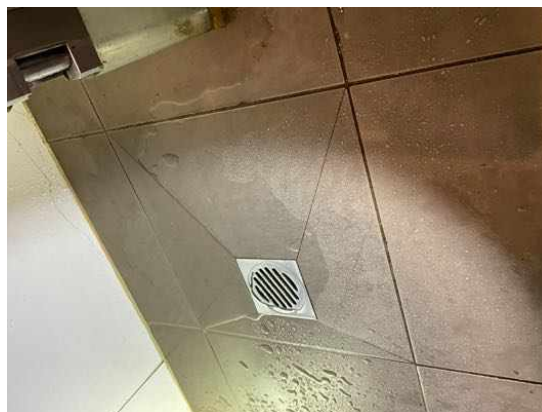
Defects 3.08

Building:	Main Building
Location:	Ensuite - Master
Finding:	Shower base - Water pooling
Information:	Evidence of water pooling around the floor waste in the shower recess was noticed at the time of inspection. It is suspected that this excessive moisture is attributed to insufficient fall in the shower floor tiles.

This pooling is minor overall but is still considered unsatisfactory, as standard tiling practices would not permit this situation to occur. Pooling water around floor wastes can create a slip hazard in extreme cases and create conditions that are conducive to mould growth over time. Where left unmanaged, the degradation of sealant and grouting is also likely to occur, possibly necessitating further repair works.

Remedial works may involve some sections of tiling and flooring repair and replacement. A tiling contractor or bathroom specialist should be appointed to provide further advice on reparation options and to perform works as necessary.

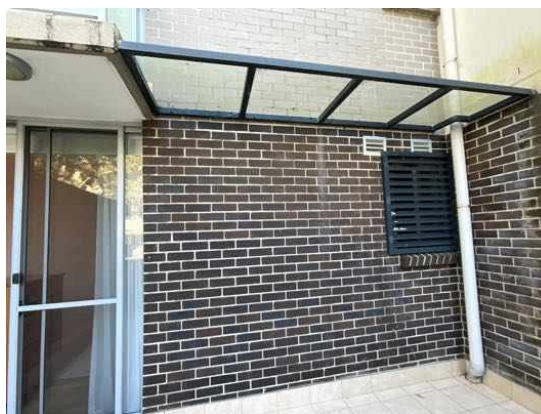
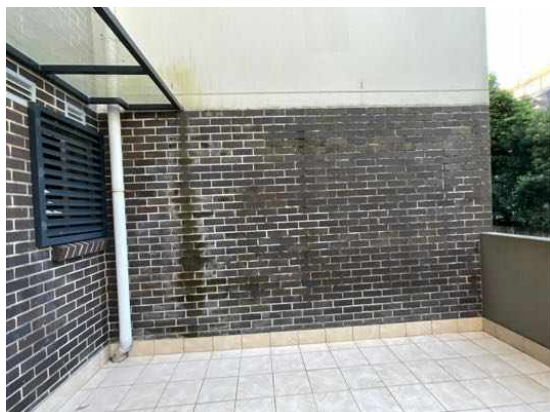
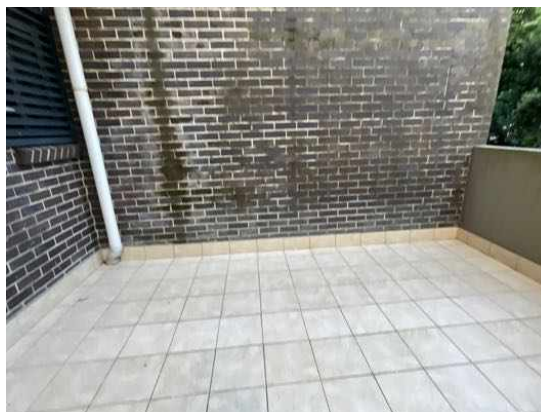
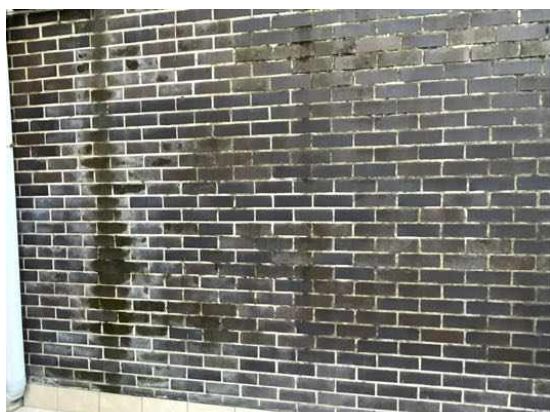
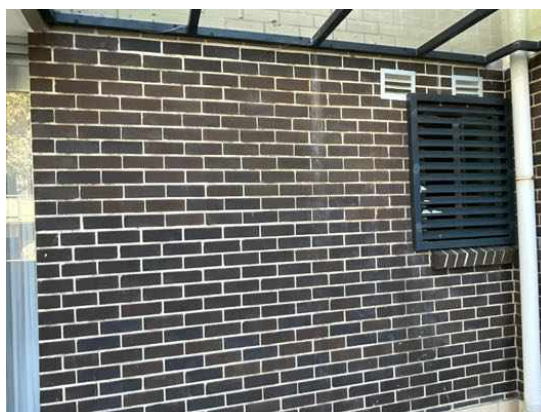
Defects 3.09

Building: Main Building
 Location: Courtyard Yard 1
 Finding: Water staining
 Information:

Water staining was evident in this area at the time of inspection. Water staining indicates that surfaces have been exposed to excessive moisture over time. The minerals and other elements in the water lead to staining, which may graduate to corrosion and deterioration if left unmanaged.

While mostly an appearance defect, water staining can be indicative of more serious defects, which may be currently concealed by other building elements.

Where water staining is active, a licensed plumber must be consulted to identify the cause of the staining and to provide advice on any reparation works that may be required. Replacement of any broken or damaged structures is advised.

Conversely, where water staining is old and inactive, affected building materials may be repaired or replaced at client discretion. A qualified carpenter or registered builder may be appointed to perform these works.

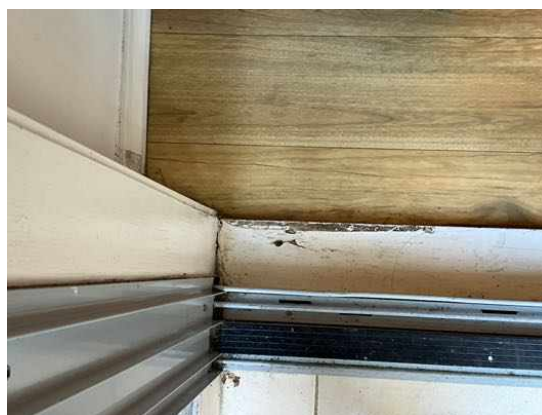
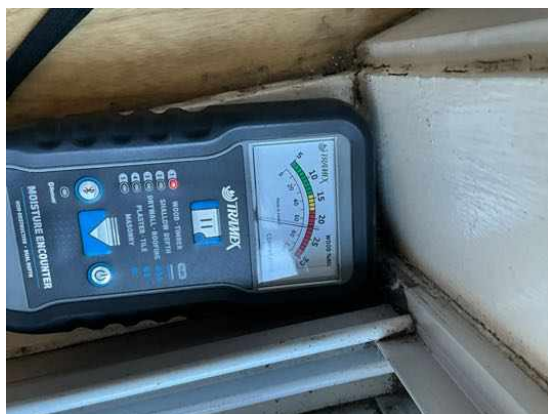
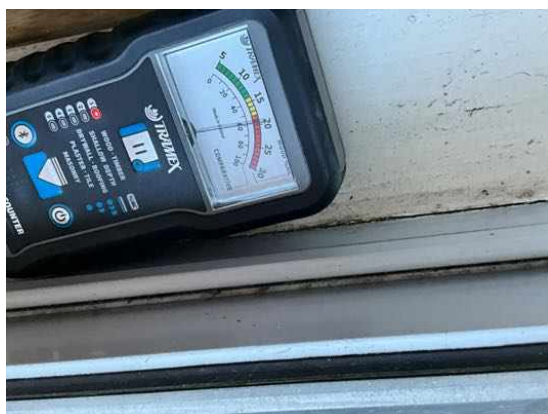
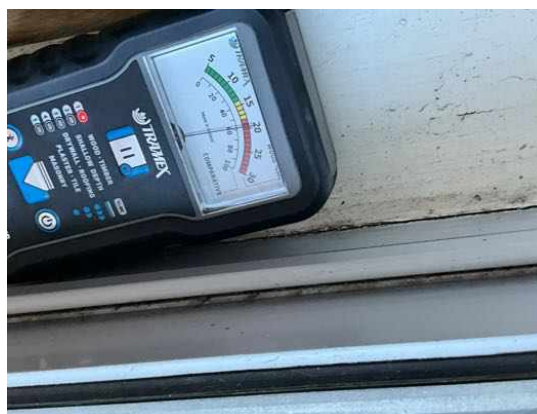
Defects 3.10

Building:	Main Building
Location:	Bedroom - Master
Finding:	Excessive Moisture in Timber Frame at Time of Inspection
Information:	The timber frame exhibits signs of excessive moisture during the inspection. This condition may result from leaks, condensation, poor sealing, or inadequate drainage around the area.
Risk:	<ul style="list-style-type: none"> • Structural Damage: Persistent moisture can lead to rot, warping, or deterioration of the timber, compromising the structural integrity and functionality of the window

- **Mold and Mildew Growth:** Excessive moisture promotes the growth of mold and mildew, which poses health risks to occupants and can require extensive and costly remediation efforts.
- **Energy Efficiency:** Damaged window frames can lead to gaps and air leaks, reducing the energy efficiency of the building and increasing heating and cooling costs.
- **Aesthetic Impact:** Moisture damage can cause discoloration, paint peeling, and an overall unsightly appearance, diminishing the visual appeal of the property.
- **Decreased Durability:** The lifespan of the window frame is significantly reduced when exposed to high moisture levels, leading to premature failure and higher maintenance costs.

- **Window Specialist:** A timber frame specialist can assess and repair the frame, ensuring proper sealing and drainage.
- **Carpenter or General Contractor:** For significant structural repairs or replacement of the timber window frame, a skilled carpenter or general contractor should be engaged.
- **Plumber:** If the moisture source is due to plumbing leaks, a licensed plumber should be consulted to address the issue.
- **Mold Remediation Specialist:** If mold or mildew is present, a mold remediation specialist should be contacted to safely treat and remove the mold.
- **Restoration Specialist:** For comprehensive drying and restoration services, a restoration specialist can provide professional solutions to dry out the timber window frame and prevent future moisture problems.

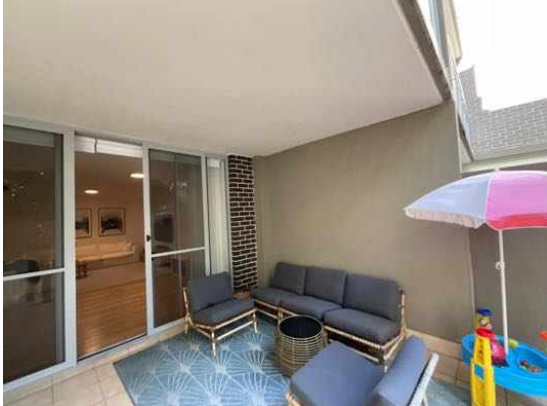
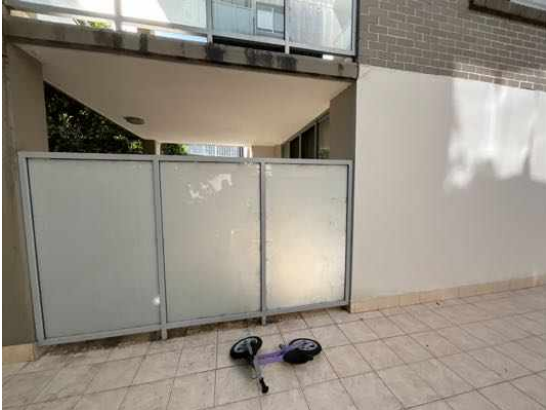
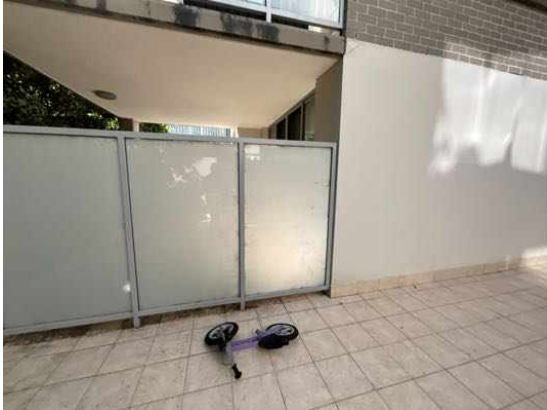
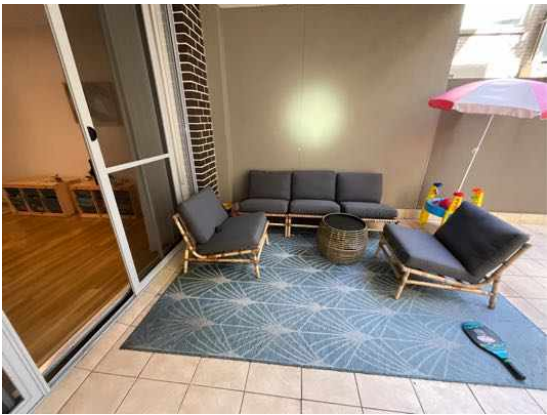
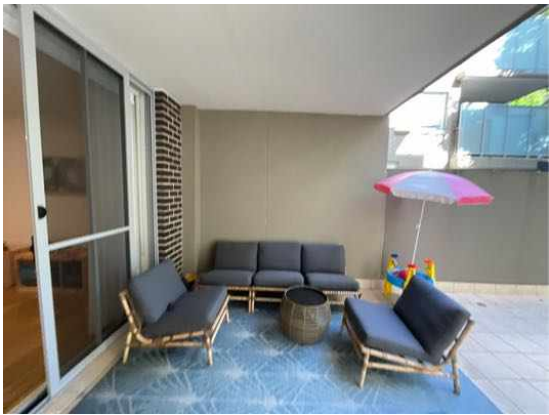
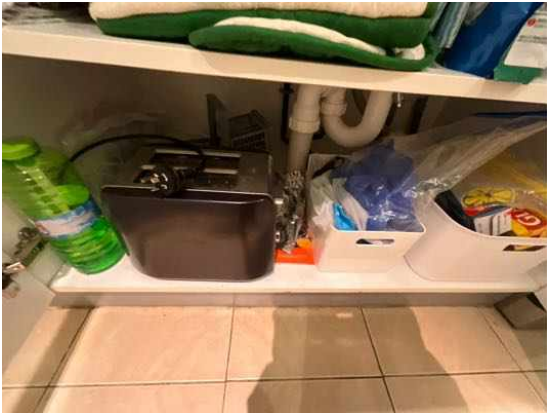
Building: Main Building
Location: All Areas
Finding: Additional Photos - Obstructions and Limitations
Information: These photographs are an indication of the obstructions and limitations which impeded full inspection of the property at the time of inspection. These obstructions can hide an array of defects and should be removed to allow full inspection to be carried out. A re-inspection is recommended once the areas are made accessible.
