Building and Timber Pest Inspection Report

Inspection Date: Tue, 17 Mar 2026

Property Address: 36 Simkin Dr, Benalla VIC 3672, Australia

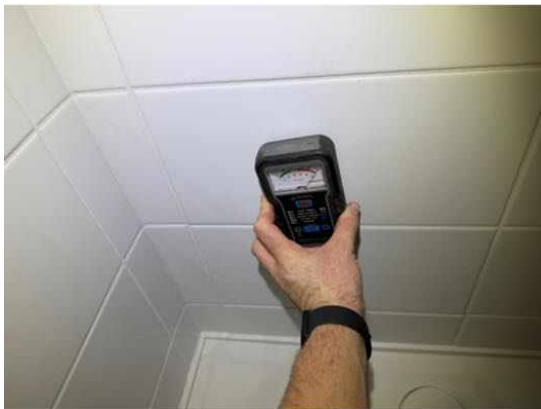
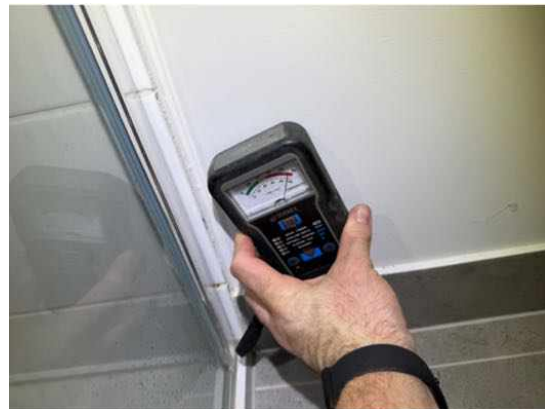
Finding 3.01

Building: Main Building
 Location: Main Shower
 Finding: Shower - High Moisture
 Information: It appears that high moisture is present at but not limited to, the base of the main shower walls. Potential causes of leaking include but are not limited to loose or damaged plumbing fittings and fixtures, and/or deteriorated seals or waterproofing.

Areas of leaking and high moisture create an environment conducive to termite activity. Recommend engaging a licensed plumber promptly, to identify the cause of the moisture and provide remedial works where necessary.

Evidence of high moisture was identified at but not limited to, the base of the main shower walls. Recommend engaging a licensed plumber promptly, to identify the cause of the moisture & provide remedial works where necessary.

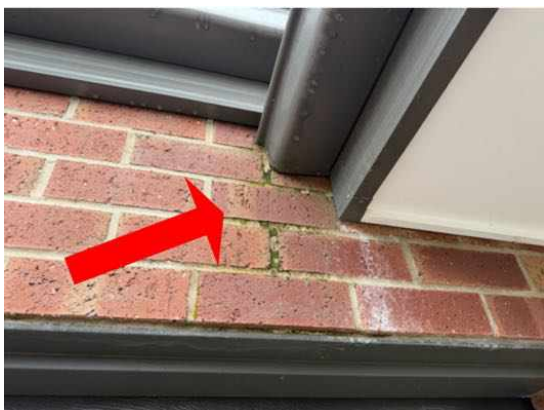
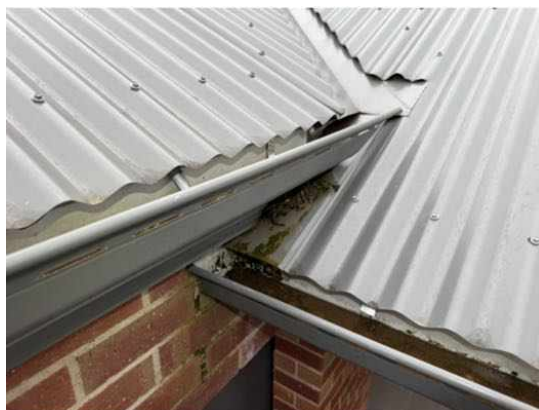
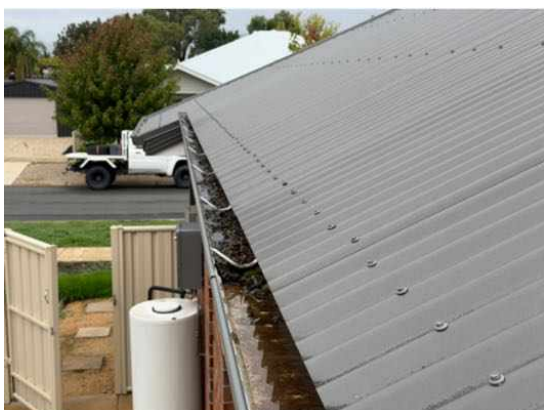
Finding 3.02

Building: Main Building
 Location: Gutters
 Finding: Gutters - Debris & Leak/Dripping
 Information: It appears that the gutter at, but not limited to the front elevation was leaking / dripping. Some debris was also noted in areas of the gutters.

Recommend engaging a licensed roof plumber to provide further advice & maintenance works where necessary. Debris should be removed from the gutters to avoid blockages overtime.

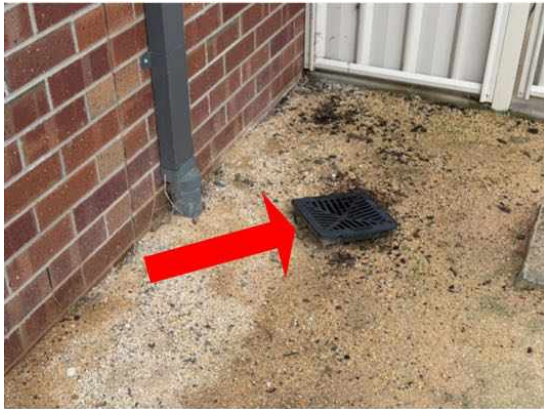
Finding 3.03

Building:	Main Building
Location:	External Areas
Finding:	Potential Water pooling - against property
Information:	Potential areas of water pooling around the perimeter of the property were identified. It appears the stormwater pit is higher than the ground level.

Where insufficient site drainage is present, water pooling is likely to occur, and can create areas conducive to timber pests. Recommend consulting with a licensed plumber and/or landscaping contractor to provide further advice.

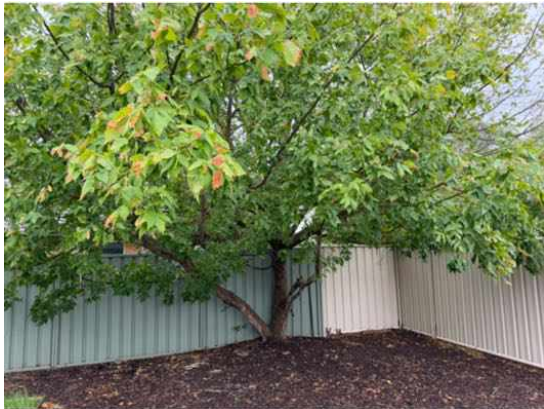
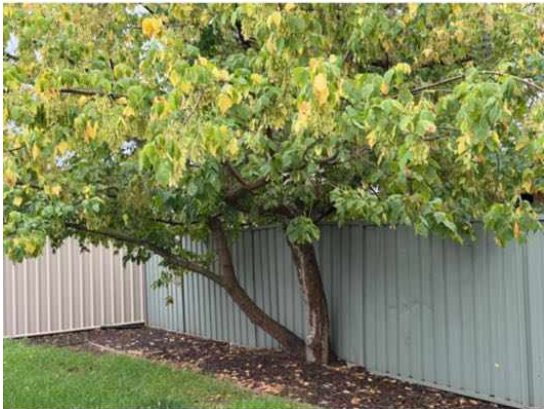
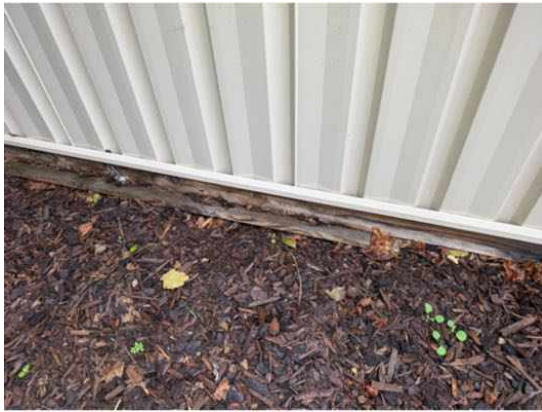
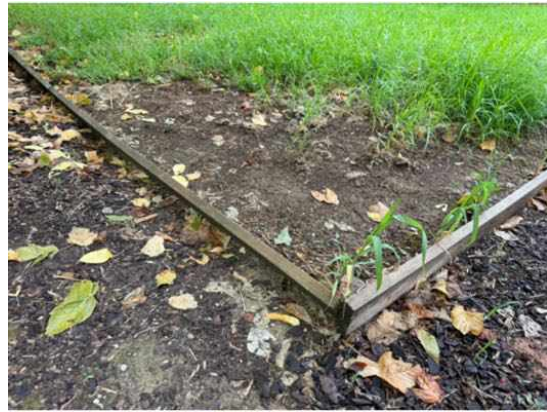
Finding 6.01

- Building: Main Building
- Location: All External Areas
- Finding: Timber in direct ground contact & trees - conducive to termites
- Information: Where timber materials are in direct contact with the ground and consequently moisture, they become conducive to termite activity. The landscaping timbers, and trees surrounding the building create an environment conducive to termite activity.

Where feasible, any timbers in direct contact with the ground should be removed and any trees in close proximity to the building should be inspected at least annually to reduce the risk of termite infestation & detect any early signs of termite activity.

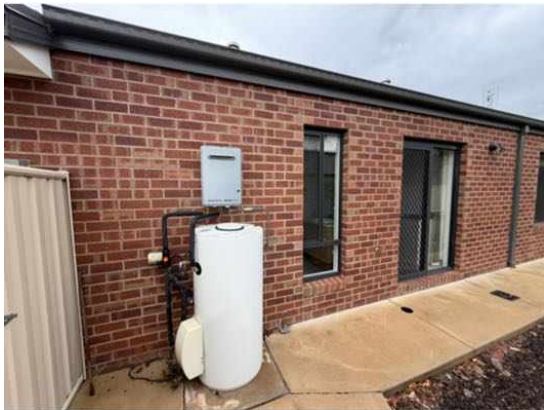
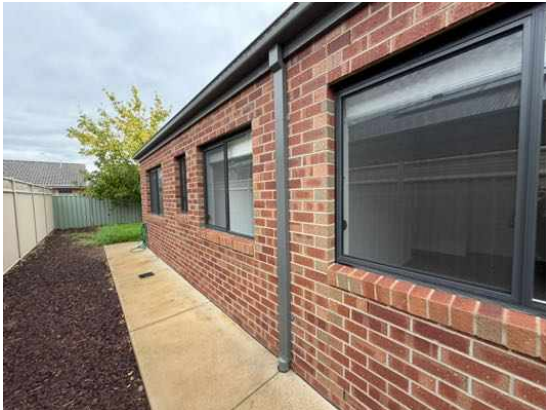
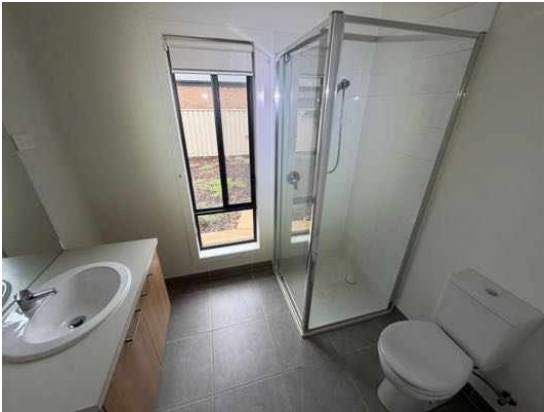
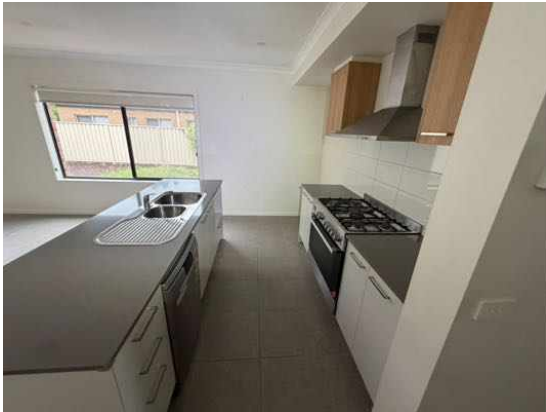
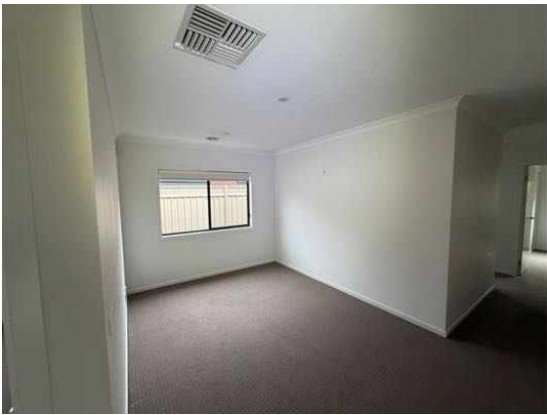
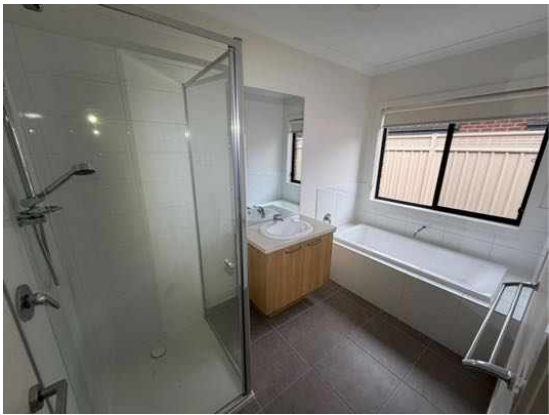
Building: Main Building
Location: All Areas
Finding: Additional Photos - Obstructions and Limitations
Information: These photographs are an indication of the obstructions and limitations which impeded full inspection of the property at the time of inspection. These obstructions can hide an array of defects and should be removed to allow full inspection to be carried out. A re-inspection is recommended once the areas are made accessible.

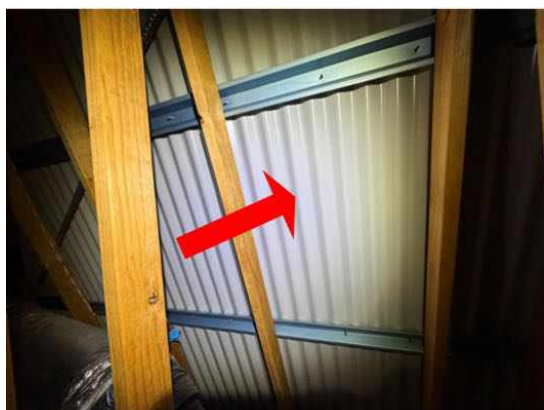
Building: Main Building
 Location: Roof Void
 Finding: Sarking - Not Present
 Information: It is noted for your information that sarking has not been installed on the roof. Sarking is a laminated aluminium foil applied to the interior of the roof covering, assists in insulating the property and acting as a vapour-barrier to the roof void.

The client can consult with a licensed roofing contractor at their discretion, to provide further advice.

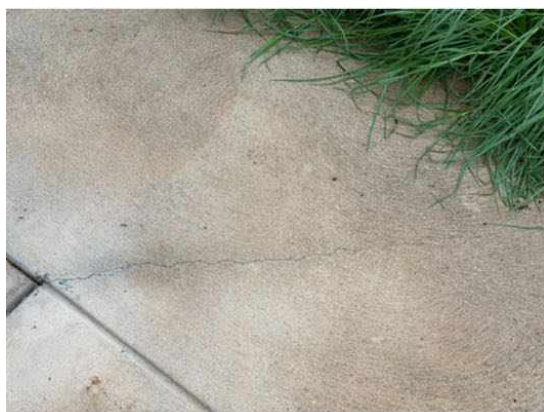
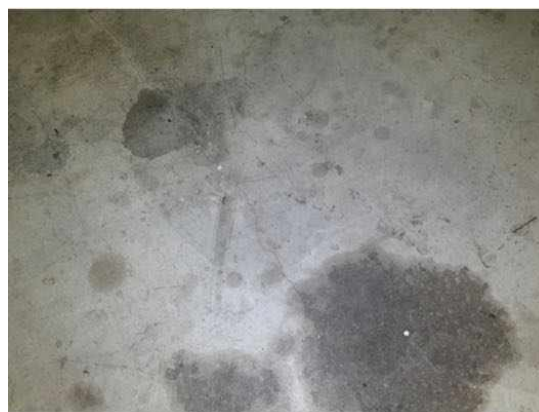
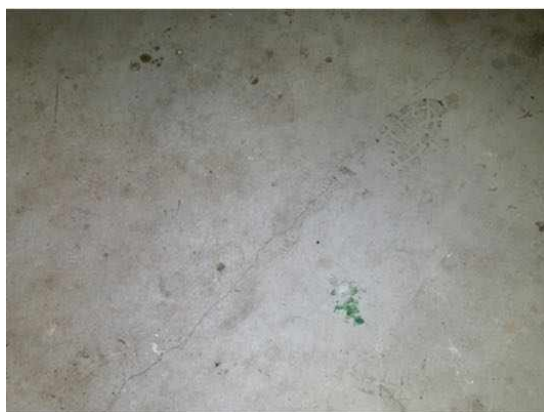
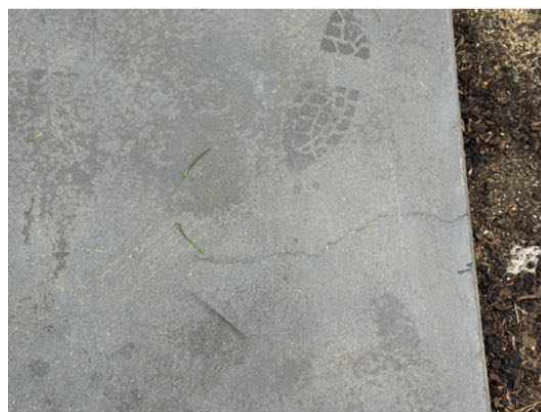
Building: Main Building
 Location: Pavement, Garage Slab
 Finding: Cracking - Garage Slab
 Information: Minor hairline cracking was identified to the garage slab and pavement. This type of cracking is common, and can be caused by general movement over time or “settling” of the building after construction.

The client should monitor the cracking. Should the cracking widen, lengthen or become more numerous, a concrete specialist should be engaged for further evaluation.

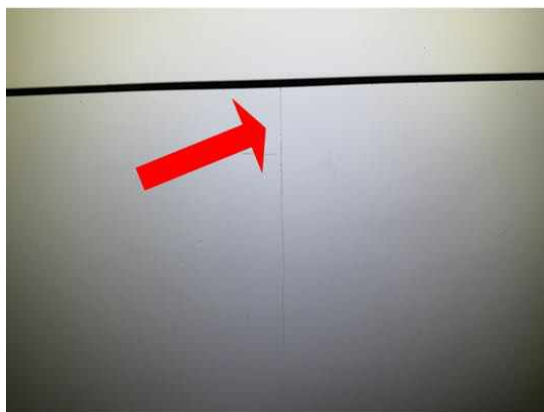
Building: Main Building
 Location: Dining room
 Finding: Plaster - Minor Cracking
 Information: There appears to be minor hairline cracking to some areas of the wall linings. Cracking of this type is common in buildings of a similar age.

Although this is mostly a visual defect, it is advised that the client monitor the area.

Should cracking widen, lengthen, or become more numerous, the client should consult with their building inspector to provide further advice.

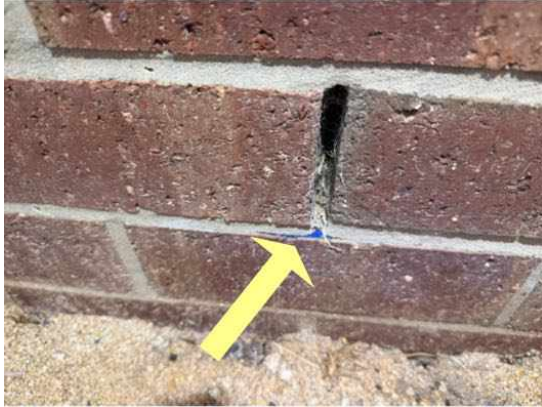
Building: Main Building
 Location: Brickwork
 Finding: Evidence of a previous termite management system
 Information: Although a durable notice was not present in the meter box, it appears that a physical

termite barrier has been installed. This barrier prevents concealed termite entry into the building and forces termites out into the open.

Recommend consulting with the pest control company that installed the barrier to provide further advice regarding the system and a future termite management plan. Regular 12 monthly inspections should be conducted by a qualified termite inspector, to identify any timber-pest activity.
